Township 8S, Range 39E
SECTION 13

Cliff Features

Revised 4/06; Reference – South Fork Extension Amendment #00174

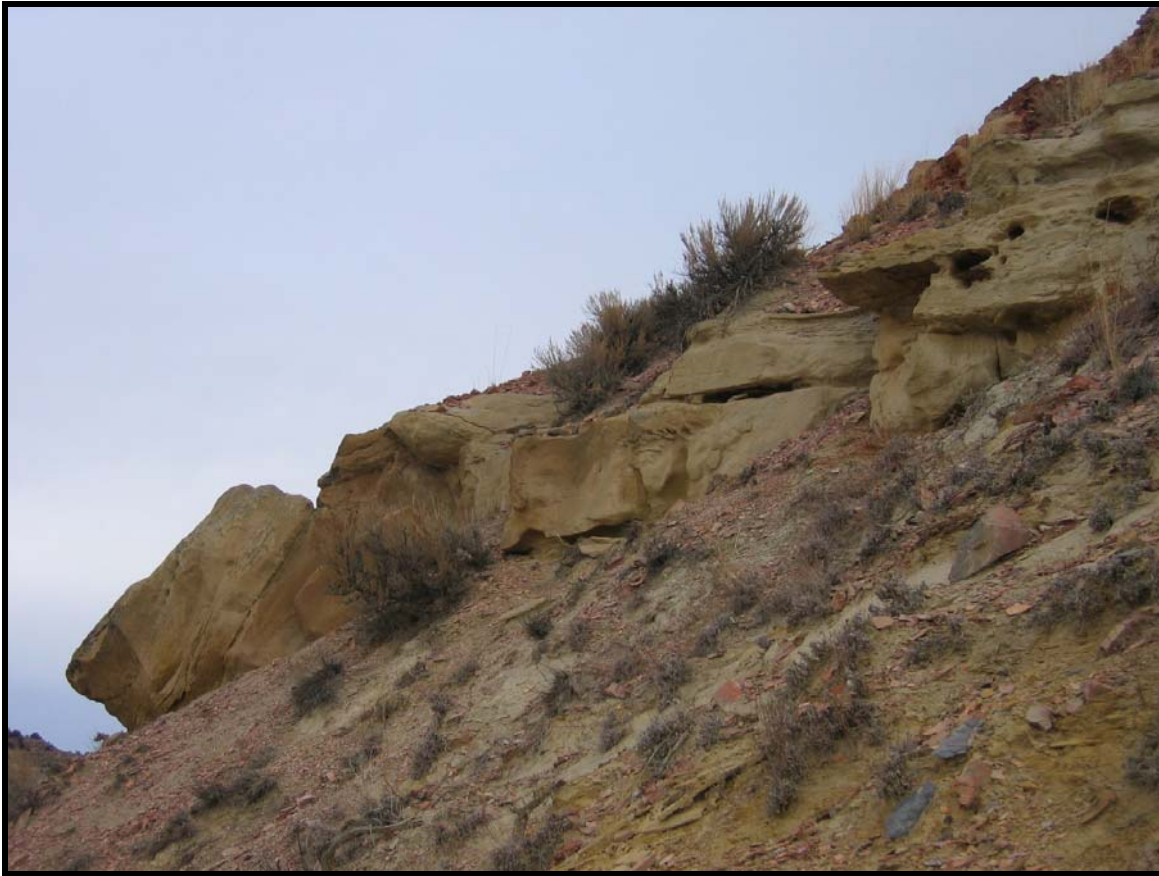
CLIFF FEATURE: C_0057

DESCRIPTION OF FEATURE: The cliff feature shown above has a solid sandstone/siltstone rock face that is approximately 10 feet tall. The feature sits on sandy silt soil that contains small pieces of scoria. This cliff overlooks riparian feature R_0058.

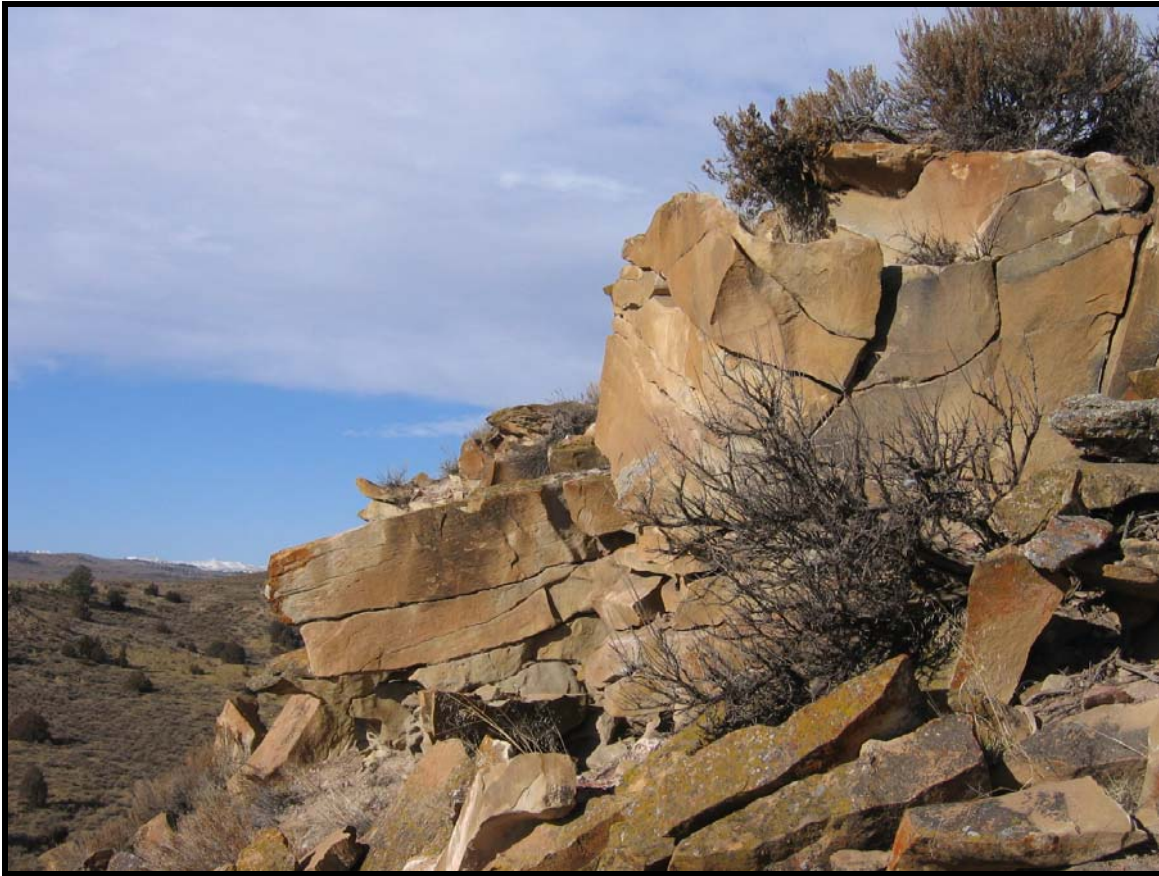
CLIFF FEATURE: C_0058

DESCRIPTION OF FEATURE: The cliff feature shown above has a fractured sandstone/siltstone rock face that is approximately 20 feet tall. The feature sits on sandy silt soil and overlooks the Spring Creek drainage.

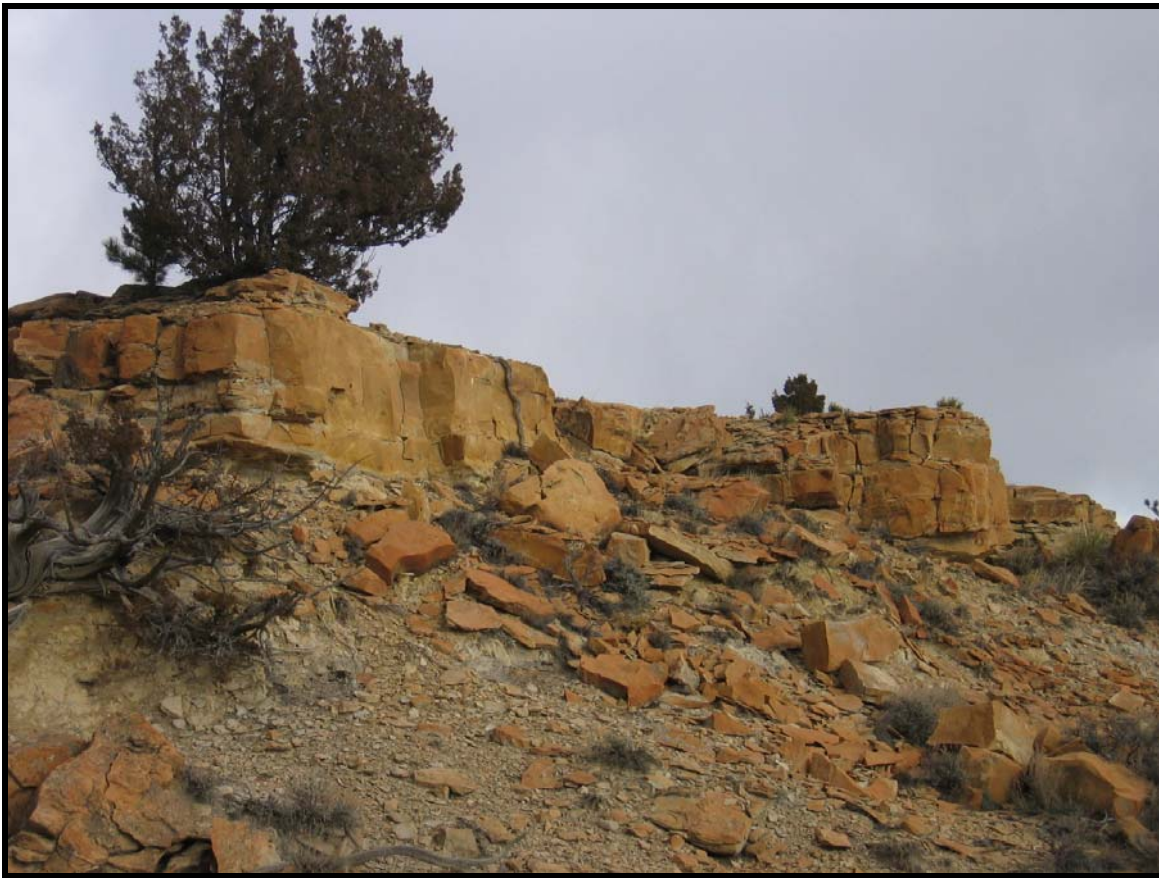
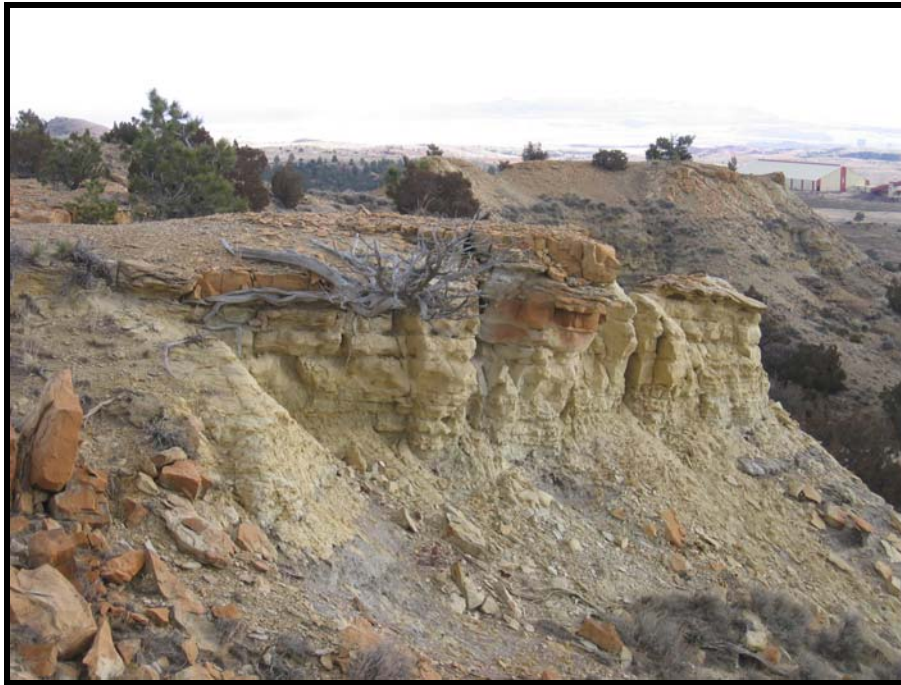
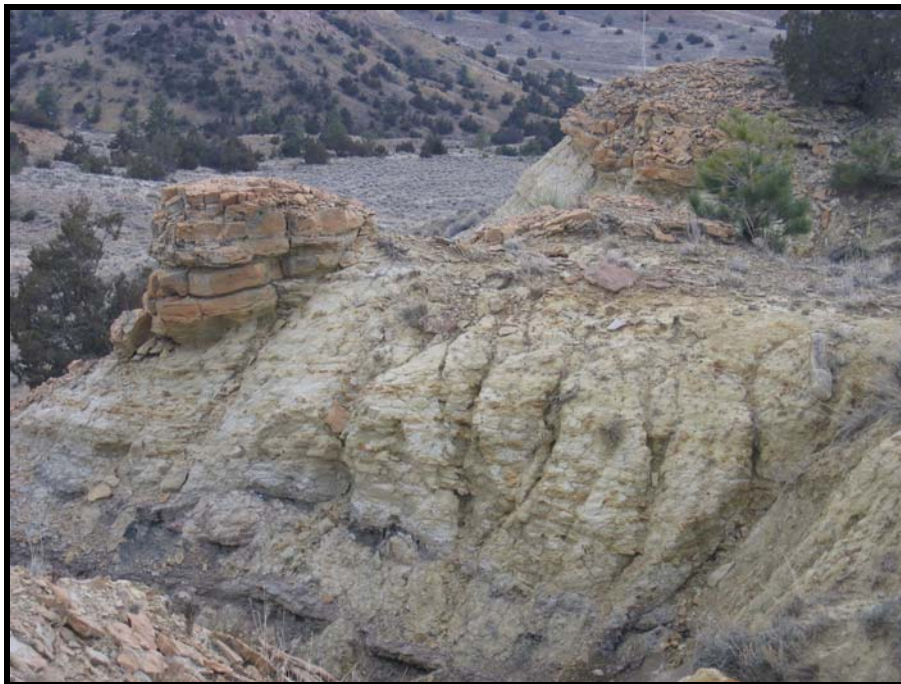
CLIFF FEATURE: C_0060

DESCRIPTION OF FEATURE: The cliff feature shown above is composed of hard sandstone/siltstone rock and sits on a highly erosive sandy silt soil. The feature stands about 10 ft tall along the top of a southern facing slope. See the pictures on the next page for additional views of this feature.

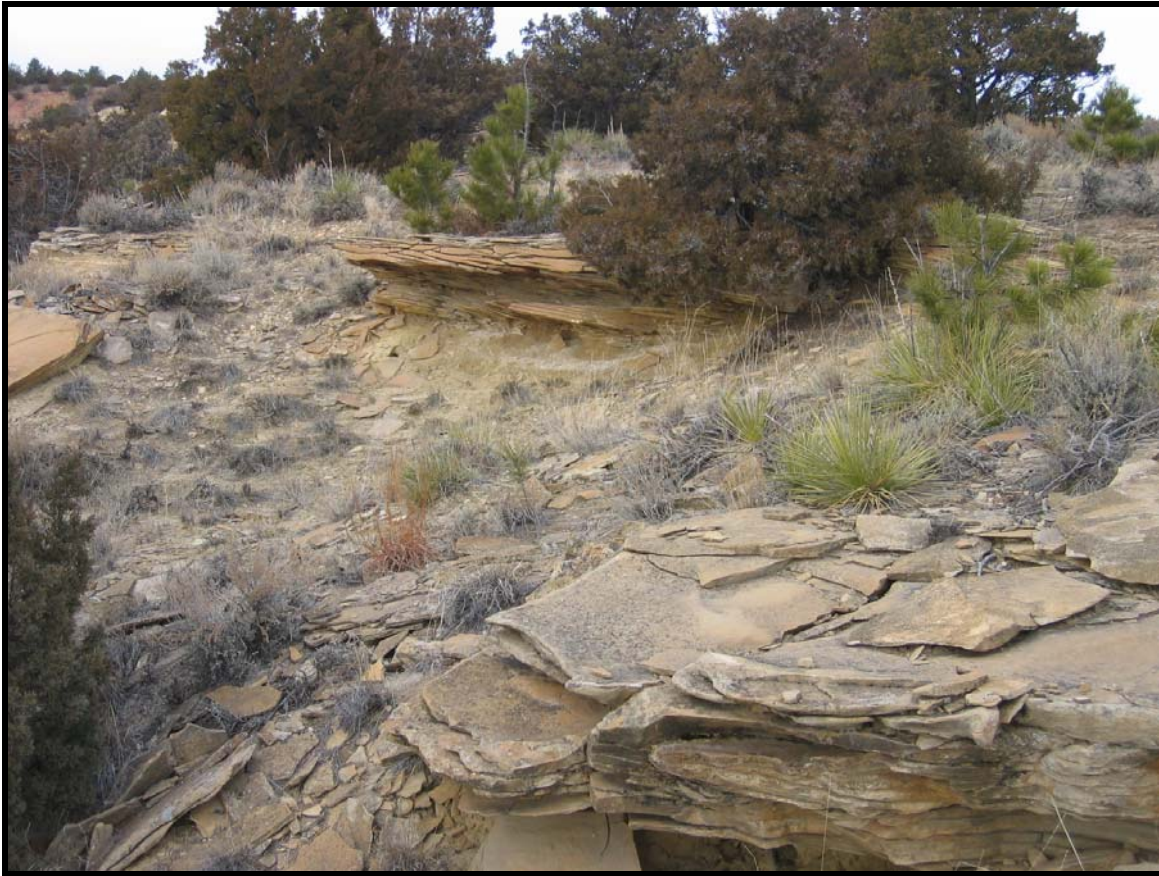
ROCK OUTCROP FEATURE: RO_0234

FEATURE TYPE:	Rock Outcrop		
GEOMETRIC DIMENSIONS:	Length: 285 ft	Width: 20 ft	
LOCATION:	Township: 8S	Range: 39E	Section: 13
HANDHELD GPS POINTS:	Northing	Easting	
	15042	425441.31	2668684.28
	15043	425201.92	2668839.19
SUBSTRATE:	Sandstone/siltstone		
EXPOSURE:	Southern facing slope		
DESCRIPTION OF FEATURE:	The rock outcrop shown above is located at the top of a small hill. The weathered, layered rocks sit on highly erosive, sandy silt. This soil has eroded, leaving overhangs beneath the rocks.

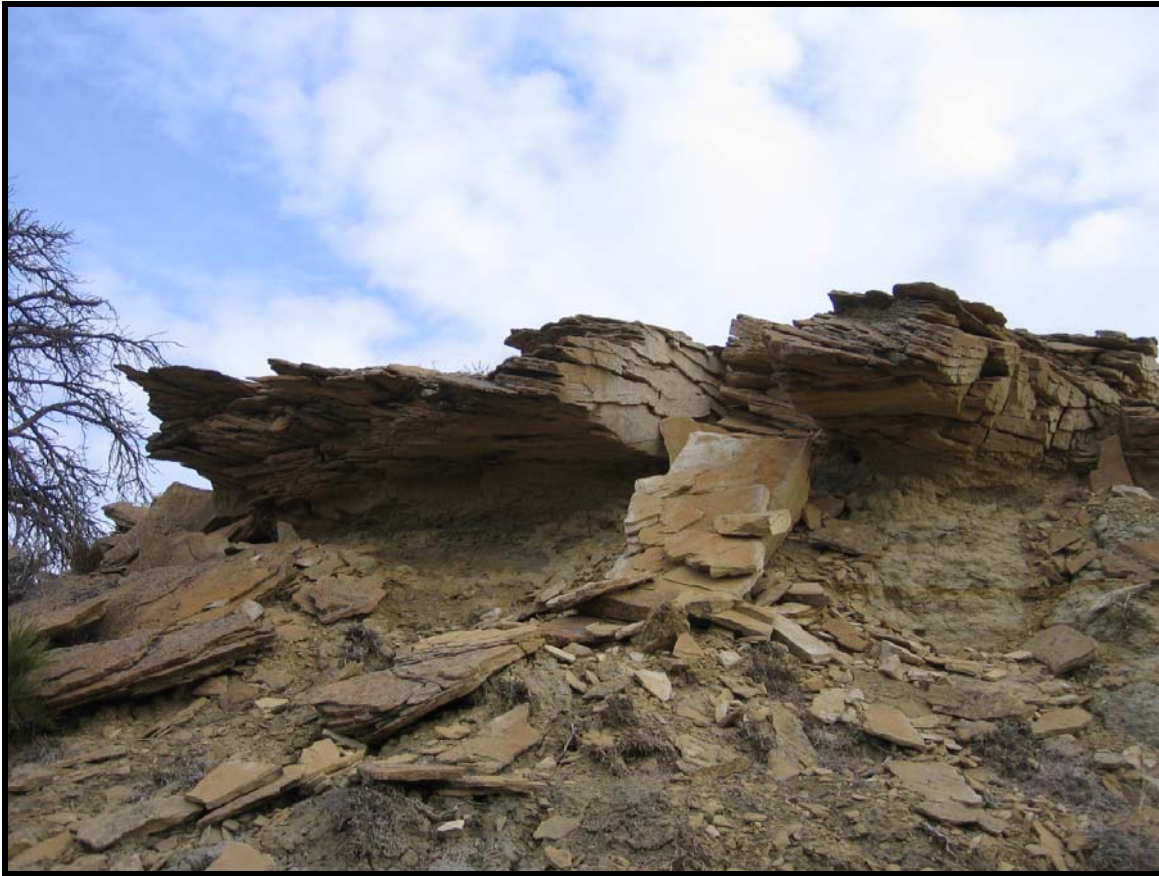
ROCK OUTCROP FEATURE: RO_0235

FEATURE TYPE:	Rock Outcrop		
GEOMETRIC DIMENSIONS:	Length: 120 ft	Height: 5 ft	
LOCATION:	Township: 8S	Range: 39E	Section: 13
HANDHELD GPS POINTS:	Northing	Easting	
	15044	424965.53	2669086.96
	15045	424925.39	2669199.28
SUBSTRATE:	Sandstone/siltstone		
EXPOSURE:	Southern facing slope		
DESCRIPTION OF FEATURE:	The rock outcrop shown above is located at the top of a small hill. The weathered, layered rocks sit on highly erosive, sandy silt. This soil has eroded, leaving overhangs beneath the rocks. The rocks in this outcropping are very thin.

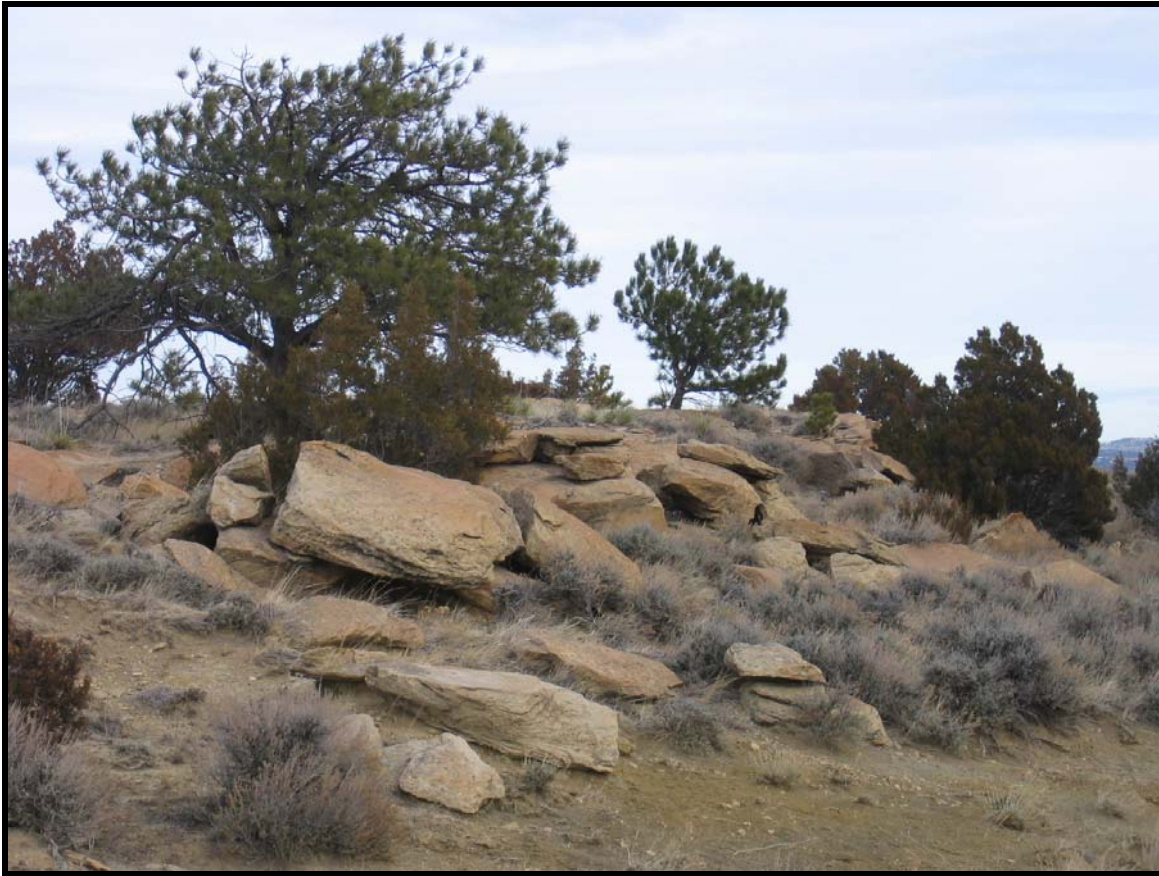
ROCK OUTCROP FEATURE: RO_0236

DESCRIPTION OF FEATURE: The rock outcrop shown above is located on a relatively flat hilltop. The rocks are rounded and large over the length of this feature. The surrounding vegetation includes grass, sagebrush, and trees.

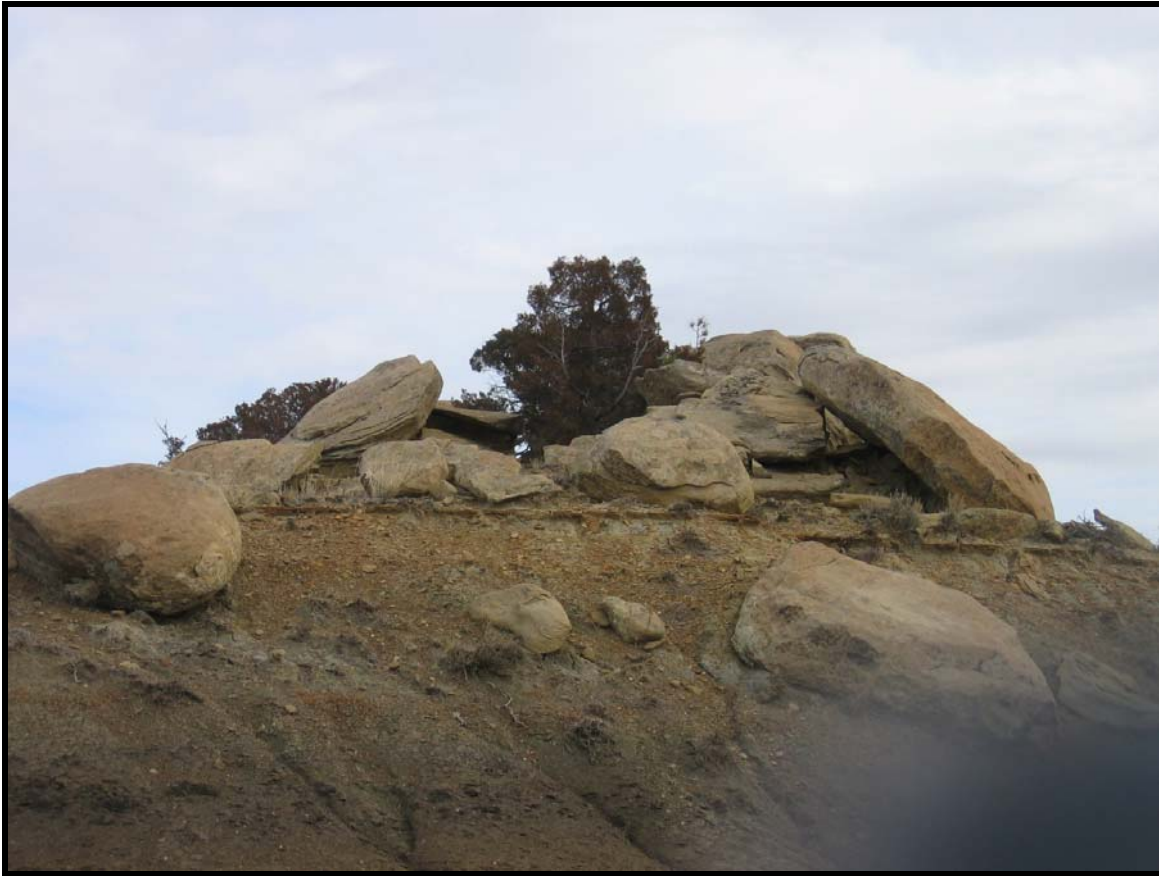
ROCK OUTCROP FEATURE: RO_0237

DESCRIPTION OF FEATURE: The rock outcrop shown above is located on a hill composed of highly erosive, sandy silt soil. Due to the layout of the large, rounded rocks, there are voids between and below the rocks.

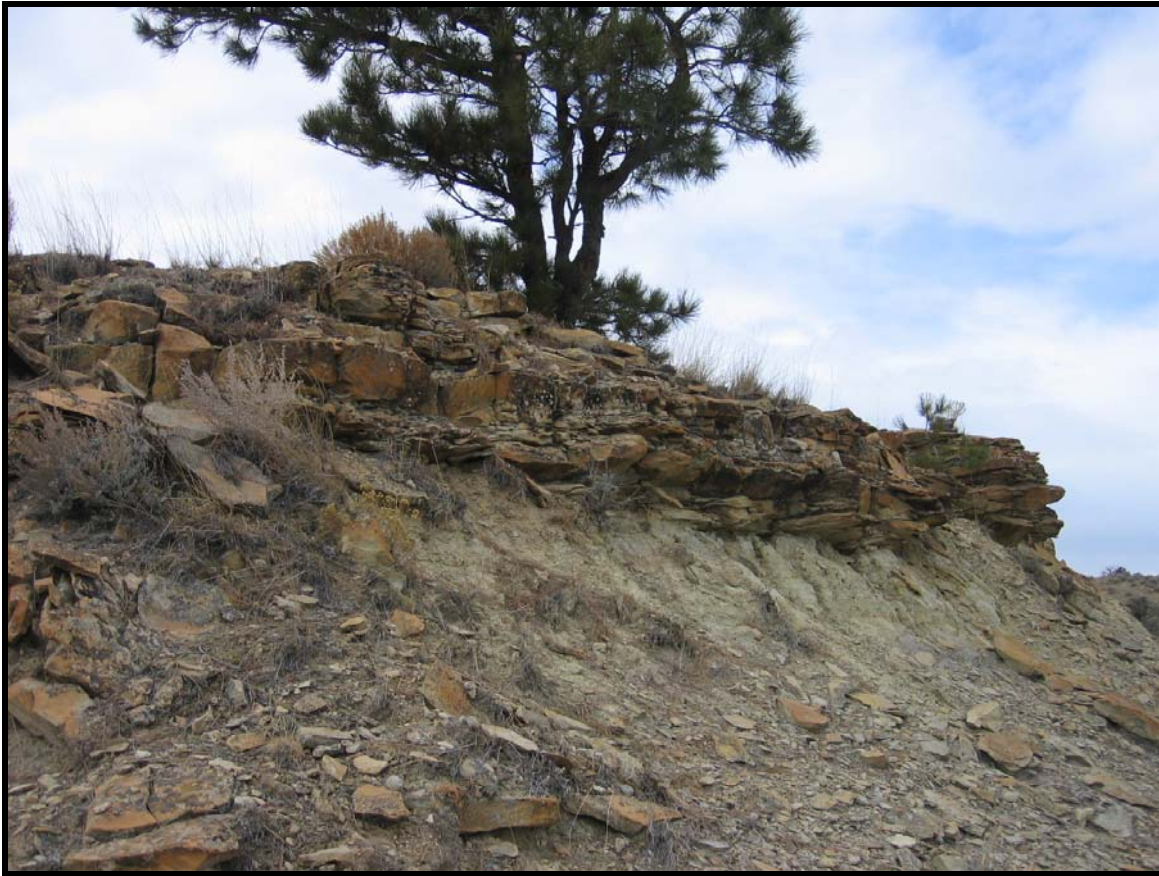
ROCK OUTCROP FEATURE: RO_0238

DESCRIPTION OF FEATURE: The rock outcrop shown above is located on a hill composed of highly erosive, sandy silt soil. The sandstone/siltstone rocks in this feature are layered and very weathered. There are areas where overhangs have been created beneath the rocks due to erosion of the subsoil.

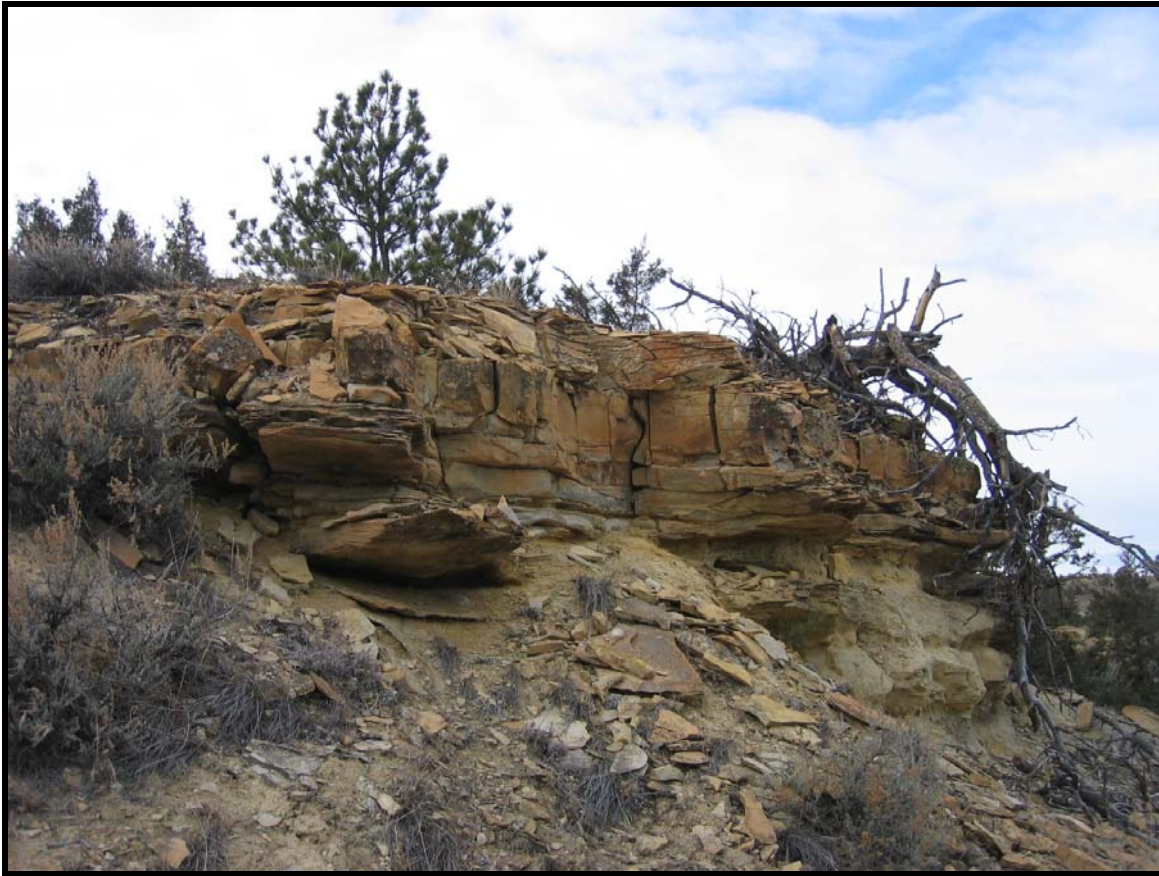
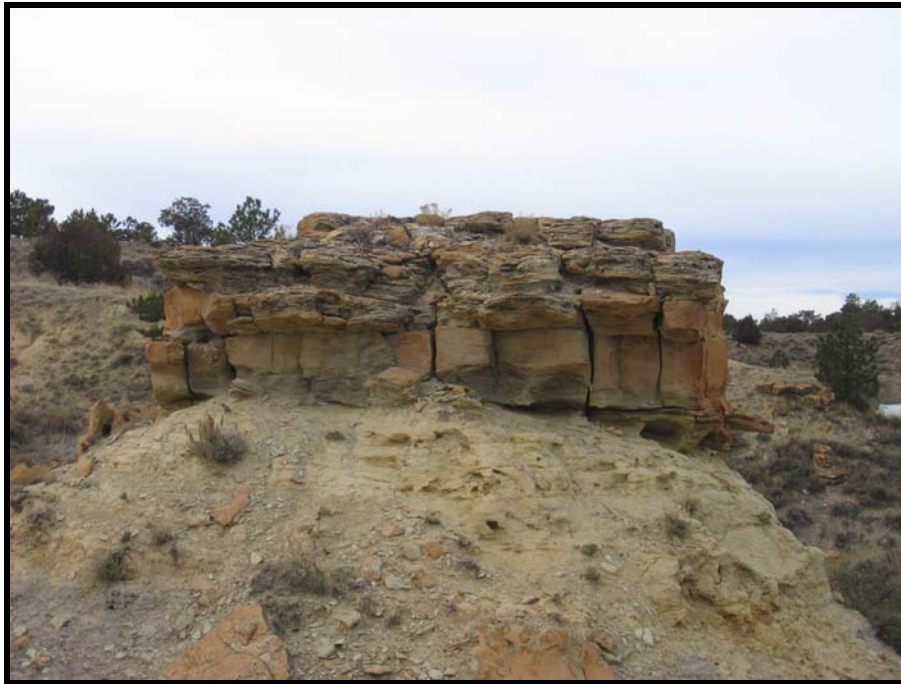
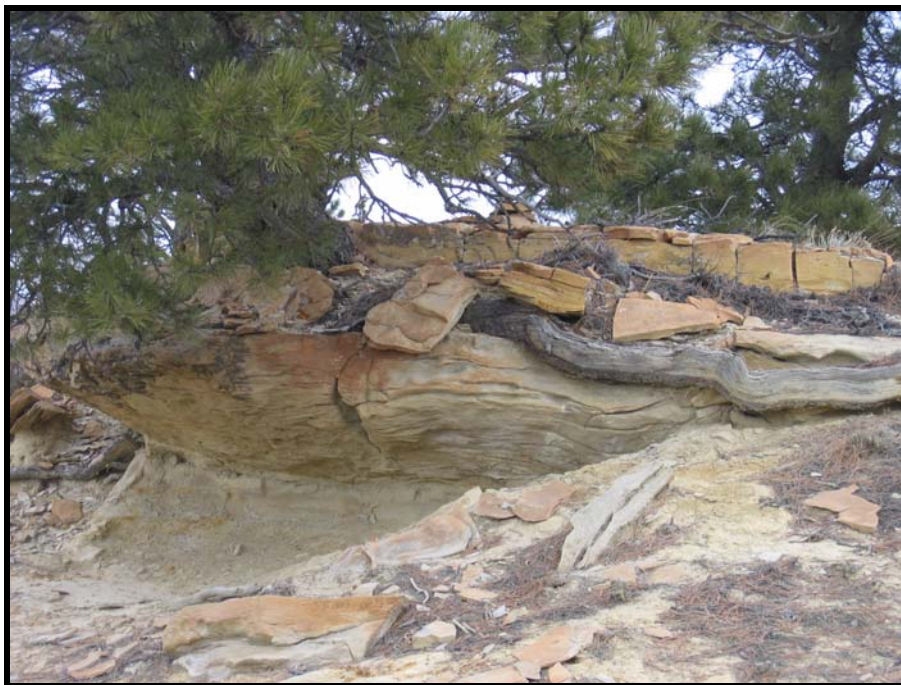
ROCK OUTCROP FEATURE: RO_0239

DESCRIPTION OF FEATURE: The rock outcrop shown above is located on a highly erosive, sandy silt soil. The sandstone/siltstone rocks in this feature are layered and very weathered. There are areas where overhangs have been created beneath the rocks due to erosion of the subsoil. See the pictures on the next page for additional views of this feature.

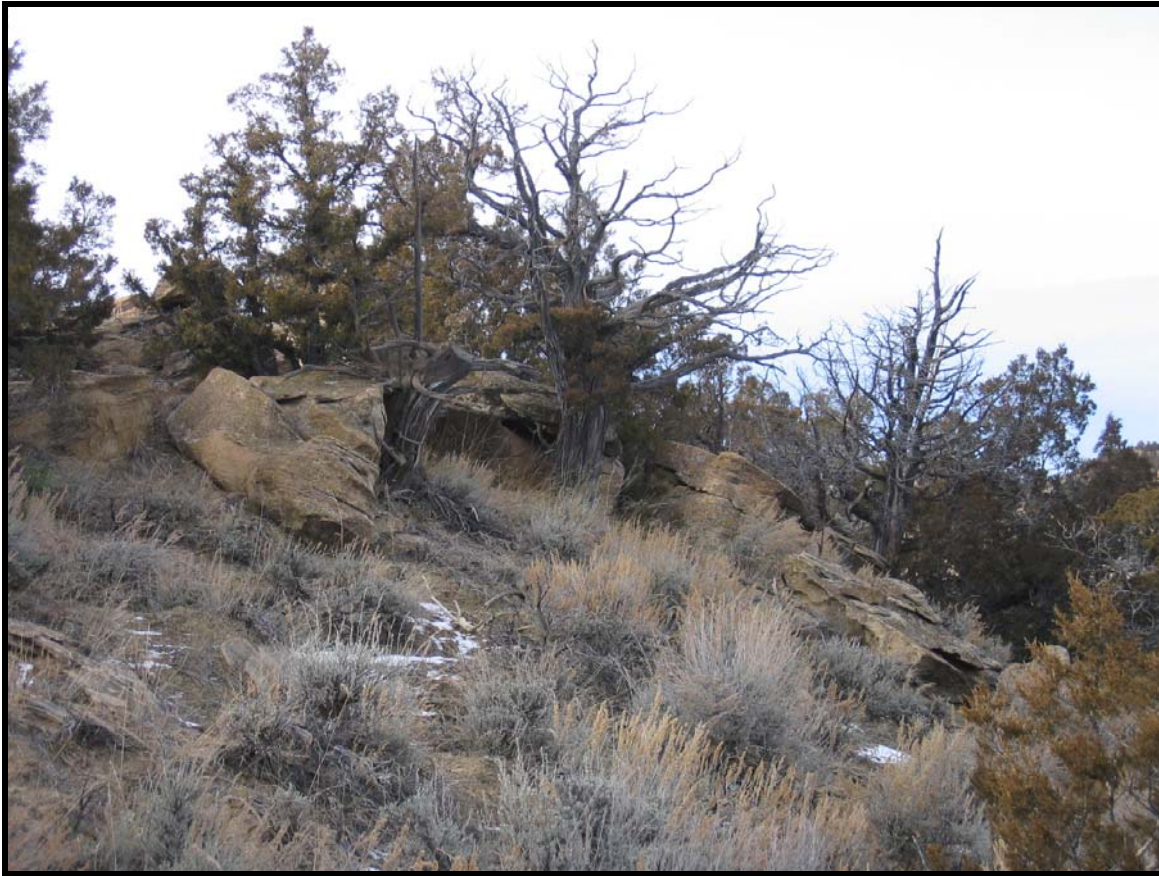
ROCK OUTCROP FEATURE: RO_0240

DESCRIPTION OF FEATURE: The rock outcrop shown above is located on a northern slope vegetated with grass, sagebrush and trees. The rocks are low-lying and weathered. This feature also falls into Section 14 but the majority of the area was in Section 13.

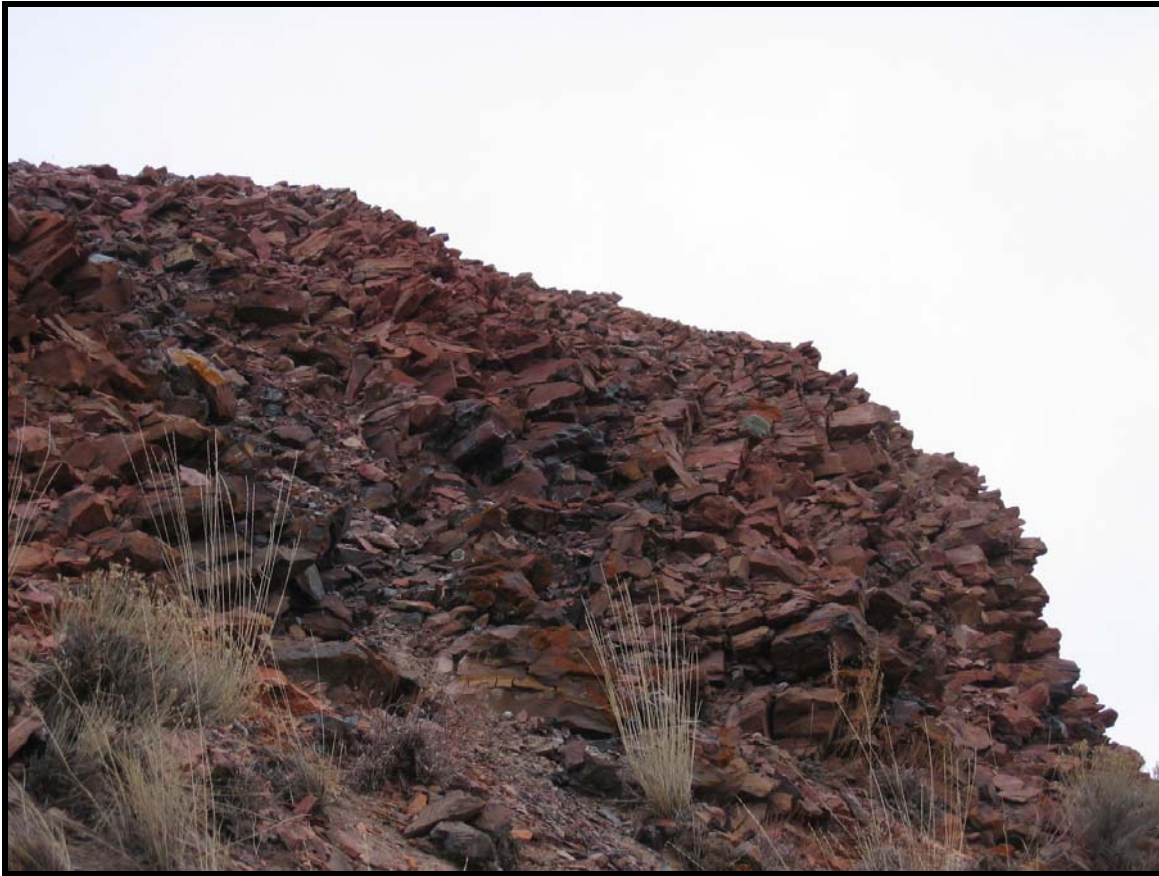
ROCK OUTCROP FEATURE: RO_0247

DESCRIPTION OF FEATURE: The rock outcrop shown above consists of scoria that sits at the top of a steep (greater than 3H:1V) slope. The face of the feature is jagged and fractured. This feature overlooks riparian feature R_0058.

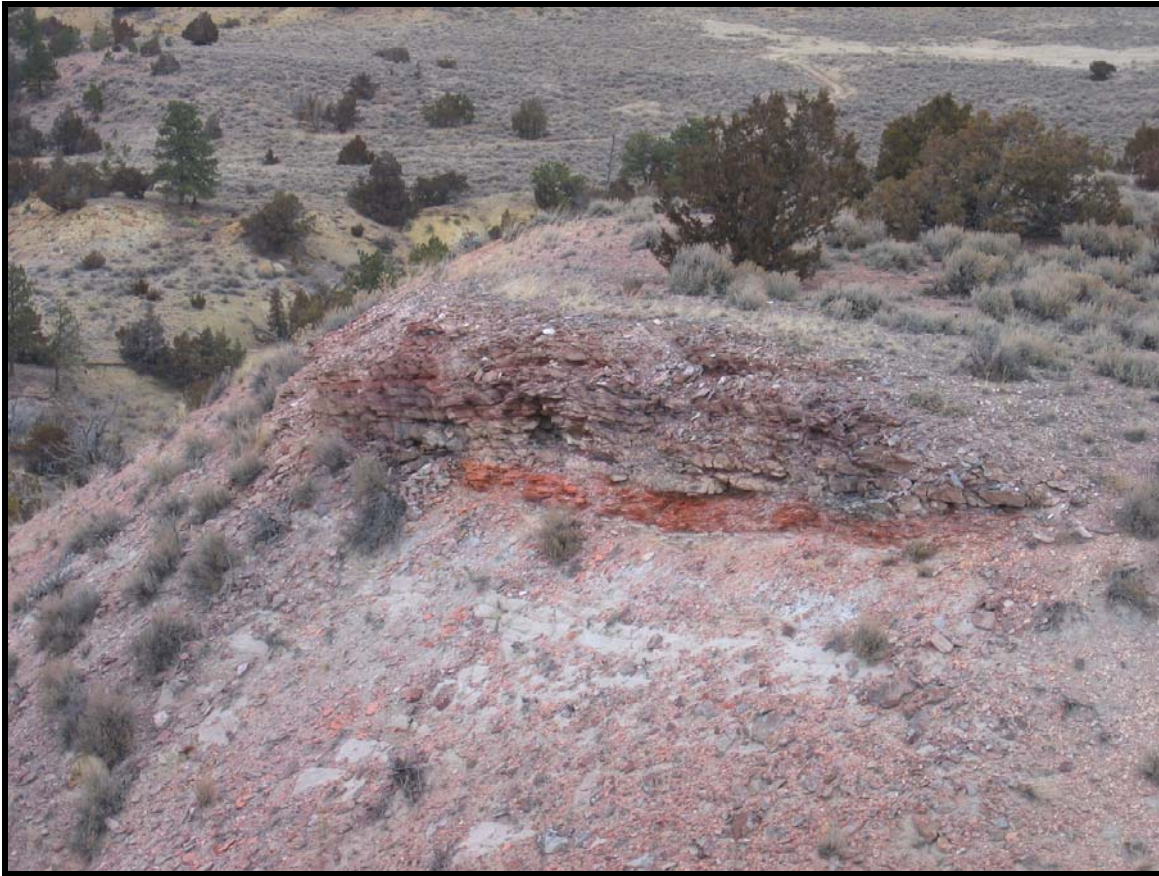
ROCK OUTCROP FEATURE: RO_0248

DESCRIPTION OF FEATURE: The rock outcrop shown above consists of scoria that sits at the top of a steep (greater than 3H:1V) slope. The face of the feature is jagged and fractured. This feature overlooks riparian feature R_0058.

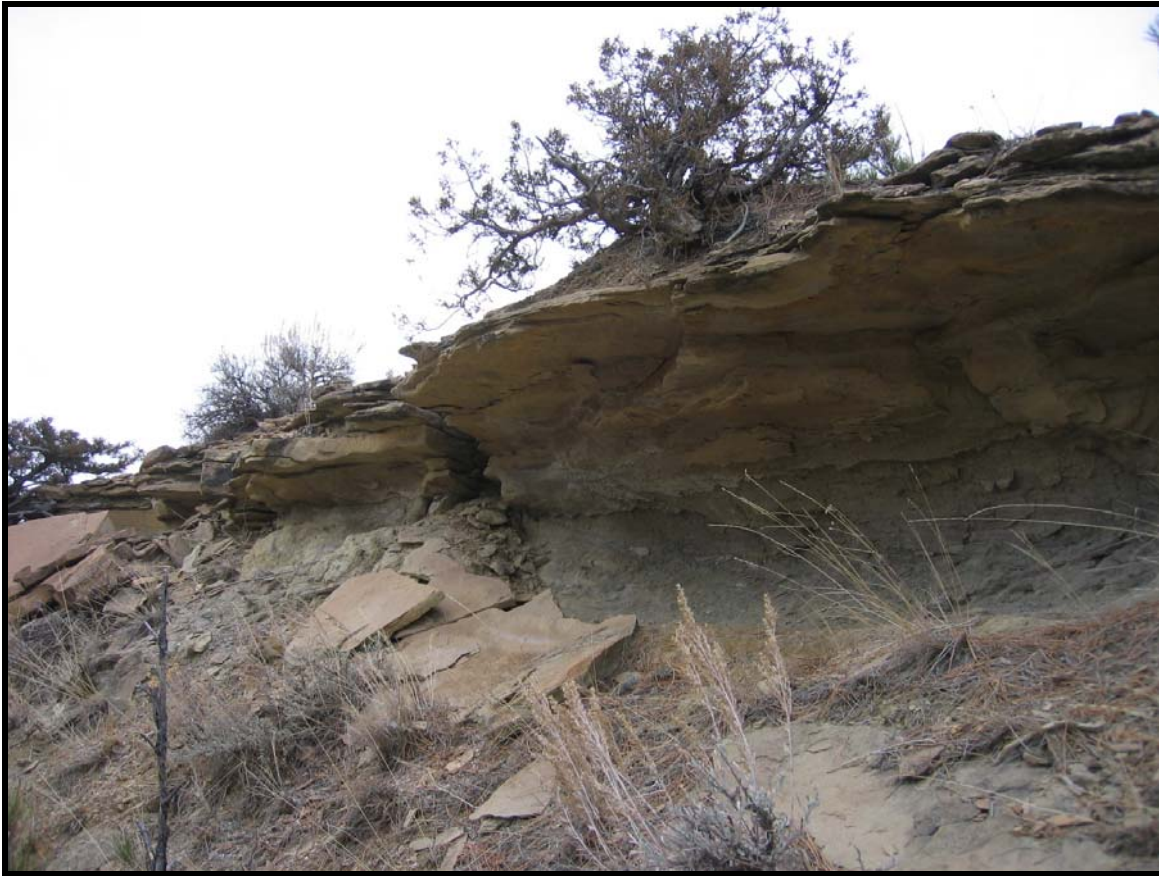
ROCK OUTCROP FEATURE: RO_0249

DESCRIPTION OF FEATURE: Rock outcrops like the one shown above are very common in this area. The rock layer is composed of layered sandstone/siltstone, which is embedded within a sandy silt soil. The soil beneath the rock layer has eroded, leaving an overhang.

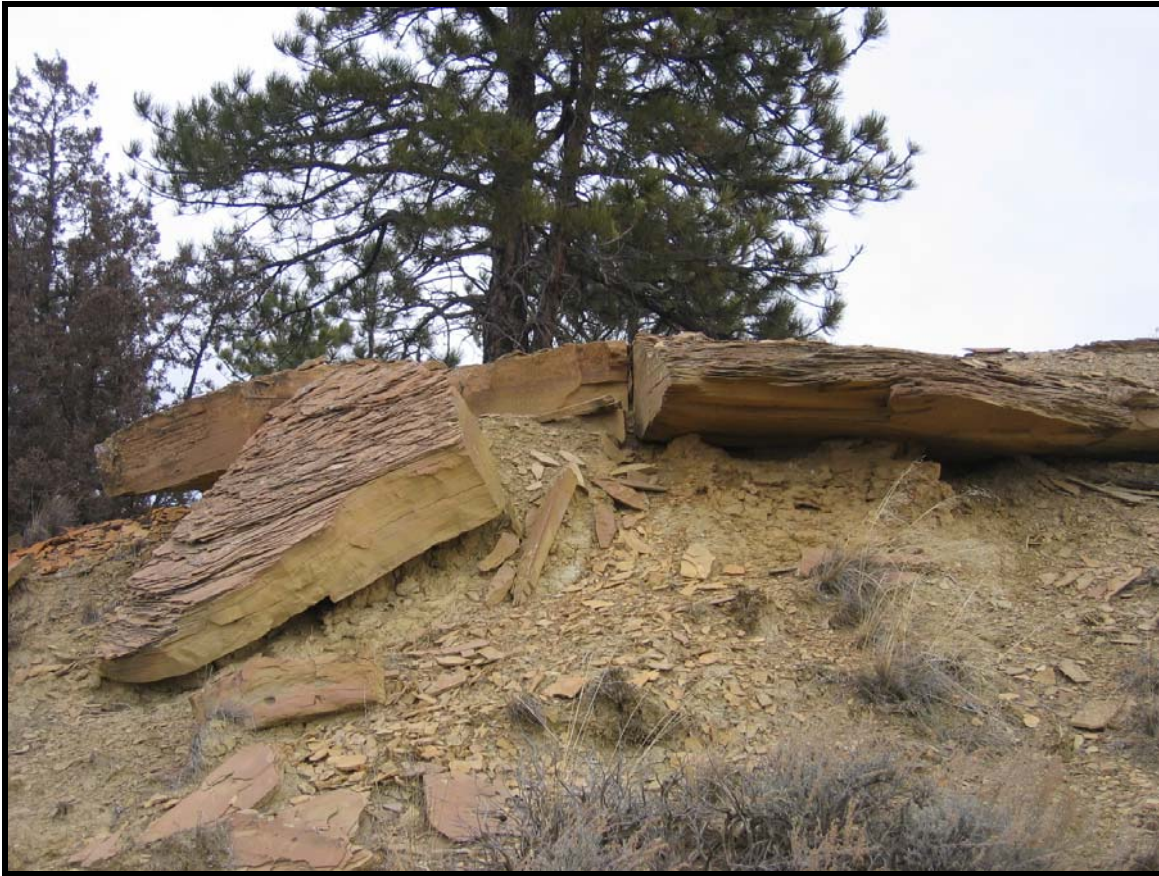
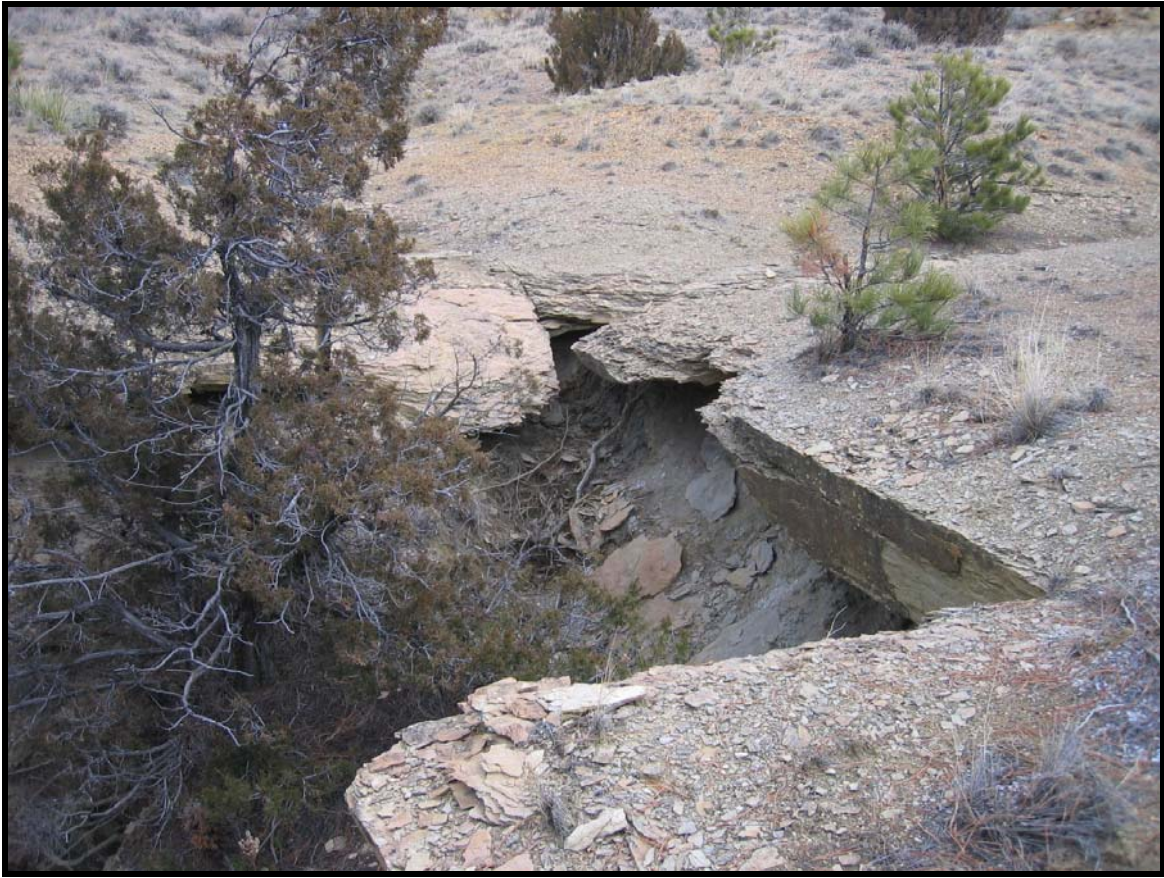
ROCK OUTCROP FEATURE: RO_0250

DESCRIPTION OF FEATURE: Rock outcrops like the one shown above are very common in this area. The rock layer is composed of layered sandstone/siltstone, which is embedded within a sandy silt soil. The soil beneath the rock layer has eroded, leaving an overhang. This feature also intersects a small draw. See the picture on the next page for another view of this feature.

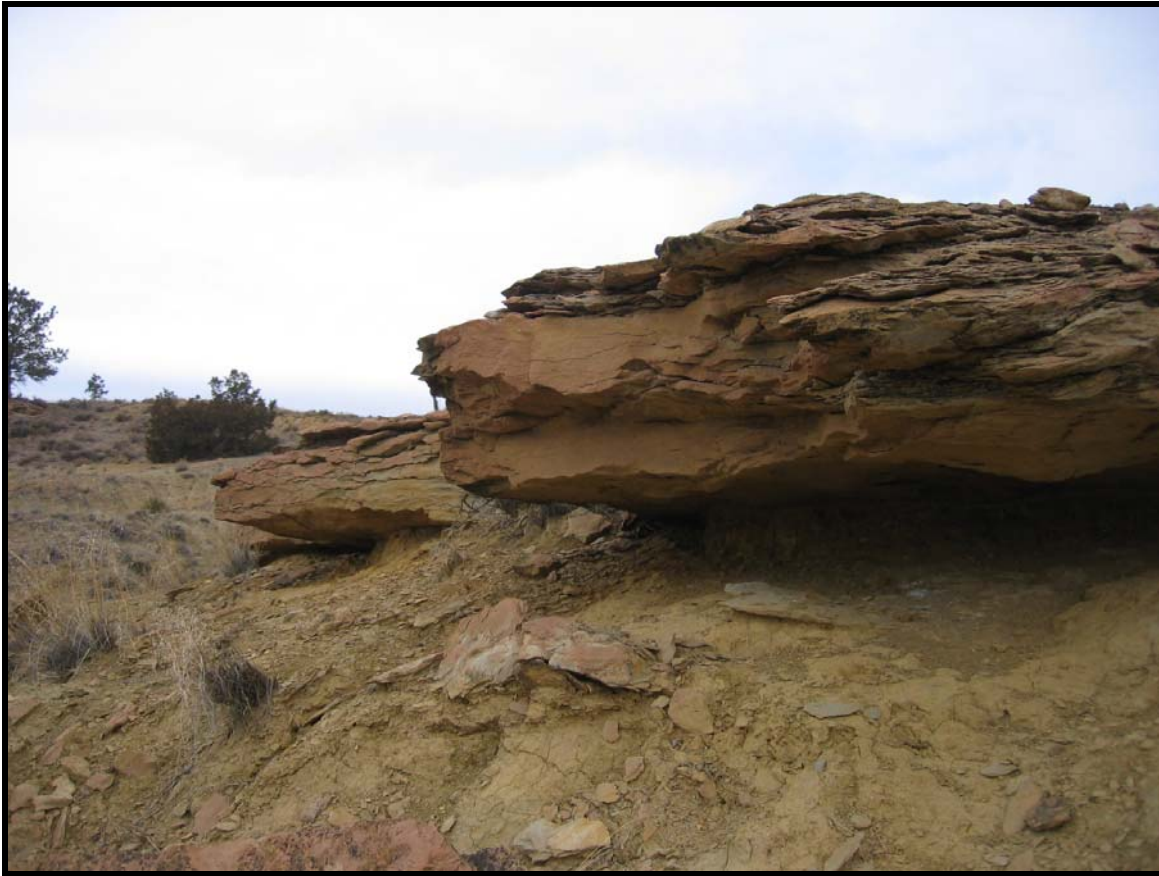
ROCK OUTCROP FEATURE: RO_0251

FEATURE TYPE:	Rock Outcrop		
GEOMETRIC DIMENSIONS:	Length: 90 ft	Height: 5 ft	
LOCATION:	Township: 8S	Range: 39E	Section: 13
HANDHELD GPS POINTS:	Northing	Easting	
	16021	422161.18	2671251.31
	16022	422243.82	2671212.47
SUBSTRATE:	Sandstone/siltstone		
EXPOSURE:	Southern facing slope		
DESCRIPTION OF FEATURE:	Rock outcrops like the one shown above are very common in this area. The rock layer is composed of layered sandstone/siltstone, which is embedded within a sandy silt soil. The soil beneath the rock layer has eroded, leaving an overhang. This feature overlooks a small draw.

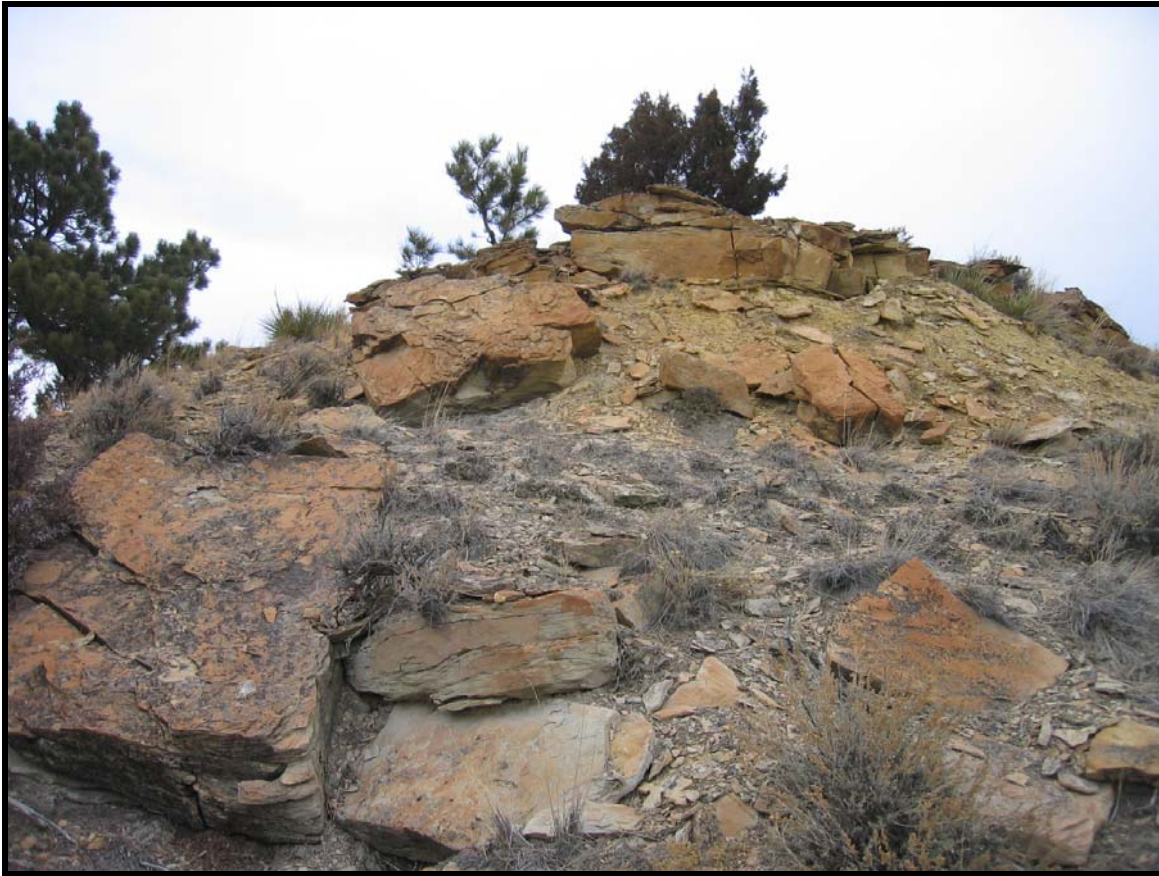
ROCK OUTCROP FEATURE: RO_0252

DESCRIPTION OF FEATURE: The rock outcrop shown above is located at the top of a small hill that consists of sandy silt soil. The sandstone/siltstone rocks are thin and layered. Sparse grass, sagebrush, and some small trees vegetate the area around this feature.

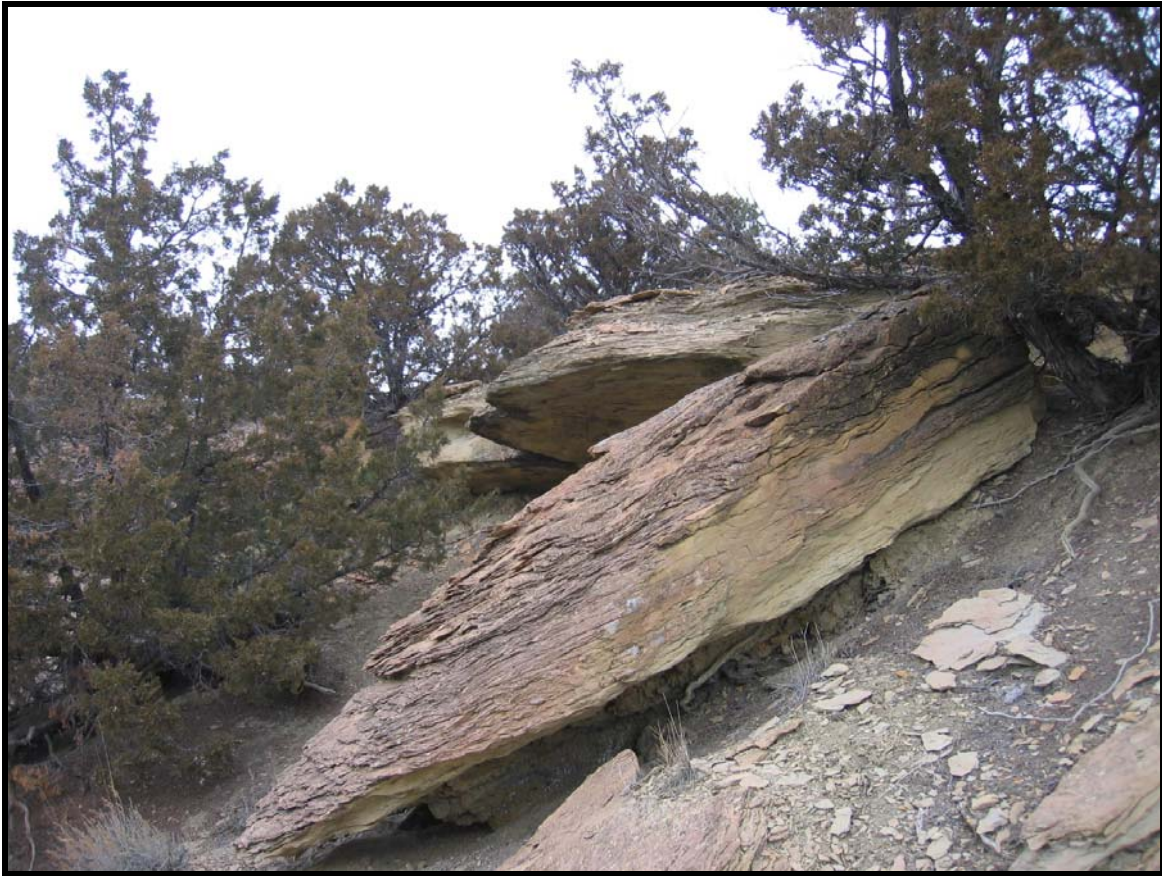
ROCK OUTCROP FEATURE: RO_0253

DESCRIPTION OF FEATURE: The rock outcrop feature shown above consists of a sandstone/siltstone rock layer that sits at the top of a sandy silt slope. The rock is weathered and voids have been created beneath the rock due to erosion caused by runoff flows. The feature overlooks a small channel.
