Township 8S, Range 39E
SECTION 13

Cliff Features

Revised 4/06; Reference – South Fork Extension Amendment #00174

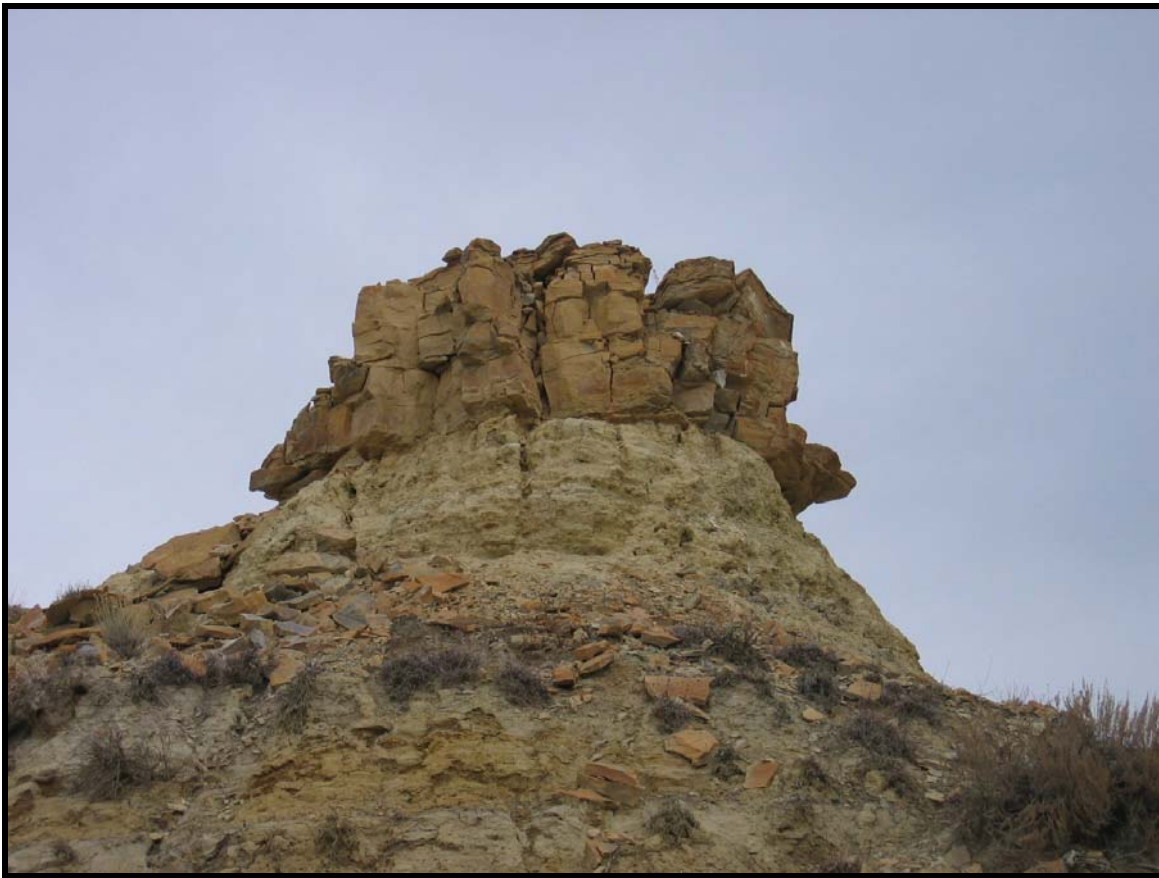
ROCK OUTCROP FEATURE: RO_0254

DESCRIPTION OF FEATURE: The rock outcrop feature shown above consists of fractured sandstone/siltstone rock that sits on a sandy soil. Due to erosion, small pedestals emerge in several locations over the feature area.

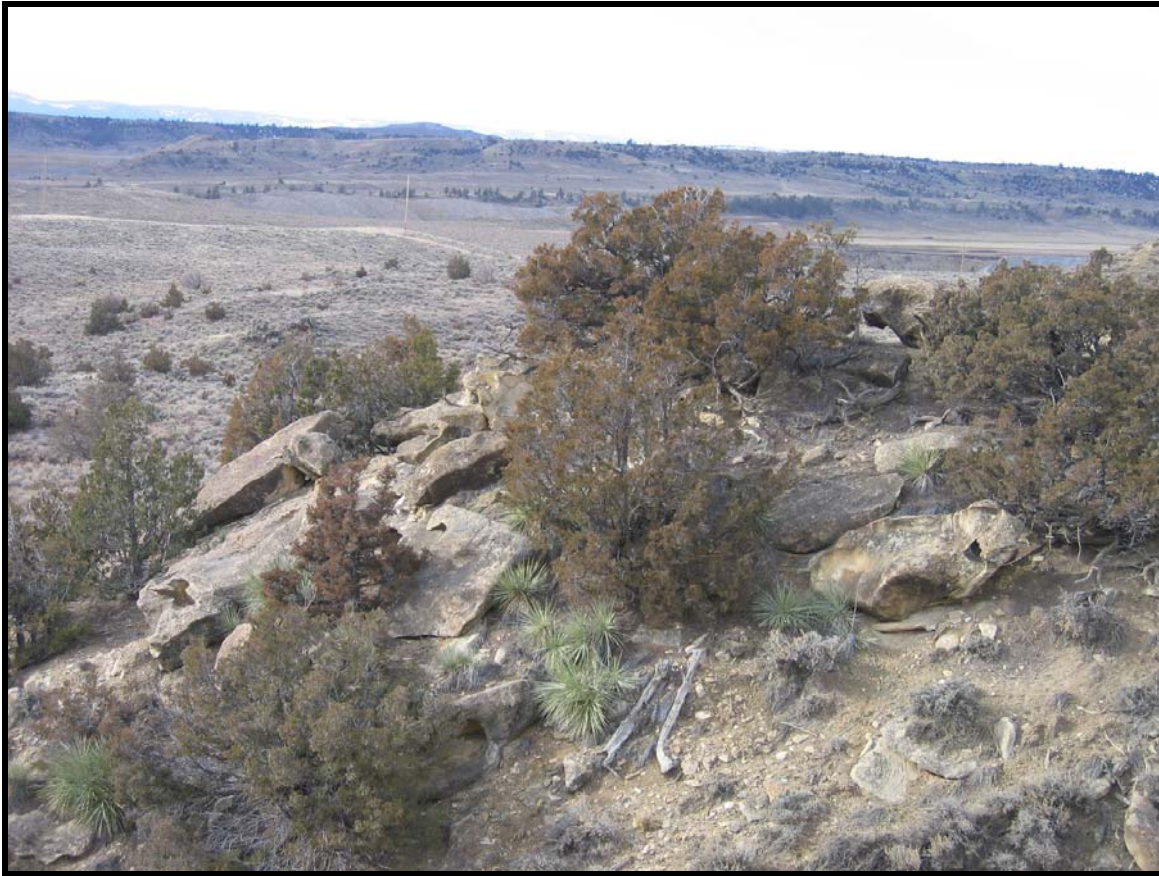
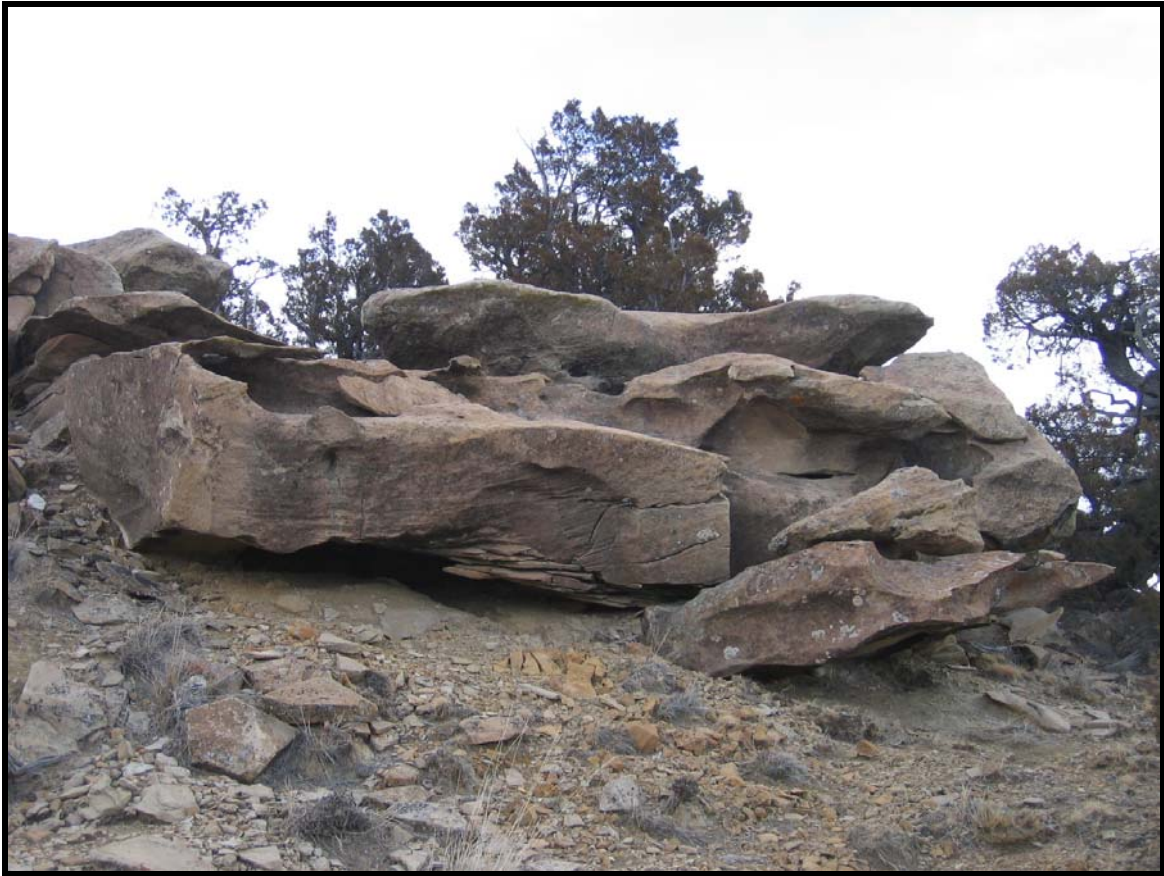
ROCK OUTCROP FEATURE: RO_0255

DESCRIPTION OF FEATURE: The rock feature shown above is located at a small point on a southern facing slope. The sandstone/siltstone rocks are highly weathered and pocketed. The area around the feature is vegetated with grass, sagebrush, and some small trees. See the picture on the next page for another view of the rocks in this outcrop.

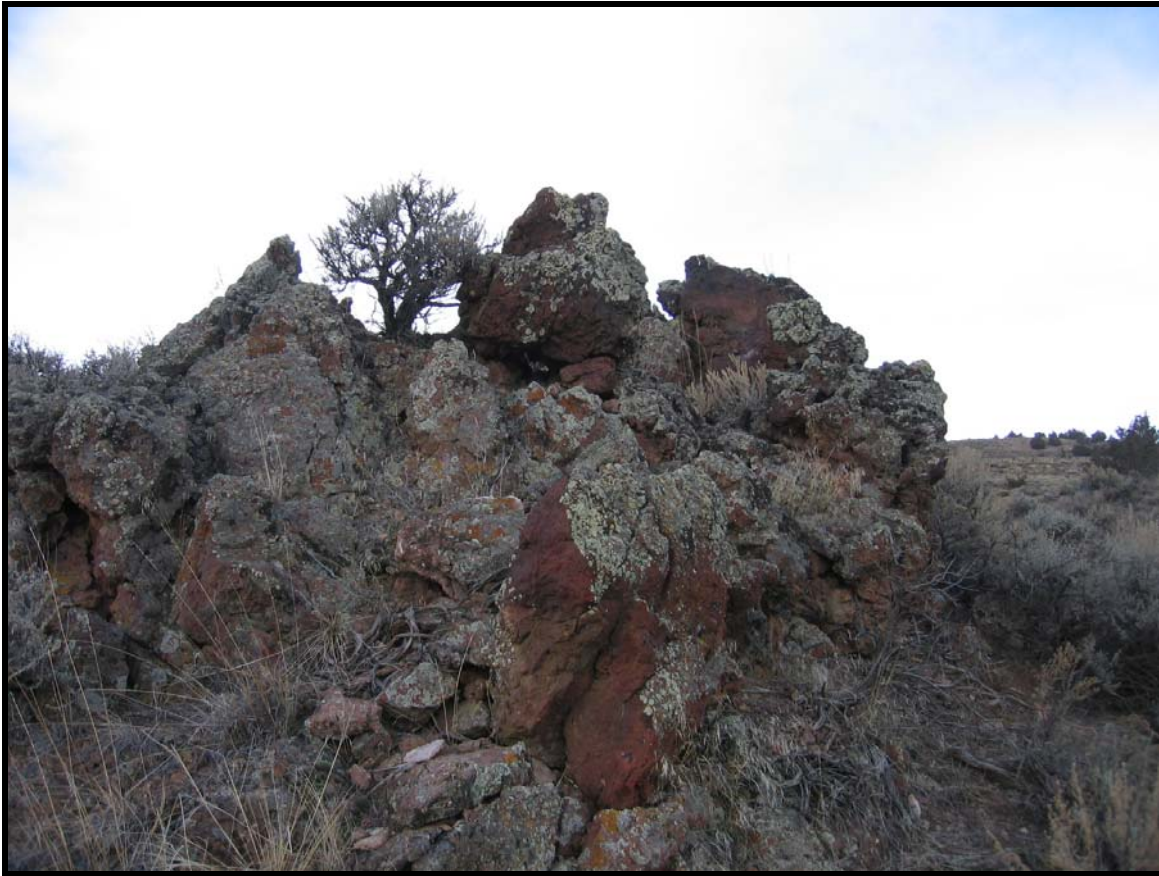
ROCK OUTCROP FEATURE: RO_0256

DESCRIPTION OF FEATURE: Scoria outcrops, like the one shown above, are very common across the mine area. The dark scoria is covered with lichens and extends up to seven feet high. This feature is located overlooking a small draw. The feature area is vegetated with grass and sagebrush.

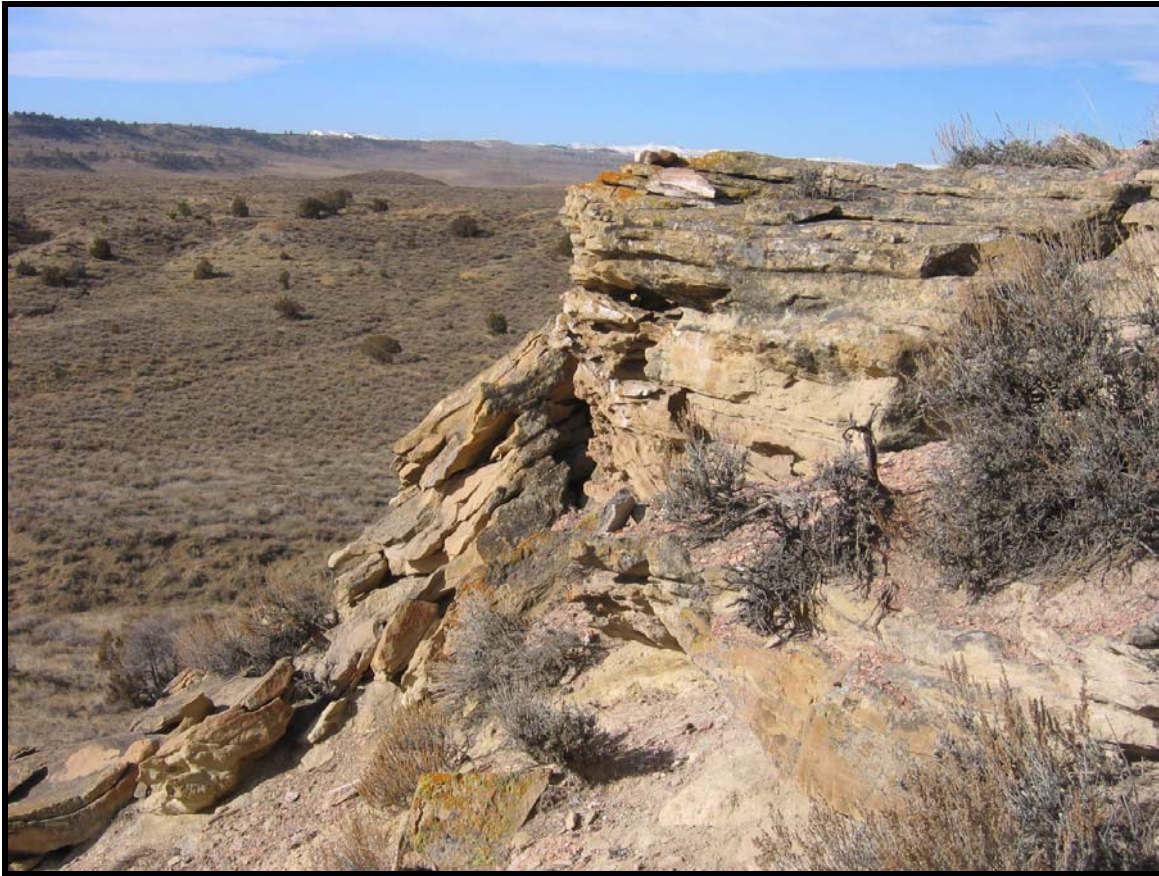
ROCK OUTCROP FEATURE: RO_0257

DESCRIPTION OF FEATURE: The rock outcrop shown above is located on the side of a hill composed of sandy silt subsoil. The rocks are layered and weathered. Overhangs and pockets within the face of the rock are common in this feature.

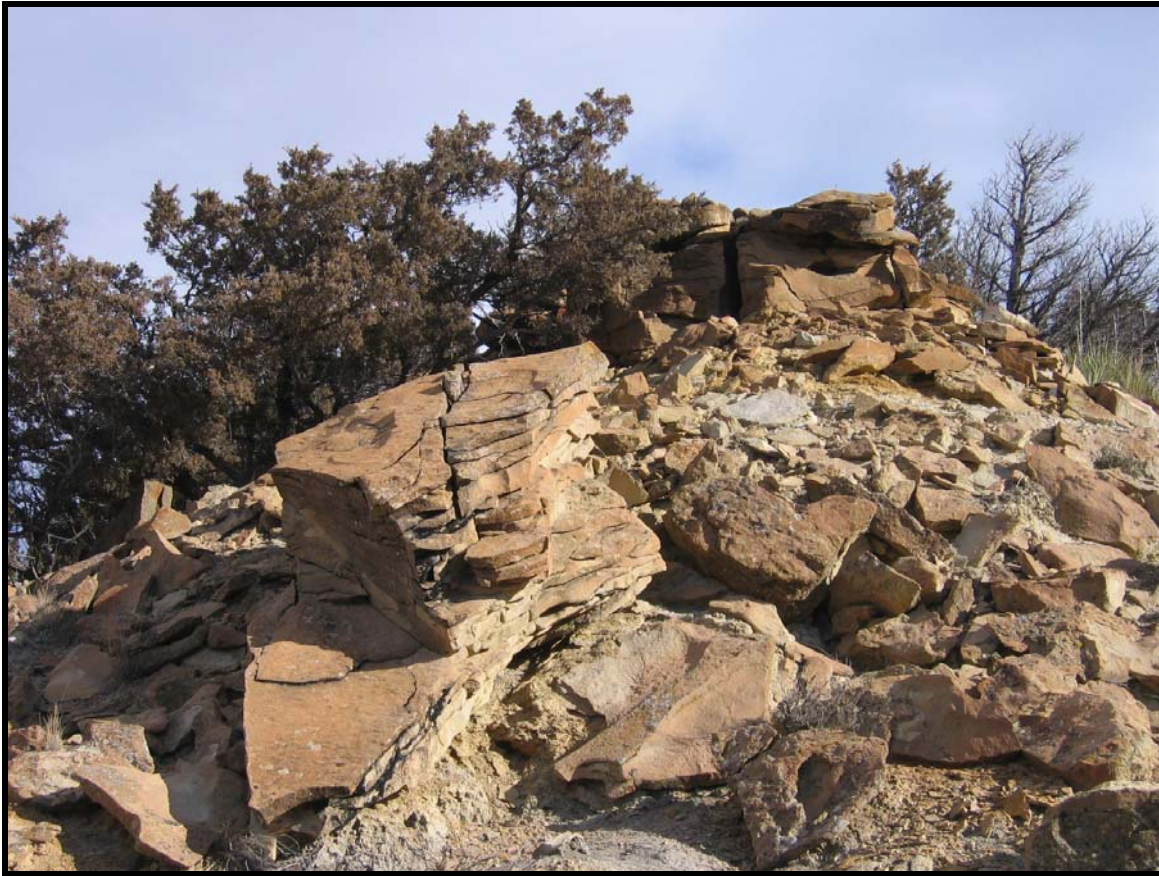
ROCK OUTCROP FEATURE: RO_0258

DESCRIPTION OF FEATURE: The rock outcrop shown above is located on the side of a hill composed of sandy silt subsoil. The rocks are layered and weathered. Overhangs and pockets within the face of the rock are common in this feature. The area is vegetated with sparse grass, sagebrush, and trees.

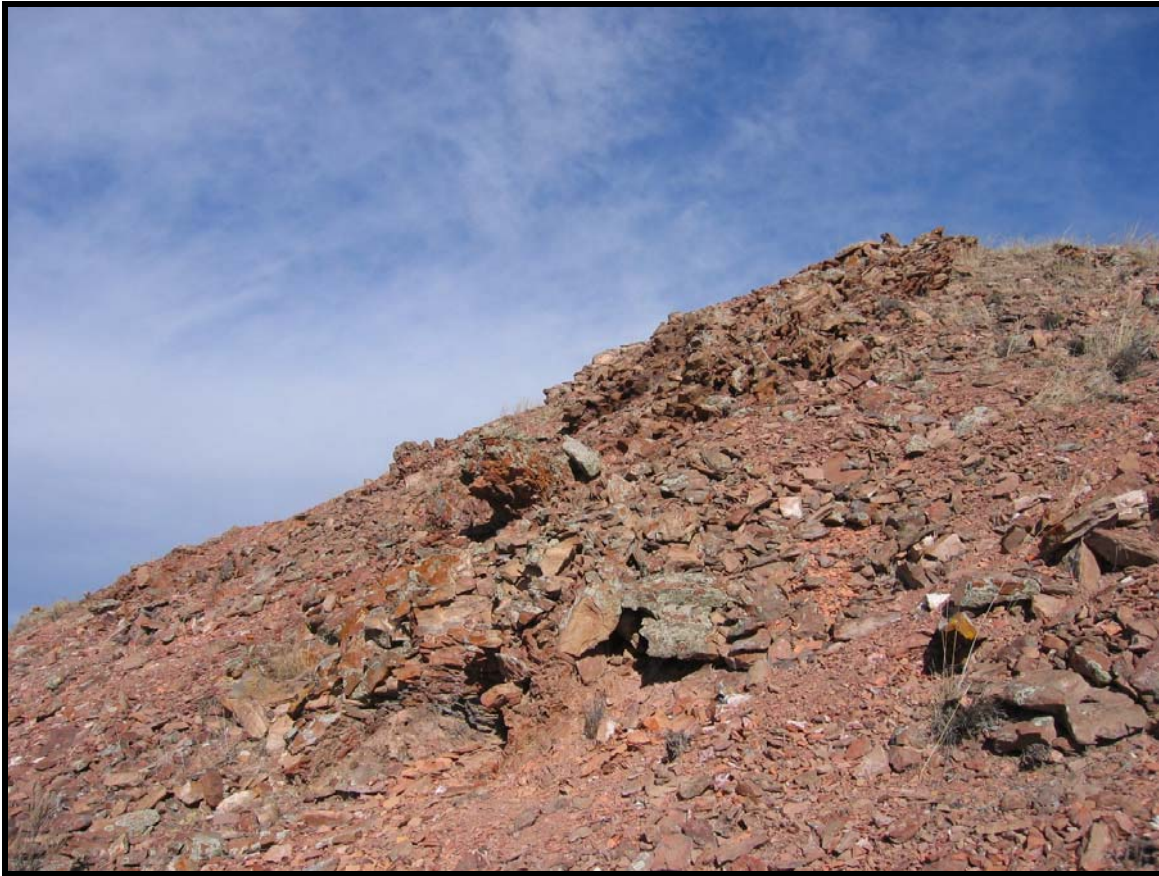
ROCK OUTCROP FEATURE: RO_0259

FEATURE TYPE:	Rock Outcrop		
GEOMETRIC DIMENSIONS:	Length: 105 ft	Height: 20 ft	
LOCATION:	Township: 8S	Range: 39E	Section: 13
HANDHELD GPS POINTS:	Northing	Easting	
	16052	421252.61	2669328.55
	16053	421326.88	2669256.42
SUBSTRATE:	Scoria		
EXPOSURE:	Southern facing slope		
DESCRIPTION OF FEATURE:	Scoria outcrops, like the one shown above, are common across the minesite. The face of the feature is fractured and jagged and sits at the top of a hill.

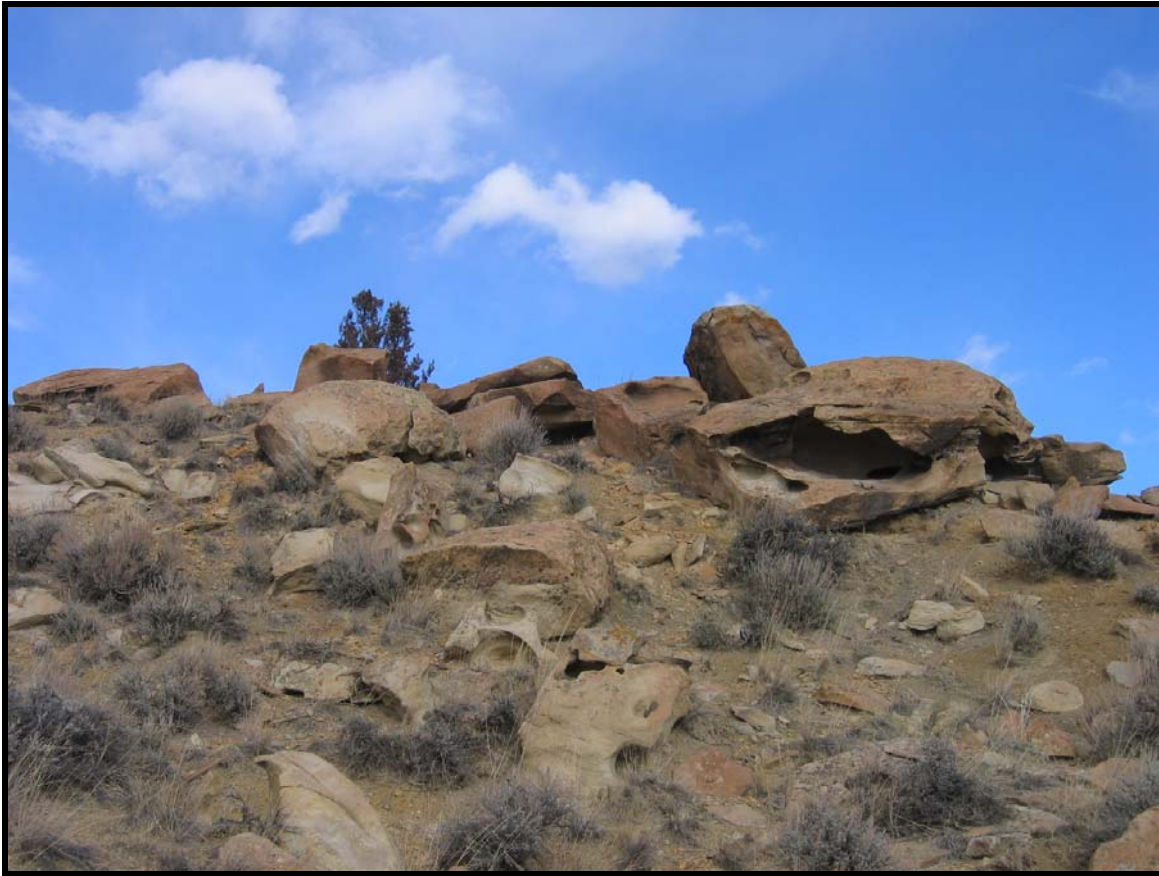
ROCK OUTCROP FEATURE: RO_0267

DESCRIPTION OF FEATURE: The rock outcrop shown above is located on a gentle slope composed of sandy silt soil. The rocks are weathered and have unique holes in their face. This feature is located below cliff feature C_0059 and some of these rocks may have been deposited from that rock face.

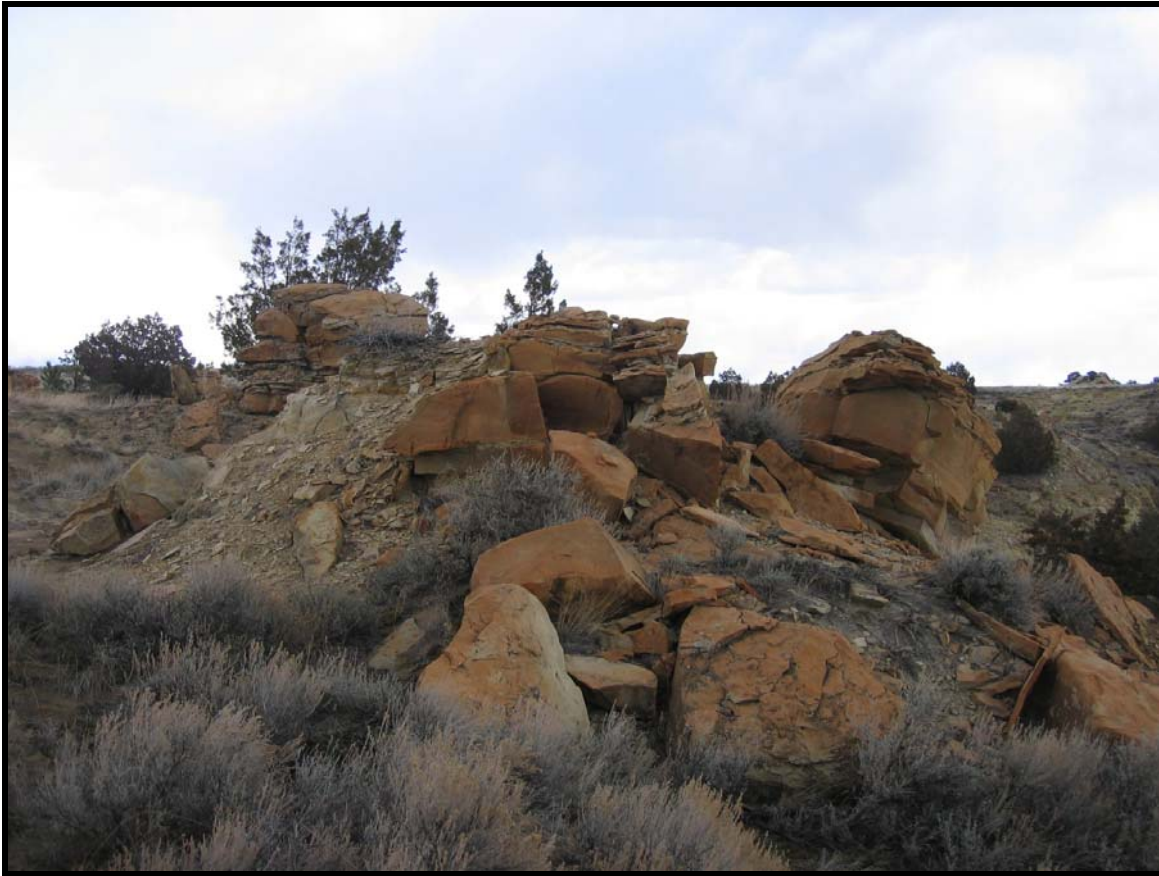
ROCK OUTCROP FEATURE: RO_0268

DESCRIPTION OF FEATURE: The rock outcrop shown above is located at the top of a southern facing slope. The layered, sandstone/siltstone rocks are located on sandy silt soil, which is highly erosive. The rocks are weathered and fractured.

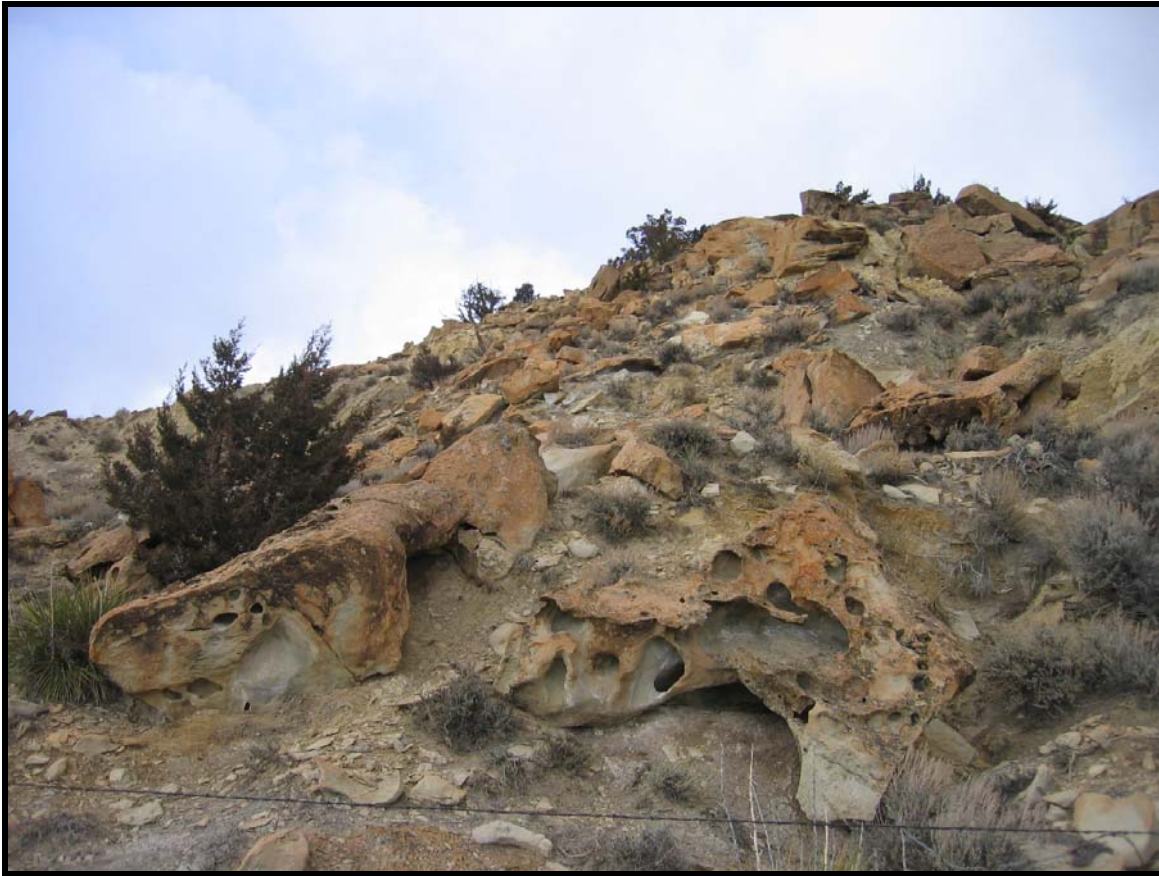
ROCK OUTCROP FEATURE: RO_0269

DESCRIPTION OF FEATURE: The rock outcrop shown above is located along the top and the face of a southern facing slope. The layered, sandstone/siltstone rocks are located on sandy silt soil, which is highly erosive. The rocks are weathered, which has formed unique pockets and holes.

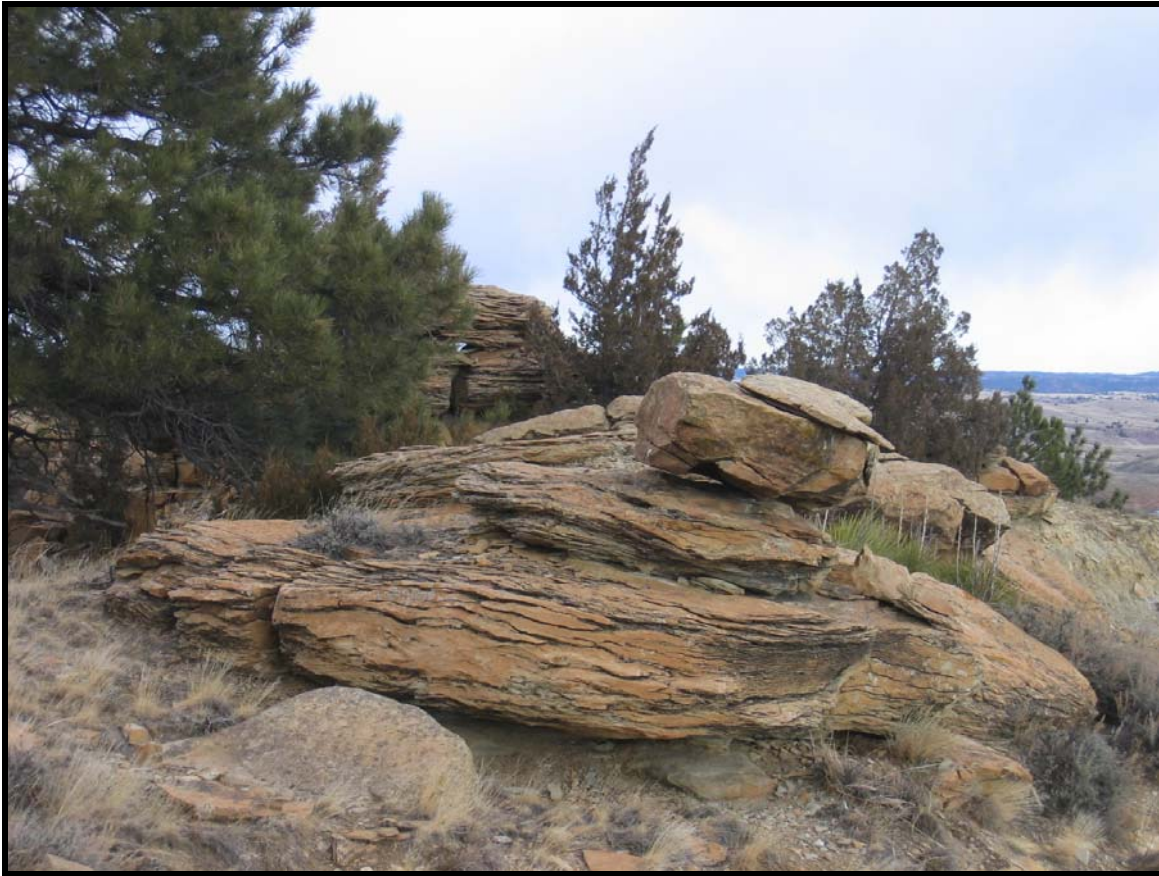
ROCK OUTCROP FEATURE: RO_0270

DESCRIPTION OF FEATURE: The rock outcrop shown above is located along the top and the face of a southern facing slope. The layered, sandstone/siltstone rocks are located on sandy silt soil, which is highly erosive. The area around the feature is vegetated with grass, sagebrush, and trees.

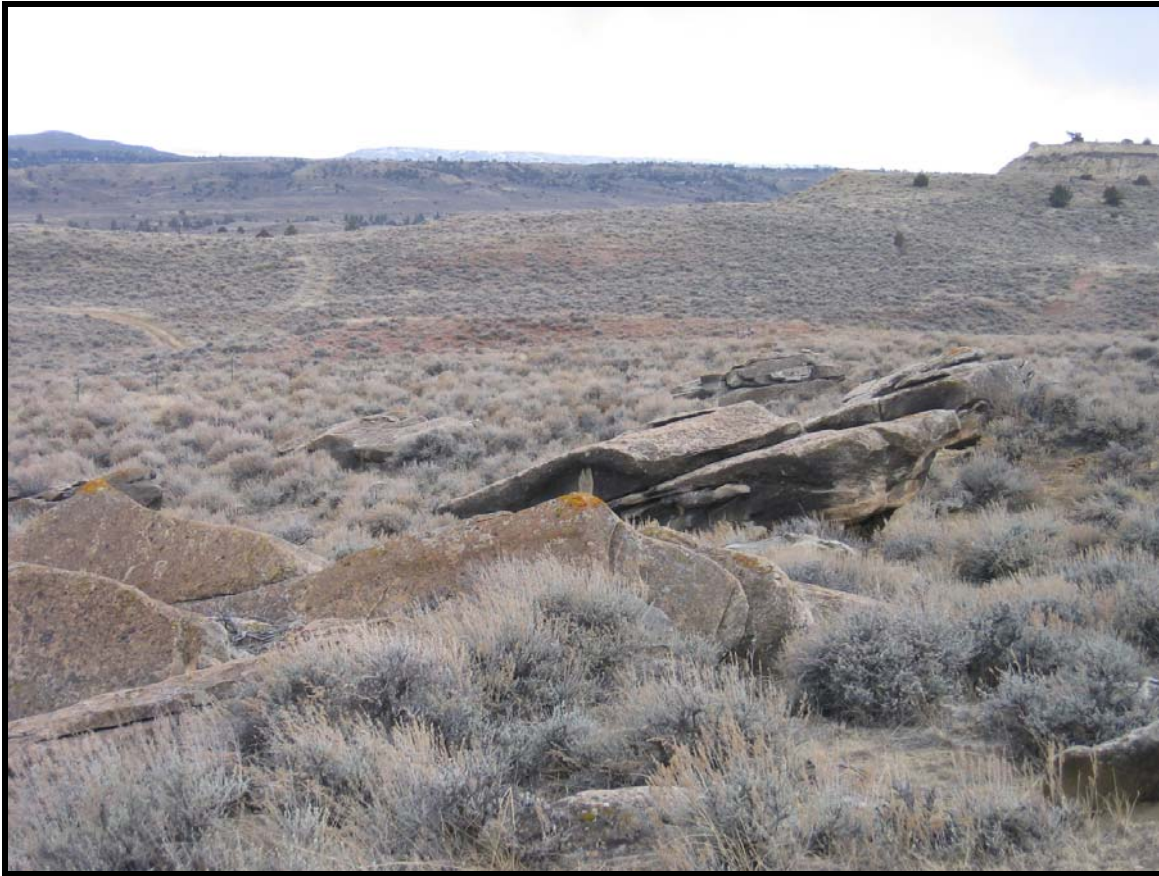
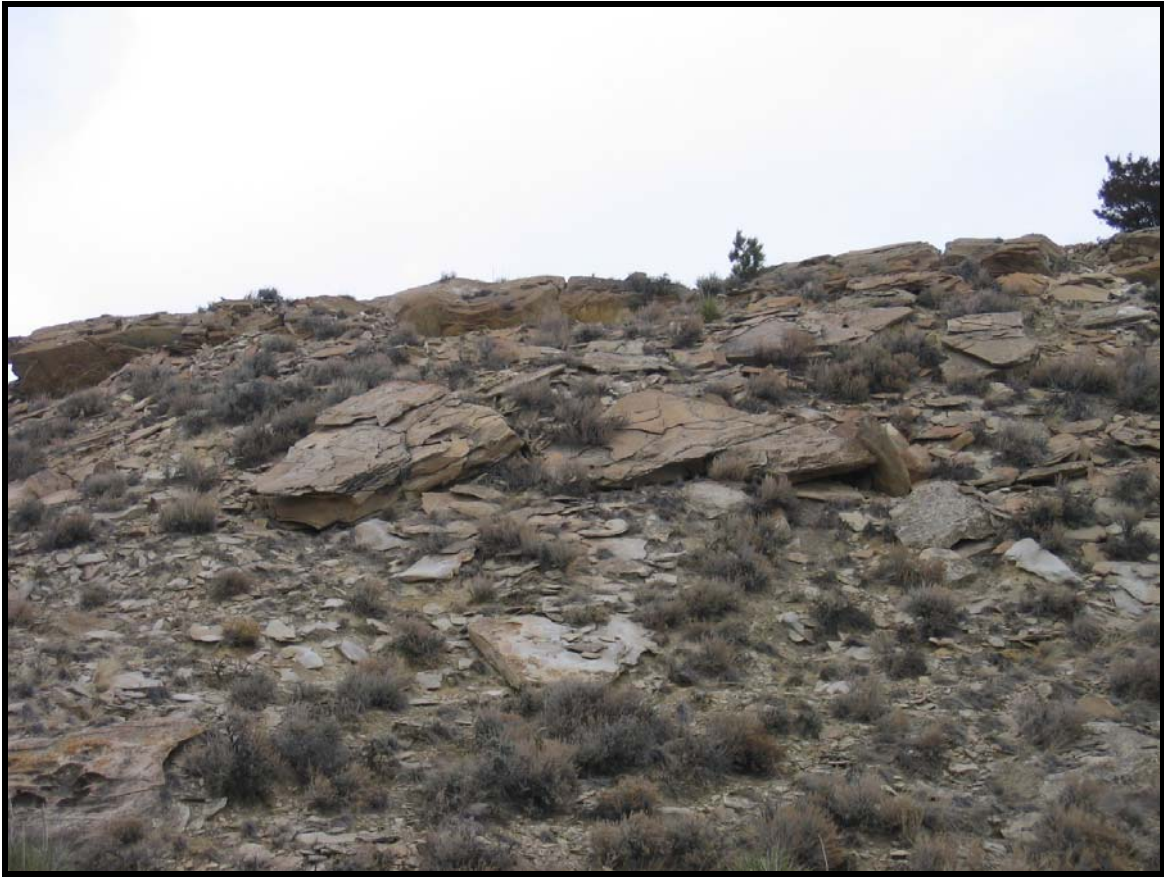
ROCK OUTCROP FEATURE: RO_0271

DESCRIPTION OF FEATURE: This rock outcrop is located along the bottom, side and top of a steep (greater than 3H:1V) slope. The rocks range from large solid-faced sandstone/siltstone to smaller, layered sandstone/siltstone. See the picture on the next page for another view of the feature along the face of the hill.

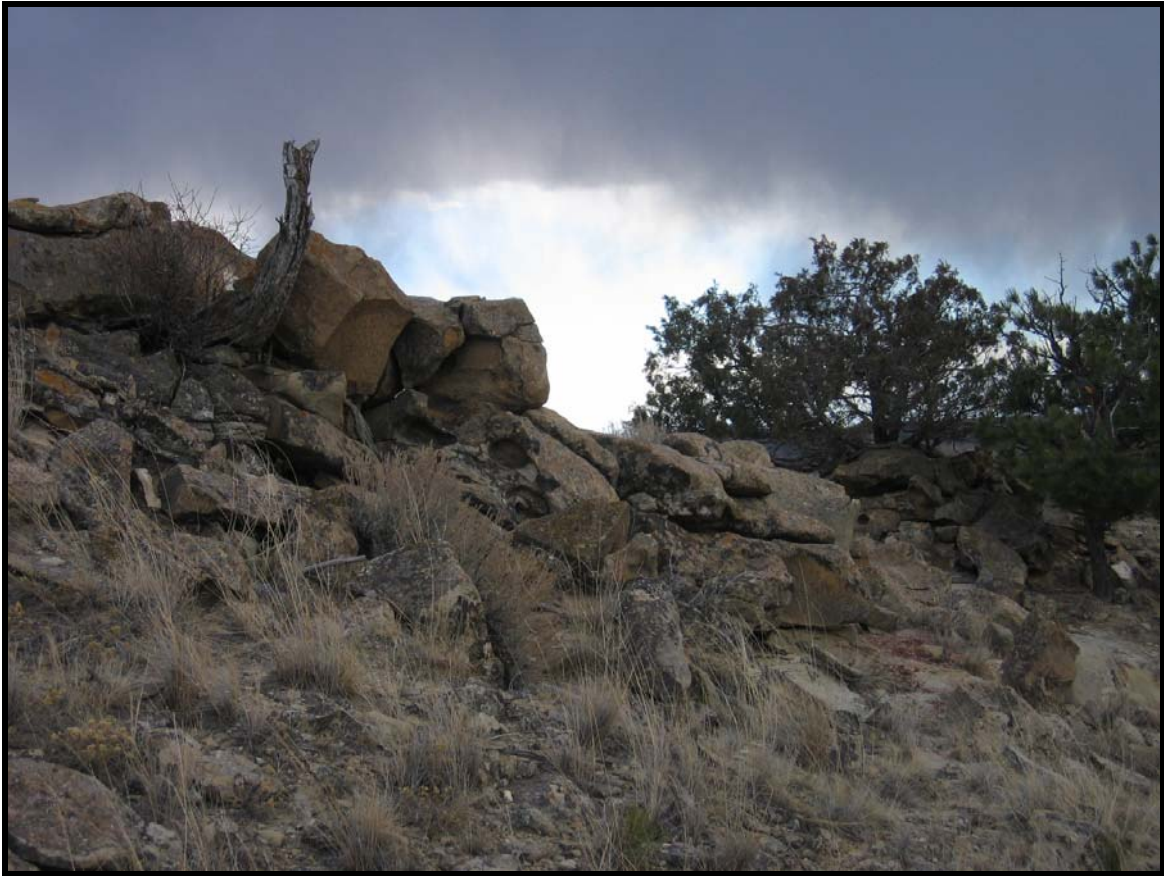
ROCK OUTCROP FEATURE: RO_0272

DESCRIPTION OF FEATURE: The rock outcrop shown above is located at the head of a small draw. The feature consists of fractured sandstone/siltstone, which stands approximately five feet high. The feature is surrounded by grass and sagebrush.

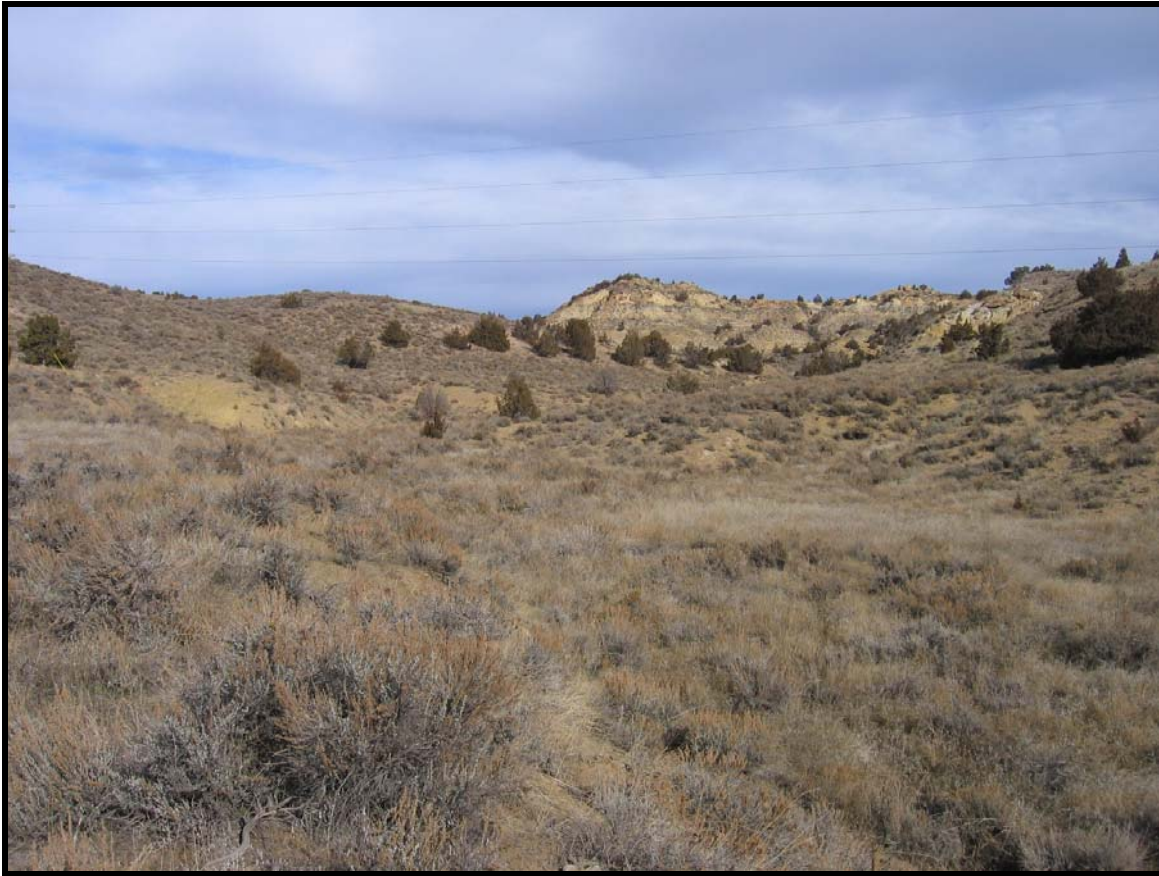
RIPARIAN FEATURE: R_0059

DESCRIPTION OF FEATURE: The drainage shown above has a wide channel that is vegetated with grass and sagebrush. The channel varies from having an undefined geometry, to cutting deeply into the sandy silt subsoil.

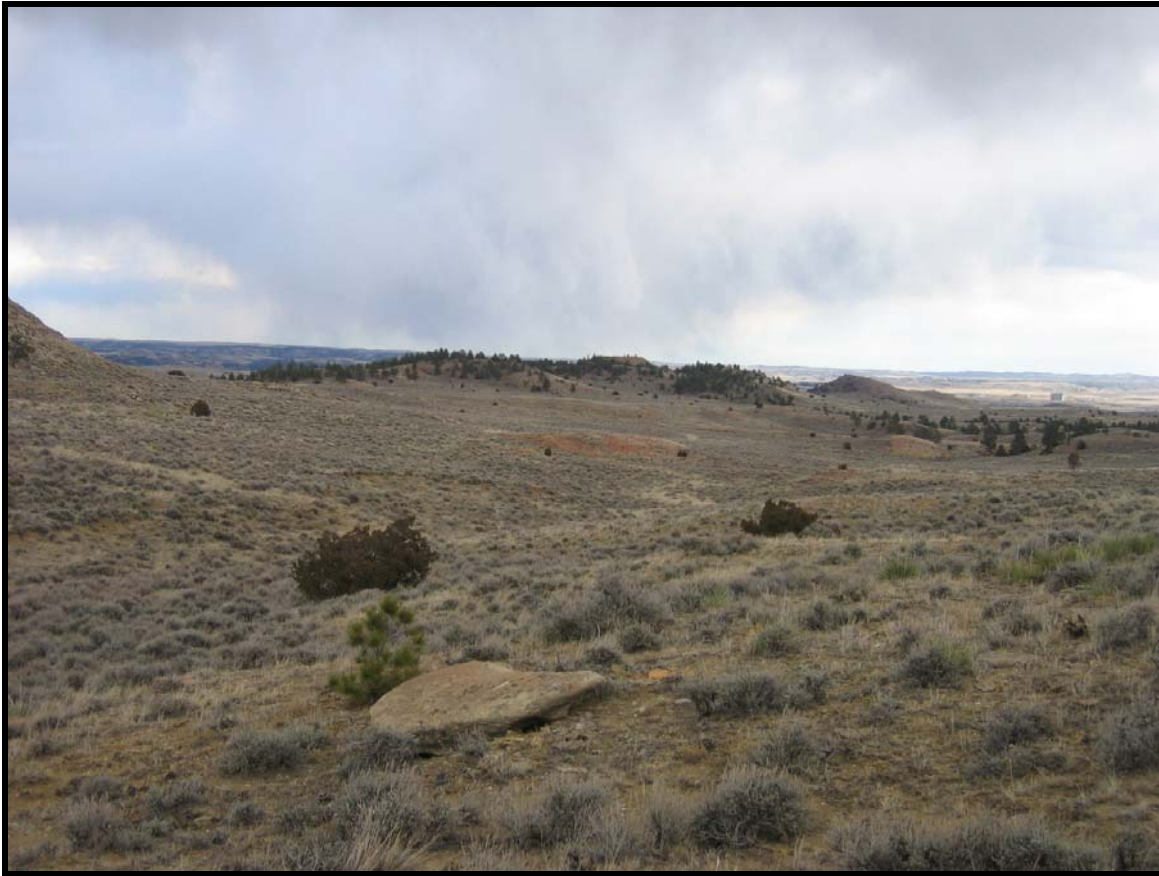
RIPARIAN FEATURE: R_0061

DESCRIPTION OF FEATURE: The drainage shown above has a wide, undefined channel that is vegetated with grass and sagebrush. The surrounding hills vary from steep to moderately sloped.
