**Township 8S, Range 39E**

**SECTION 14**

*Cliff Features*

Revised 4/06; Reference - South Fork Extension Amendment #00174

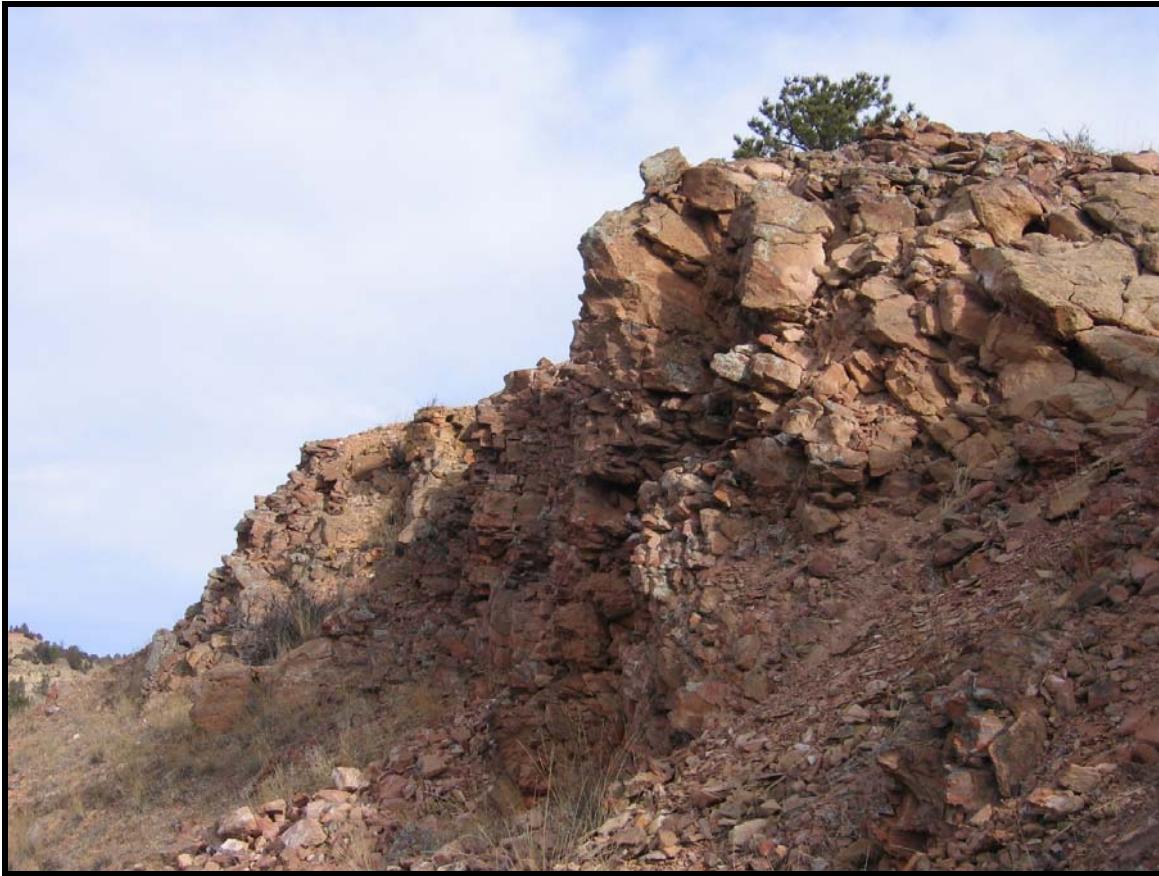
Photo: 1\_30\_06\_12

**CLIFF FEATURE: C\_0052**

**Looking Northeast**

**GEOMETRIC DIMENSIONS:** Length: 570 ft      Height: 25 ft

**SUBSTRATE:** Sandstone/siltstone

**DESCRIPTION OF FEATURE:** The scoria cliff feature shown above is approximately 25 feet high and sits at the top of a steep slope overlooking riparian feature R\_0055. In most cases scoria outcroppings are considered rock outcrops, but this feature has a tall, vertical face and has soil at the top of its exposure.

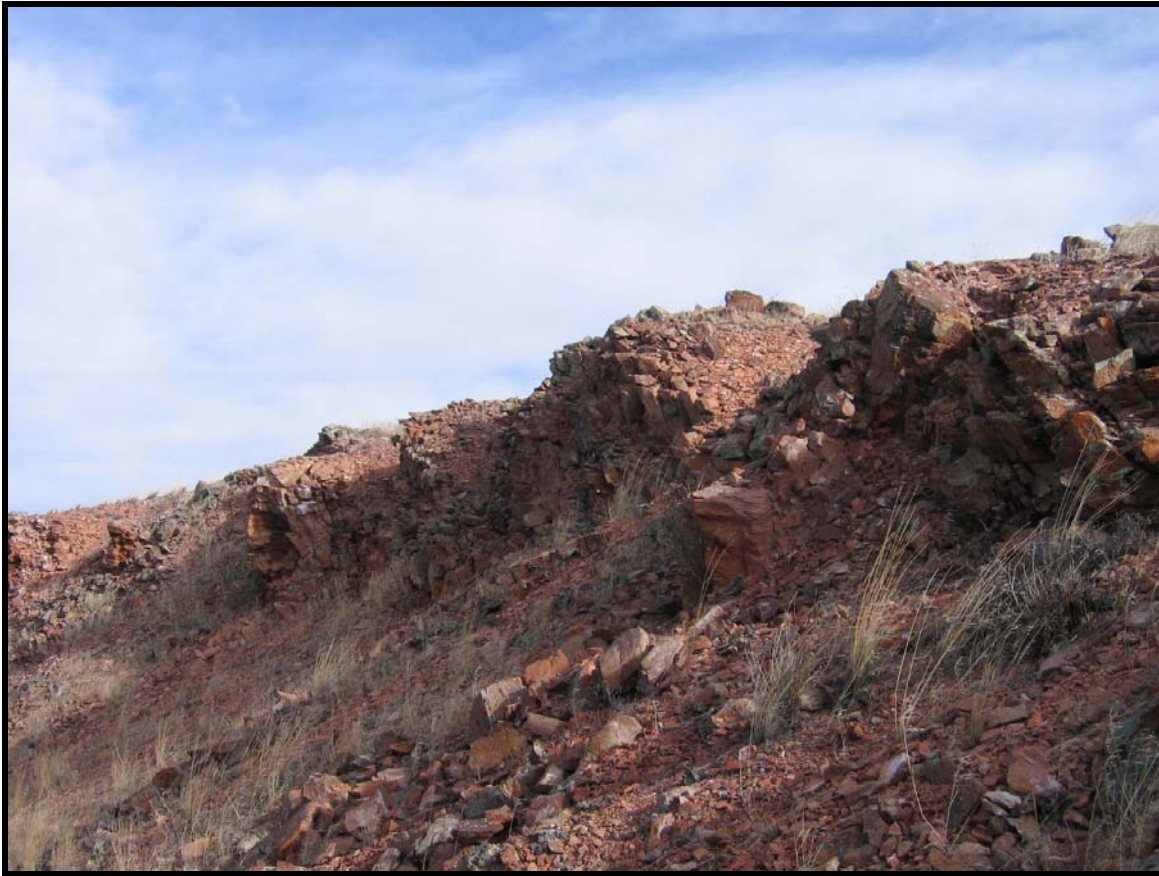
Photo: 1\_30\_06\_13

**CLIFF FEATURE: C\_0053**

**GEOMETRIC DIMENSIONS:** Length: 175 ft      Height: 15 ft

**DESCRIPTION OF FEATURE:** The scoria cliff feature shown above is approximately 25 feet high and sits at the top of a steep slope overlooking riparian feature R\_0055. In most cases scoria outcroppings are considered rock outcrops, but this feature has a tall, vertical face and has soil at the top of its exposure. This feature is located adjacent to C\_0052 and has similar characteristics.

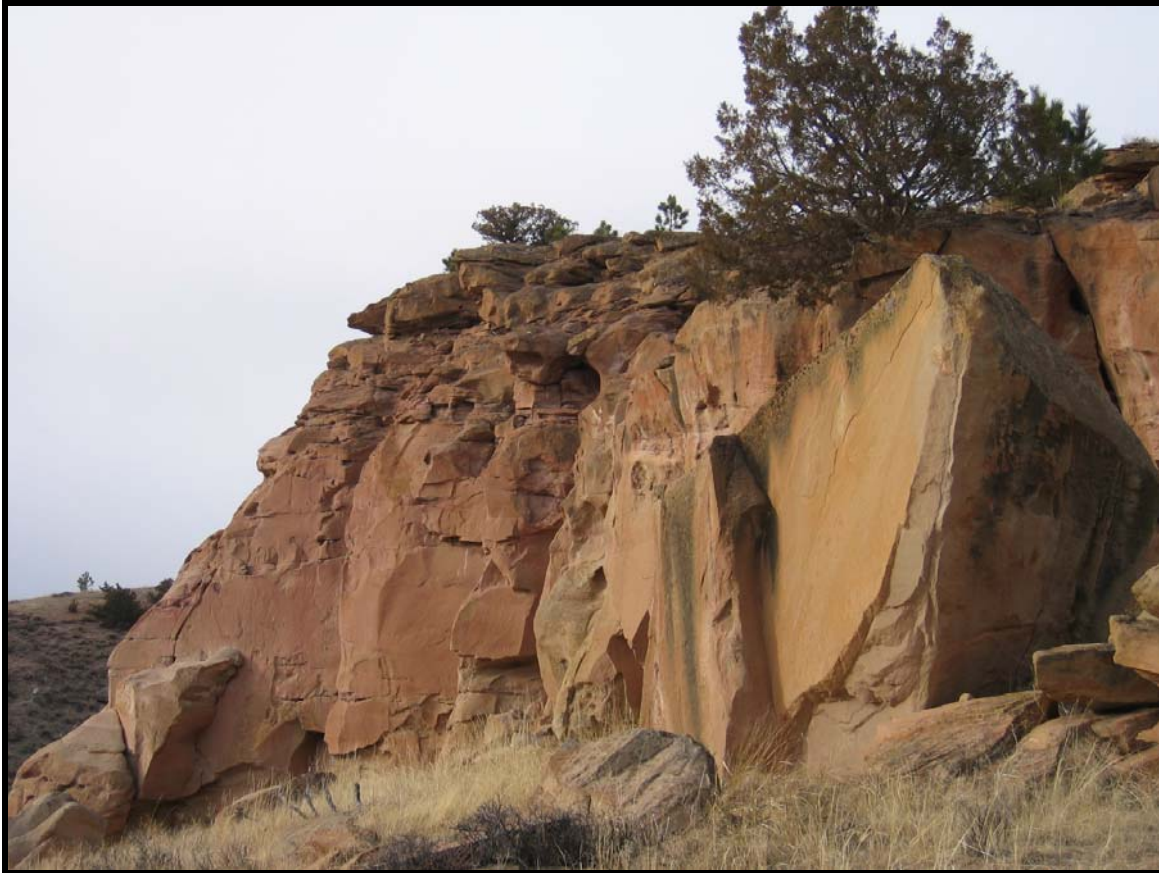
Photo: 1\_30\_06\_33

**CLIFF FEATURE: C\_0054**

FEATURE TYPE:	Cliff					
GEOMETRIC DIMENSIONS:	Length: 610 ft		Height: 100 ft			
LOCATION:	Township: 8S		Range: 39E		Section: 14	
HANDHELD GPS POINTS:		Northing	Easting		Northing	Easting
	15069	424889.57	2667186.57	15071	424980.38	2666835.08
	15070	424933.09	2666839.19	15072	425172.86	2666921.82

**DESCRIPTION OF FEATURE:** The sandstone/siltstone cliff shown above is a very unique feature. It is located at the end of a small hill, and is relatively triangular in shape. The face of the cliff is nearly 100 feet high and is generally solid over the length of the cliff. In some areas the sandstone has been weathered, leaving pockets and potential habitat. See the pictures on the following pages for additional views of this feature.

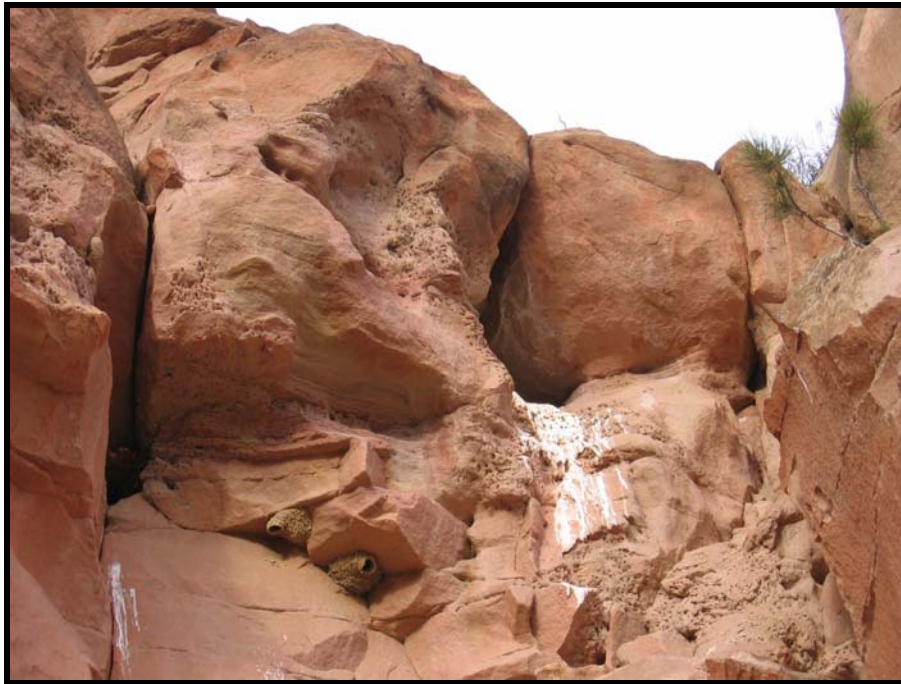
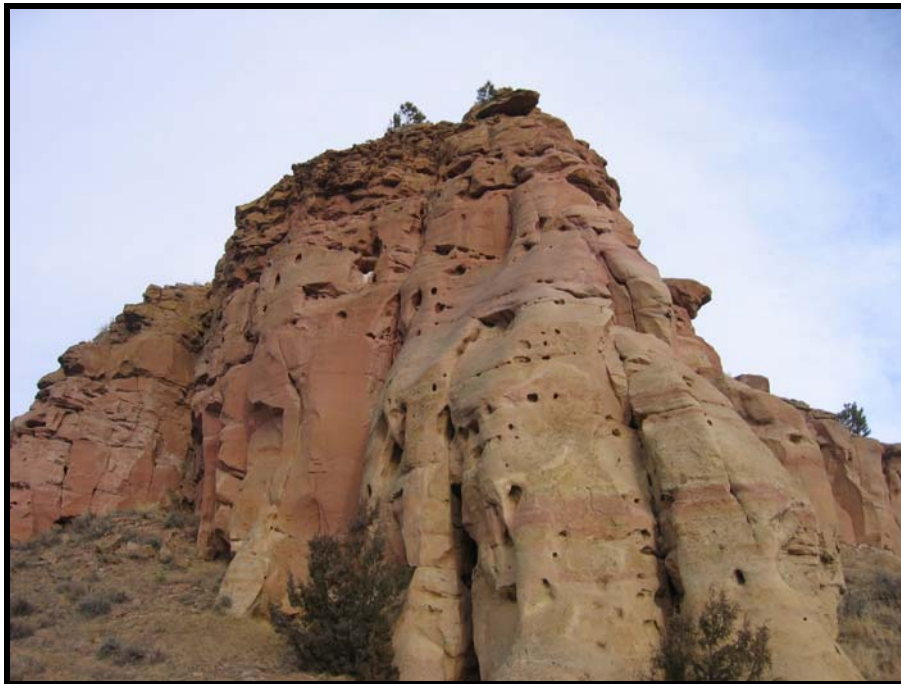
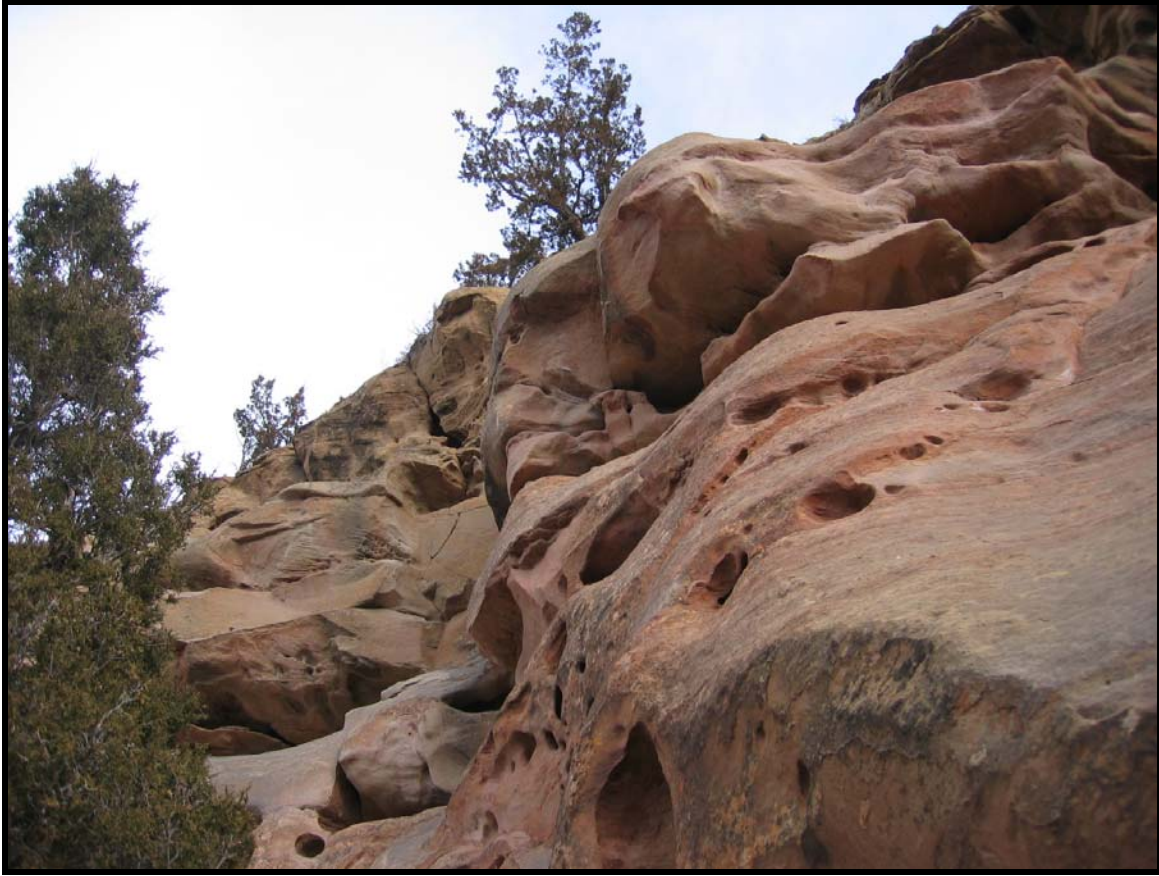
**CLIFF FEATURE: C\_0054**

Photo: 1\_30\_06\_37

Photo: 1\_30\_06\_38

Photo: 1\_30\_06\_39

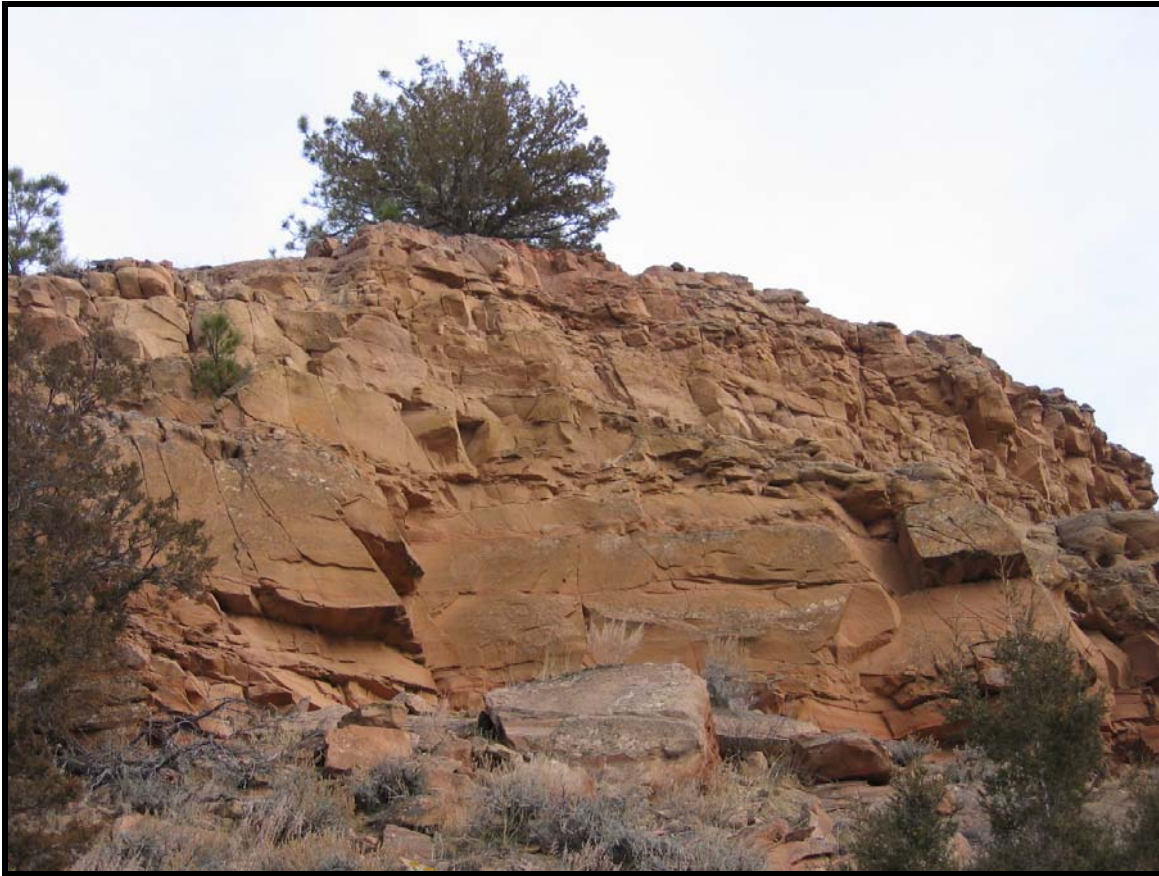
Photo: 1\_30\_06\_40

**CLIFF FEATURE: C\_0055**

**GEOMETRIC DIMENSIONS:** Length: 200 ft      Height: 35 ft

**DESCRIPTION OF FEATURE:** The cliff feature shown above is located on the same slope as feature C\_0054. It is composed of the same red sandstone/siltstone material. The feature is located above a small draw and at the top of a steep slope. The face has some weathered pockets. See the picture on the next page for another view of this feature.

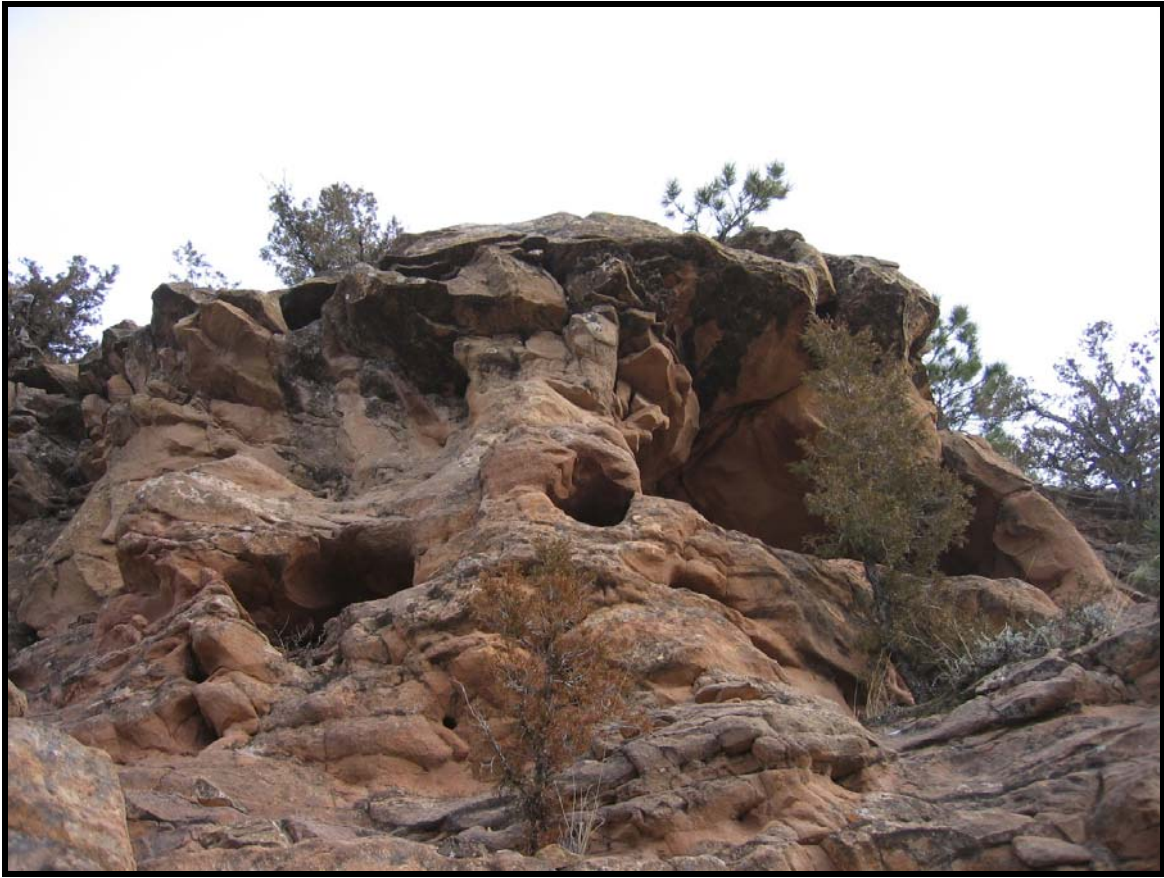
Photo: 1\_30\_06\_41

**CLIFF FEATURE: C\_0055**

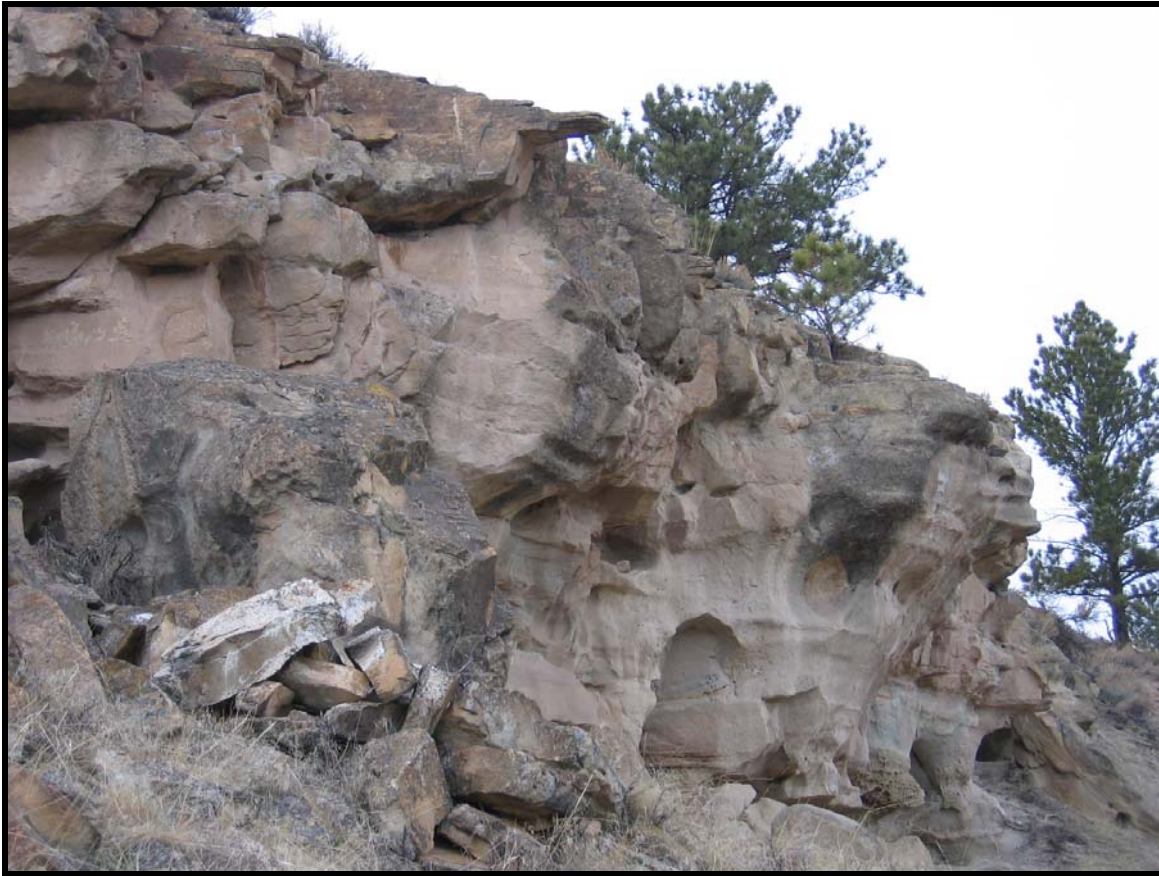
Photo: 1\_30\_06\_44

**CLIFF FEATURE: C\_0056**

**GEOMETRIC DIMENSIONS:** Length: 350 ft      Height: 20 ft

**DESCRIPTION OF FEATURE:** The cliff feature shown above is very weathered and eroded, leaving large holes and crevices in its face. The feature has an area on the south end that appears more like a rock outcrop, but a majority of its length looks like the picture above. There were areas within this feature that were currently used as habitat.

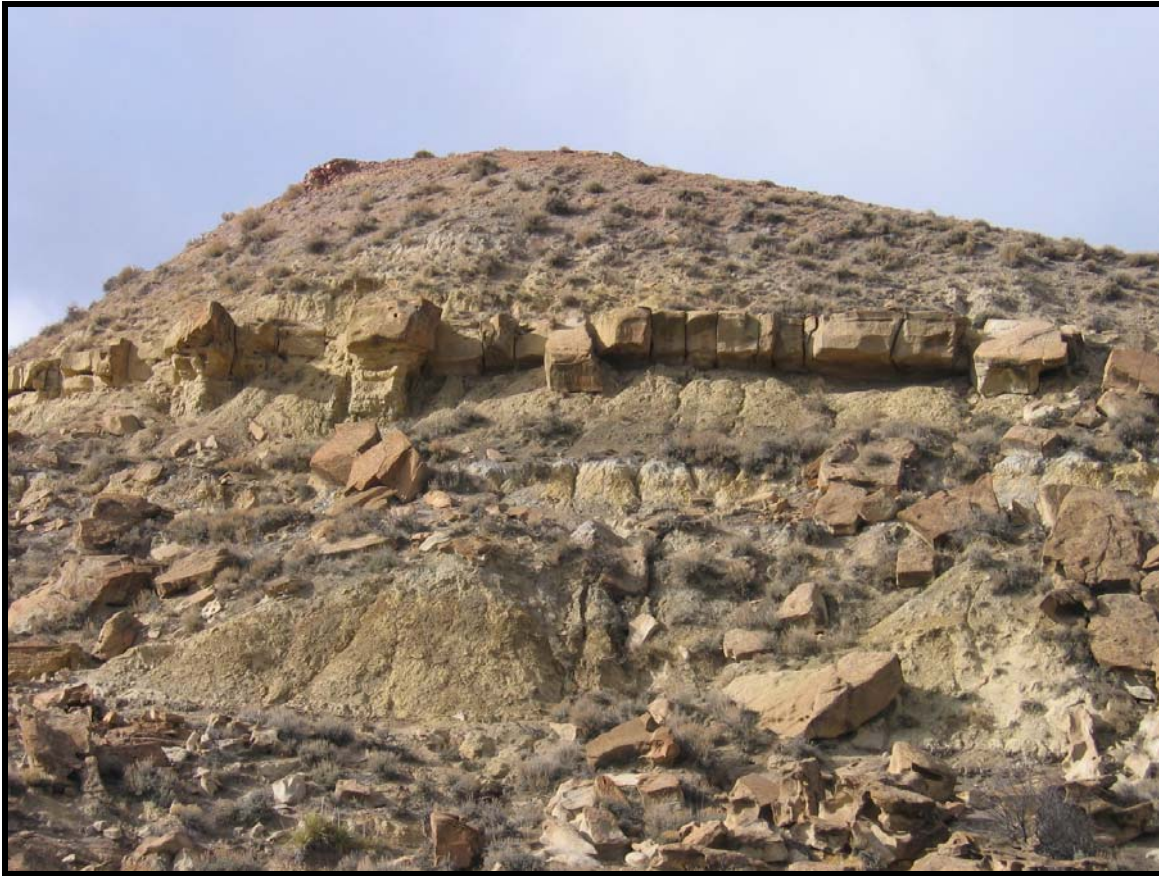
Photo: 2\_1\_06\_34

**CLIFF FEATURE: C\_0059**

**GEOMETRIC DIMENSIONS:** Length: 920 ft Height: 20 ft

**DESCRIPTION OF FEATURE:** The large cliff feature shown above travels nearly 180 degrees around a small hill. The rock layer is approximately 20 feet in thickness and has weathered pockets along its face. In some areas the rock has broken away, leaving a rock outcropping along the slope below. See the pictures on the following pages for additional views of this feature.

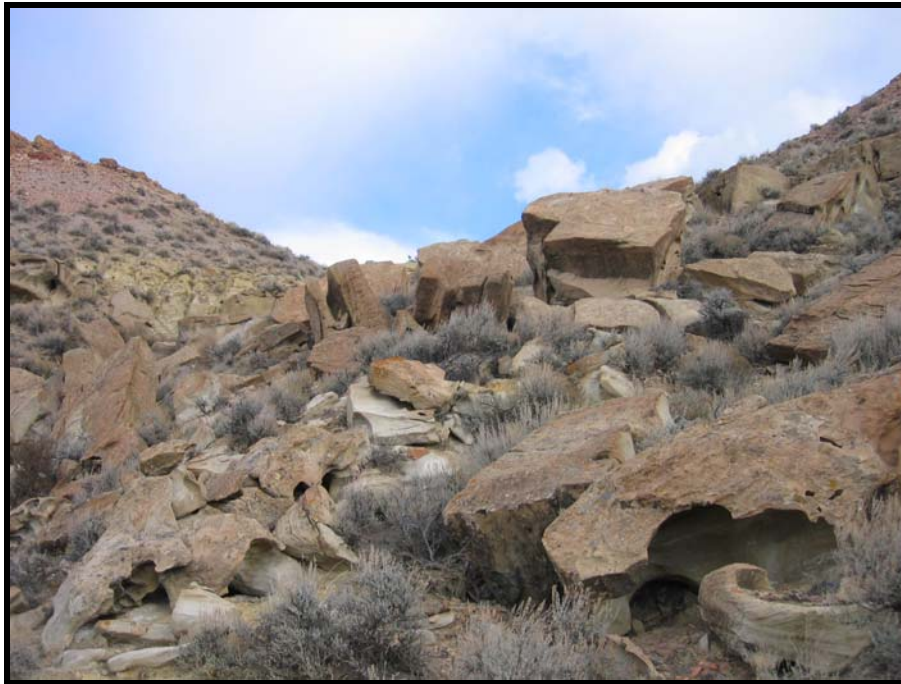
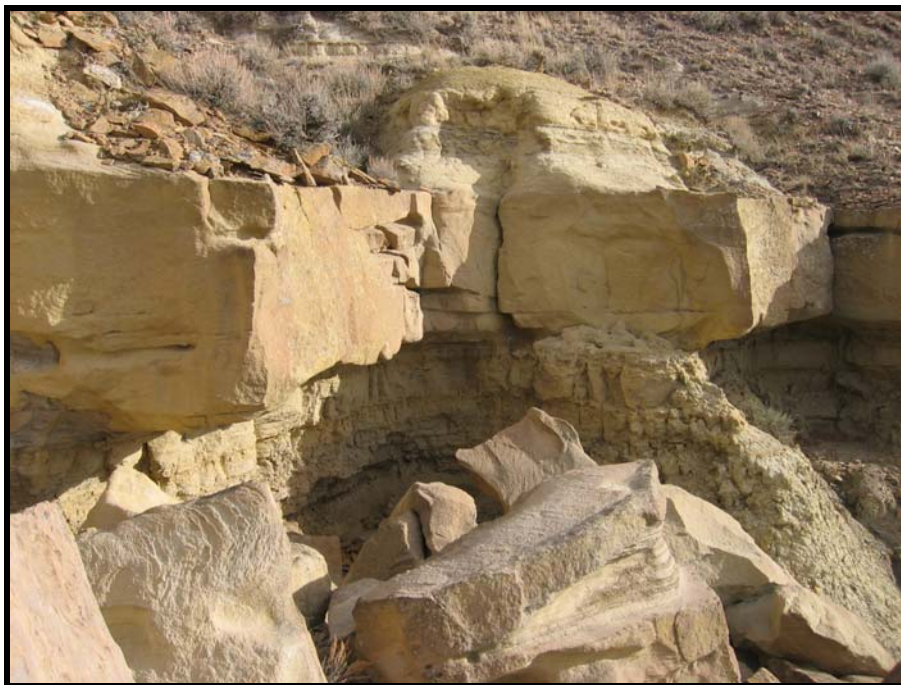
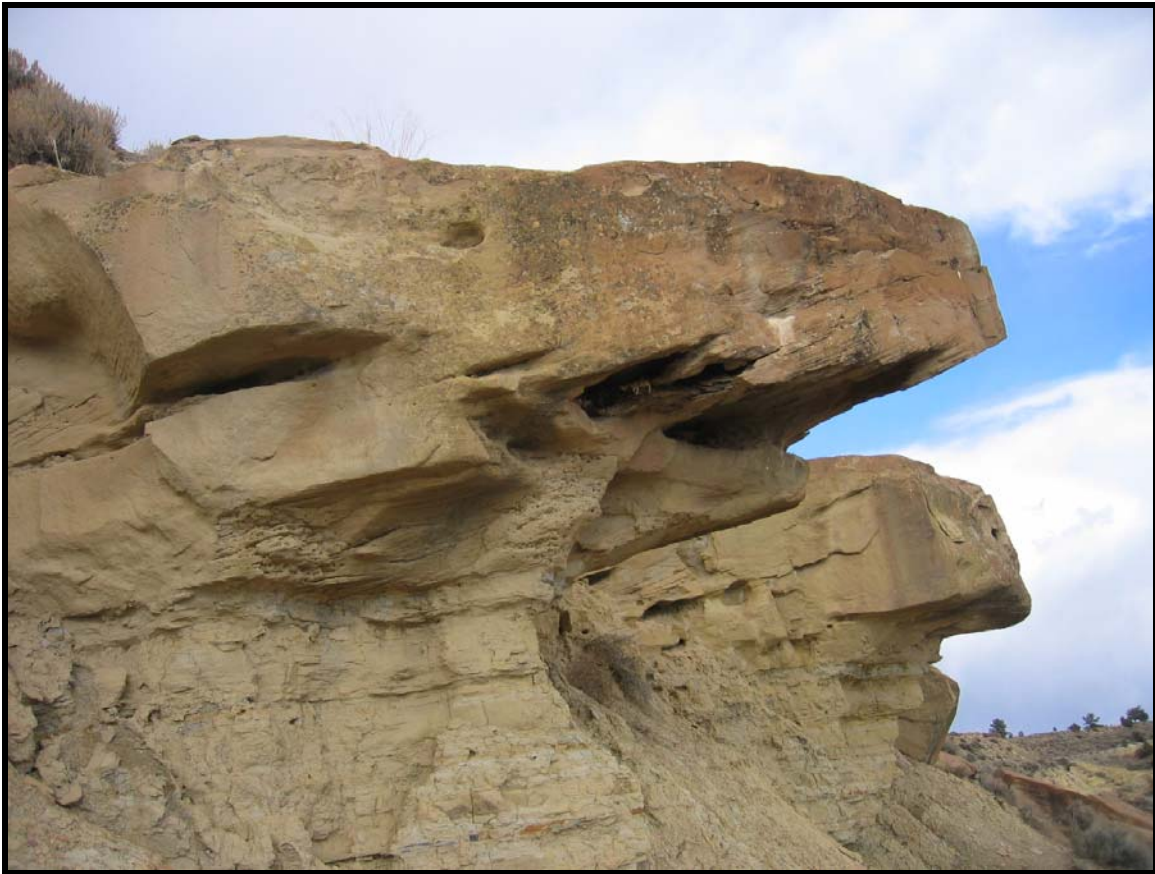
**CLIFF FEATURE: C\_0059**

Photo: 2\_1\_06\_35

Photo: 2\_1\_06\_36

Photo: 2\_1\_06\_37

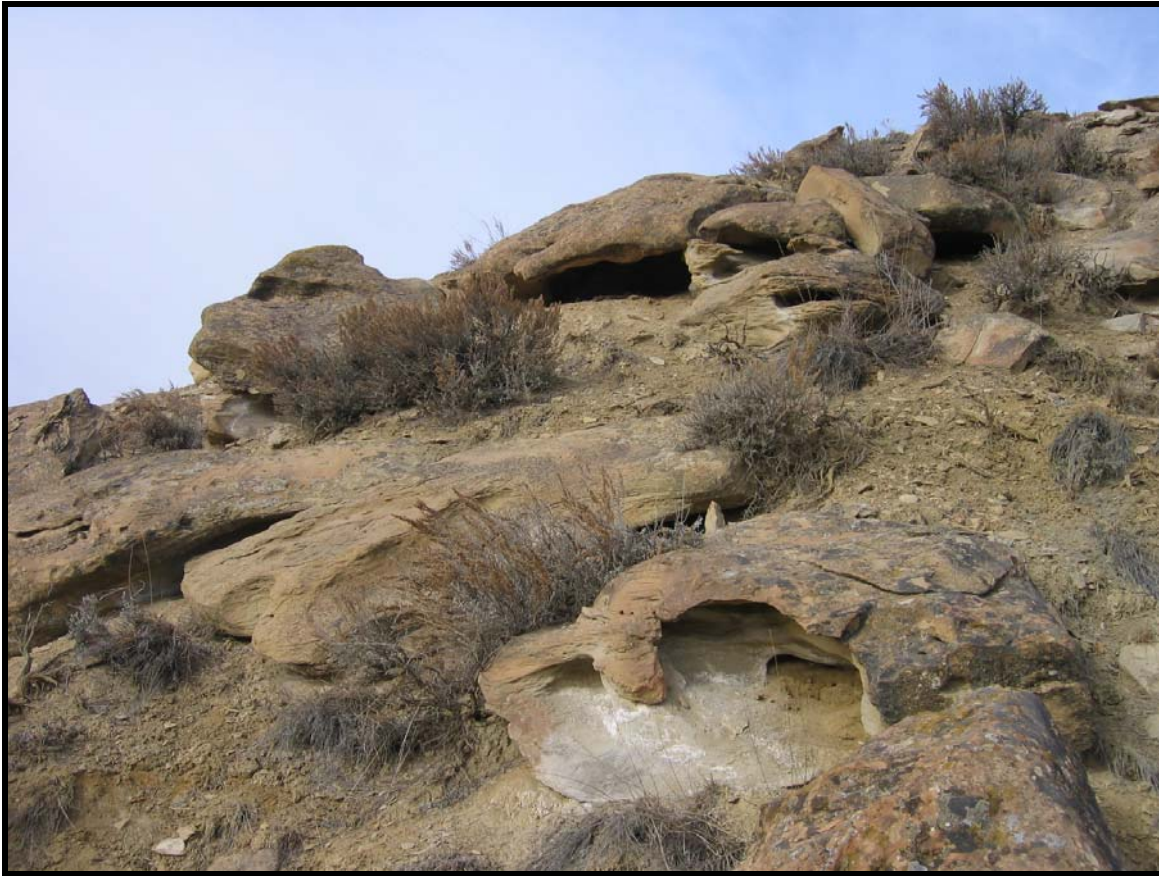
Photo: 1\_30\_06\_10

**ROCK OUTCROP FEATURE: RO\_0229**

**GEOMETRIC DIMENSIONS:** Area of outcrop: 1.00 acres

**DESCRIPTION OF FEATURE:** The rock outcrop shown above is located on a small hill composed of soft sandy silt. The sandstone/siltstone rocks have been weathered and eroded, leaving holes for habitat and protection. The area around the rocks is sparsely vegetated.

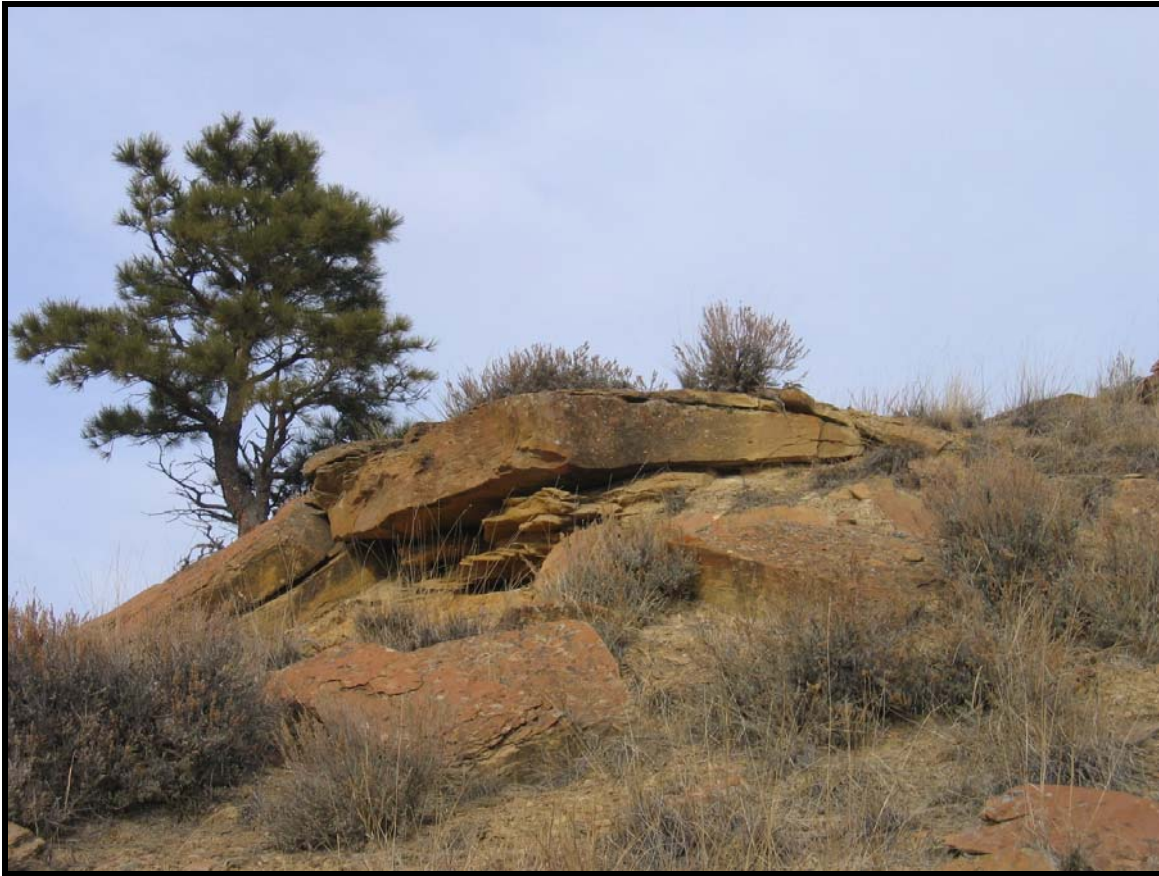
Photo: 1\_30\_06\_11

**ROCK OUTCROP FEATURE: RO\_0230**

**GEOMETRIC DIMENSIONS:** Area of outcrop: 0.21 acres

**DESCRIPTION OF FEATURE:** The rock outcrop shown above is located at the top of a slope overlooking a small draw. The sandstone/siltstone rocks sit on sandy silt soil, which is highly erosive. Holes beneath and between the rocks in this outcrop provide habitat and protection.

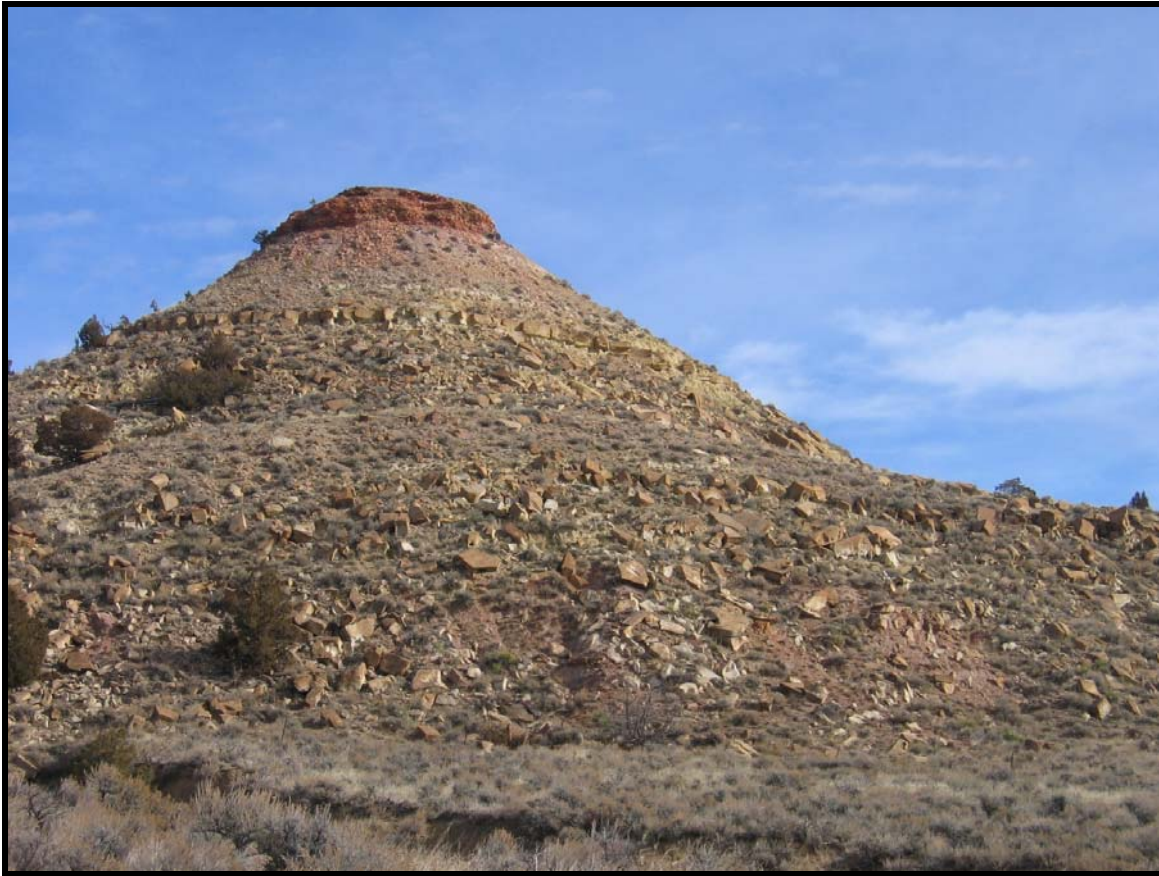
Photo: 1\_30\_06\_18

**ROCK OUTCROP FEATURE: RO\_0231**

**GEOMETRIC DIMENSIONS:** Area of outcrop: 2.56 acres

**DESCRIPTION OF FEATURE:** The rock outcrop shown above is located on a steep sandy silt slope. The feature was created by the erosion of a five-foot thick sandstone/siltstone rock layer. The rocks on the slope below the layer were deposited after the soil beneath the rock was eroded, causing the rock layer to break away. Over the area, the rocks are highly populated.

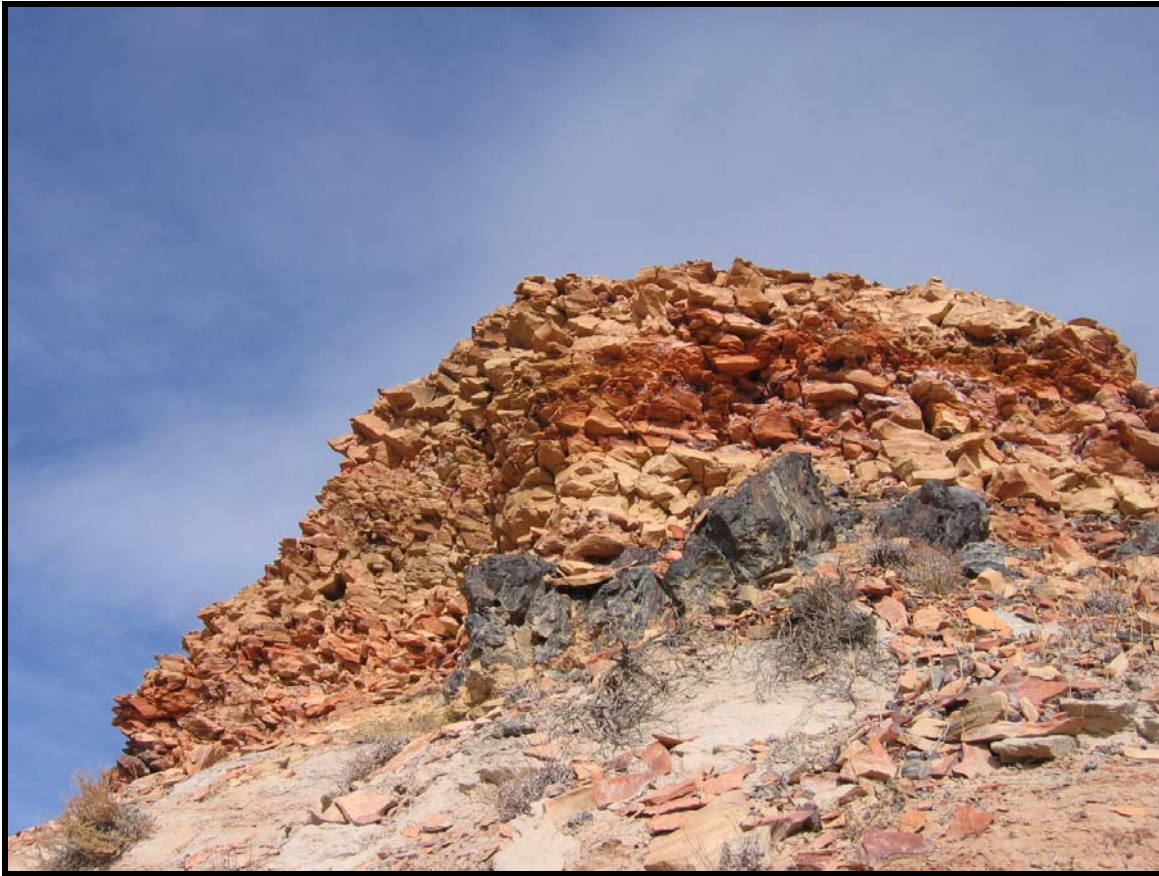
Photo: 1\_30\_06\_19

**ROCK OUTCROP FEATURE: RO\_0232**

**GEOMETRIC DIMENSIONS:** Area of outcrop: 0.04 acres

**DESCRIPTION OF FEATURE:** The scoria outcrop shown above is located at the top of a steep hill composed of soft sandy silt soil. This feature is located above feature RO\_0231 (see photo 1\_30\_06\_18 associated with rock outcrop feature RO\_0231). The face of this outcrop is fractured and jagged and has an average height of about 15 feet.

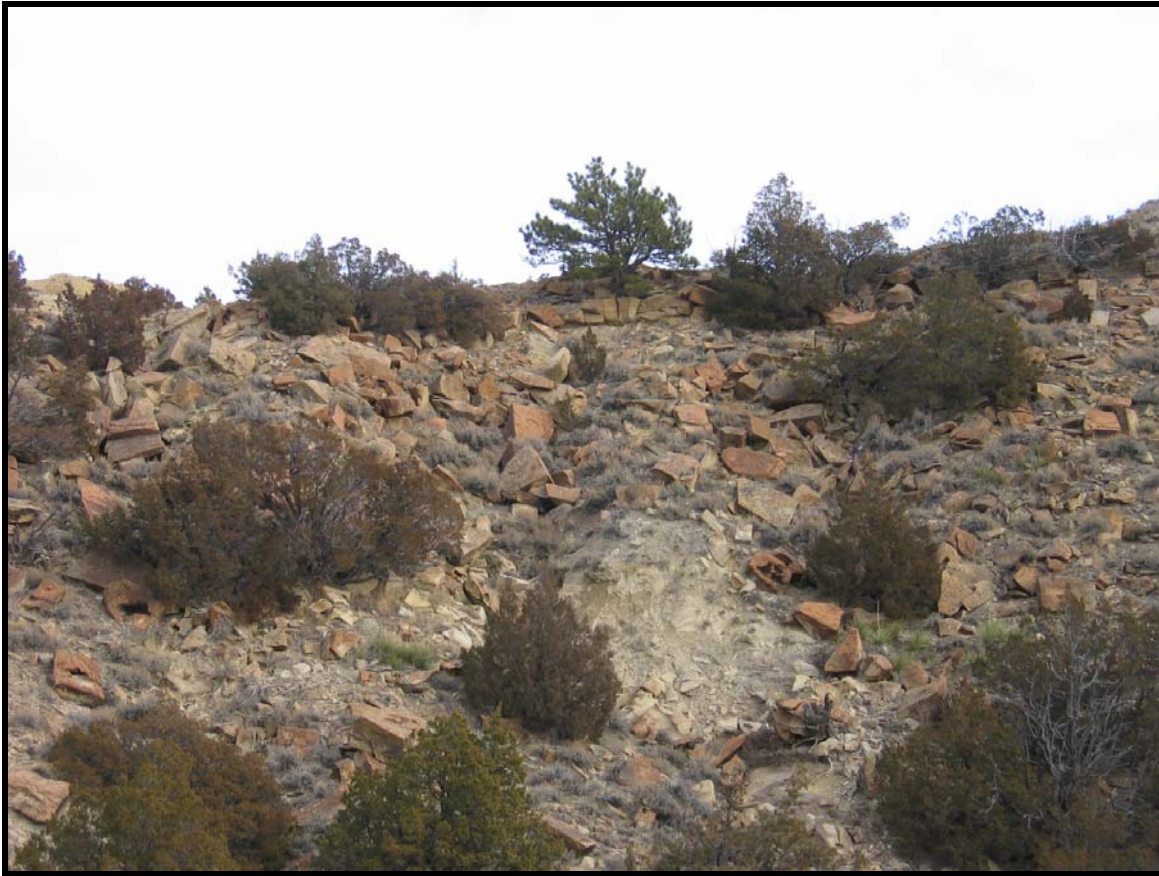
Photo: 1\_30\_06\_20

**ROCK OUTCROP FEATURE: RO\_0233**

**GEOMETRIC DIMENSIONS:** Area of outcrop: 2.5 acres

**DESCRIPTION OF FEATURE:** The rock outcrop shown above is composed of the same type of rock as feature RO\_0231. This outcrop was created by the erosion of the soil beneath a sandstone/siltstone rock layer, causing the rock to break free and be deposited on the slope below.

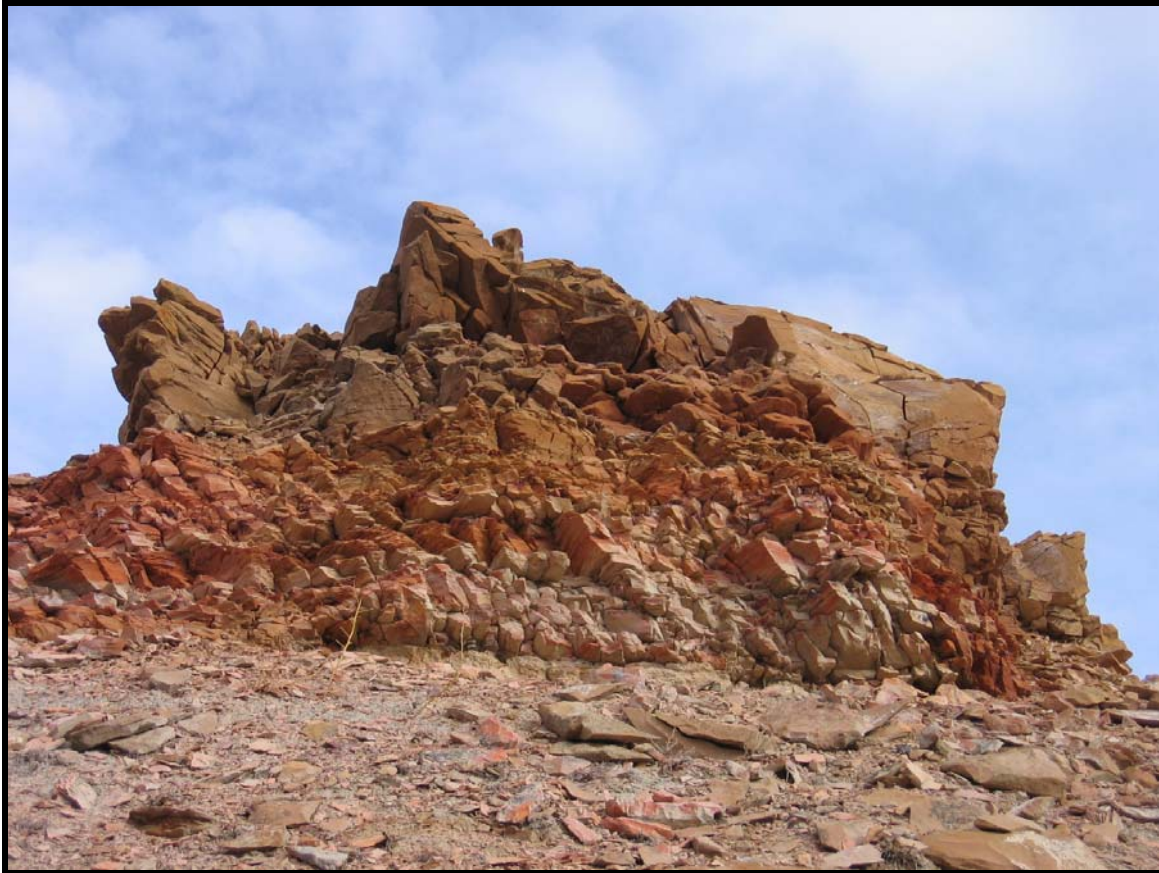
Photo: 1\_30\_06\_30

**ROCK OUTCROP FEATURE: RO\_0241**

**GEOMETRIC DIMENSIONS:** Length: 145 ft      Height: 15 ft

**DESCRIPTION OF FEATURE:** The scoria outcrop shown above is located at the top of a steep hill composed of soft sandy silt soil. The face of this feature is fractured and jagged, leaving areas for possible habitat.

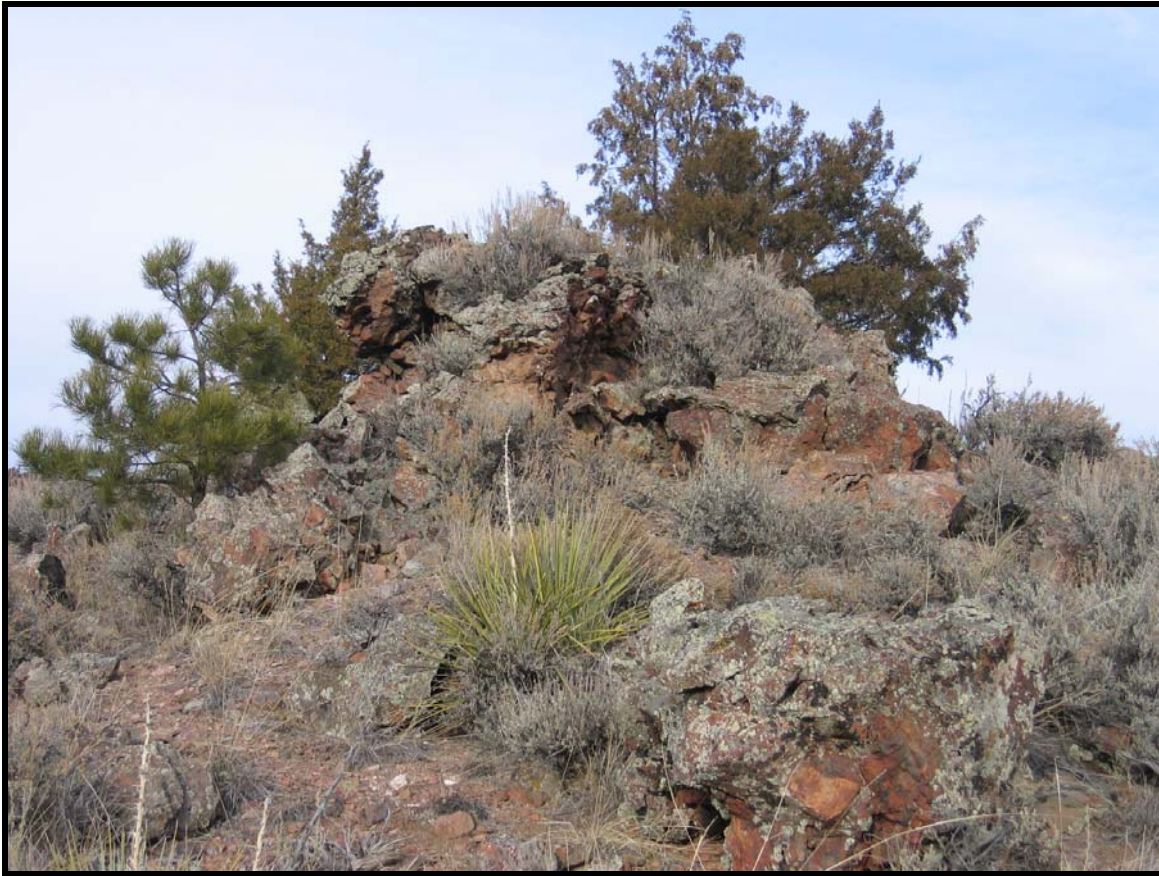
Photo: 1\_30\_06\_31

**ROCK OUTCROP FEATURE: RO\_0242**

**GEOMETRIC DIMENSIONS:** Length: 85 ft      Height: 5 ft

**DESCRIPTION OF FEATURE:** The scoria outcrop shown above overlooks feature R\_0057. The dark scoria is covered with lichens and is piled to a height of approximately five feet. The vegetation surrounding this feature is grass, sagebrush and some small trees.

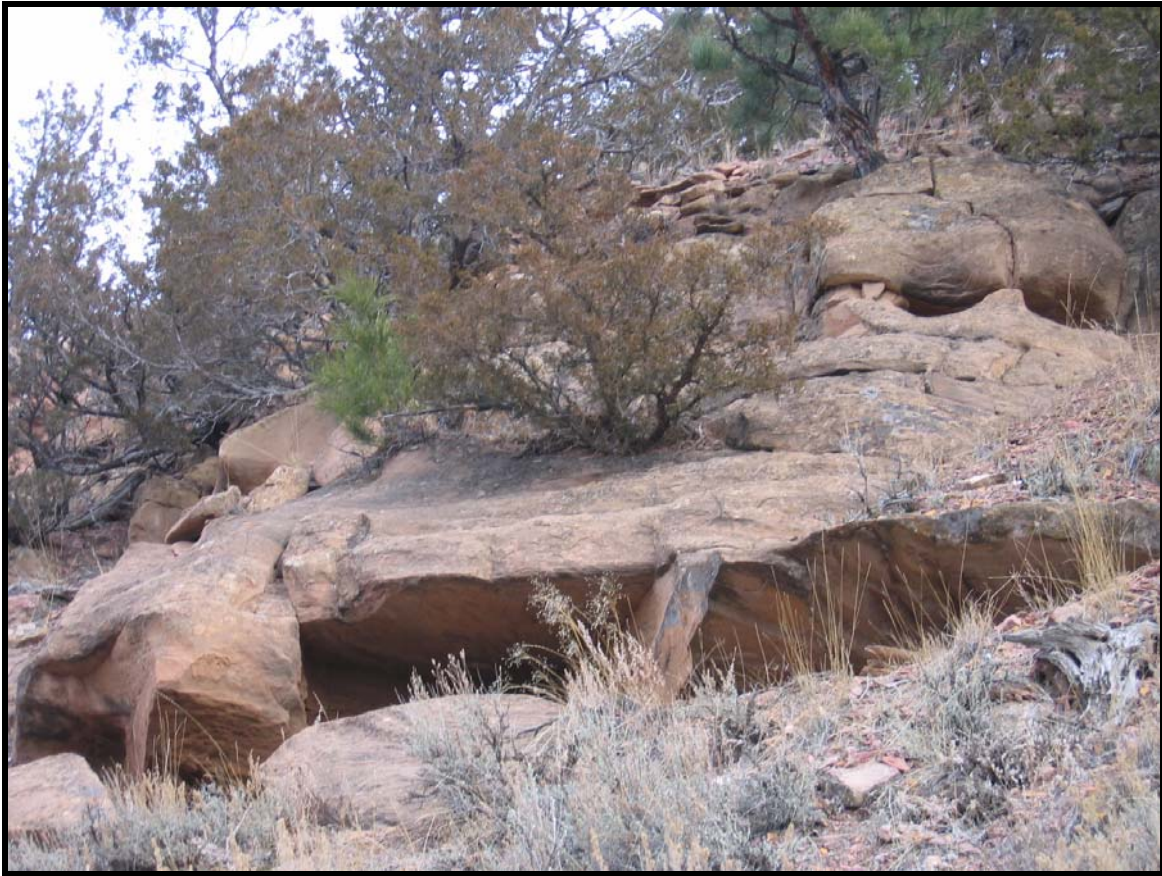
Photo: 1\_30\_06\_42

**ROCK OUTCROP FEATURE: RO\_0243**

**GEOMETRIC DIMENSIONS:** Length: 160 ft      Height: 20 ft

**DESCRIPTION OF FEATURE:** The rock outcrop feature shown above is located between cliffs C\_0054 and C\_0055. The rocks in this outcrop are large, weathered and generally low-lying. The feature is located towards the top of the slope overlooking riparian feature R\_0056.

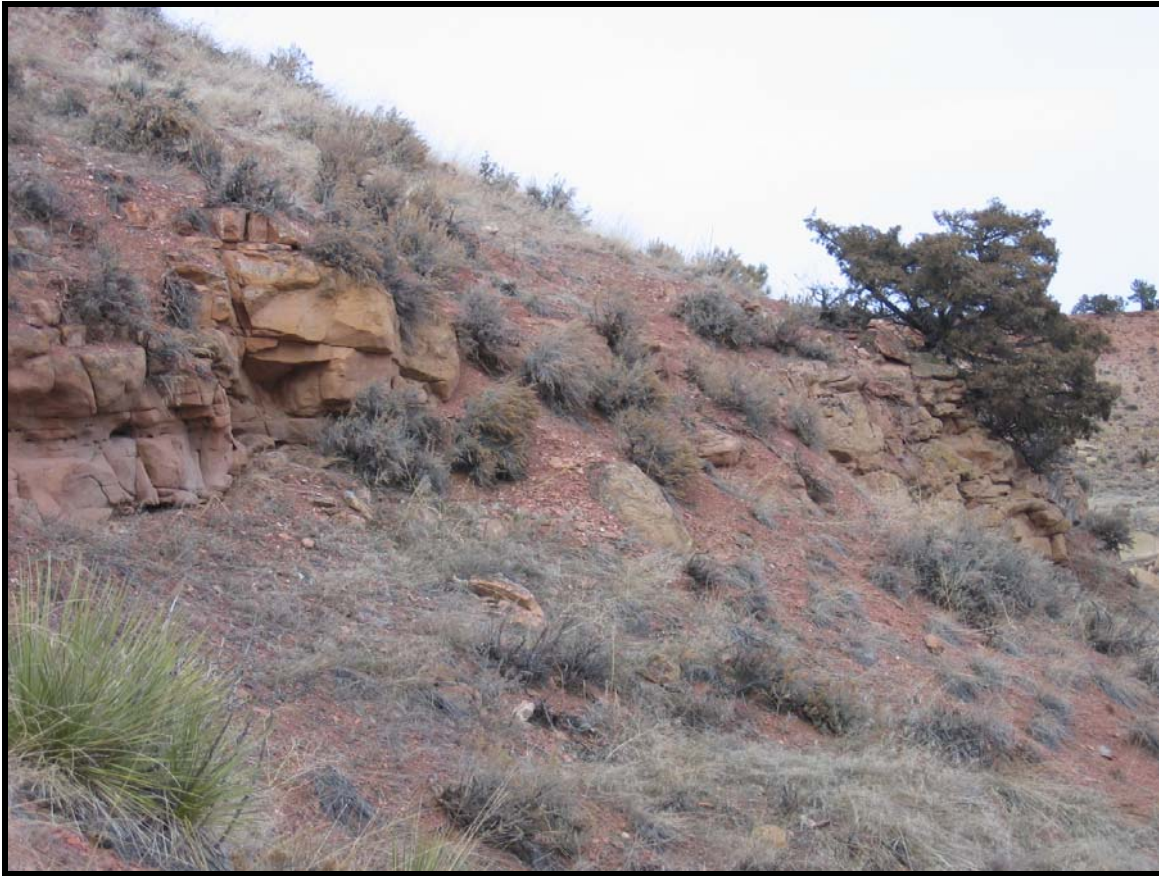
Photo: 1\_30\_06\_46

**ROCK OUTCROP FEATURE: RO\_0244**

**GEOMETRIC DIMENSIONS:** Length: 110 ft      Height: 10 ft

**DESCRIPTION OF FEATURE:** The rock outcrop shown above is adjacent to cliff feature C\_0056 and overlooks riparian feature R\_0056. The face of this feature is fractured and jagged. Holes below in within the rock face provide habitat for different species.
