**Township 8S, Range 39E**

**SECTION 14**

*Cliff Features*

Revised 4/06; Reference - South Fork Extension Amendment #00174

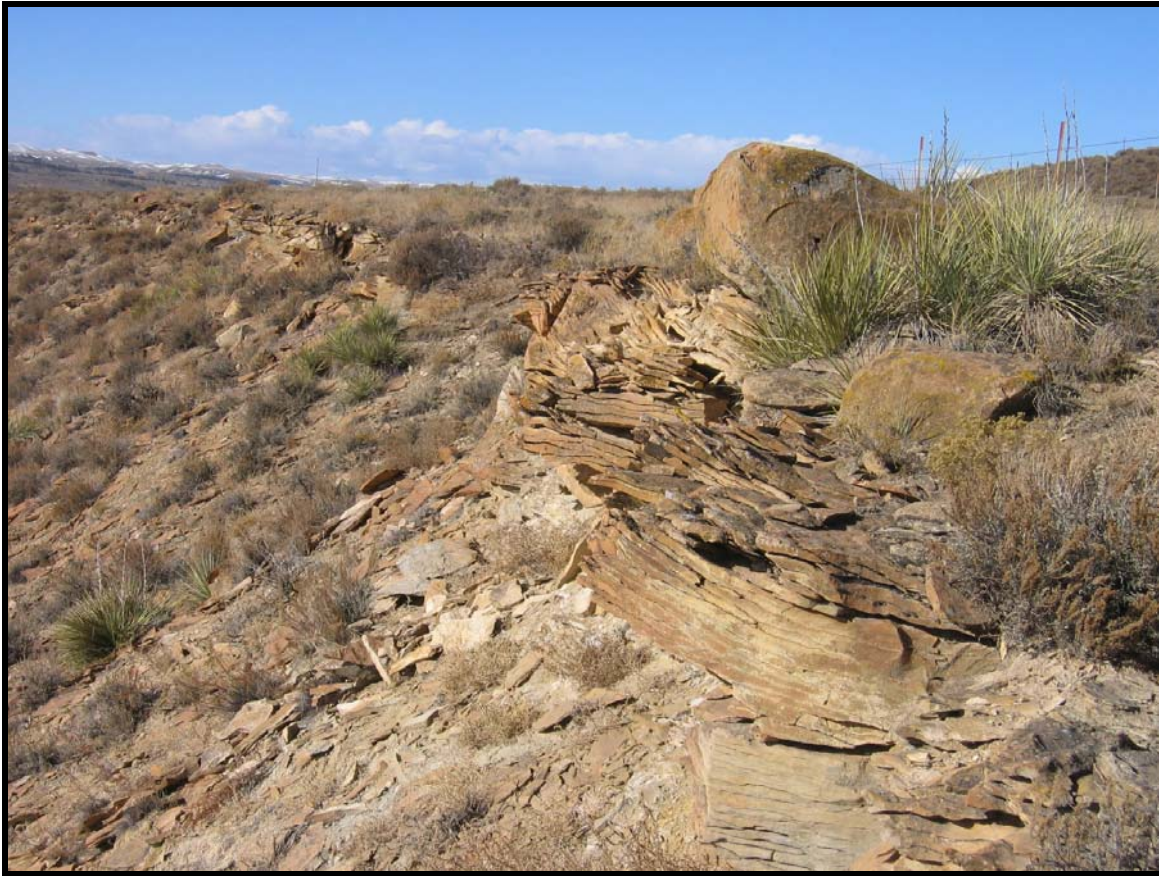
Photo: 2\_1\_06\_24

**ROCK OUTCROP FEATURE: RO\_0261**

**GEOMETRIC DIMENSIONS:** Length: 415 ft      Height: 5 ft

**DESCRIPTION OF FEATURE:** The rock outcrop shown above is composed of layered sandstone/siltstone rock that sits at the top of a sandy silt slope. The feature overlooks the Spring Creek channel and has significant length.

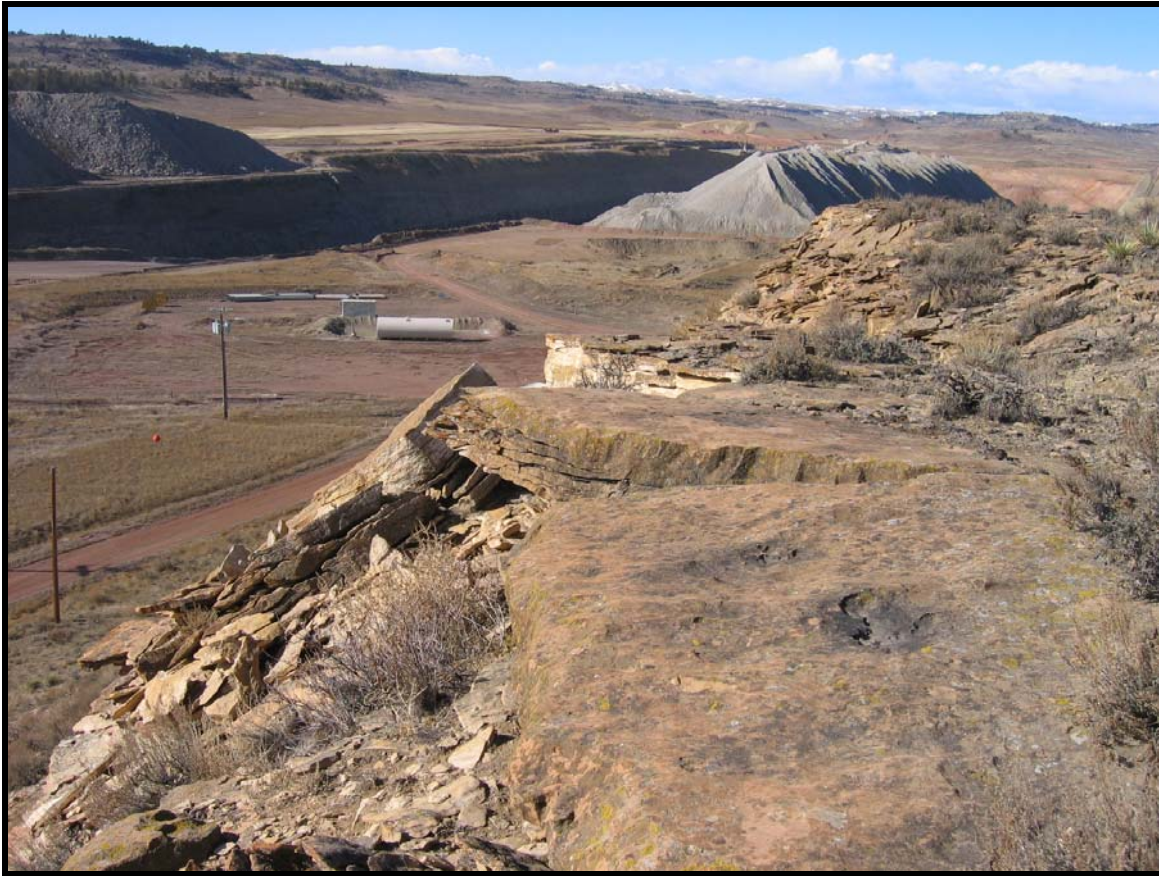
Photo: 2\_1\_06\_25

**ROCK OUTCROP FEATURE: RO\_0262**

<b>FEATURE TYPE:</b>	Rock Outcrop		
<b>GEOMETRIC DIMENSIONS:</b>	Length: 360 ft	Height: 10 ft	
<b>LOCATION:</b>	Township: 8S	Range: 39E	Section: 14
<b>HANDHELD GPS POINTS:</b>	<b>Northing</b>	<b>Easting</b>	
	<b>16060</b>	421351.84	2667770.77
	<b>16061</b>	421703.73	2667710.34

**DESCRIPTION OF FEATURE:** The rock outcrop shown above is composed of layered sandstone/siltstone rock that sits at the top of a sandy silt slope. The feature overlooks the Spring Creek channel and has significant length. This feature is located adjacent to feature RO\_0262 and is composed of rock that has very similar characteristics.

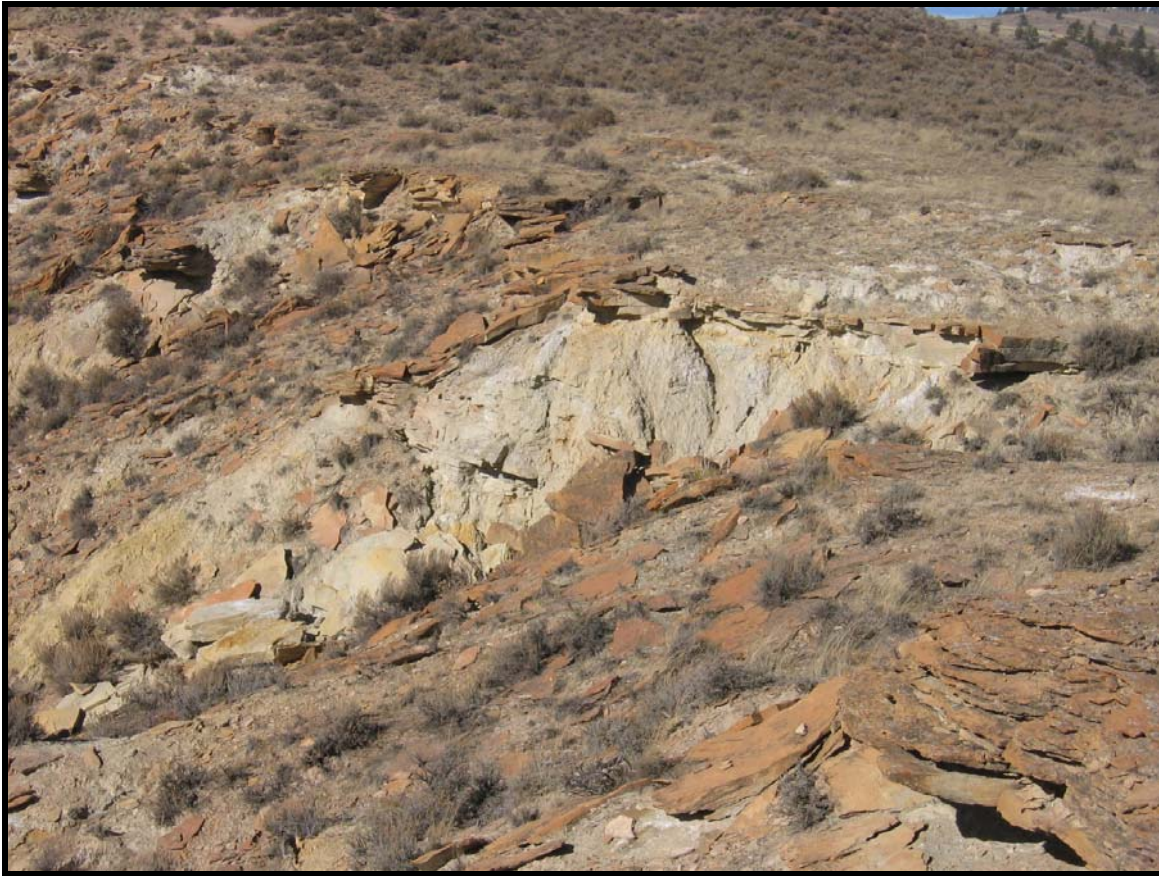
Photo: 2\_1\_06\_26

**ROCK OUTCROP FEATURE: RO\_0263**

FEATURE TYPE:	Rock Outcrop					
GEOMETRIC DIMENSIONS:	Area of outcrop: 0.54 acres					
LOCATION:	Township: 8S		Range: 39E		Section: 14	
HANDHELD GPS POINTS:		Northing	Easting		Northing	Easting
	16062	421749.85	2667670.12	16065	422266.84	2667413.27
	16063	421751.10	2667708.81	16066	422294.83	2667376.21
	16064	422116.61	2667392.3			
SUBSTRATE:	Sandstone/siltstone					
EXPOSURE:	Southern facing slope					
DESCRIPTION OF FEATURE:	The rock outcrop shown above is composed of layered sandstone/siltstone rock that sits at the top of a sandy silt slope. The rock layer has eroded, causing rocks to get deposited on the slope below. These low-lying rocks are highly populated over the entire area of the outcrop.

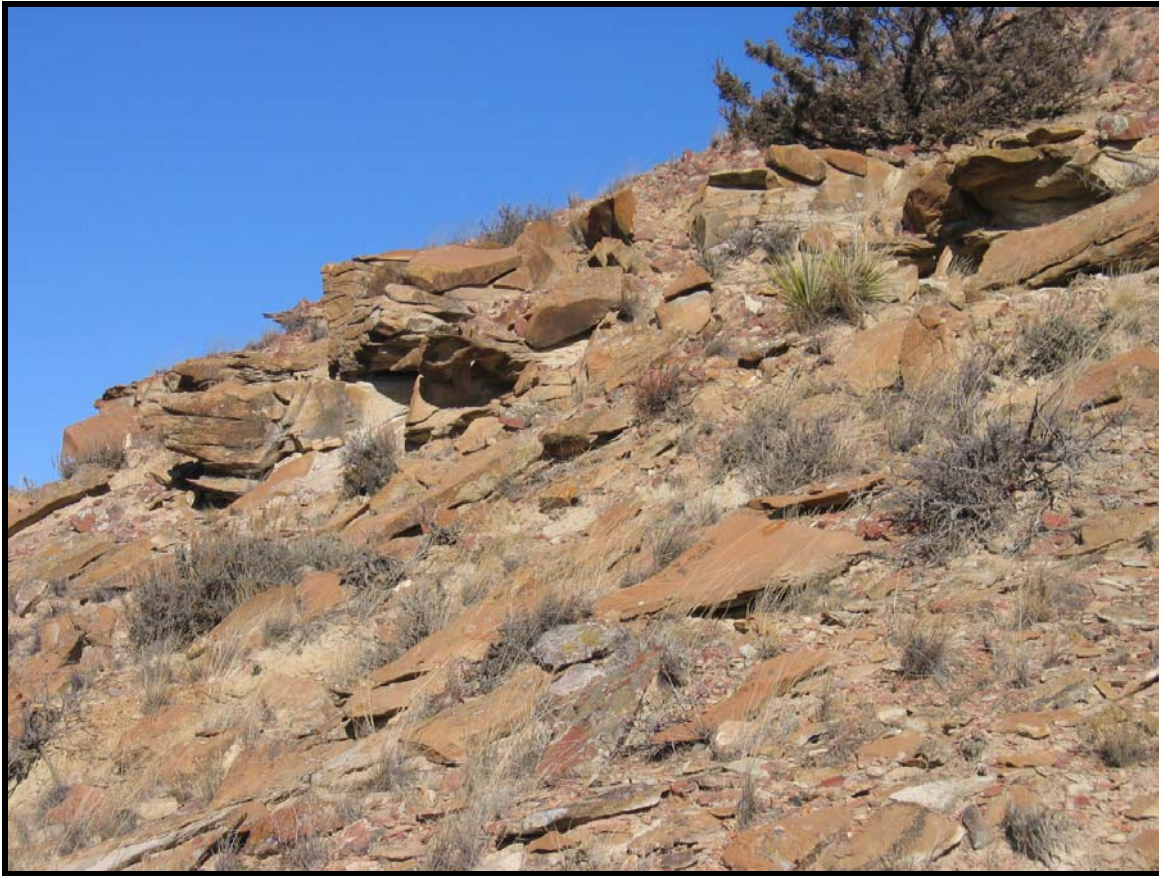
Photo: 2\_1\_06\_27

**ROCK OUTCROP FEATURE: RO\_0264**

**GEOMETRIC DIMENSIONS:** Area of outcrop: 0.03 acres

**DESCRIPTION OF FEATURE:** The rock outcrop shown above is composed of layered sandstone/siltstone rock that sits at the top of a sandy silt slope. The rock layer has eroded, causing rocks to get deposited on the slope below. This feature is very similar to features RO\_0261, RO\_0262, and RO\_0263 and is located in the same general location. This feature, however, has larger rocks that stand taller.

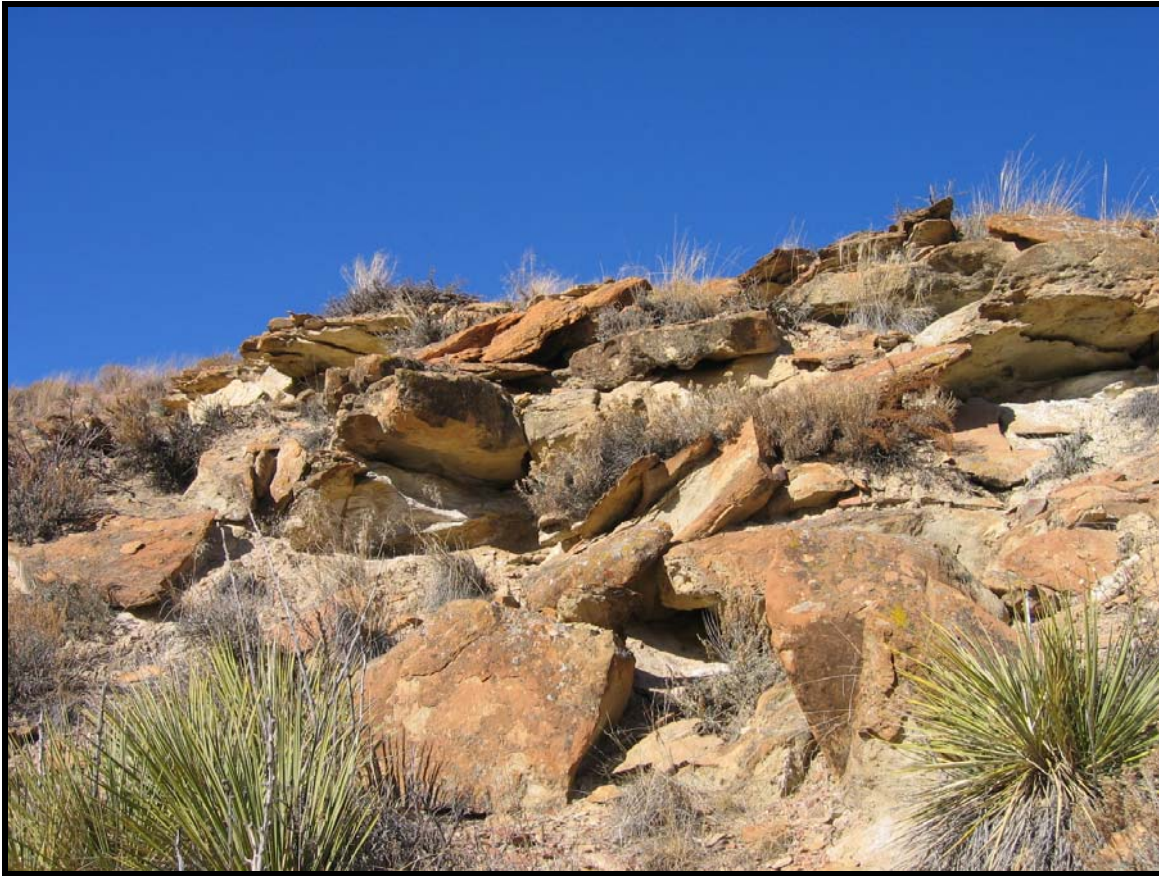
Photo: 2\_1\_06\_29

**ROCK OUTCROP FEATURE: RO\_0265**

<b>FEATURE TYPE:</b>	Rock Outcrop				
<b>GEOMETRIC DIMENSIONS:</b>	Area of outcrop: 3.66 acres				
<b>LOCATION:</b>	Township: 8S		Range: 39E		Section: 14
<b>HANDHELD GPS POINTS:</b>		<b>Northing</b>	<b>Easting</b>		<b>Northing</b>
	<b>16072</b>	423076.50	2667635.00	<b>16075</b>	423582.93
	<b>16073</b>	423018.45	2667644.63	<b>16076</b>	423514.21
	<b>16074</b>	423053.51	2667261.34		2667050.59
					2667181.92

**DESCRIPTION OF FEATURE:** The large rock outcrop shown above has dynamic characteristics over its area. The outcrop consists of thin sandstone/siltstone rock in one section and large solid-faced sandstone in another section. The outcrop was included as one feature because there was no breaking point. See the pictures on the next page for additional views of this feature.

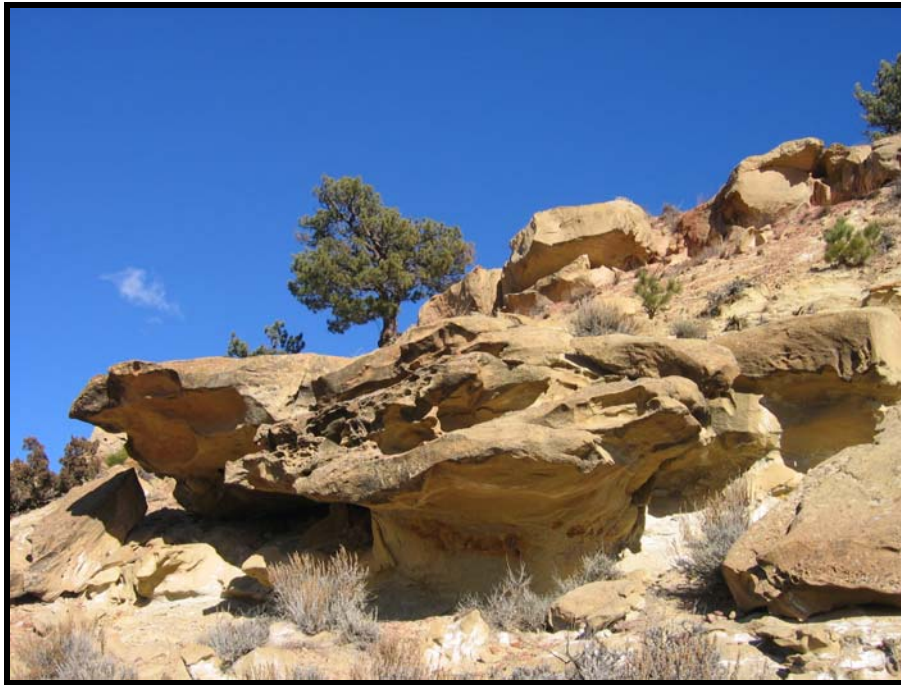
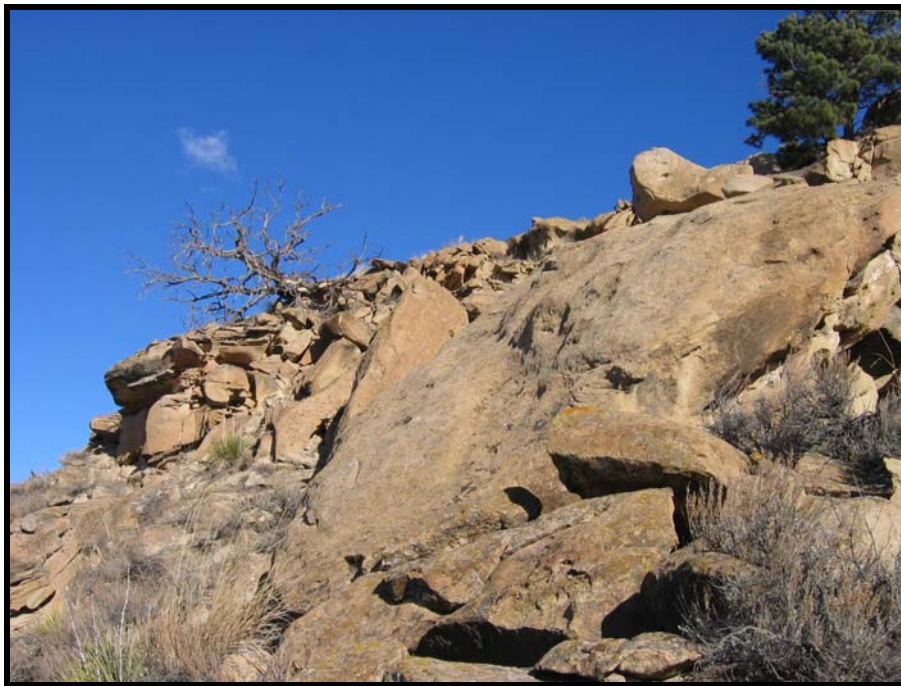
**ROCK OUTCROP FEATURE: RO\_0265**

Photo: 2\_1\_06\_30

Photo: 2\_1\_06\_31

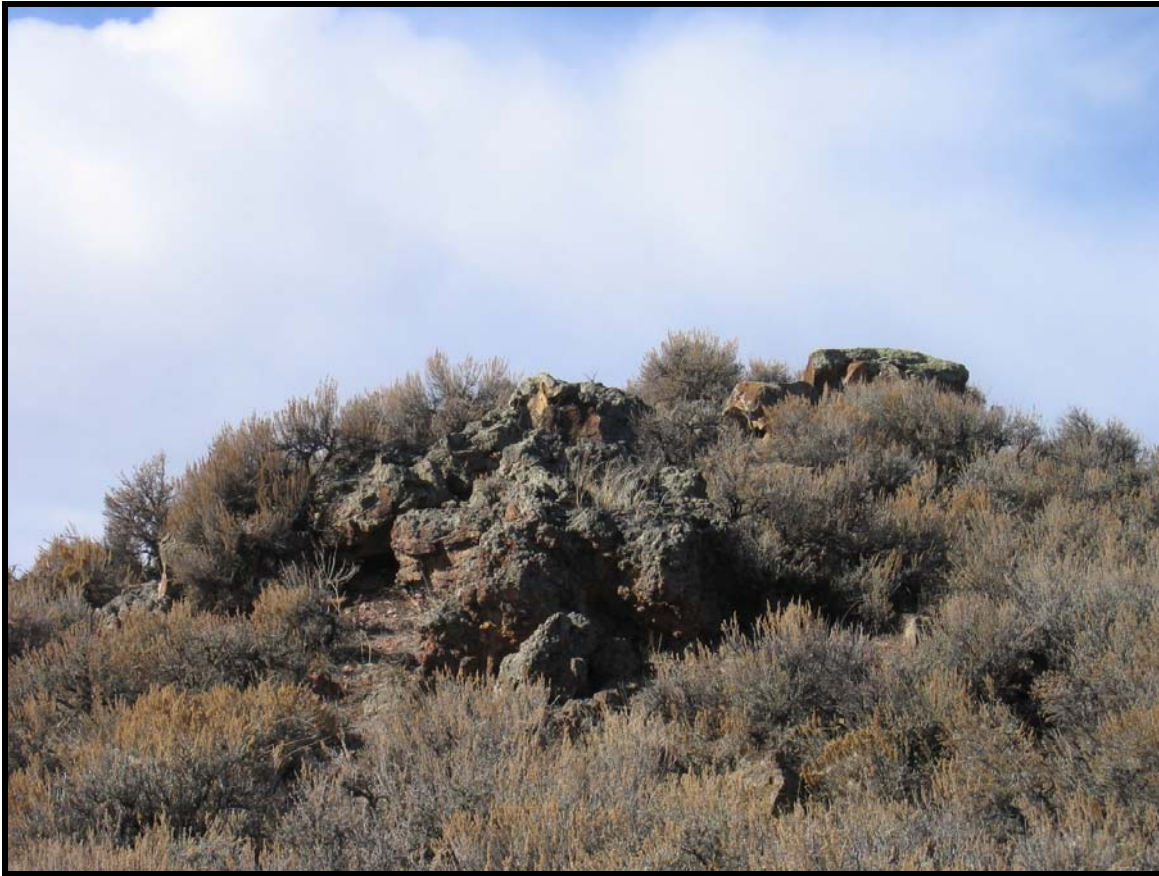
Photo: 2\_1\_06\_32

**ROCK OUTCROP FEATURE: RO\_0266**

**GEOMETRIC DIMENSIONS:** Area of outcrop: 0.22 acres

**DESCRIPTION OF FEATURE:** The scoria outcrop shown above is located on a relatively flat slope. The dark scoria is covered with lichens and is piled to a height of approximately five feet. The vegetation surrounding this feature is grass and sagebrush.

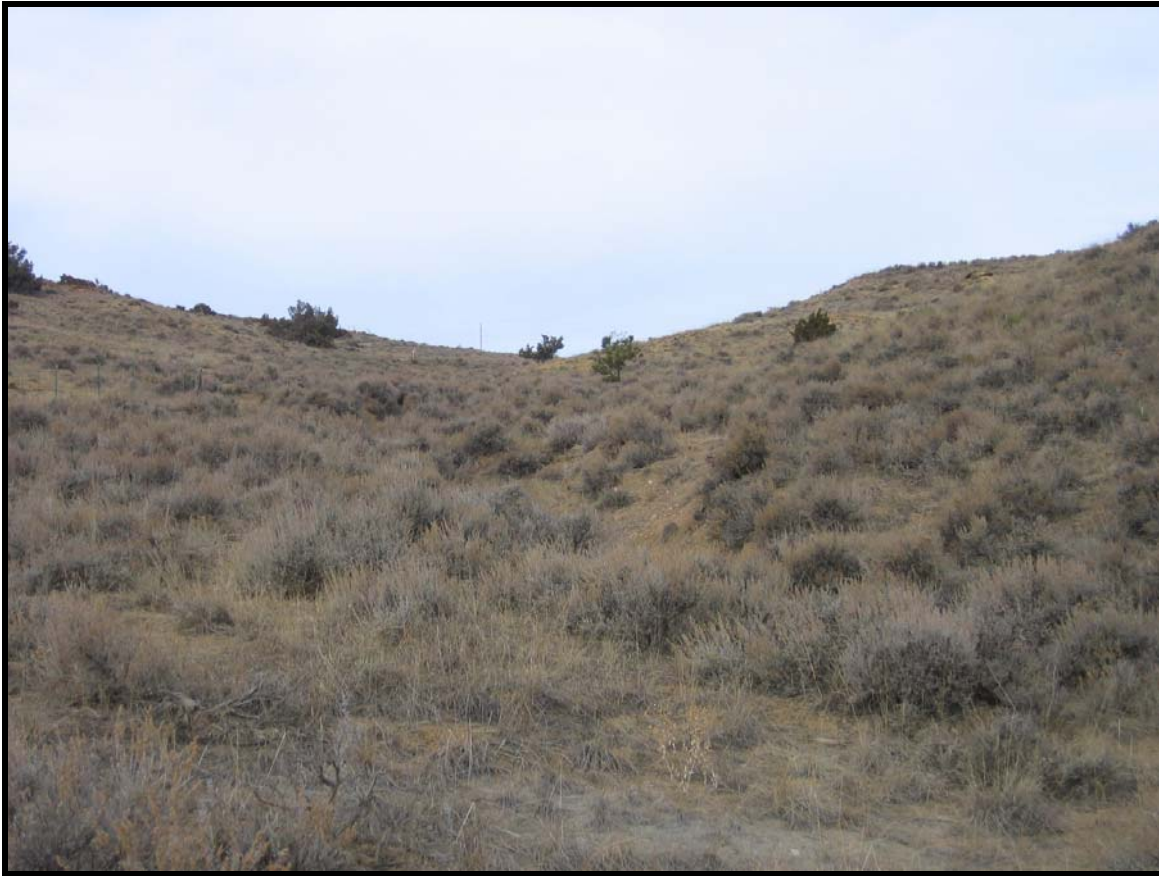
Photo: 1\_30\_06\_08

**RIPARIAN FEATURE: R\_0054**

**DESCRIPTION OF FEATURE:** The small draw shown above is a tributary to Spring Creek. The channel bottom is approximately five feet wide and has eroded the sandy silt subsoil. The bottom is vegetated with grass and sagebrush.

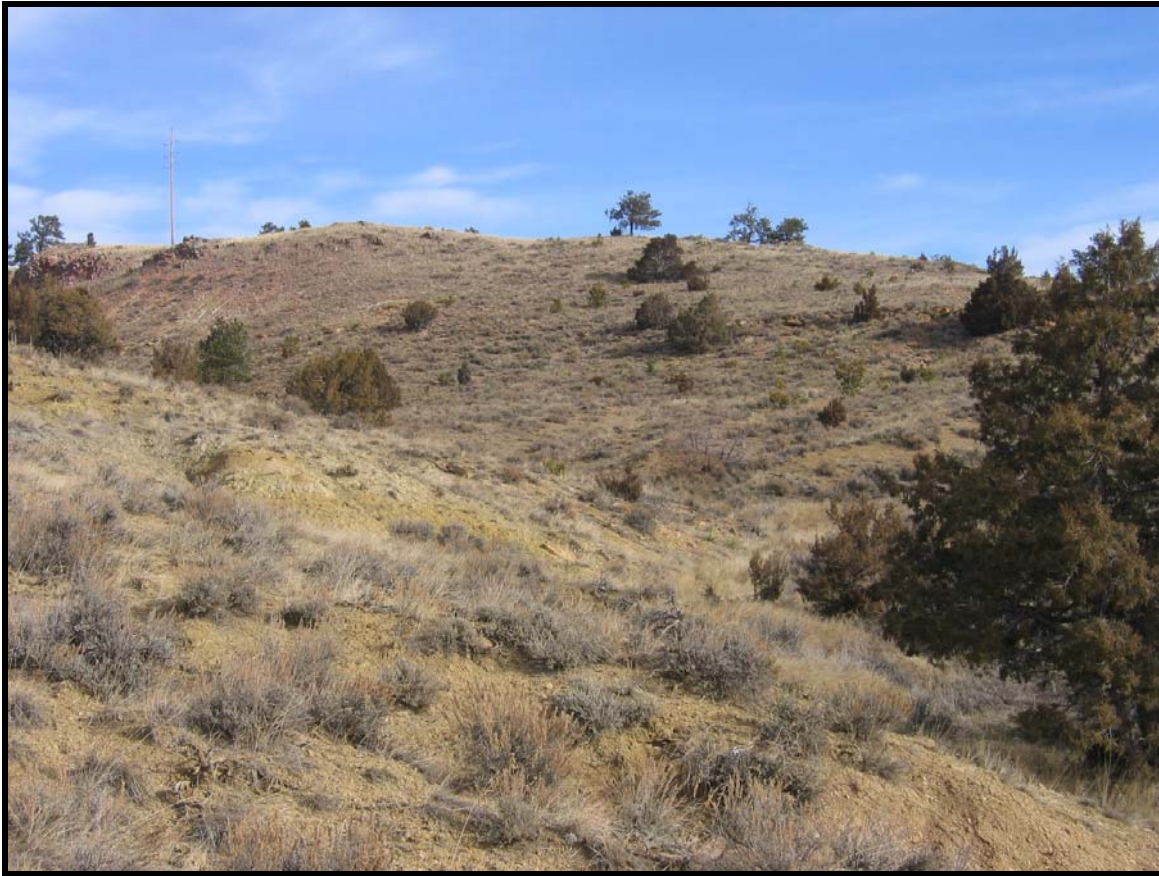
Photo: 1\_30\_06\_09

**RIPARIAN FEATURE: R\_0055**

**DESCRIPTION OF FEATURE:** The small draw shown above is a tributary to Spring Creek. The channel bottom varies in width and has eroded the sandy silt subsoil. The hills surrounding the channel are steep (greater than 3H:1V) and composed of highly erosive soil. The bottom is vegetated with grass, sagebrush, and some small trees.

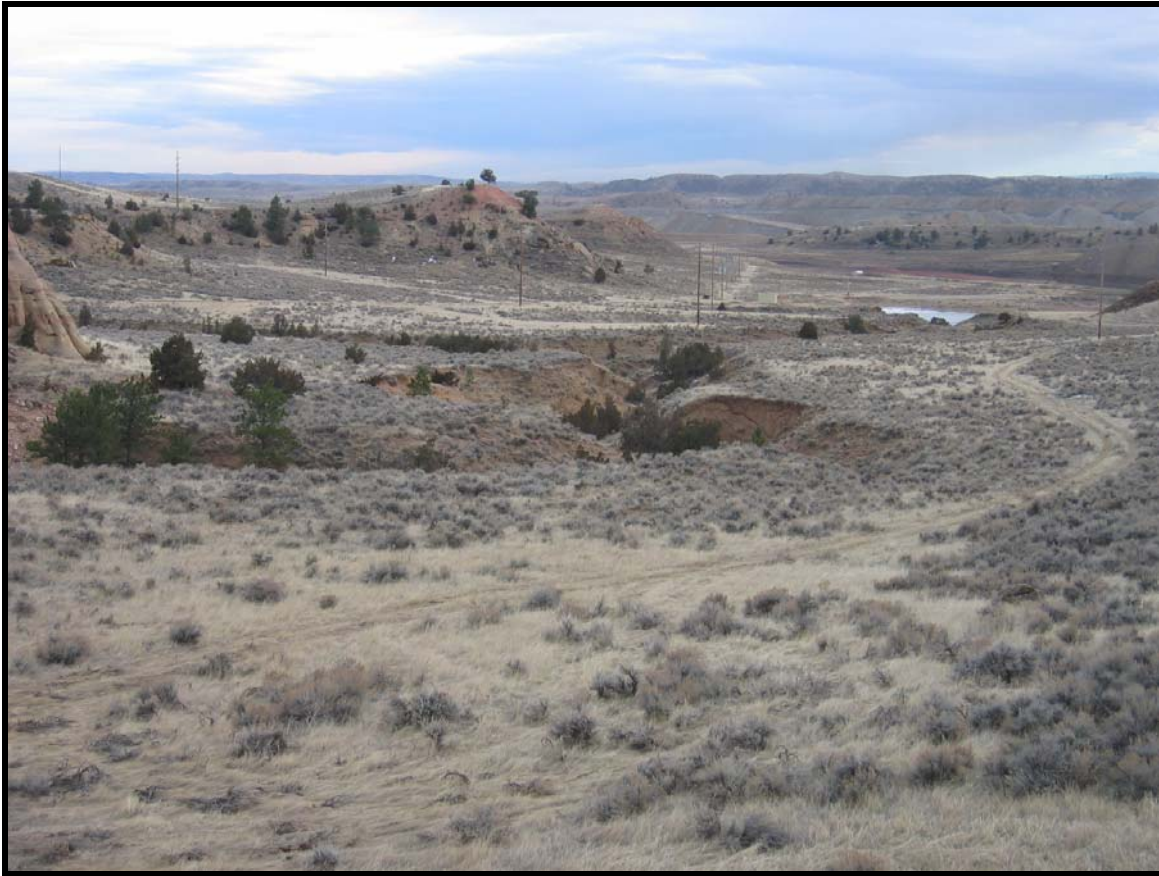
Photo: 1\_30\_06\_45

**RIPARIAN FEATURE: R\_0056**

**DESCRIPTION OF FEATURE:** The draw shown above has a very dynamic geometry. At the head of the draw, there are large deep cuts into sandy silt soil and sandstone, creating trenches that are nearly 30 feet deep in some areas. Towards the bottom of the draw, the channel is nearly twenty feet wide, and cuts deep into the sandy silt soil. As is shown in the picture above, the flood plain is relatively flat and vegetated with grass and sagebrush. See the pictures on the following pages for more views of this channel.

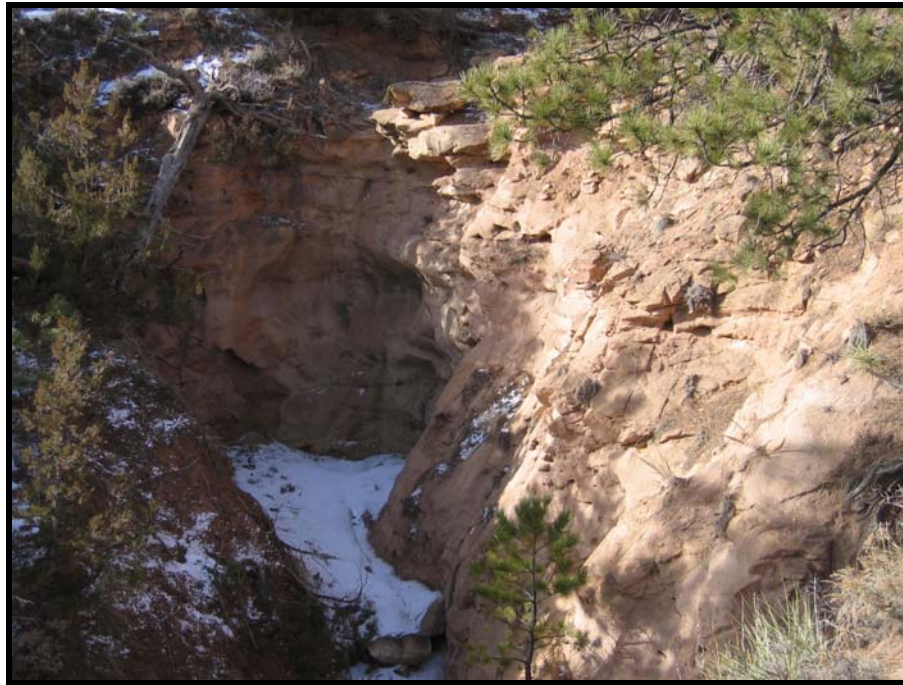
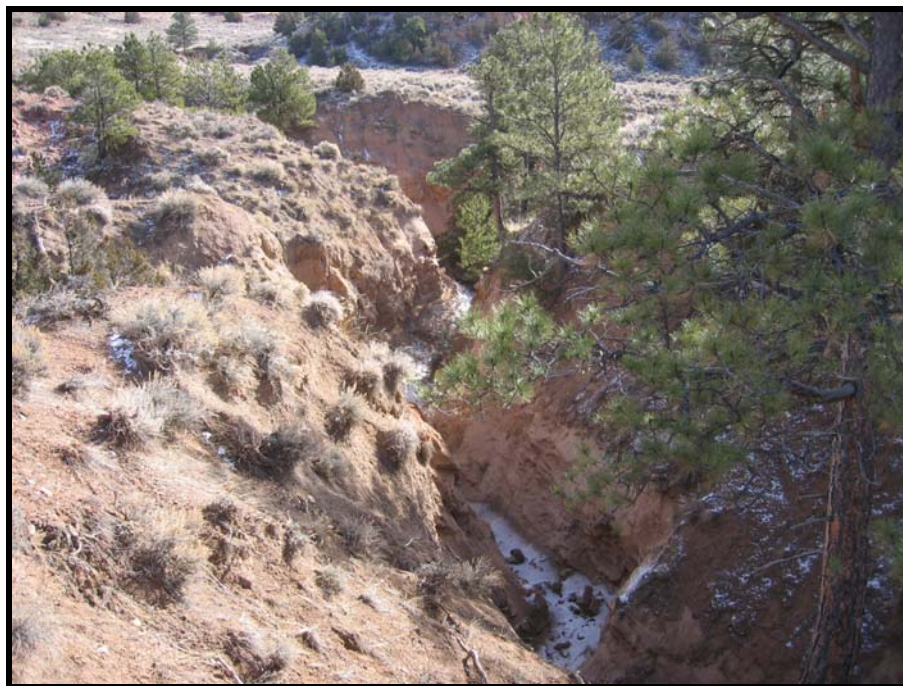
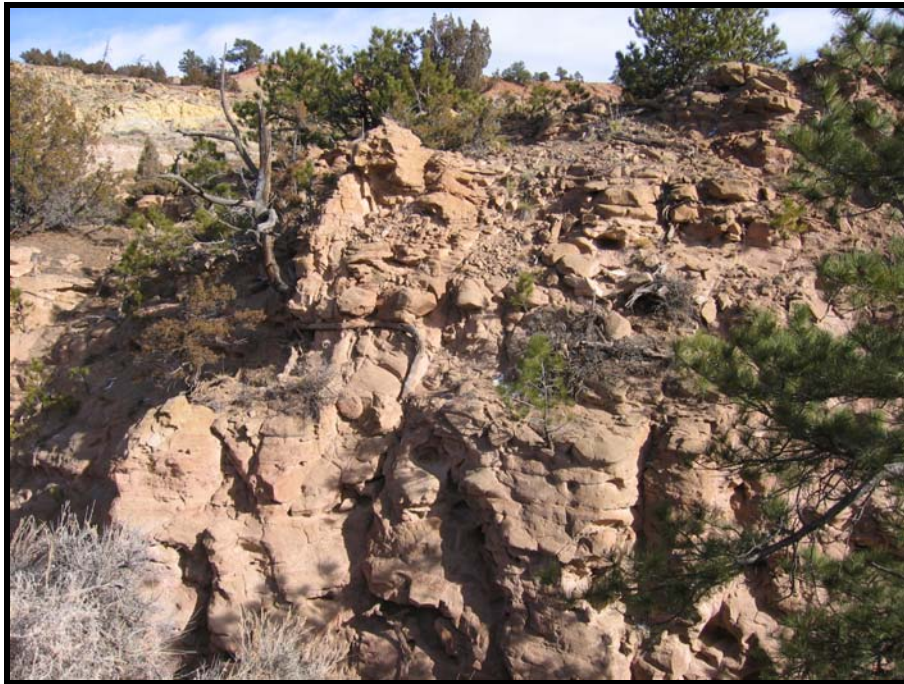
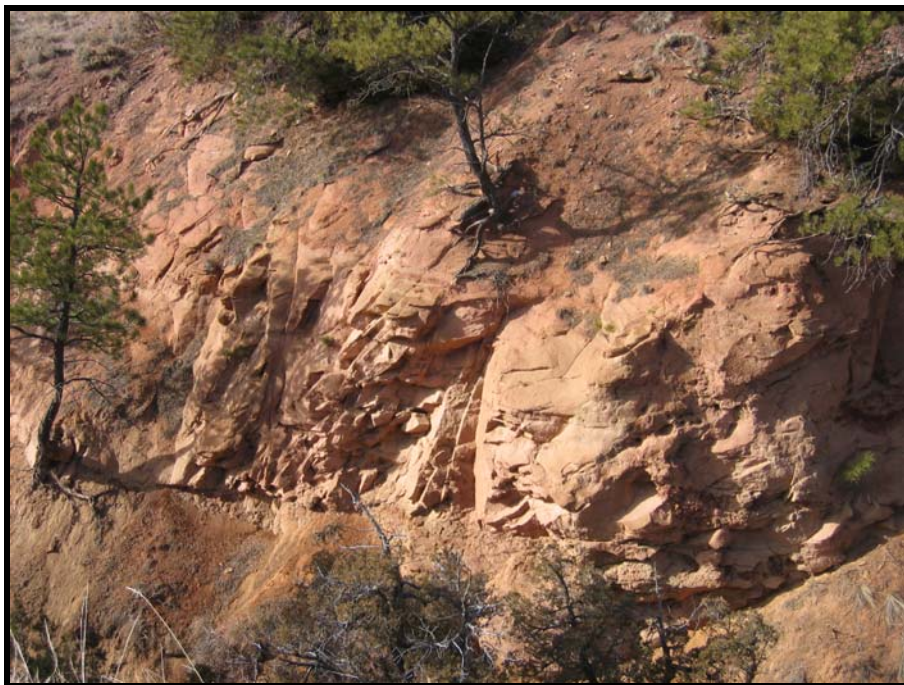
**RIPARIAN FEATURE: R\_0056**

Photo: 1\_30\_06\_14

Photo: 1\_30\_06\_15

Photo: 1\_30\_06\_16

Photo: 1\_30\_06\_17

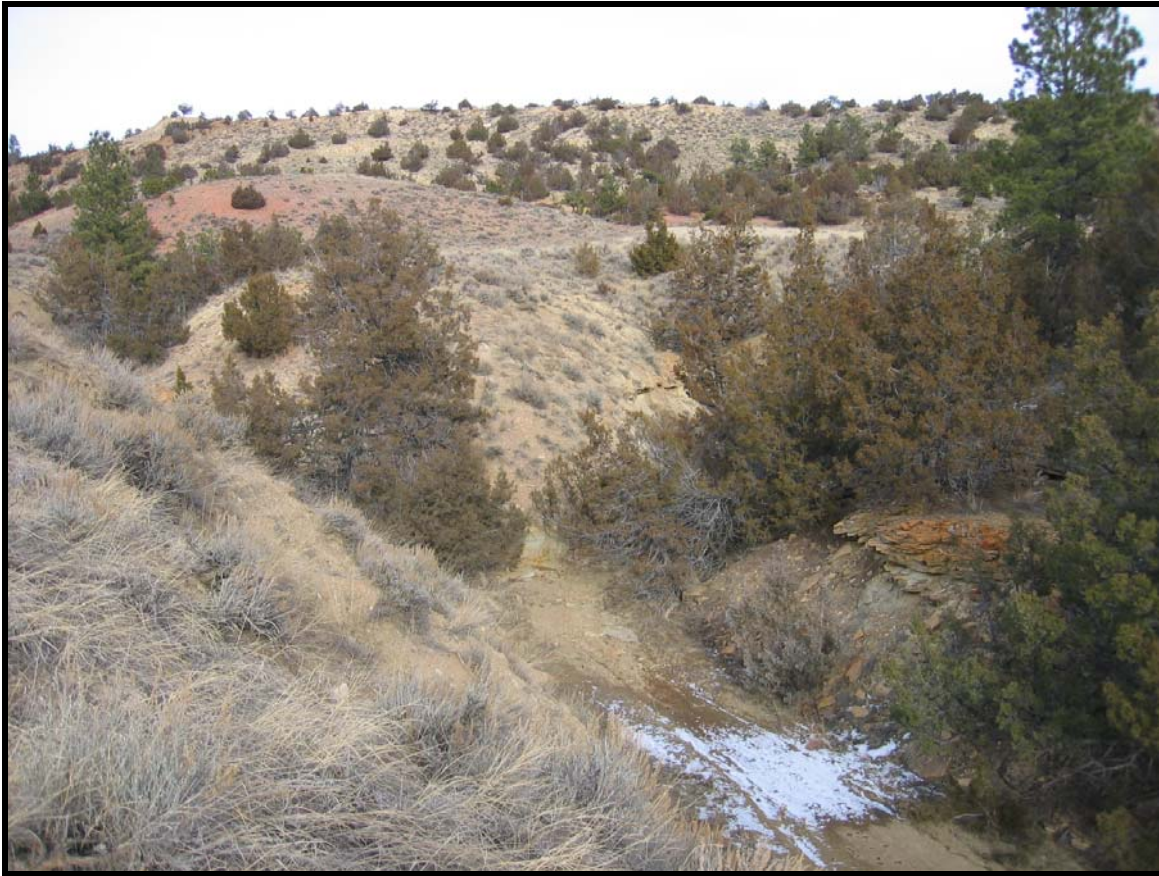
Photo: 1\_30\_06\_32

**RIPARIAN FEATURE: R\_0057**

**DESCRIPTION OF FEATURE:** The small draw shown above is a tributary to Spring Creek. The channel bottom varies in width and has eroded the sandy silt subsoil. The hills surrounding the channel are steep (greater than 3H:1V) and composed of highly erosive soil. When the bottom is not bare sand, it is vegetated with grass, sagebrush, and some small trees.

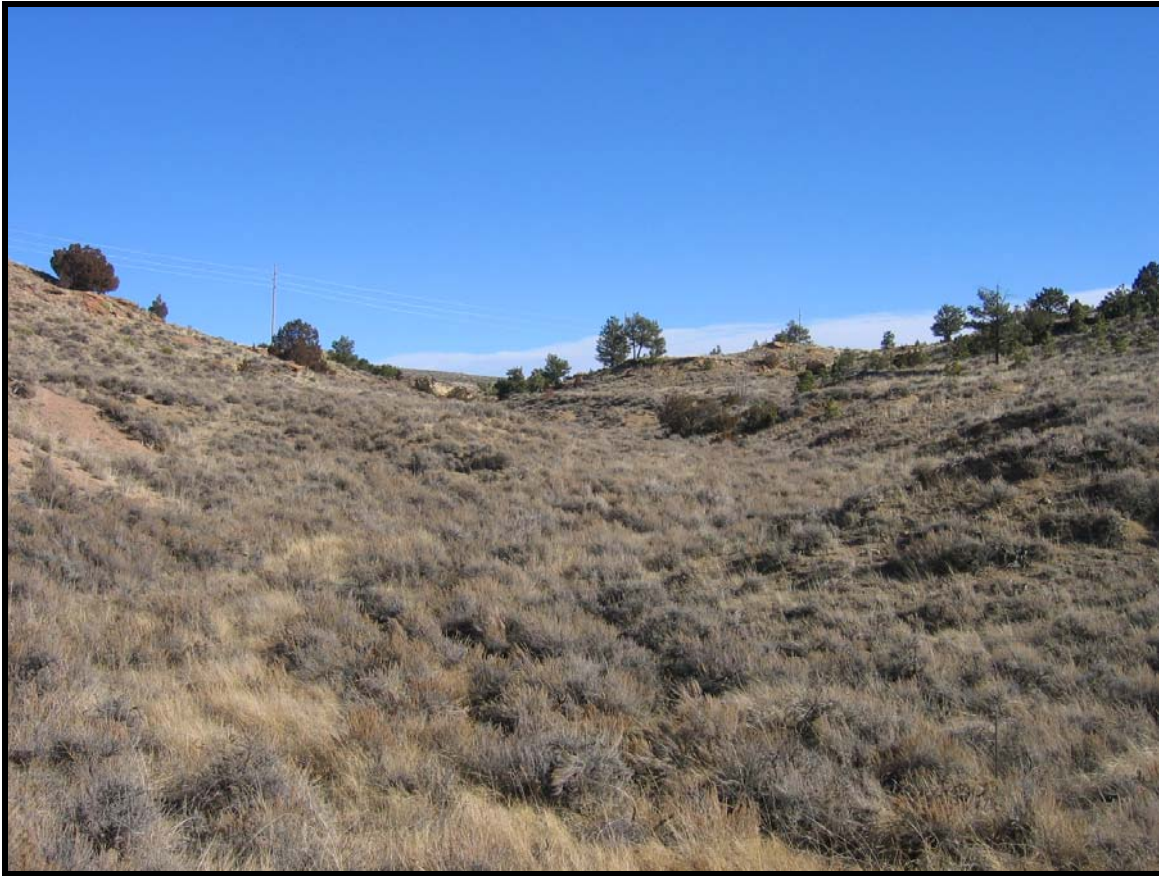
Photo: 2\_1\_06\_28

**RIPARIAN FEATURE: R\_0060**

**DESCRIPTION OF FEATURE:** The draw shown above has a rounded, undefined channel bottom that is vegetated with dense grass and sagebrush. This draw is a tributary to Spring Creek.

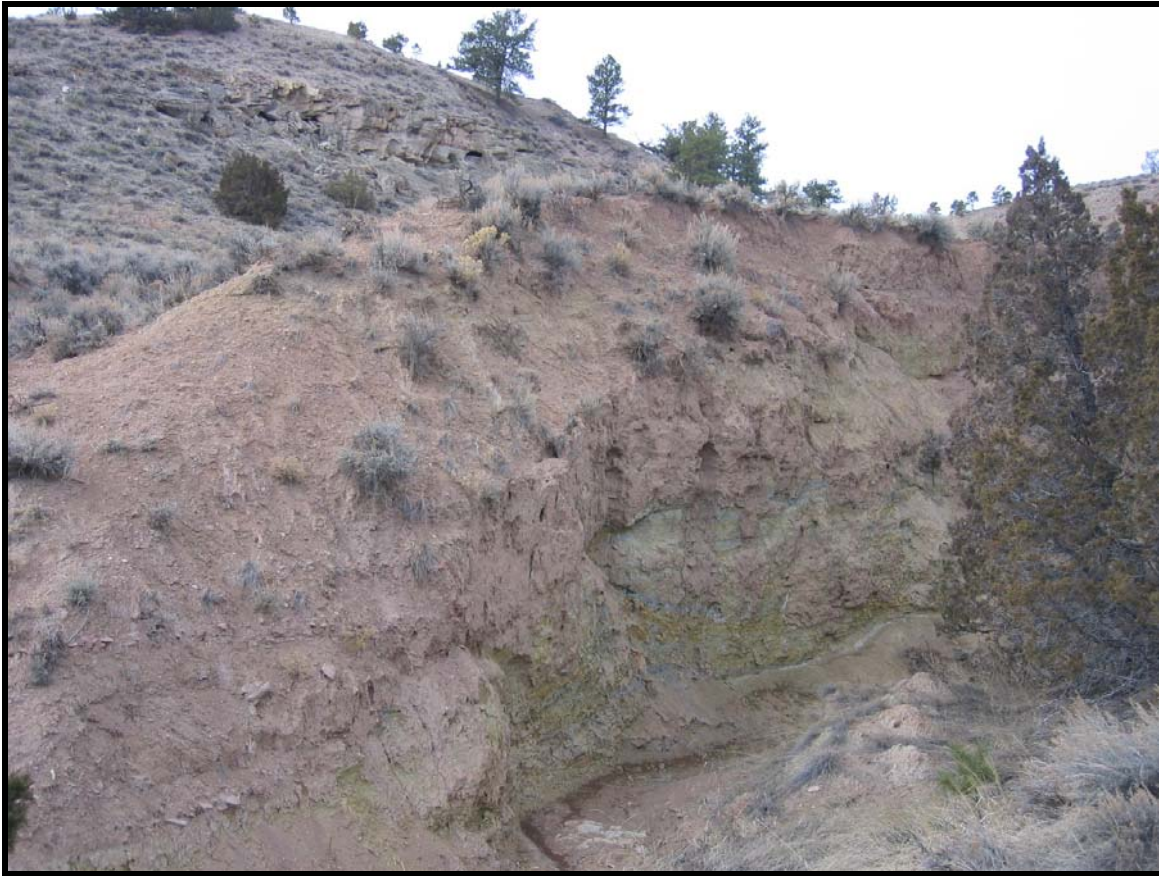
Photo: 1\_30\_06\_43

**OTHER FEATURE: O\_0019**

**FEATURE TYPE:** Cutbank

**GEOMETRIC DIMENSIONS:** Length: 140 ft      Height: 40 ft

**DESCRIPTION OF FEATURE:** This cutbank is within riparian feature R\_0056 drainage. The large size and steep face provides holes and habitat for birds and other animals. The soft sandy silt is highly erosive and will continue to erode as flows pass through this drainage.
