**Township 8S, Range 39E**

**SECTION 15**

*Cliff Features*

Revised 4/06; Reference – South Fork Extension Amendment #00174

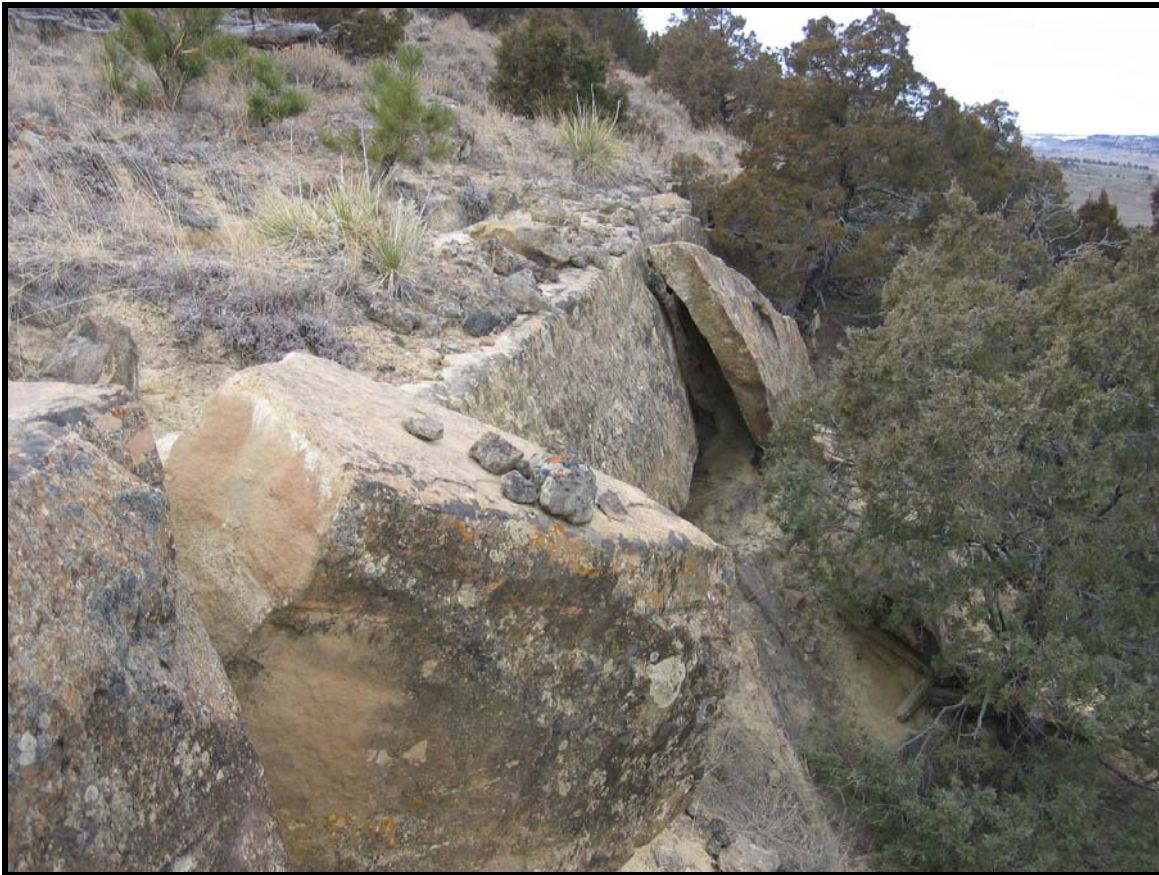
Photo: 1\_26\_06\_25

**CLIFF FEATURE: C\_0050**

**Looking West**

**GEOMETRIC DIMENSIONS:** Length: 870 ft      Height: 10 ft

**SUBSTRATE:** Sandstone/siltstone

**DESCRIPTION OF FEATURE:** The cliff feature shown above travels a significant distance along a moderately sloped hill. The face of the sandstone/siltstone rock is solid and stands approximately 10 feet high. Over the length of the cliff, some areas have broken away and appear more like a rock outcrop. Large rocks are distributed along the hill below the feature. See the pictures on the next page for additional views of this feature.

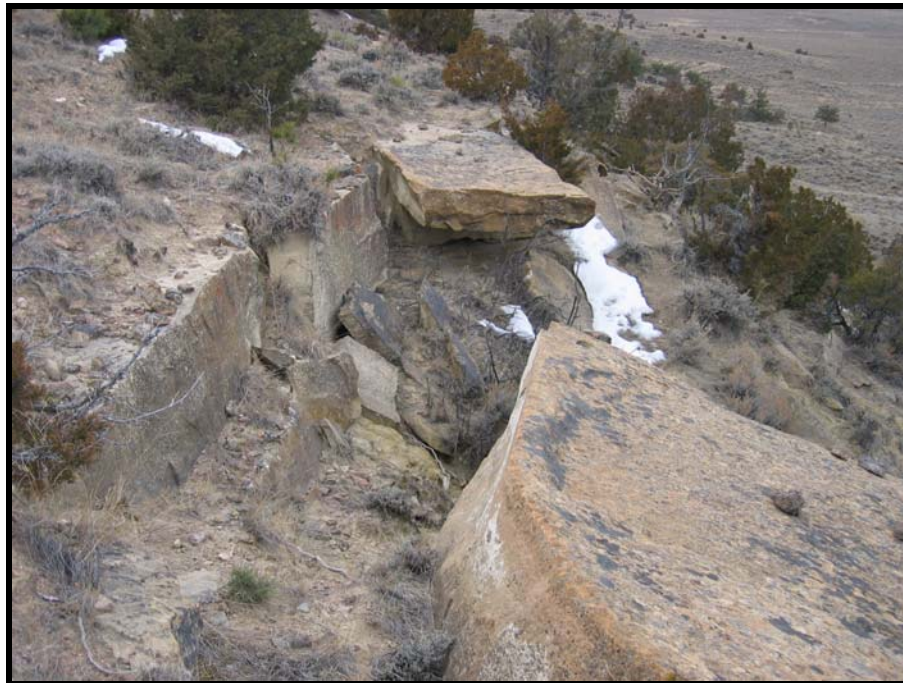
Photo: 1\_26\_06\_26

**CLIFF FEATURE: C\_0050**

**Looking West**

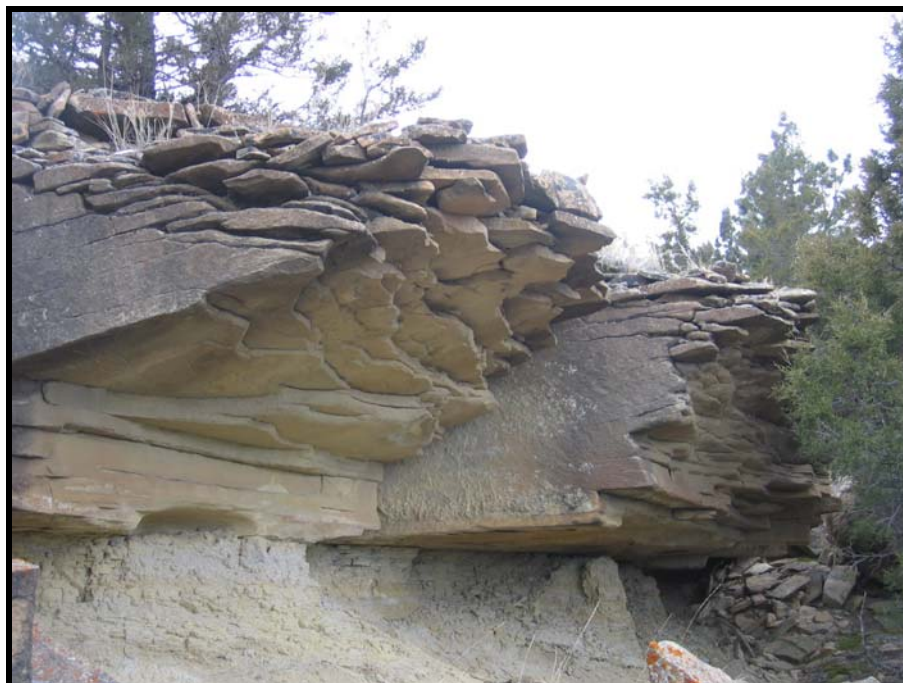
Photo: 1\_26\_06\_28

**Looking South**

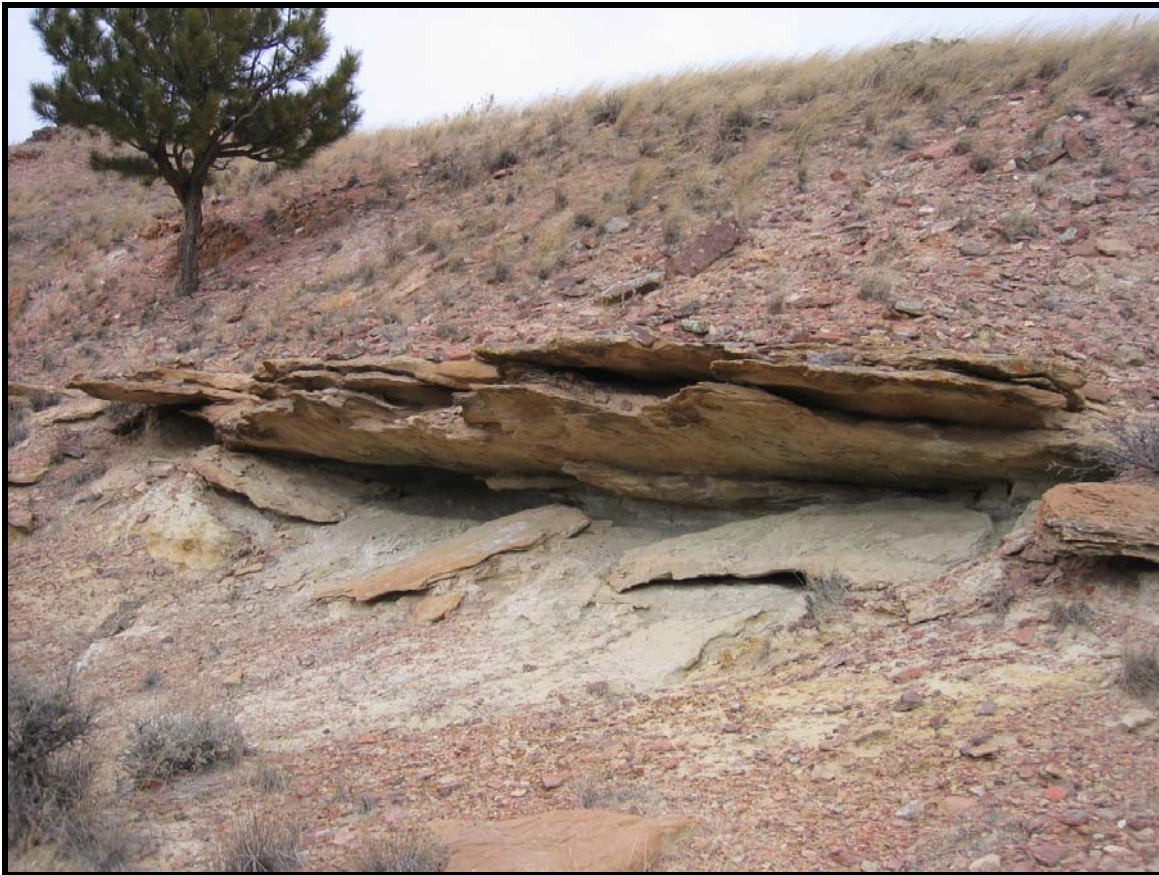
Photo: 1\_26\_06\_39

**CLIFF FEATURE: C\_0051**

**Looking North**

FEATURE TYPE:	Cliff					
GEOMETRIC DIMENSIONS:	Length: 135 ft		Height: 30 ft			
LOCATION:	Township: 8S		Range: 39E		Section: 15	
HANDHELD GPS POINTS:		Northing	Easting		Northing	Easting
	14094	421245.84	2660946.56	14096	421411.57	2660881.87
	14095	421339.10	2660897.10	14097	421440.64	2660878.36

**DESCRIPTION OF FEATURE:** The cliff feature shown above is adjacent to riparian feature R\_0050. The total length of this feature is the summation of two segments. Sandstone/siltstone rocks have surfaced along a steep sidehill, leaving overhangs and large voids. See the pictures on the next page for additional views of this feature.

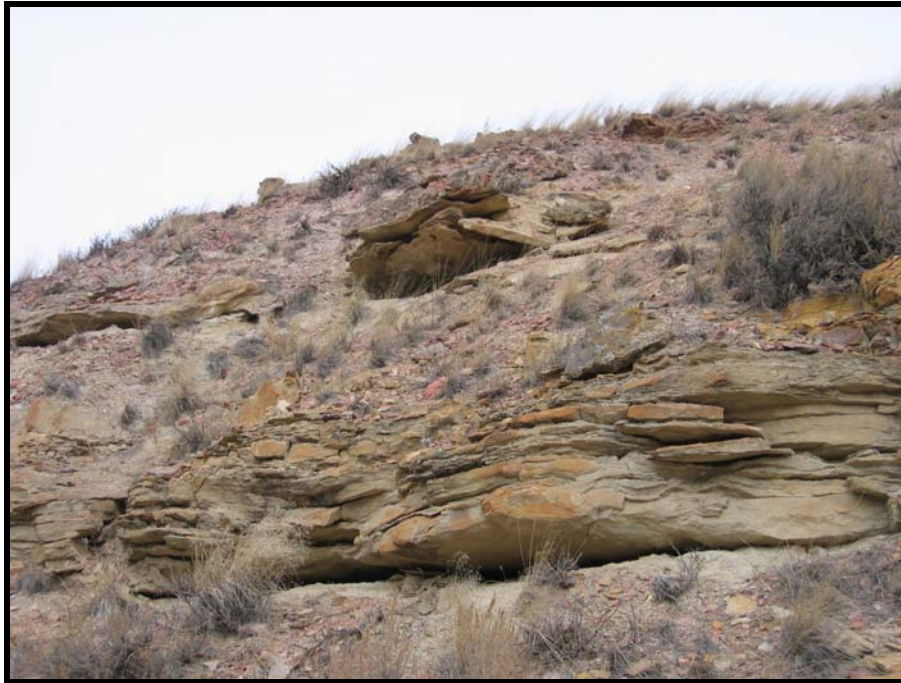
Photo: 1\_26\_06\_40

**CLIFF FEATURE: C\_0051**

**Looking Northeast**

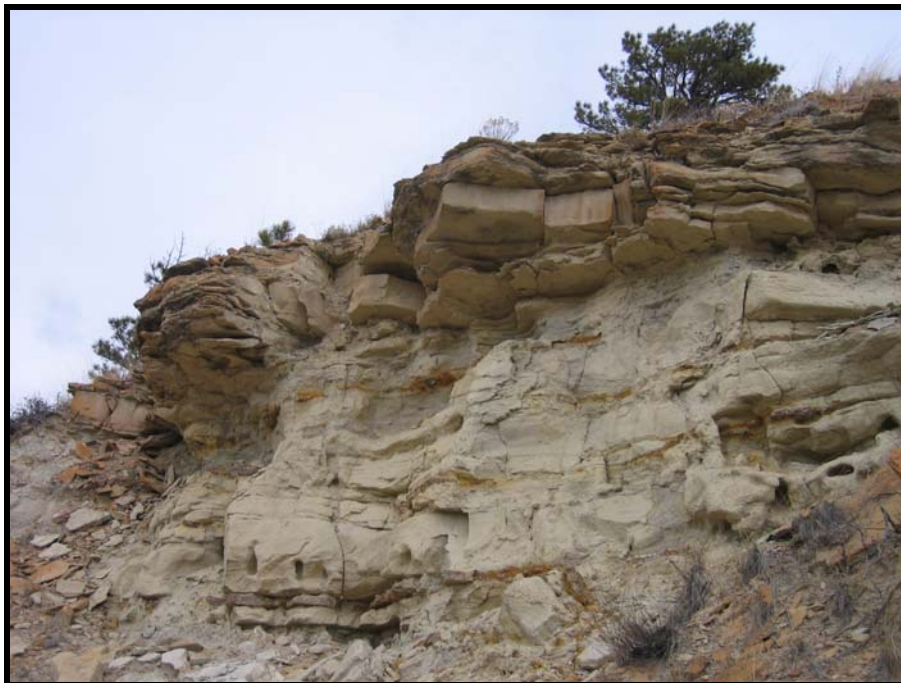
Photo: 1\_26\_06\_41

**Looking East**

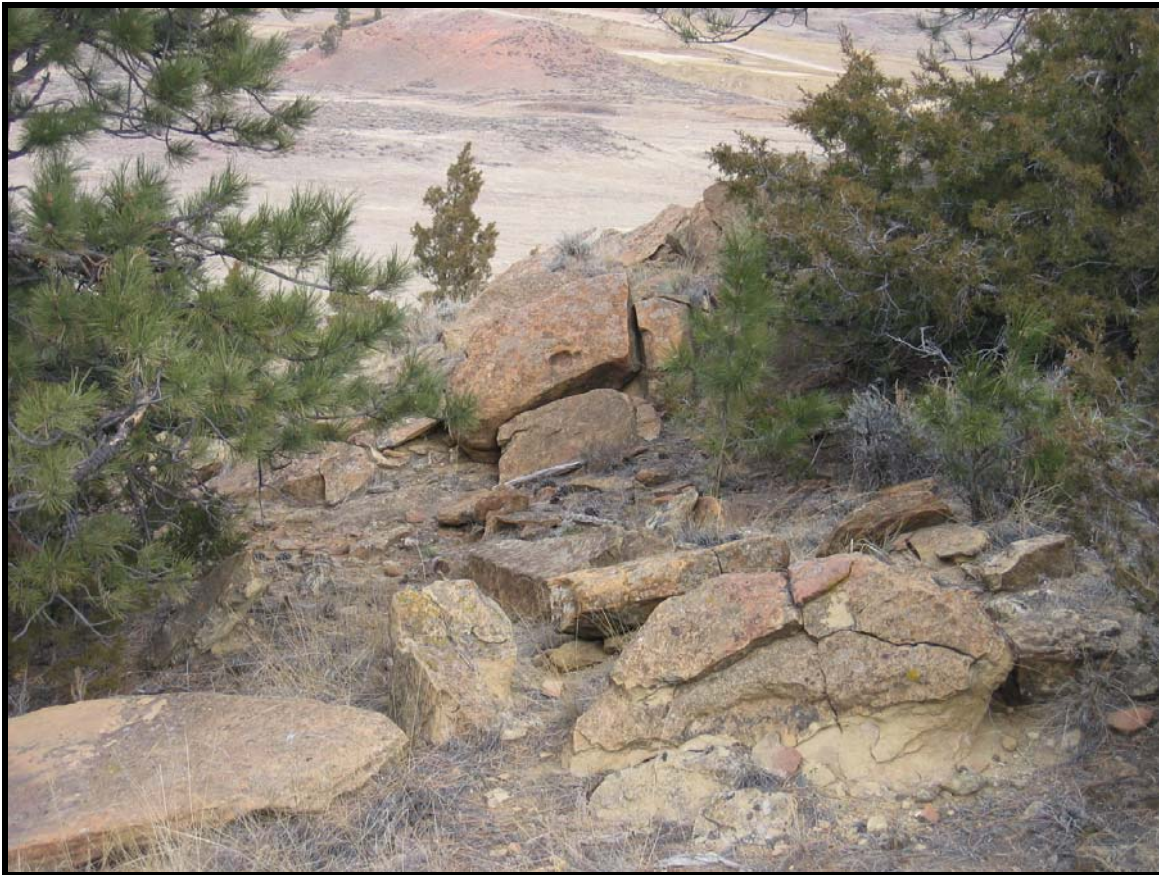
Photo: 1\_26\_06\_30

**ROCK OUTCROP FEATURE: RO\_0210**

**GEOMETRIC DIMENSIONS:** Area of outcrop: 0.16 acres

**DESCRIPTION OF FEATURE:** The outcrop shown above is located along the top of a hill overlooking a small draw. The rocks in this outcrop range in size from one foot in diameter to nearly 10 feet in diameter. Crevices between and below the rocks provide potential habitat.

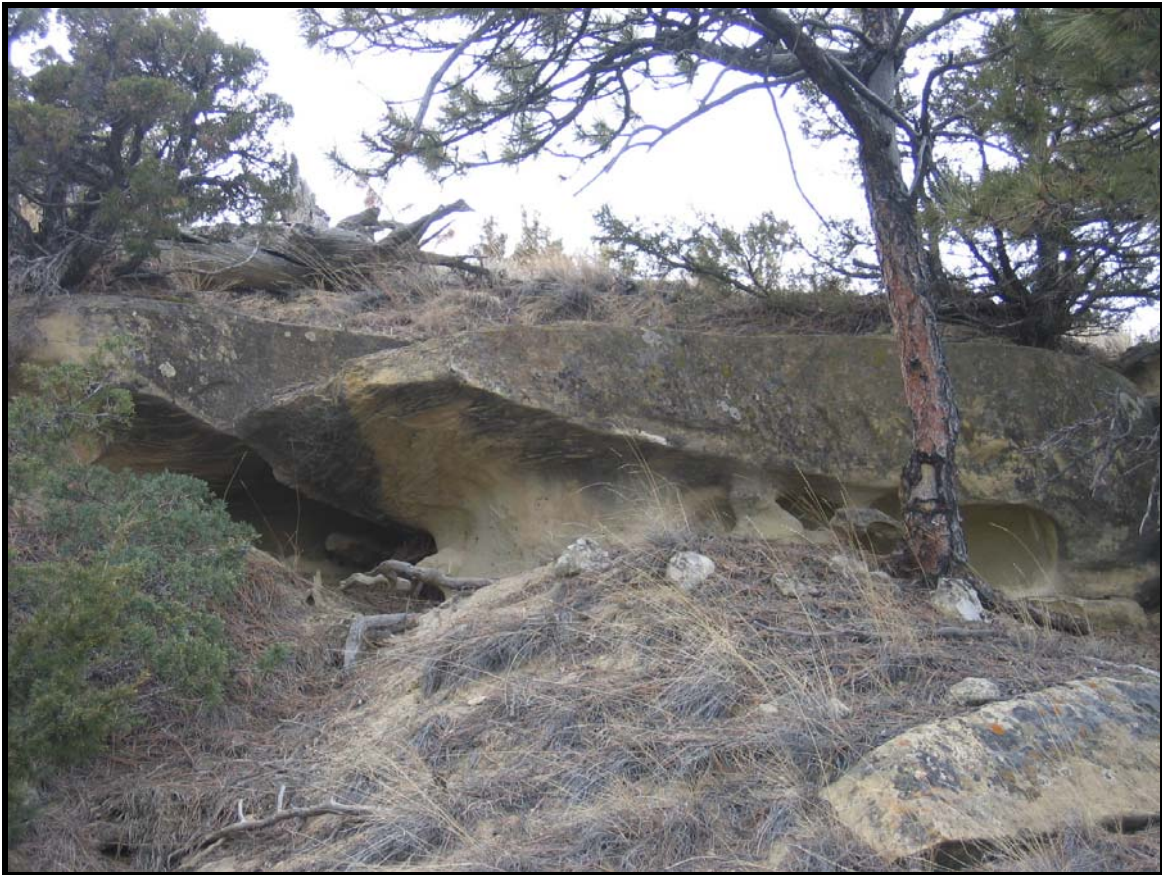
Photo: 1\_26\_06\_32

**ROCK OUTCROP FEATURE: RO\_0211**

**GEOMETRIC DIMENSIONS:** Length: 150 ft      Height: 5 ft

**DESCRIPTION OF FEATURE:** The rock outcrop shown above is not significantly tall, however it contains overhang areas caused by erosion. These overhangs create potential habitat within the outcrop. The rocks are solid sandstone/siltstone.

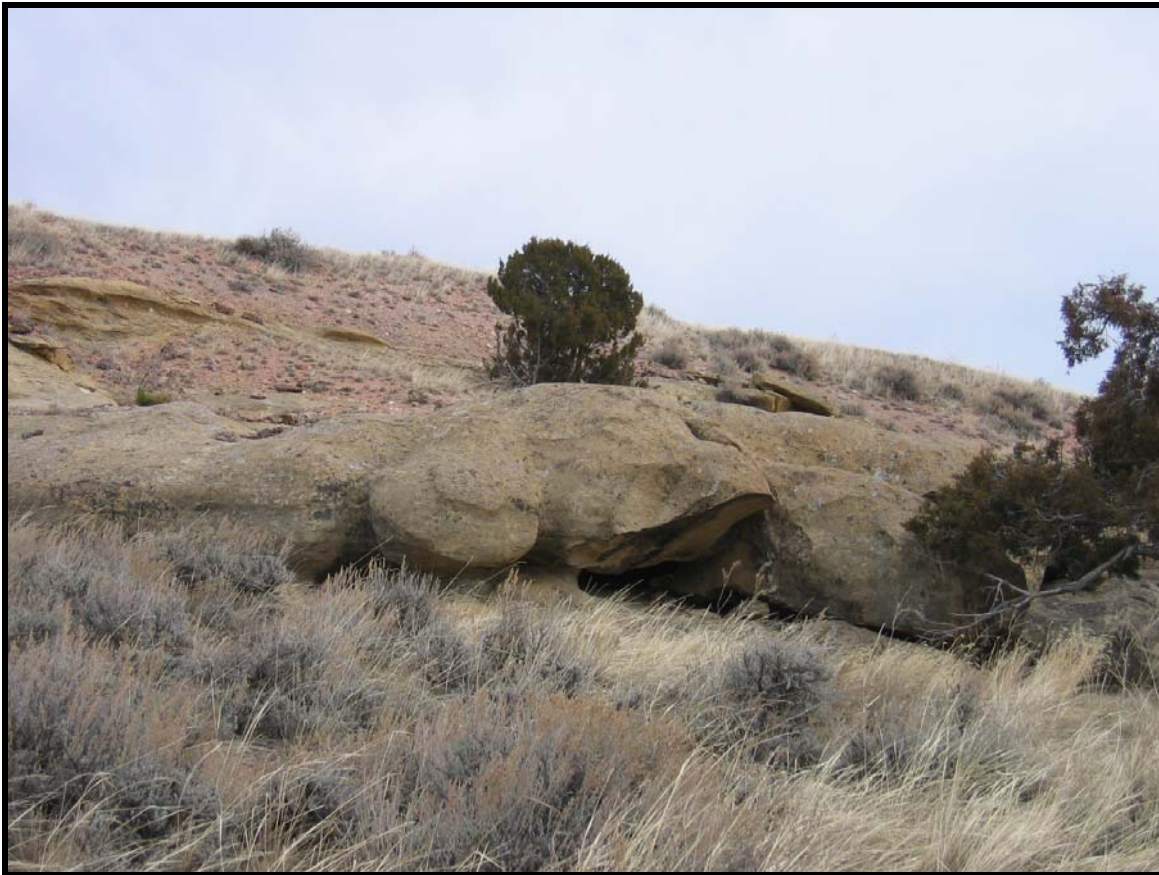
Photo: 1\_26\_06\_33

**ROCK OUTCROP FEATURE: RO\_0212**

**GEOMETRIC DIMENSIONS:** Area of outcrop: 0.09 acres

**DESCRIPTION OF FEATURE:** The rock outcrop shown above is a very unique feature in this area. The sandstone/siltstone rocks within the feature are large and cover significant surface area. As is shown above, the rocks have eroded and left large overhangs beneath the rock.

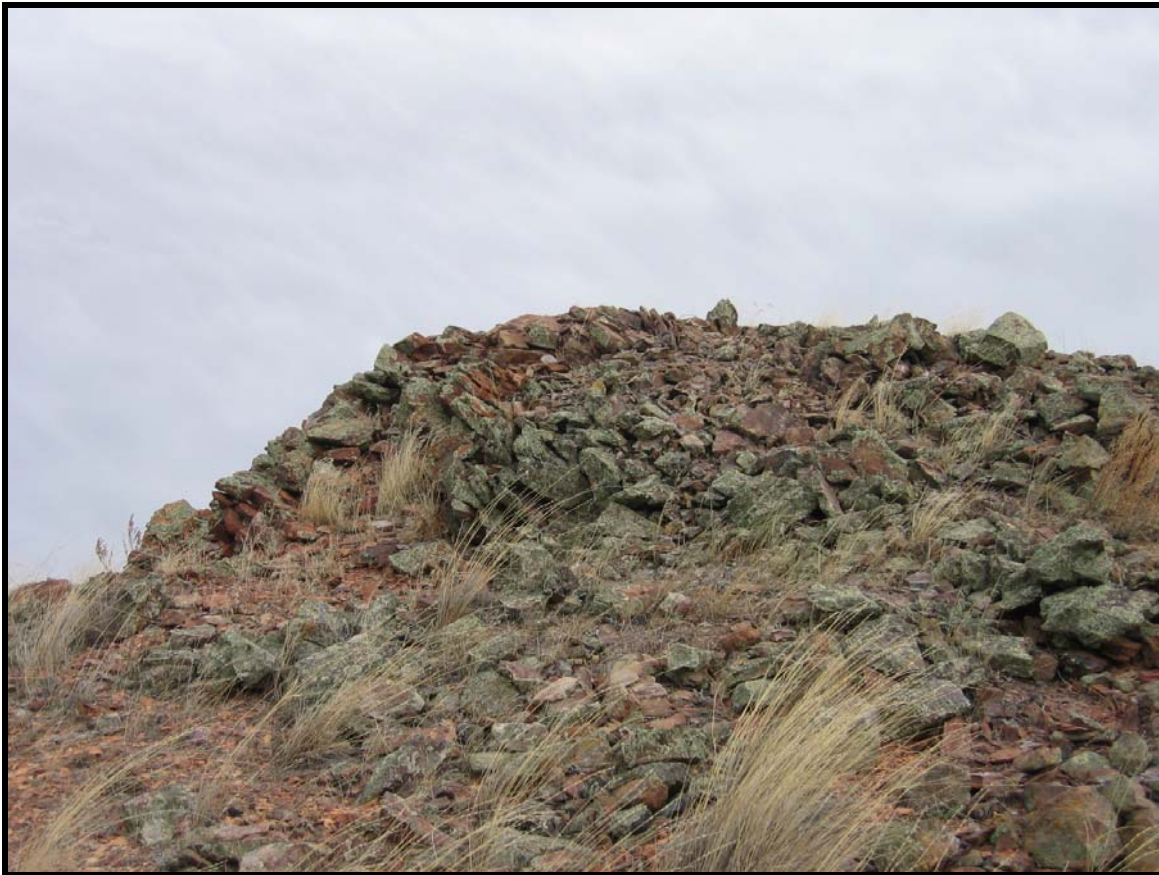
Photo: 1\_26\_06\_34

**ROCK OUTCROP FEATURE: RO\_0213**

**GEOMETRIC DIMENSIONS:** Length: 20 ft      Height: 10 ft

**DESCRIPTION OF FEATURE:** The scoria outcrop shown above is very common in this region. The feature is located at the top of a small hill adjacent to features RO\_212 and RO\_214. Although this outcrop is not significantly large, the face is jagged and weathered.

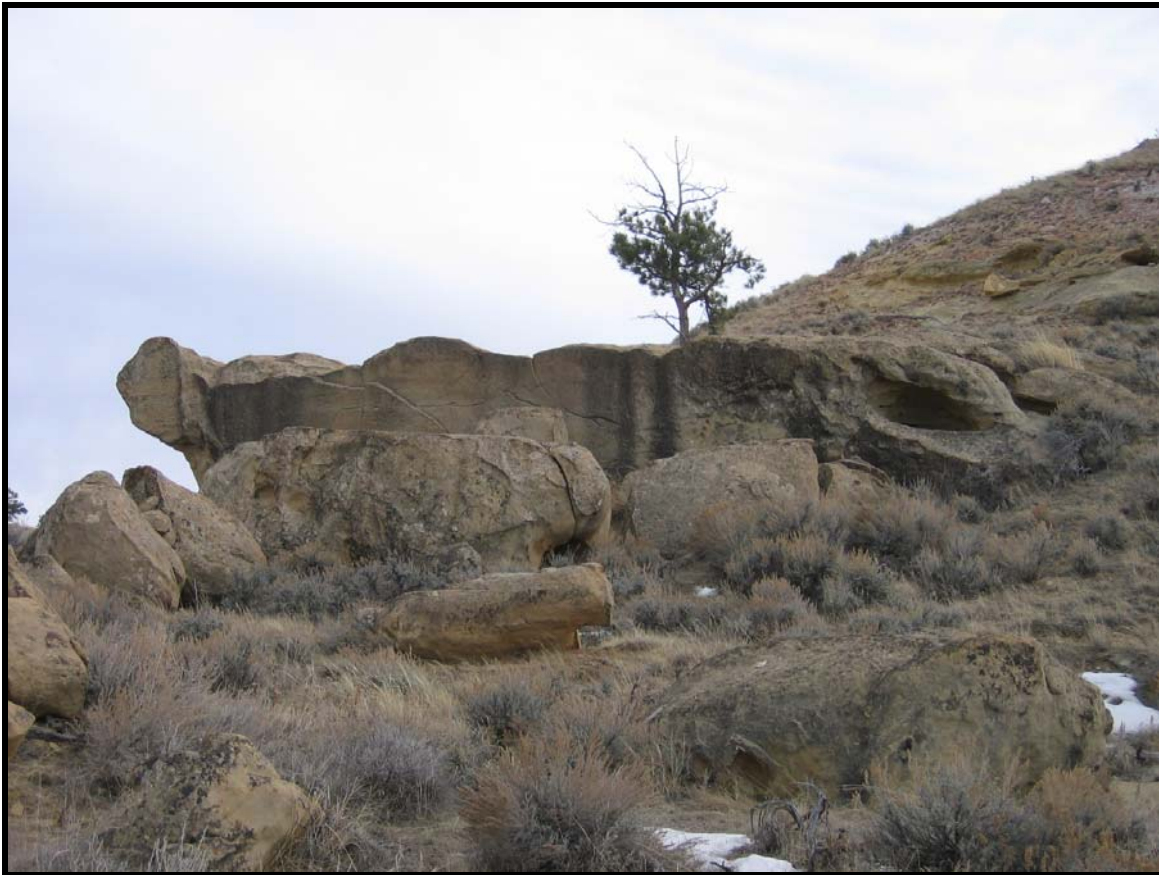
Photo: 1\_26\_06\_35

**ROCK OUTCROP FEATURE: RO\_0214**

**GEOMETRIC DIMENSIONS:** Area of outcrop: 0.21 acres

**DESCRIPTION OF FEATURE:** The rock outcrop shown above is a very unique feature in this area. The sandstone/siltstone rocks within the feature are large and vary in height from several feet to over twenty feet tall. The rocks are in close proximity of one another and are located on a relatively flat slope.

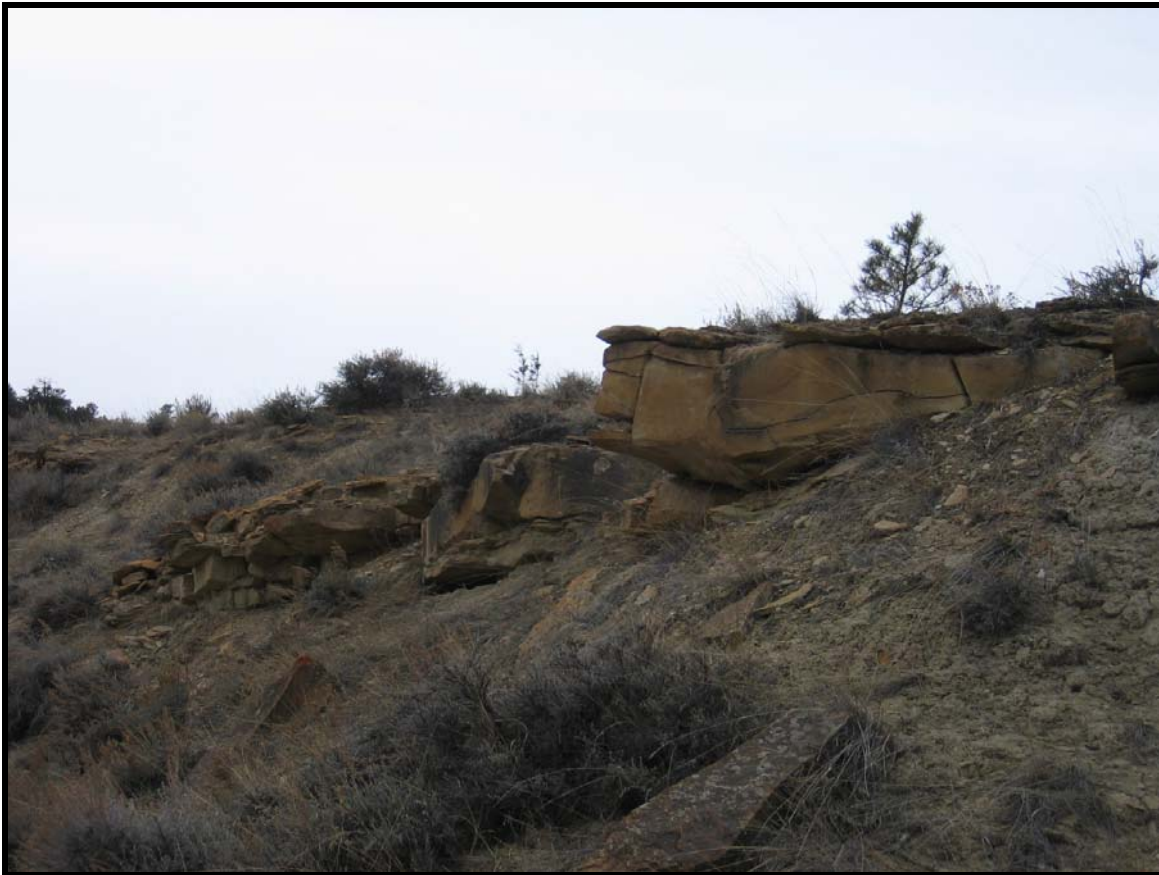
Photo: 1\_26\_06\_37

**ROCK OUTCROP FEATURE: RO\_0215**

<b>FEATURE TYPE:</b>	Rock Outcrop		
<b>GEOMETRIC DIMENSIONS:</b>	Length: 110 ft	Height: 5 ft	
<b>LOCATION:</b>	Township: 8S	Range: 39E	Section: 15
<b>HANDHELD GPS POINTS:</b>	<b>Northing</b>	<b>Easting</b>	
	<b>14090</b>	421264.78	2660625.75
	<b>14091</b>	421203.59	2660537.33
<b>SUBSTRATE:</b>	Sandstone/siltstone		
<b>EXPOSURE:</b>	Southern facing slope		
<b>DESCRIPTION OF FEATURE:</b>	The small outcrop shown above is located adjacent to a small draw. The feature consists of layered sandstone/siltstone rocks sitting on a highly erosive, sandy silt soil. The soil beneath the rocks has eroded, leaving overhangs and voids and creating potential habitat.

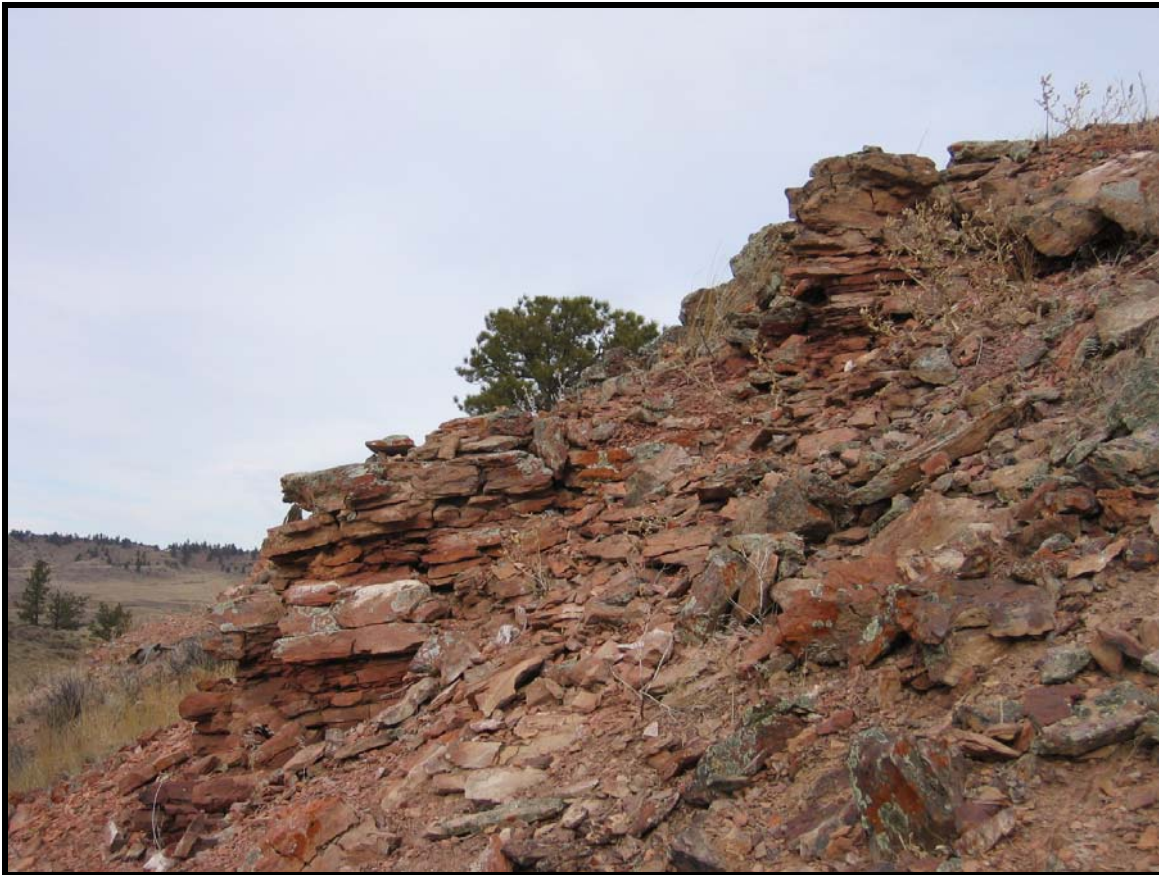
Photo: 1\_26\_06\_38

**ROCK OUTCROP FEATURE: RO\_0216**

<b>FEATURE TYPE:</b>	Rock Outcrop		
<b>GEOMETRIC DIMENSIONS:</b>	Length: 390 ft	Height: 15 ft	
<b>LOCATION:</b>	Township: 8S	Range: 39E	Section: 15
<b>HANDHELD GPS POINTS:</b>	<b>Northing</b>	<b>Easting</b>	
	<b>14092</b>	421352.17	2660963.82
	<b>14093</b>	421707.68	2661130.62
<b>SUBSTRATE:</b>	Scoria		
<b>EXPOSURE:</b>	Northern facing slope		
<b>DESCRIPTION OF FEATURE:</b>	This large scoria outcrop runs along the top of a hill. The feature is located above cliff feature C_0051. This outcrop is tall and has a jagged, weathered face.

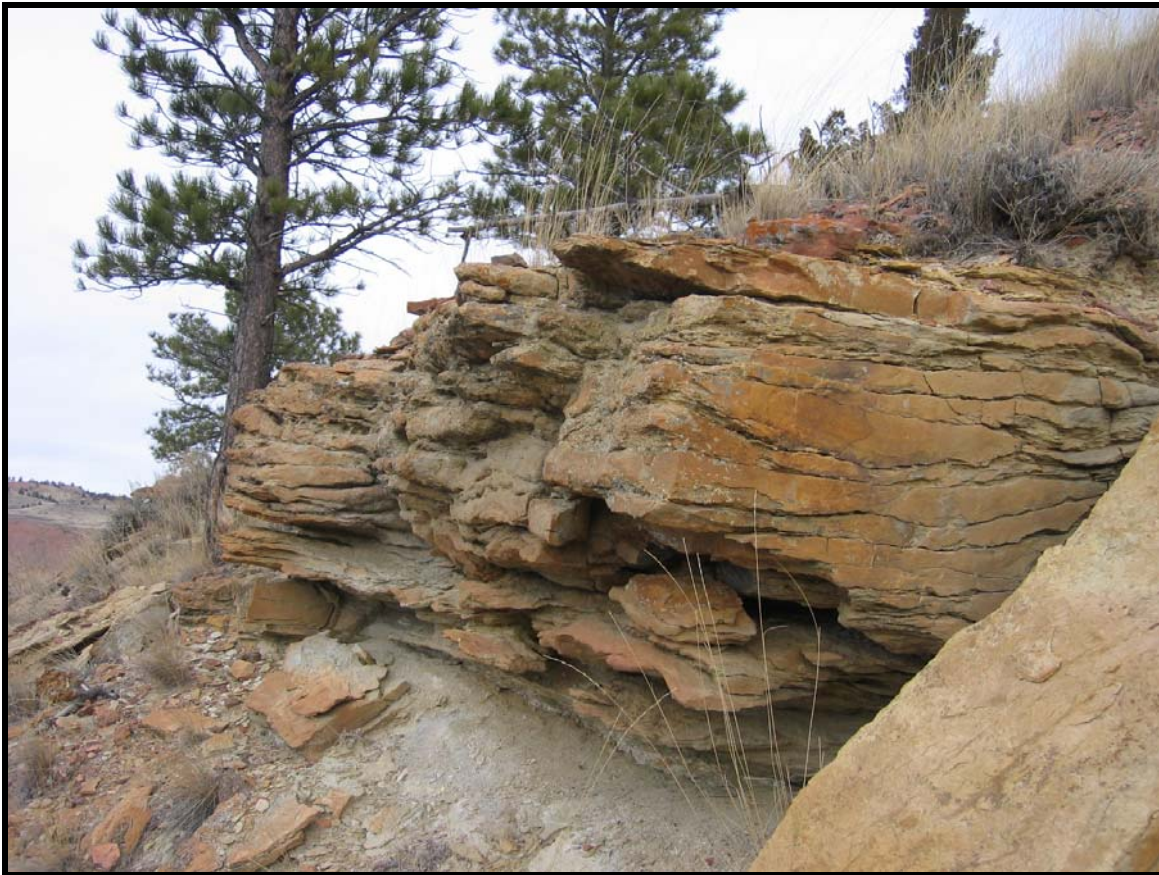
Photo: 1\_26\_06\_45

**ROCK OUTCROP FEATURE: RO\_0219**

**GEOMETRIC DIMENSIONS:** Length: 510 ft      Height: 5 ft

**DESCRIPTION OF FEATURE:** The rock outcrop shown above consists of sandstone/siltstone rocks that run along the side of a long slope. The rocks are weathered and layered and have high numbers of overhangs and voids.

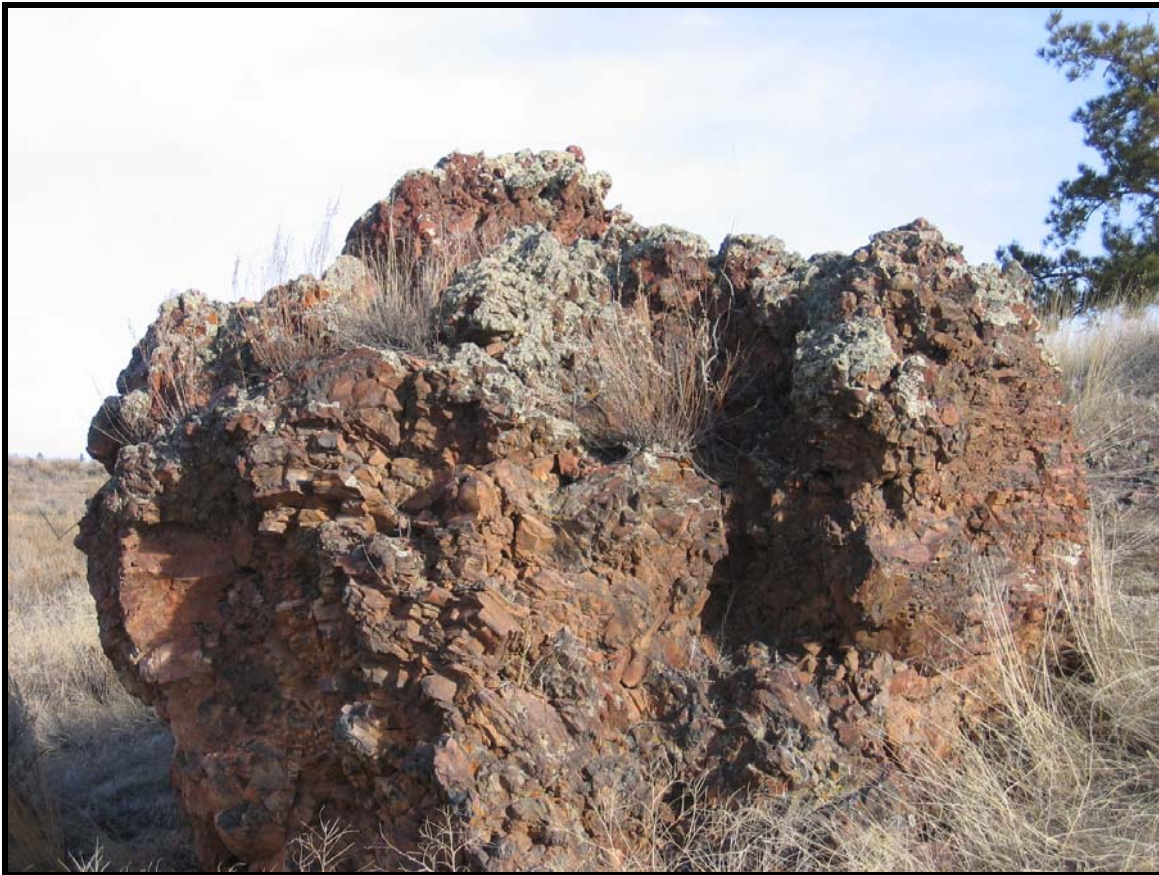
Photo: 1\_30\_06\_01

**ROCK OUTCROP FEATURE: RO\_0225**

**GEOMETRIC DIMENSIONS:** Area of outcrop: 180 square feet

**DESCRIPTION OF FEATURE:** The scoria rock outcrop shown above is located on a southern facing slope overlooking a small draw. Scoria outcrops, like this feature, are very common in this area. The largest individual piece of scoria is nearly ten feet tall.

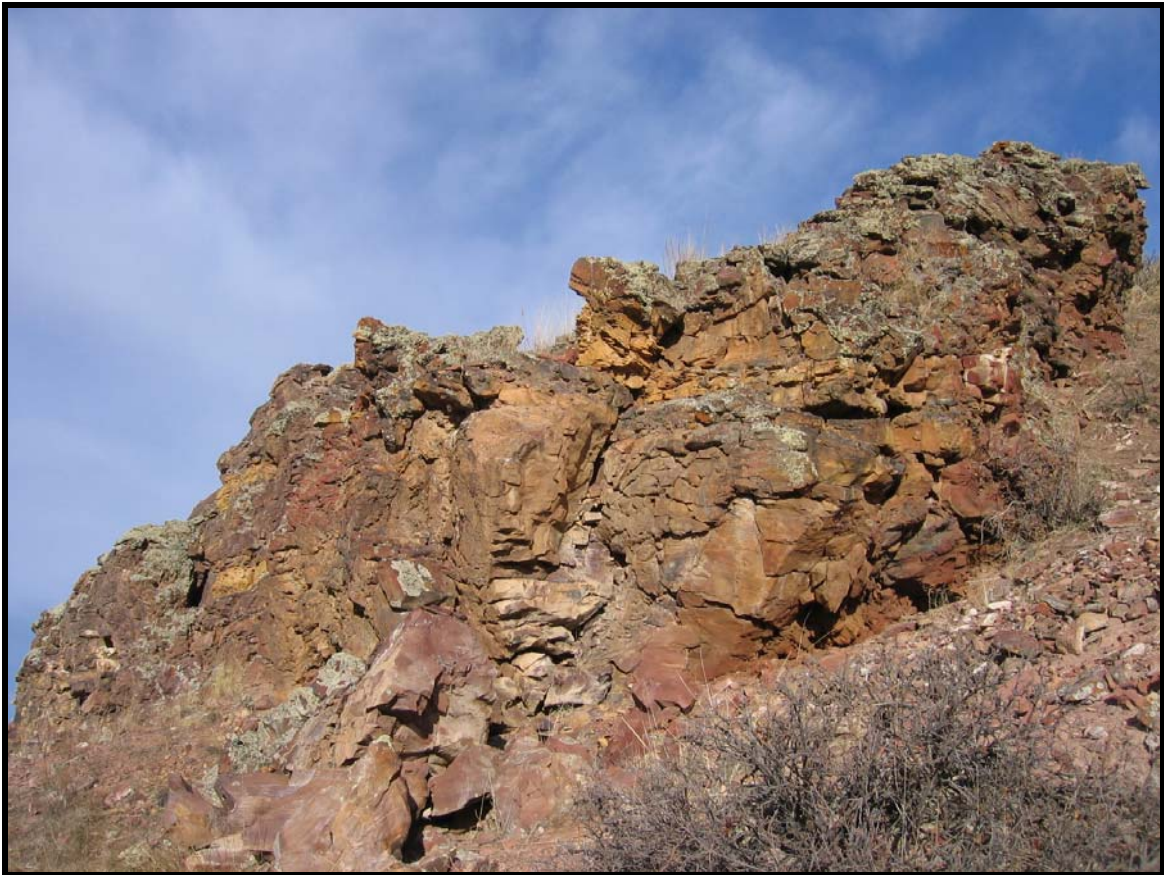
Photo: 1\_30\_06\_02

**ROCK OUTCROP FEATURE: RO\_0226**

**GEOMETRIC DIMENSIONS:** Area of outcrop: 1.46 acres

**DESCRIPTION OF FEATURE:** The scoria rock outcrop shown above is located on a southern facing slope overlooking the Spring Creek channel bottom. Scoria outcrops, like this feature, are very common in this area. This feature looks like a cliff in some areas and some pieces of scoria reach a height of almost 25 feet. See the pictures on the following page for additional views of this feature.

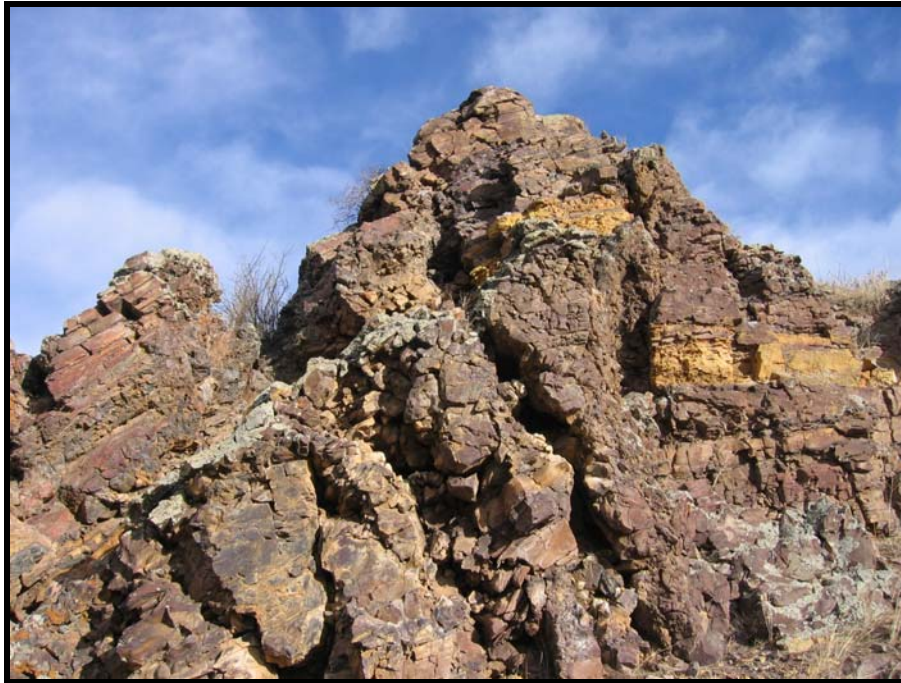
Photo: 1\_30\_06\_03

**ROCK OUTCROP FEATURE: RO\_0226**

**Looking North**

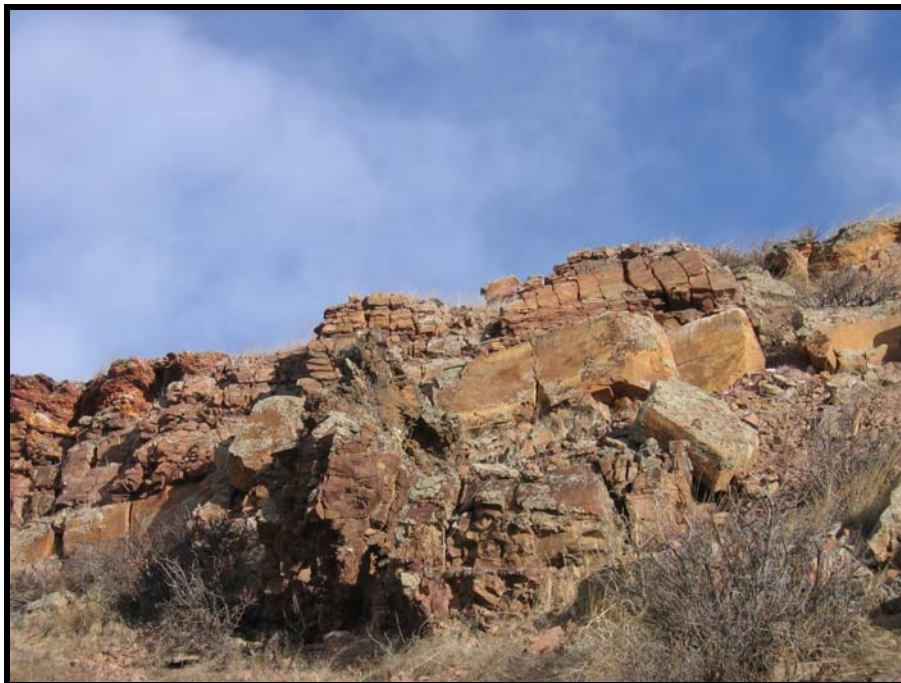
Photo: 1\_30\_06\_04

**Looking East**

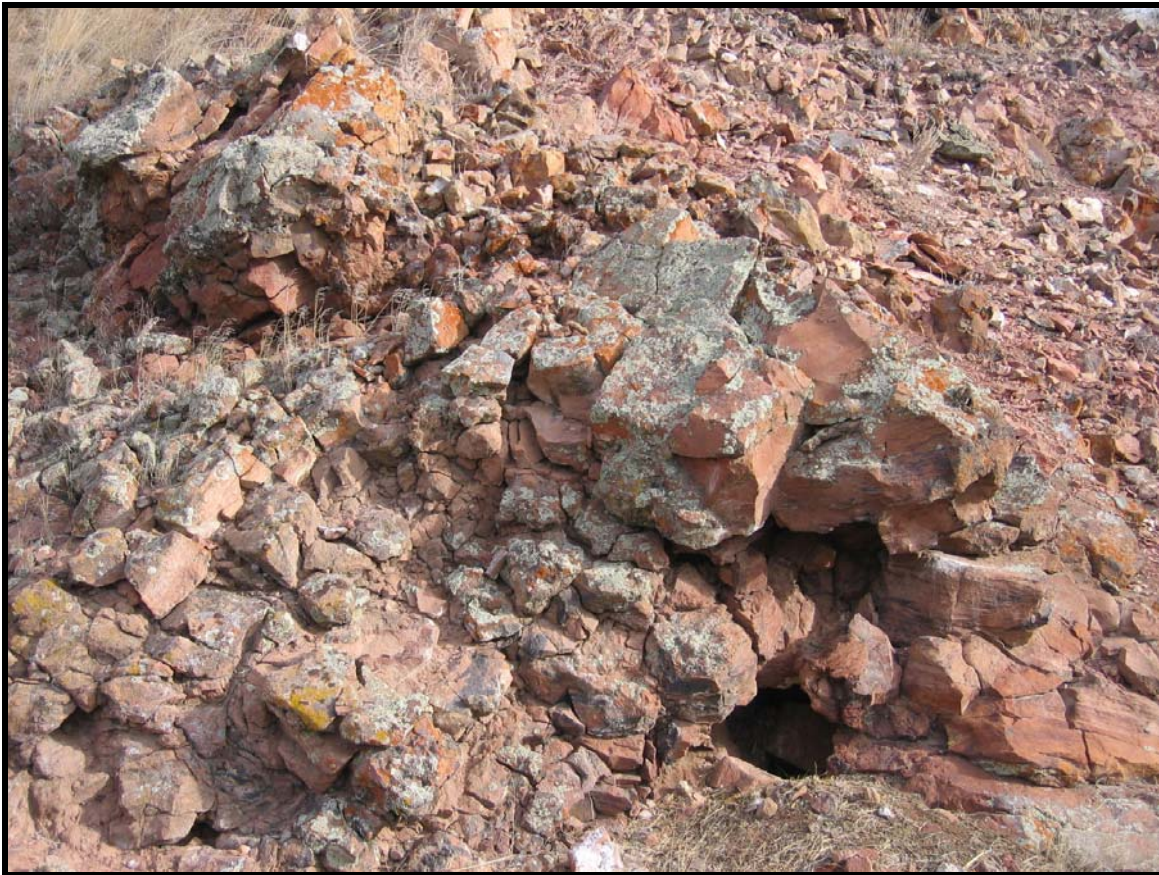
Photo: 1\_30\_06\_06

**ROCK OUTCROP FEATURE: RO\_0227**

**GEOMETRIC DIMENSIONS:** Area of outcrop: 0.55 acres

**DESCRIPTION OF FEATURE:** The scoria rock outcrop shown above is located on a southern facing slope overlooking the Spring Creek channel bottom. Scoria outcrops, like this feature, are very common in this area. As can be seen in the picture above, holes have been created below the rocks in this outcrop to form habitat.

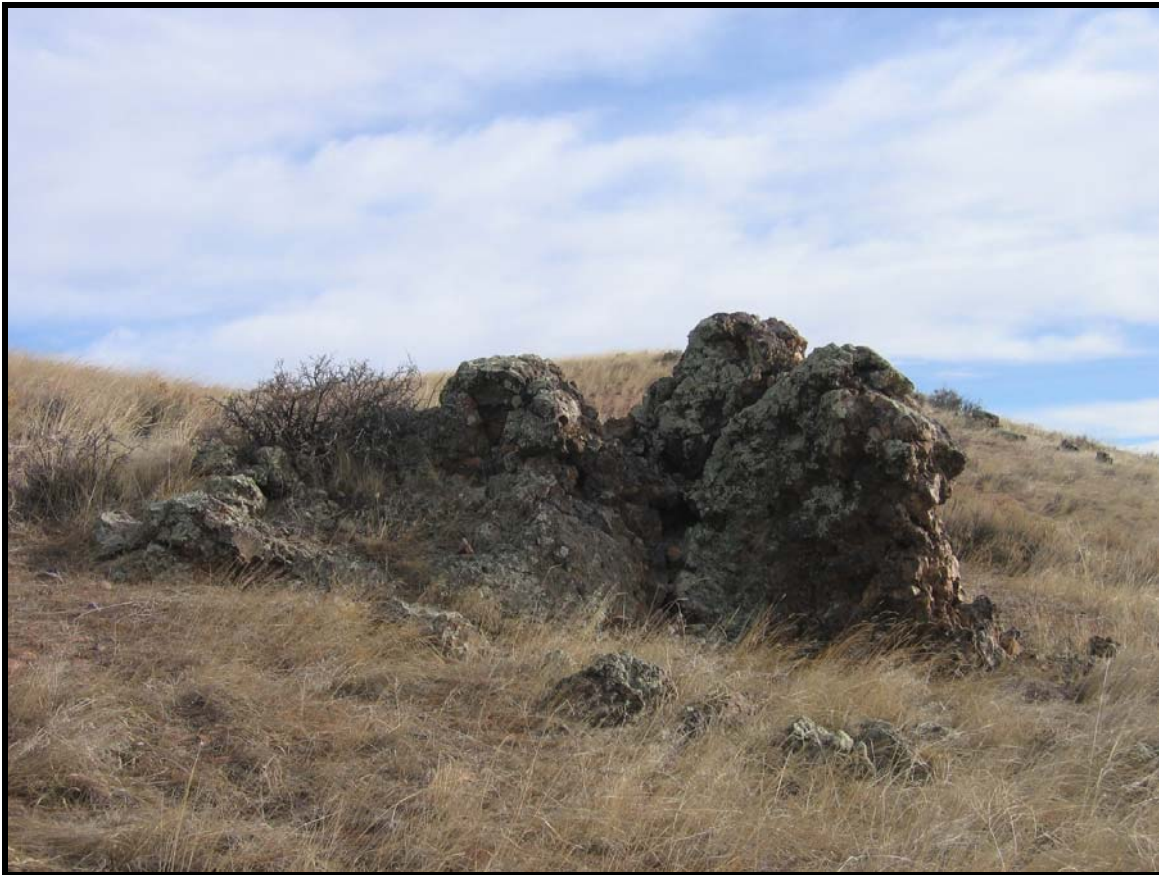
Photo: 1\_30\_06\_07

**ROCK OUTCROP FEATURE: RO\_0228**

**GEOMETRIC DIMENSIONS:** Area of outcrop: 1.01 acres

**DESCRIPTION OF FEATURE:** The scoria rock outcrop shown above is located on a southern facing slope overlooking the Spring Creek channel bottom. Scoria outcrops, like this feature, are very common in this area. The surrounding area is vegetated with grass and sparsely populated sagebrush.

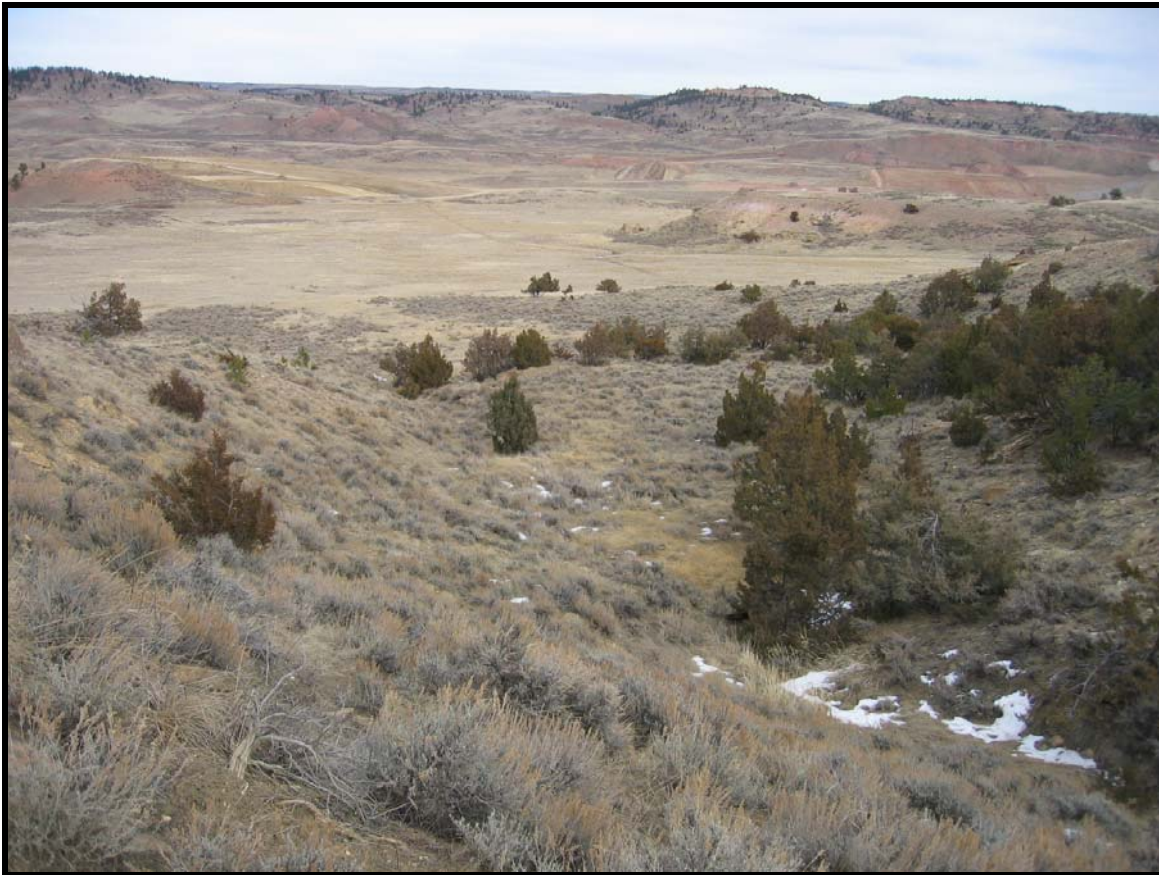
Photo: 1\_26\_06\_31

**RIPARIAN FEATURE: R\_0049**

**DESCRIPTION OF FEATURE:** The small draw shown above is a tributary to Spring Creek. The draw is adjacent to features C\_0050 and RO\_0210. The channel bottom varies in width and is vegetated with grass, sagebrush and small trees.

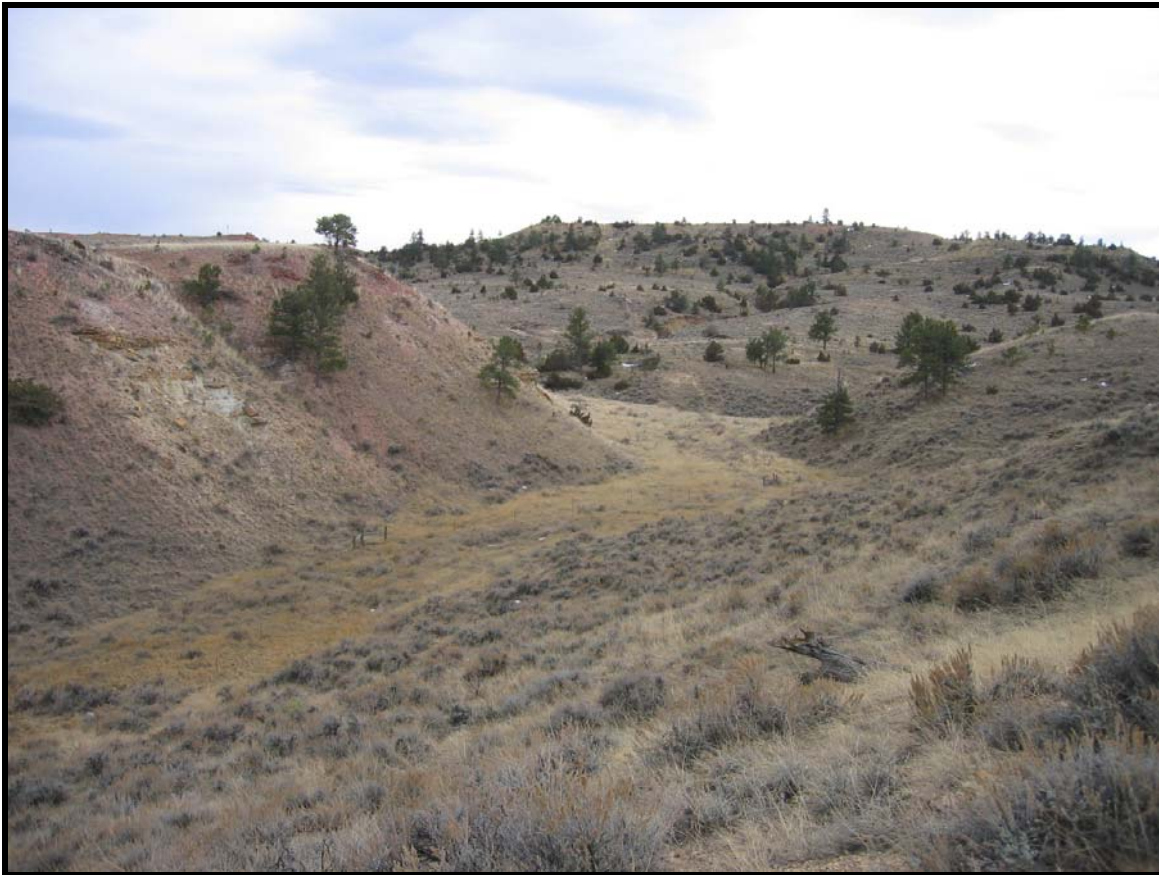
Photo: 1\_26\_06\_36

**RIPARIAN FEATURE: R\_0050**

**DESCRIPTION OF FEATURE:** The large draw shown above has a bottom width of greater than fifty feet. The bordering hills are steep and covered with grass, sagebrush and some small trees. At the head of the channel, the channel is cut deep into the sandy silt soil.

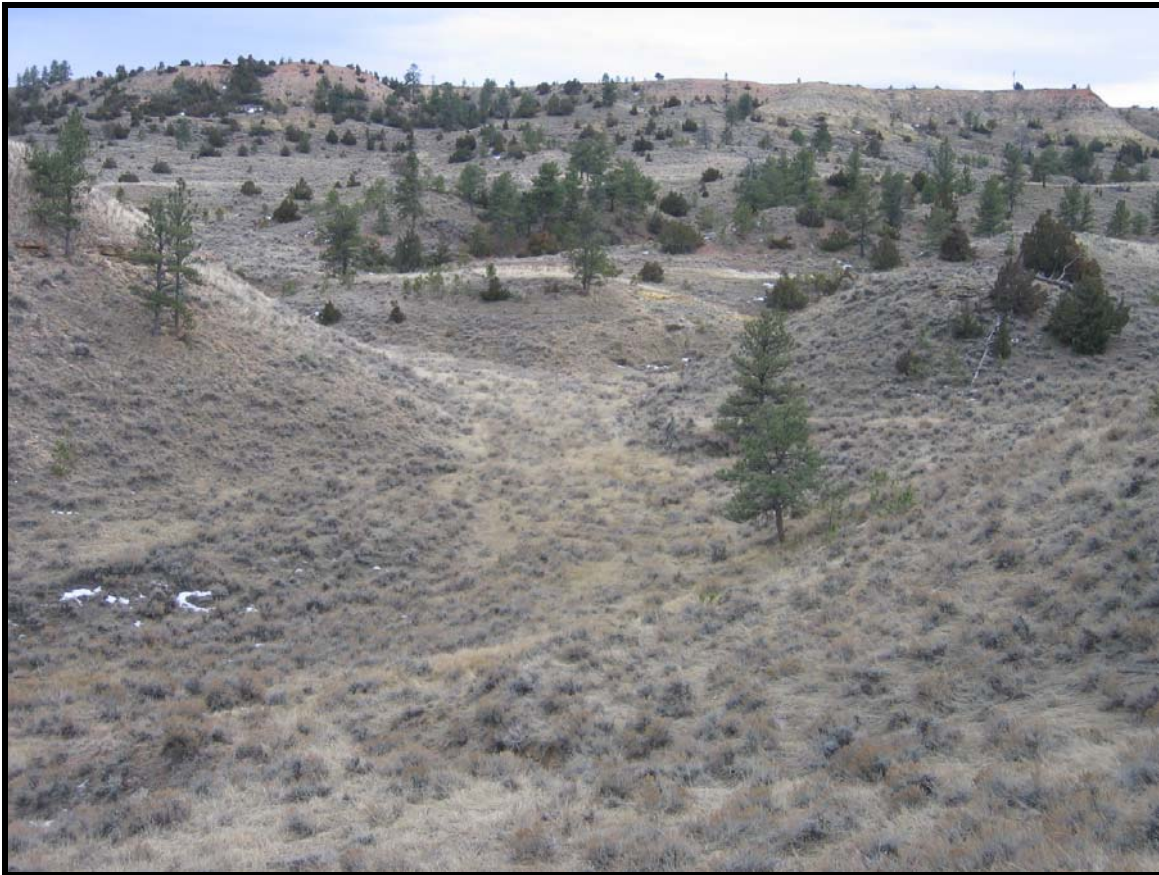
Photo: 1\_26\_06\_42

**RIPARIAN FEATURE: R\_0051**

**DESCRIPTION OF FEATURE:** The large draw shown above has a bottom width of greater than fifty feet. The bordering hills are steep and covered with grass, sagebrush and some small trees. At the head of the channel, the channel is cut deep into the sandy silt soil. The view above is towards the end of the draw. The drainage splits into two tributary channels above this point.
