Township 8S, Range 39E
SECTION 23

Rock Outcrop Features

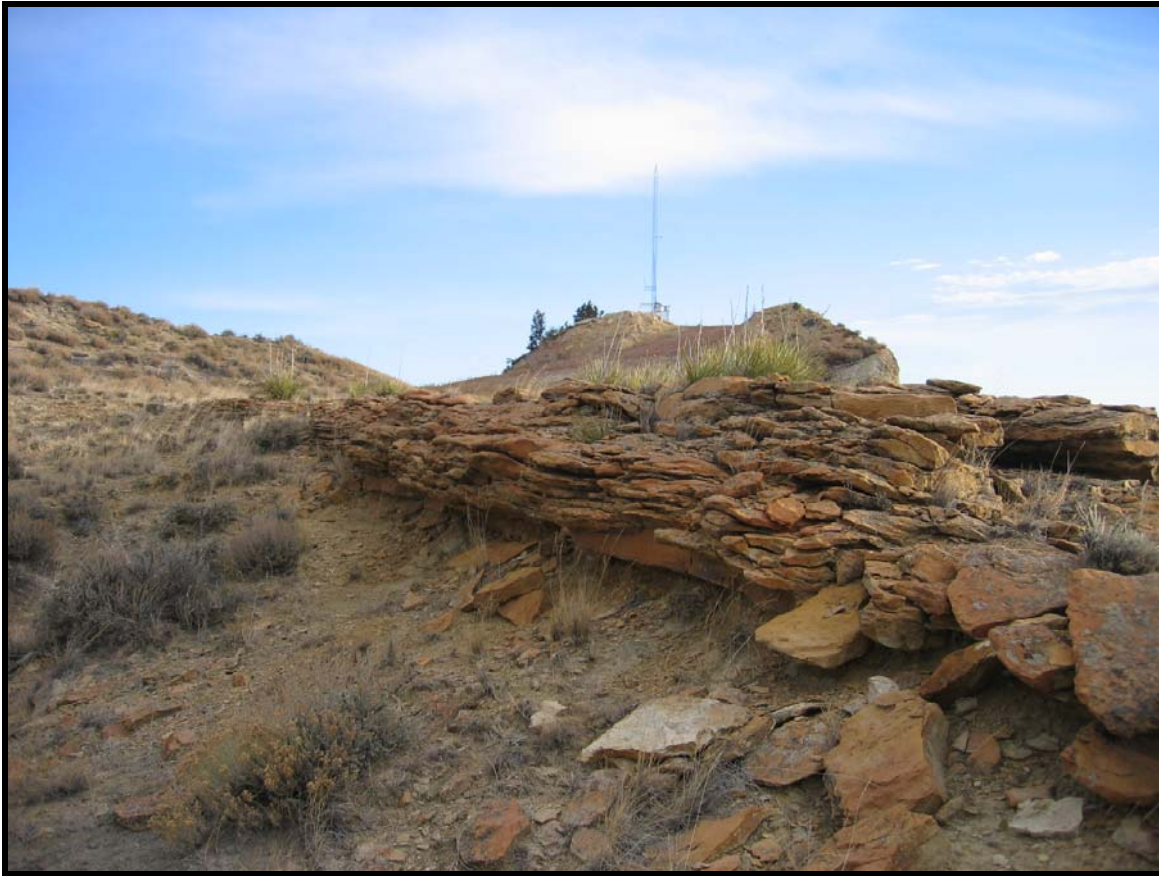
Photo: 1_26_06_01

GEOMETRIC DIMENSIONS: Length: 60 ft Height: 5 ft

SUBSTRATE: Sandstone/siltstone

EXPOSURE: Southern facing slope

DESCRIPTION OF FEATURE: The small rock outcrop shown above consists of layered sandstone/siltstone rocks that are located at the top of a small southern facing hill. This feature has a long, narrow geometry.

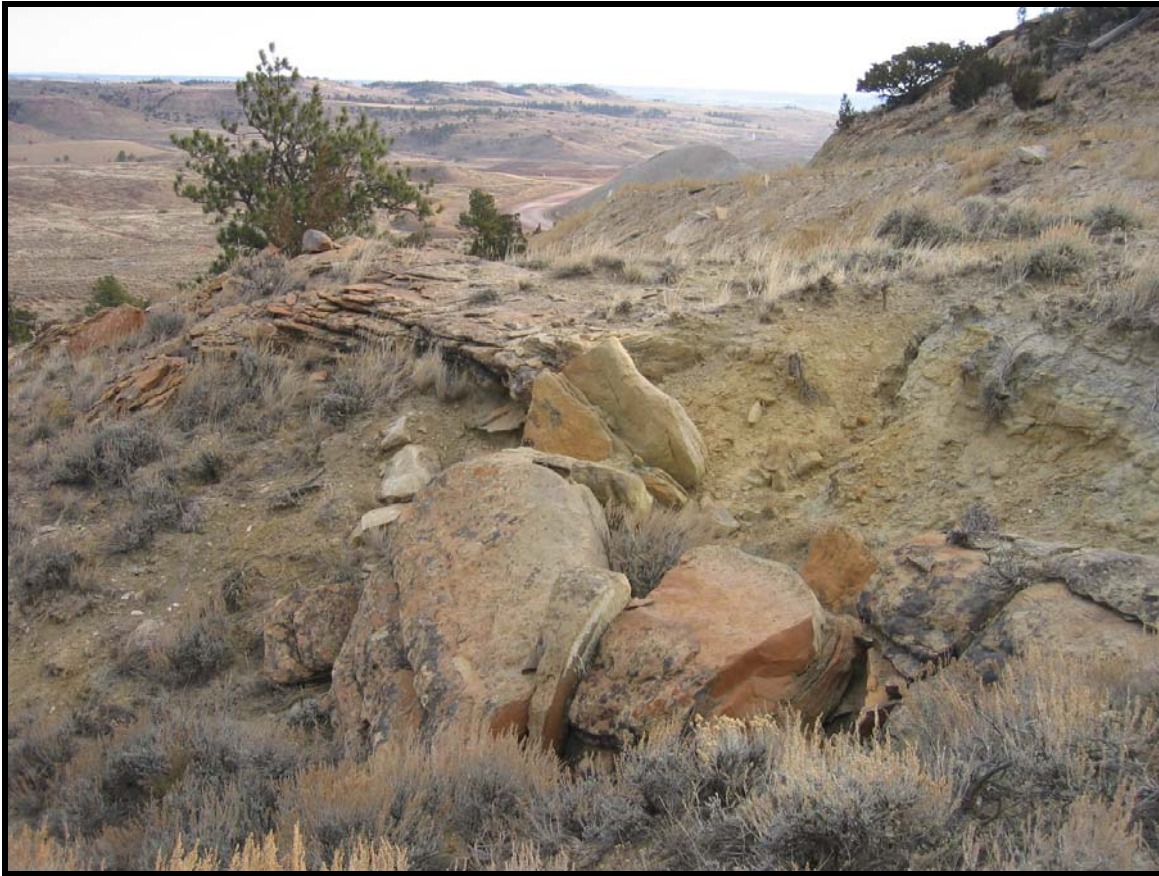
Photo: 1_26_06_02

GEOMETRIC DIMENSIONS: Length: 60 ft Width: 15 ft

SUBSTRATE: Sandstone/siltstone

EXPOSURE: Northern facing slope

DESCRIPTION OF FEATURE: The small rock outcrop shown above overlooks a small draw, which is a tributary to Spring Creek. The feature sits on highly erosive, sandy silt material and the layout of the rocks creates potential habitat. The rocks within this feature vary in size.

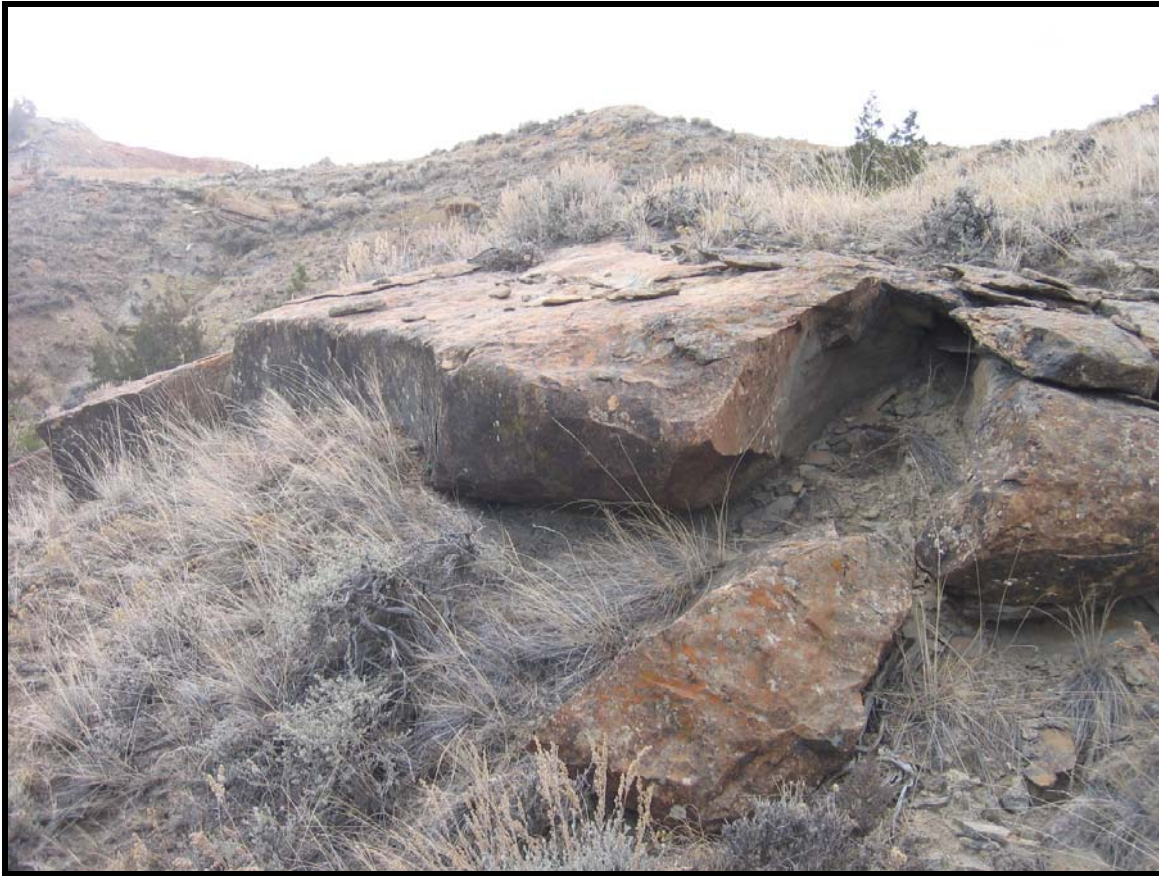
Photo: 1_26_06_03

GEOMETRIC DIMENSIONS: Area of outcrop: 0.09 acres

SUBSTRATE: Sandstone/siltstone

EXPOSURE: Northern facing slope

DESCRIPTION OF FEATURE: The small rock outcrop shown above sits on highly erosive, sandy silt material and voids are present between the rocks. Most of these rocks are flat and approximately 2 feet in thickness. In one area this outcrop intersects a small draw.

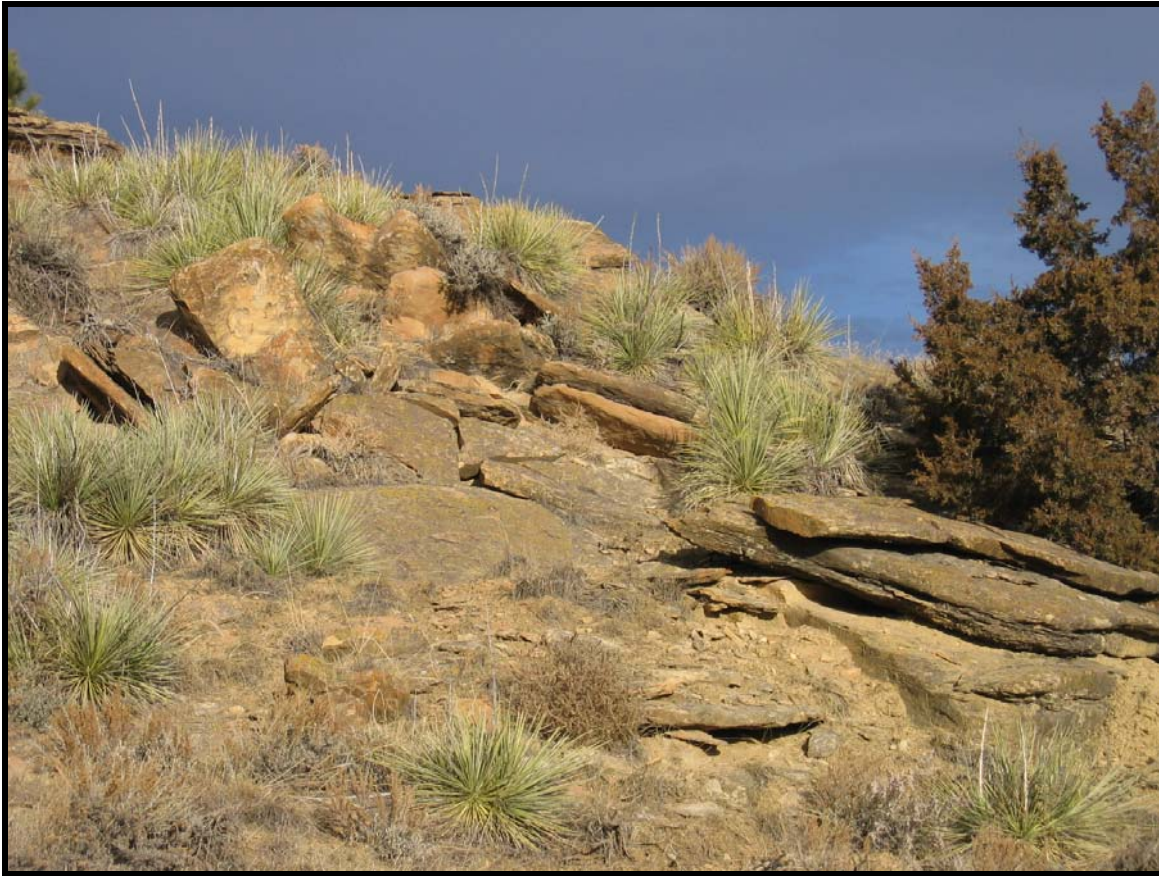
Photo: 1_26_06_04

GEOMETRIC DIMENSIONS: Area of outcrop: 1.08 acres

SUBSTRATE: Sandstone/siltstone

EXPOSURE: Northern facing slope

DESCRIPTION OF FEATURE: The small rock outcrop shown above sits on highly erosive, sandy silt material. Throughout the outcrop area, the rocks vary from small, flat, sandstone/siltstone rocks to large, layered, sandstone/siltstone rocks. See the picture on the next page for another view of the rocks in this outcrop.

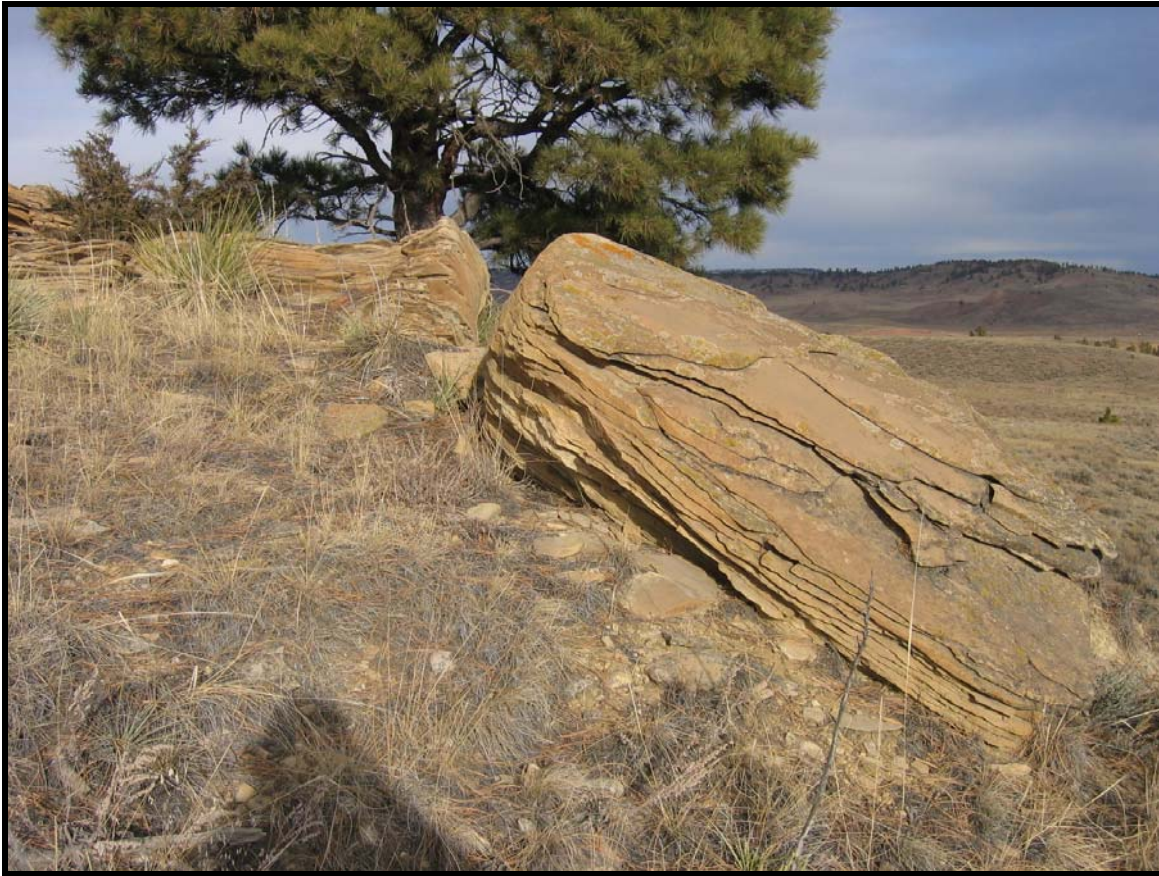
Photo: 1_26_06_07

FEATURE TYPE:	Rock Outcrop				
GEOMETRIC DIMENSIONS:	Area of outcrop: 0.12 acres				
LOCATION:	Township: 8S		Range: 39E		Section: 23
HANDHELD GPS POINTS:	14014	Northing	Easting	14016	Northing
		419510.20	2663817.00		419499.35
	14015	419557.07	2663800.00	14017	419456.20
					2663706.30
					2663725.77
SUBSTRATE:	Sandstone/siltstone				
EXPOSURE:	Northern facing slope				
DESCRIPTION OF FEATURE:	The type of rock outcrop shown above is very common in this area. The layered sandstone/siltstone rocks are stacked over the area, leaving voids beneath and between the rocks. The subsoil consists of sandy silt.

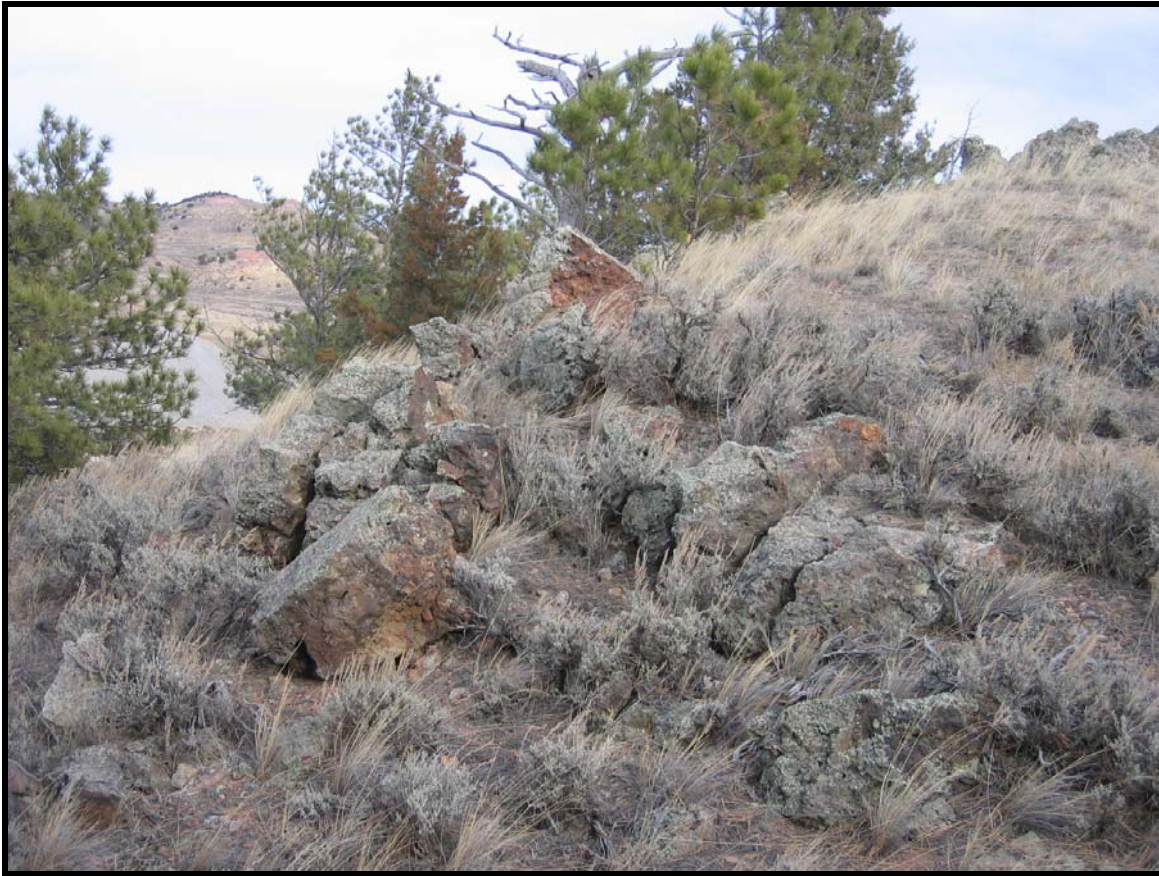
Photo: 1_26_06_46

GEOMETRIC DIMENSIONS: Length: 70 ft Width: 20 ft

SUBSTRATE: Scoria

EXPOSURE: Northern facing slope

DESCRIPTION OF FEATURE: Scoria outcrops like the one shown above appear in many areas across the mine. This feature is located at the top of a small, tree covered hill. The rocks in this outcrop are small and covered with lichens.

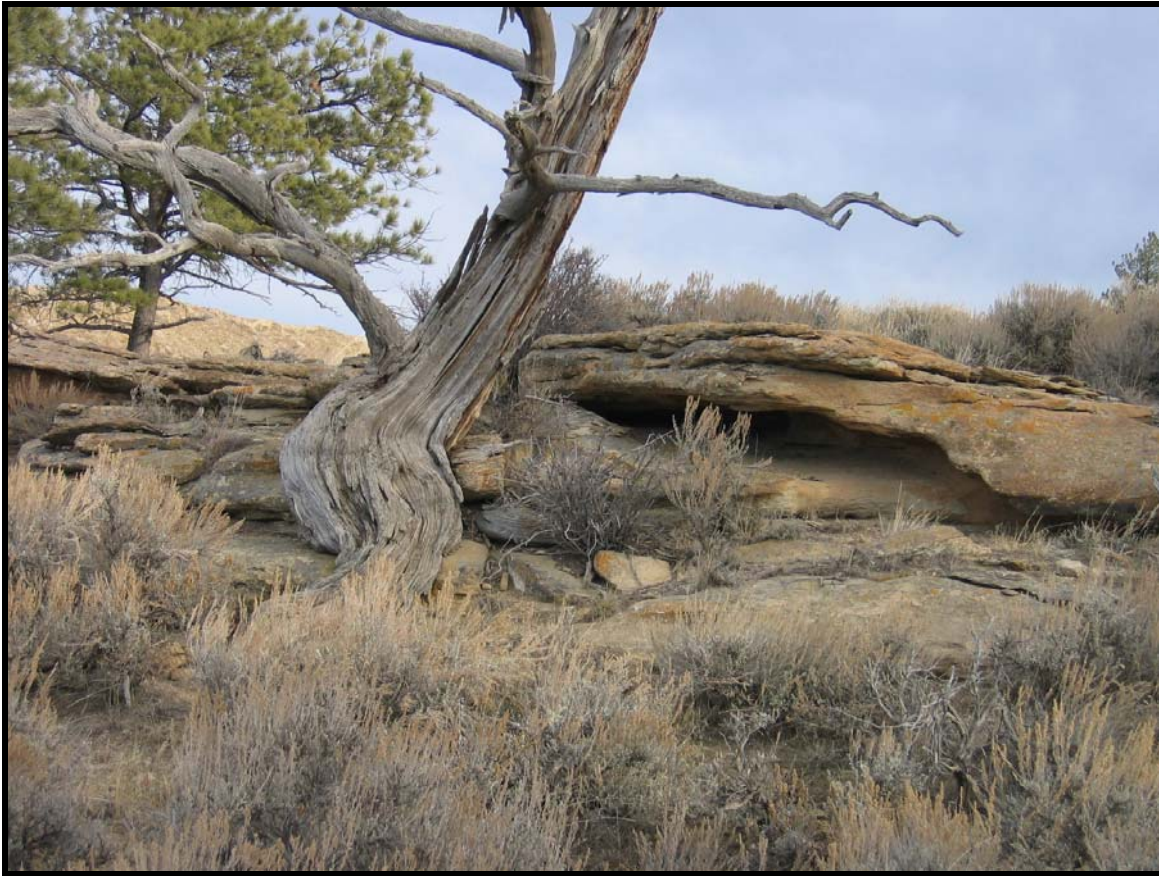
Photo: 1_26_06_47

GEOMETRIC DIMENSIONS: Length: 115 ft Height: 10 ft

SUBSTRATE: Sandstone/siltstone

EXPOSURE: Northern facing slope

DESCRIPTION OF FEATURE: The sandstone/siltstone rock outcrop shown above is weathered and eroded. It is located on a sandy silt subsoil and has overhangs and areas where holes have been dug below the rock.

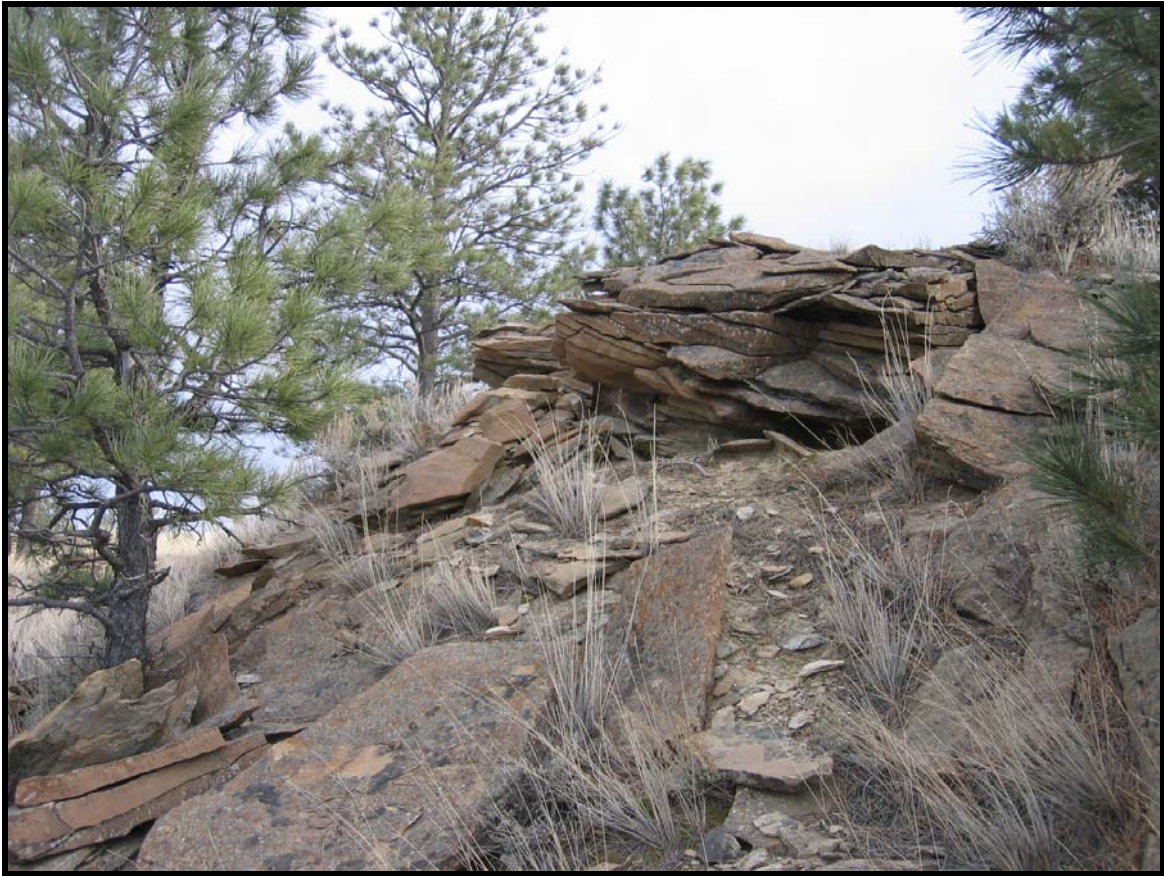
Photo: 1_26_06_48

GEOMETRIC DIMENSIONS: Area of outcrop: 0.14 acres

SUBSTRATE: Sandstone/siltstone

EXPOSURE: Northern facing slope

DESCRIPTION OF FEATURE: The small rock outcrop shown above is located in an area vegetated with small trees, grass and sagebrush. The sandstone/siltstone rocks within the feature have the same characteristics as many outcrops in this area.

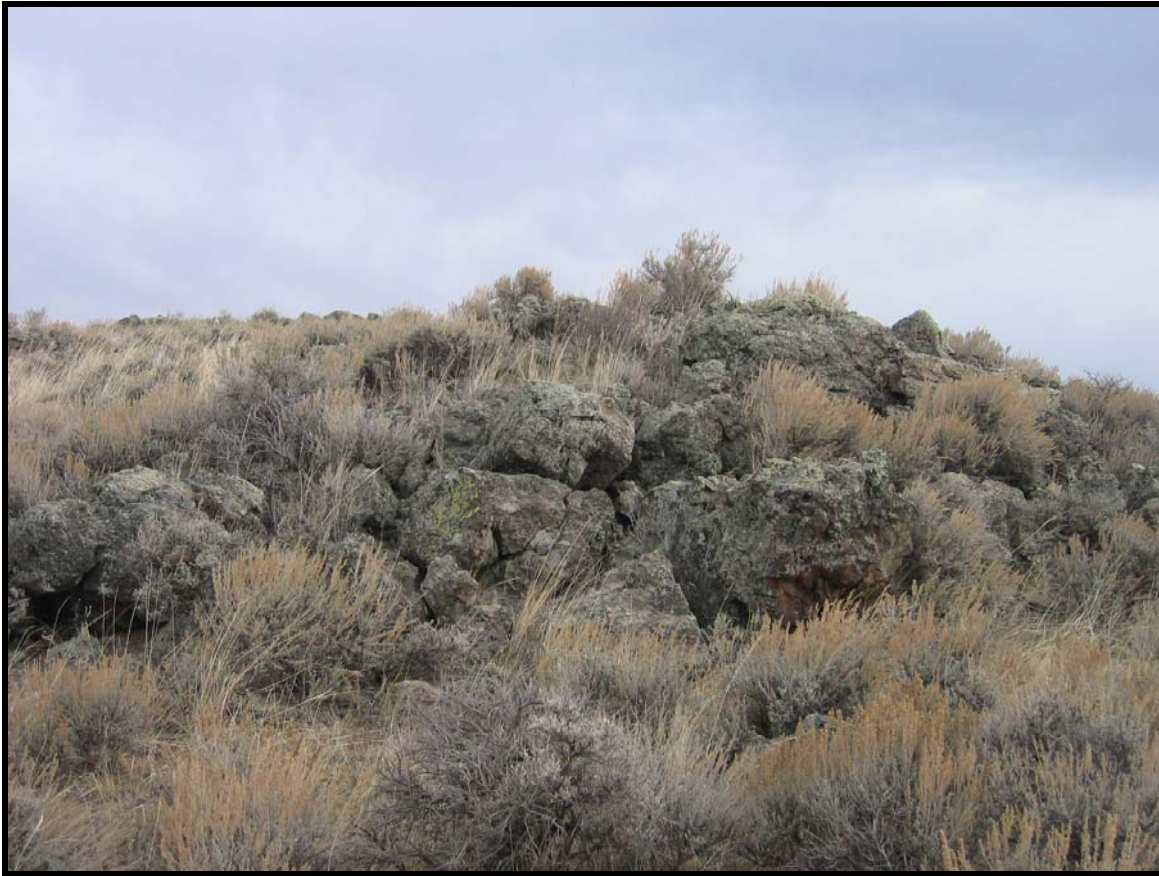
Photo: 1_26_06_49

GEOMETRIC DIMENSIONS: Area of outcrop: 0.02 acres

SUBSTRATE: Scoria

EXPOSURE: Northern facing slope

DESCRIPTION OF FEATURE: This small rock outcrop is located in an area vegetated with small trees, grass and sagebrush. Scoria outcrops, like the one shown above, appear in many areas across the mine. This feature is located at the top of a small, tree covered hill. The rocks in this outcrop are small and covered with lichens.

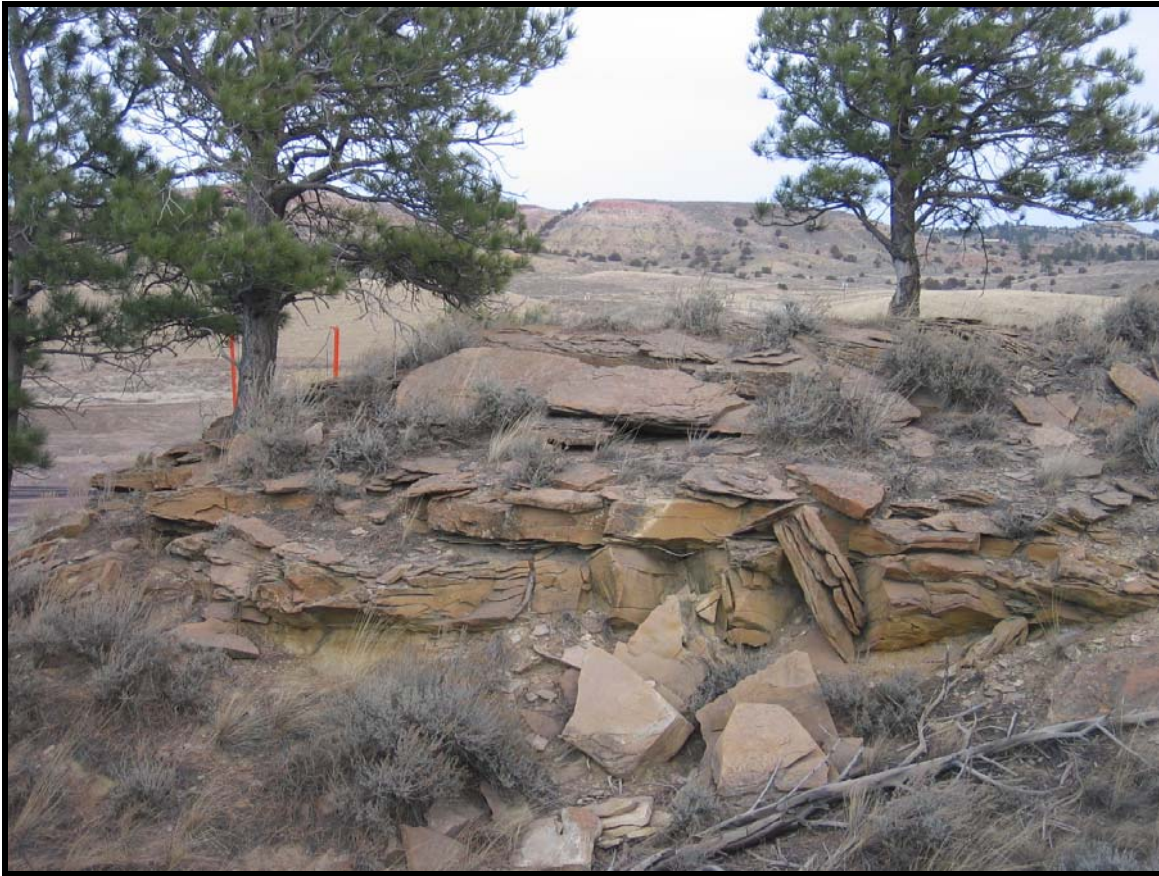
Photo: 1_26_06_51

GEOMETRIC DIMENSIONS: Length: 45 ft Height: 15 ft

SUBSTRATE: Sandstone/siltstone

EXPOSURE: Northern facing slope

DESCRIPTION OF FEATURE: The small rock outcrop shown above is located in an area vegetated with small trees, grass and sagebrush. The layered sandstone/siltstone outcrop creates areas of habitat. It was noted in the field that there were holes and areas of current habitat within this outcrop.

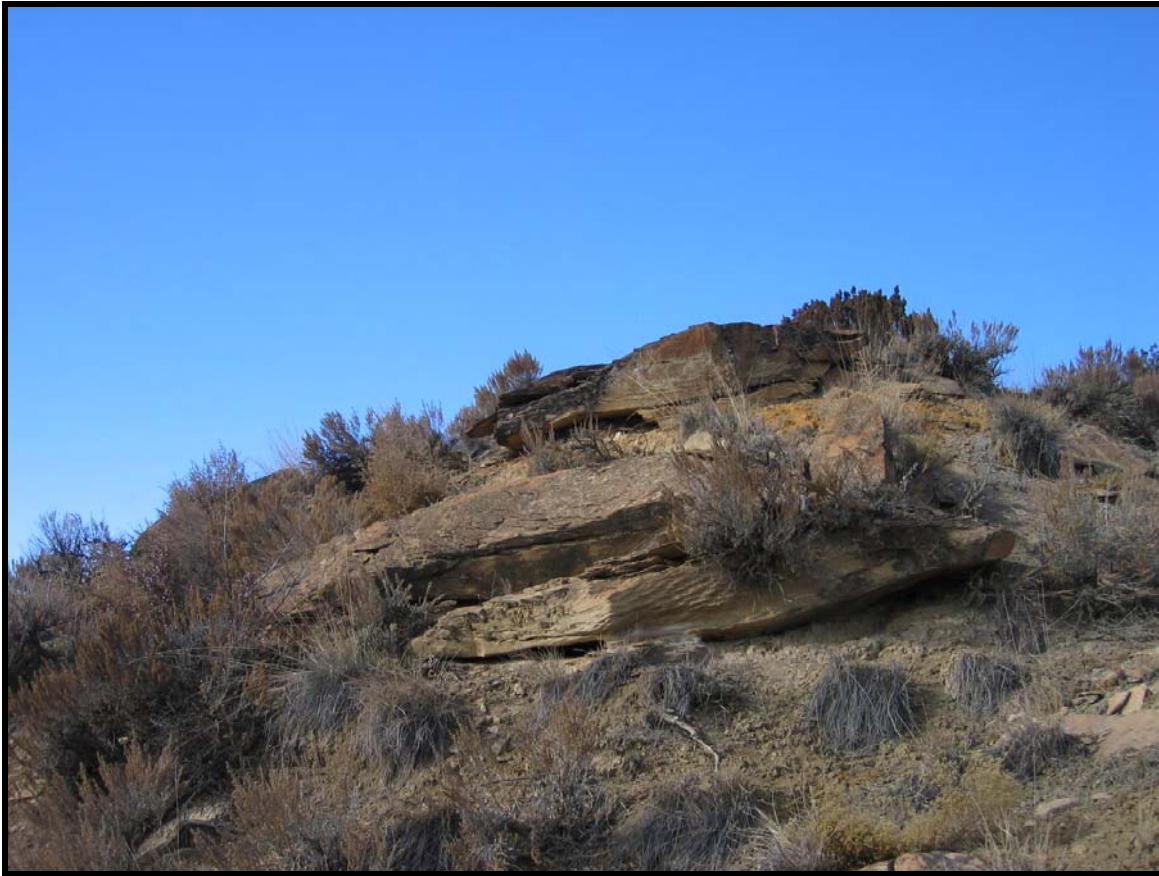
Photo: 2_1_06_23

GEOMETRIC DIMENSIONS: Area of outcrop: 0.11 acres

SUBSTRATE: Sandstone/siltstone

EXPOSURE: Southern facing slope

DESCRIPTION OF FEATURE: The small rock outcrop shown above is located at the top of a small, sandy silt hill overlooking the Spring Creek channel bottom. The large, flat, layered rocks have voids between and below.

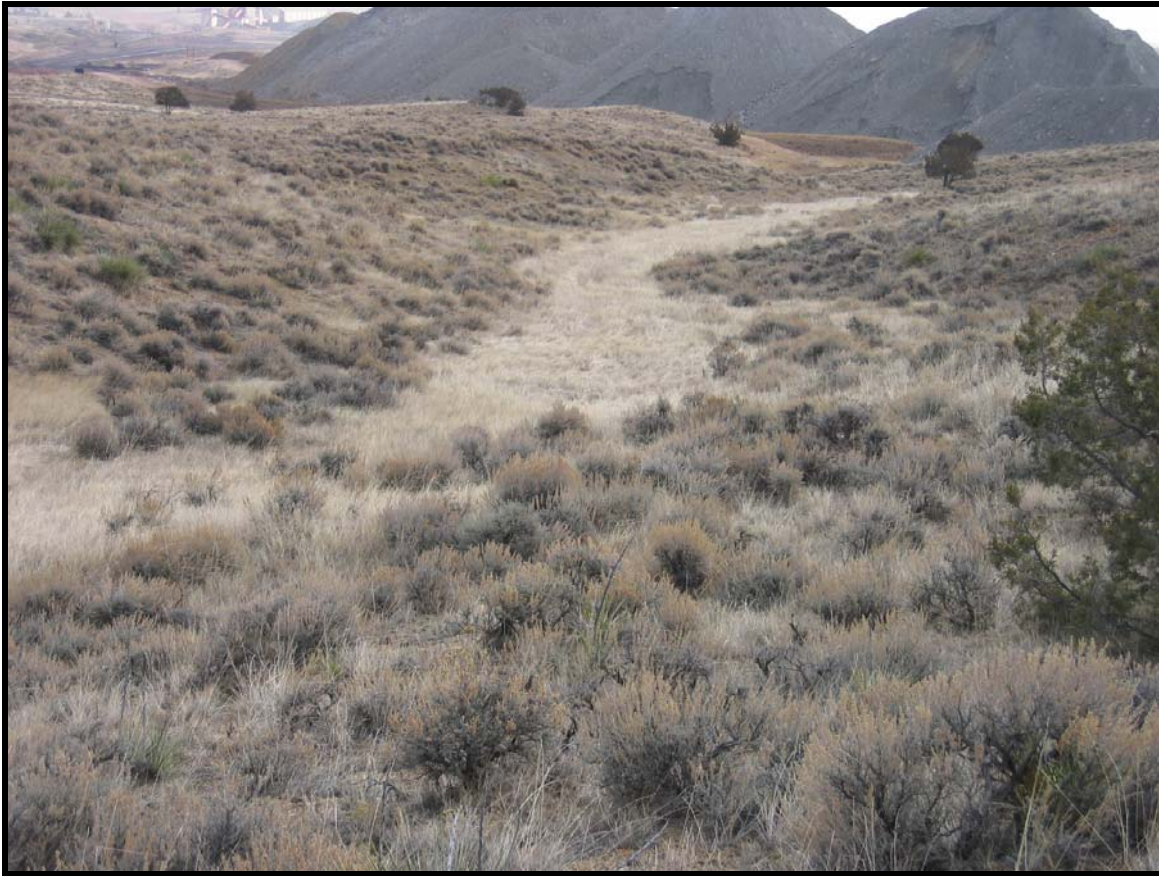
Photo: 1_26_06_06

EXPOSURE: Drainage runs in an easterly direction

DESCRIPTION OF FEATURE: This draw is a tributary to Spring Creek. The picture above looks downstream and shows geometry of the channel. The channel bottom is vegetated with grass and sagebrush.

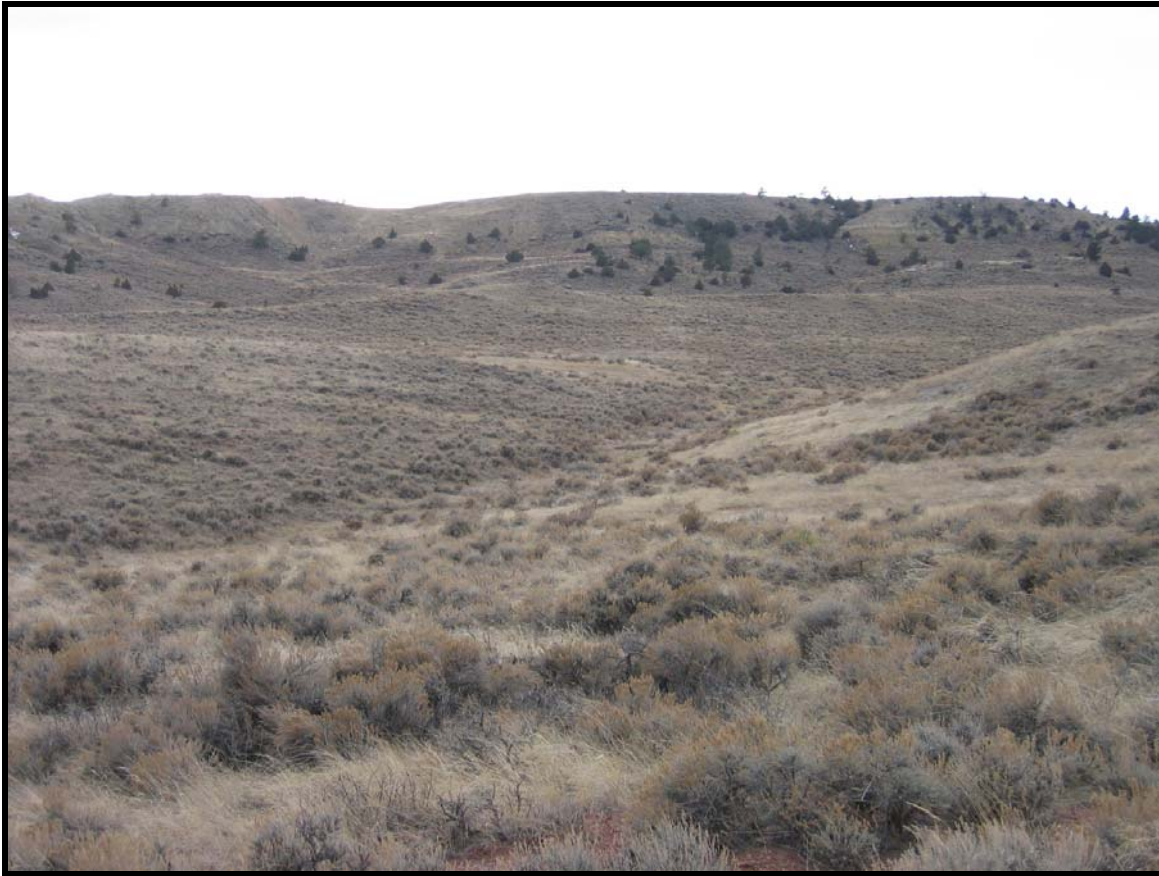
Photo: 1_26_06_50

SUBSTRATE: Not applicable
EXPOSURE: Drainage runs in an easterly direction
DESCRIPTION OF FEATURE: This draw is a tributary to Spring Creek. The picture above looks upstream and shows geometry of the channel. The channel bottom is vegetated with grass and sagebrush. This drainage runs parallel to R_0047.
