Township 8S, Range 39E

SECTION 24

Rock Outcrop Features

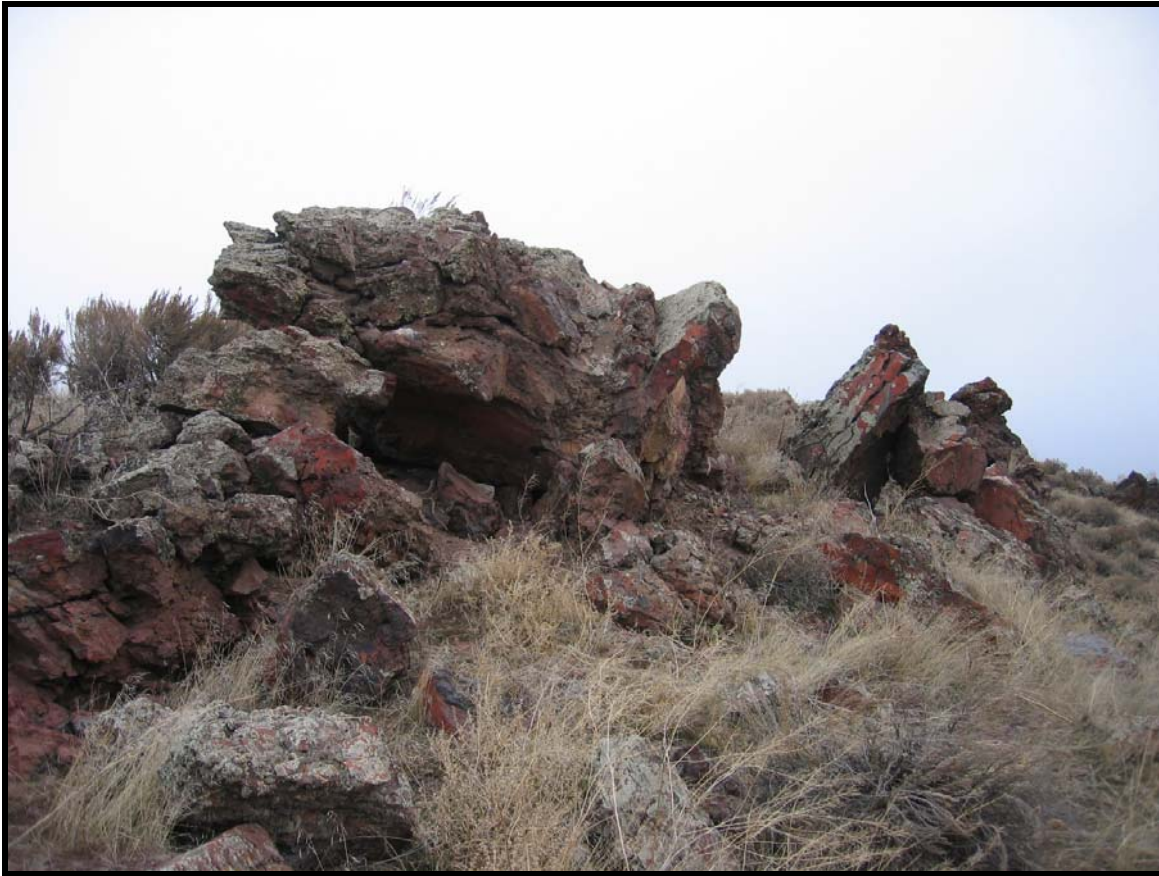
Photo: 2_1_06_01

ROCK OUTCROP FEATURE: RO_0245

FEATURE TYPE: Rock Outcrop

GEOMETRIC DIMENSIONS: Area of outcrop: 0.61 acres

SUBSTRATE: Scoria

EXPOSURE: Southern facing slope

DESCRIPTION OF FEATURE: The scoria rock outcrop shown above is located at the top of a small hill overlooking the Spring Creek channel bottom. The scoria is located on silty sand soil, which is vegetated with sagebrush and grass.

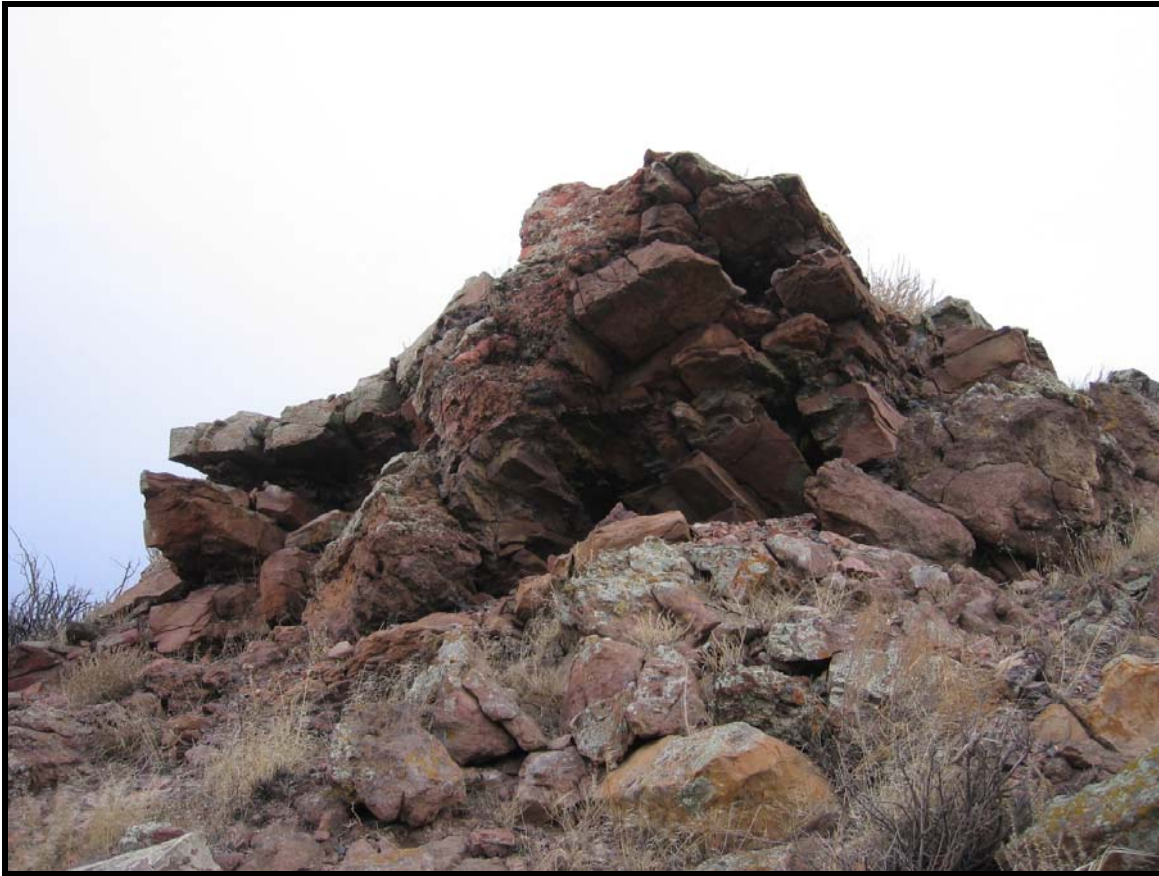
Photo: 2_1_06_02

ROCK OUTCROP FEATURE: RO_0246

FEATURE TYPE:	Rock Outcrop				
GEOMETRIC DIMENSIONS:	Area of outcrop: 0.10 acres				
LOCATION:	Township: 8S		Range: 39E		Section: 24
HANDHELD GPS POINTS:		Northing	Easting		
	16005	419461.23	2669544.10	16007	419504.32
	16006	419418.26	2669568.74	16008	419521.12
					2669635.68
					2669591.23
SUBSTRATE:	Scoria				
EXPOSURE:	Southern facing slope				
DESCRIPTION OF FEATURE:	The scoria rock outcrop shown above is located at the top of a small hill overlooking the Spring Creek channel bottom. The scoria is located on silty sand soil, which is vegetated with sagebrush and grass. This feature is located on the same bank as rock outcrop feature RO_0245.

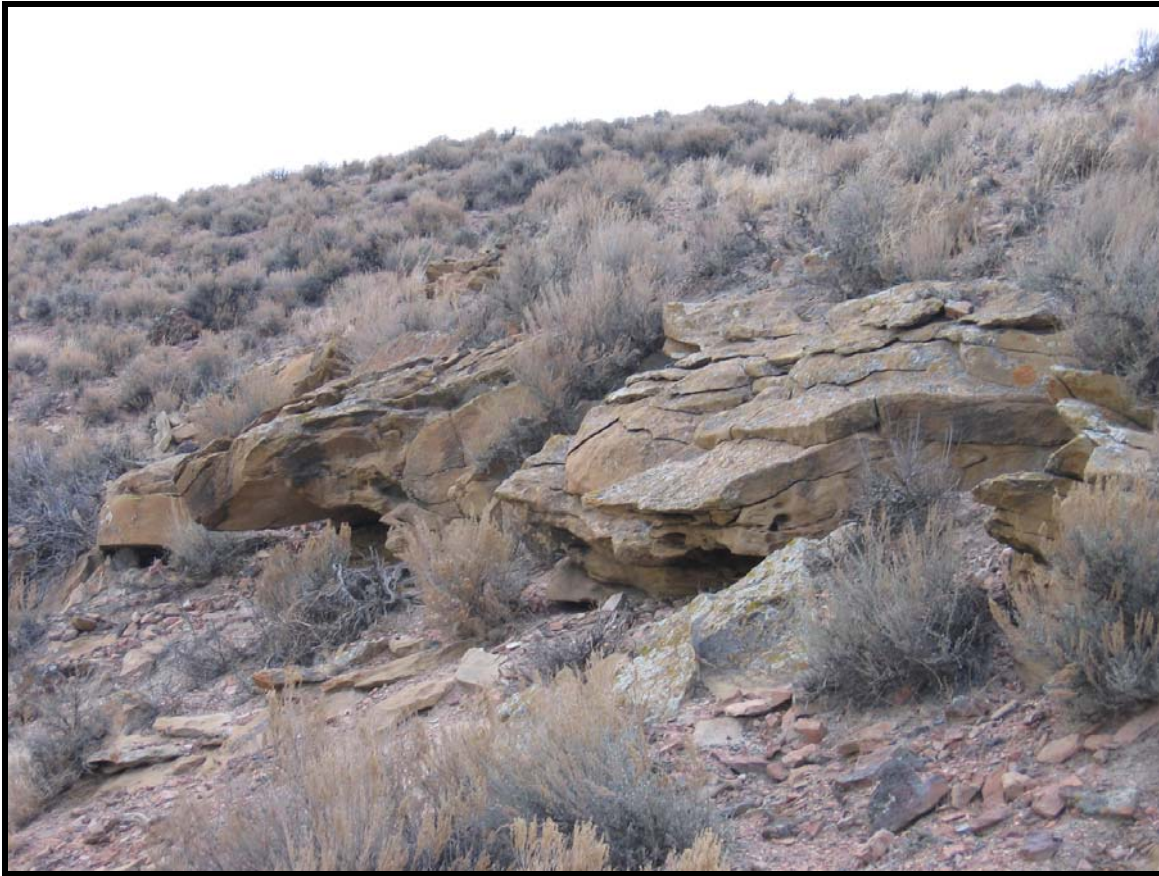
Photo: 2_1_06_48

ROCK OUTCROP FEATURE: RO_0273

FEATURE TYPE:	Rock Outcrop		
GEOMETRIC DIMENSIONS:	Length: 50 ft	Height: 5 ft	
LOCATION:	Township: 8S	Range: 39E	Section: 24
HANDHELD GPS POINTS:	Northing	Easting	
	16112	421041.03	2671130.16
	16113	421080.02	2671095.32

SUBSTRATE: Sandstone/siltstone

EXPOSURE: Southern facing slope

DESCRIPTION OF FEATURE: Rock outcrop features, like the one shown above, are very common in this area. The flat, layered sandstone/siltstone rocks sit on a silty sand slope that also contains pieces of scoria. The soil beneath the rock layer has eroded, leaving an overhang.

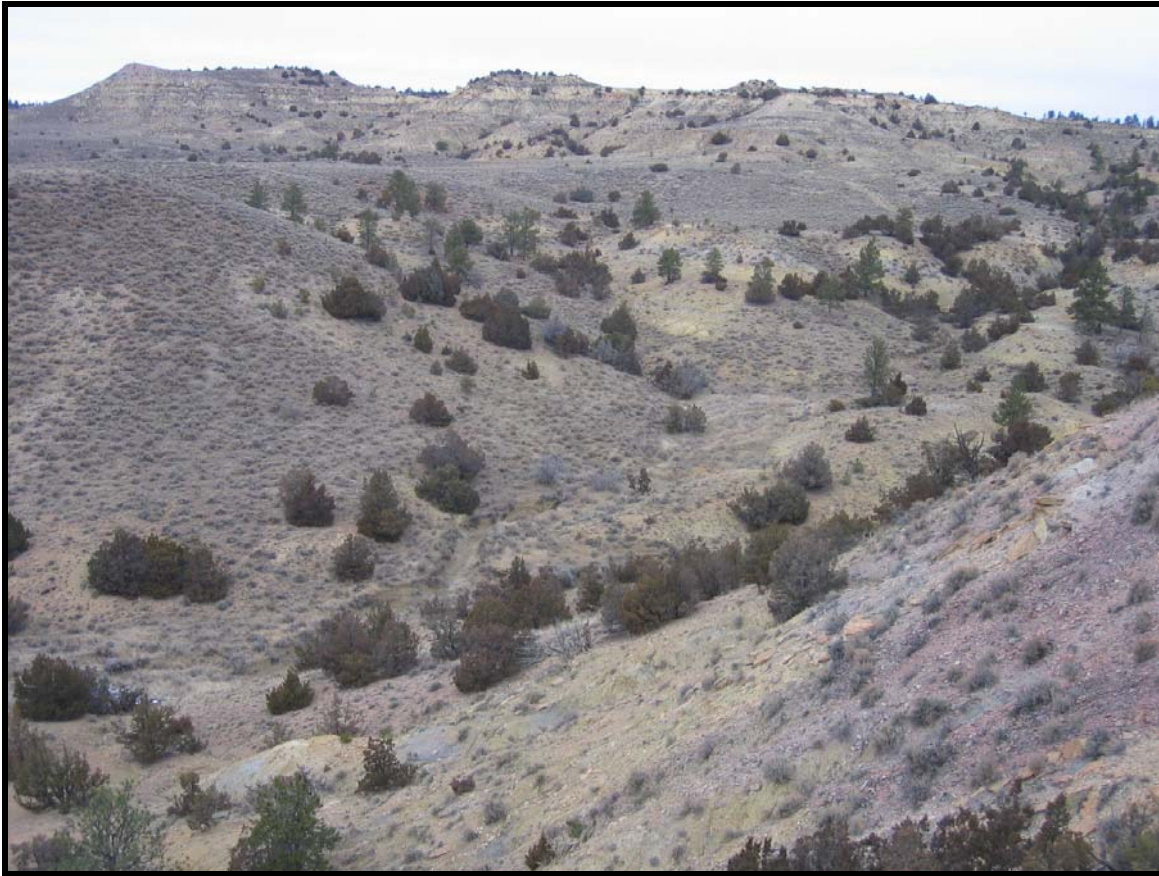
Photo: 2_1_06_06

RIPARIAN FEATURE: R_0058

FEATURE TYPE: Riparian Area
GEOMETRIC DIMENSIONS: See attached topographic map
LOCATION: Township: 8S Range: 39E Section: 24
HANDHELD GPS POINTS:

EXPOSURE: Drainage runs in an easterly direction

DESCRIPTION OF FEATURE: This draw is a tributary to Spring Creek. The picture above looks upstream and shows the geometry of the channel. The channel bottom is vegetated with grass, sagebrush, and some small trees.

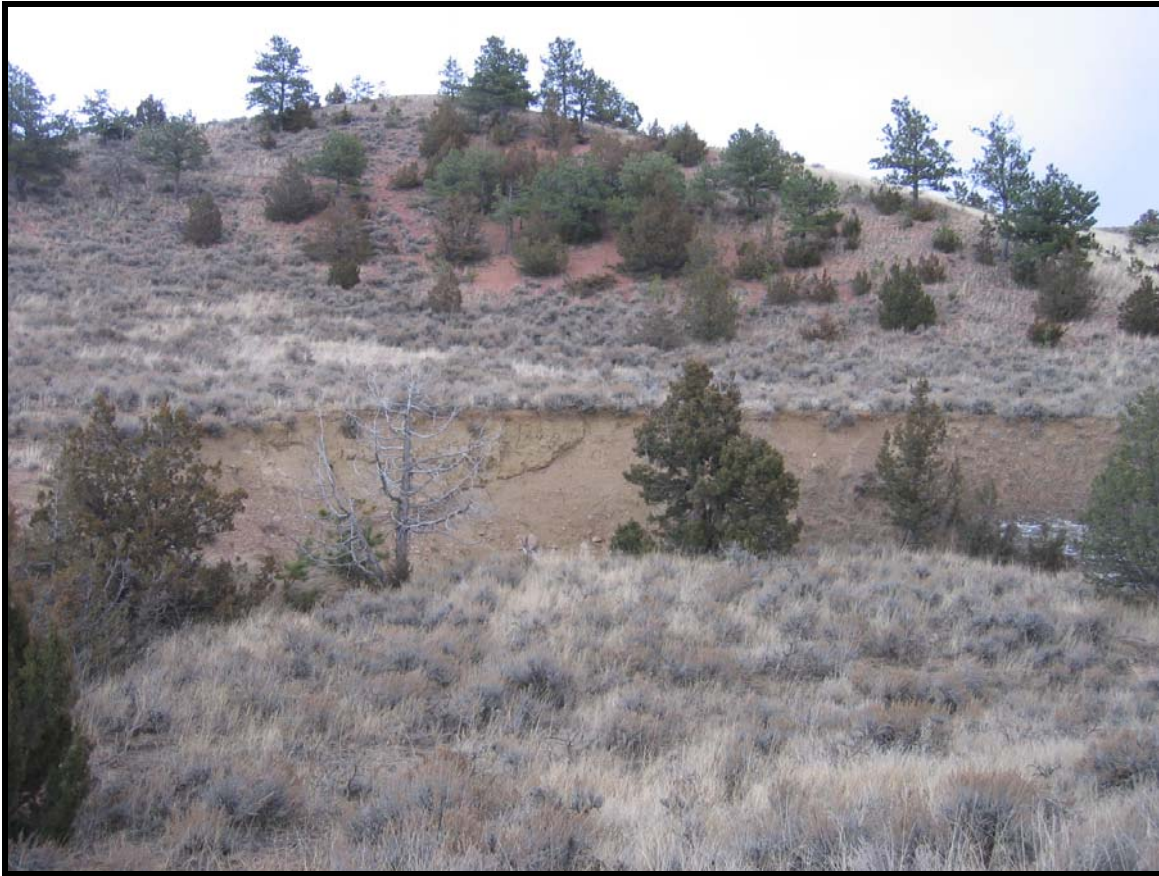
Photo: 2_1_06_49

OTHER FEATURE: O_0020

FEATURE TYPE: Cutbank

GEOMETRIC DIMENSIONS: Length: 40 ft Height: 15 ft

SUBSTRATE: Sandy Silt

EXPOSURE: Northern facing slope

DESCRIPTION OF FEATURE: This cutbank is located along the channel bottom of riparian feature R_0058. The large size and steep face provide holes and habitat for birds and other animals. The soft, sandy silt is highly erosive and will continue to erode as flows pass through this drainage.

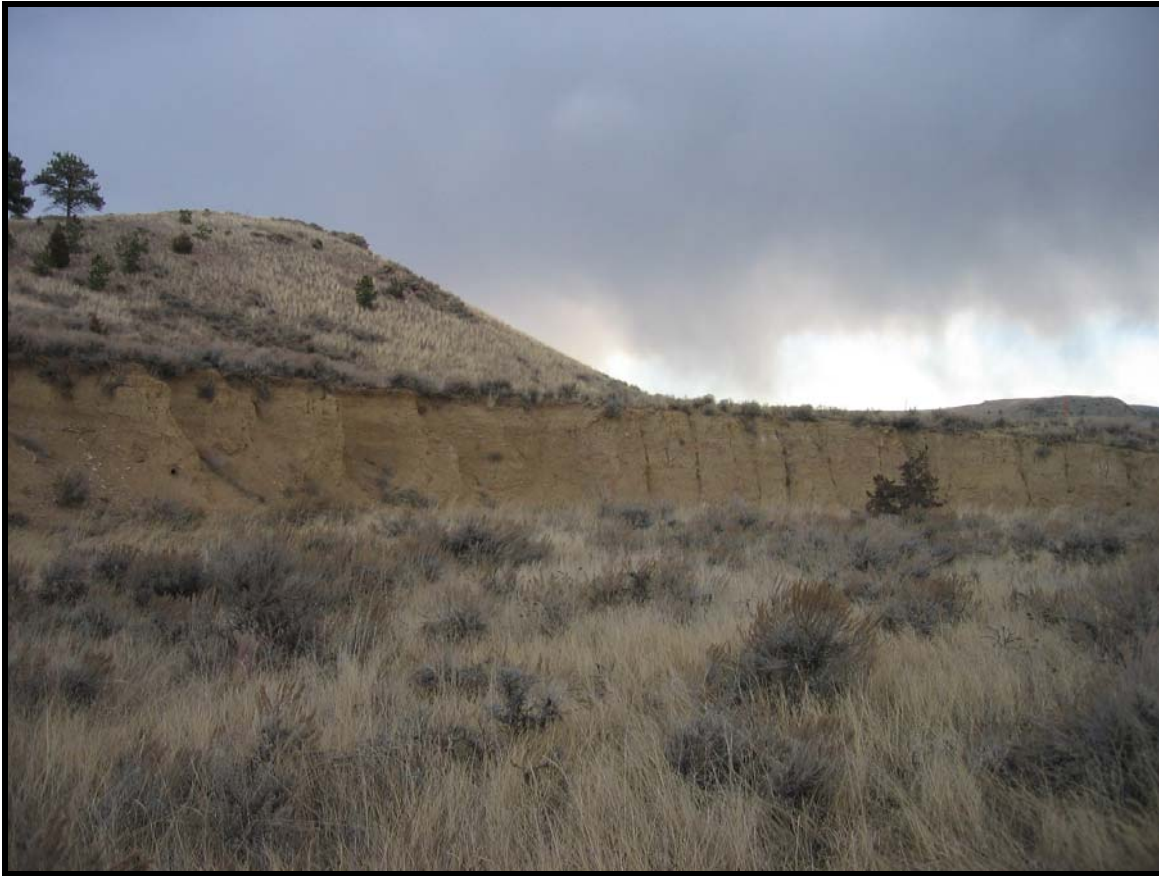
Photo: 2_1_06_50

OTHER FEATURE: O_0021

FEATURE TYPE: Cutbank

GEOMETRIC DIMENSIONS: Length: 205 ft Height: 15 ft

SUBSTRATE: Sandy Silt

EXPOSURE: Northern facing slope

DESCRIPTION OF FEATURE: This cutbank is located along the channel bottom of riparian feature R_0058. The large size and steep face provide holes and habitat for birds and other animals. The soft, sandy silt is highly erosive and will continue to erode as flows pass through this drainage. This feature is located just downstream of other feature O_0020.
