Township 8S, Range 39E
SECTION 25

Cliff Features

Revised 4/06; Reference – South Fork Extension Amendment #00174

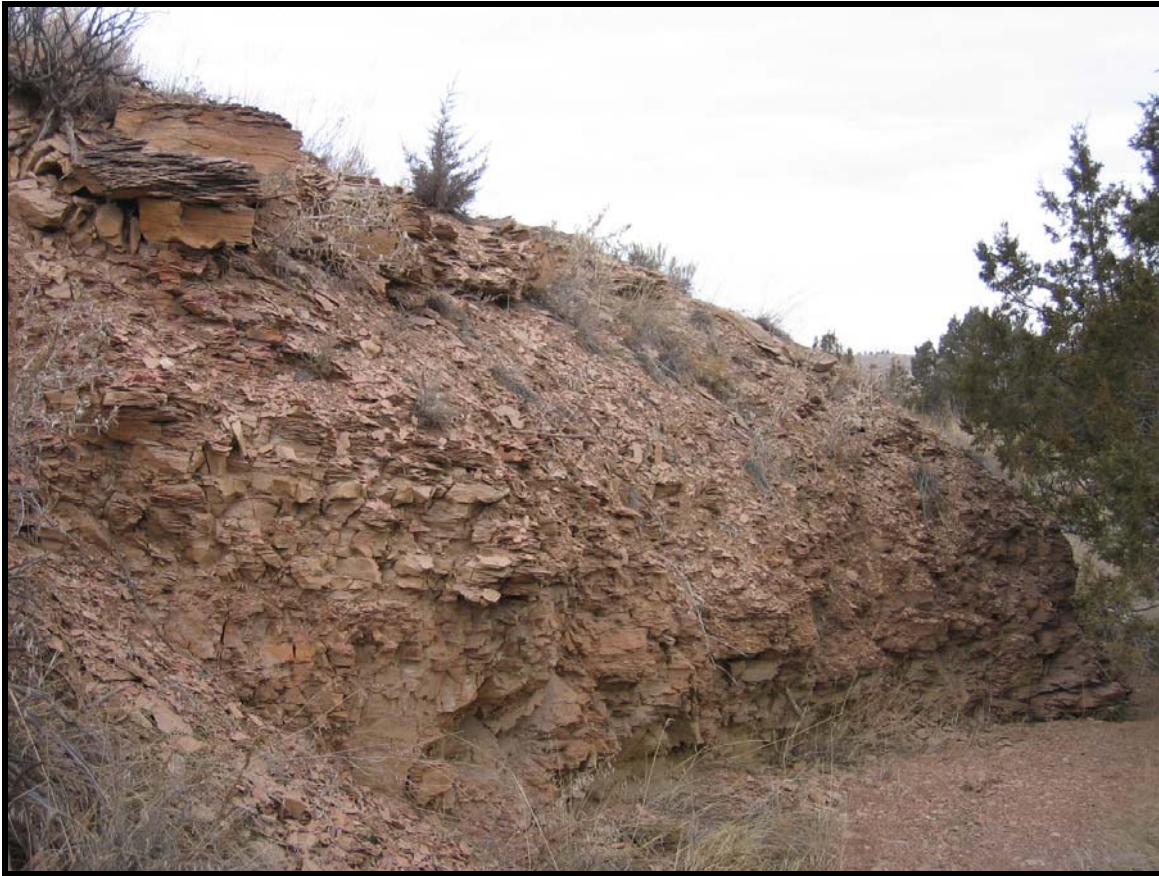
Photo: 1_17_06_13

GEOMETRIC DIMENSIONS: Length: 65 ft Height: 15 ft

SUBSTRATE: Scoria and siltstone

DESCRIPTION OF FEATURE: This scoria/siltstone cliff feature is adjacent to a small draw that is a tributary to South Fork Spring Creek. The flows through this draw have created this feature. As can be seen in the picture above, the face of this cliff is very jagged.

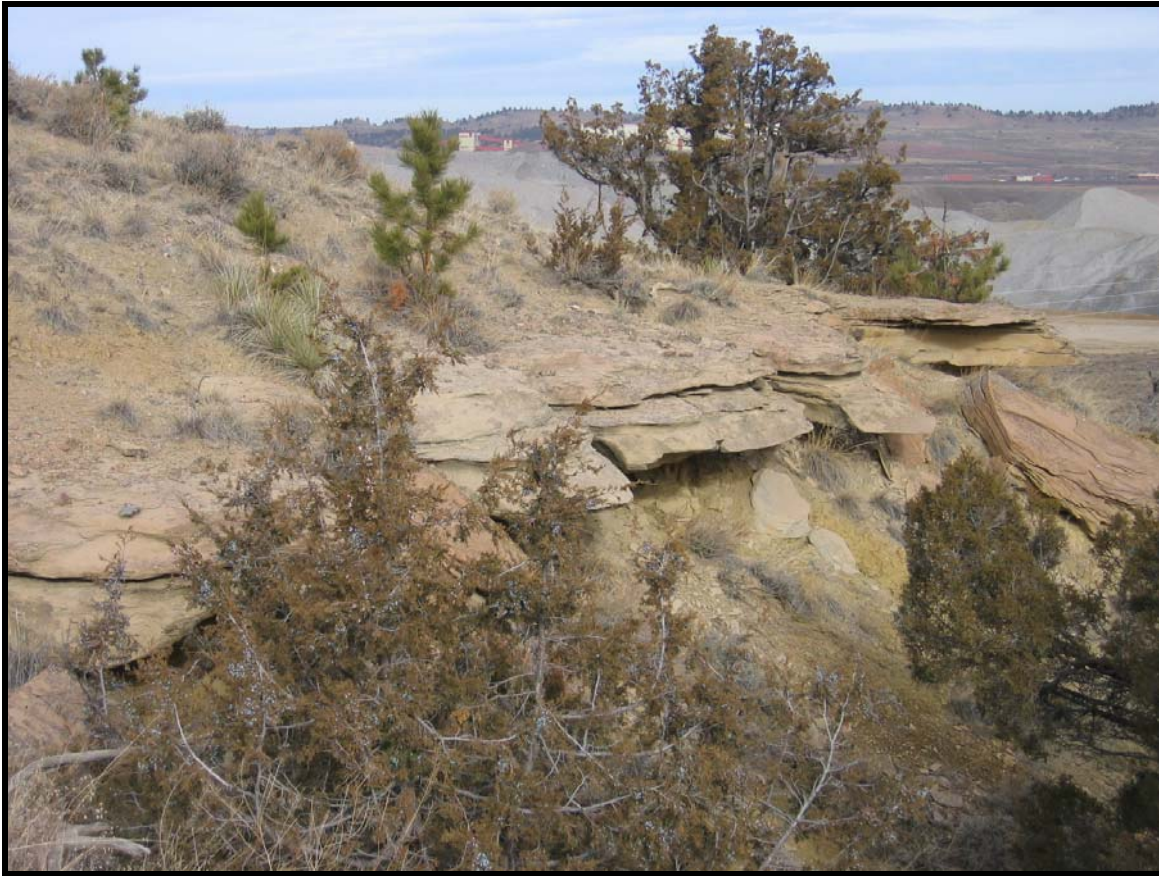
Photo: 1_17_06_15

GEOMETRIC DIMENSIONS: Length: 40 ft Height: 10 ft

SUBSTRATE: Sandstone/Siltstone

DESCRIPTION OF FEATURE: This sandstone/siltstone cliff feature is adjacent to a small draw south of South Fork Spring Creek. Erosion has created voids below the rock of this feature. Some of the rock layer that is exposed has fallen from the cliff and is laying on the slope below the feature.

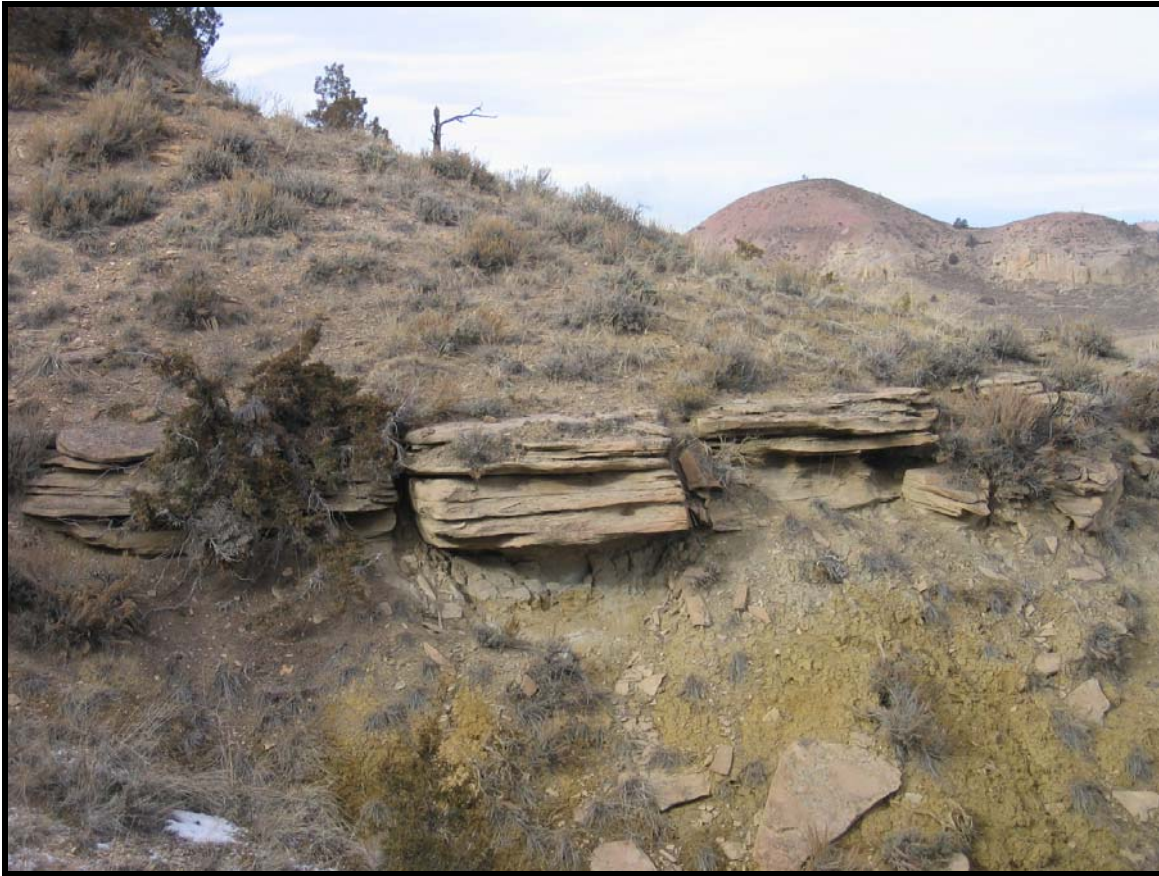
Photo: 1_17_06_16

GEOMETRIC DIMENSIONS: Length: 55 ft Height: 10 ft

SUBSTRATE: Sandstone/Siltstone

DESCRIPTION OF FEATURE: This sandstone/siltstone cliff feature is adjacent to a small draw south of South Fork Spring Creek. Erosion has created voids below the rock of this feature. Some of the rock layer that is exposed has fallen from the cliff and is laying on the slope below the feature.

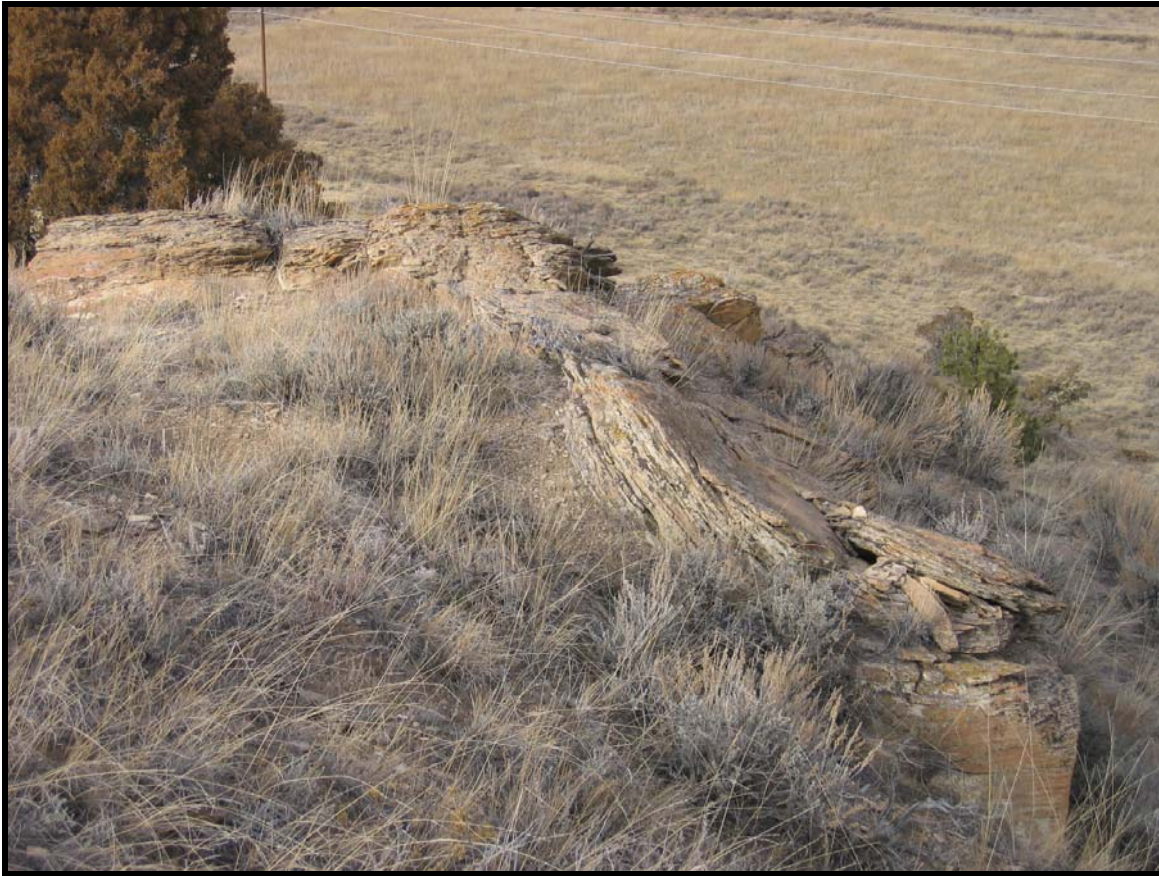
Photo: 1_17_06_20

GEOMETRIC DIMENSIONS: Length: 100 ft Height: 10 ft

SUBSTRATE: Sandstone/siltstone

DESCRIPTION OF FEATURE: This feature has several areas that appear to be a rock outcrop, as can be seen in picture 1_17_06_20 above. The majority of the feature, however, is a 10-foot cliff feature, so it has been classified as a cliff. Pictures 1_17_06_21, 1_17_06_22, 1_17_06_23, 1_17_06_24 on the next two pages show additional views of this feature.

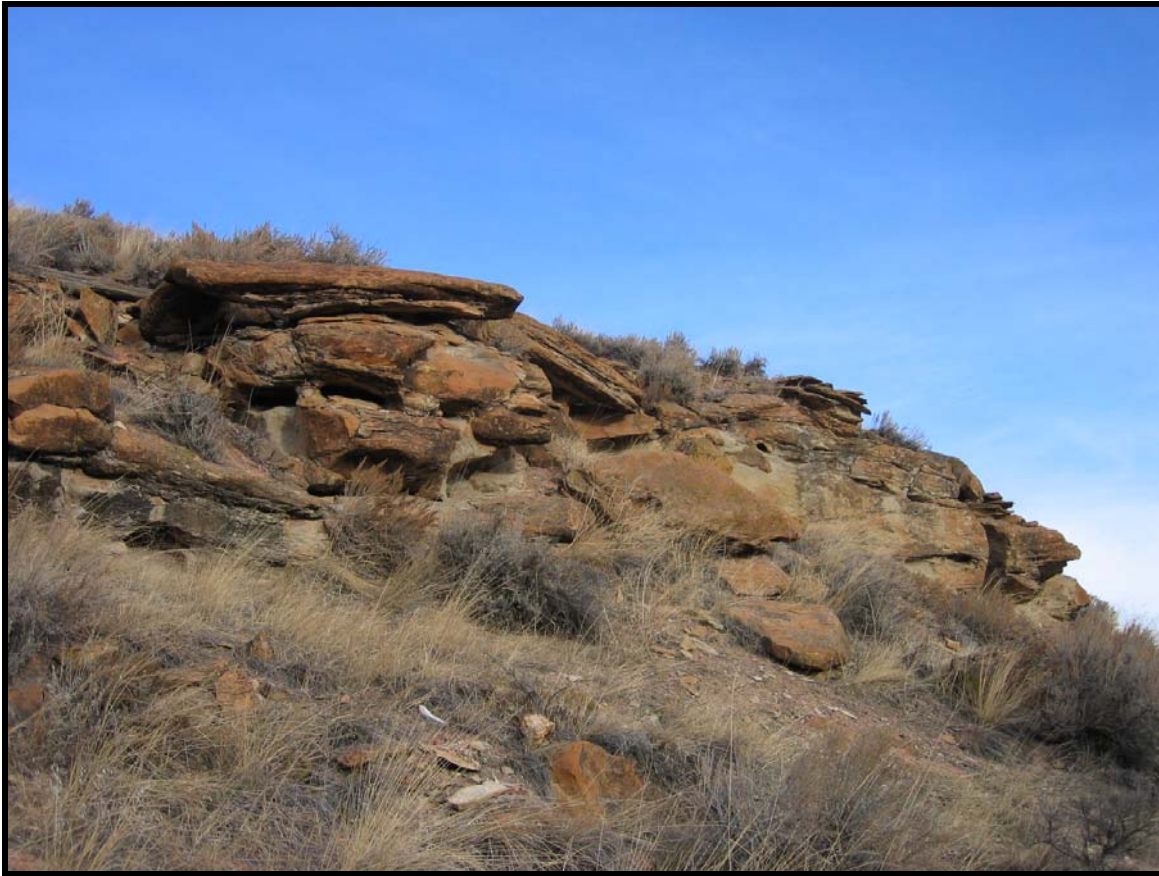
Photo: 1_17_06_37

GEOMETRIC DIMENSIONS: Length: 130 ft Height: 15 ft

SUBSTRATE: Siltstone/sandstone

DESCRIPTION OF FEATURE: The cliff shown in the picture above is a very typical feature in this area. The sandstone/siltstone rock layer has been exposed by weathering and erosion, creating voids and overhangs over the length of the feature. As more of the subsoil erodes, the rock layer breaks, and large rocks are deposited along the slope beneath the feature.

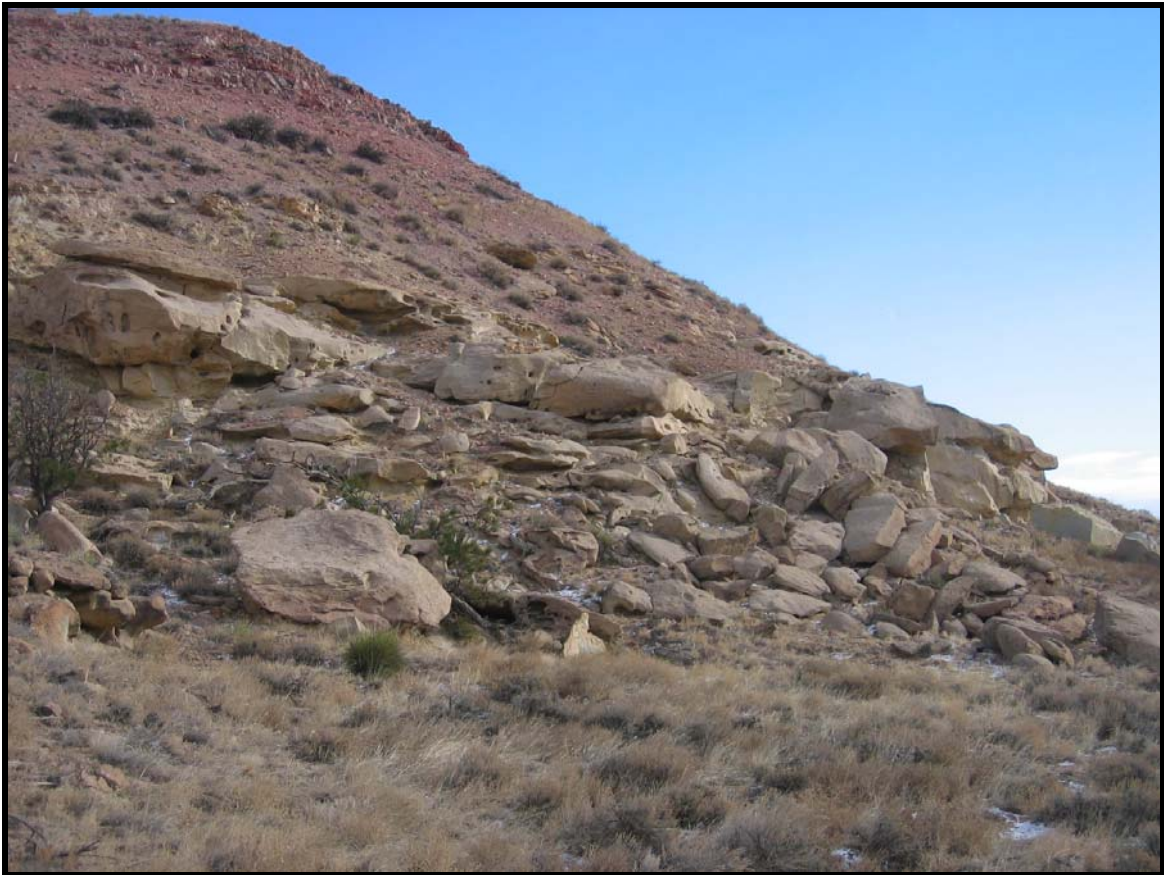
Photo: 2_2_06_15

GEOMETRIC DIMENSIONS: Length: 210 ft Height: 25 ft

SUBSTRATE: Siltstone/sandstone

DESCRIPTION OF FEATURE: This large cliff feature is located near the bottom of a steep slope. The sandstone/siltstone rock has been weathered, leaving holes and crevices along its face. This cliff has a lot of rock that has been deposited below, making it appear like a rock outcrop. See the pictures on the following pages for additional views of this feature.

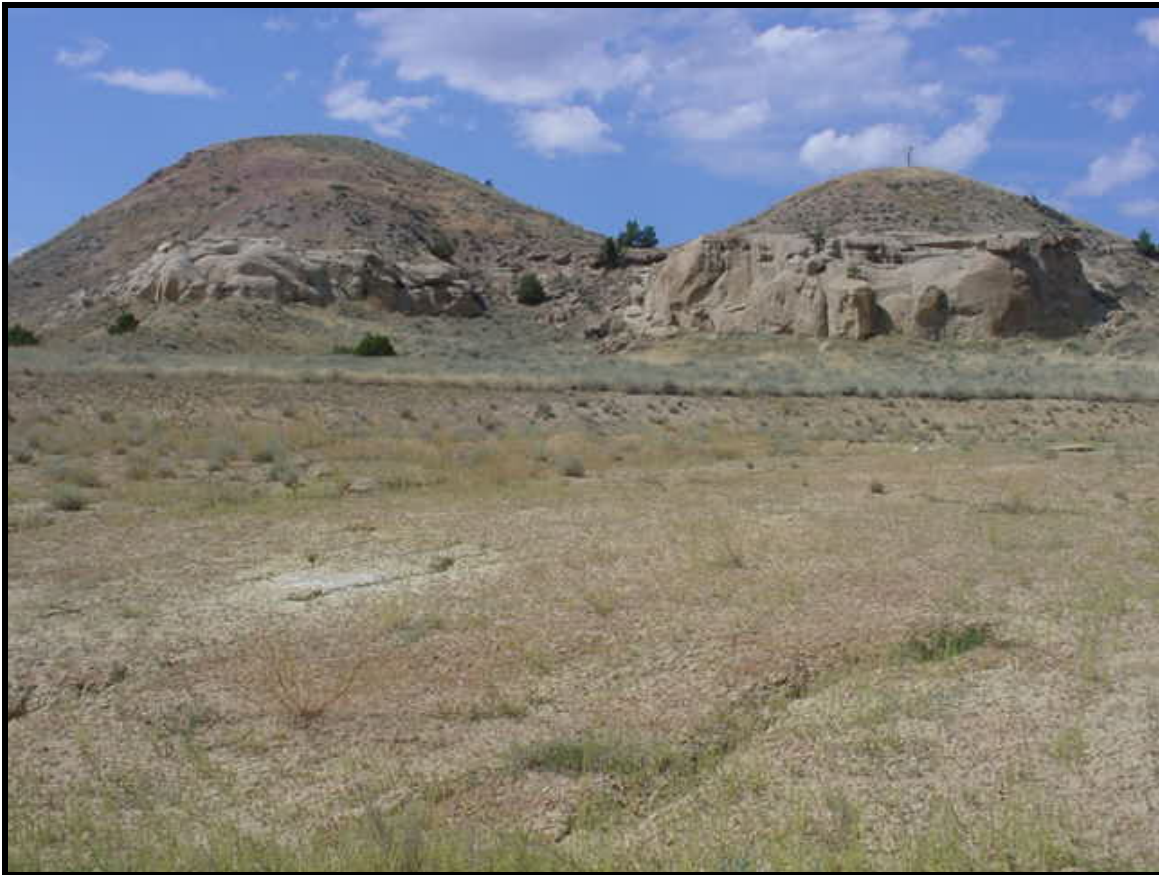
Photo: pre_2

FEATURE TYPE:	Cliff					
GEOMETRIC DIMENSIONS:	Length: 195 ft		Height: 45 ft			
LOCATION:	Township: 8S		Range: 39E		Section: 25	
HANDHELD GPS POINTS:		Northing	Easting		Northing	Easting
	17034	413526.40	2670898.85	17036	413692.13	2670947.72
	17035	413553.49	2670947.05

SUBSTRATE: Siltstone/sandstone

DESCRIPTION OF FEATURE: This large cliff feature is located near the bottom of a steep slope. The sandstone/siltstone rock has been weathered, leaving holes and crevices along its face. This cliff has a tall, solid face that overlooks the South Fork Spring Creek. See the pictures on the following page for additional views of this feature. In the photo above, this feature is the cliff to the left hand side of the view.

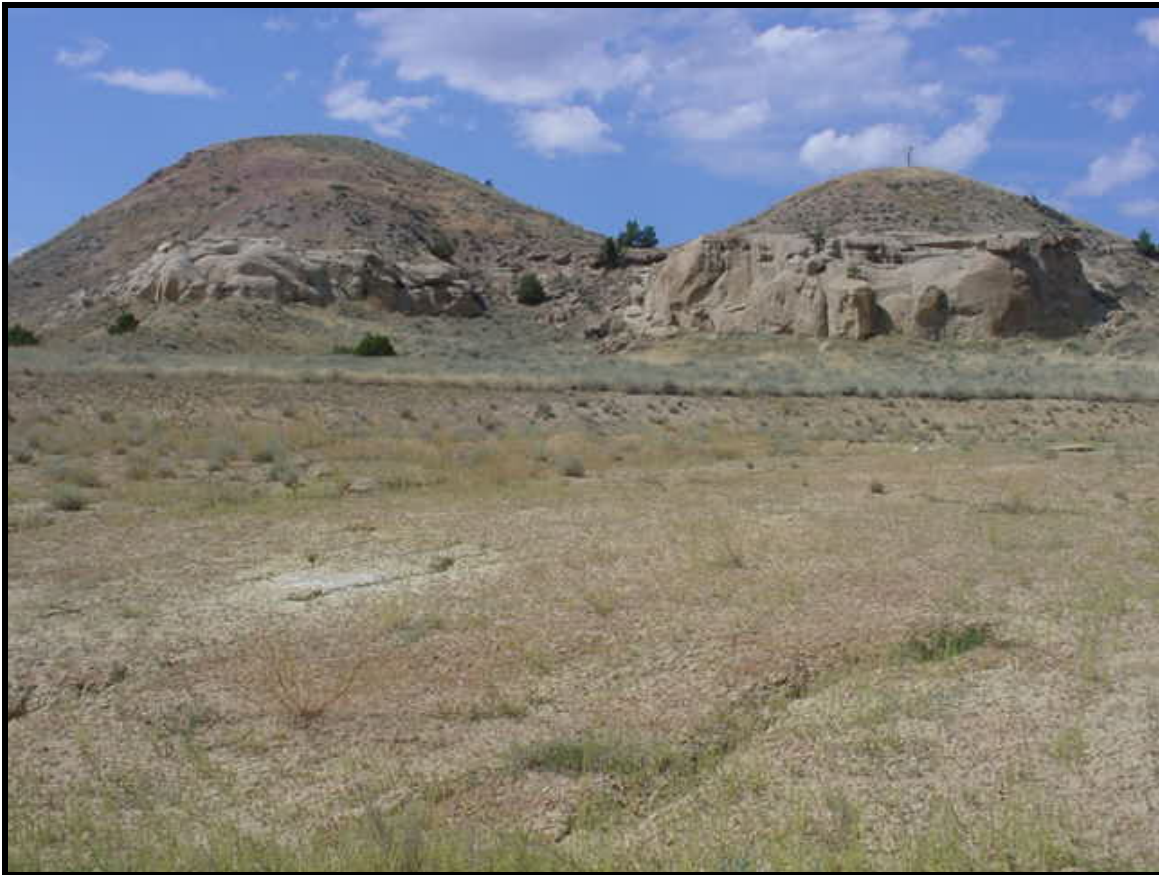
Photo: pre_2

FEATURE TYPE:	Cliff					
GEOMETRIC DIMENSIONS:	Length: 200 ft		Height: 45 ft			
LOCATION:	Township: 8S		Range: 39E		Section: 25	
HANDHELD GPS POINTS:		Northing	Easting		Northing	Easting
	17037	413715.58	2670996.04	17039	413732.04	2671166.00
	17038	413735.48	2671047.06	17040	413750.93	2671186.06

SUBSTRATE: Siltstone/sandstone

DESCRIPTION OF FEATURE: The large cliff feature shown above is located near the bottom of a steep slope adjacent to cliffs C_0062 and C_0064. The sandstone/siltstone rock has been weathered, leaving holes and crevices along its face. This feature has similar characteristics to the cliffs mentioned above. See the pictures on the following page for additional views of this feature. In the photo above this feature is the cliff on the right side of the view.

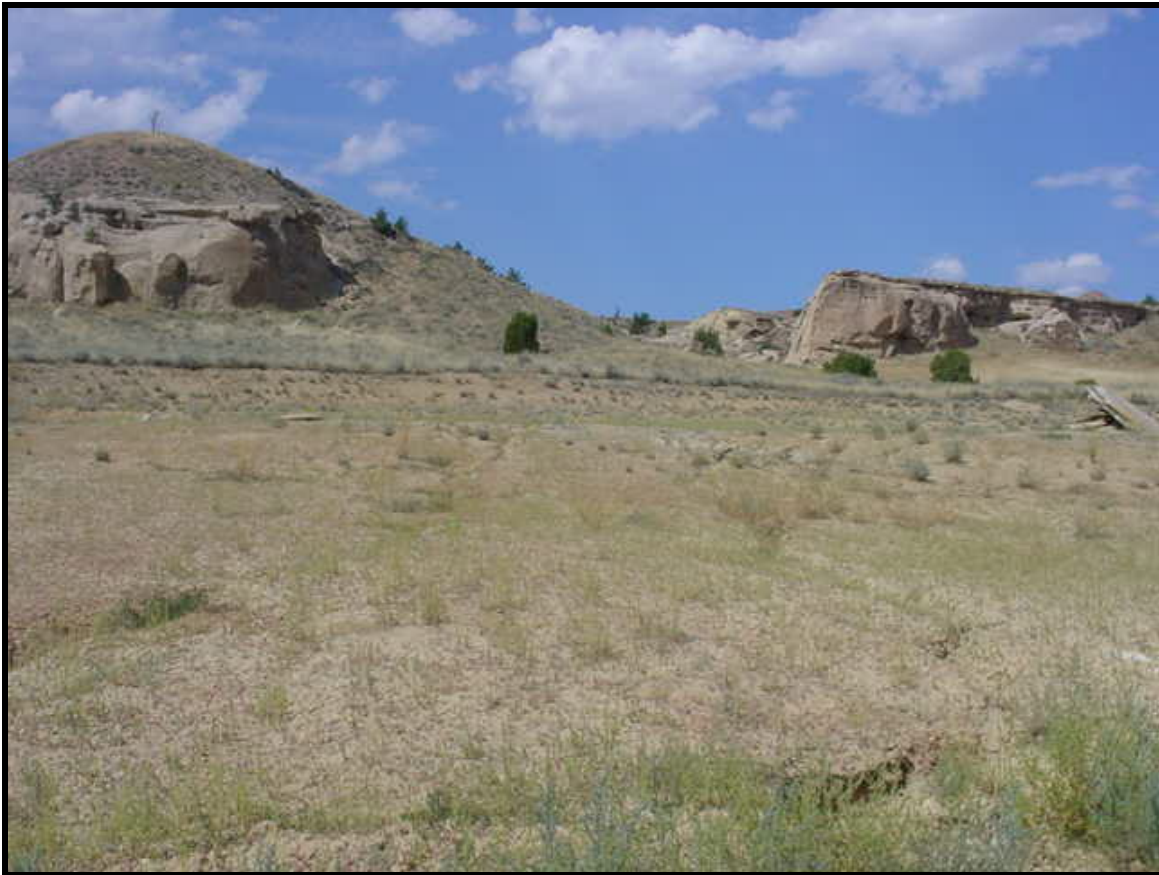
Photo: pre_3

FEATURE TYPE:	Cliff					
GEOMETRIC DIMENSIONS:	Length: 425 ft		Height: 50 ft			
LOCATION:	Township: 8S		Range: 39E		Section: 25	
HANDHELD GPS POINTS:		Northing	Easting		Northing	Easting
	17041	413952.35	2671210.52	17043	413853.91	2671324.79
	17042	413996.03	2671320.18	17044	414033.76	2671471.37

SUBSTRATE: Siltstone/sandstone

DESCRIPTION OF FEATURE: The large cliff feature shown above is located toward the bottom of a steep slope adjacent to cliff C_0062 and C_0063. The sandstone/siltstone rock has been weathered, leaving holes and crevices along its face. This feature has similar characteristics to the cliffs mentioned above. This feature includes an area at the head of a draw. This area includes rocks that have been deposited like a rock outcrop. See the pictures on the following page for additional views of this feature. In the picture above, this feature is the cliff on the right side of the view.

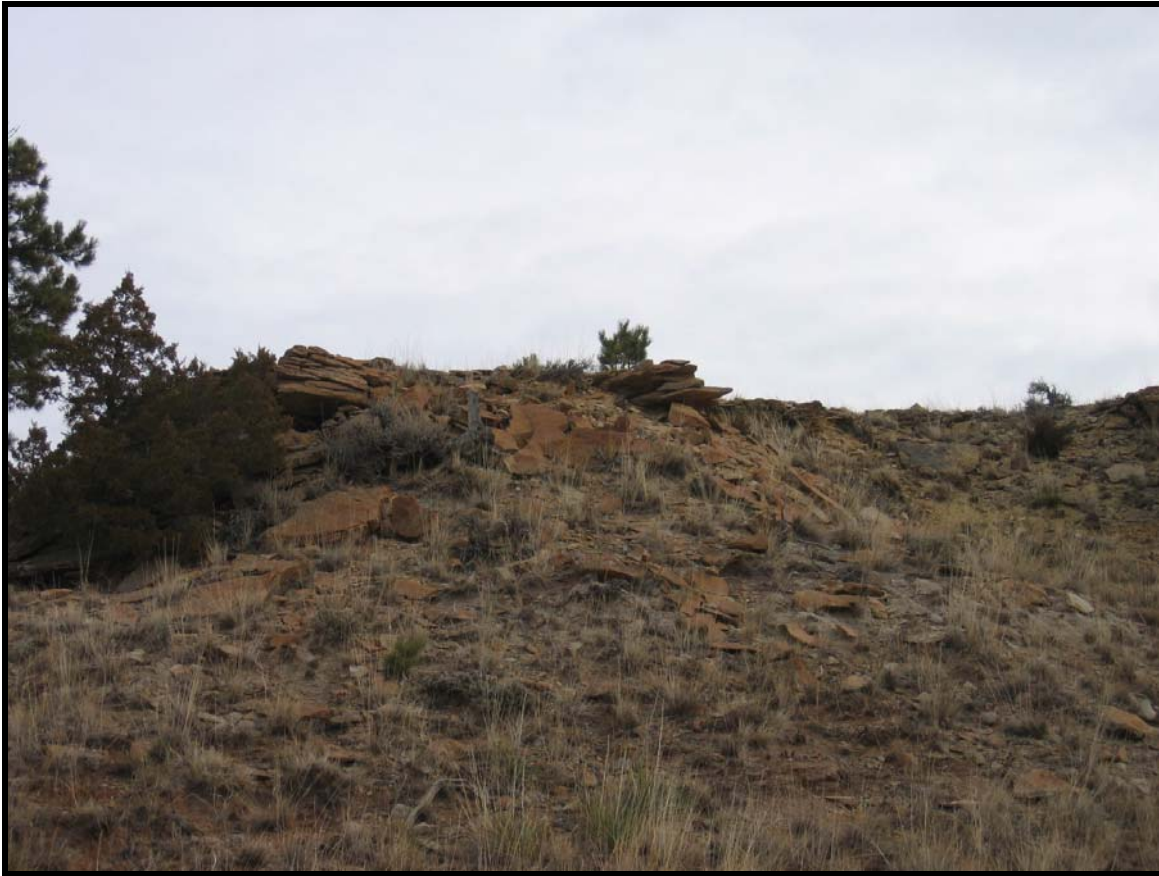
Photo: 1_17_06_14

GEOMETRIC DIMENSIONS: Outcrop area: 0.08 acres

SUBSTRATE: Siltstone/sandstone

DESCRIPTION OF FEATURE: The sandstone/siltstone rock outcrop shown above creates voids and pockets where the rocks are stacked together. This type of outcrop is very typical across the minesite. The surrounding vegetation includes sparsely populated grass and sagebrush.

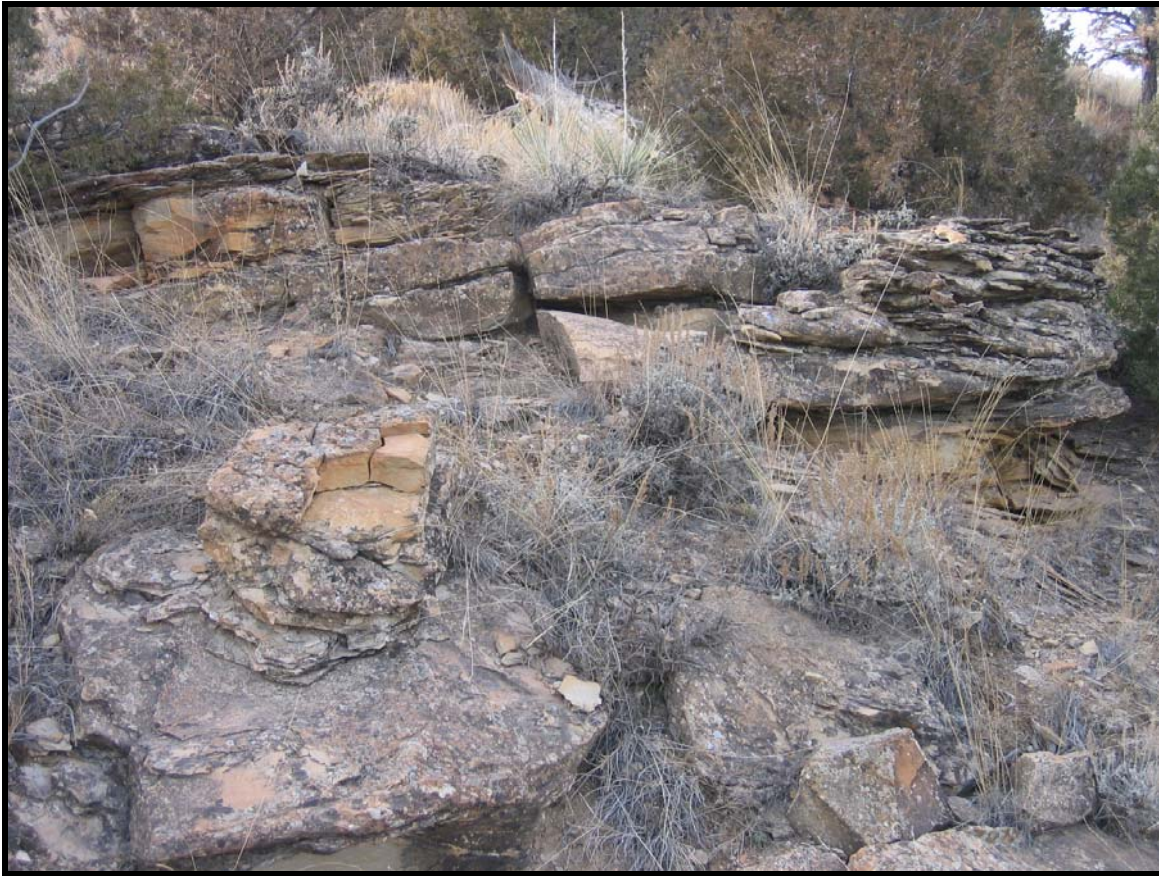
Photo: 1_17_06_17

GEOMETRIC DIMENSIONS: Area of Outcrop: 0.07 acres

SUBSTRATE: Siltstone

DESCRIPTION OF FEATURE: This small rock outcrop occurs at the top of a gentle slope. Due to the configuration of the rock in this outcrop, there are areas that animals have used for protection and habitat. This area is vegetated with juniper and sagebrush.

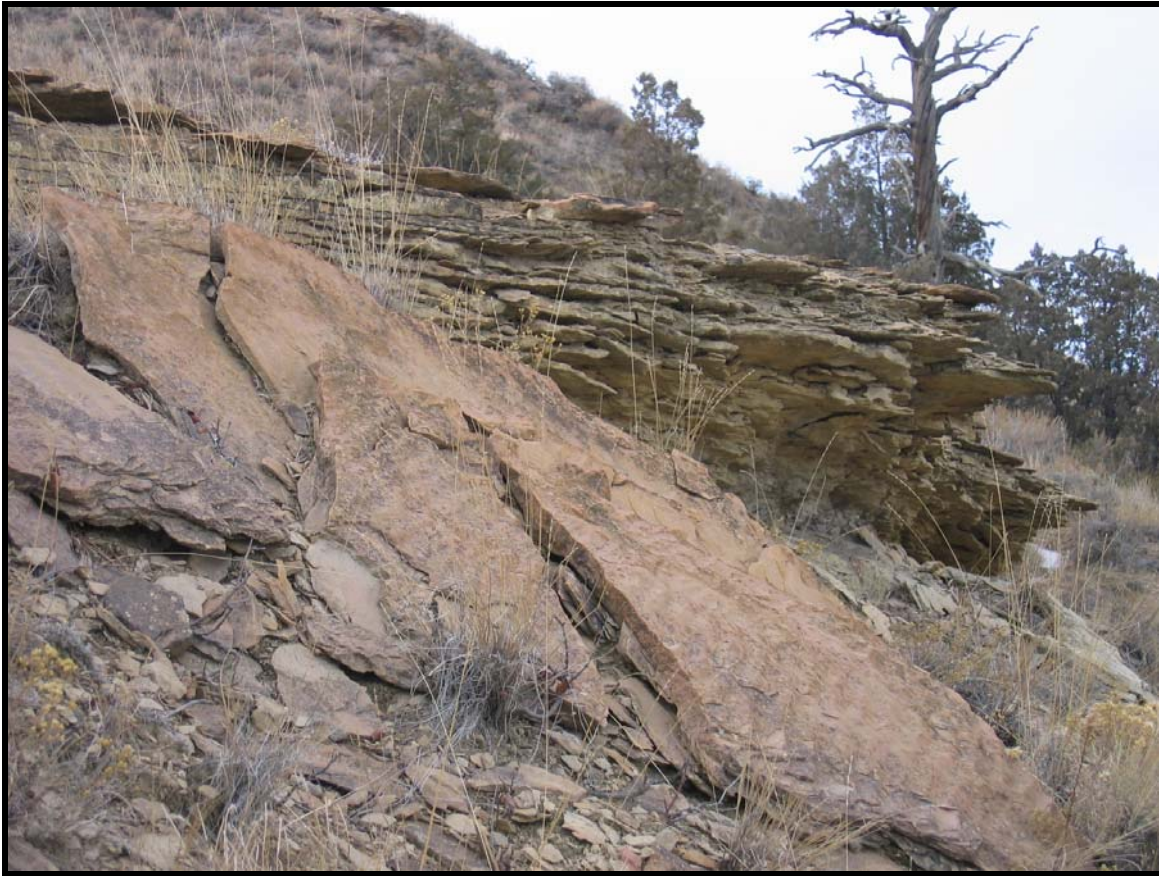
Photo: 1_17_06_18

GEOMETRIC DIMENSIONS: Length: 65 ft Height: 5 ft

SUBSTRATE: Siltstone

DESCRIPTION OF FEATURE: This is a feature created by an outcrop of thin siltstone. Although this feature is relatively small, the geometry of the outcrop creates areas for habitat beneath and within the rocks. This outcrop is localized in this area and is located on a gently sloped, grass-covered hill.

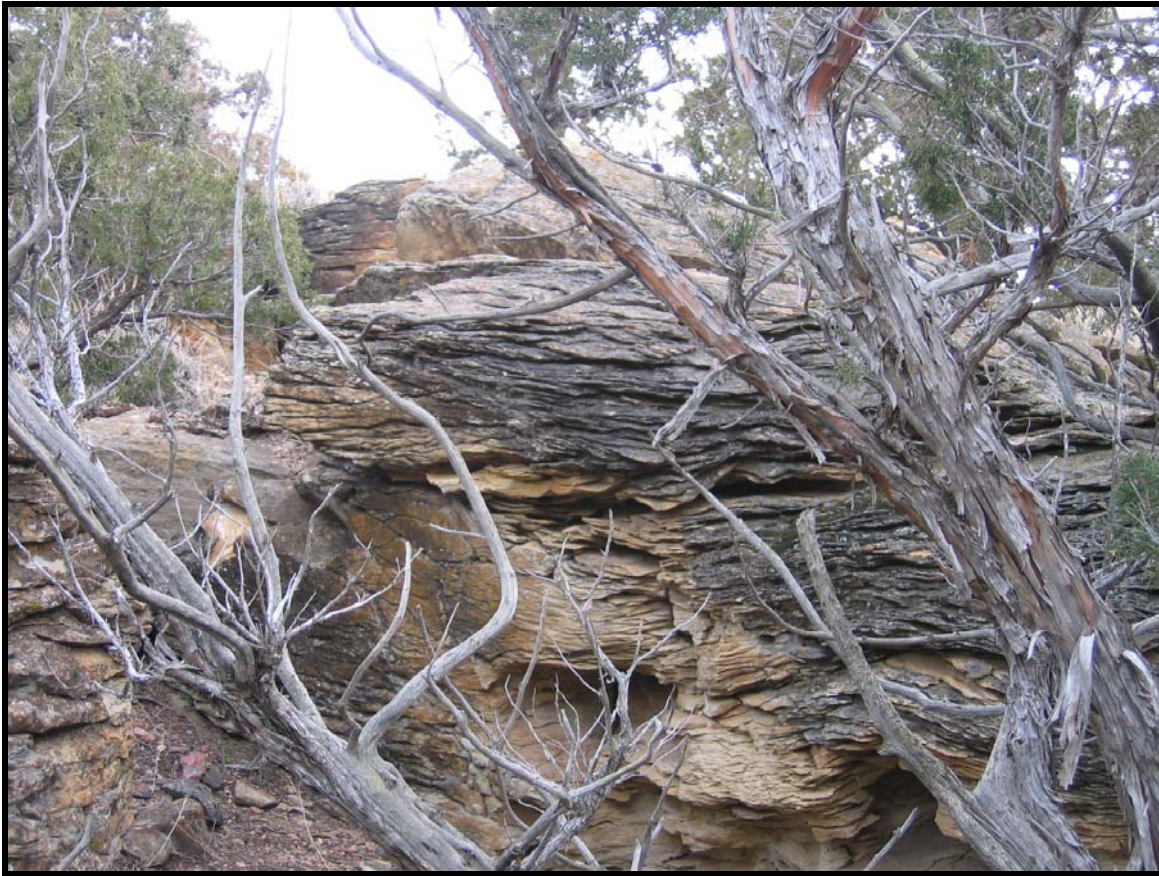
Photo: 1_17_06_25

GEOMETRIC DIMENSIONS: Area of outcrop: 0.03 acres

SUBSTRATE: Siltstone/sandstone

DESCRIPTION OF FEATURE: The rock outcrop shown above is located within an area, which is densely populated with juniper trees. The outcrop in this area is relatively small, but appears to create good habitat due to its location and surrounding vegetation.

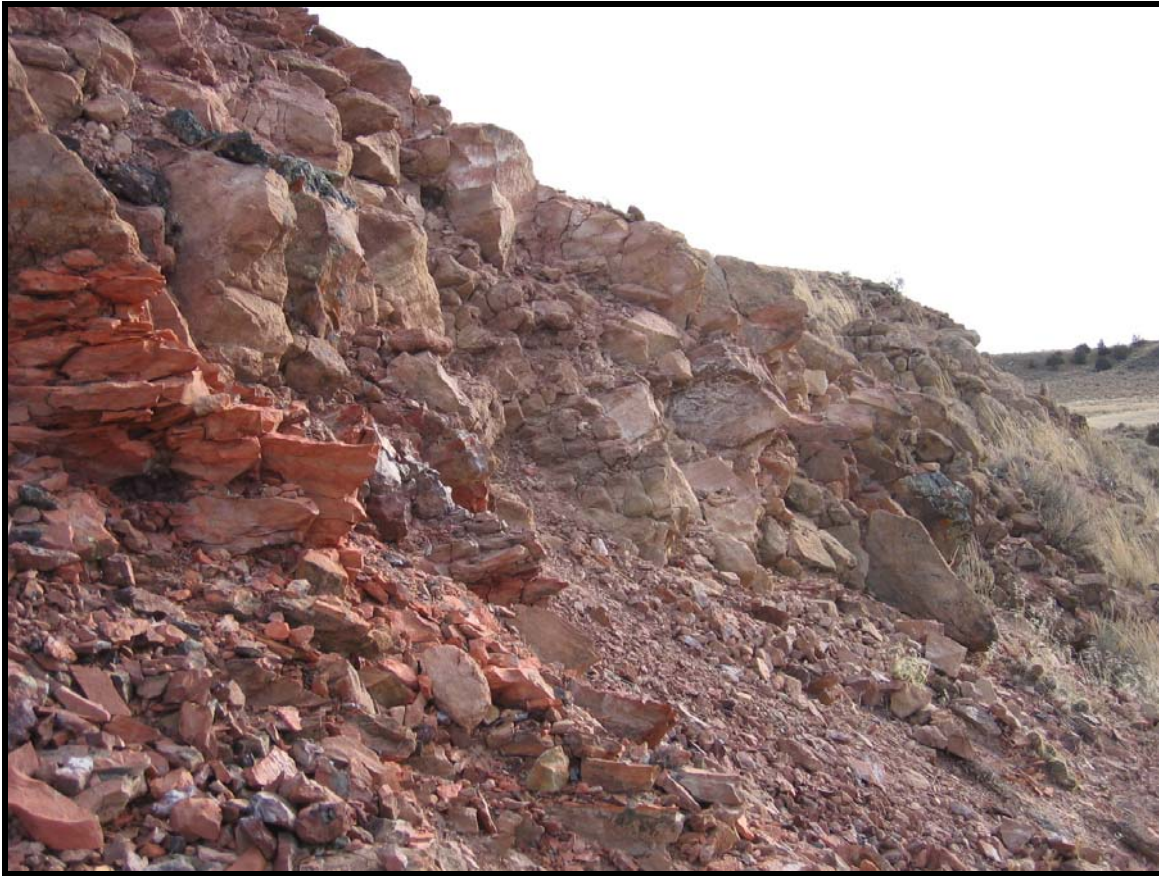
Photo: 1_17_06_26

GEOMETRIC DIMENSIONS: Length: 200 ft Height: 10 ft

SUBSTRATE: Scoria

DESCRIPTION OF FEATURE: In many areas around the minesite, the peaks of hillsides are capped with a highly fractured scoria rock. This feature is an example of one of these scoria outcrops. This outcrop crosses into Township 8S, Range 39E, Section 36 but was included into this section because it contains the majority of this feature.

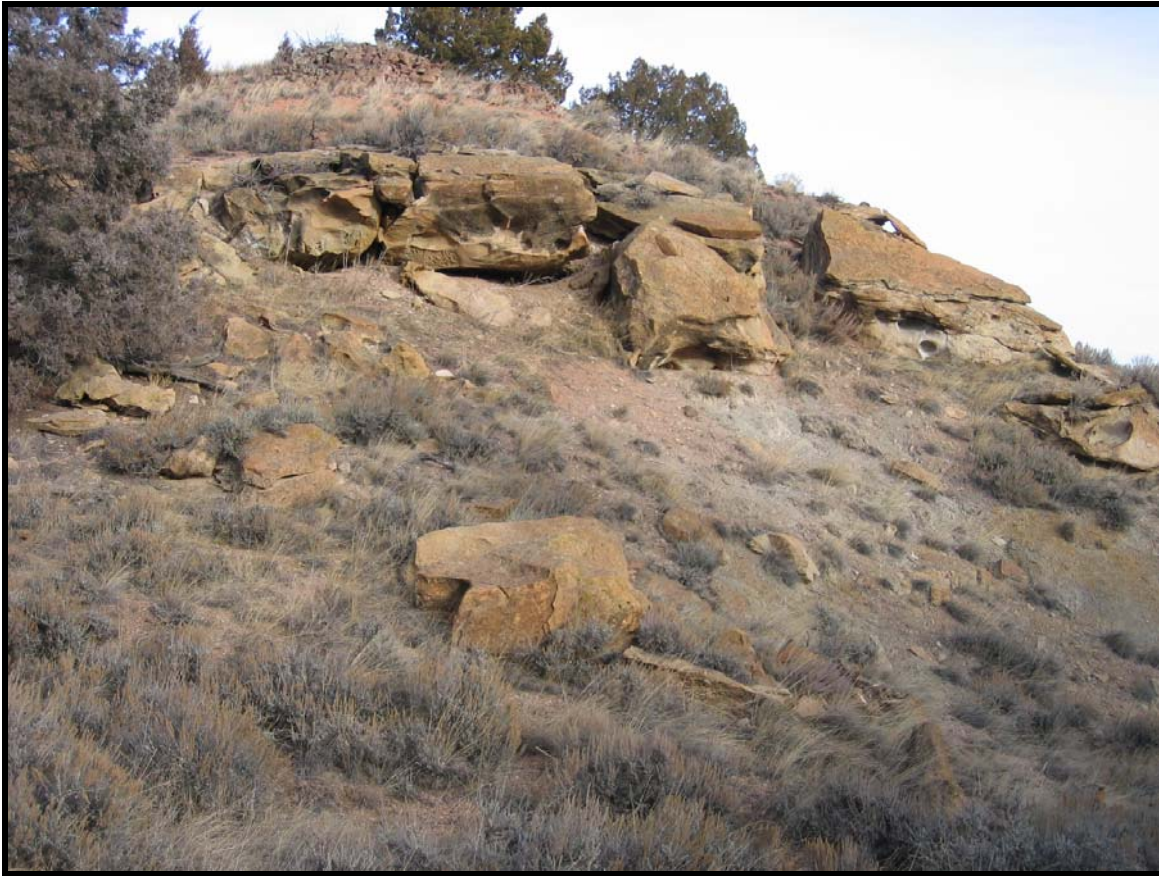
Photo: 1_17_06_35

GEOMETRIC DIMENSIONS: Area of outcrop: 0.15 acres

SUBSTRATE: Siltstone/sandstone

DESCRIPTION OF FEATURE: This rock outcrop is located at the head of a small draw that is a tributary to the South Fork Spring Creek. The formations created by the weathering of the sandstone has created habitat within the rocks. Picture 1_17_06_36 on the next page shows a closer view of the rocks in this feature.

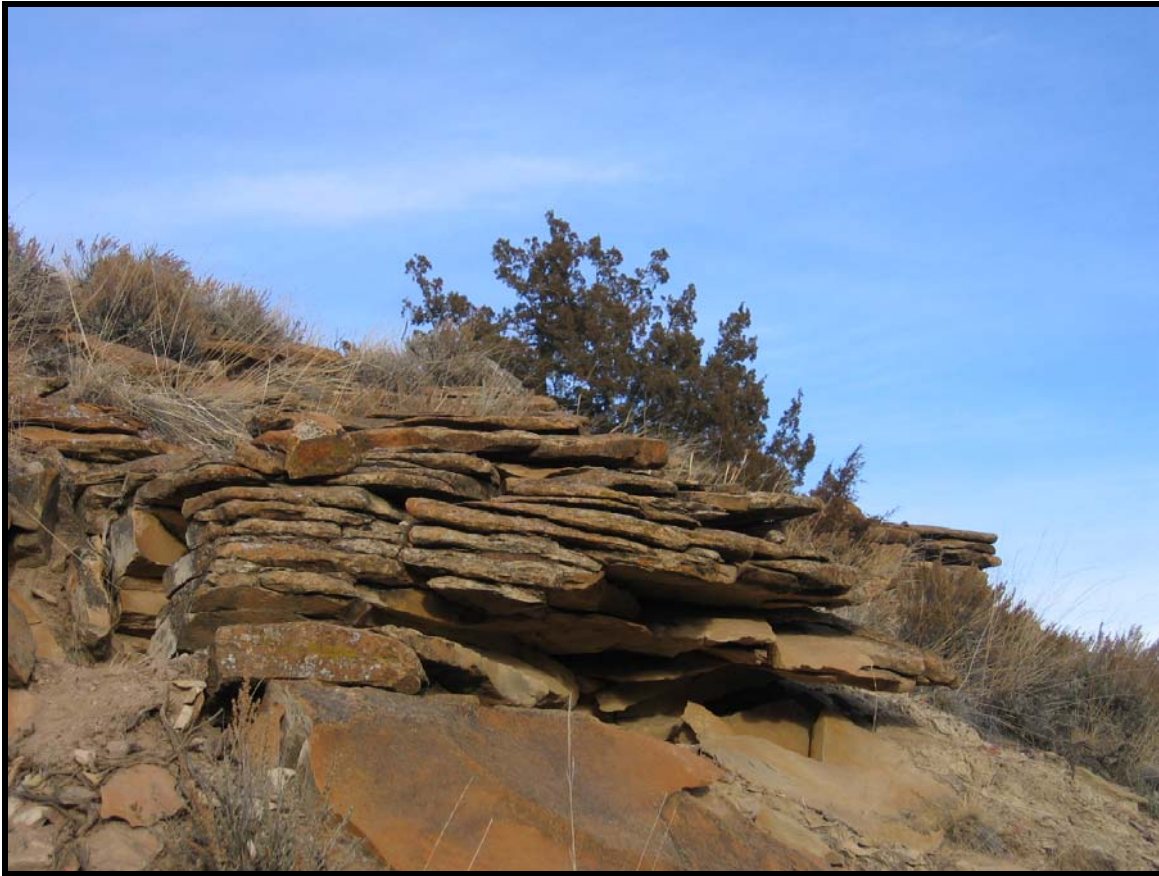
Photo: 1_17_06_38

GEOMETRIC DIMENSIONS: Length: 85 ft Height: 5 ft

SUBSTRATE: Siltstone/sandstone

DESCRIPTION OF FEATURE: The rock outcrop shown above travels along the top of a hill overlooking a small draw. This feature is composed of siltstone/sandstone rock and overlies sandy silt subsoil. Overhangs and crevices within the rock are frequent in this feature.

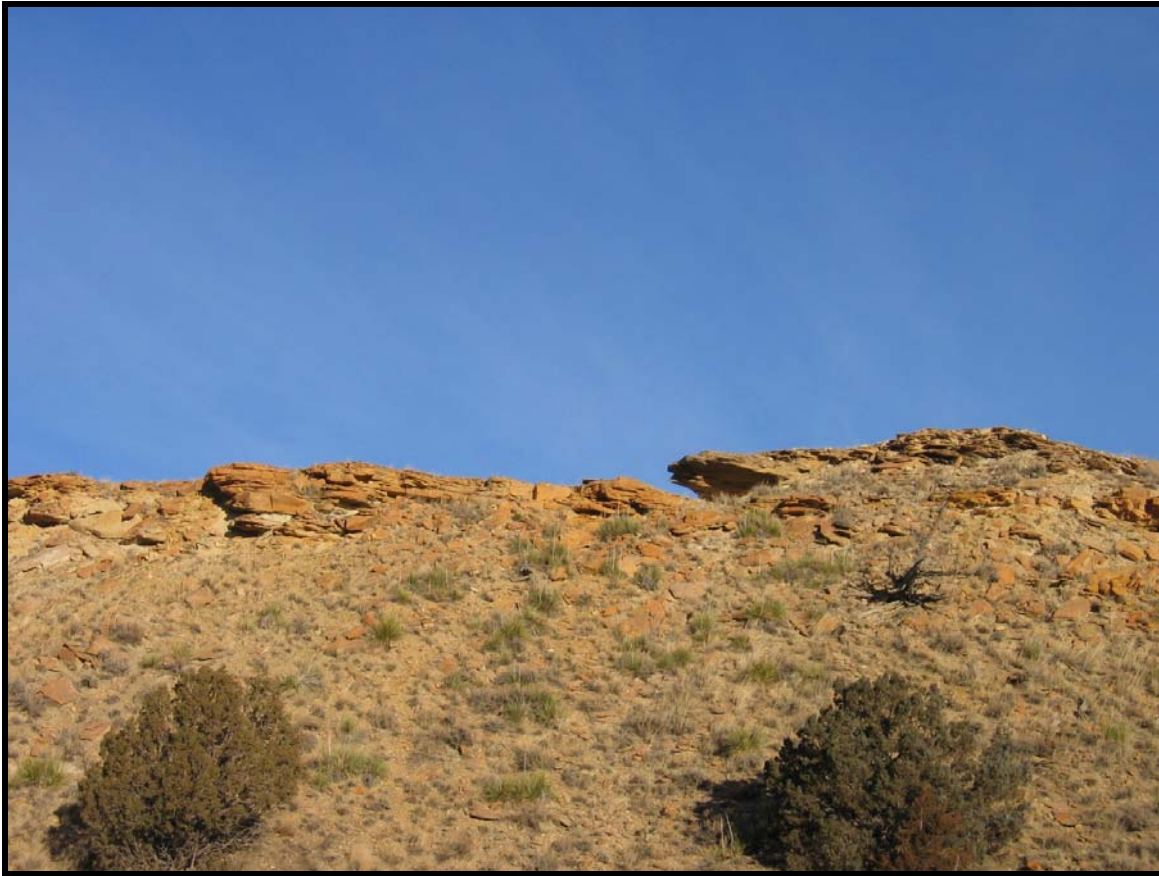
Photo: 1_23_06_34

GEOMETRIC DIMENSIONS: Length: 330 ft Height: 15 ft

SUBSTRATE: Siltstone/sandstone

DESCRIPTION OF FEATURE: The rock outcrop shown above travels along the top of a hill overlooking a small draw. This feature is composed of siltstone/sandstone rock and overlies sandy silt subsoil. Overhangs and crevices within the rock are frequent in this feature. See the picture on the following page for an example of the overhangs within this outcrop.

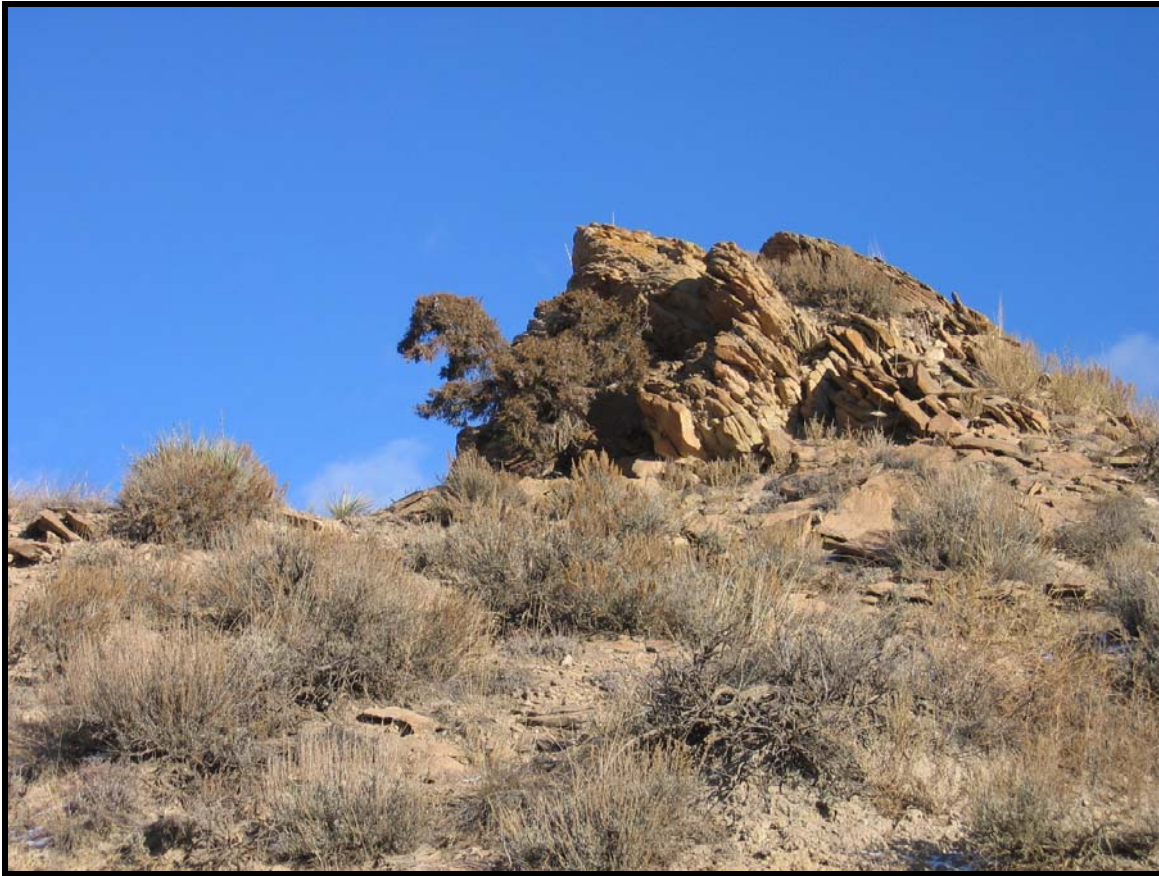
Photo: 2_2_06_07

GEOMETRIC DIMENSIONS: Area of outcrop: 0.60 acres

SUBSTRATE: Siltstone/sandstone

DESCRIPTION OF FEATURE: The rock outcrop shown above is located along the side of a hill composed of sandy silt soil. This feature consists of layered, siltstone/sandstone rock that is separated from other rocks within this feature by an average of 50 feet.

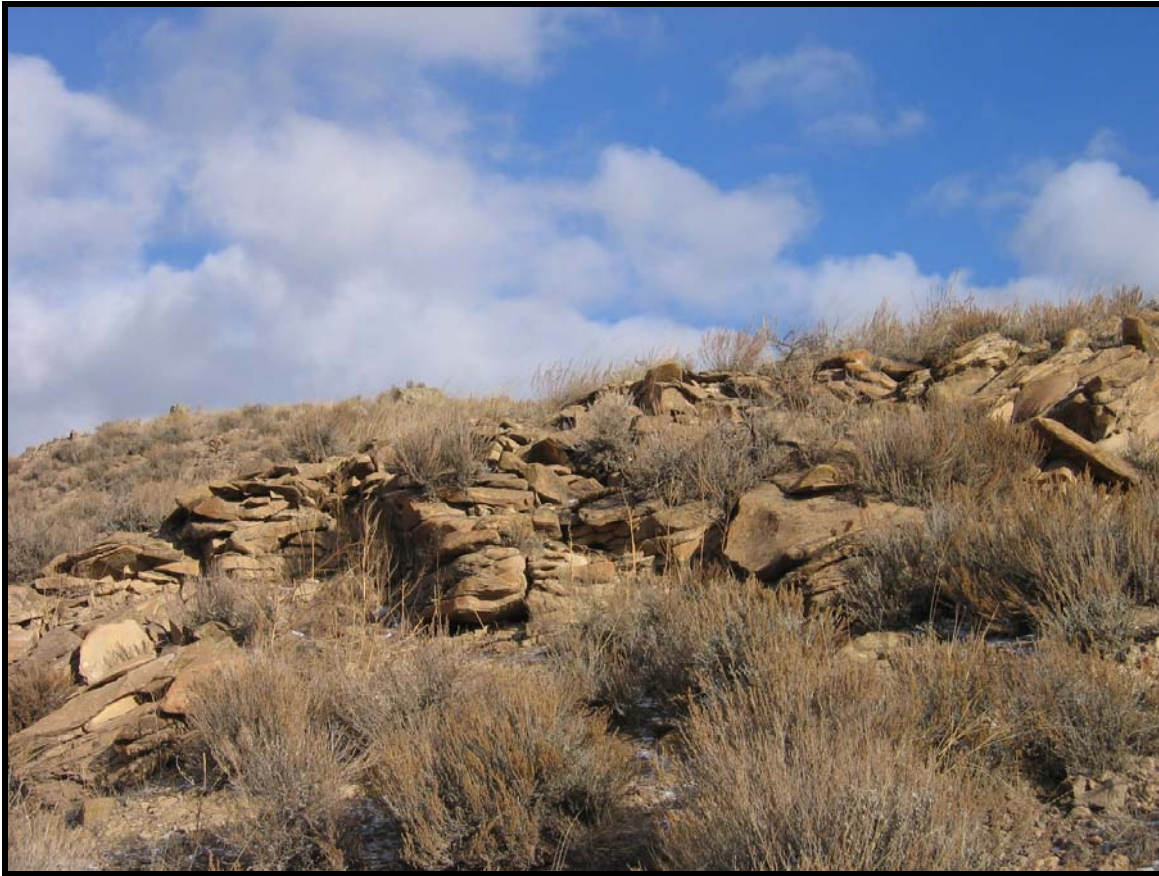
Photo: 2_2_06_08

GEOMETRIC DIMENSIONS: Area of outcrop: 0.11 acres

SUBSTRATE: Siltstone/sandstone

DESCRIPTION OF FEATURE: The rock outcrop shown above is located along the side of a hill composed of sandy silt soil. This feature consists of layered, siltstone/sandstone rock.

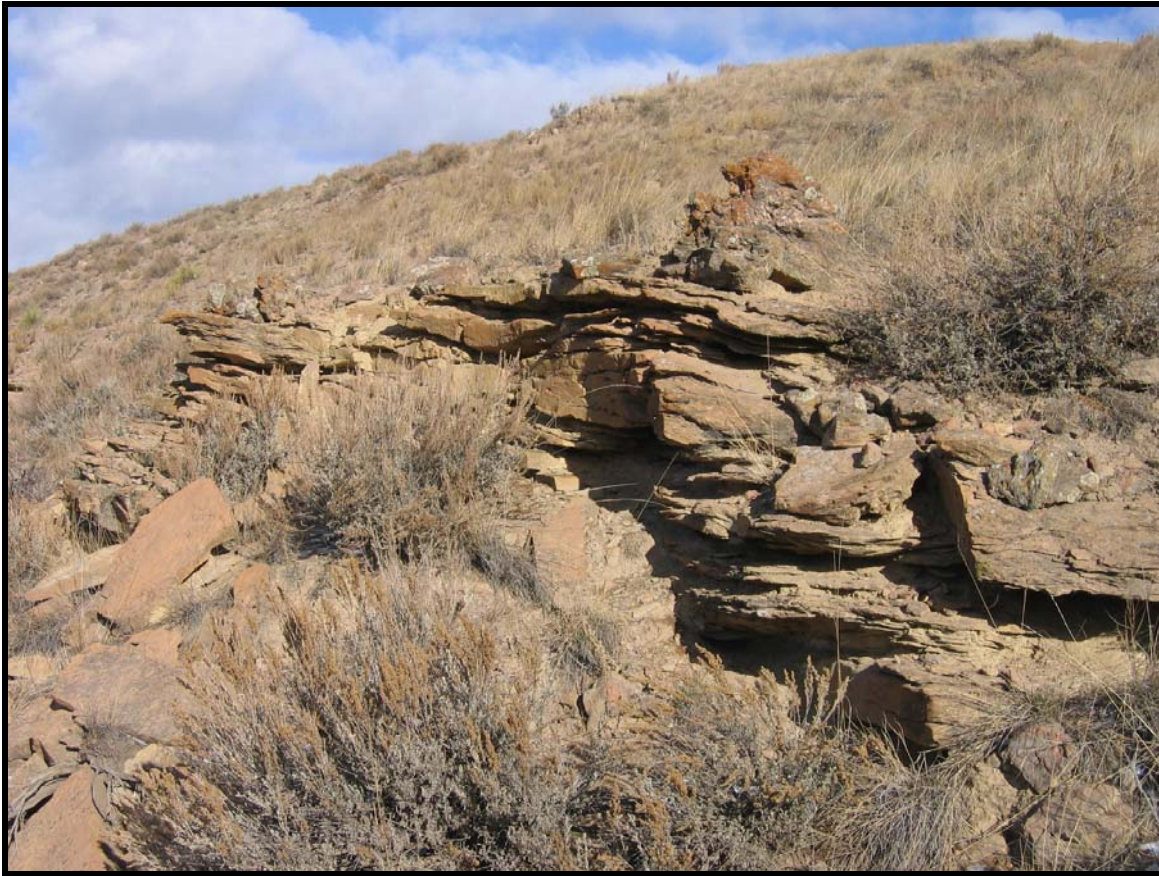
Photo: 2_2_06_09

FEATURE TYPE:	Rock Outcrop		
GEOMETRIC DIMENSIONS:	Length: 255 ft	Height: 5 ft	
LOCATION:	Township: 8S	Range: 39E	Section: 25
HANDHELD GPS POINTS:	Northing	Easting	
	17014	415332.74	2669117.30
	17015	415516.72	2668940.87

SUBSTRATE: Siltstone/sandstone

DESCRIPTION OF FEATURE: The rock outcrop shown above is located along the side of a hill composed of sandy silt soil. This feature is composed of layered, siltstone/sandstone rock. Erosion has created overhangs and crevices within and beneath the rock layer.
