Township 8S, Range 39E
SECTION 25

Cliff Features

Revised 4/06; Reference – South Fork Extension Amendment #00174

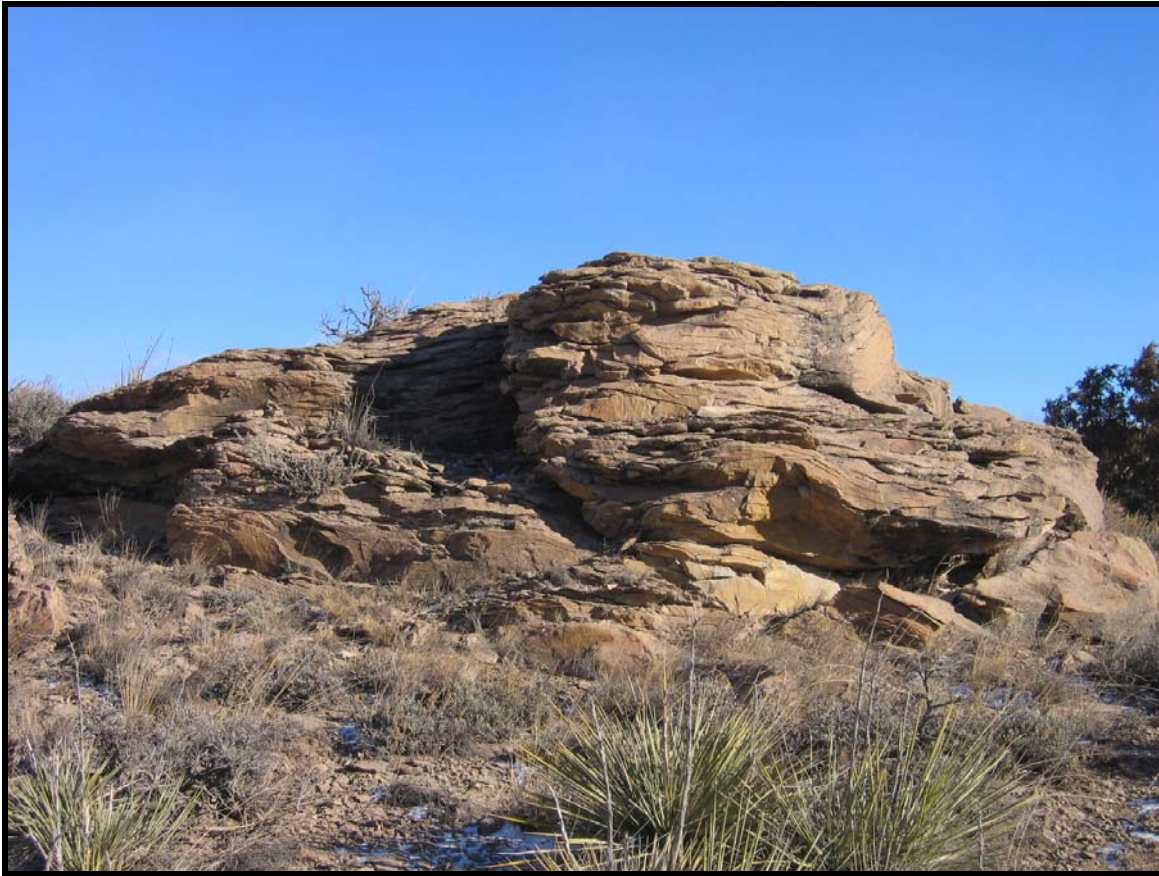
Photo: 2_2_06_10

GEOMETRIC DIMENSIONS: Area of outcrop: 0.14 acres

SUBSTRATE: Siltstone/sandstone

DESCRIPTION OF FEATURE: The rock outcrop shown above is located along the side of a hill composed of sandy silt soil. This feature consists of layered, siltstone/sandstone rock. Erosion has created overhangs and crevices within and beneath the rock layer. The area around this feature is vegetated with grass and sagebrush.

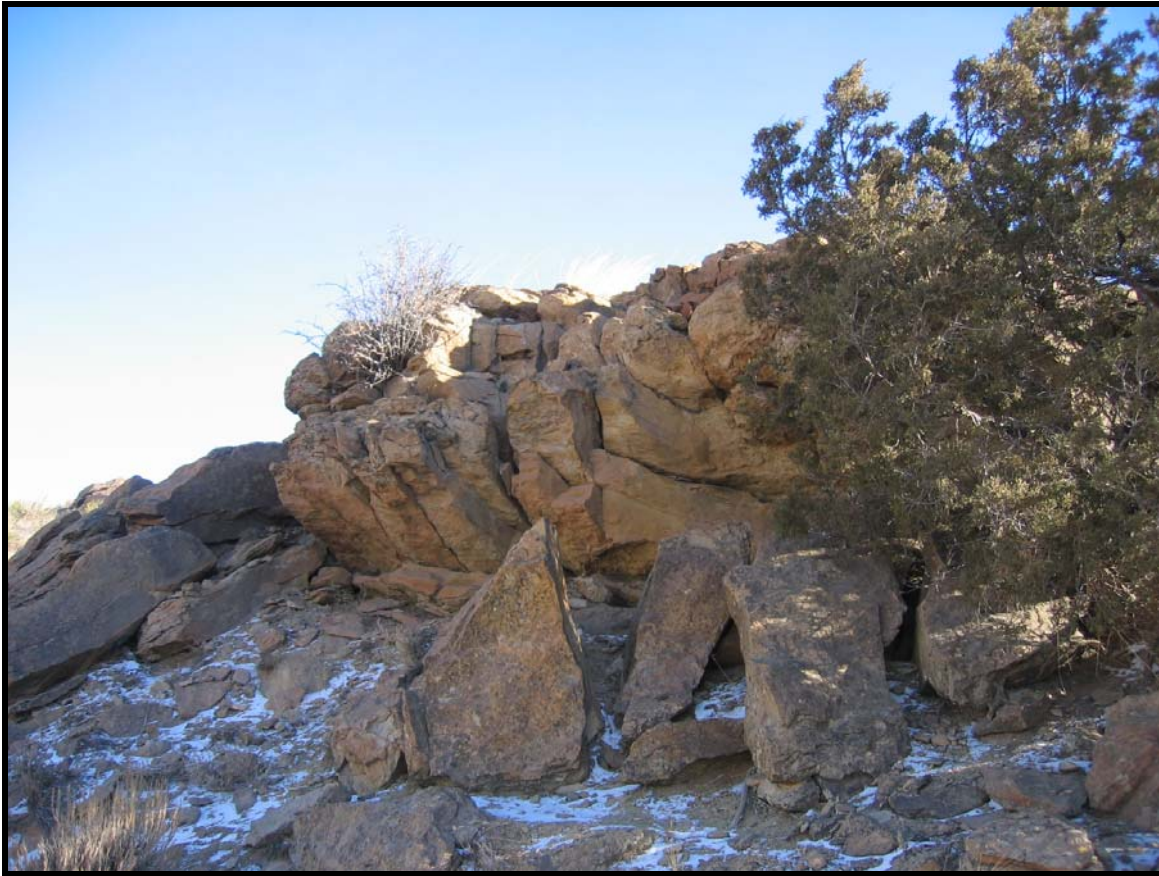
Photo: 2_2_06_11

GEOMETRIC DIMENSIONS: Length: 215 ft Height: 10 ft

SUBSTRATE: Sandstone/siltstone

DESCRIPTION OF FEATURE: The rock feature shown above consists of fractured sandstone/siltstone rock that has formed a long, narrow outcrop. Along its length, the area is vegetated with grass, sagebrush and some small trees. This feature stands approximately 10 feet tall.

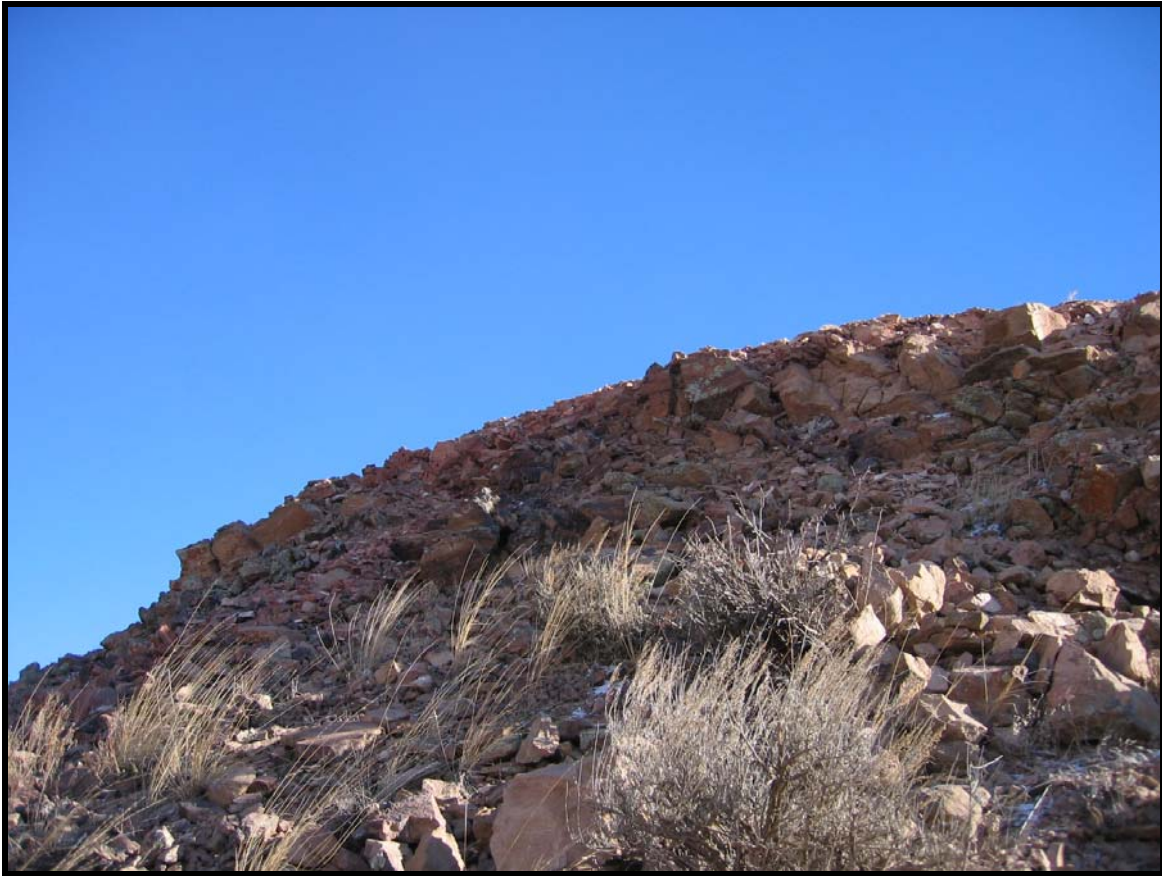
Photo: 2_2_06_12

GEOMETRIC DIMENSIONS: Length: 50 ft Height: 5 ft

SUBSTRATE: Scoria

DESCRIPTION OF FEATURE: In many areas around the minesite, the peaks of hillsides are capped with a highly fractured scoria rock. This feature is an example of one of these scoria outcrops. The face of this feature is jagged and stands approximately five feet high.

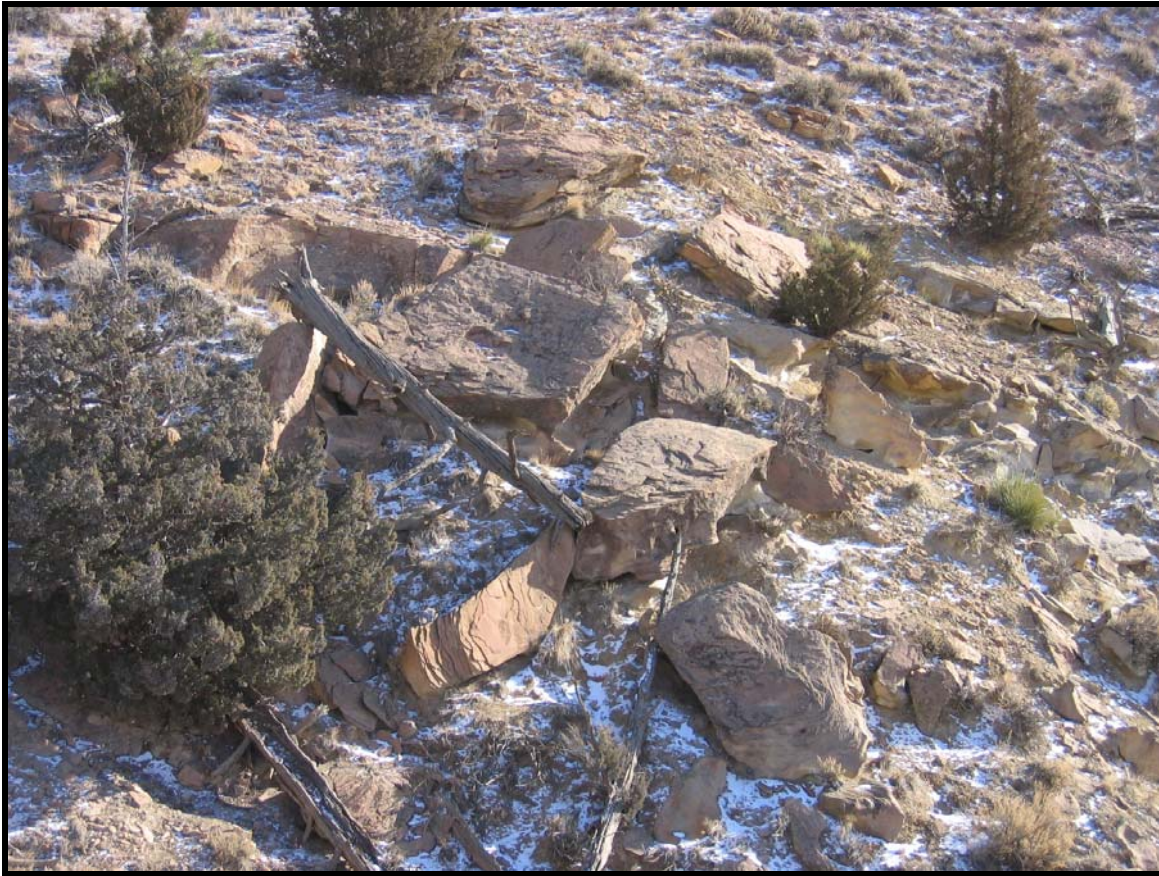
Photo: 2_2_06_13

GEOMETRIC DIMENSIONS: Area of outcrop: 0.10 acres

SUBSTRATE: Siltstone/sandstone

DESCRIPTION OF FEATURE: The rock outcrop shown above is located along the side of a hill composed of sandy silt soil. This feature is composed of layered, siltstone/sandstone rock. The area around the feature is vegetated with grass, sagebrush, and some small trees.

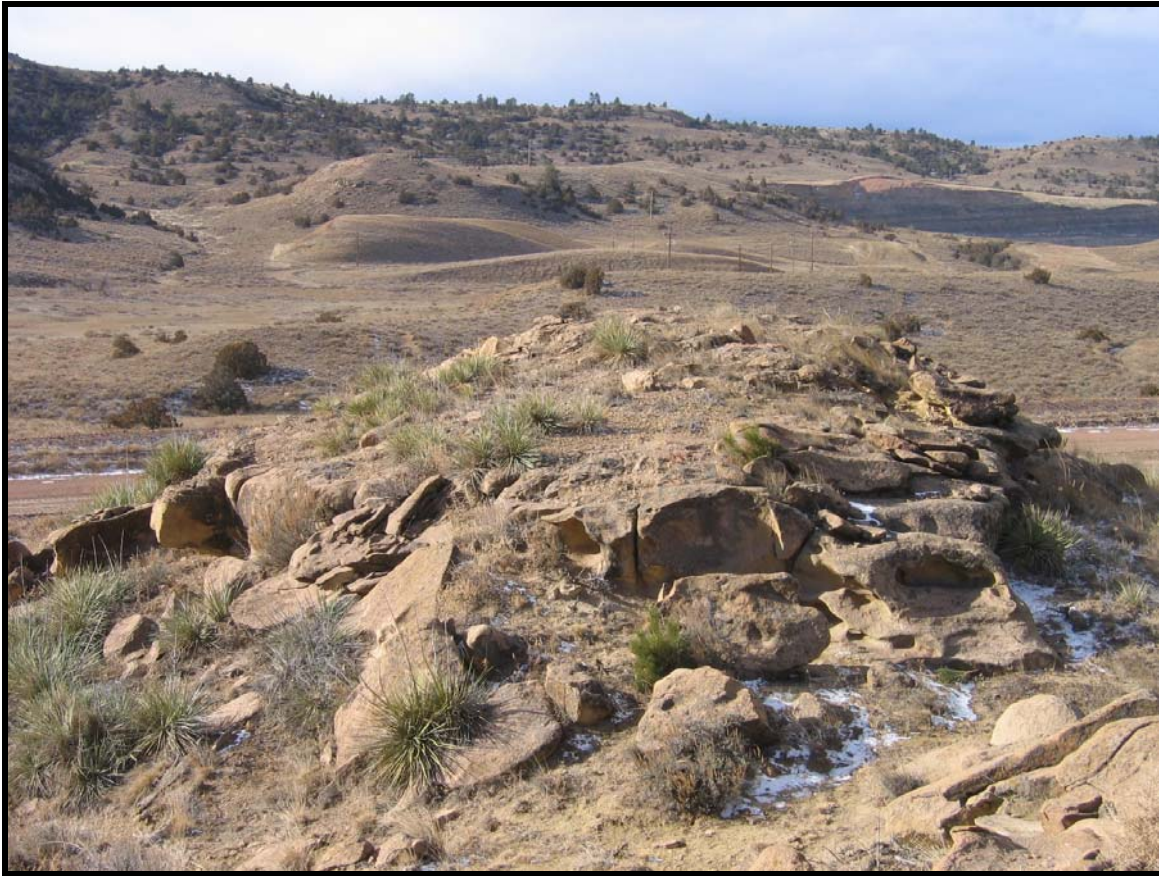
Photo: 2_2_06_14

GEOMETRIC DIMENSIONS: Area of outcrop: 0.14 acres

SUBSTRATE: Siltstone/sandstone

DESCRIPTION OF FEATURE: The rock outcrop shown above is located at the top of a small hill composed of sandy silt soil, which is highly erosive. This feature is composed of solid, siltstone/sandstone rock. Due to erosion, voids have been created between and below the rocks.

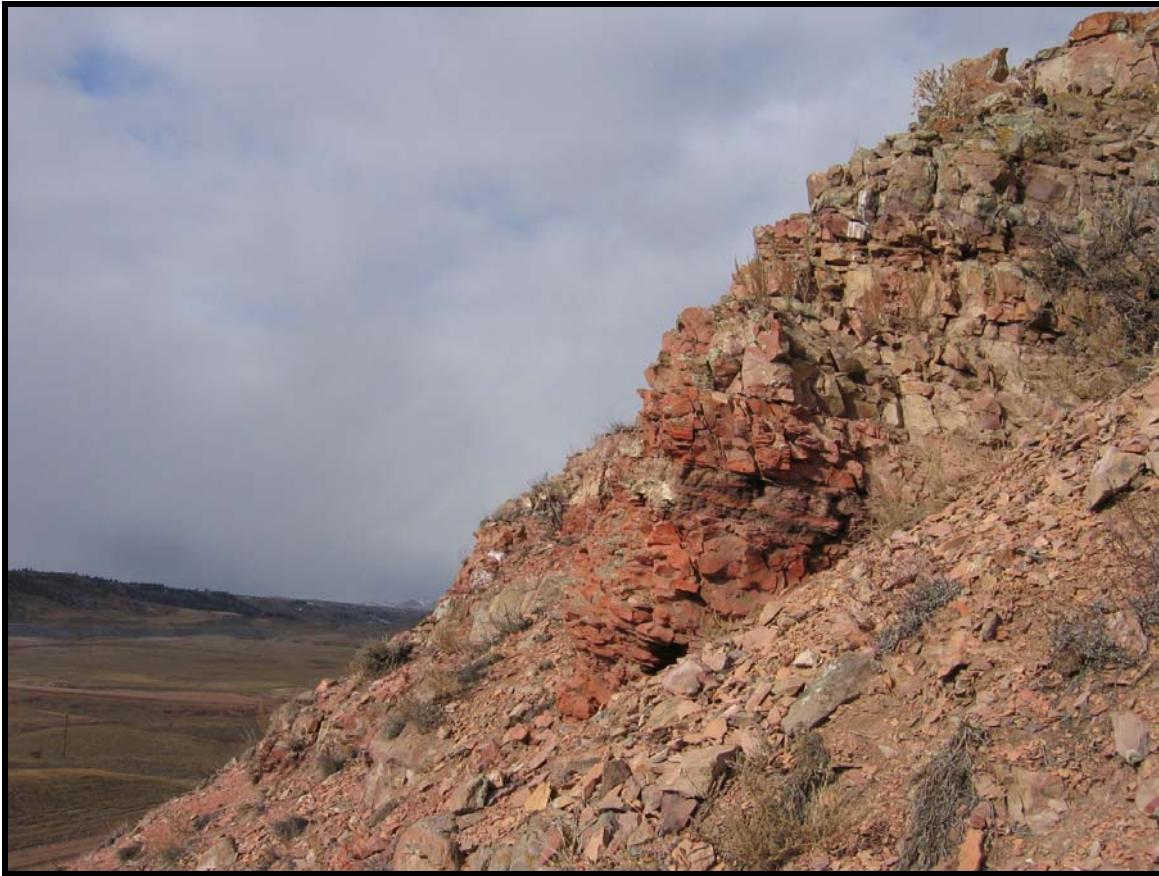
Photo: 2_2_06_20

GEOMETRIC DIMENSIONS: Length: 90 ft Height: 15 ft

SUBSTRATE: Scoria

DESCRIPTION OF FEATURE: In many areas around the minesite, the peaks of hillsides are capped with a highly fractured scoria rock. This feature is an example of one of these scoria caprocks. The face of this feature is jagged and stands approximately 15 feet high. This rock outcrop is above C_0061.

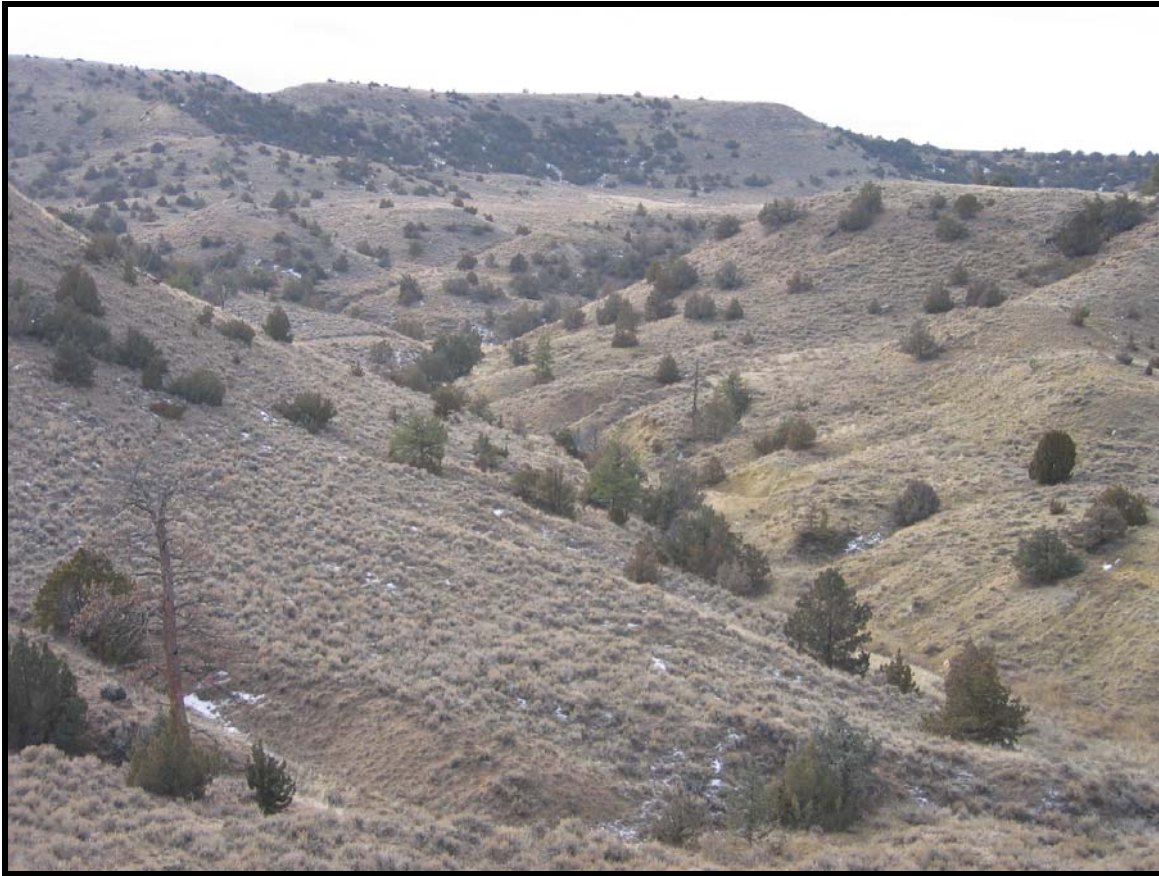
Photo: 1_17_06_19

EXPOSURE: Drainage runs in a northerly direction

DESCRIPTION OF FEATURE: This large drainage is a tributary to South Fork Spring Creek. The hills within the drainage vary from rolling to steep. Although there is a certain amount of vegetation, a large amount of erosion has occurred in the bottom of the channel due to the sandy silt subsoil.

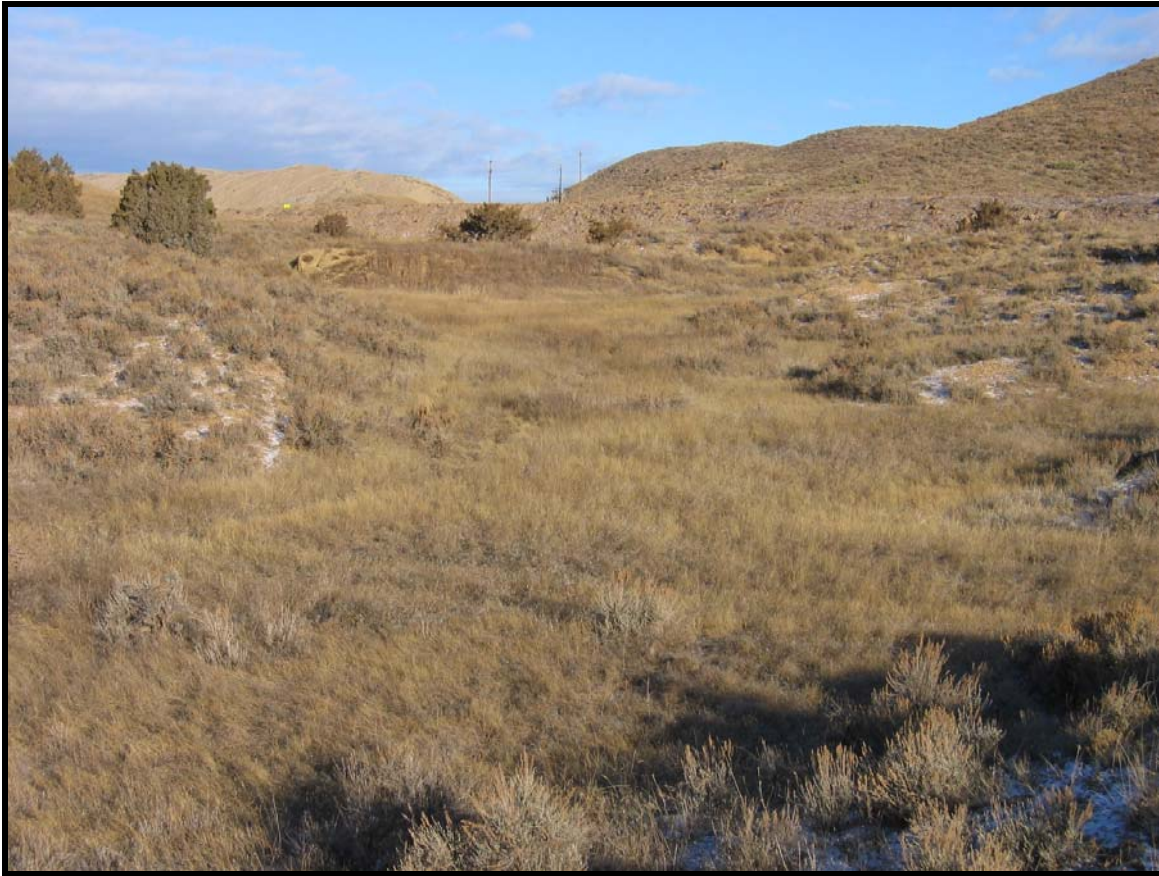
Photo: 2_2_06_03

EXPOSURE: Drainage runs in a northerly direction

DESCRIPTION OF FEATURE: This drainage is a tributary to South Fork Spring Creek. The bottom is approximately 30 feet wide at the point where the photo above was taken. The channel is vegetated with grass and sagebrush.

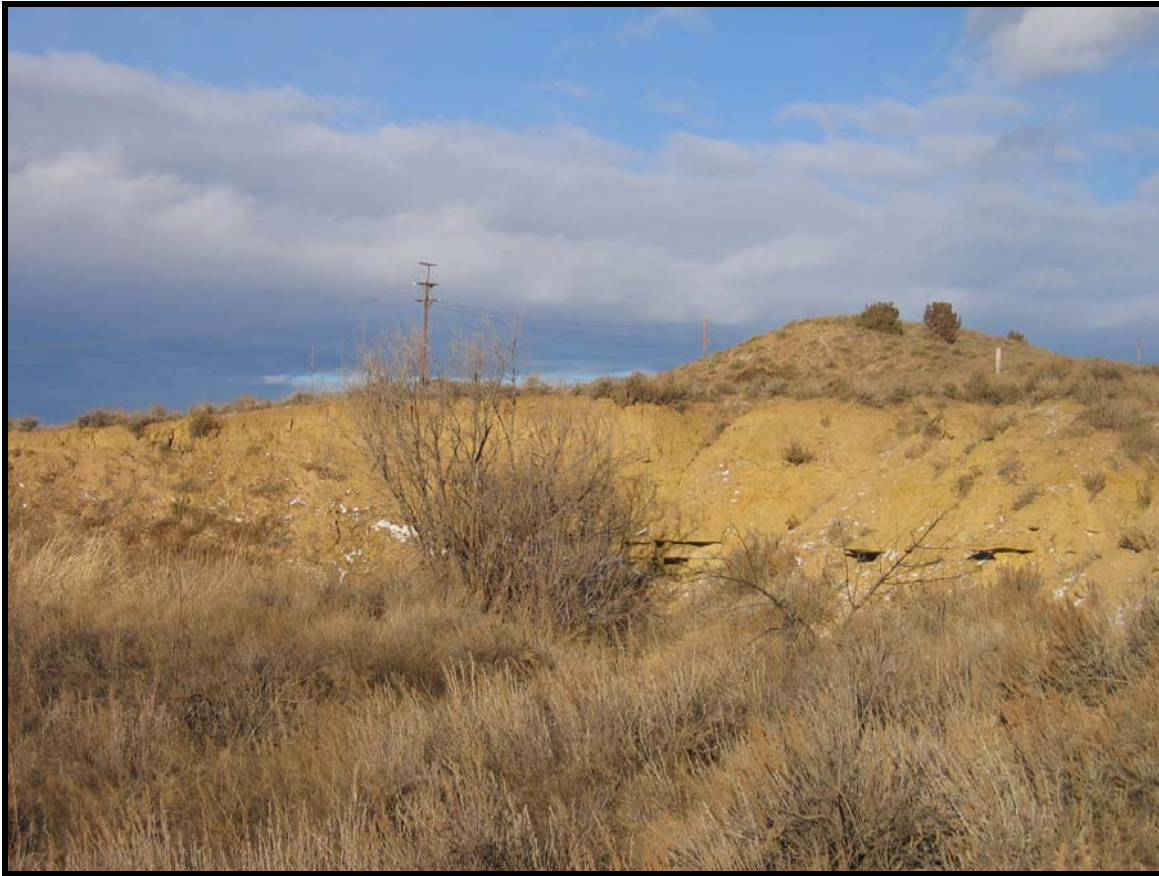
Photo: 2_2_06_02

GEOMETRIC DIMENSIONS: Length: 145 ft Height: 20 ft

SUBSTRATE: Sandy Silt

DESCRIPTION OF FEATURE: This cutbank is located on the South Fork Spring Creek. The face of the feature has been eroded by flows down this channel. This feature has a layer of sandstone/siltstone at mid-height.
