**Township 8S, Range 39E**  
**SECTION 26**

*Cliff Features*

Revised 4/06; Reference – South Fork Extension Amendment #00174

313D-T8SR39E26-3

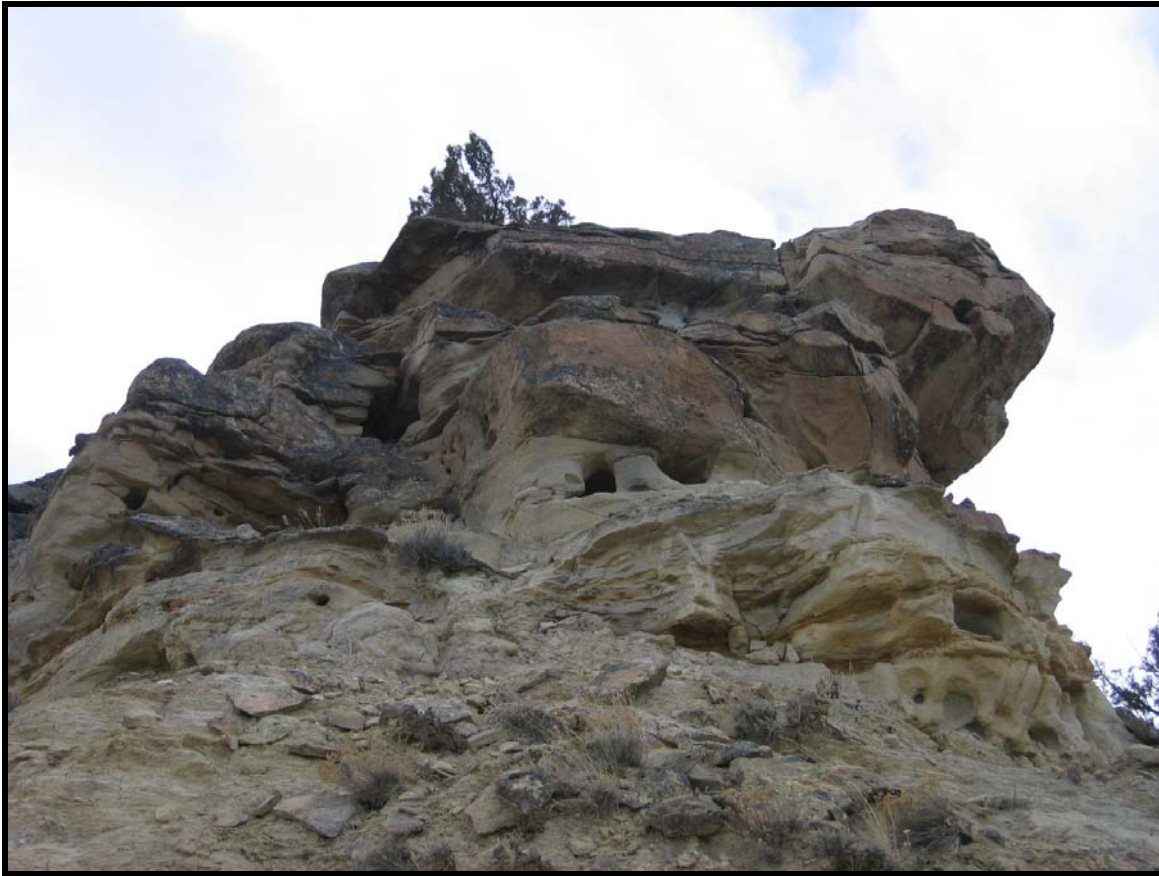
**CLIFF FEATURE: C\_0038**

Photo: 1\_18\_06\_13

**Looking Southwest**

**DESCRIPTION OF FEATURE:** The cliff feature shown above consists of weathered sandstone rock. The erosion of the face of the cliff has created holes and pockets. This feature is located at the top of a soft sandy silt slope. The pictures on the following page show additional views of this feature.

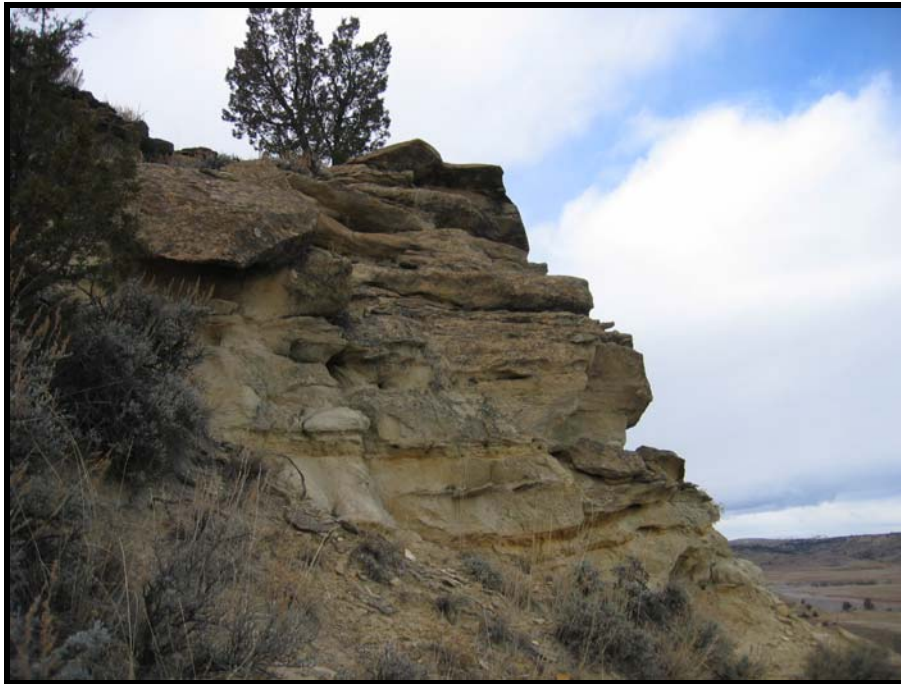
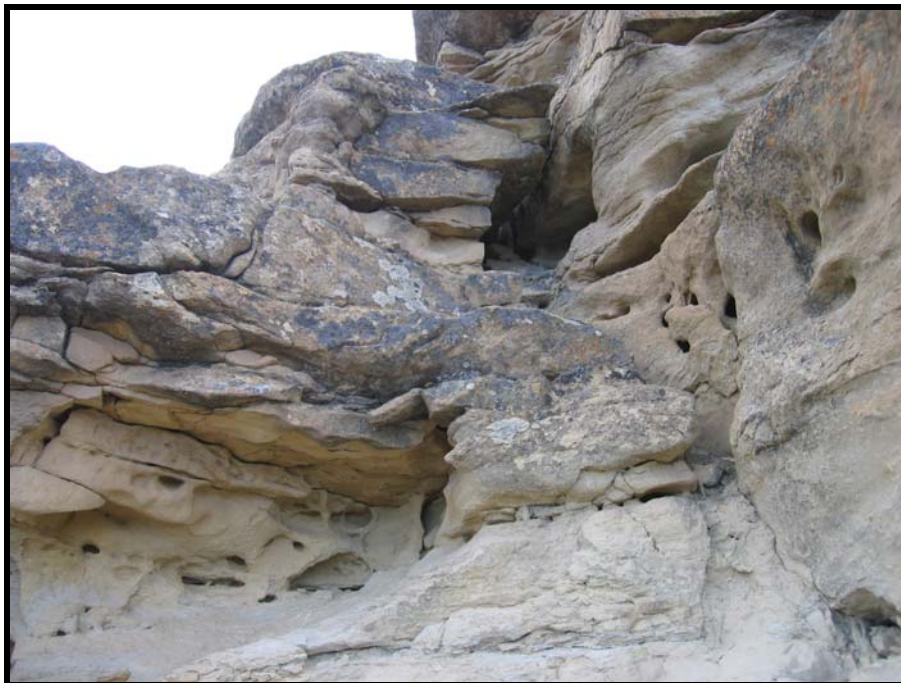
**CLIFF FEATURE: C\_0038**

Photo: 1\_18\_06\_14

**Looking West**

Photo: 1\_18\_06\_15

**Looking South**

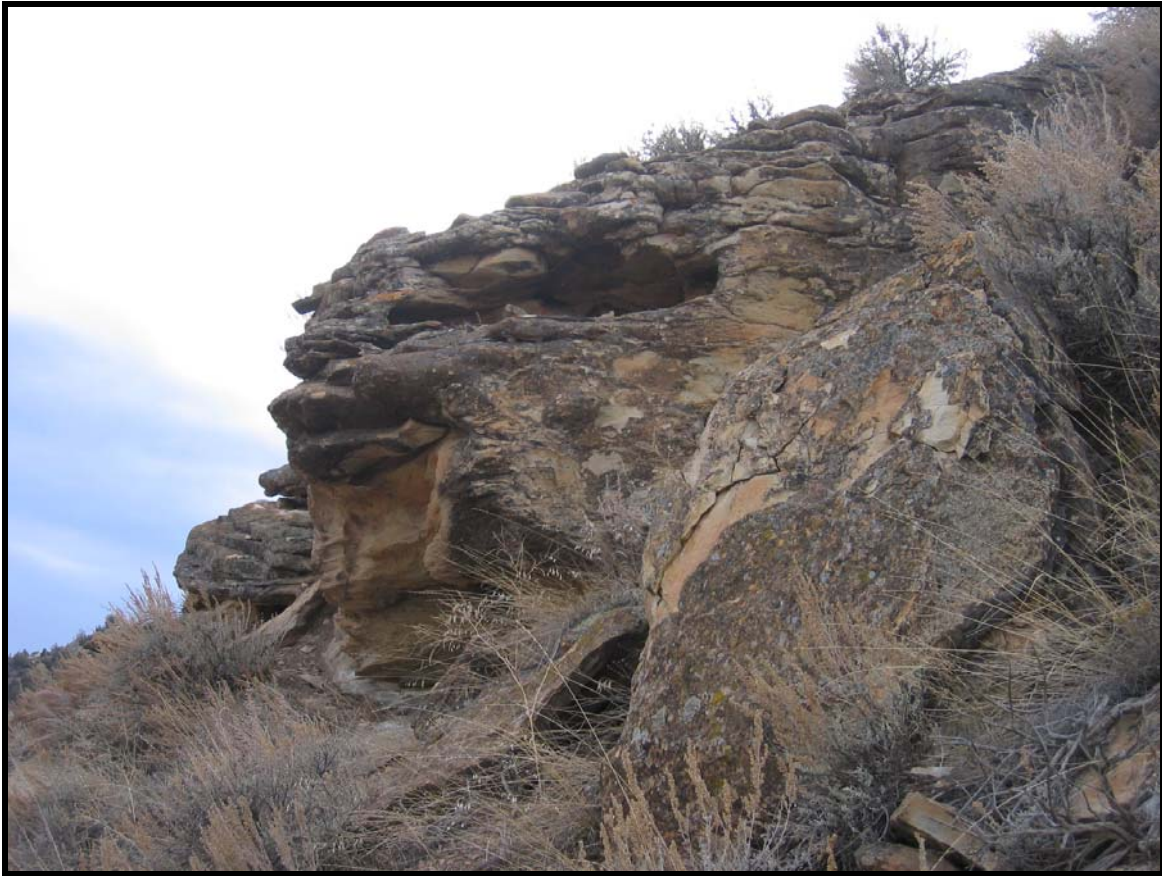
**CLIFF FEATURE: C\_0039**

Photo: 1\_18\_06\_32

**Looking South**

**DESCRIPTION OF FEATURE:** The weathered face of this sandstone/siltstone rock feature creates potential habitat. The rock is layered and has a jagged face. This outcropping occurs in an area vegetated with sagebrush and grass.

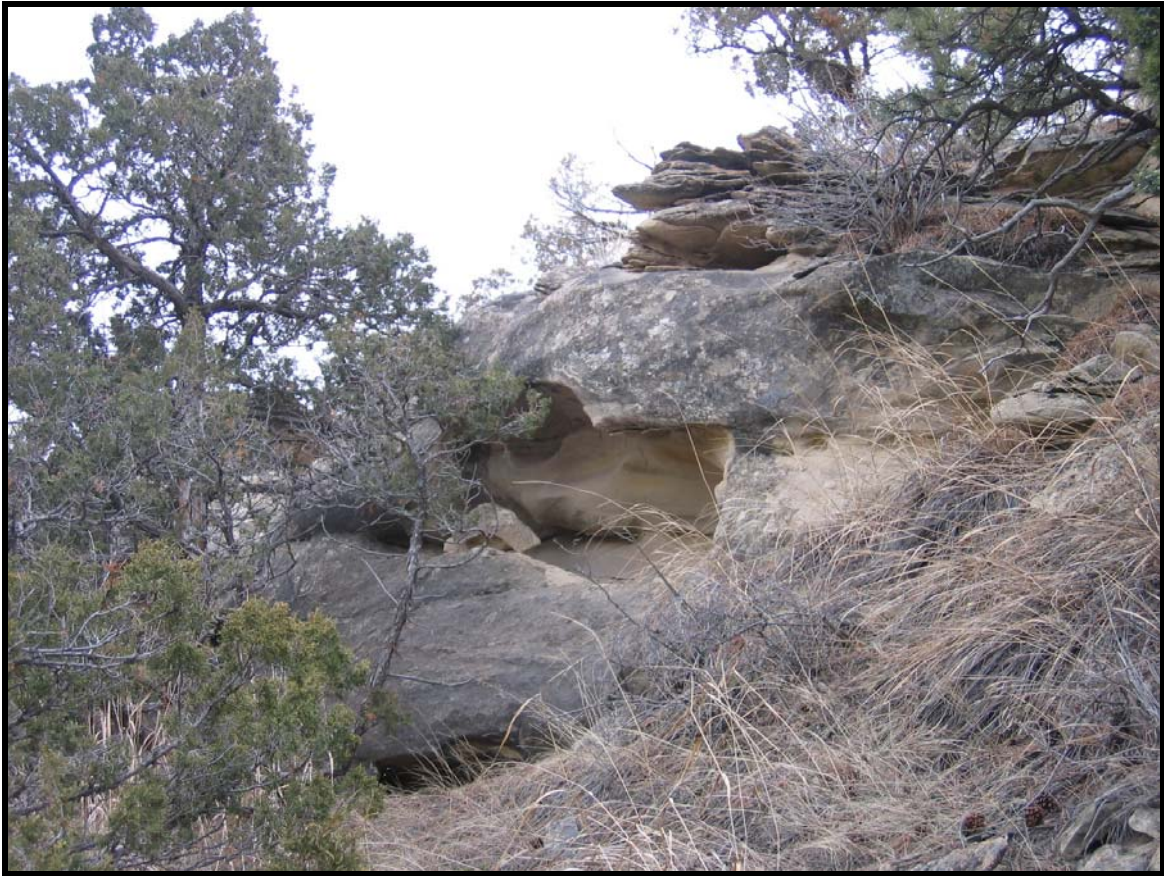
**CLIFF FEATURE: C\_0040**

Photo: 1\_18\_06\_36

**Looking Southeast**

**DESCRIPTION OF FEATURE:** The cliff feature shown above is located on a northern slope vegetated with grass, sagebrush and some small trees. The weathered rocks within this feature have holes and areas for protection.

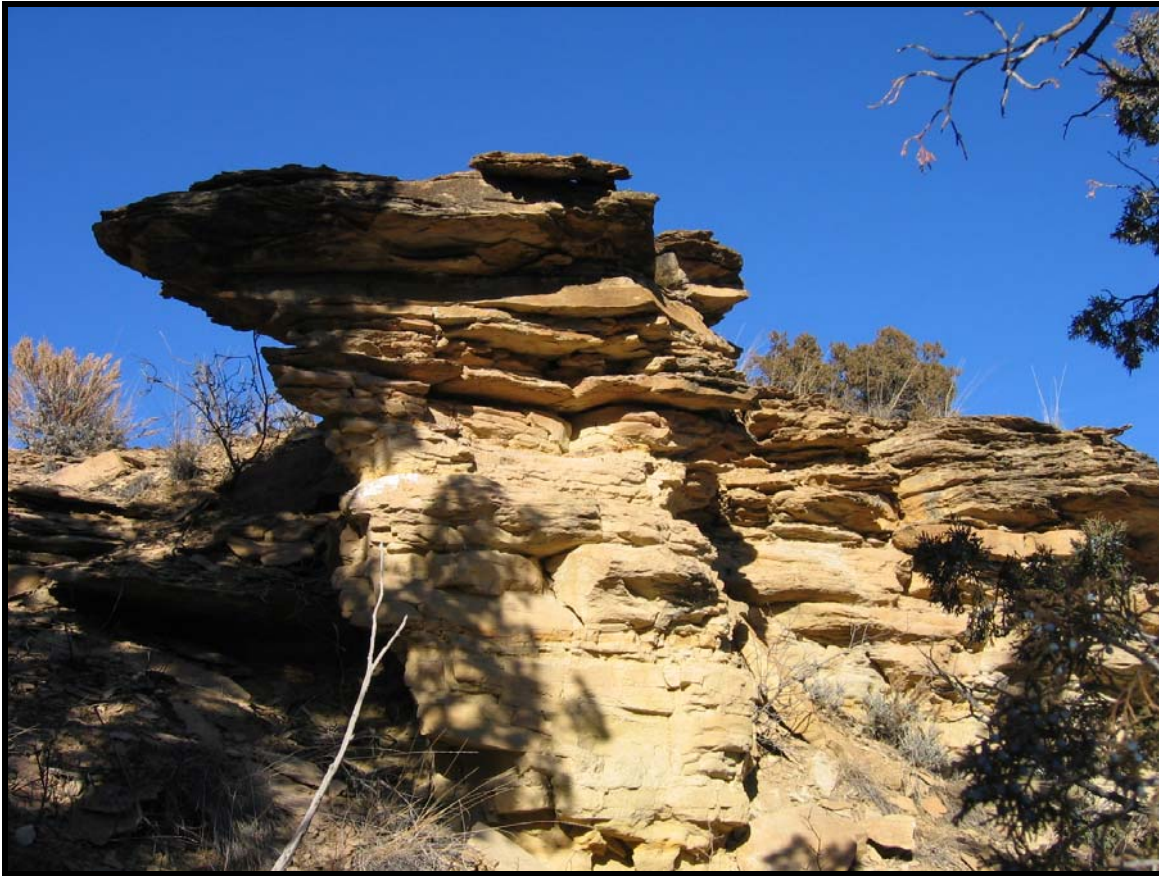
**CLIFF FEATURE: C\_0041**

Photo: 1\_23\_06\_06

**Looking North**

**DESCRIPTION OF FEATURE:** The small cliff feature shown above is a unique feature created by weathering and erosion. The hard sandstone/siltstone rock sits on a softer sandy material, which continually erodes beneath the rock layer. This feature also is composed of rocks that appear layered.

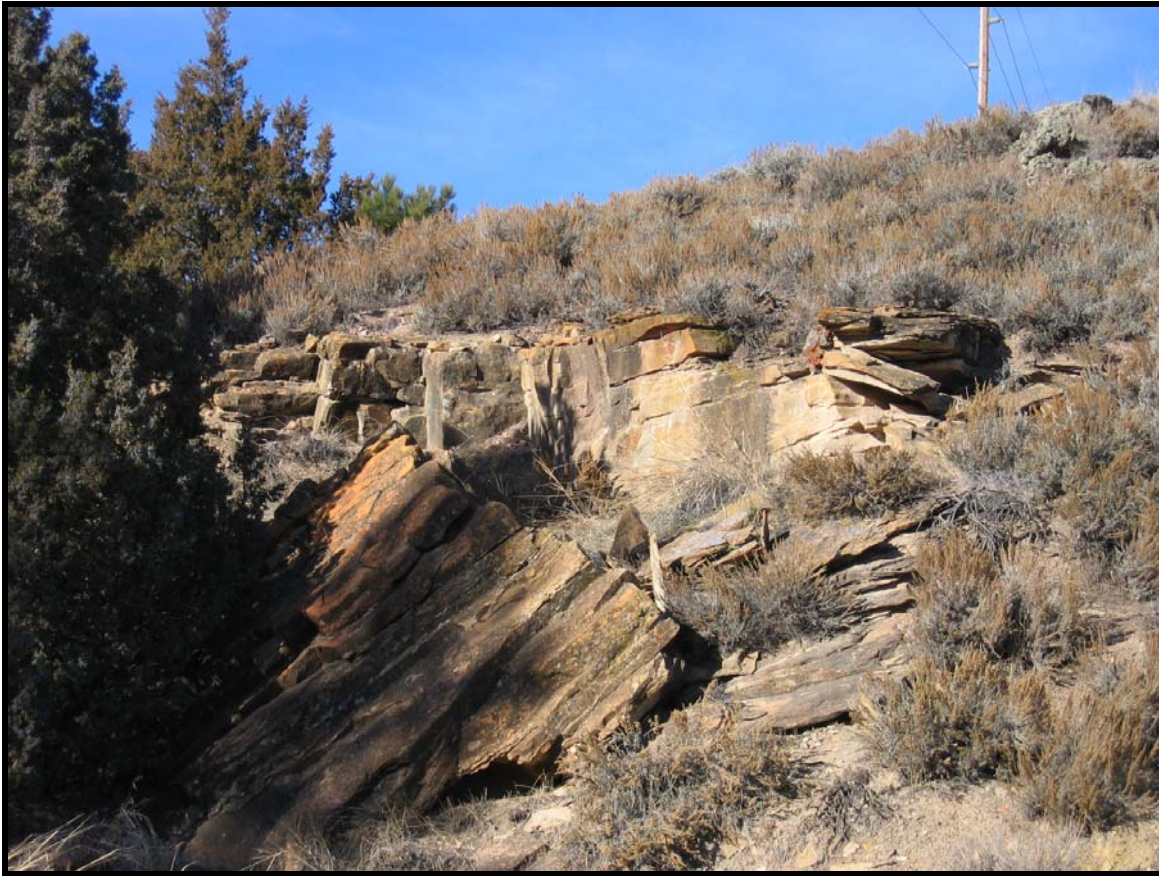
**CLIFF FEATURE: C\_0042**

Photo: 1\_23\_06\_09

**Looking West**

**DESCRIPTION OF FEATURE:** The cliff shown above is a small cliff feature. Within the crevices and the small overhang, various holes appeared to provide protection for animals. This feature is located adjacent to a small draw.

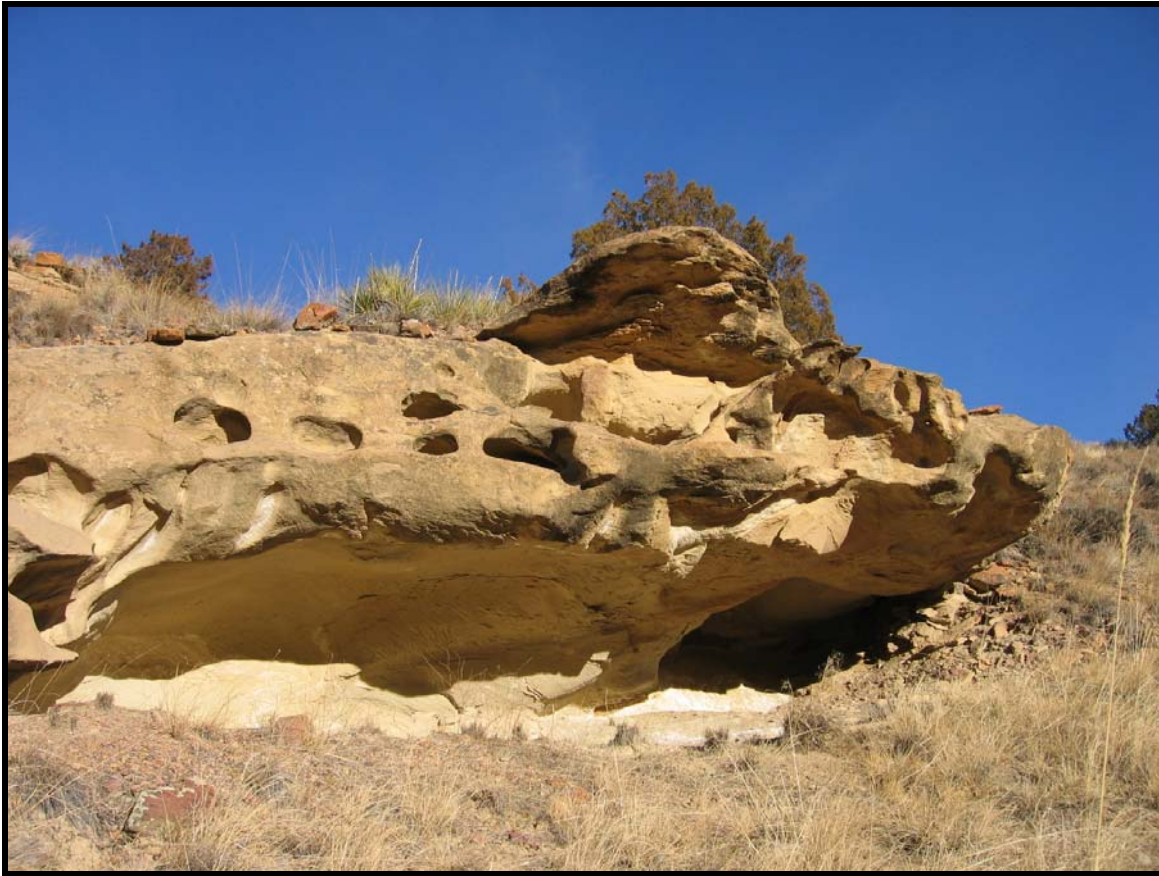
**CLIFF FEATURE: C\_0043**

Photo: 1\_23\_06\_28

**Looking North**

**DESCRIPTION OF FEATURE:** The cliff shown above is a large feature. Although a majority of this feature has a solid rock face with significant vertical height, a small portion toward the center of the cliff appears more like a rock outcrop. The face of the feature above has many holes and overhangs for habitat. Within the portion that resembles an outcrop, there are many areas between and below the rocks for protection. The pictures on the following pages show additional views of this feature.

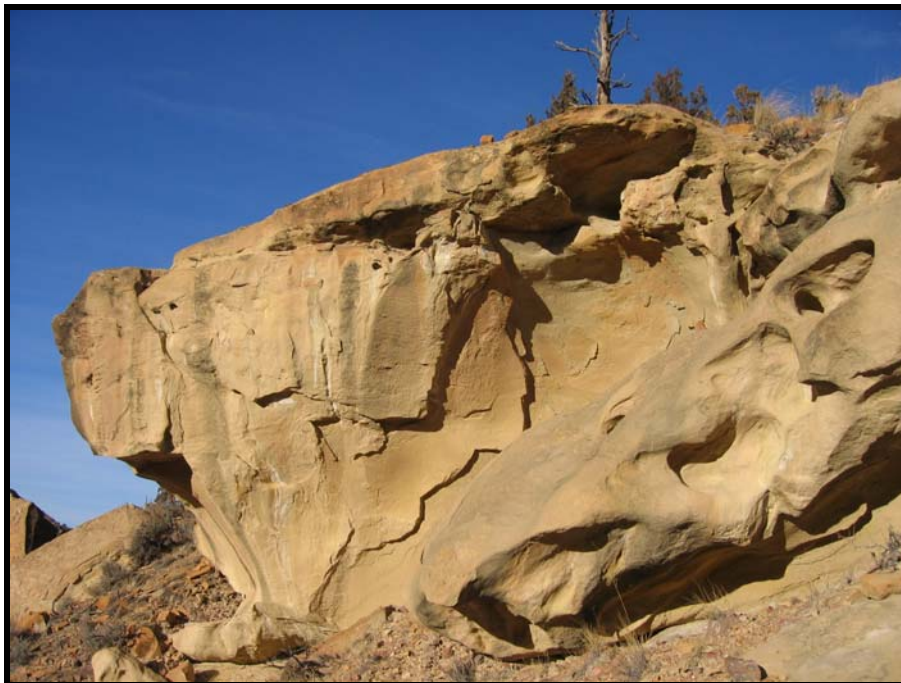
**CLIFF FEATURE: C\_0043**

Photo: 1\_23\_06\_29

**Looking Northwest**

Photo: 1\_23\_06\_30

**Looking Southeast**

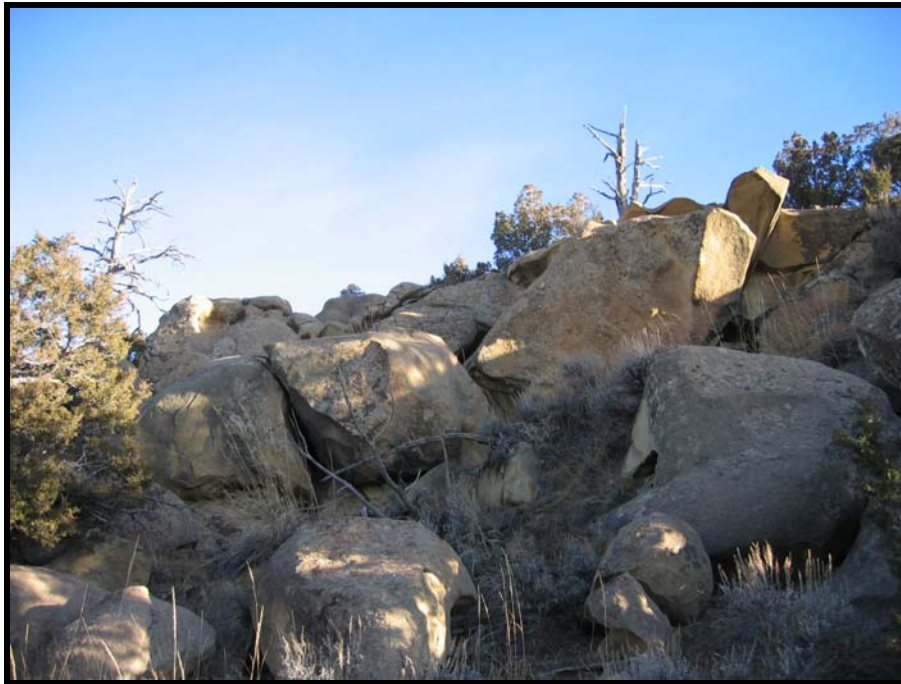
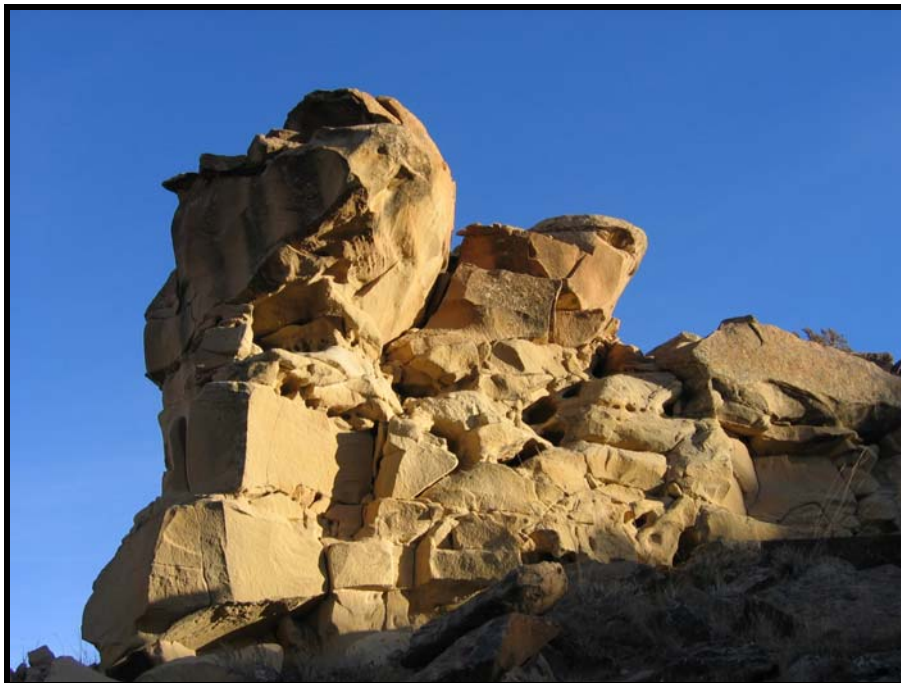
**CLIFF FEATURE: C\_0043**

Photo: 1\_23\_06\_31

**Looking South**

Photo: 1\_23\_06\_32

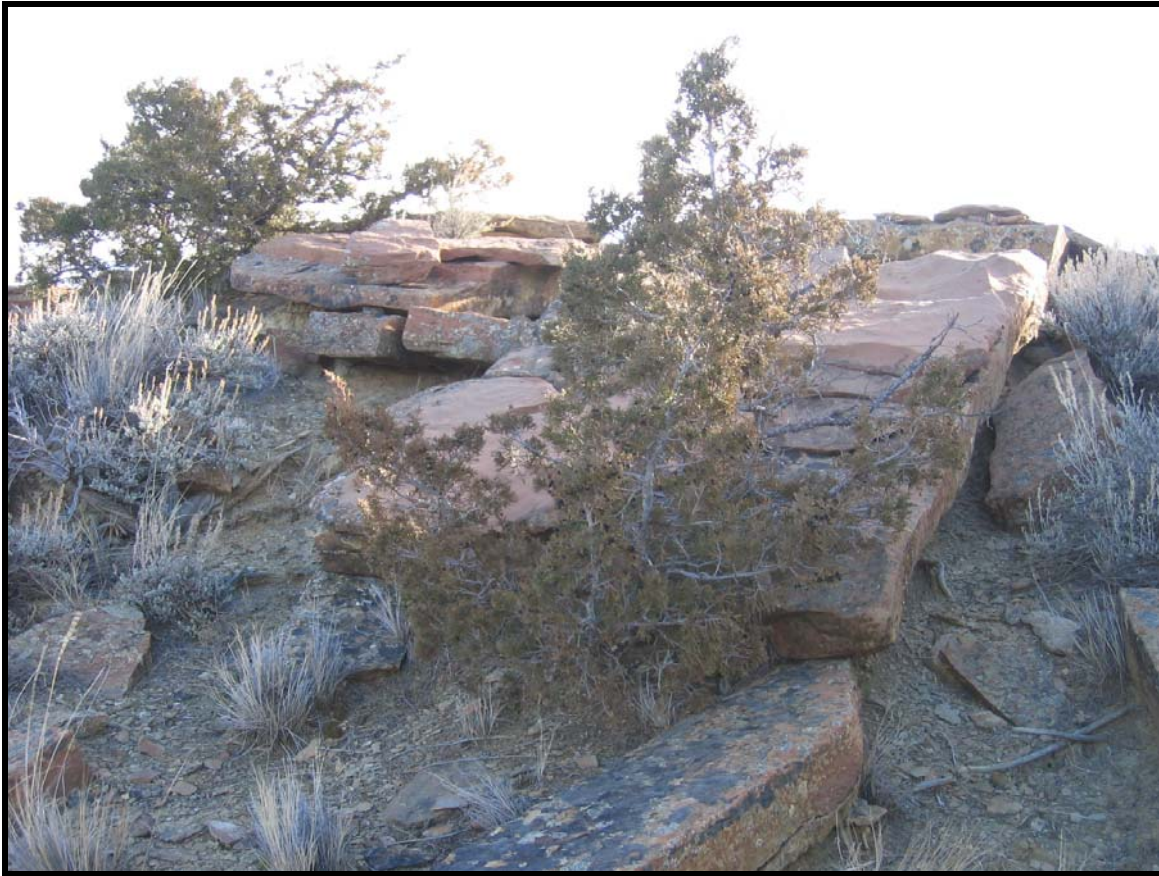
**ROCK OUTCROP FEATURE: RO\_0109**

Photo: 1\_18\_06\_10

**Looking East**

**DESCRIPTION OF FEATURE:** The rock outcrop shown above is located in an area vegetated with grass, sagebrush and some small trees. Due to the layout of the feature, voids have been created between and beneath the sandstone/siltstone rocks.

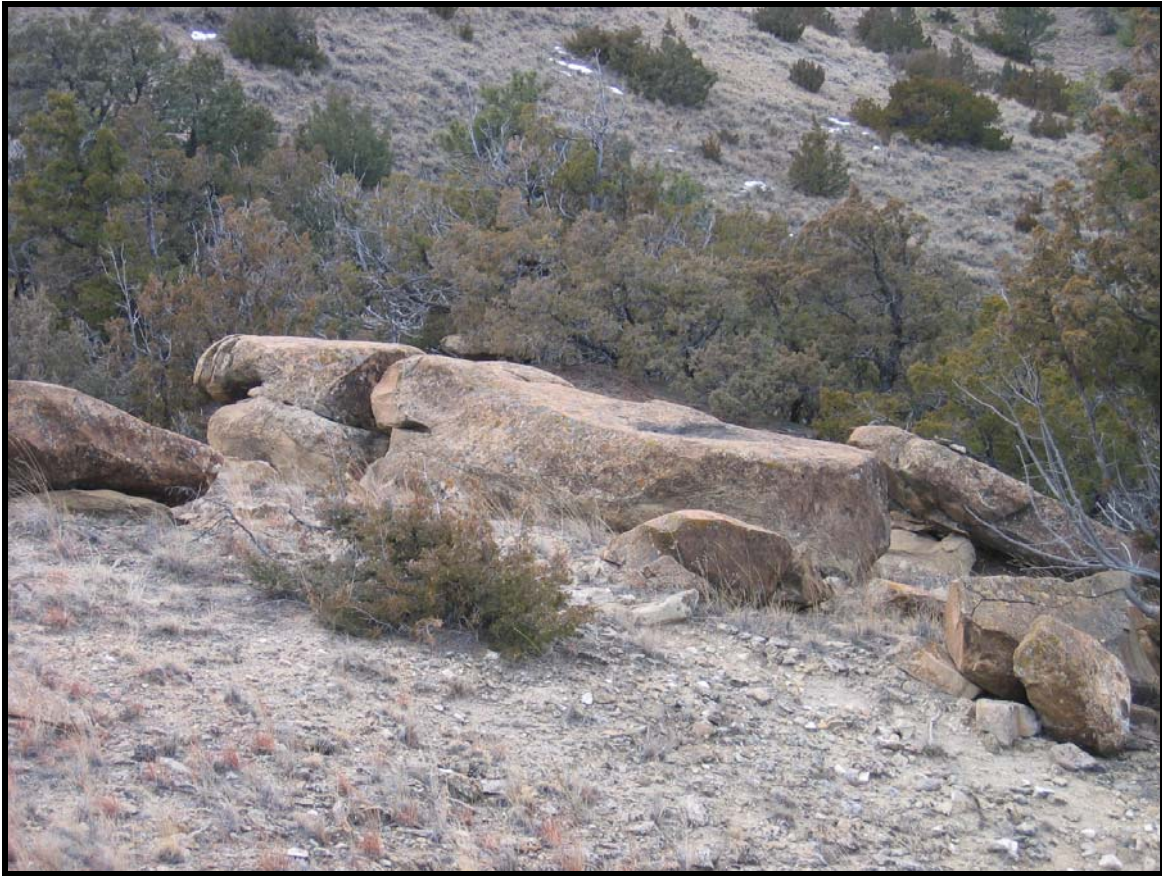
**ROCK OUTCROP FEATURE: RO\_0112**

Photo: 1\_18\_06\_16

**Looking Southwest**

**DESCRIPTION OF FEATURE:** This rock outcrop is located on sandy silt subsoil, which is highly erosive. The rocks are relatively flat and are scattered along the slope. Areas beneath some rocks have been eroded, leaving overhangs and voids.

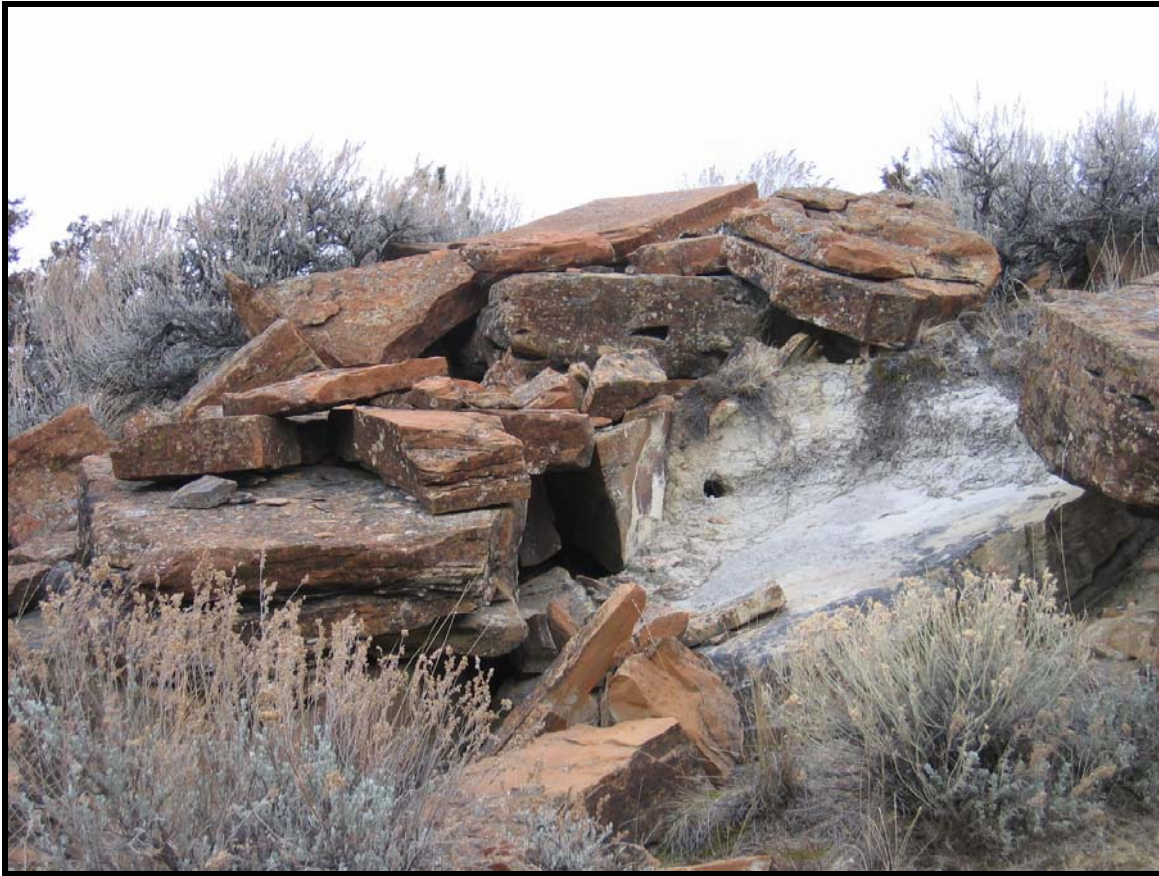
**ROCK OUTCROP FEATURE: RO\_0113**

Photo: 1\_18\_06\_17

**Looking Northeast**

**DESCRIPTION OF FEATURE:** The sandstone/siltstone rock outcrop shown above occurs in an area that has a high population of sagebrush. The flat, rectangular rocks are stacked in manner that leaves void areas.

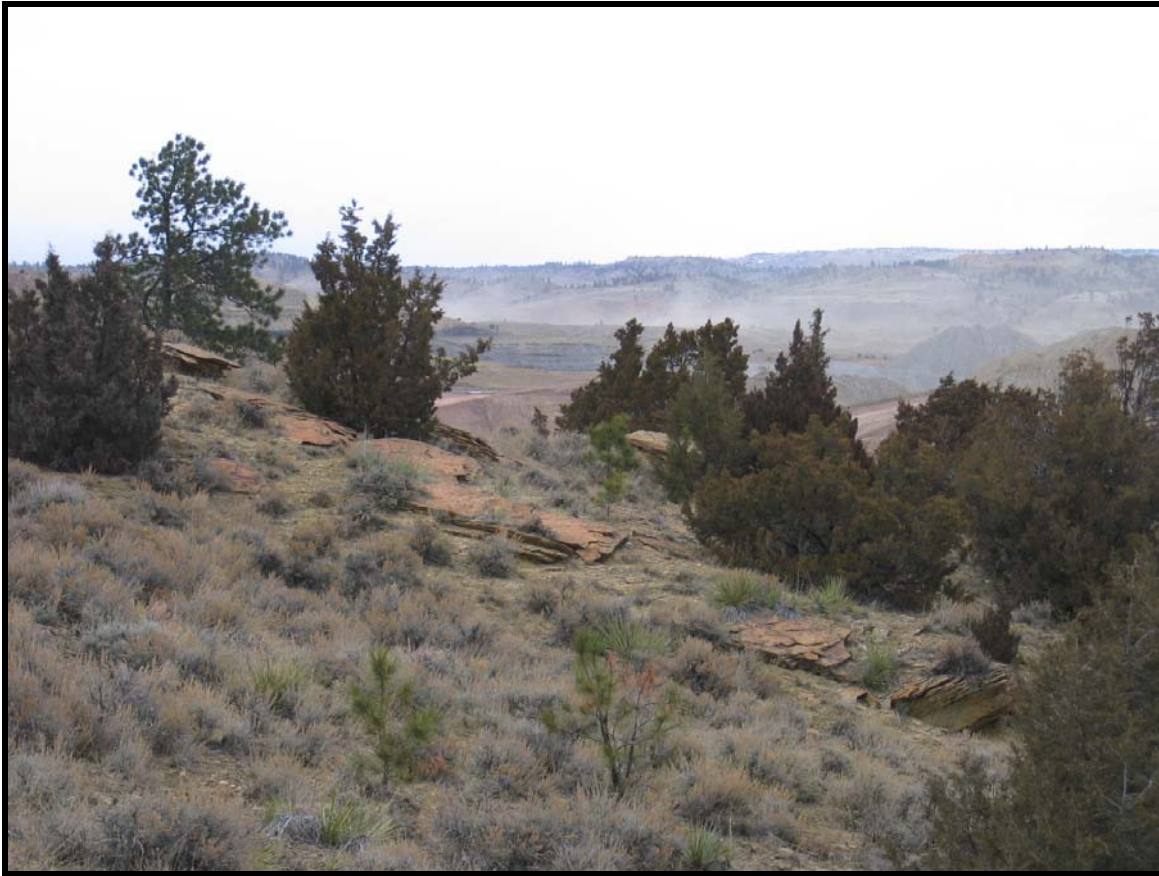
**ROCK OUTCROP FEATURE: RO\_0114**

Photo: 1\_18\_06\_18

**Looking West**

**DESCRIPTION OF FEATURE:** The rock outcrop shown above is located on a moderately sloped, north facing hill. The rocks are generally low-lying and consist of layered sandstone/siltstone rocks.

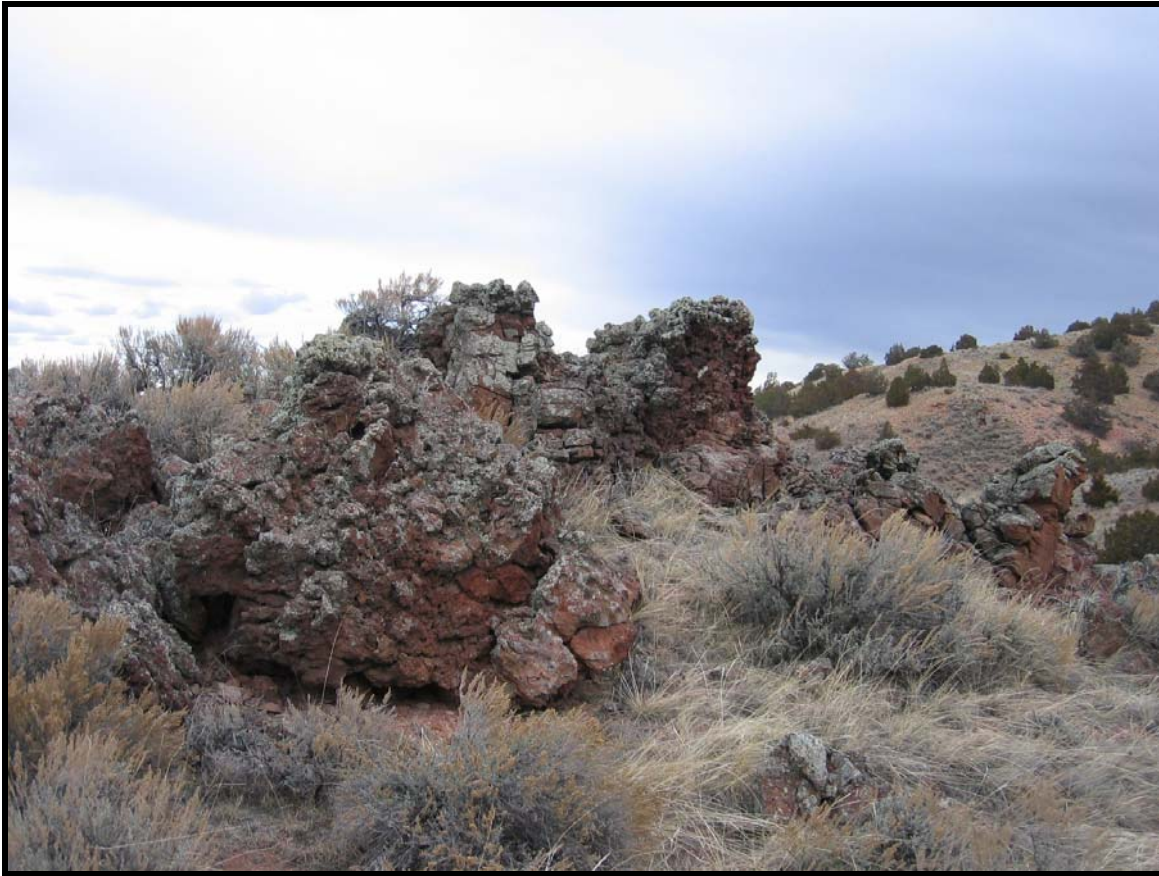
**ROCK OUTCROP FEATURE: RO\_0115**

Photo: 1\_18\_06\_19

**Looking Northeast**

**DESCRIPTION OF FEATURE:** The scoria outcrop feature shown above consists of lichen covered scoria rocks at the top of a hill. Outcrops like this are common across the mine area.

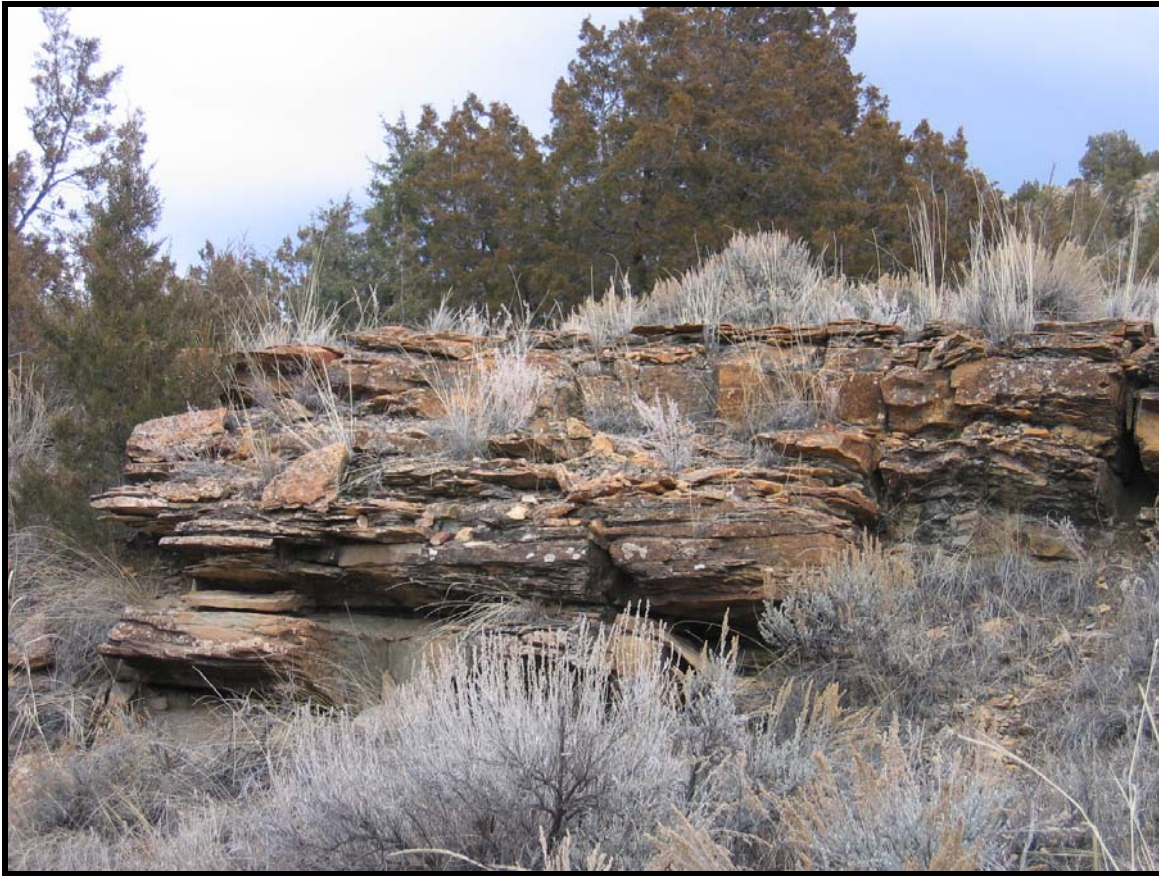
**ROCK OUTCROP FEATURE: RO\_0116**

Photo: 1\_18\_06\_20

**Looking Northeast**

**DESCRIPTION OF FEATURE:** The sandstone/siltstone rock outcrop shown above is layered and very weathered. Erosion of the soil beneath the rocks has created overhangs and voids.

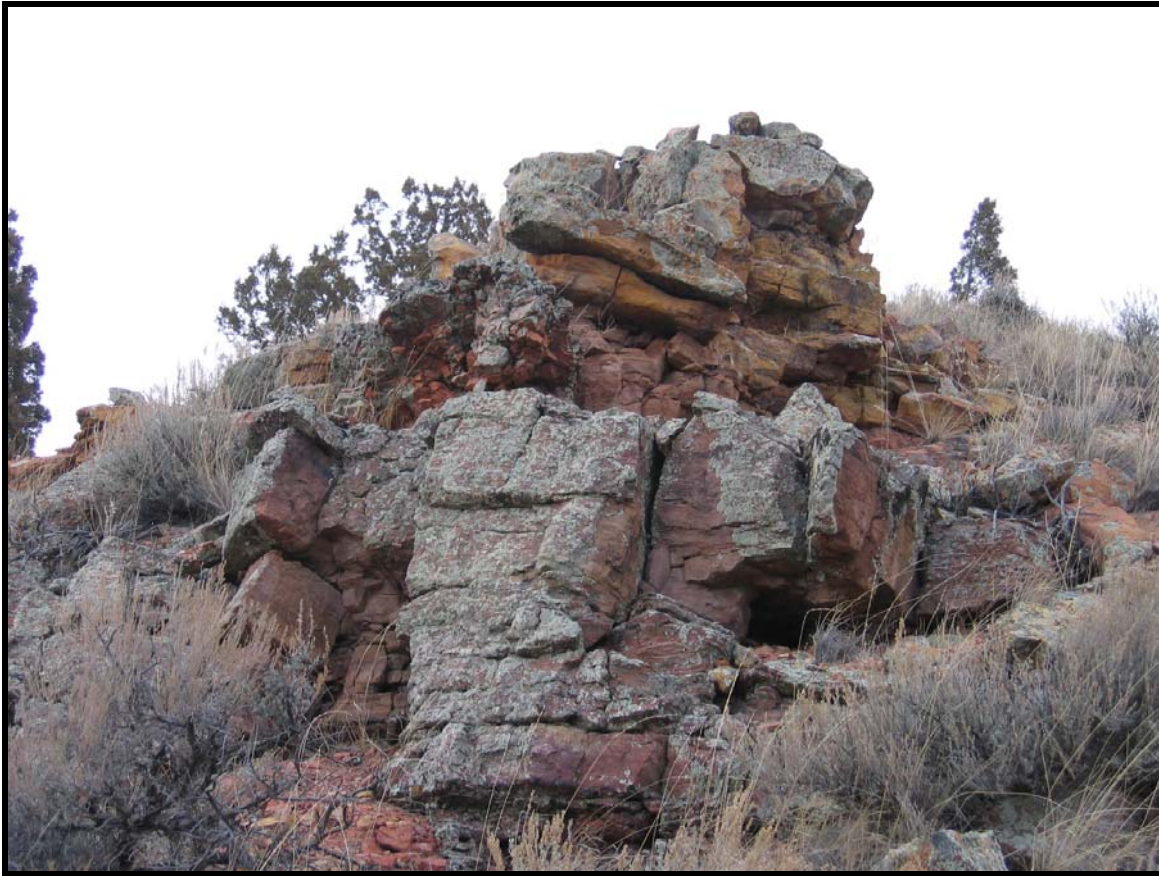
**ROCK OUTCROP FEATURE: RO\_0117**

Photo: 1\_18\_06\_21

**Looking Northeast**

**DESCRIPTION OF FEATURE:** The scoria outcrop feature shown above consists of lichen covered scoria rocks at the top of a hill. Outcrop likes this are common across the mine area. However, this scoria outcrop is taller than most of the other outcrops.

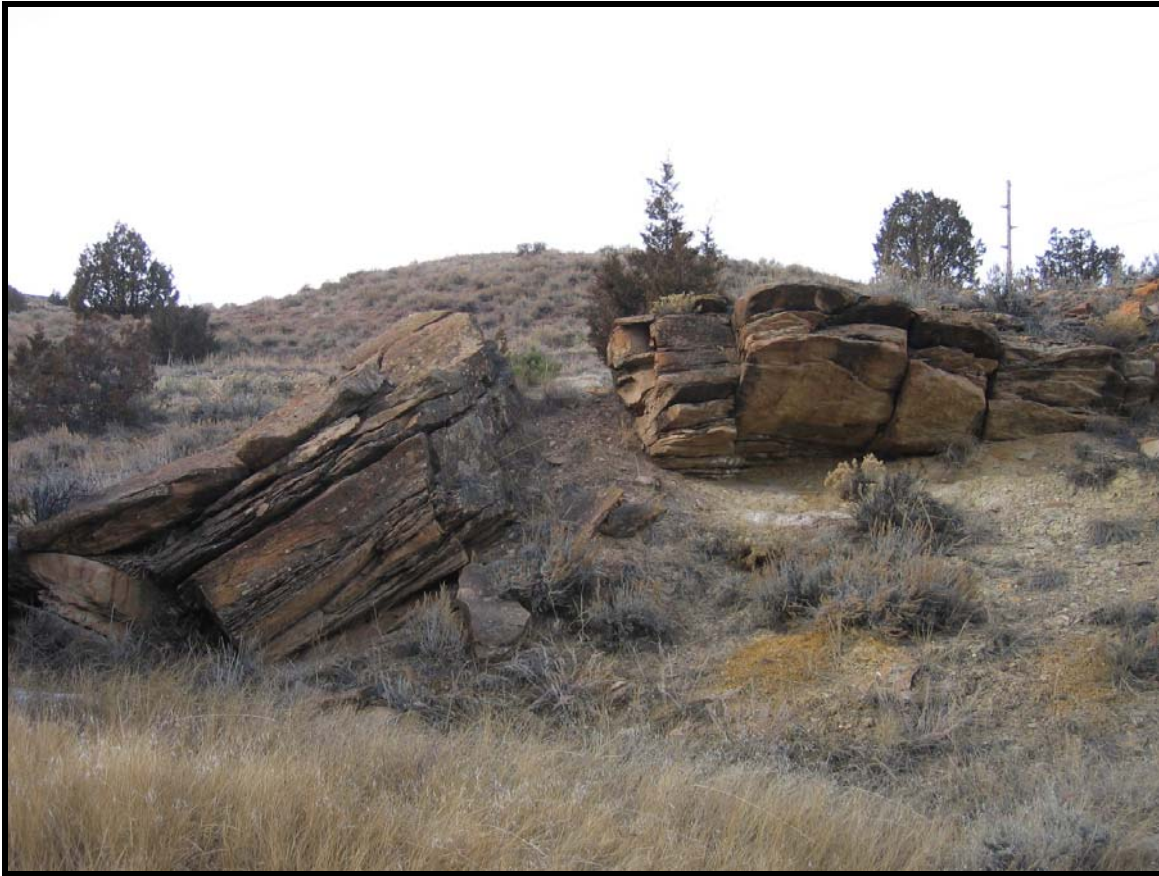
**ROCK OUTCROP FEATURE: RO\_0118**

Photo: 1\_18\_06\_22

**Looking Northwest**

**DESCRIPTION OF FEATURE:** The sandstone/siltstone rock outcrop shown above consists of layered rock on sandy silt subsoil. Animals have utilized the soft soil underneath the rocks by digging holes and using the outcrop as protection.

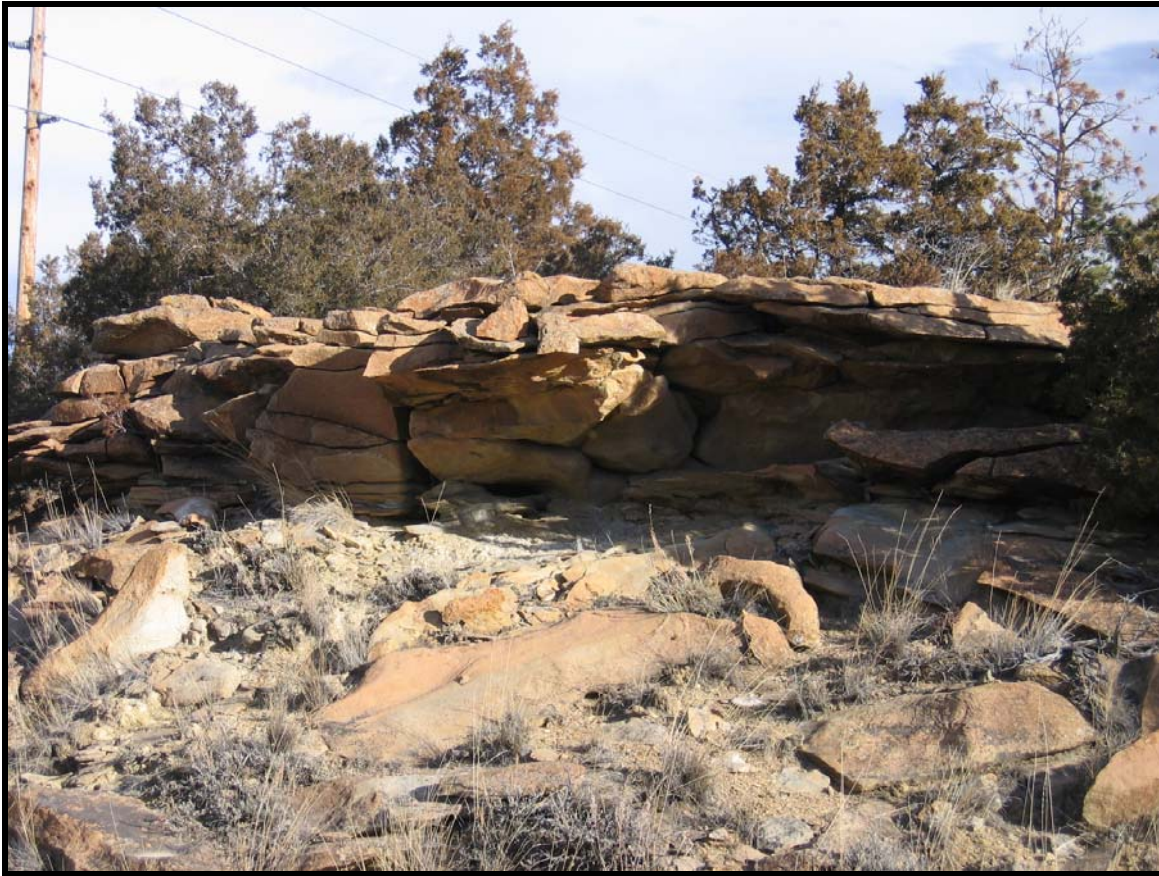
**ROCK OUTCROP FEATURE: RO\_0119**

Photo: 1\_18\_06\_23

**Looking East**

**DESCRIPTION OF FEATURE:** The face of the rock outcrop shown above is very fractured and jagged. The sandstone/siltstone rock has been weathered along the length of the feature. It sits on a sandy silt subsoil.

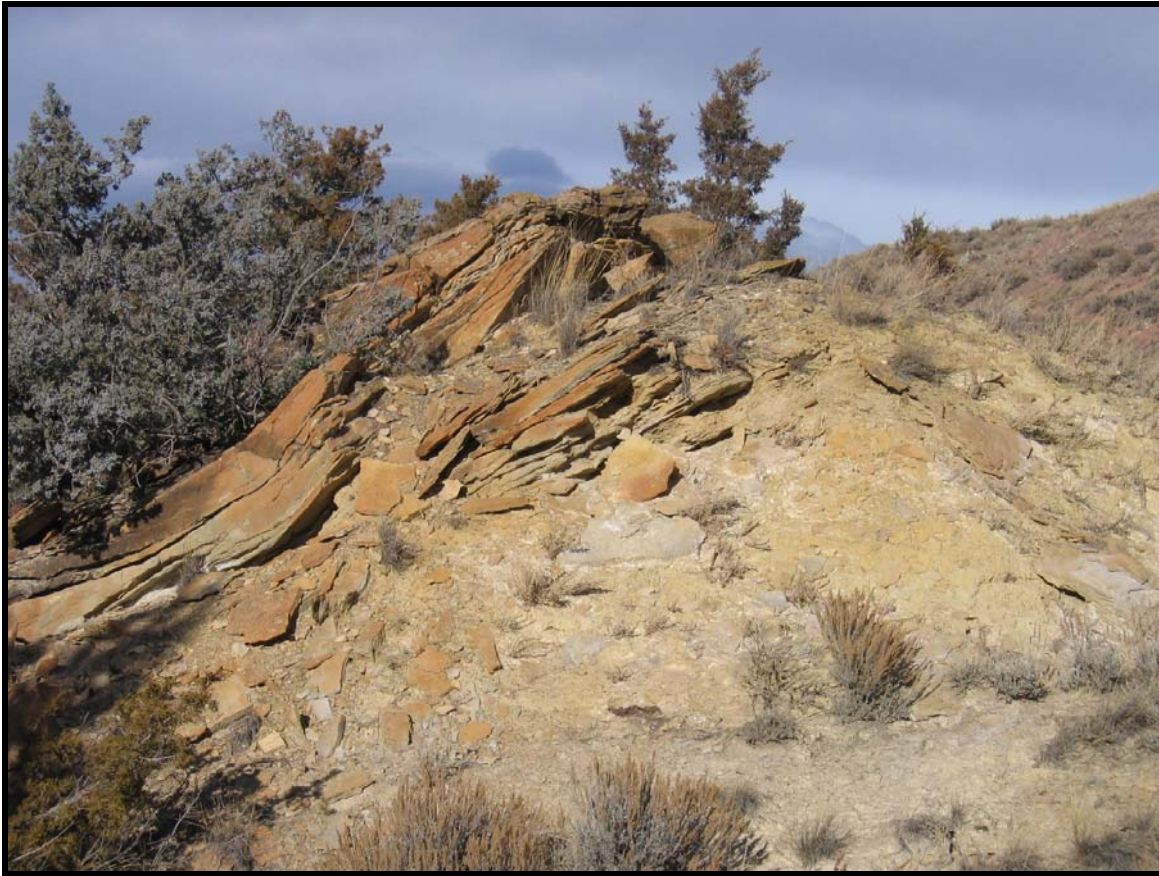
**ROCK OUTCROP FEATURE: RO\_0120**

Photo: 1\_18\_06\_24

**Looking North**

<b>FEATURE TYPE:</b>	Rock Outcrop		
<b>GEOMETRIC DIMENSIONS:</b>	Length: 45 ft	Height: 15 ft	
<b>LOCATION:</b>	Township: 8S	Range: 39E	Section: 26
<b>HANDHELD GPS POINTS:</b>	<b>Northing</b>	<b>Easting</b>	
	<b>10055</b>	411896.55	2667874.75
	<b>10056</b>	411895.71	2667848.94
	<b>10057</b>	411932.15	2667847.77
<b>SUBSTRATE:</b>	Sandstone/siltstone, sand, and silt		
<b>EXPOSURE:</b>	Northern facing slope		
<b>DESCRIPTION OF FEATURE:</b>	The rock outcrop feature shown above sits on a mound of soft, sandy silt soil. The rocks have outcropped on the western side and on the top of this small mound. Animals have utilized the soft soil by digging holes beneath the rocks in this feature.

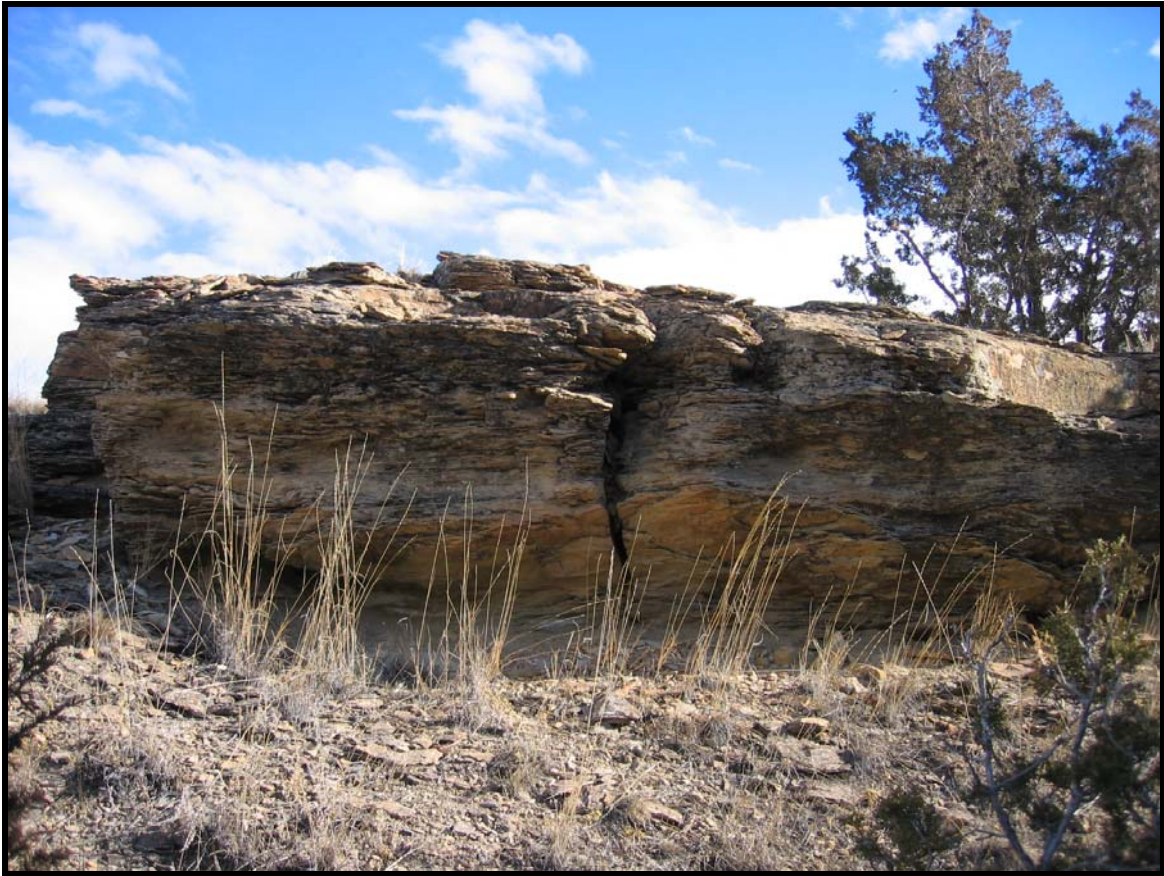
**ROCK OUTCROP FEATURE: RO\_0121**

Photo: 1\_18\_06\_25

**Looking Southeast**

**DESCRIPTION OF FEATURE:** The rock outcrop shown above consists of large, layered sandstone/siltstone rocks. The depth of these rocks is approximately five feet. The rocks sit on sandy silt soil and are surrounded by sparse vegetation.

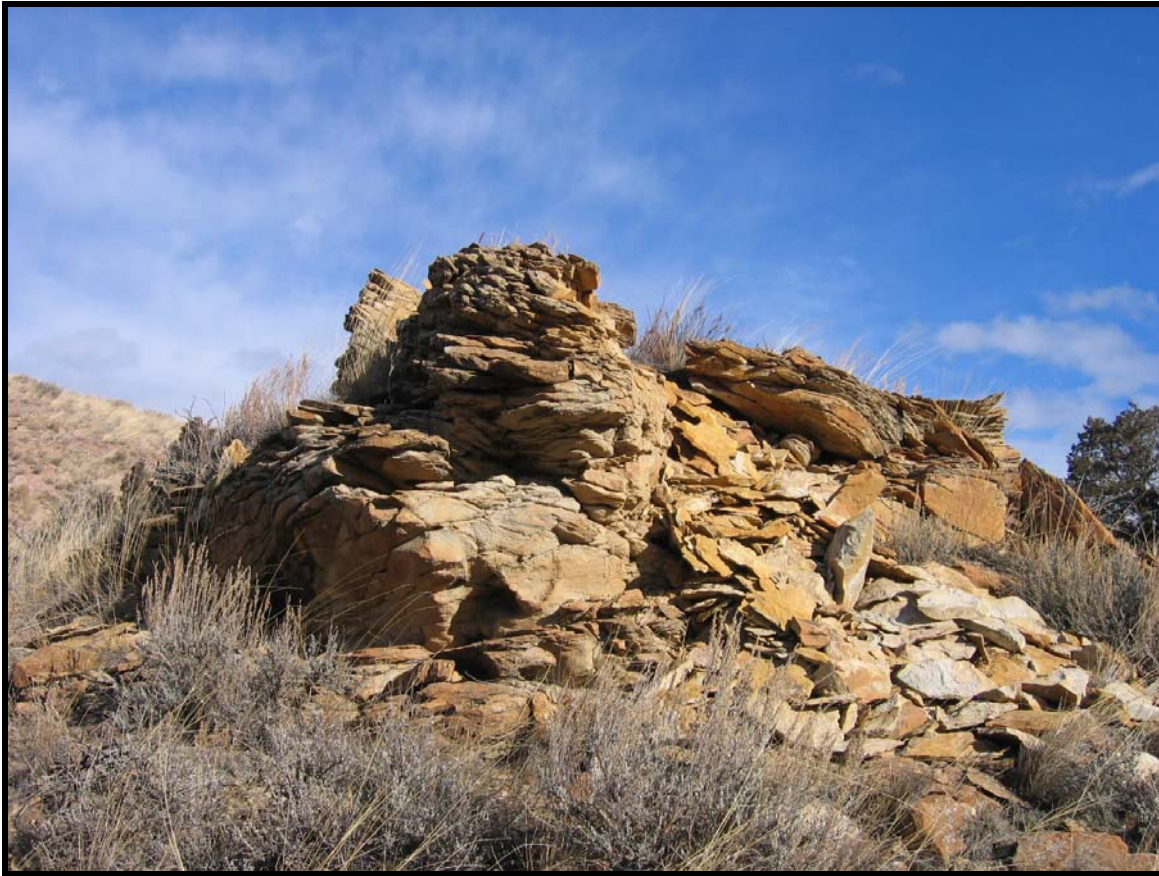
**ROCK OUTCROP FEATURE: RO\_0122**

Photo: 1\_18\_06\_26

**Looking Northeast**

**DESCRIPTION OF FEATURE:** This feature consists of stacked, sandstone/siltstone rocks. The rocks are flat, thin and small. This feature contains holes below and within its face.
