**Township 8S, Range 39E**  
**SECTION 26**

*Cliff Features*

Revised 4/06; Reference – South Fork Extension Amendment #00174

313D-T8SR39E26-3

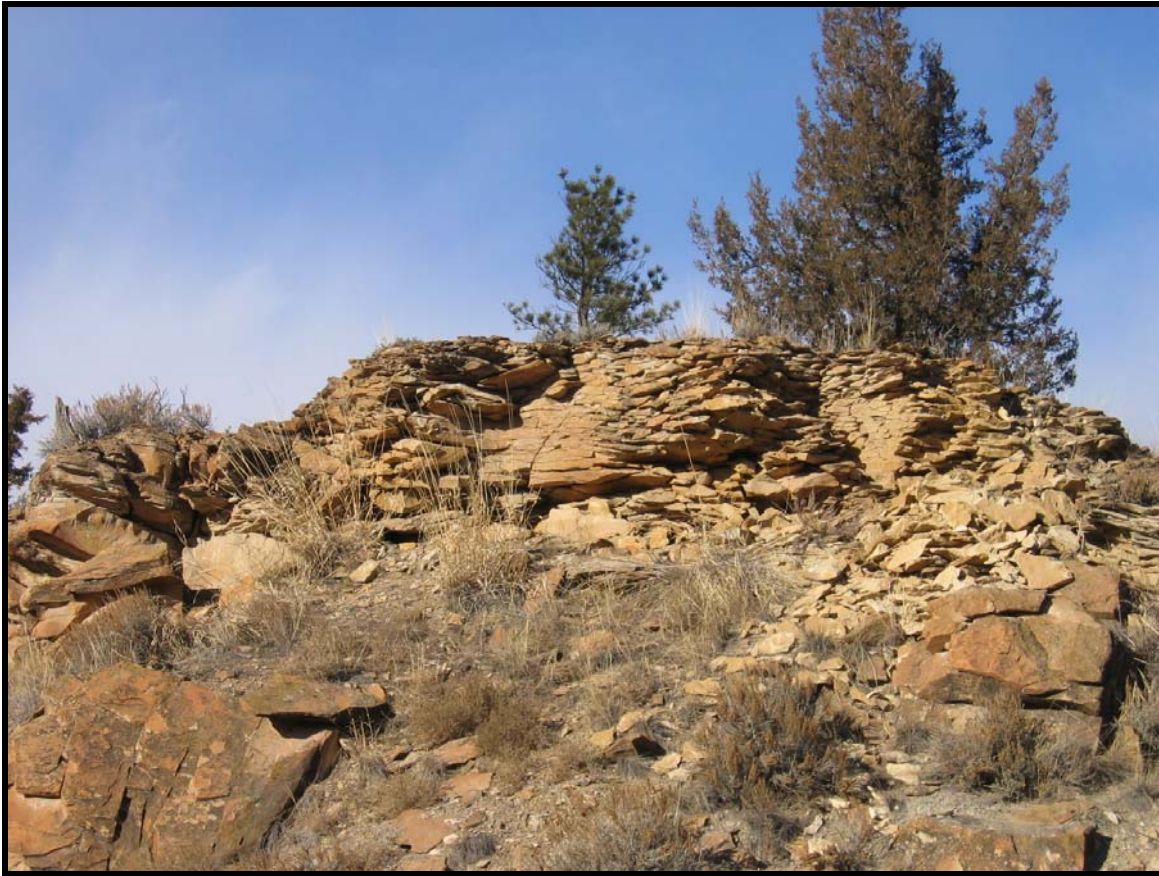
**ROCK OUTCROP FEATURE: RO\_0123**

Photo: 1\_18\_06\_27

**Looking North**

**DESCRIPTION OF FEATURE:** This feature consists of layered, sandstone/siltstone rocks. The rocks are flat and thin. This feature contains holes below and within its face.

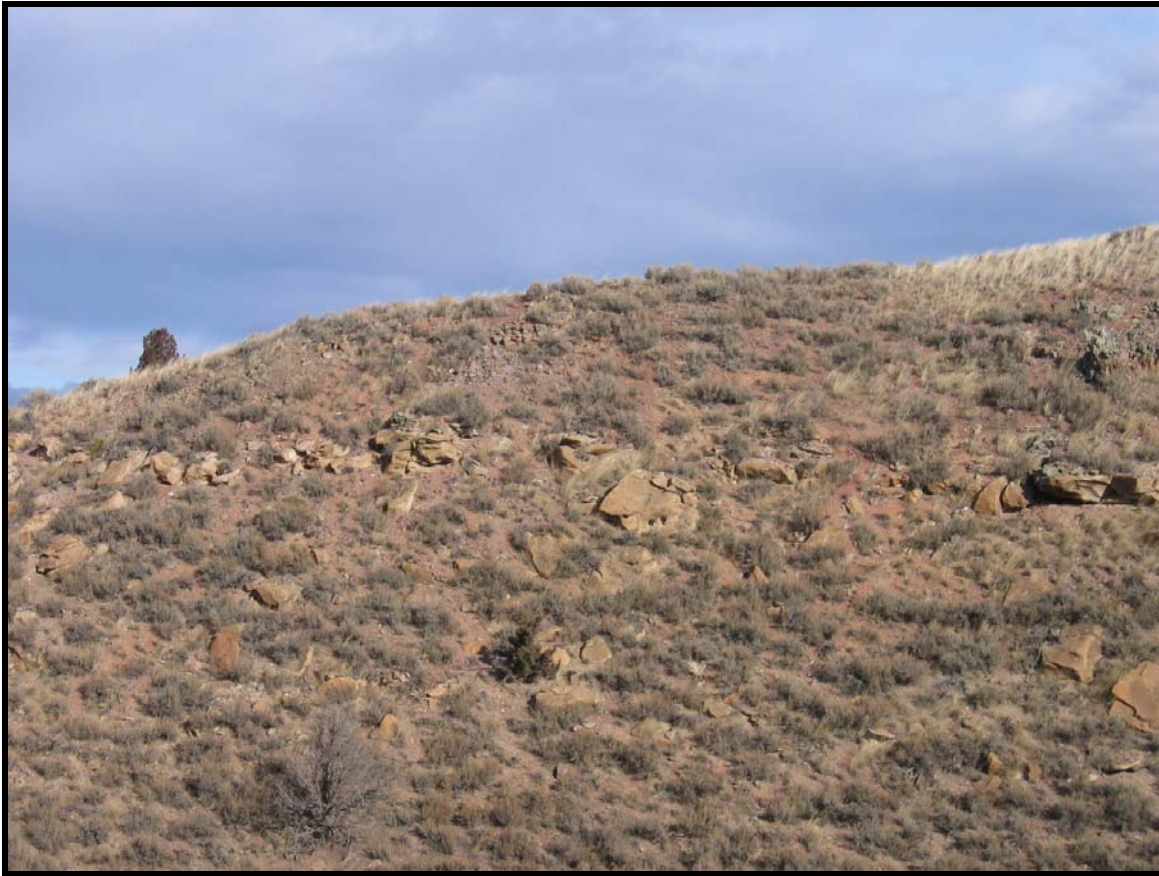
**ROCK OUTCROP FEATURE: RO\_0124**

Photo: 1\_18\_06\_29

**Looking East**

**DESCRIPTION OF FEATURE:** The rock outcrop shown above is located on the side of a steep (greater than 3H:1V) hill. The sandstone/siltstone rocks have been exposed by erosion at mid-height of the slope. The thickness of the rocks is approximately five feet.

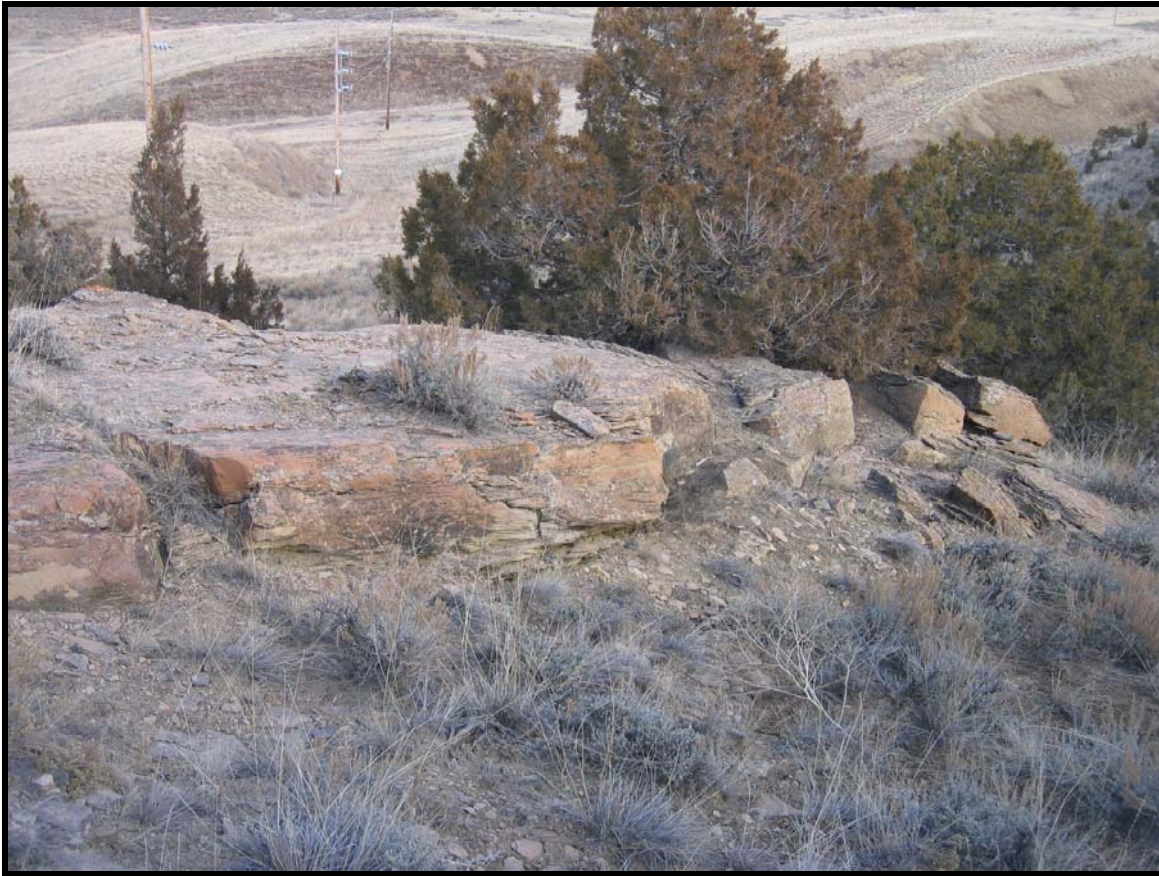
**ROCK OUTCROP FEATURE: RO\_0125**

Photo: 1\_18\_06\_30

**Looking East**

**DESCRIPTION OF FEATURE:** The small rock outcrop shown above consists of a sandstone/siltstone rock layer that is approximately two feet in thickness. Pieces of the rock layer that have broken free lie on the adjacent slope.

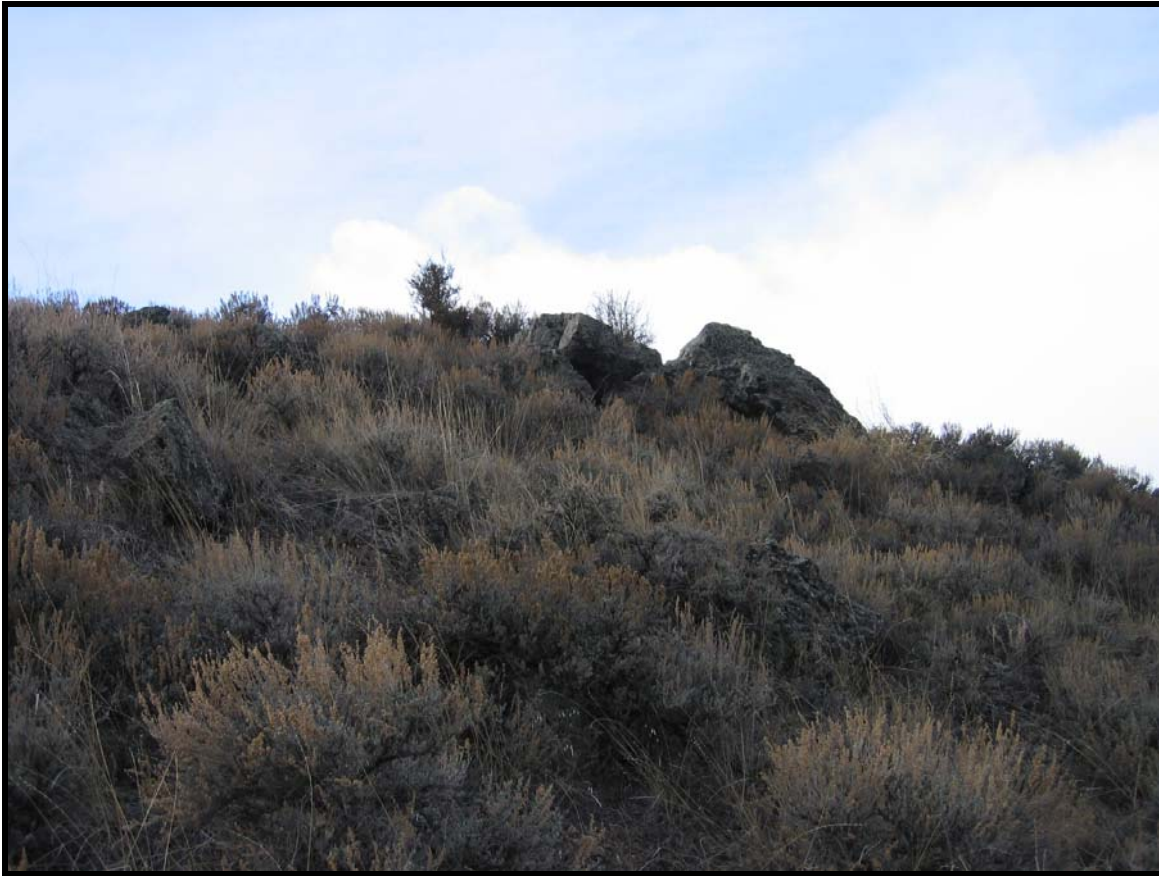
**ROCK OUTCROP FEATURE: RO\_0126**

Photo: 1\_18\_06\_31

**Looking West**

**DESCRIPTION OF FEATURE:** The scoria outcrop feature shown above consists of lichen covered scoria rocks at the top of a hill. Outcrops like this are common across the mine area.

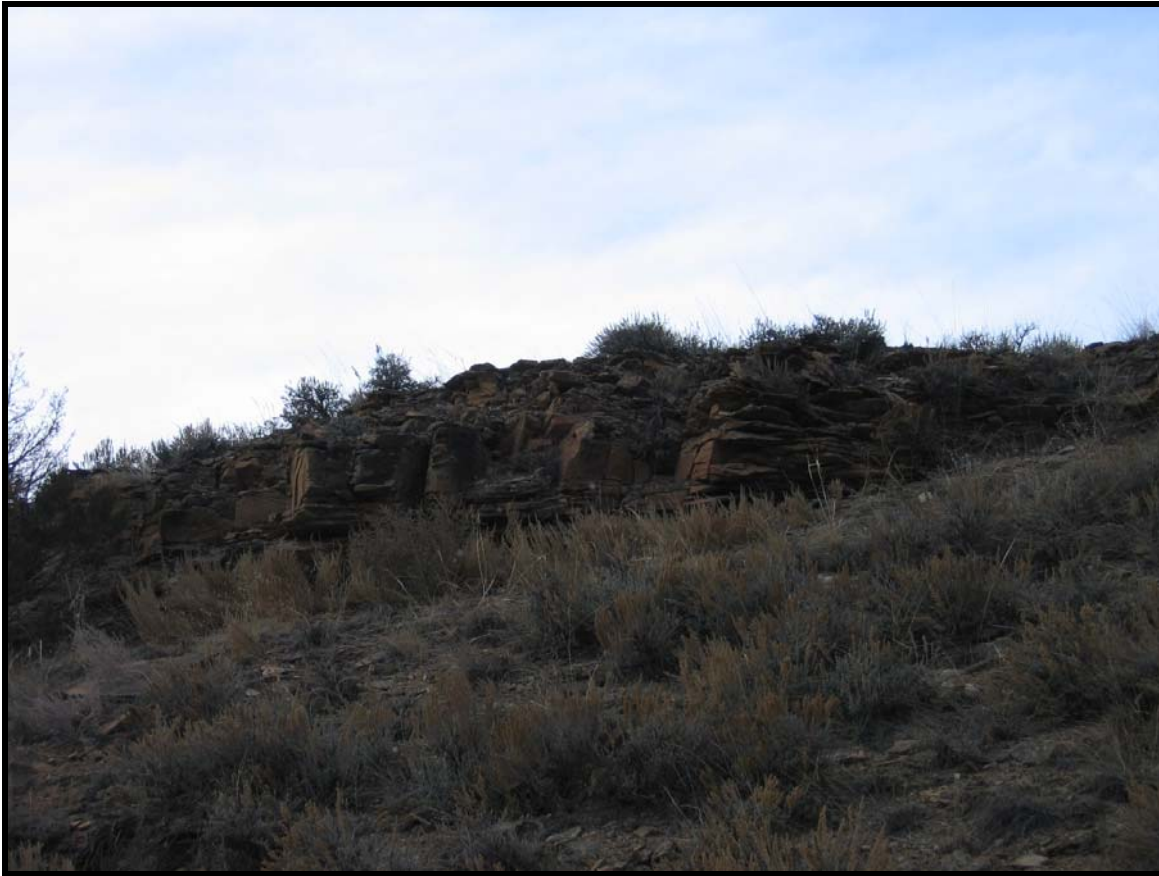
**ROCK OUTCROP FEATURE: RO\_0127**

Photo: 1\_18\_06\_34

**Looking West**

**DESCRIPTION OF FEATURE:** The rock outcrop shown above is located on a moderately sloped, southern facing hill. The rocks are generally low-lying and consist of layered sandstone/siltstone rocks.

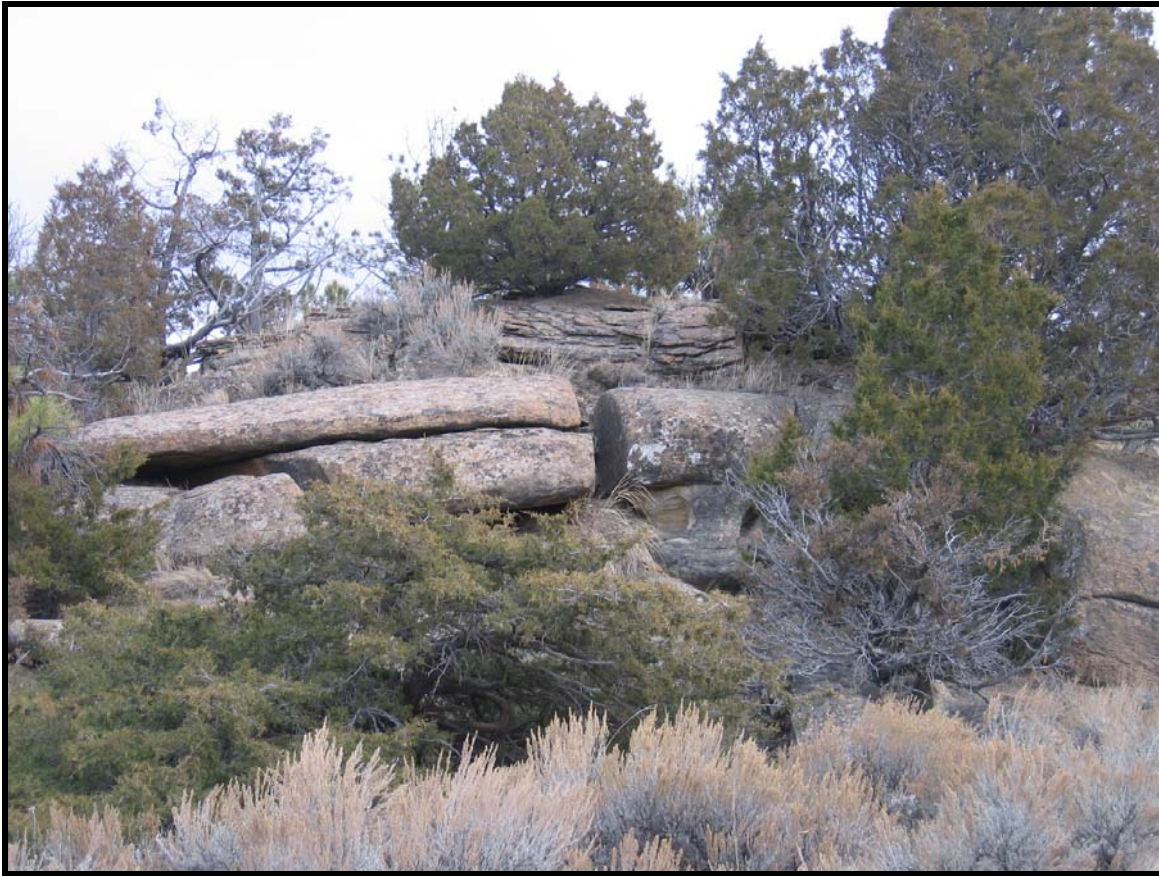
**ROCK OUTCROP FEATURE: RO\_0128**

Photo: 1\_18\_06\_35

**Looking East**

**DESCRIPTION OF FEATURE:** The rock outcrop shown above is located in an area vegetated with grass, sagebrush and small trees. The rocks are large, rounded and scattered over the area. Voids between and below the rocks are frequent in this feature.

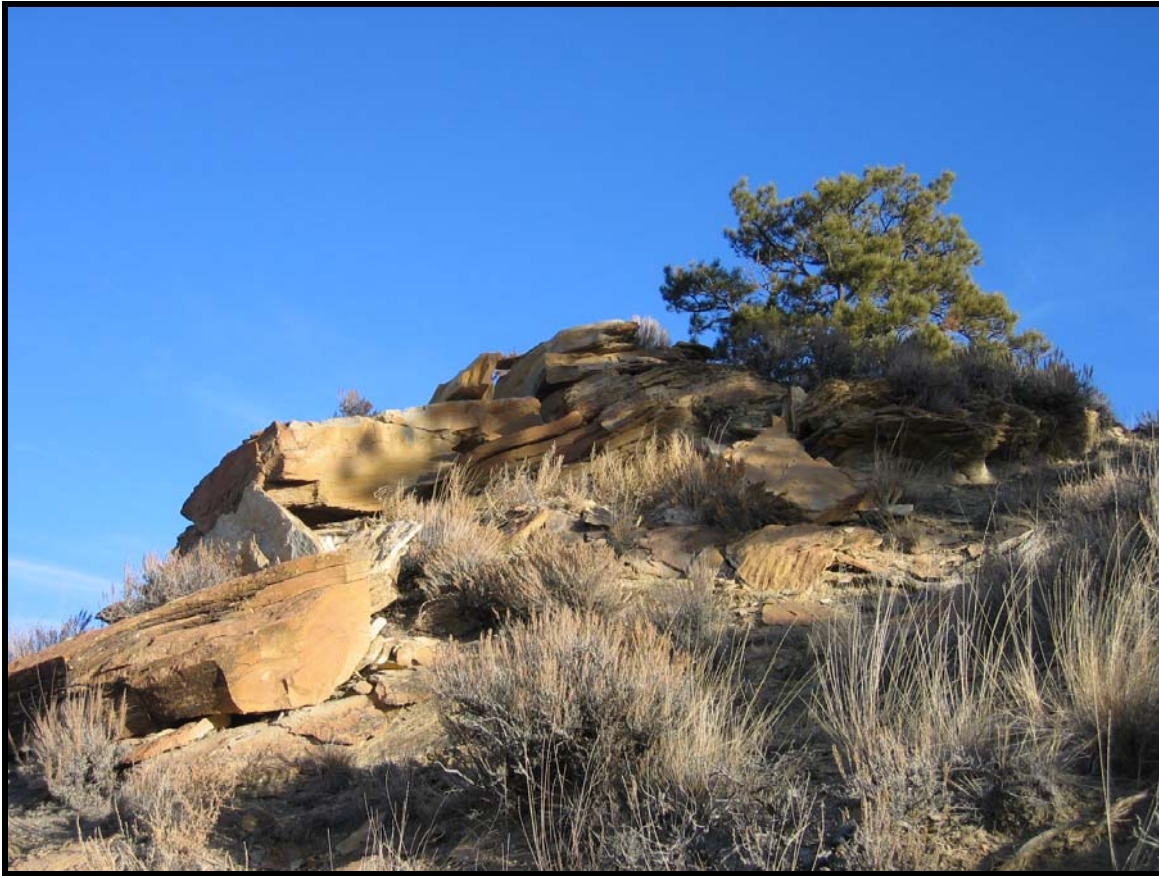
**ROCK OUTCROP FEATURE: RO\_0129**

Photo: 1\_23\_06\_02

**Looking North**

**DESCRIPTION OF FEATURE:** The rock outcrop shown above travels along the top of a hill overlooking a small draw. This feature is composed of siltstone/sandstone rock and overlies sandy silt subsoil. Over the length of the feature there are areas where the rocks are large and heavily populated and areas where the rocks are smaller and less populated.

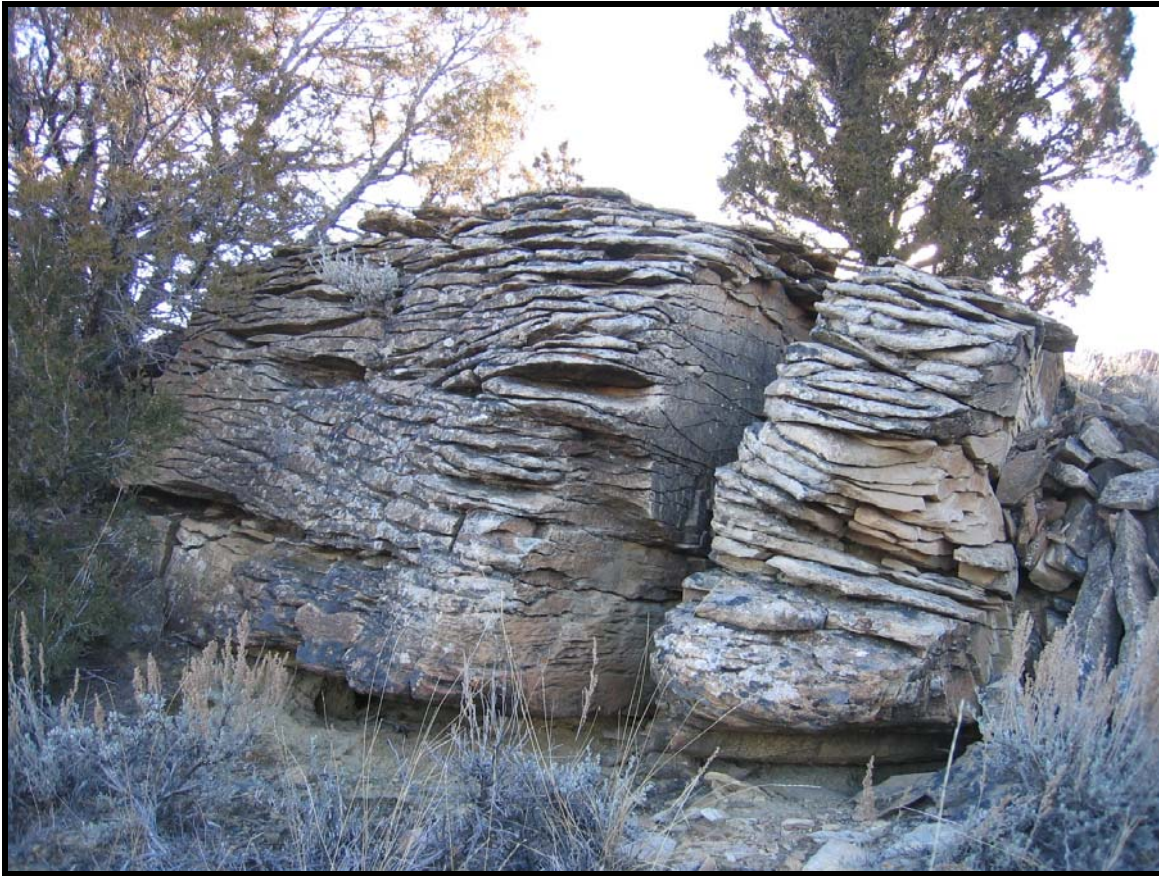
**ROCK OUTCROP FEATURE: RO\_0130**

Photo: 1\_23\_06\_03

**Looking South**

**DESCRIPTION OF FEATURE:** This feature is composed of siltstone/sandstone rock and overlies sandy silt subsoil. Several rocks like the one shown above are scattered over the small area to form this outcrop. These rocks are layered and weathered. They appear in an area of thick vegetative cover on a northern slope.

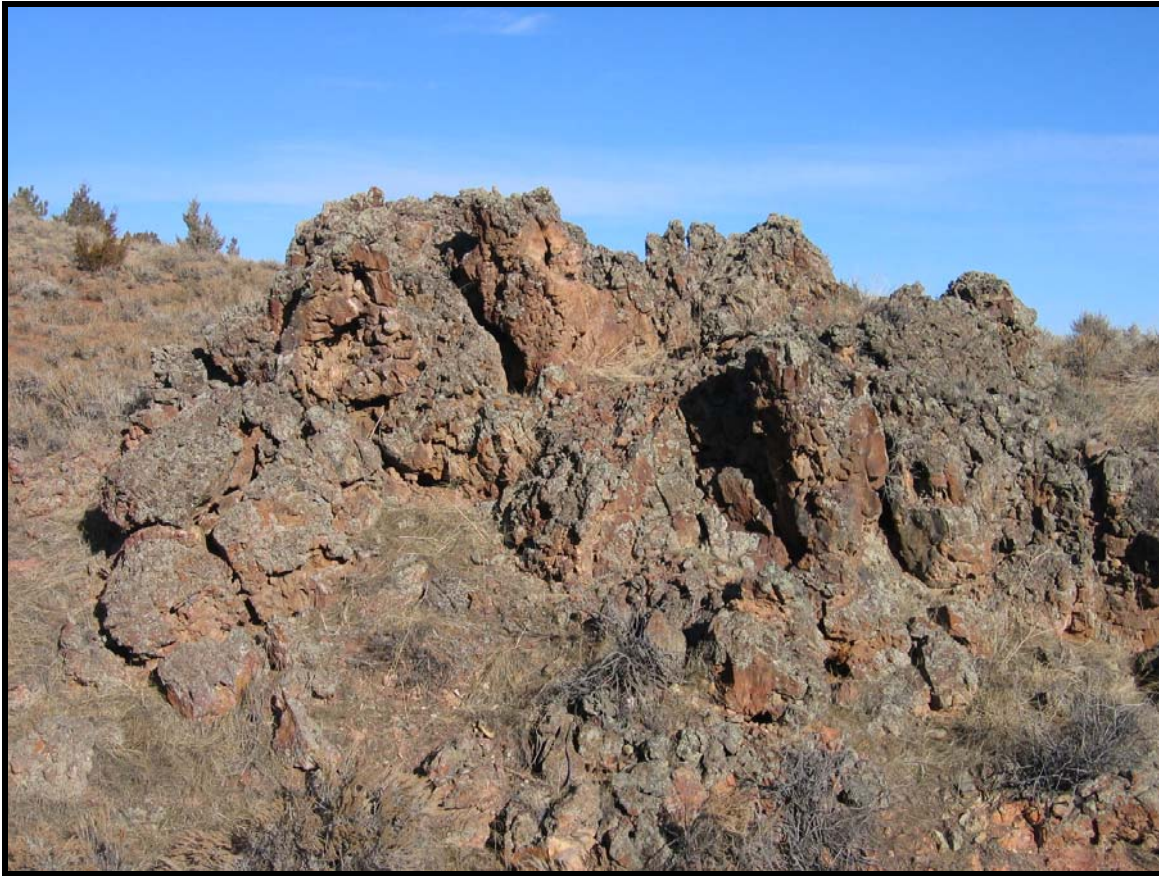
**ROCK OUTCROP FEATURE: RO\_0131**

Photo: 1\_23\_06\_04

**Looking North**

**DESCRIPTION OF FEATURE:** The scoria outcrop shown above is located adjacent to a small tributary draw to South Fork Spring Creek. This feature is located on the bank north of the channel bottom. The scoria in this outcrop is very large and in some instances extends as high as 15 feet. The surface of the scoria is covered with green lichens.

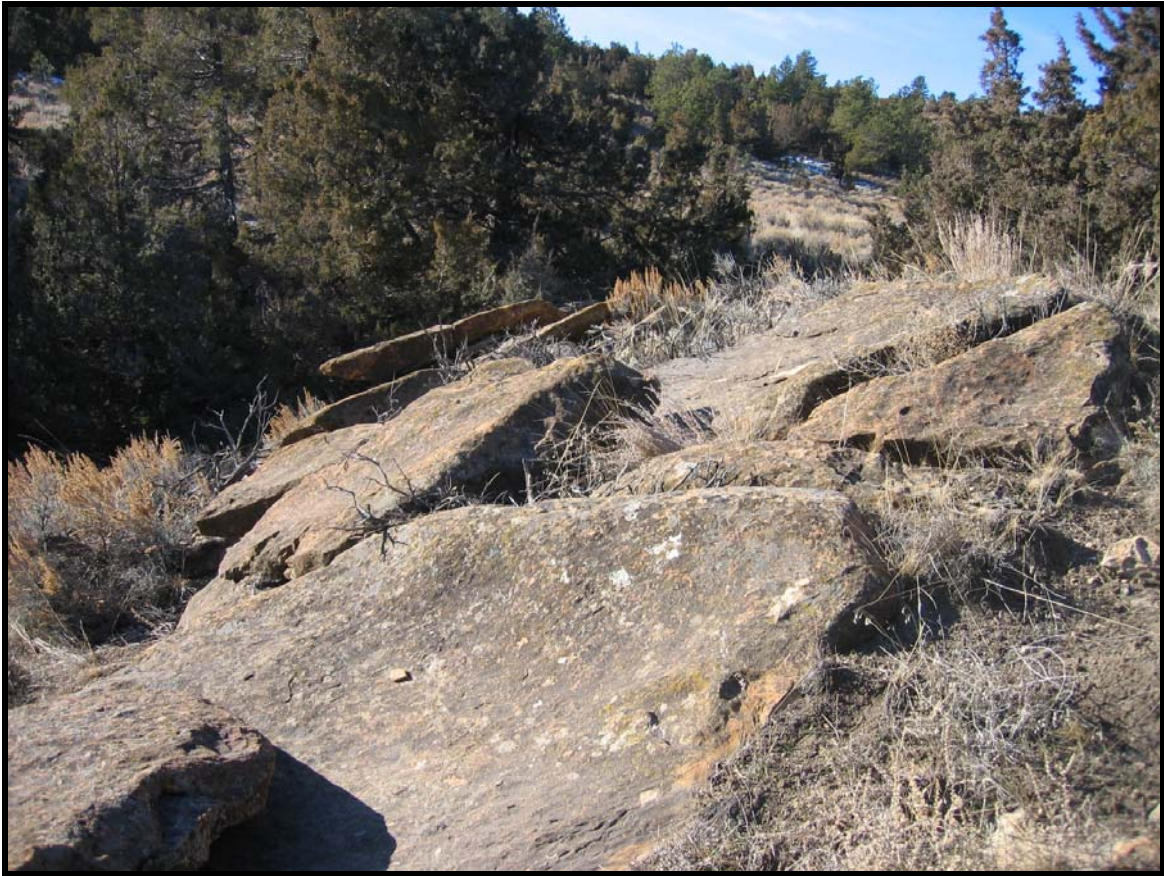
**ROCK OUTCROP FEATURE: RO\_0132**

Photo: 1\_23\_06\_05

**Looking Southwest**

**DESCRIPTION OF FEATURE:** This feature is composed of siltstone/sandstone rock and overlies sandy silt subsoil. The rocks are very low-lying and are highly populated along the channel bank. Some of the rocks are also in the channel bottom.

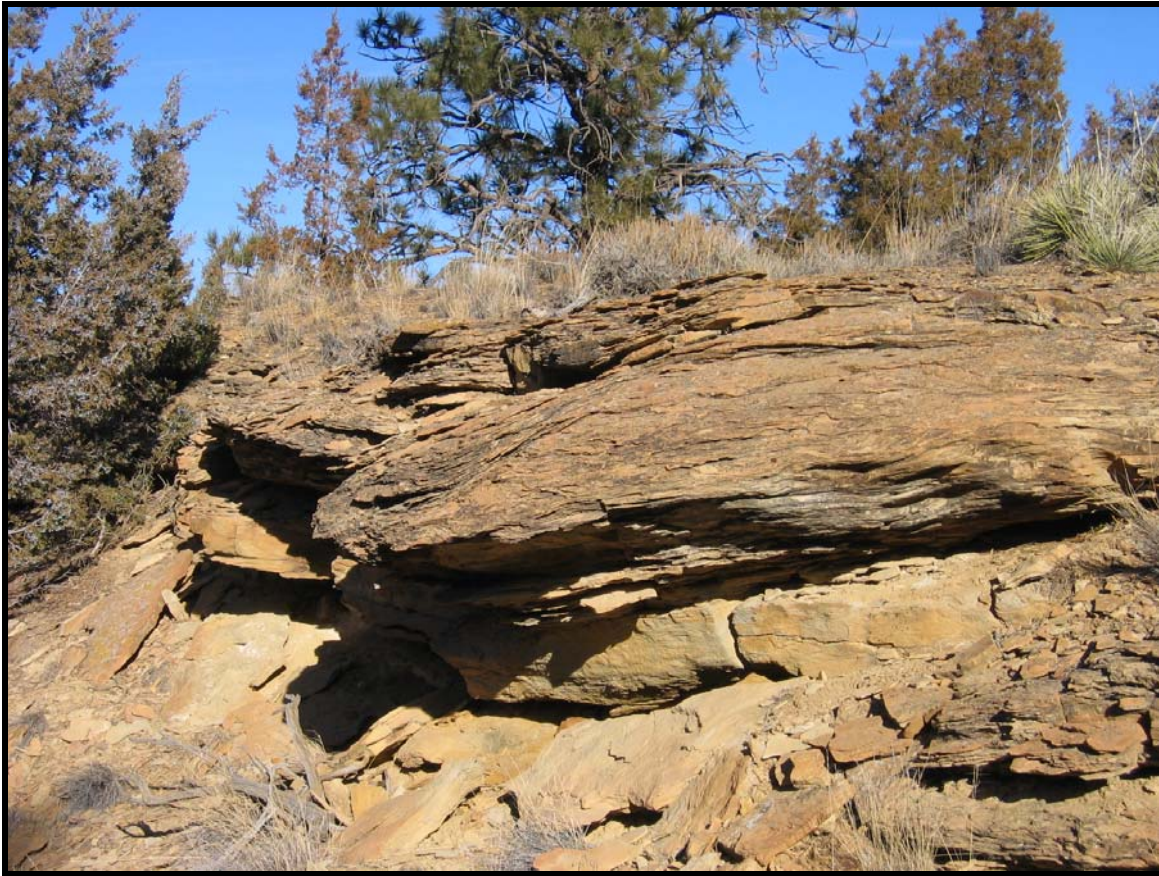
**ROCK OUTCROP FEATURE: RO\_0133**

Photo: 1\_23\_06\_07

**Looking North**

**DESCRIPTION OF FEATURE:** The rock outcrop feature shown above does not have significant vertical size; however, the feature is very long and contains a lot of areas beneath and between the rocks. The hard, sandstone/siltstone rock layer sits on soft sandy silt subsoil.

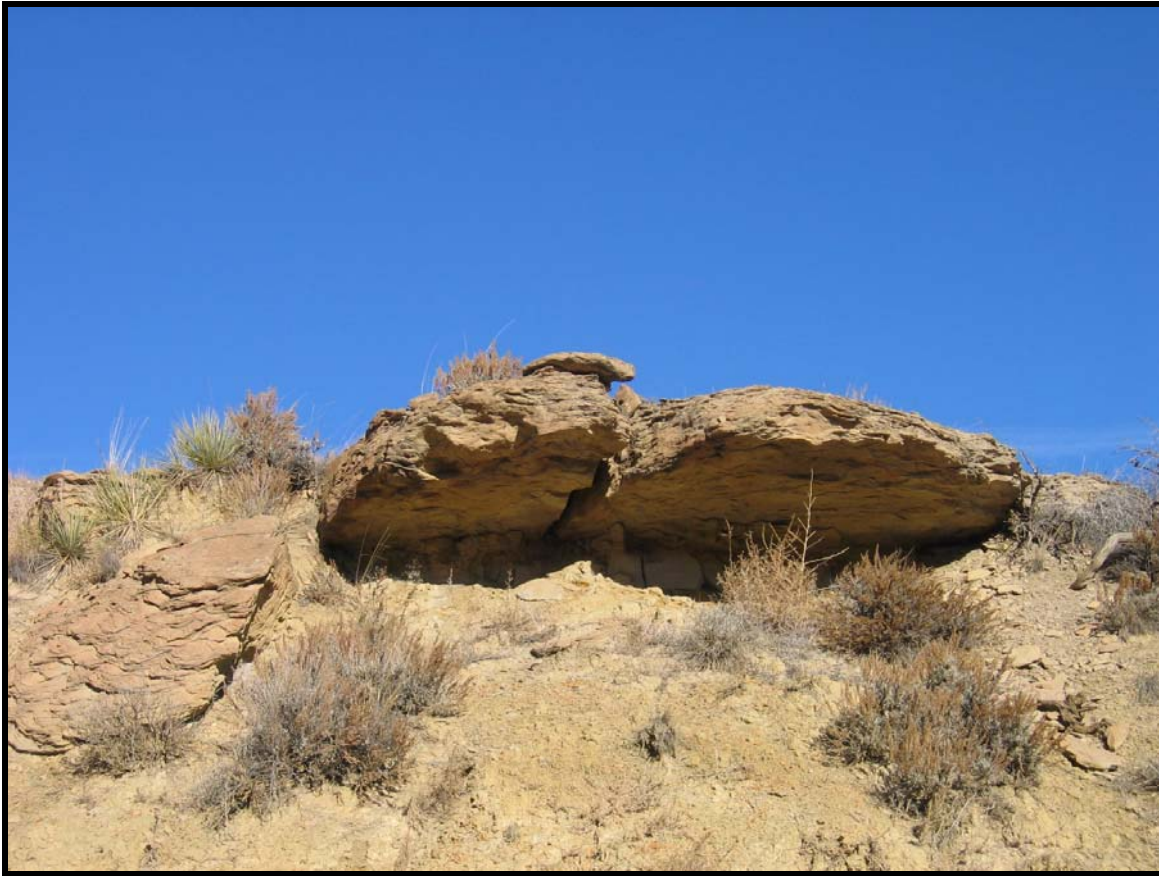
**ROCK OUTCROP FEATURE: RO\_0134**

Photo: 1\_23\_06\_08

**Looking North**

**DESCRIPTION OF FEATURE:** The rock outcrop consists of an overhang that is located on soft, sandy silt soil. The top of the feature is completely exposed, which is why it is not considered a cliff feature. The outcrop faces a small draw that is a tributary to South Fork Spring Creek. Only one survey point was included to give the location.

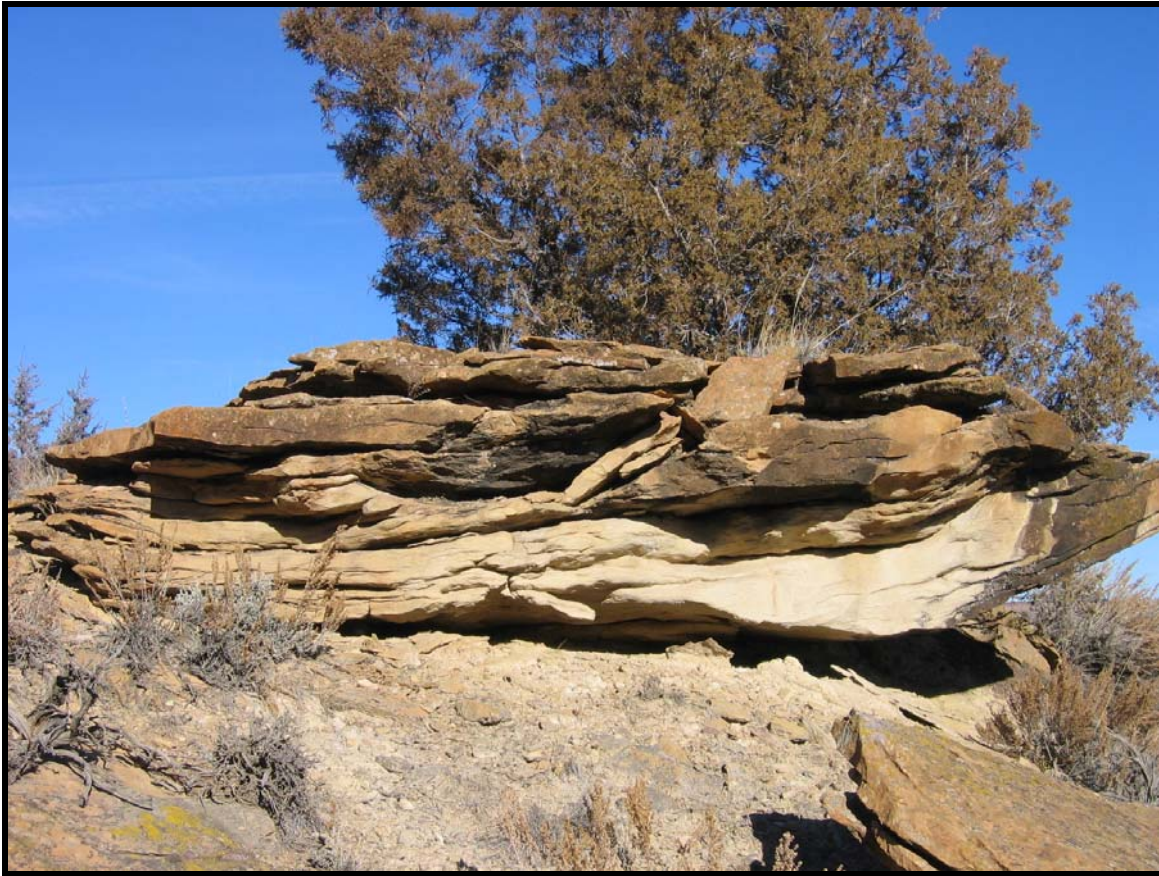
**ROCK OUTCROP FEATURE: RO\_0135**

Photo: 1\_23\_06\_10

**Looking North**

**DESCRIPTION OF FEATURE:** The rock outcrop shown above is typical for this area. It is located at the top of a steep hill, to a small draw. The rock outcrop creates voids within and below the rocks. This feature has a long, narrow geometry.

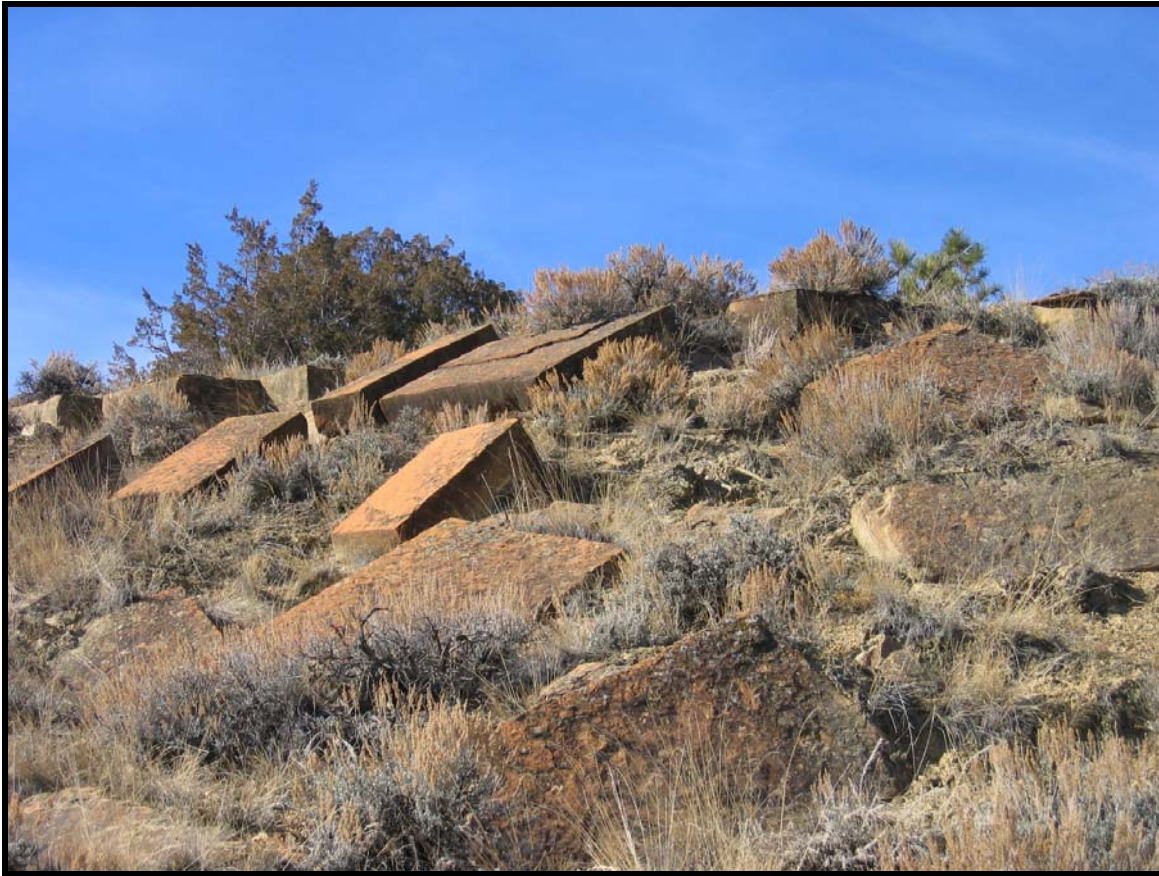
**ROCK OUTCROP FEATURE: RO\_0136**

Photo: 1\_23\_06\_11

**Looking West**

**DESCRIPTION OF FEATURE:** The rock outcrop shown above is located on a moderately sloped hill. The sandstone/siltstone rocks within this outcrop are very flat and rectangular. The rocks vary in size from small to large.

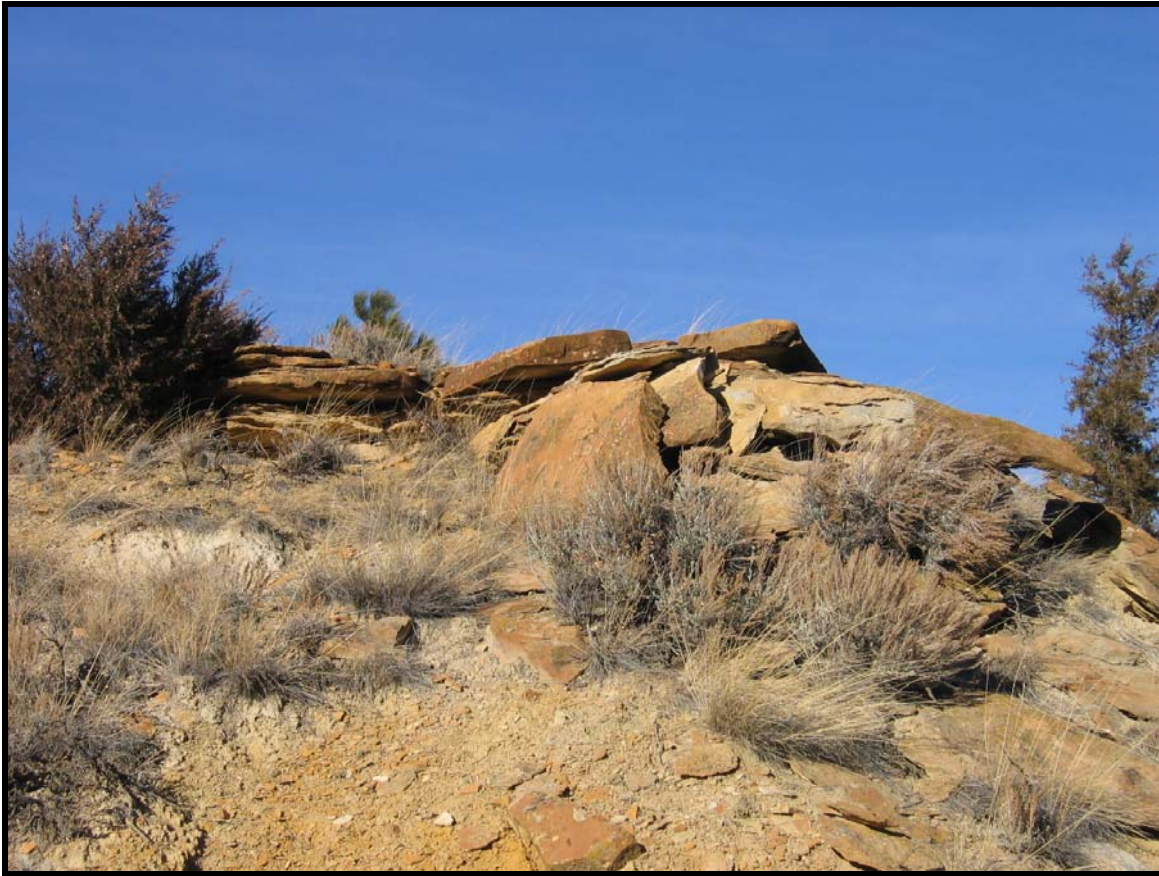
**ROCK OUTCROP FEATURE: RO\_0148**

Photo: 1\_23\_06\_27

**Looking Northeast**

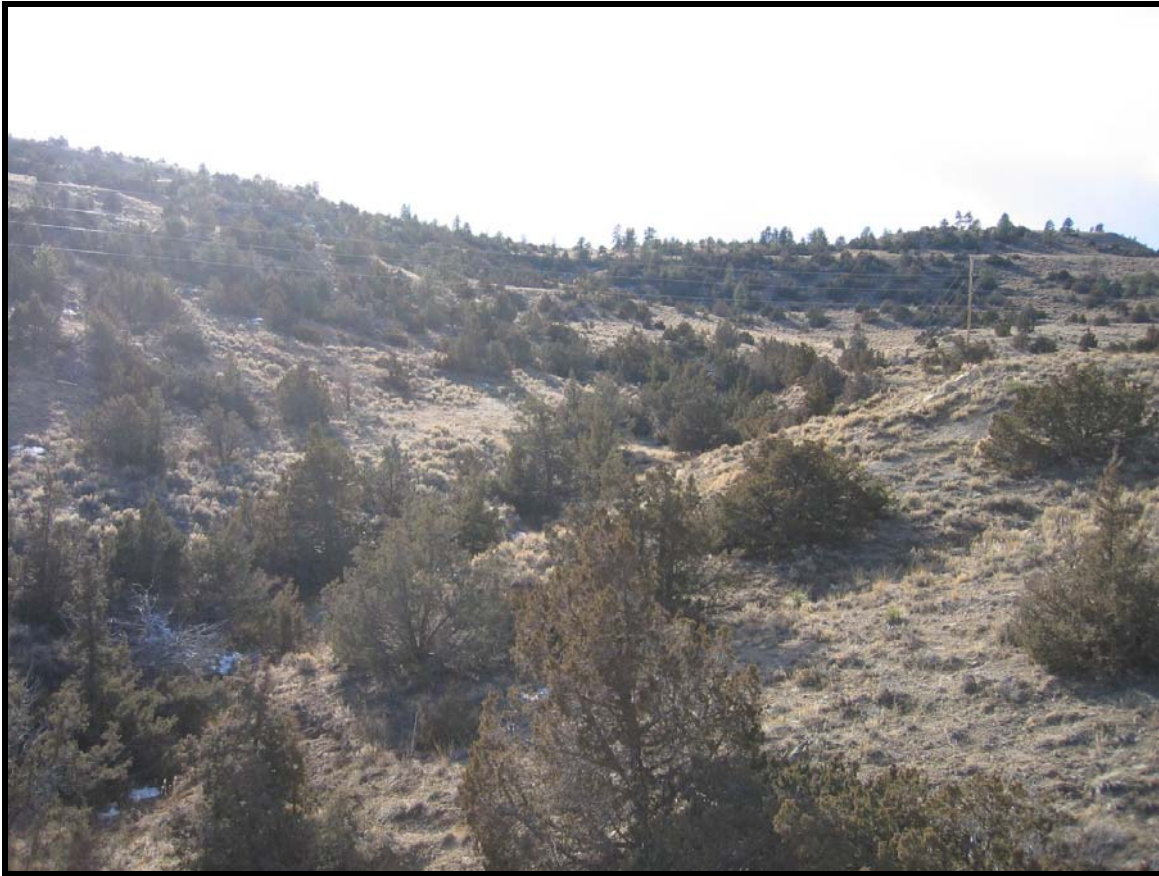
**RIPARIAN FEATURE: R\_0034**

Photo: 1\_18\_06\_28

**Looking Southwest**

**DESCRIPTION OF FEATURE:** This small draw has a channel bottom that varies in width and is vegetated with grass, sagebrush and some small trees. The surrounding hills are rolling to moderately steep.

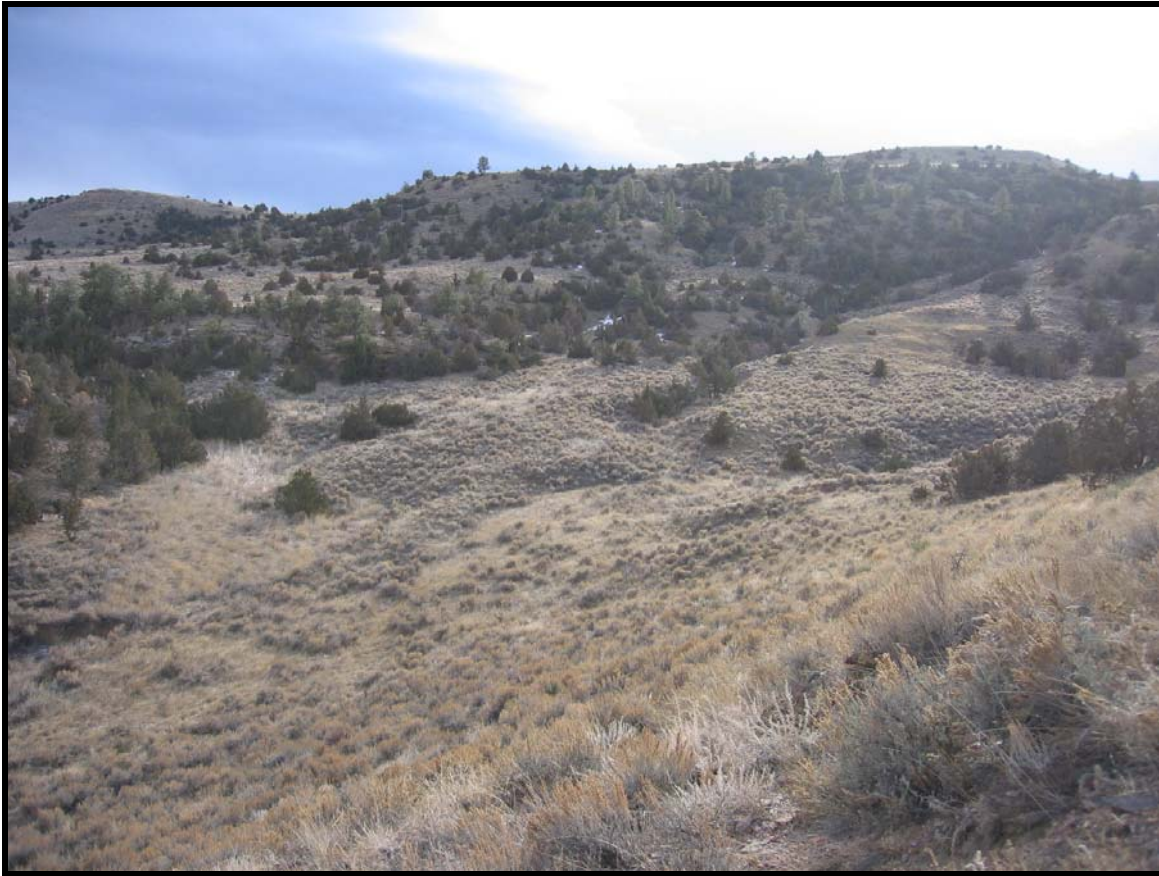
**RIPARIAN FEATURE: R\_0035**

Photo: 1\_18\_06\_33

**Looking Southeast**

**DESCRIPTION OF FEATURE:** This large draw has a wide channel bottom that is vegetated with grass, sagebrush and some small trees. The drainage is a tributary to South Fork Spring Creek.

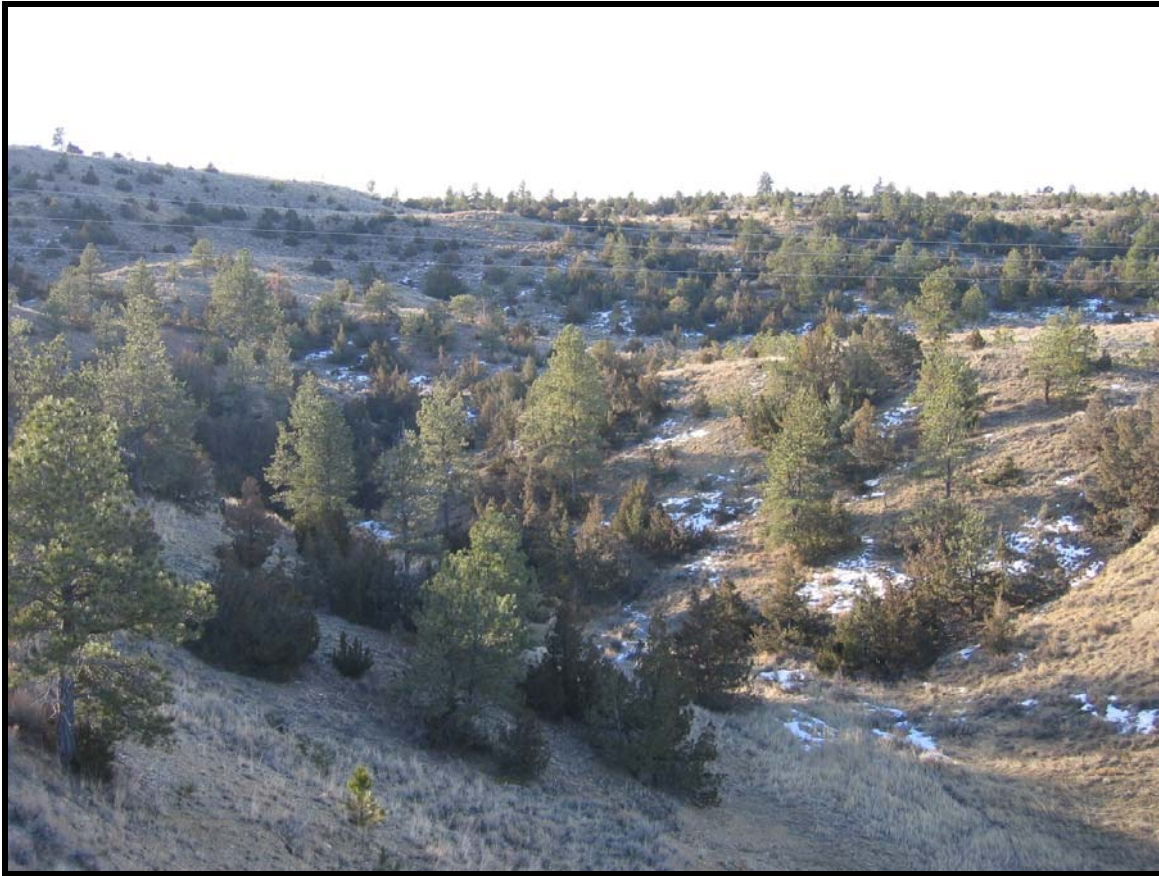
**RIPARIAN FEATURE: R\_0036**

Photo: 1\_23\_06\_01

**Looking Southwest**

**DESCRIPTION OF FEATURE:** This drainage is a tributary to South Fork Spring Creek. The draw has a wide bottom and is bordered by moderately sloped hills. The channel bottom is vegetated with grass, sagebrush and small trees.

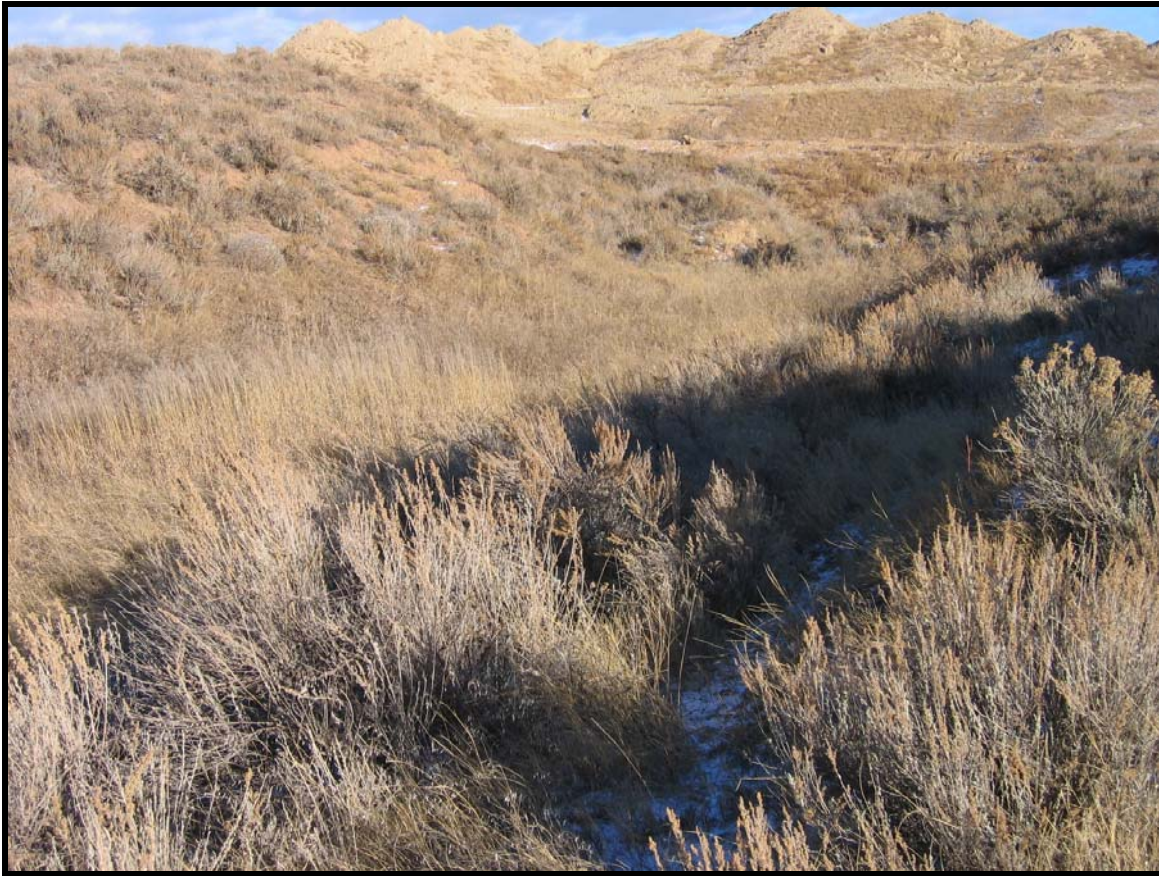
**RIPARIAN FEATURE: R\_0063**

Photo: 2\_2\_06\_06

**Looking North**

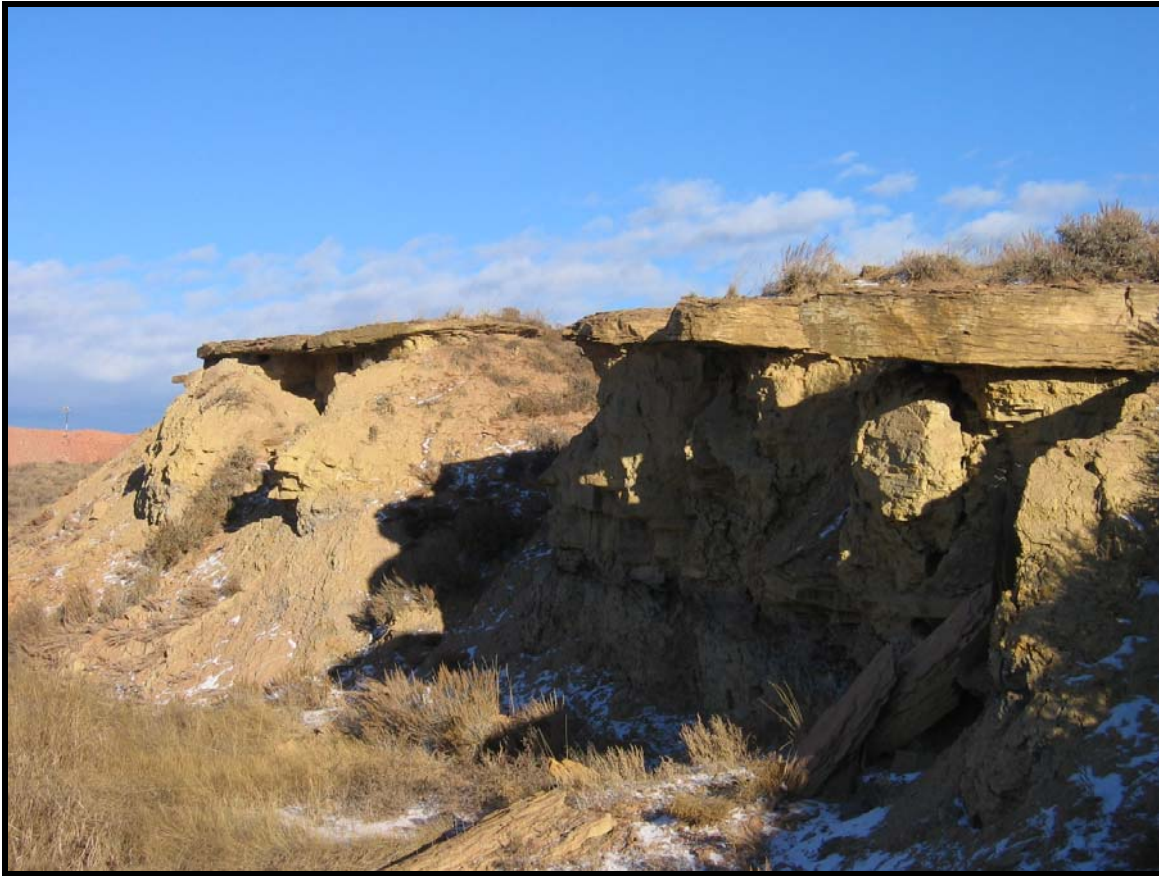
**OTHER FEATURE: O\_0023**

Photo: 2\_2\_06\_04

**Looking Northwest**

**DESCRIPTION OF FEATURE:** This cutbank is located on the South Fork Spring Creek. The face of the feature has been eroded by flows down this channel. This feature has a layer of sandstone/siltstone at the very top of the cut. See the picture on the following page for another view of this feature.

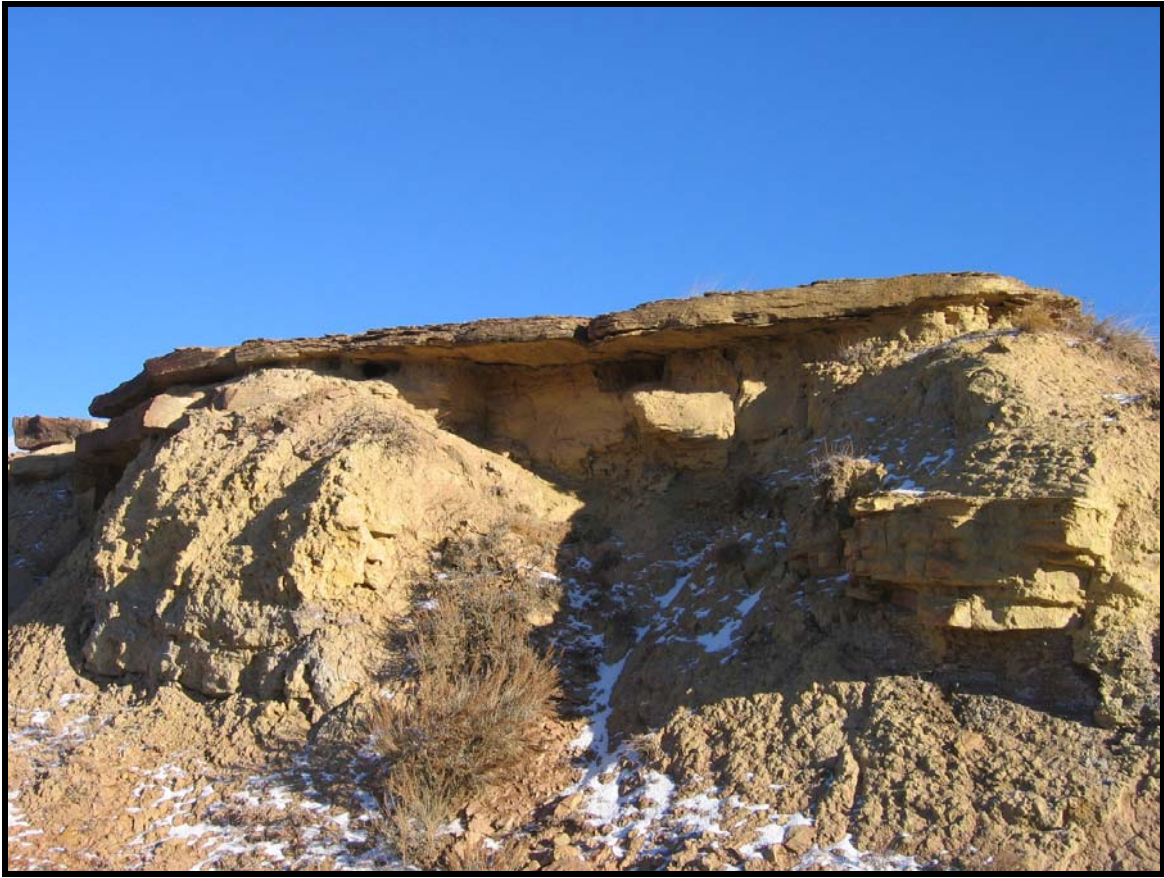
**OTHER FEATURE: O\_0023**

Photo: 2\_2\_06\_05

**Looking North**
