**Township 8S, Range 39E**

**SECTION 35**

*Cliff Features*

313D-T8SR39E35-3

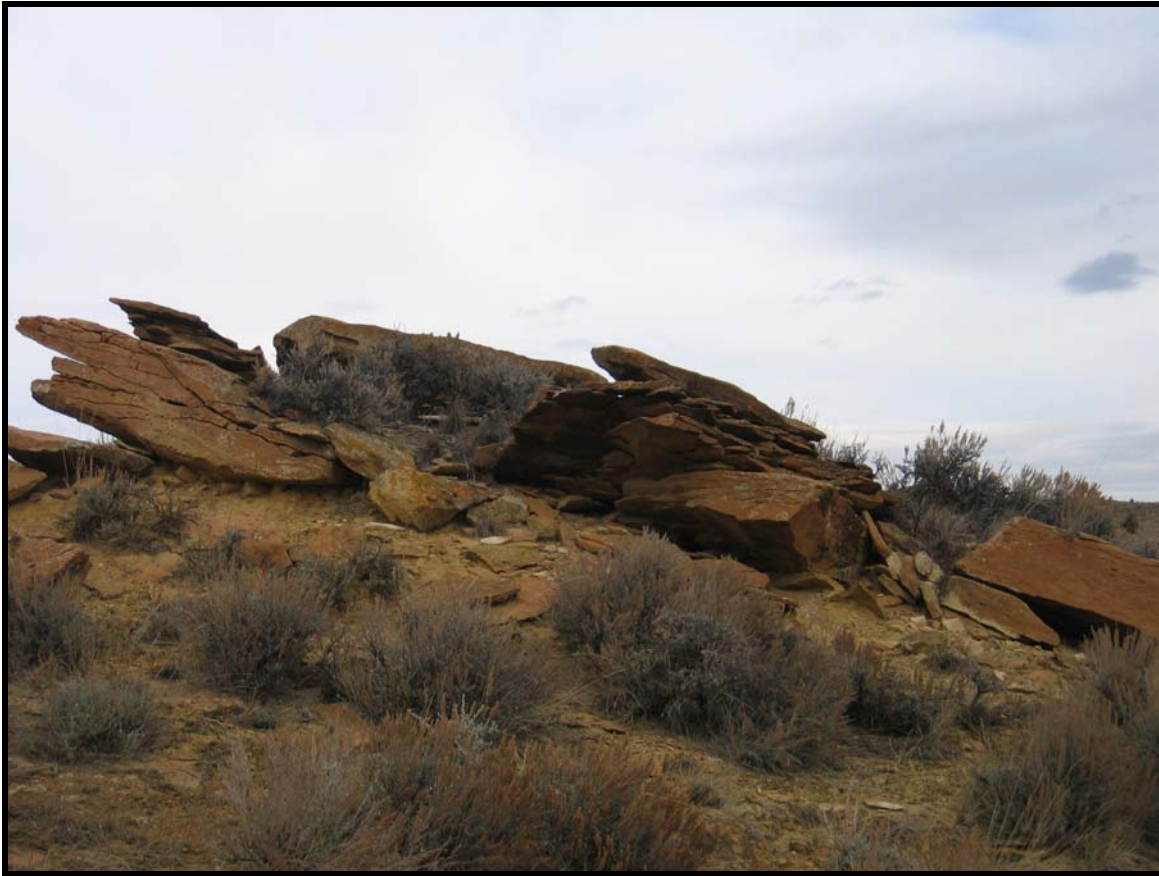
Photo: 1\_10\_06\_21

**Looking Northwest**

<b>FEATURE TYPE:</b>	Cliff		
<b>GEOMETRIC DIMENSIONS:</b>	Length: 125 ft	Height: 40 ft	
<b>LOCATION:</b>	Township: 8S	Range: 39E	Section: 35
<b>HANDHELD GPS POINTS:</b>	<b>Northing</b>	<b>Easting</b>	
	<b>5035</b>	408146.81	2667427.39
	<b>5036</b>	408143.40	2667321.56
	<b>5037</b>	408125.01	2667316.98
<b>SUBSTRATE:</b>	Sandstone and scoria		
<b>EXPOSURE:</b>	Southern facing slope		
<b>DESCRIPTION OF FEATURE:</b>	This small sandstone and scoria cliff has areas beneath the rock where the sandy silt soil has eroded away. The location of this feature is in a relatively flat area populated with sagebrush. Pictures 1_10_06_22, 1_10_06_23, 1_10_06_24, and 1_10_06_25 on the following pages show other views of this feature.

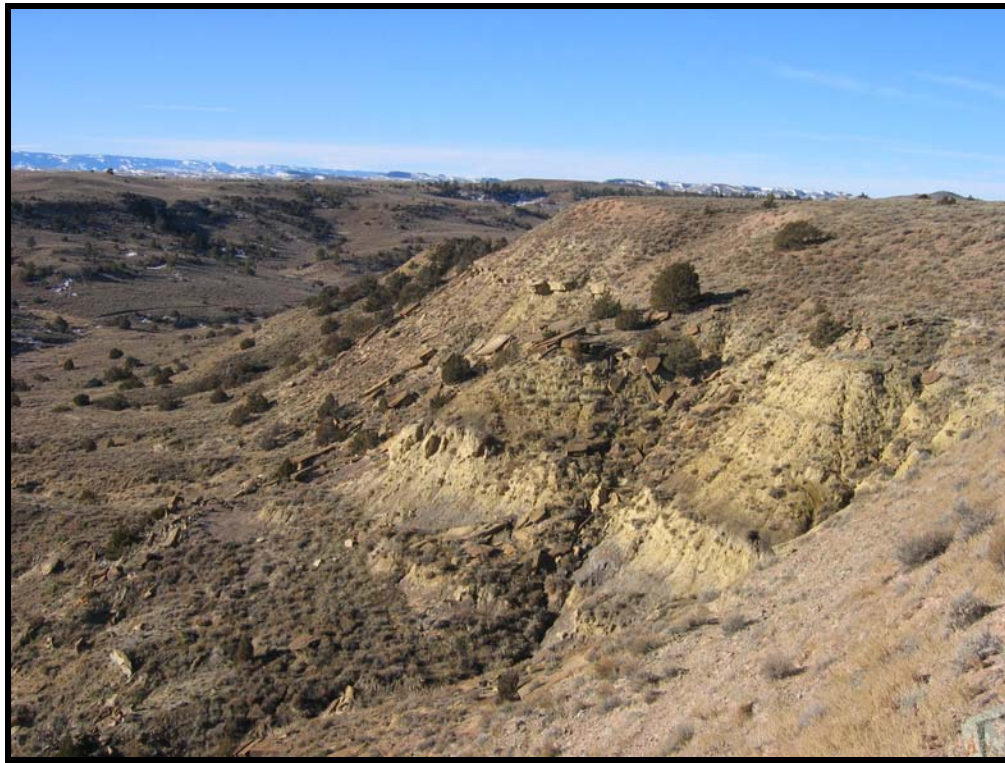
Photo: 1\_5\_06\_06

**FEATURE TYPE:** Rock Outcrop

**GEOMETRIC DIMENSIONS:** Length: 4530 ft Width: 200 ft

**SUBSTRATE:** Sandstone/siltstone

**EXPOSURE:** Southern facing slope

**DESCRIPTION OF FEATURE:** This is a very large rock outcrop on a steep, southern facing hill. The outcrop was created by the erosion of the soil beneath the sandstone/siltstone rock layer along the top of the hill. As the soil eroded, the rock layer broke away, leaving stacks of large rectangular rocks. The pictures on the next pages show more views of this outcrop.

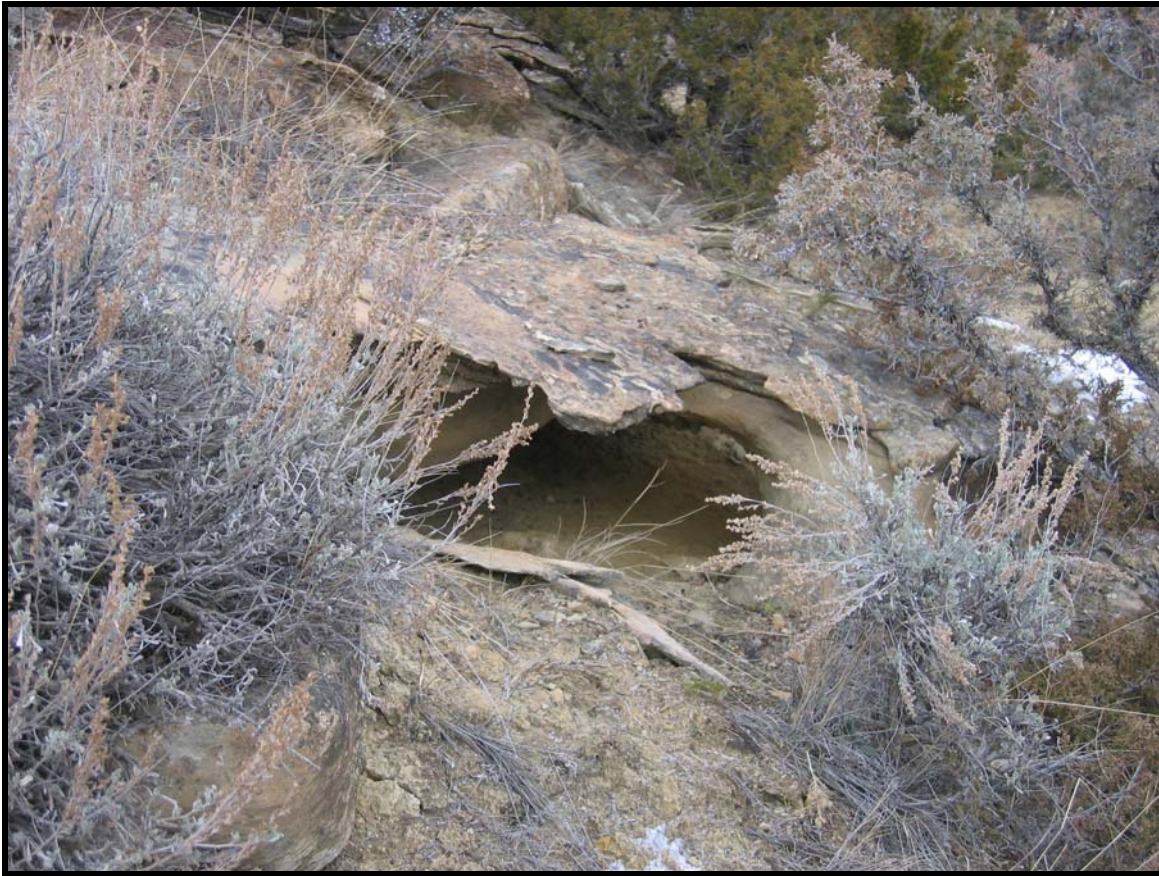
Photo: 1\_10\_06\_16

**FEATURE TYPE:** Rock Outcrop

**GEOMETRIC DIMENSIONS:** Area of outcrop: 0.03 acres

**SUBSTRATE:** Sandstone/siltstone

**EXPOSURE:** Northern facing slope

**DESCRIPTION OF FEATURE:** This large overhang was created by the erosion of the sandy silt subsoil beneath a sandstone/siltstone rock layer. The resultant overhang creates holes beneath the rock layer, and within the rock that has broken away. See pictures 1\_10\_06\_17 and 1\_10\_06\_18 on the following pages for more views of this feature.

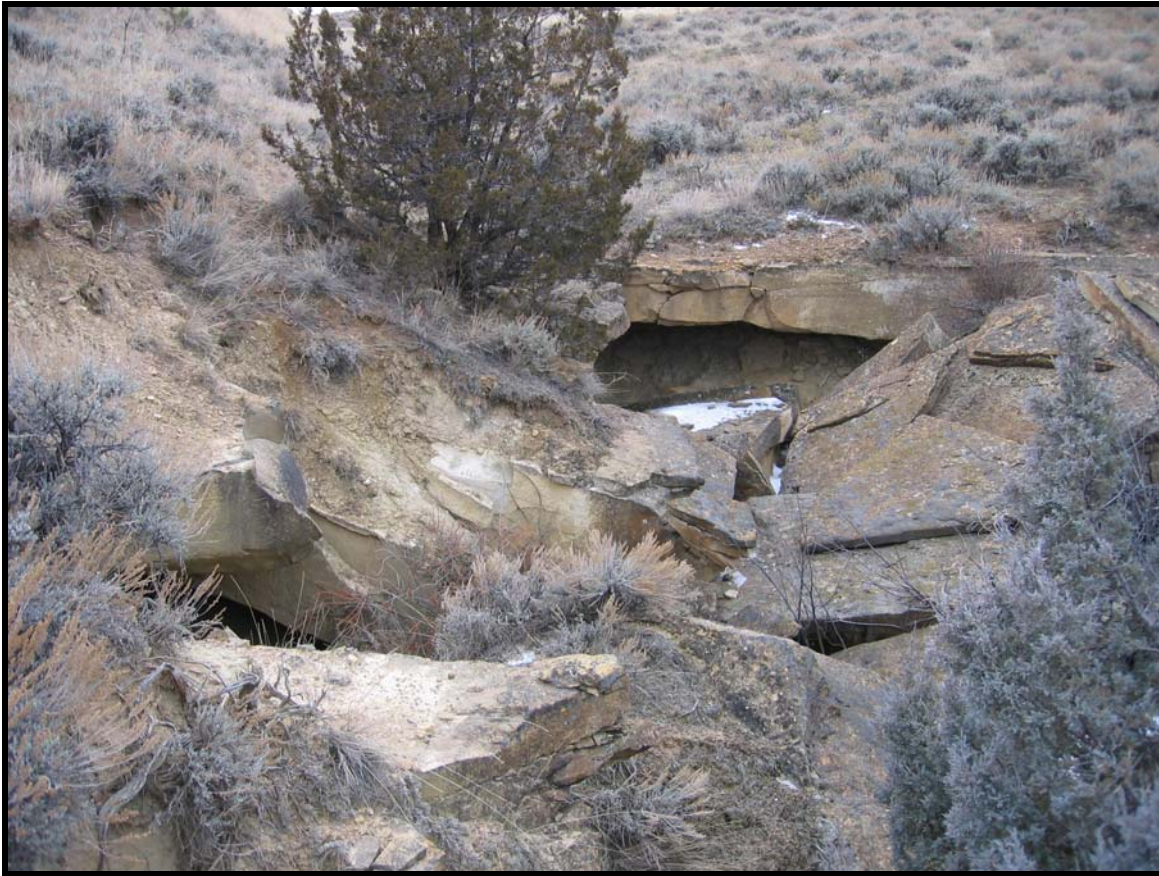
Photo: 1\_10\_06\_19

**FEATURE TYPE:** Rock Outcrop

**GEOMETRIC DIMENSIONS:** Length: 340 ft      Height: 20 ft

**SUBSTRATE:** Sandstone/siltstone

**EXPOSURE:** Northern facing slope

**DESCRIPTION OF FEATURE:** This overhang was created by the erosion of the sandy silt subsoil beneath a sandstone/siltstone rock layer. This feature is located at the headwaters of a small draw. Features of this type are very common in this area.

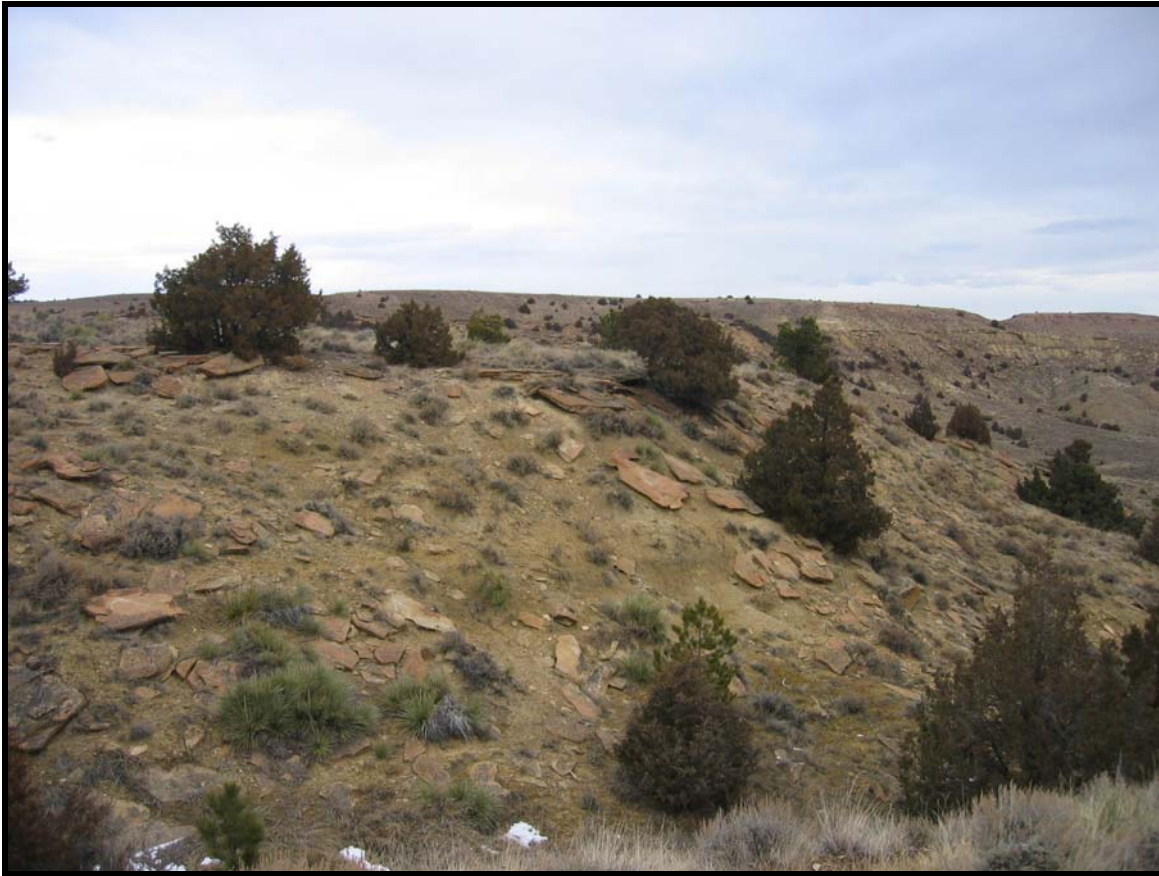
Photo: 1\_10\_06\_20

<b>FEATURE TYPE:</b>	Rock Outcrop		
<b>GEOMETRIC DIMENSIONS:</b>	Length: 30 ft	Height: 5 ft	
<b>LOCATION:</b>	Township: 8S	Range: 39E	Section: 35
<b>HANDHELD GPS POINTS:</b>	<b>Northing</b>	<b>Easting</b>	
	<b>5033</b>	407422.21	2667807.38
	<b>5034</b>	407439.60	2667780.97
<b>SUBSTRATE:</b>	Sandstone/siltstone		
<b>EXPOSURE:</b>	Northern facing slope		
<b>DESCRIPTION OF FEATURE:</b>	The outcrop shown above occurs at the top of a moderately steep hill formed from sandy silt soil. The surrounding area is sparsely vegetated with grass and sagebrush.

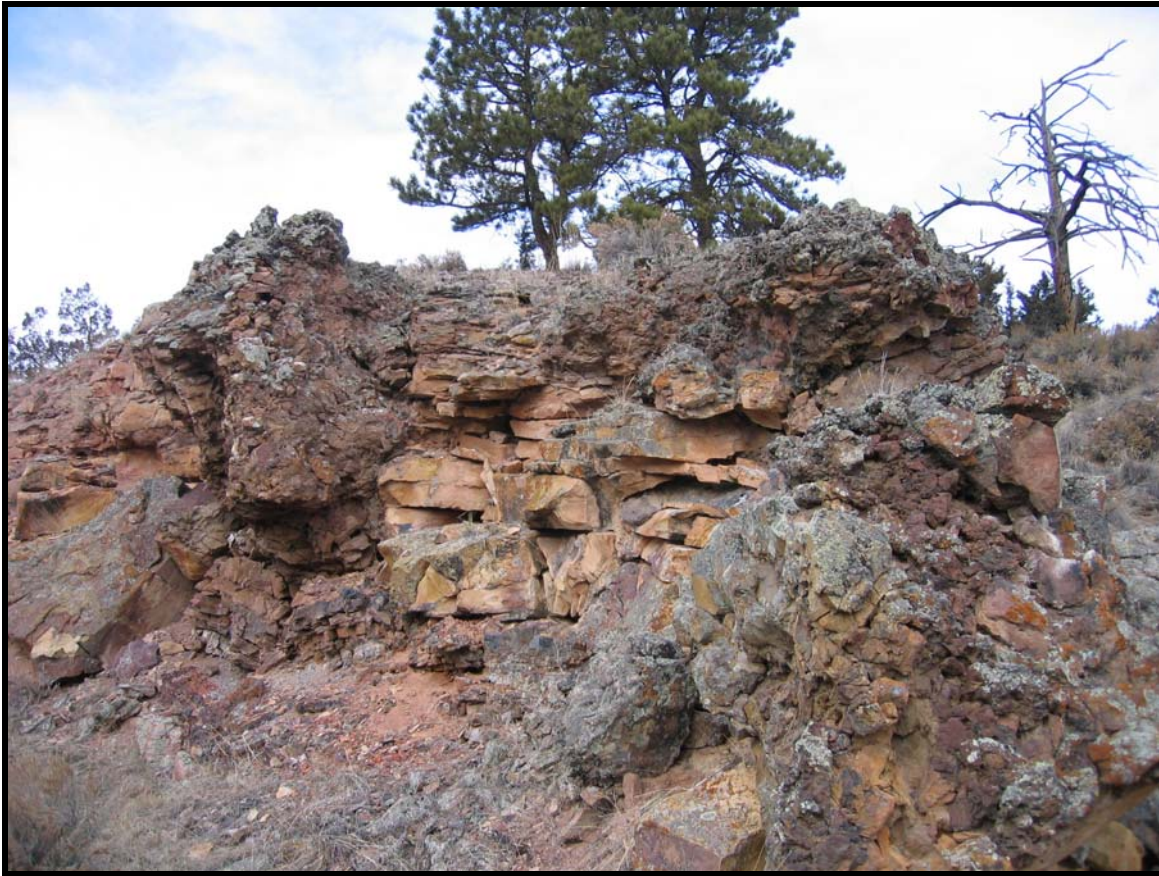
Photo: 1\_10\_06\_26

<b>FEATURE TYPE:</b>	Rock Outcrop		
<b>GEOMETRIC DIMENSIONS:</b>	Length: 120 ft	Height: 10 ft	
<b>LOCATION:</b>	Township: 8S	Range: 39E	Section: 35
<b>HANDHELD GPS POINTS:</b>	<b>Northing</b>	<b>Easting</b>	
	<b>5038</b>	408149.67	2666497.07
	<b>5039</b>	408030.25	2666526.75
<b>SUBSTRATE:</b>	Scoria		
<b>EXPOSURE:</b>	Southern facing slope		
<b>DESCRIPTION OF FEATURE:</b>	Outcrops of scoria are very common in this area. The outcrop has many holes and the face is very jagged.

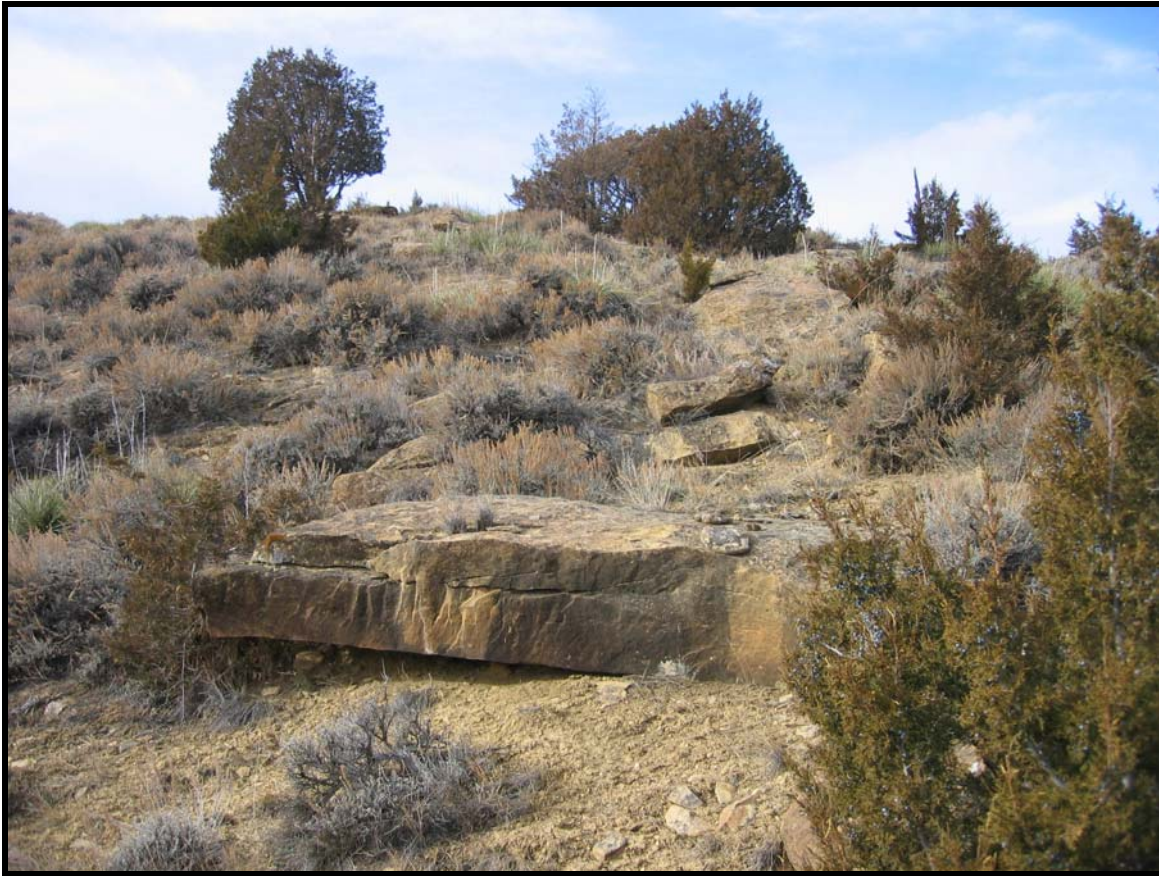
Photo: 1\_10\_06\_27

<b>FEATURE TYPE:</b>	Rock Outcrop					
<b>GEOMETRIC DIMENSIONS:</b>	Area of outcrop: 7.56 acres					
<b>LOCATION:</b>	Township: 8S		Range: 39E		Section: 35	
<b>HANDHELD GPS POINTS:</b>		<b>Northing</b>	<b>Easting</b>		<b>Northing</b>	<b>Easting</b>
	<b>5040</b>	405890.24	2666564.71	<b>5045</b>	405448.24	2667225.03
	<b>5041</b>	405508.79	2666613.18	<b>5046</b>	405410.49	2667298.61
	<b>5042</b>	405899.73	2666972.72	<b>5047</b>	405546.73	2667338.15
	<b>5044</b>	405795.24	2667125.98	<b>5055</b>	405250.37	2667084.11
<b>SUBSTRATE:</b>	Sandstone/siltstone					
<b>EXPOSURE:</b>	Southern facing slope					
<b>DESCRIPTION OF FEATURE:</b>	This type of large outcrop occurs in many locations around the minesite. The large, flat rocks are surrounded by grass, sagebrush and small trees. See pictures 1_10_06_28, 1_10_06_29, and 1_10_06_30 on the following pages.

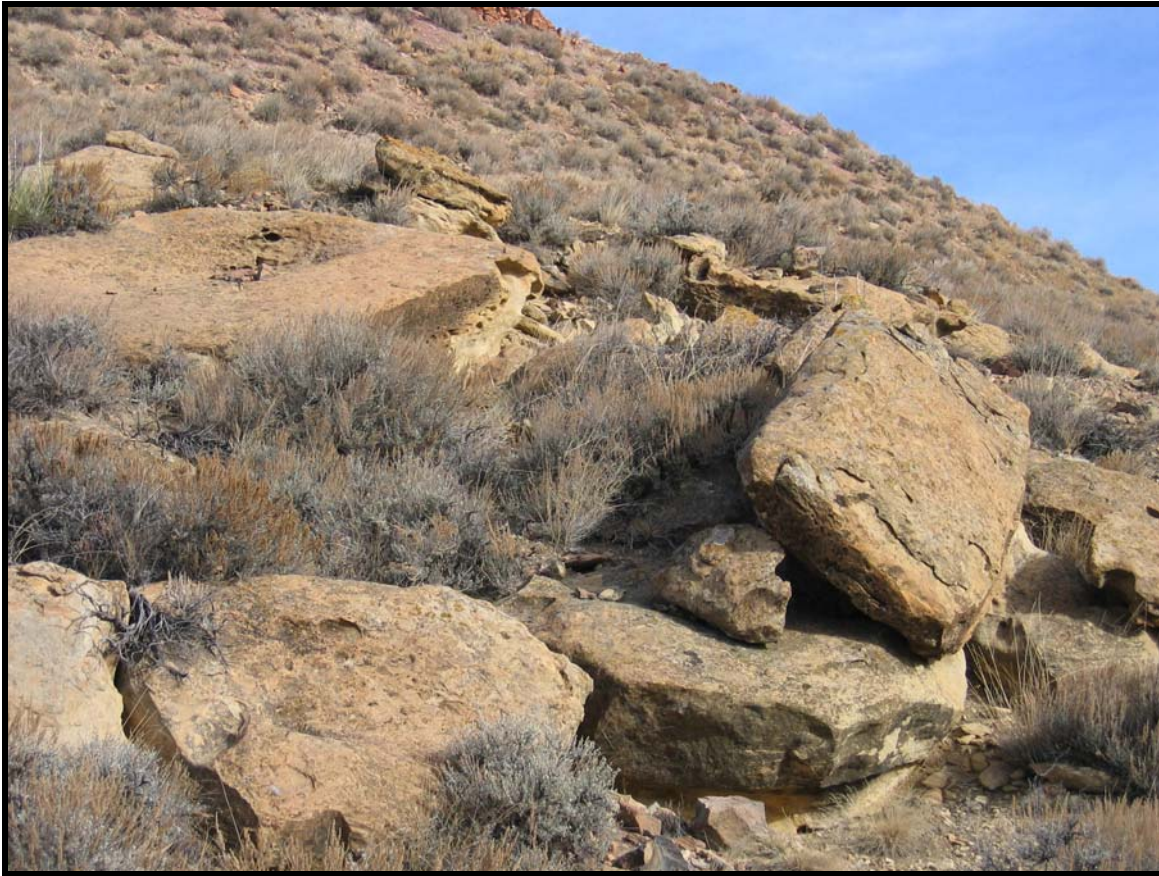
Photo: 1\_10\_06\_32

<b>FEATURE TYPE:</b>	Rock Outcrop		
<b>GEOMETRIC DIMENSIONS:</b>	Length: 465 ft	Height: 10 ft	
<b>LOCATION:</b>	Township: 8S	Range: 39E	Section: 35
<b>HANDHELD GPS POINTS:</b>	<b>Northing</b>	<b>Easting</b>	
	<b>5048</b>	405671.71 2667367.71	
	<b>5049</b>	405602.92 2667610.27	
	<b>5050</b>	405547.55 2667816.22	
<b>SUBSTRATE:</b>	Scoria		
<b>EXPOSURE:</b>	Southern facing slope		
<b>DESCRIPTION OF FEATURE:</b>	The rock outcrop shown above consists of large, weathered, sandstone/siltstone rocks, which are located on highly erosive subsoil. This feature is surrounded by a moderately steep, sagebrush covered slope.

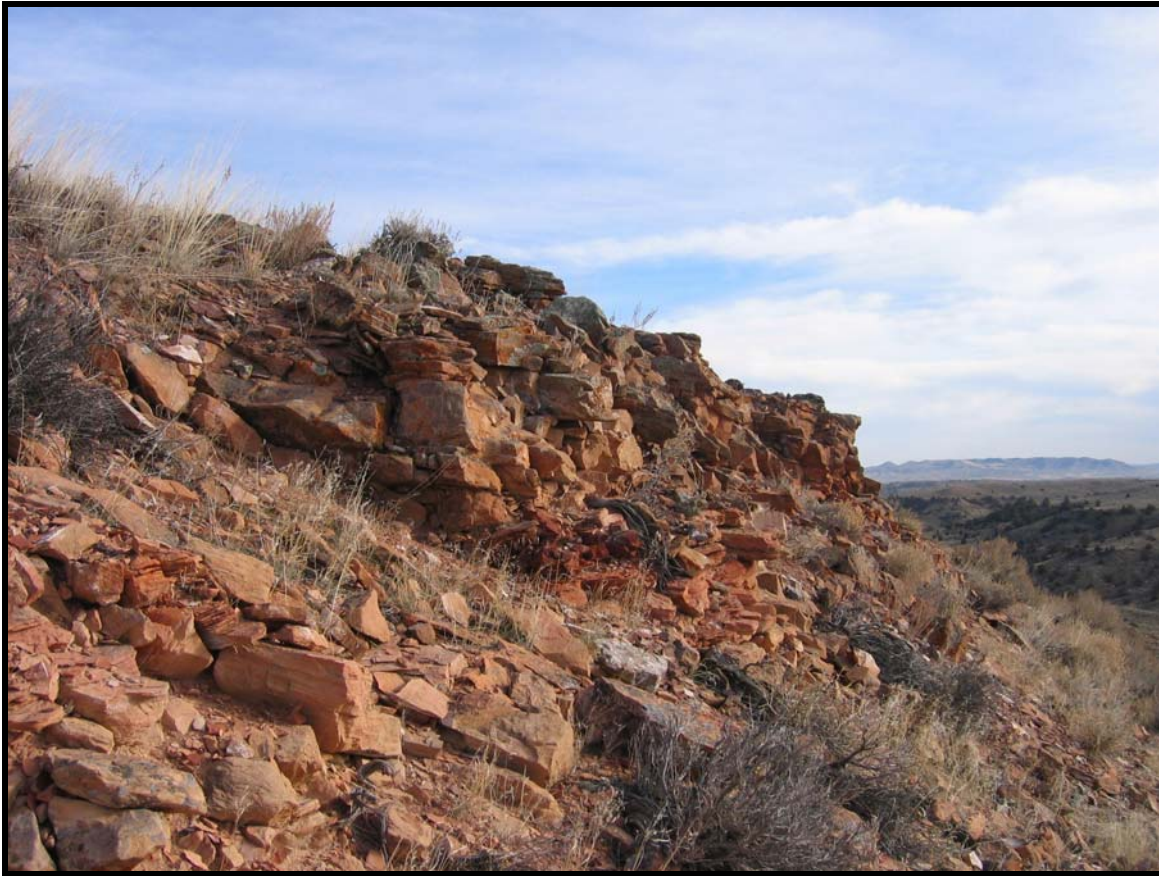
Photo: 1\_10\_06\_33

**FEATURE TYPE:** Rock Outcrop

**GEOMETRIC DIMENSIONS:** Length: 230 ft      Height: 10 ft

**SUBSTRATE:** Scoria

**EXPOSURE:** Southern facing slope

**DESCRIPTION OF FEATURE:** The top of this hillside is capped with a highly fractured, scoria rock. This caprock is located at the top of a steep (greater than 3H:1V) slope.

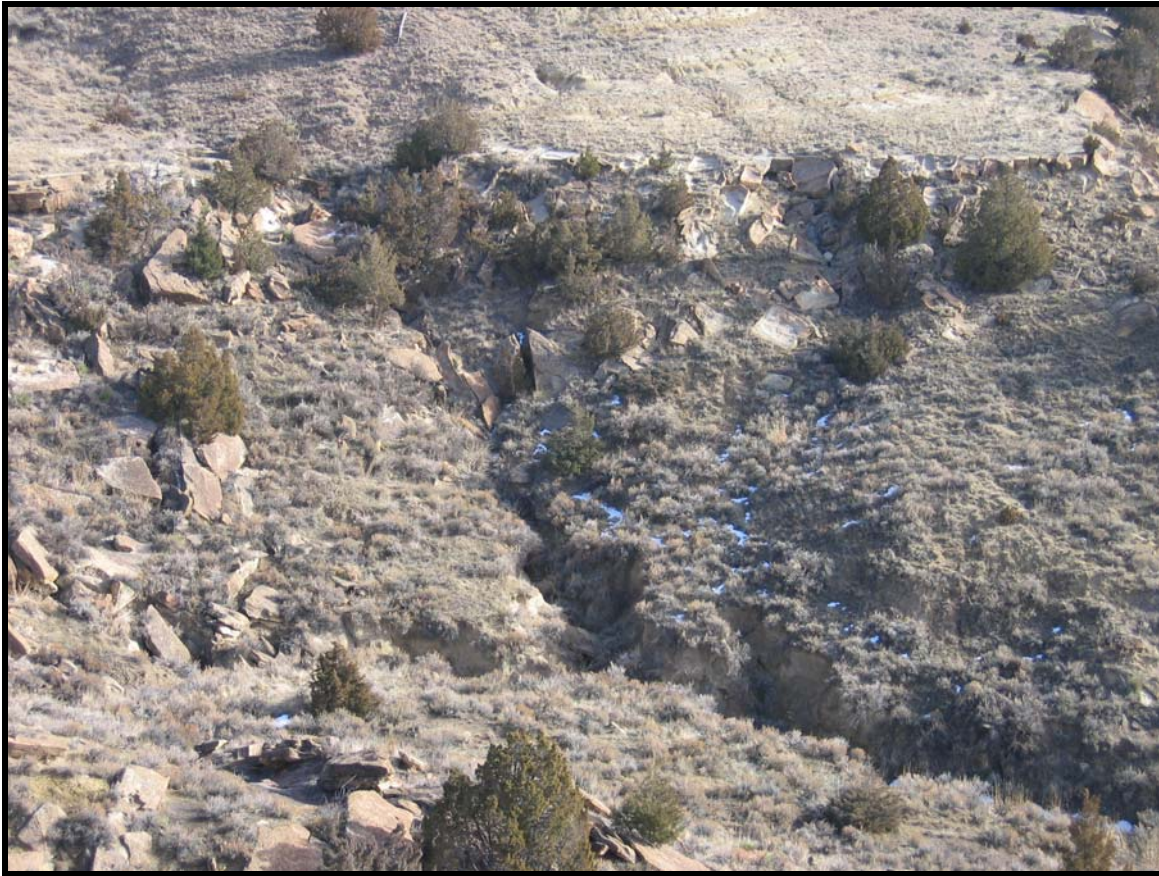
Photo: 1\_10\_06\_35

**FEATURE TYPE:** Rock Outcrop

**GEOMETRIC DIMENSIONS:** Area of outcrop: 1.72 acres

**SUBSTRATE:** Sandstone/siltstone

**EXPOSURE:** Southern facing slope

**DESCRIPTION OF FEATURE:** The large rock outcrop shown above covers a significant amount of area. The rocks are large, flat, sandstone/siltstone rocks. The surrounding vegetation includes grass, sagebrush and small trees. See pictures 1\_10\_06\_37, 1\_10\_06\_38, 1\_10\_06\_39, and 1\_10\_06\_40 on the following pages for a closer view of this outcrop.

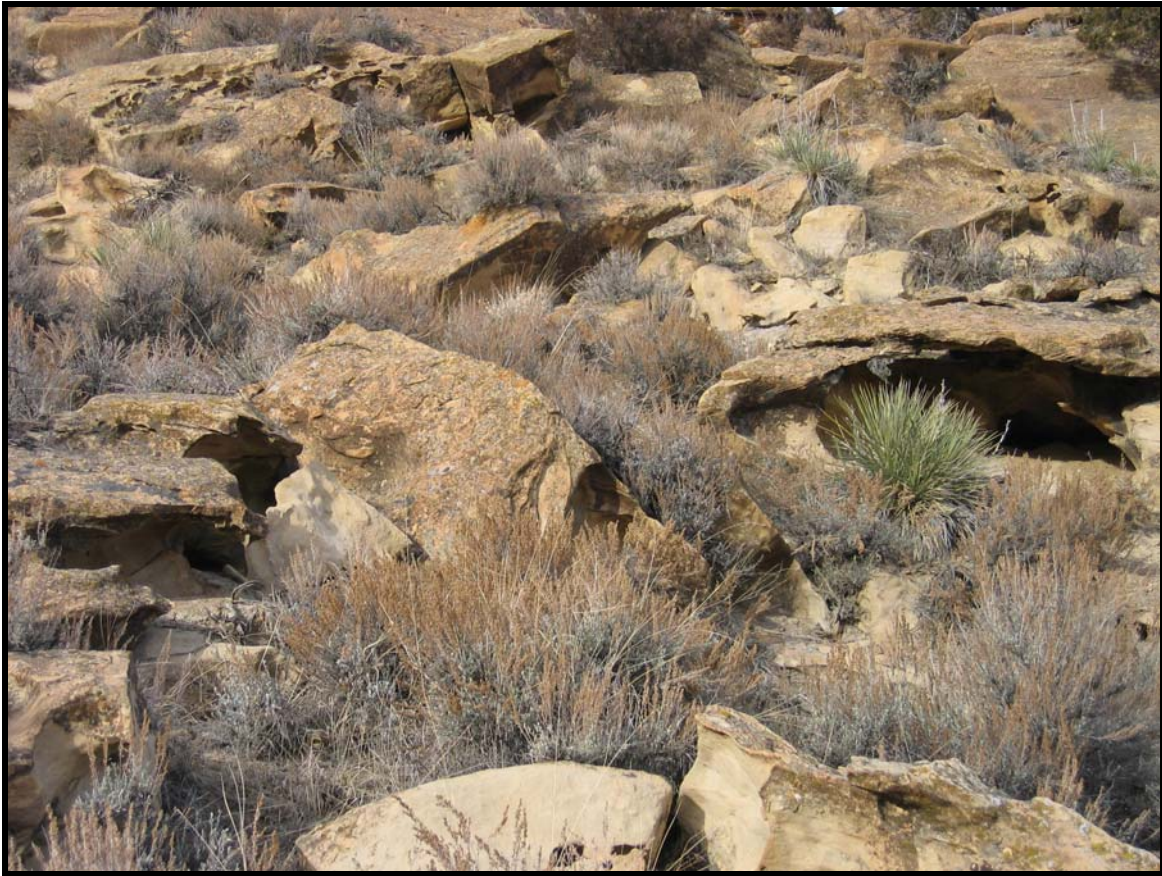
Photo: 1\_10\_06\_43

<b>FEATURE TYPE:</b>	Rock Outcrop		
<b>GEOMETRIC DIMENSIONS:</b>	Length: 160 ft	Height: 5 ft	
<b>LOCATION:</b>	Township: 8S	Range: 39E	Section: 35
<b>HANDHELD GPS POINTS:</b>	<b>Northing</b>	<b>Easting</b>	
	<b>5069</b> 405258.71	2668812.77

It was observed that this outcrop travels to the southern boundary of Section 35.

<b>SUBSTRATE:</b>	Sandstone/siltstone
<b>EXPOSURE:</b>	Southern facing slope
<b>DESCRIPTION OF FEATURE:</b>	The rock outcrop shown above is very common in this area. The large, flat, sandstone/siltstone rocks are low-lying and are surrounded with grass and sagebrush.

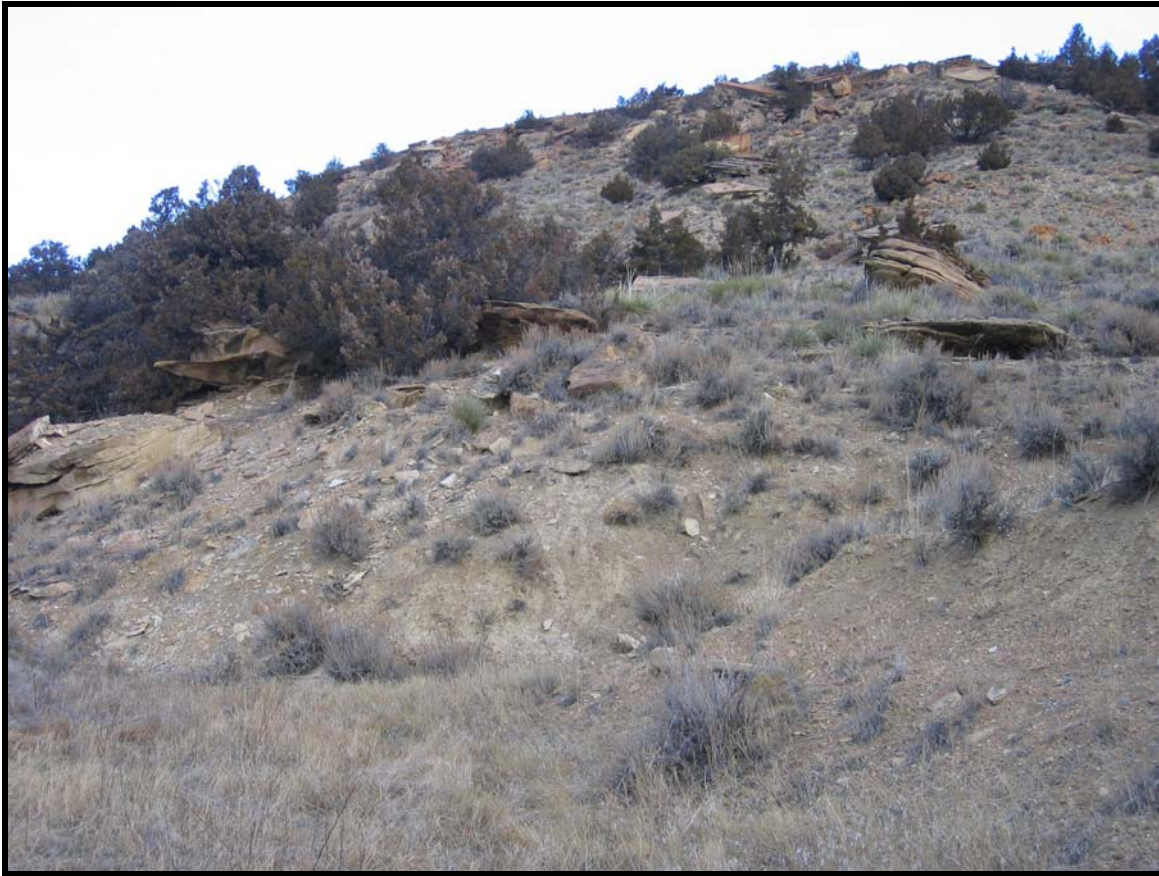
Photo: 1\_11\_06\_16

**FEATURE TYPE:** Rock Outcrop

**GEOMETRIC DIMENSIONS:** Area of outcrop: 0.23 acres

**SUBSTRATE:** Sandstone/siltstone

**EXPOSURE:** Southern facing slope

**DESCRIPTION OF FEATURE:** This small outcrop adjacent to the Pearson Creek channel bottom. Small crevices created within and between the rocks have created good habitat. The southern facing hillside, on which the outcrop is located, is steep (greater than 3H:1V).

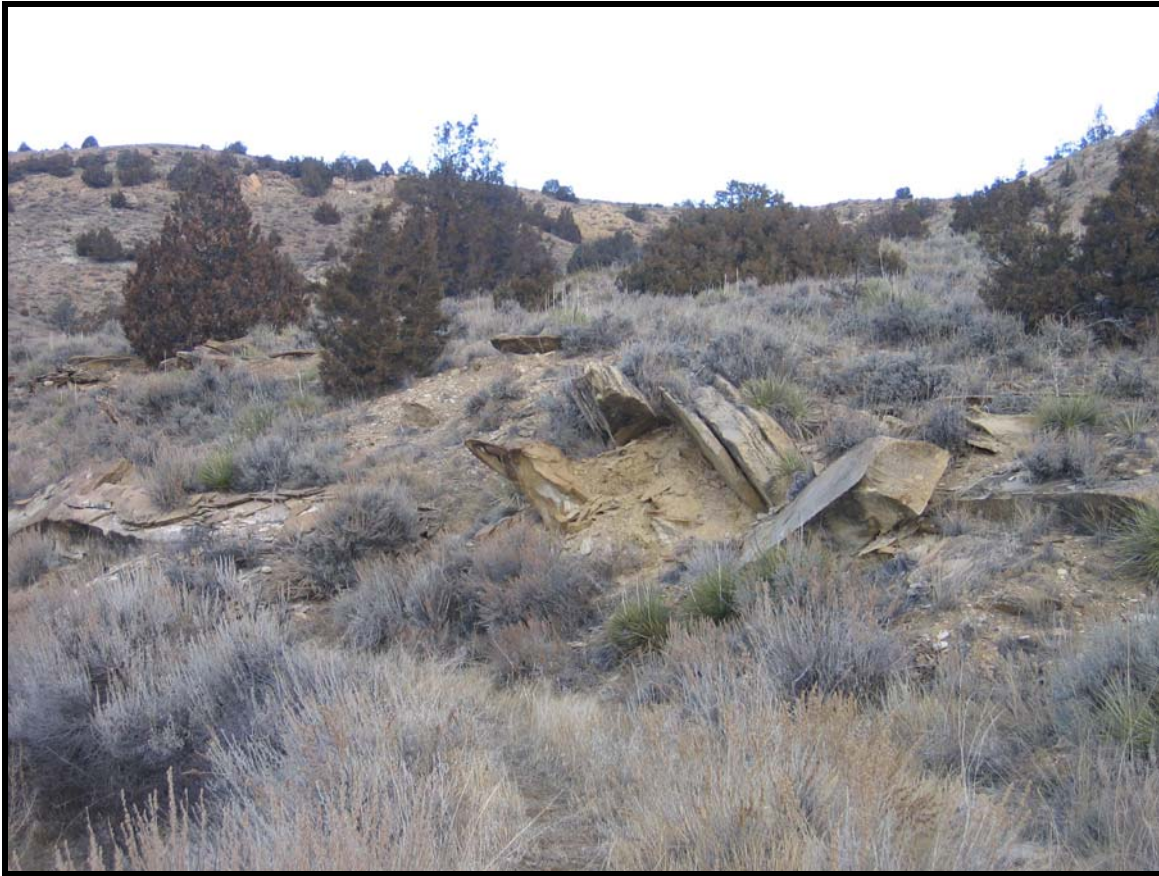
Photo: 1\_11\_06\_17

**FEATURE TYPE:** Rock Outcrop

**GEOMETRIC DIMENSIONS:** Area of outcrop: 0.15 acres

**SUBSTRATE:** Sandstone/siltstone

**EXPOSURE:** Southern facing slope

**DESCRIPTION OF FEATURE:** This small rock outcrop is located within a soft sandy silt material. The surrounding vegetation consists of grass, sagebrush, and some small trees.

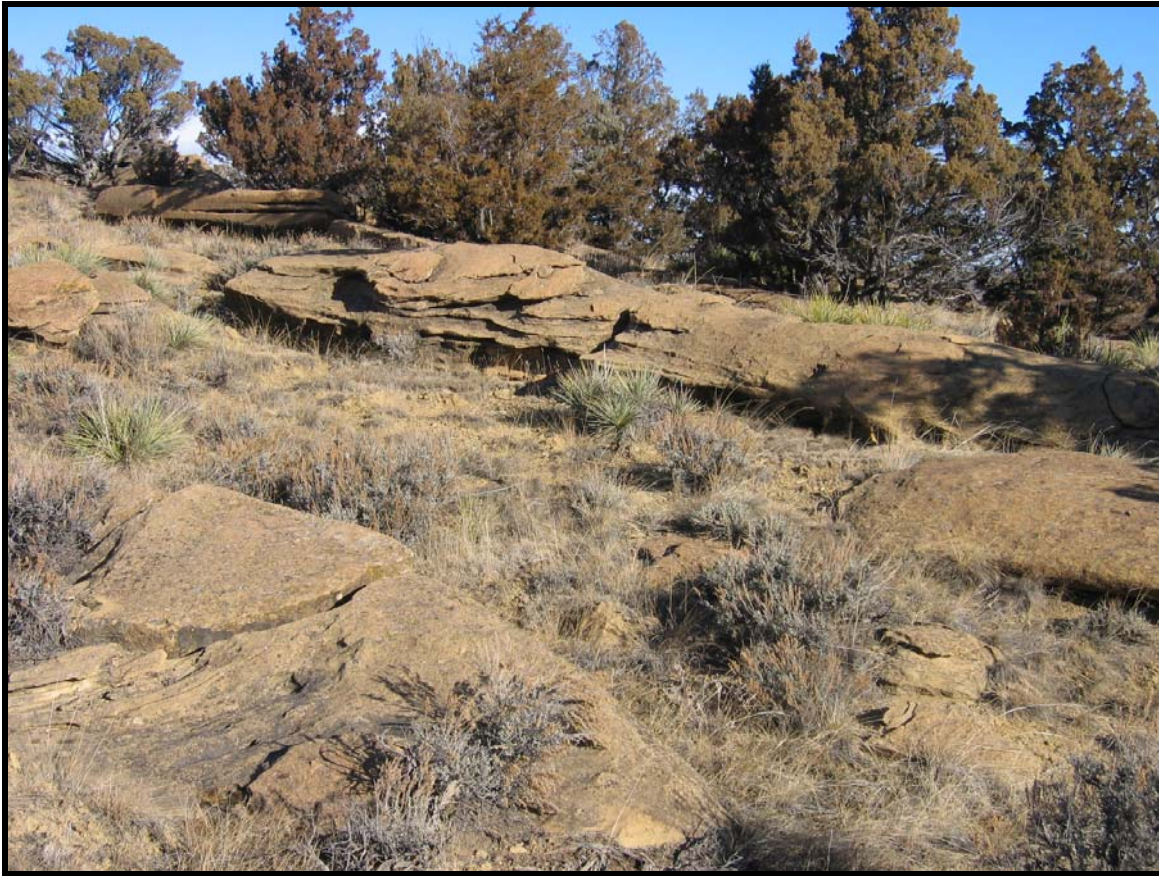
Photo: 1\_18\_06\_08

**FEATURE TYPE:** Rock Outcrop

**GEOMETRIC DIMENSIONS:** Area of outcrop: 1.21 acres

**SUBSTRATE:** Sandstone/siltstone

**EXPOSURE:** Northern facing slope

**DESCRIPTION OF FEATURE:** Small crevices created within and between the rocks are frequent within this sandstone/siltstone rock outcrop. This feature is located on a moderately sloped hill. See the picture on the following page for another view of this outcrop.

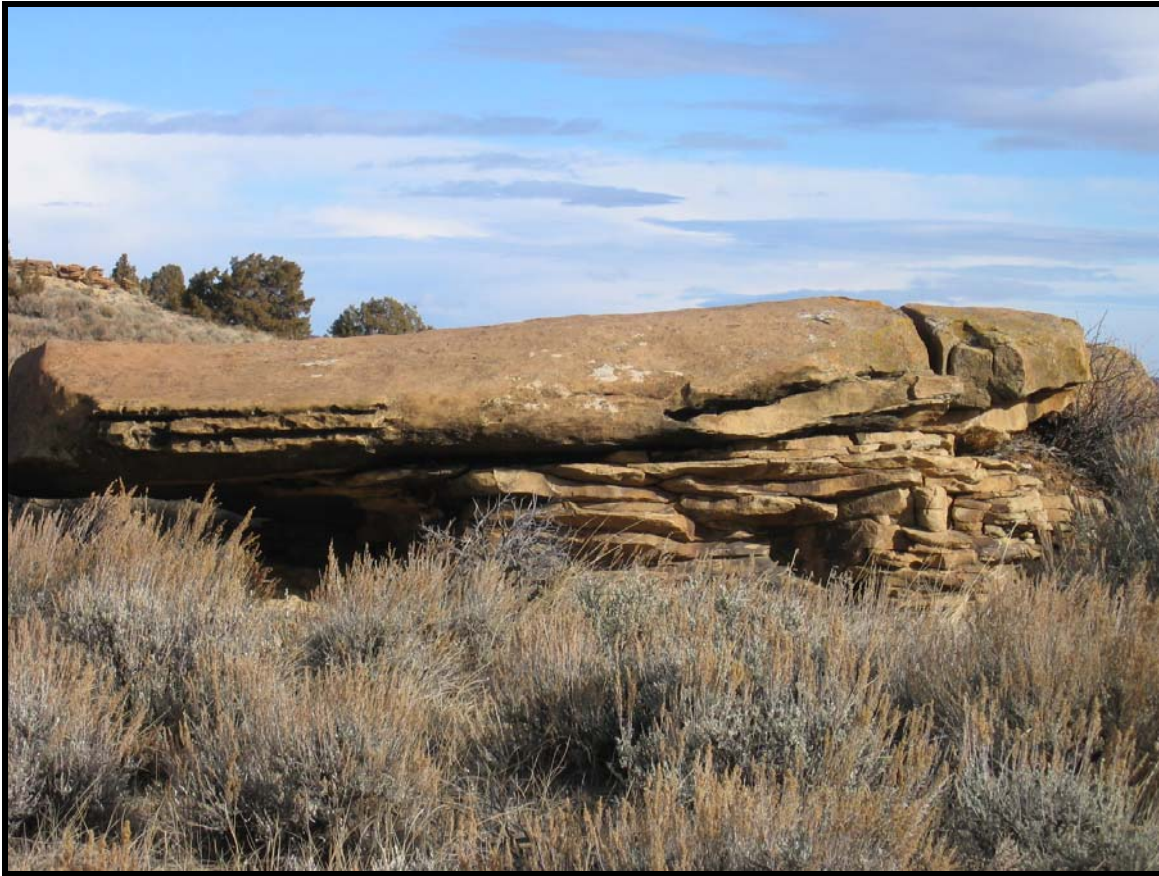
Photo: 1\_18\_06\_11

**FEATURE TYPE:** Rock Outcrop

**GEOMETRIC DIMENSIONS:** Area of outcrop: 0.23 acres

**SUBSTRATE:** Sandstone/siltstone

**EXPOSURE:** Southern facing slope

**DESCRIPTION OF FEATURE:** This type of rock outcrop is very typical in this area. The large siltstone/sandstone rocks have created extensive habitat. The individual rocks are very large and typically create voids between their bottom and the top of the soil.

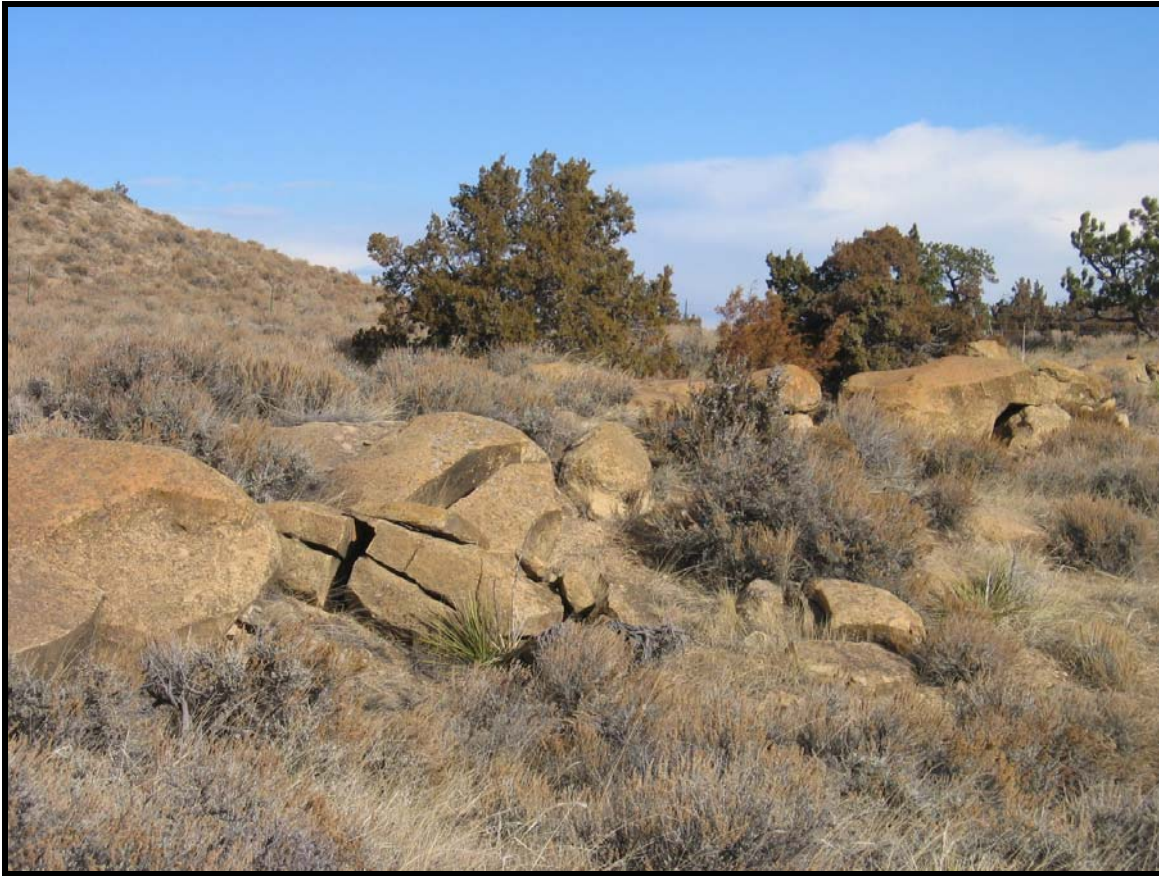
Photo: 1\_18\_06\_12

**FEATURE TYPE:** Rock Outcrop

**GEOMETRIC DIMENSIONS:** Length: 275 ft      Width: 15 ft

**SUBSTRATE:** Sandstone/siltstone

**EXPOSURE:** Northern facing slope

**DESCRIPTION OF FEATURE:** This type of rock outcrop is very typical in this area. The individual rocks are very large and typically create voids between their bottom and the top of the soil.

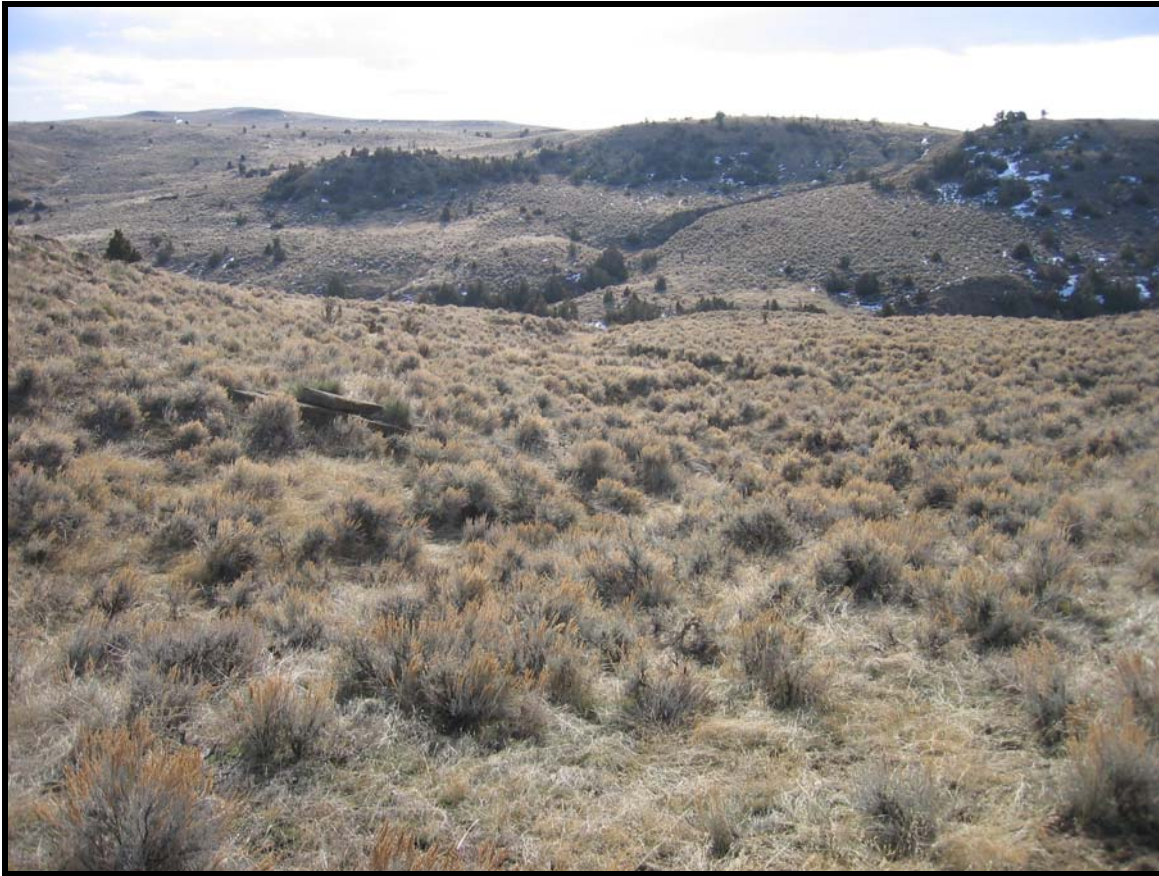
Photo: 1\_10\_06\_31

**FEATURE TYPE:** Riparian Area

**EXPOSURE:** Drainage runs in a southerly direction

**DESCRIPTION OF FEATURE:** This drainage covers a large area and runs in a southerly direction. As is shown on the picture above, the channel has extensive vegetative cover.

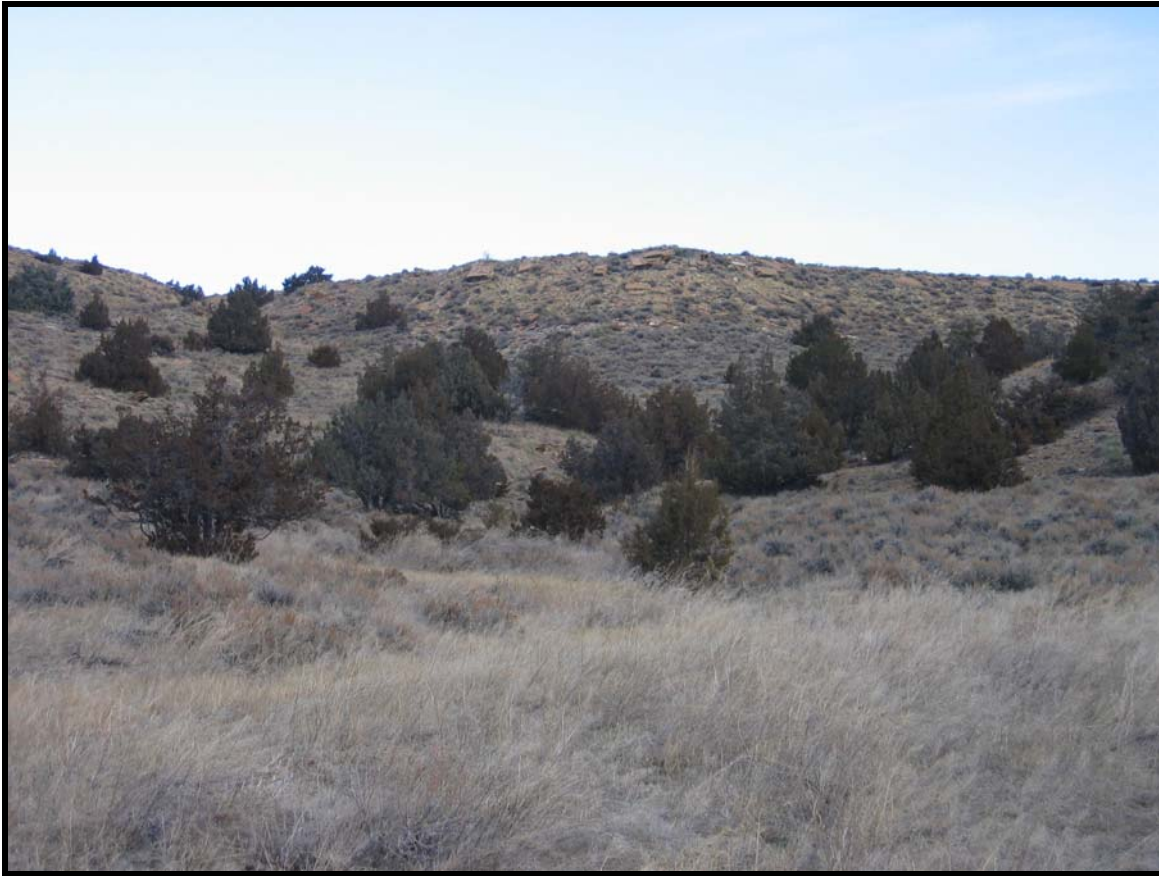
Photo: 1\_11\_06\_18

**FEATURE TYPE:** Riparian Area

**EXPOSURE:** Drainage runs in a southerly direction

**DESCRIPTION OF FEATURE:** This small draw is a tributary to Pearson Creek. The channel bottom for this draw is wide and has extensive vegetative cover, which consists of grass, sagebrush, and small trees.

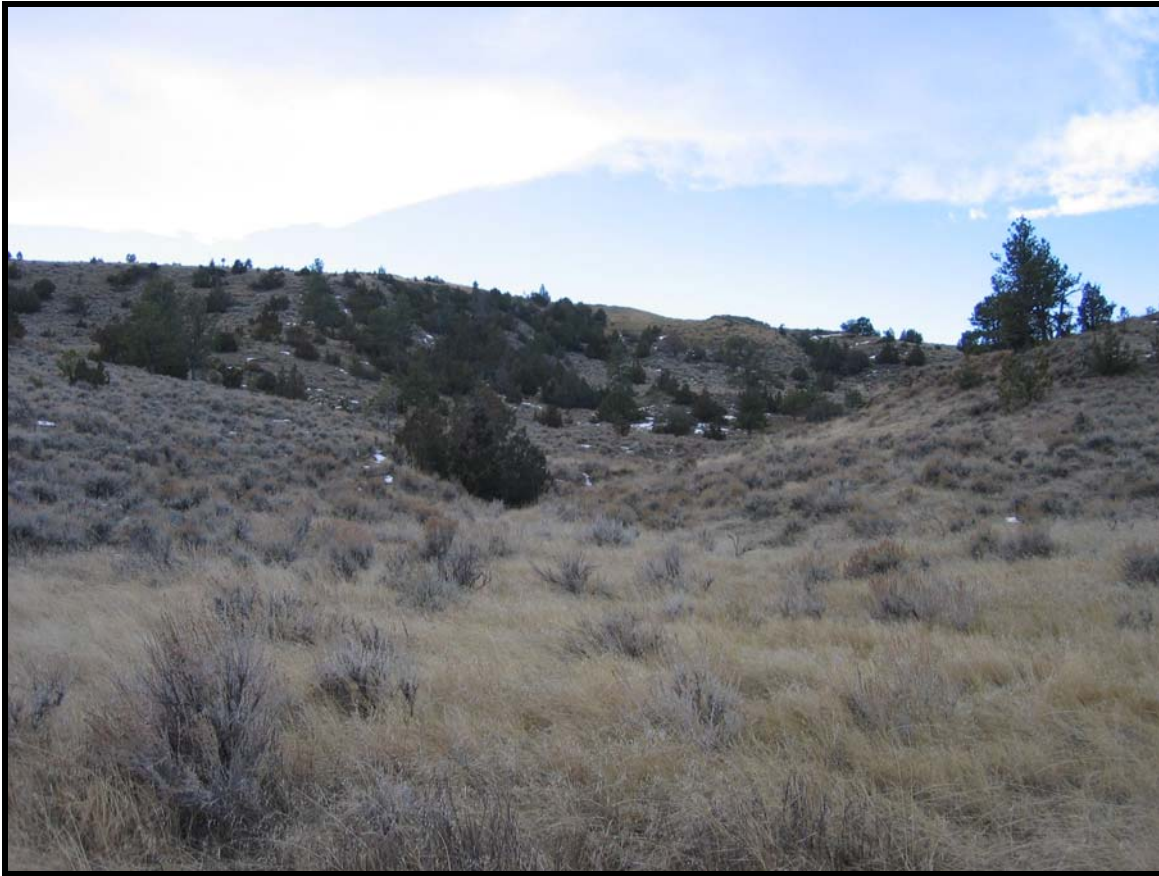
Photo: 1\_11\_06\_19

**FEATURE TYPE:** Riparian Area

**EXPOSURE:** Drainage runs in a northerly direction

**DESCRIPTION OF FEATURE:** This small draw is a tributary to Pearson Creek. The channel bottom for this draw is wide and has extensive vegetative cover.

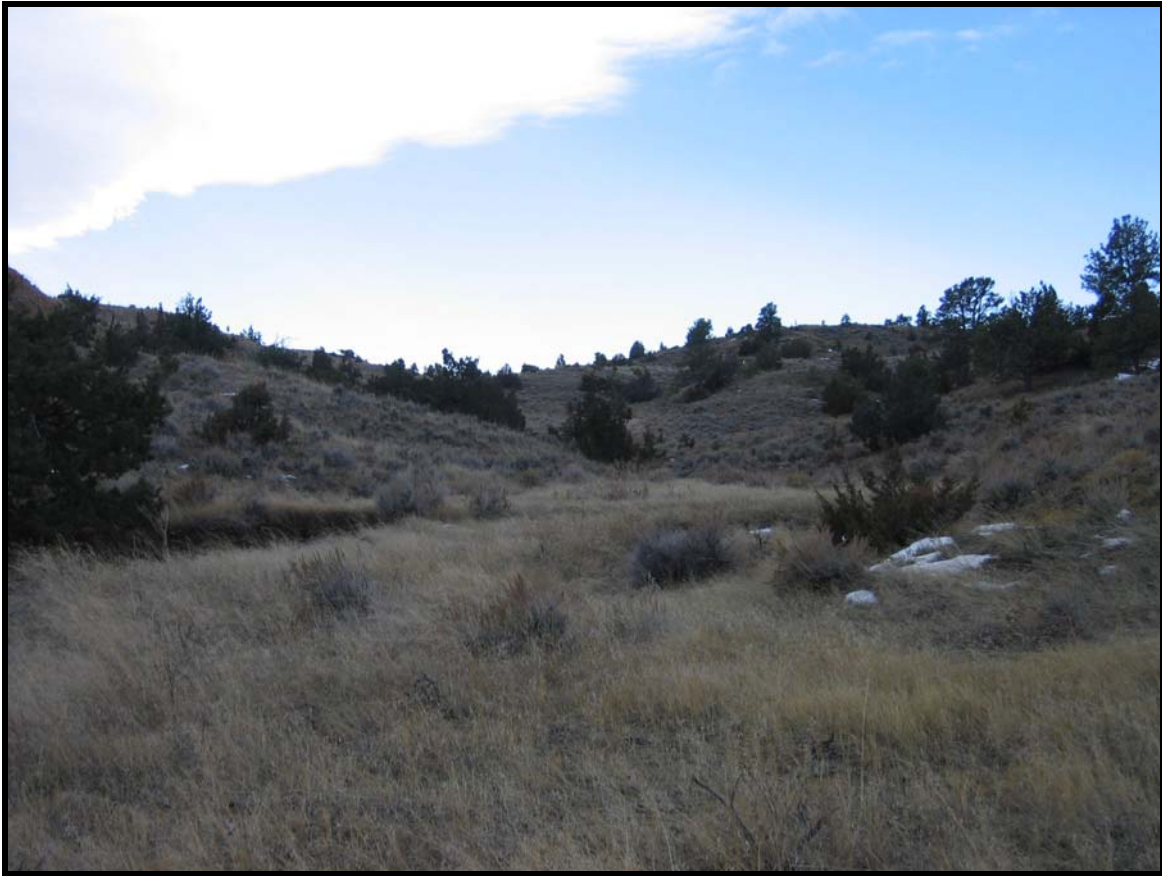
Photo: 1\_11\_06\_21

**FEATURE TYPE:** Riparian Area

**EXPOSURE:** Drainage runs in a northerly direction

**DESCRIPTION OF FEATURE:** This small draw is a tributary to Pearson Creek. The channel bottom for this draw is wide and has extensive vegetative cover.
