**Township 8S, Range 39E**

**SECTION 35**

*Cliff Features*

313D-T8SR39E35-3

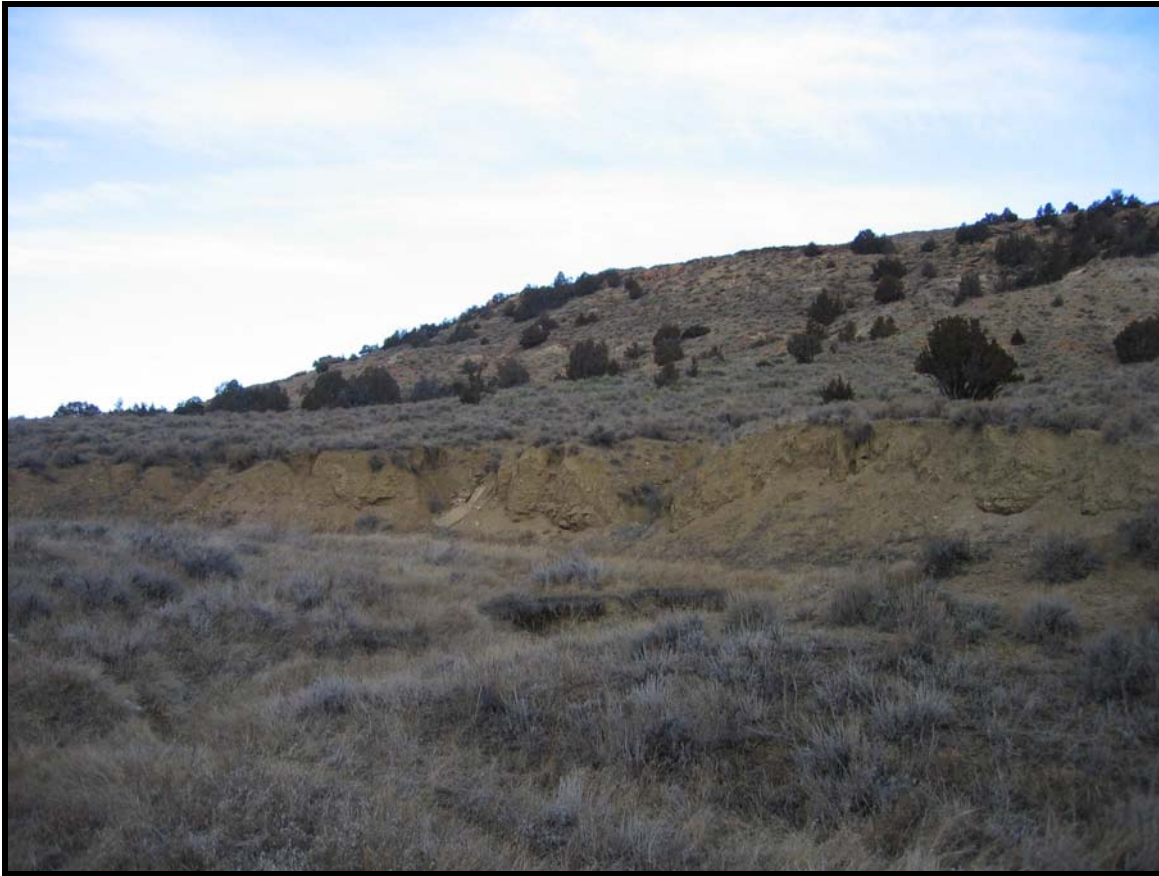
Photo: 1\_11\_06\_15

**FEATURE TYPE:** Cutbank

**GEOMETRIC DIMENSIONS:** Length: 155 ft      Height: 20 ft

**SUBSTRATE:** Silty sand

**EXPOSURE:** Southern facing slope

**DESCRIPTION OF FEATURE:** As shown in the picture above, this cutbank is adjacent to Pearson Creek. This feature has a large amount of holes in the soft, sandy silt material.

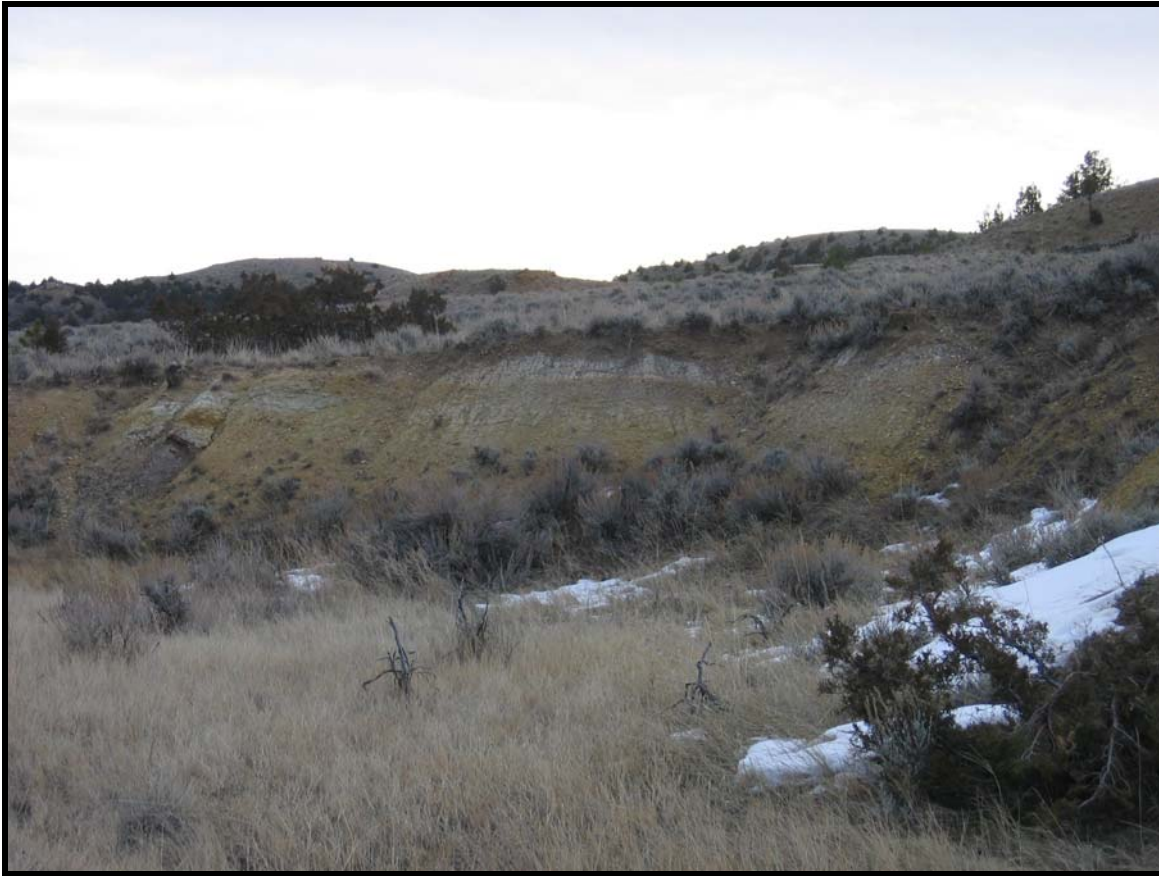
Photo: 1\_11\_06\_20

**FEATURE TYPE:** Cutbank

**GEOMETRIC DIMENSIONS:** Length: 115 ft      Height: 15 ft

**SUBSTRATE:** Silty sand

**EXPOSURE:** Northern facing slope

**DESCRIPTION OF FEATURE:** As shown in the picture above, this cutbank is adjacent to Pearson Creek. This feature has a large amount of holes in the soft, sandy silt material.

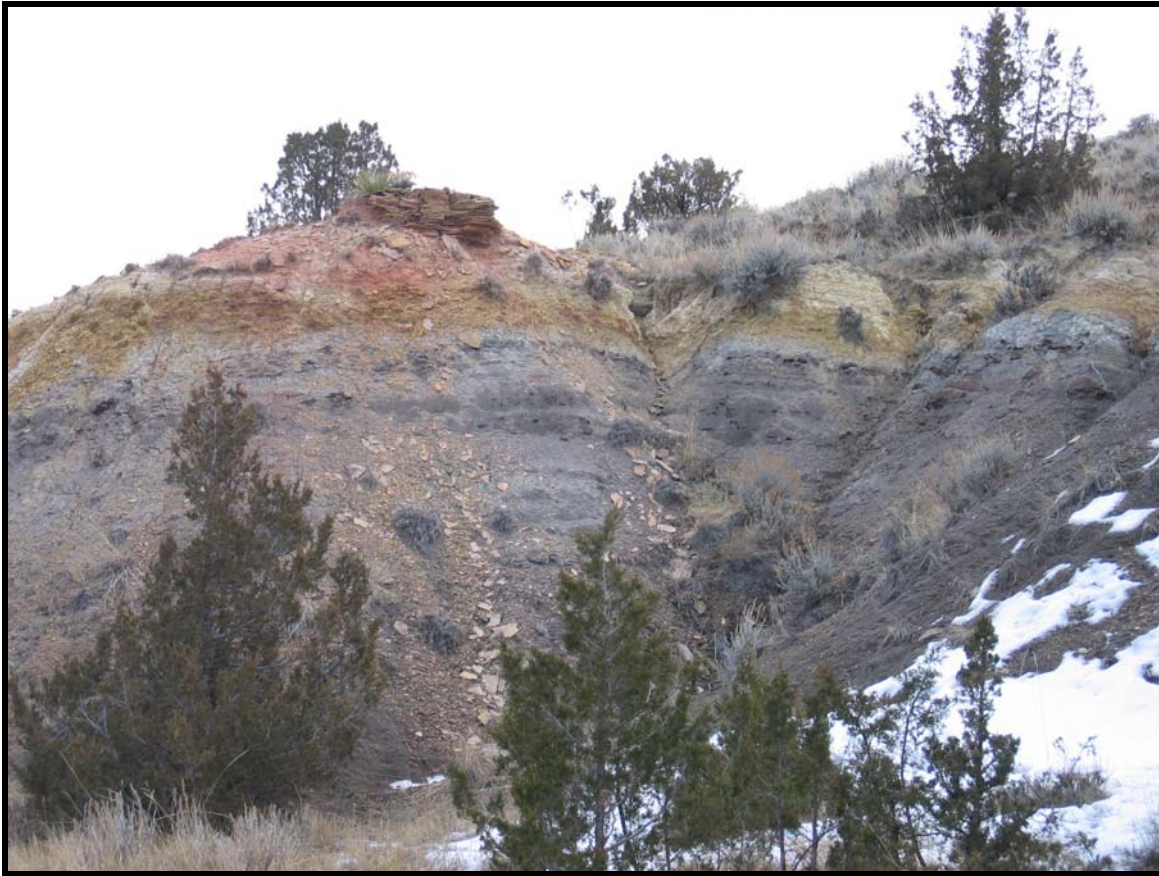
Photo: 1\_11\_06\_22

**FEATURE TYPE:** Cutbank

**GEOMETRIC DIMENSIONS:** Length: 90 ft Height: 30 ft

**SUBSTRATE:** Silt, sand, and scoria

**EXPOSURE:** Northern facing slope

**DESCRIPTION OF FEATURE:** As shown in the picture above, this cutbank is adjacent to Pearson Creek. This feature has a large amount of holes in the soft, sandy silt material. This bank also contains scoria, which is imbedded into the soil.
