Township 8S, Range 39E
SECTION 36

Cliff Features

Revised 4/06; Reference – South Fork Extension Amendment #00174

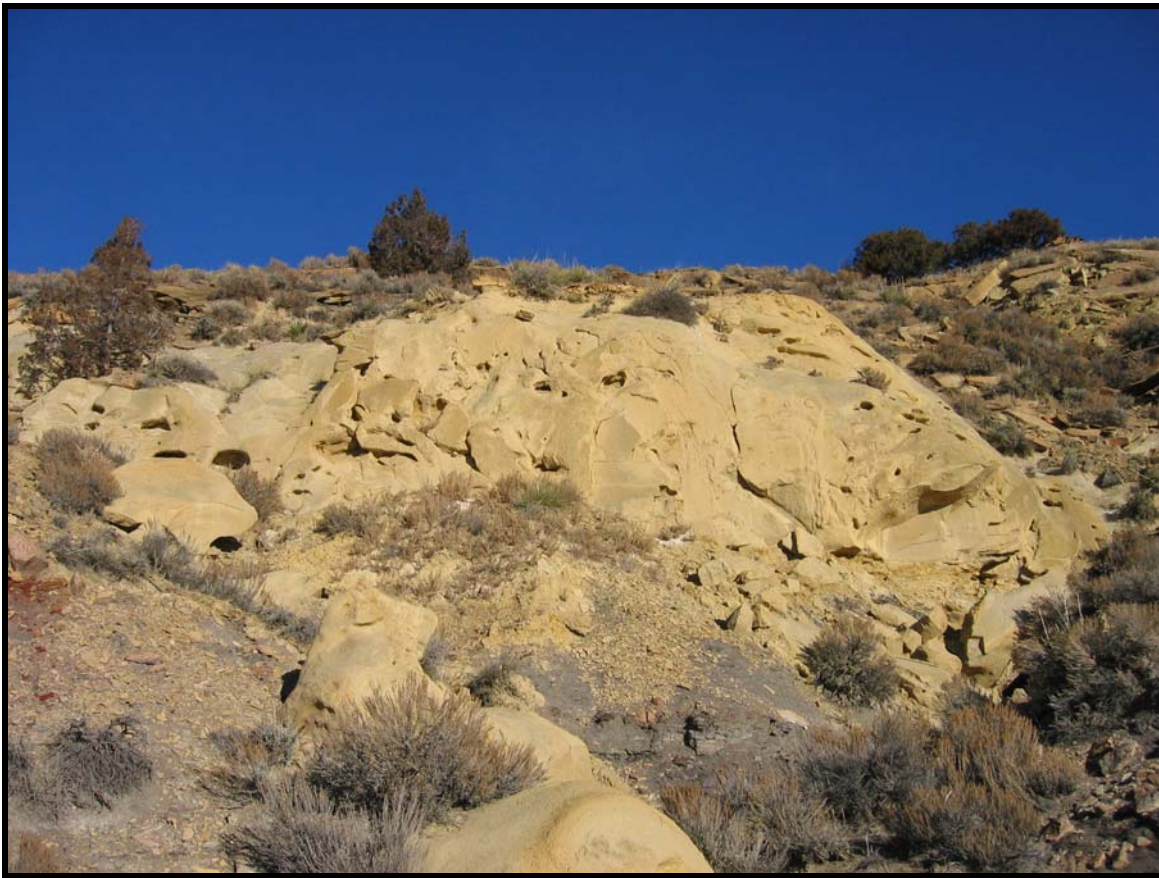
CLIFF FEATURE: C_0005

FEATURE TYPE:	Cliff					
GEOMETRIC DIMENSIONS:	Length: 65 ft		Height: 30 ft			
LOCATION:	Township: 8S		Range: 39E		Section: 36	
HANDHELD GPS POINTS:		Northing	Easting		Northing	Easting
	3007	409058.71	2670361.67	3009	409051.92	2670377.39
	3008	409041.74	2670400.98	3010	409061.68	2670340.90
SUBSTRATE:	Sandstone/siltstone					
EXPOSURE:	Southern facing slope					
DESCRIPTION OF FEATURE:	The cliff feature shown above has a hard sandstone/siltstone face that is exposed near the middle of a sandy silt slope. The solid rock face of the feature has pockets and crevices due to weathering and erosion.

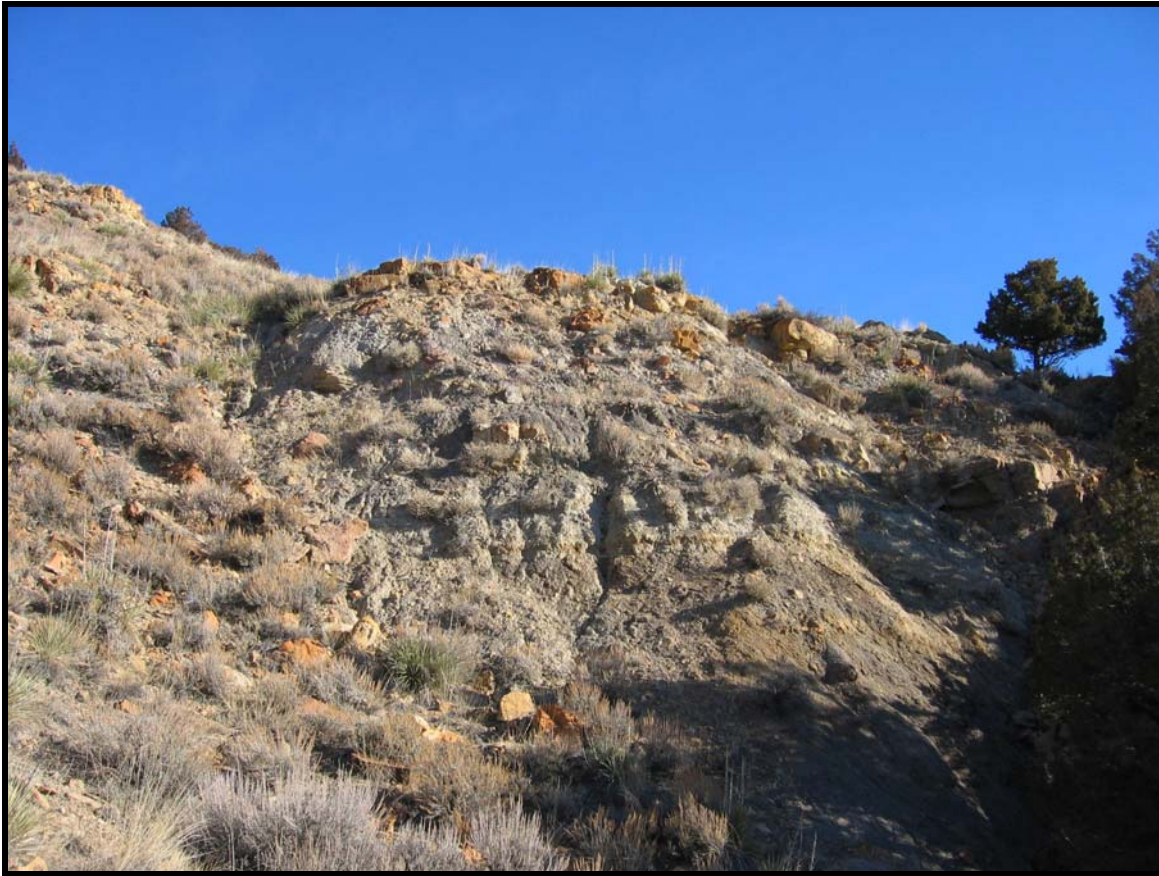
CLIFF FEATURE: C_0006

FEATURE TYPE:	Cliff				
GEOMETRIC DIMENSIONS:	Length: 50 ft		Height: 40 ft		
LOCATION:	Township: 8S		Range: 39E		Section: 36
HANDHELD GPS POINTS:	Northing	Easting		Northing	Easting
	3011	408935.28	2670267.48	3013	408958.78 2670204.71
	3012	408981.98	2670245.30	3014	408922.09 2670198.14
SUBSTRATE:	Sandy silt				
EXPOSURE:	Southern facing slope				
DESCRIPTION OF FEATURE:	The cliff feature shown above is composed of sandy silt soil, with a sandstone/siltstone rock layer at the top. The soil is highly erosive and overlooks a small draw.

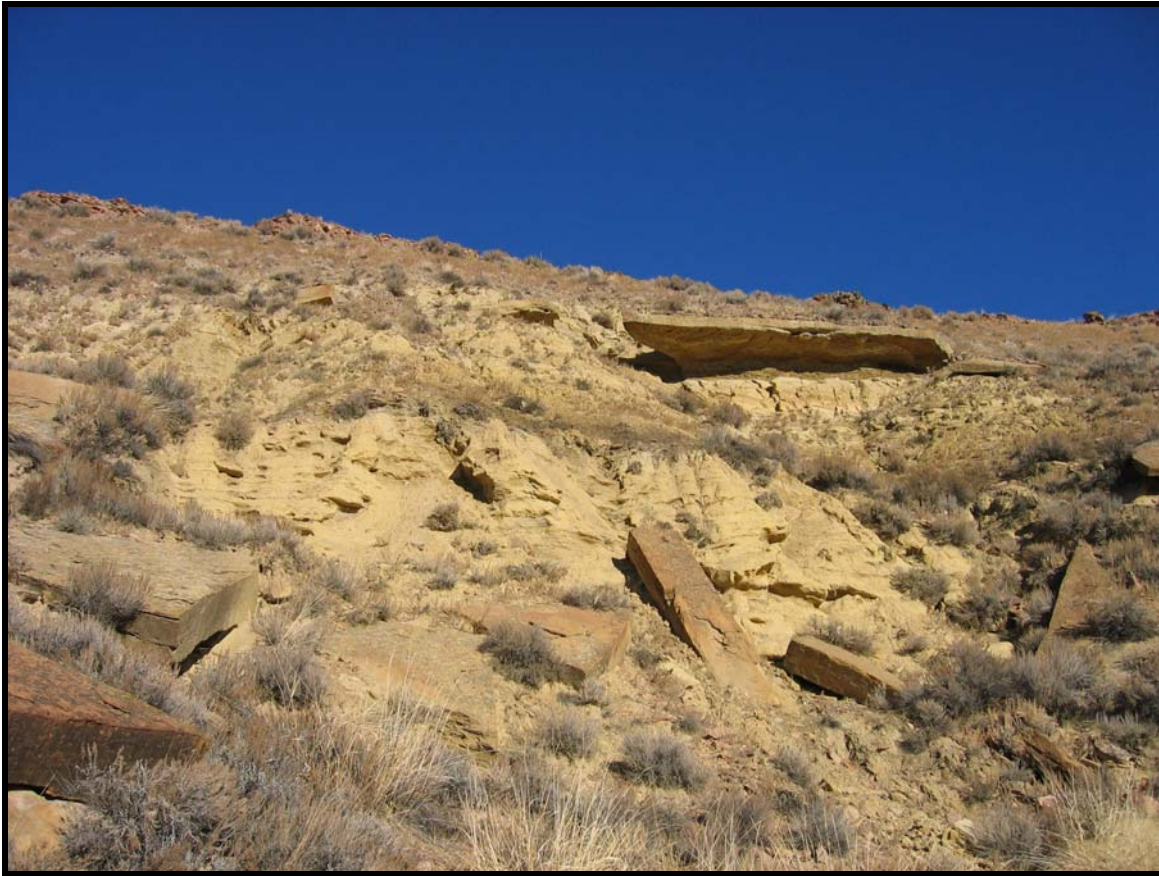
CLIFF FEATURE: C_0007

DESCRIPTION OF FEATURE: This overhang has been exposed due to the erosion of the sandy silt soil around and below the hard sandstone/siltstone rock layer. Large, flat rocks have been deposited below the feature as a result of the rock layer breaking away.

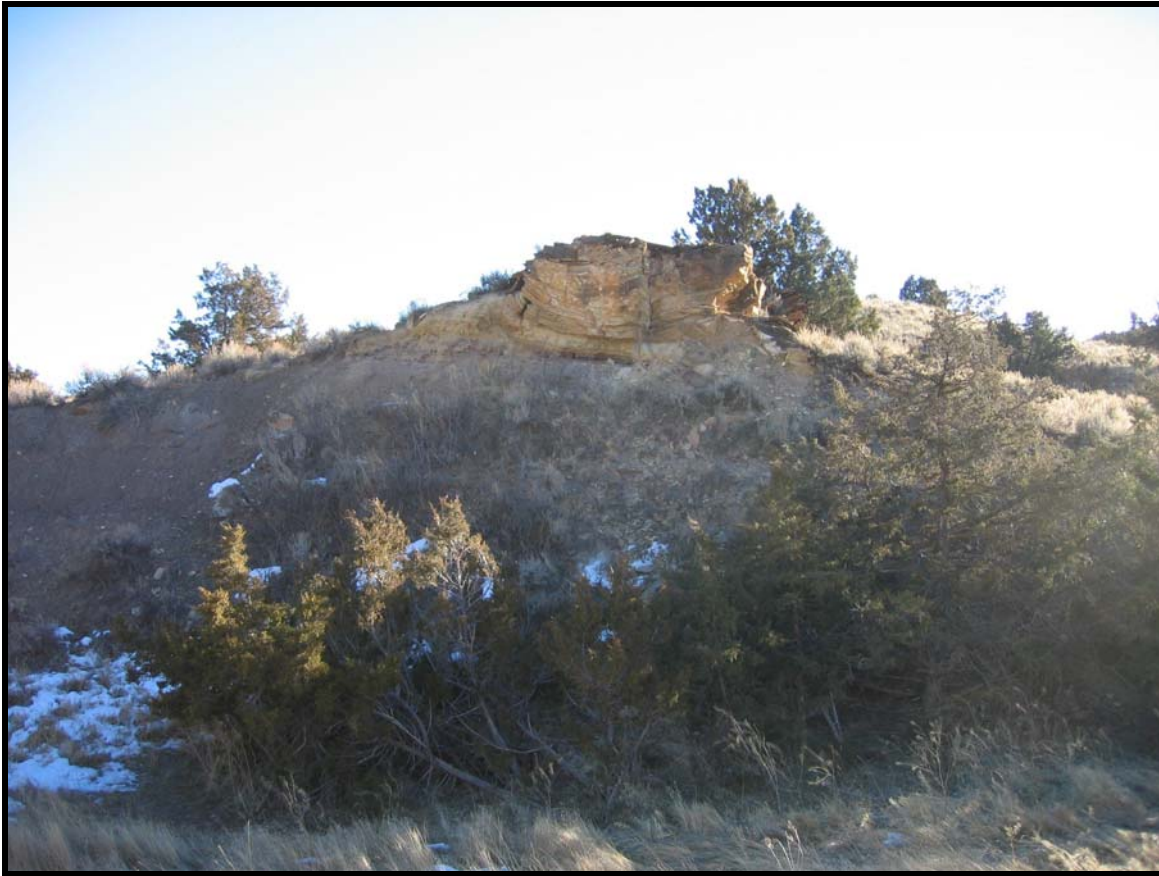
CLIFF FEATURE: C_0008

FEATURE TYPE:	Cliff		
GEOMETRIC DIMENSIONS:	Length: 25 ft	Height: 30 ft	
LOCATION:	Township: 8S	Range: 39E	Section: 36
HANDHELD GPS POINTS:	Northing	Easting	
	3029	407918.46	2669731.95
	3030	407935.13	2669796.01
	3031	407894.46	2669779.24
SUBSTRATE:	Sandstone/siltstone		
EXPOSURE:	Northern facing slope		
DESCRIPTION OF FEATURE:	The cliff feature shown above has a hard sandstone/siltstone face that rests at the top of a sandy silt slope. The feature is located adjacent to the Pearson Creek channel bottom. The face of the cliff is weathered and eroded, leaving pockets and voids.

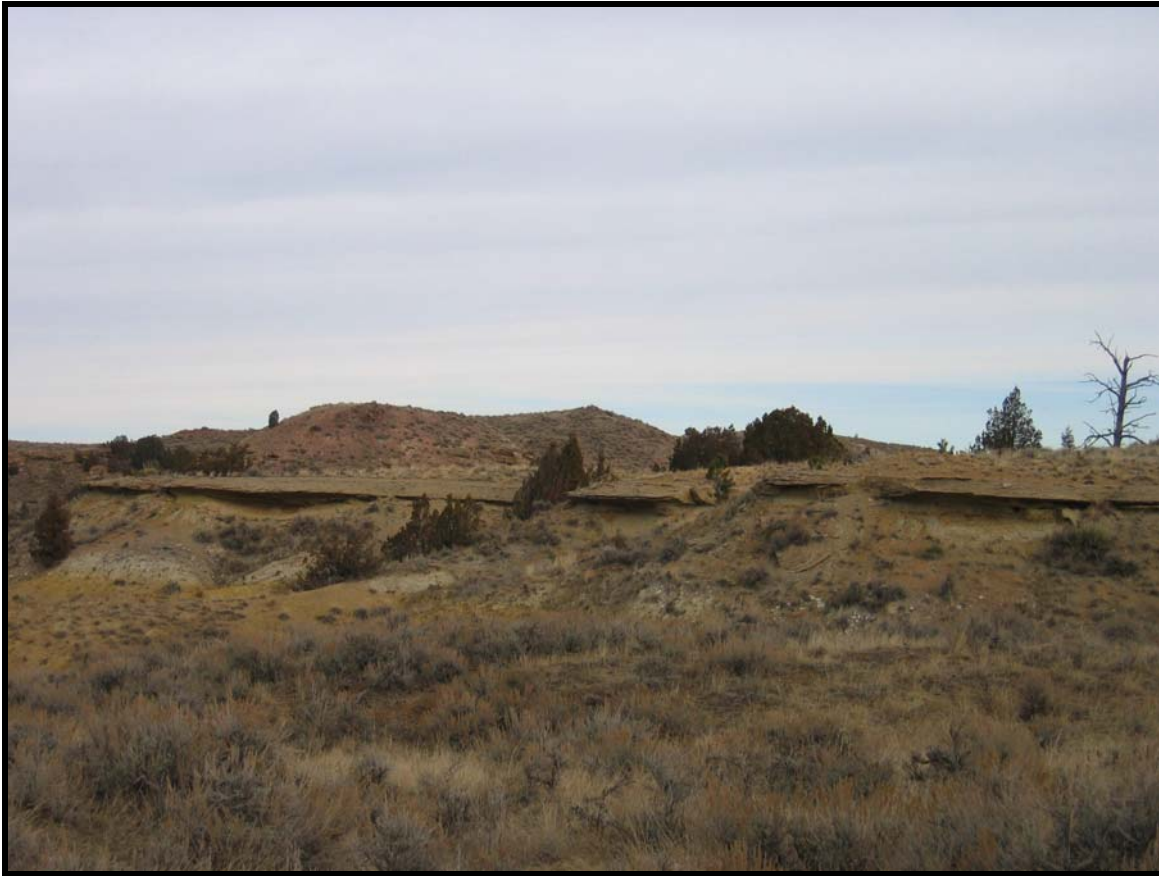
CLIFF FEATURE: C_0013

DESCRIPTION OF FEATURE: The cliff feature shown above has a hard sandstone/siltstone face that rests at the top of a sandy silt slope. The solid rock face of the feature has pockets and crevices due to weathering and erosion. The sandy silt soil beneath the rocks has also eroded creating voids and overhangs. See the pictures on the next page for additional views of this feature.

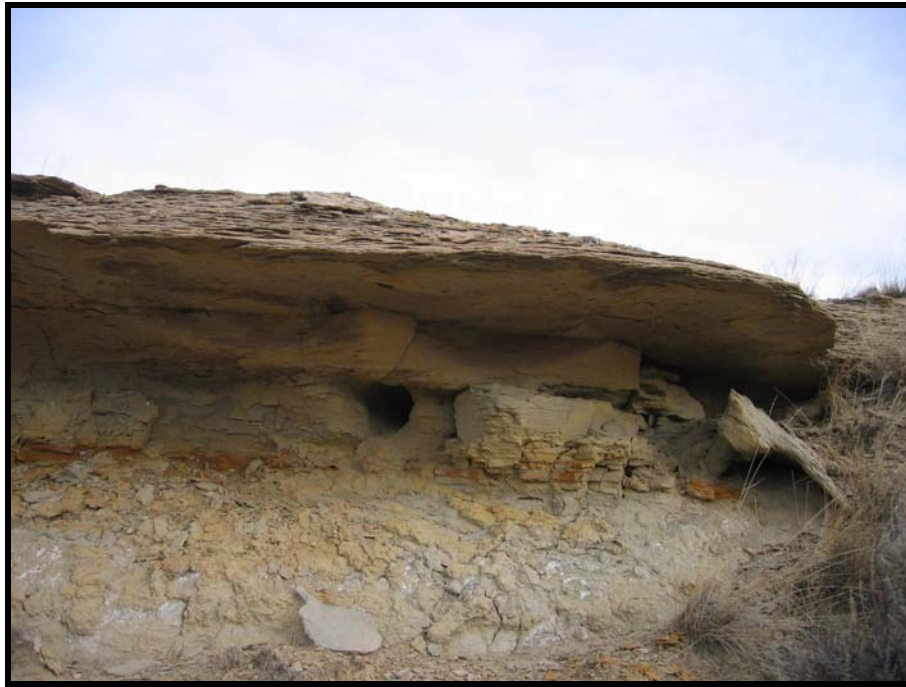
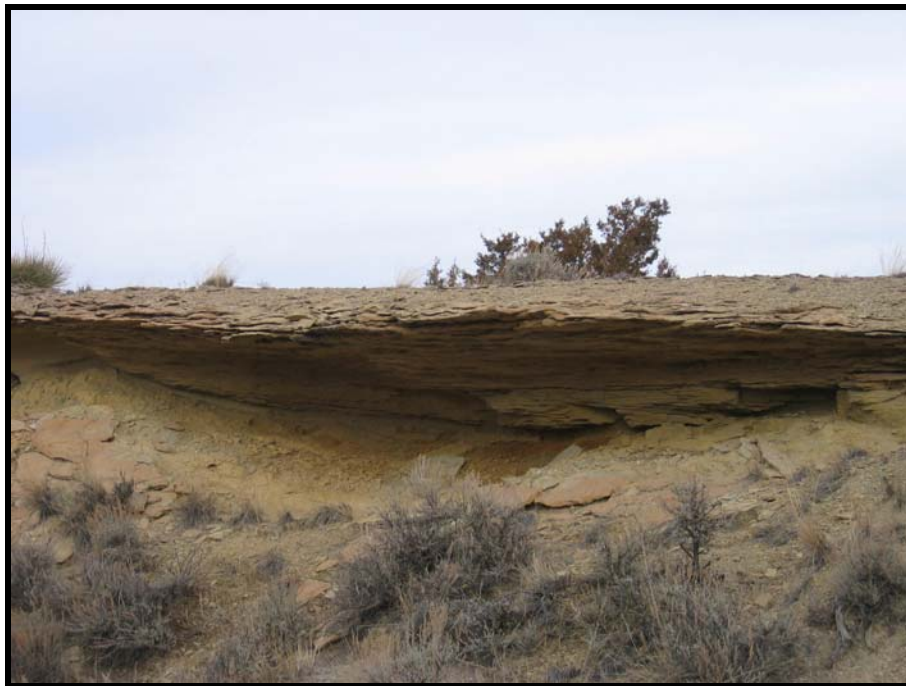
CLIFF FEATURE: C_0013

Photo: 1_9_06_31

Looking East

Photo: 1_9_06_32

Looking North

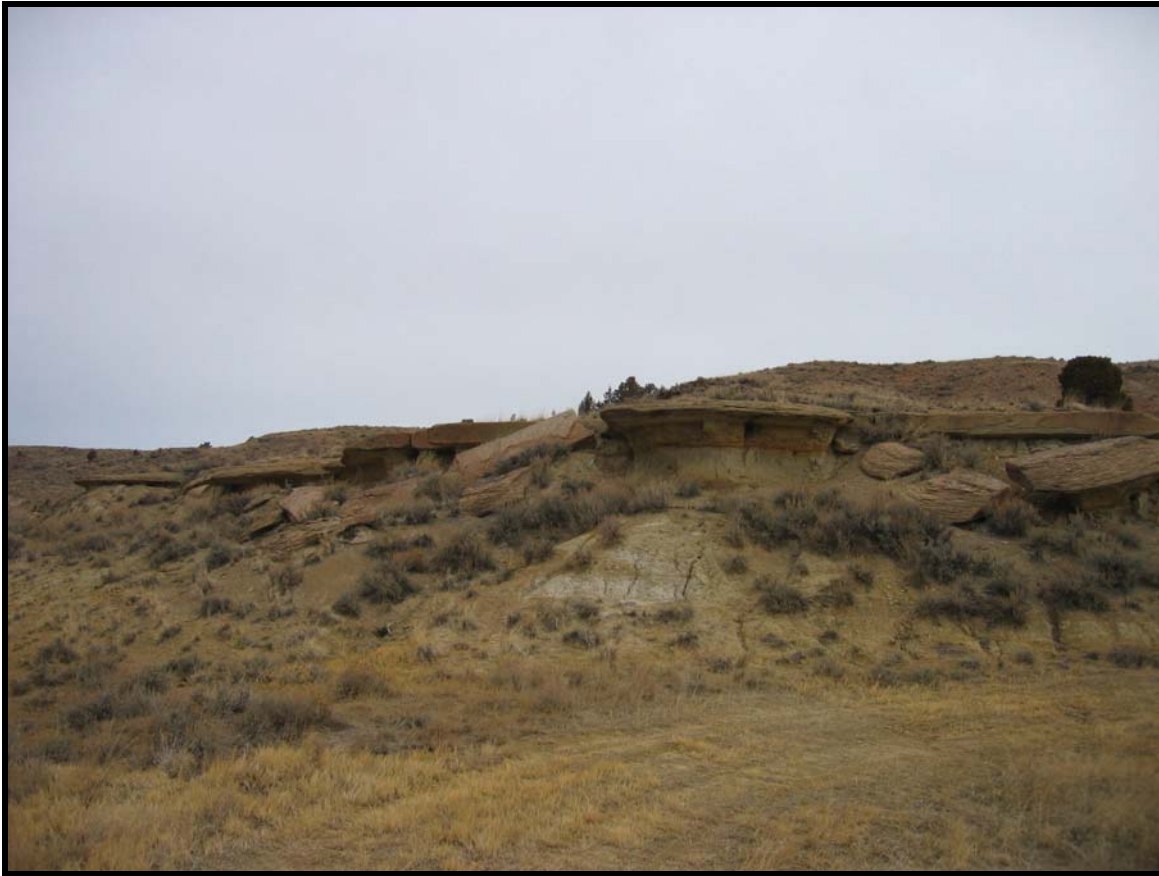
CLIFF FEATURE: C_0014

DESCRIPTION OF FEATURE: The cliff feature shown above has a hard sandstone/siltstone face that rests at the top of a sandy silt slope. It is located adjacent to the Pearson Creek channel bottom. The soil beneath the rock layer has eroded, leaving overhangs. See the pictures on the next page for additional views of this feature.

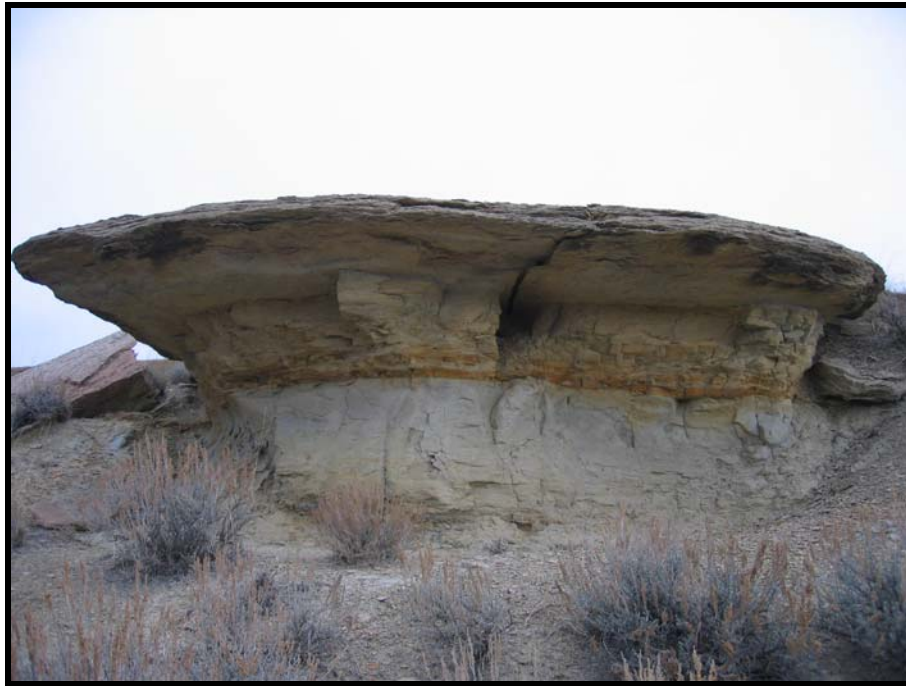
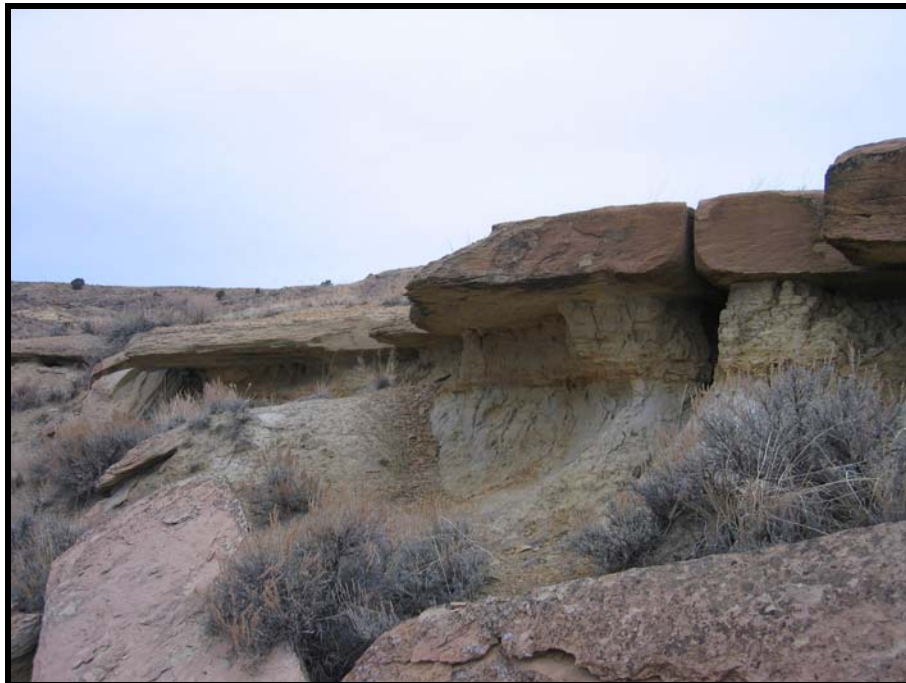
CLIFF FEATURE: C_0014

Photo: 1_10_06_02

Looking Northwest

Photo: 1_10_06_03

Looking West

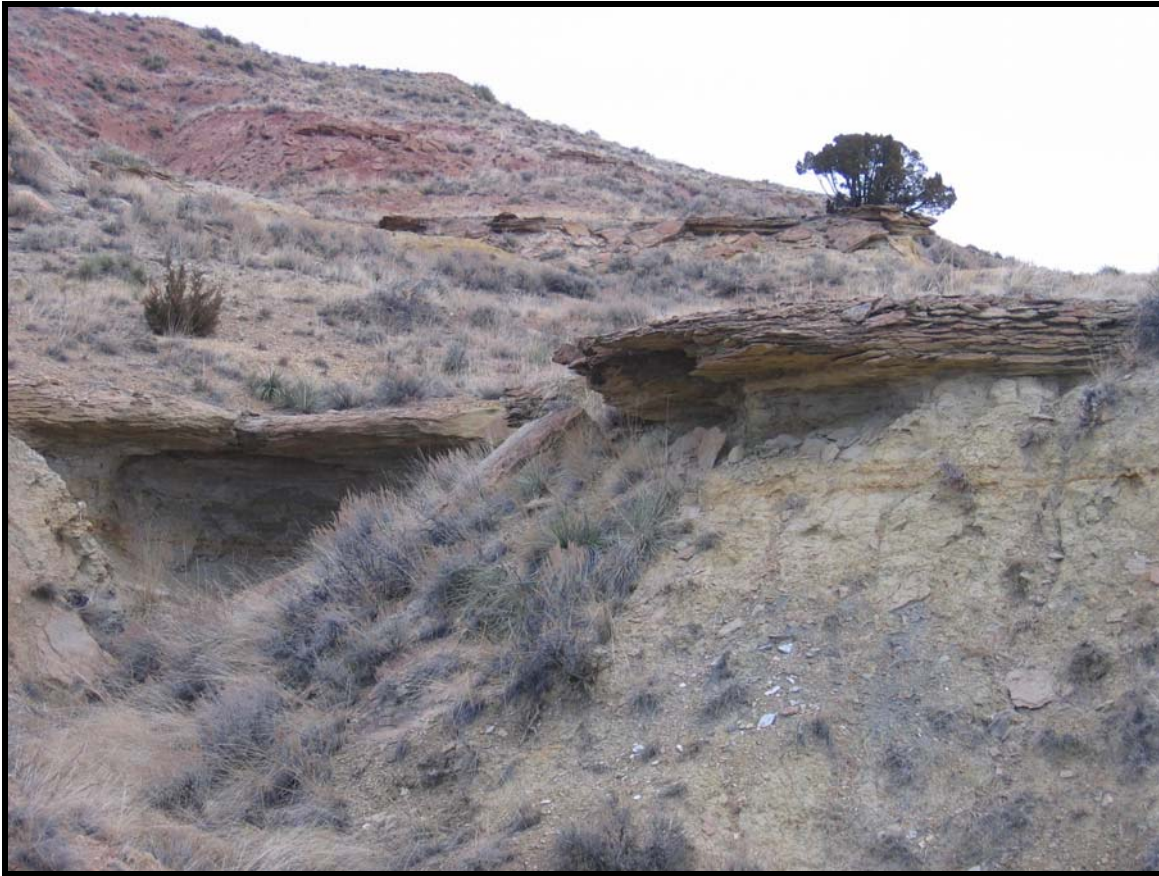
CLIFF FEATURE: C_0015

DESCRIPTION OF FEATURE: The cliff feature shown above has a hard sandstone/siltstone face that rests at the top of a sandy silt slope. Features like the one shown above are very common in this area. The soil beneath the rock layer has eroded, leaving overhangs. See the pictures on the next page for additional views of this feature.

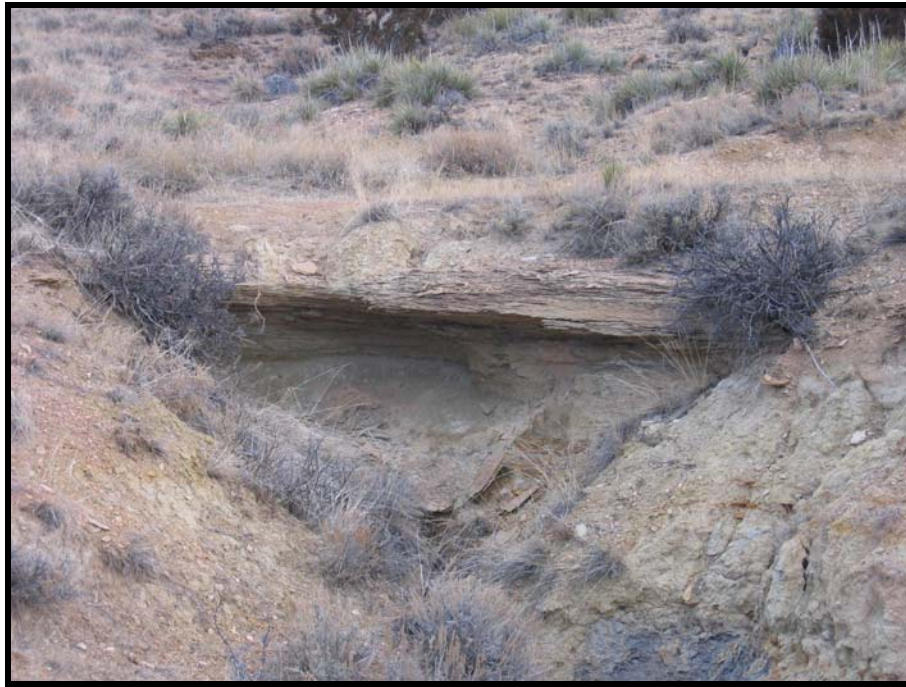
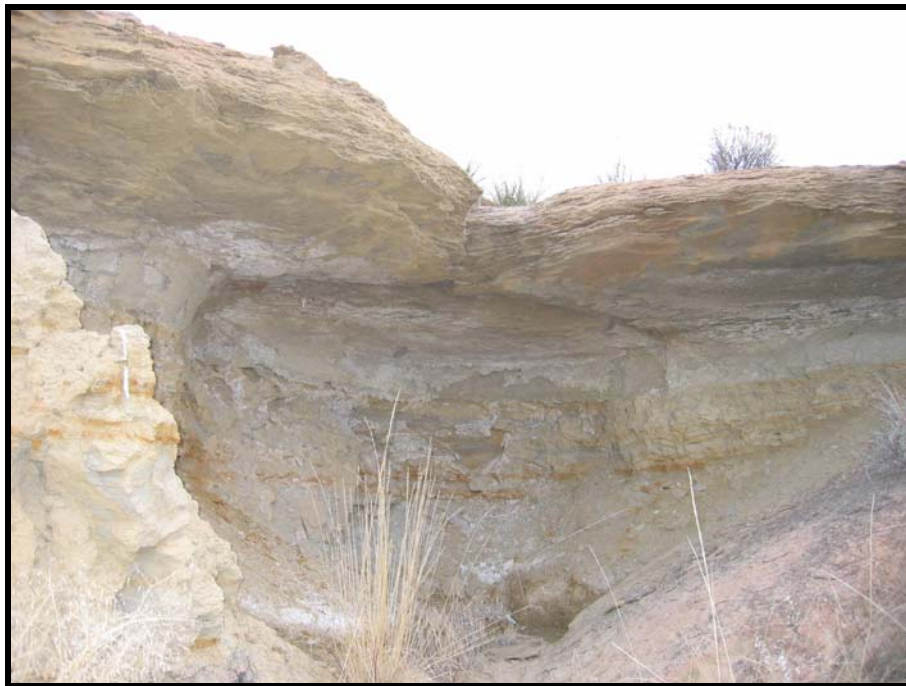
CLIFF FEATURE: C_0015

Photo: 1_10_06_05

Looking Northwest

Photo: 1_10_06_06

Looking North

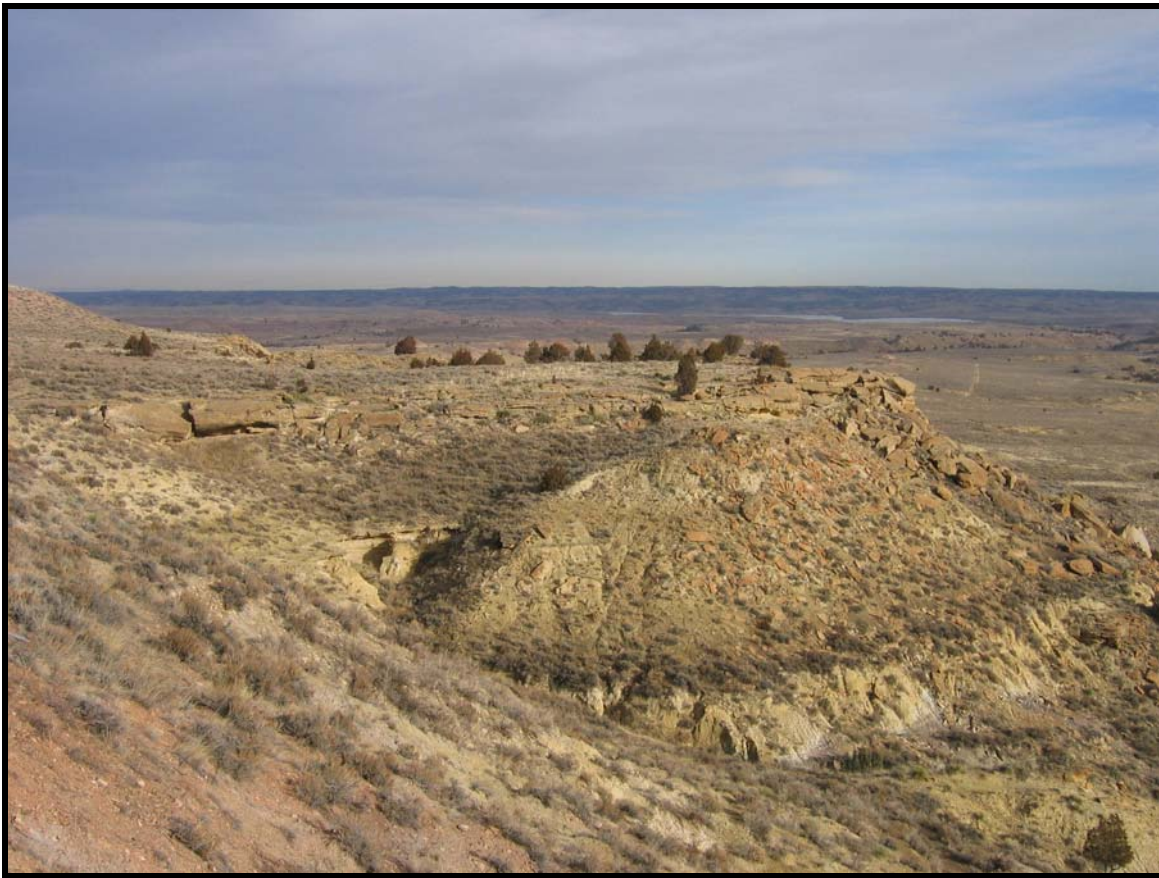
CLIFF FEATURE: C_0017

FEATURE TYPE:	Cliff				
GEOMETRIC DIMENSIONS:	Length: 570 ft		Height: 25 ft		
LOCATION:	Township: 8S		Range: 39E		Section: 36
HANDHELD GPS POINTS:	Northing	Easting	Northing	Easting	
	5071	405548.97	2669441.71	5073	405342.57
	5072	405377.06	2669540.31	5074	405424.94
					2669714.58
					2669892.82
SUBSTRATE:	Sandstone/siltstone				
EXPOSURE:	Southern facing slope				
DESCRIPTION OF FEATURE:	The cliff feature shown above has a hard sandstone/siltstone face that rests at the top of a sandy silt slope. The solid rock face of the feature has pockets and crevices due to weathering and erosion. This feature consists of three cliff features that are separated by less than 50 feet. See the pictures on the following pages for additional views of this feature.

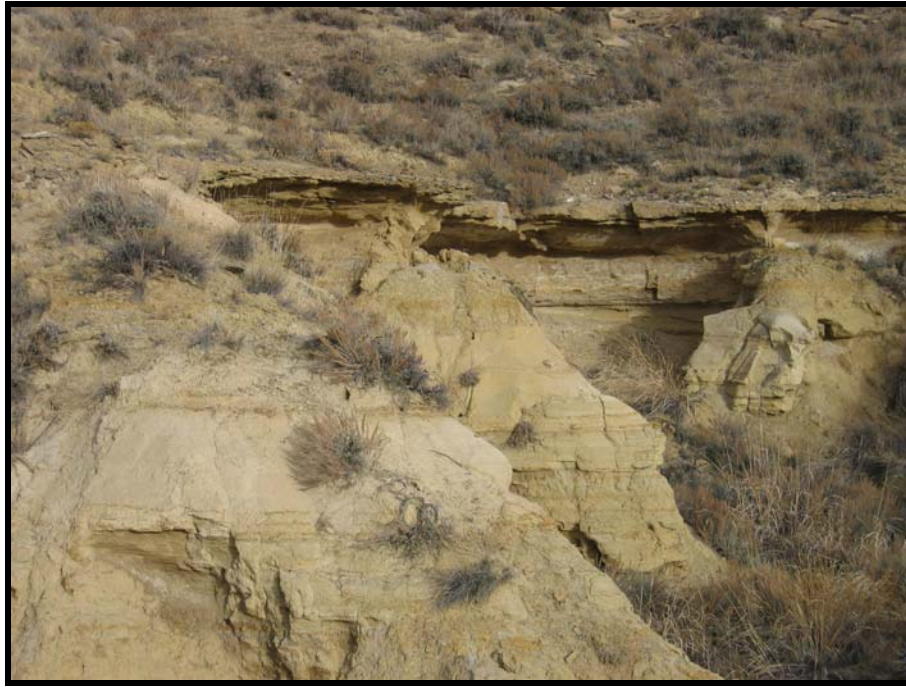
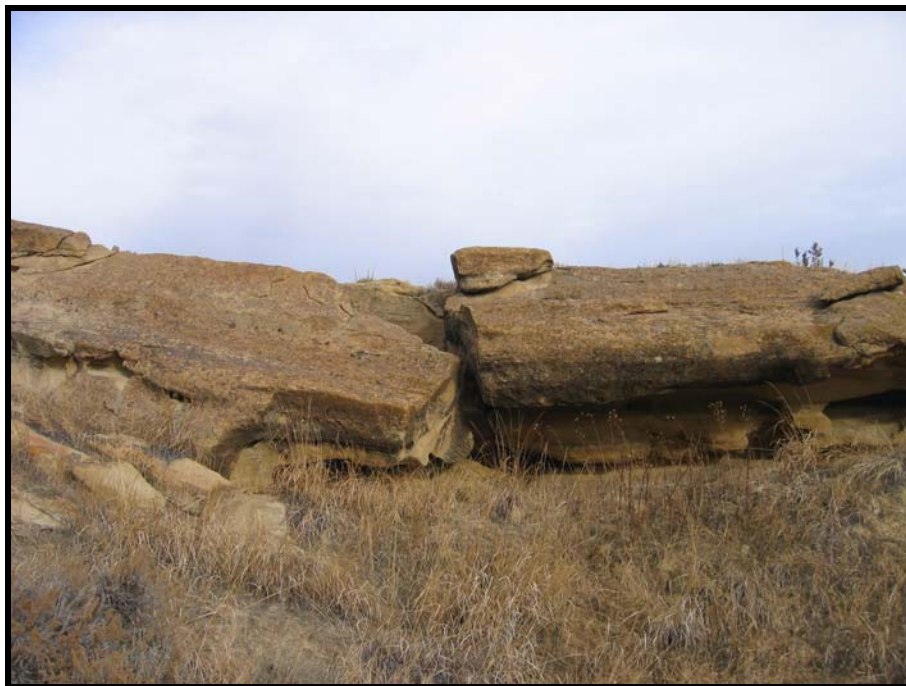
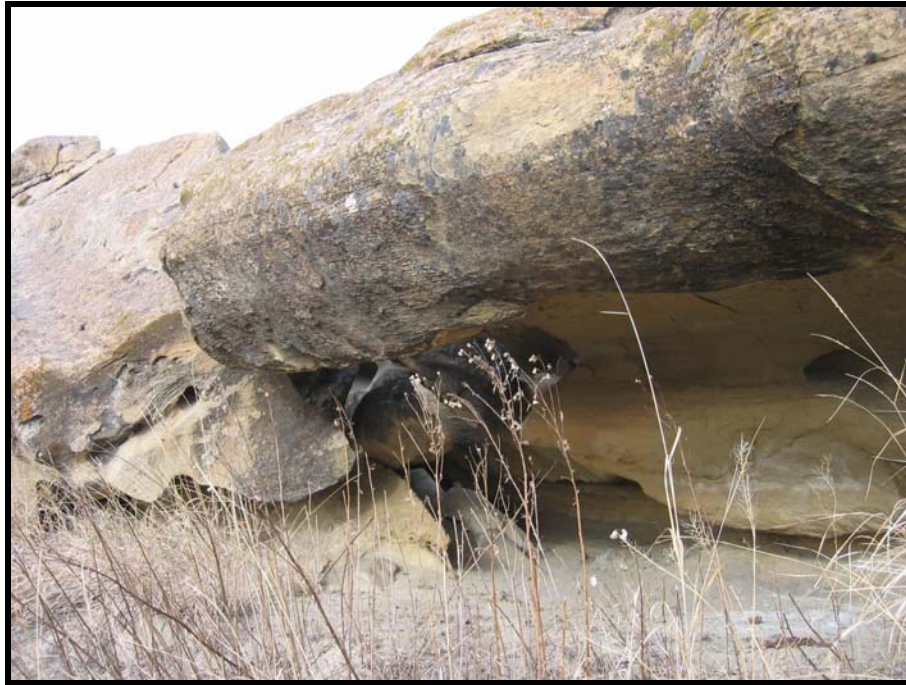
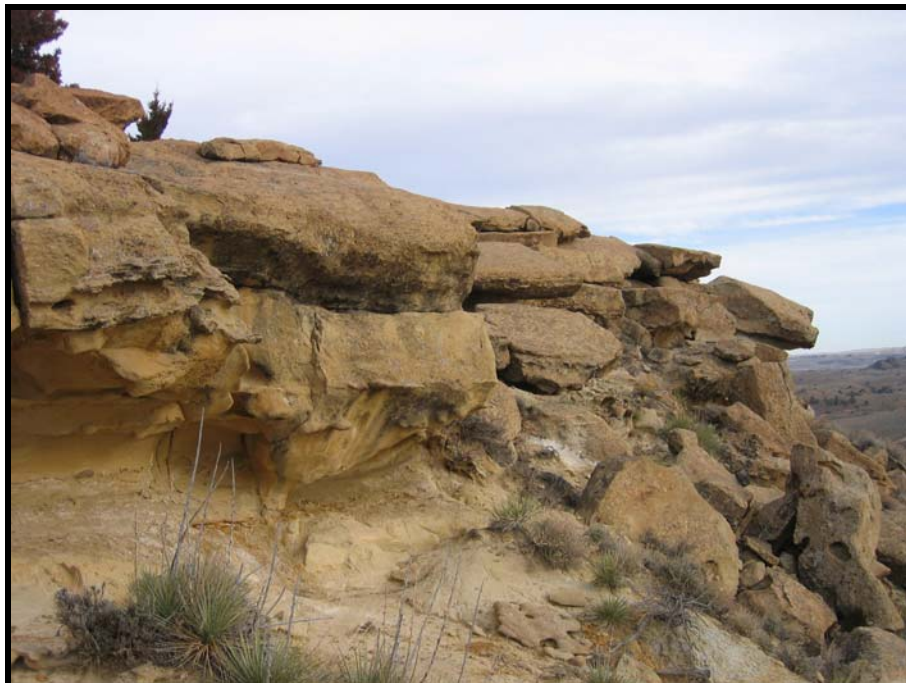
CLIFF FEATURE: C_0017

Photo: 1_10_06_47

Looking Northeast

Photo: 1_10_06_48

Photo: 1_10_06_49

Looking North

Photo: 1_10_06_50

Looking East

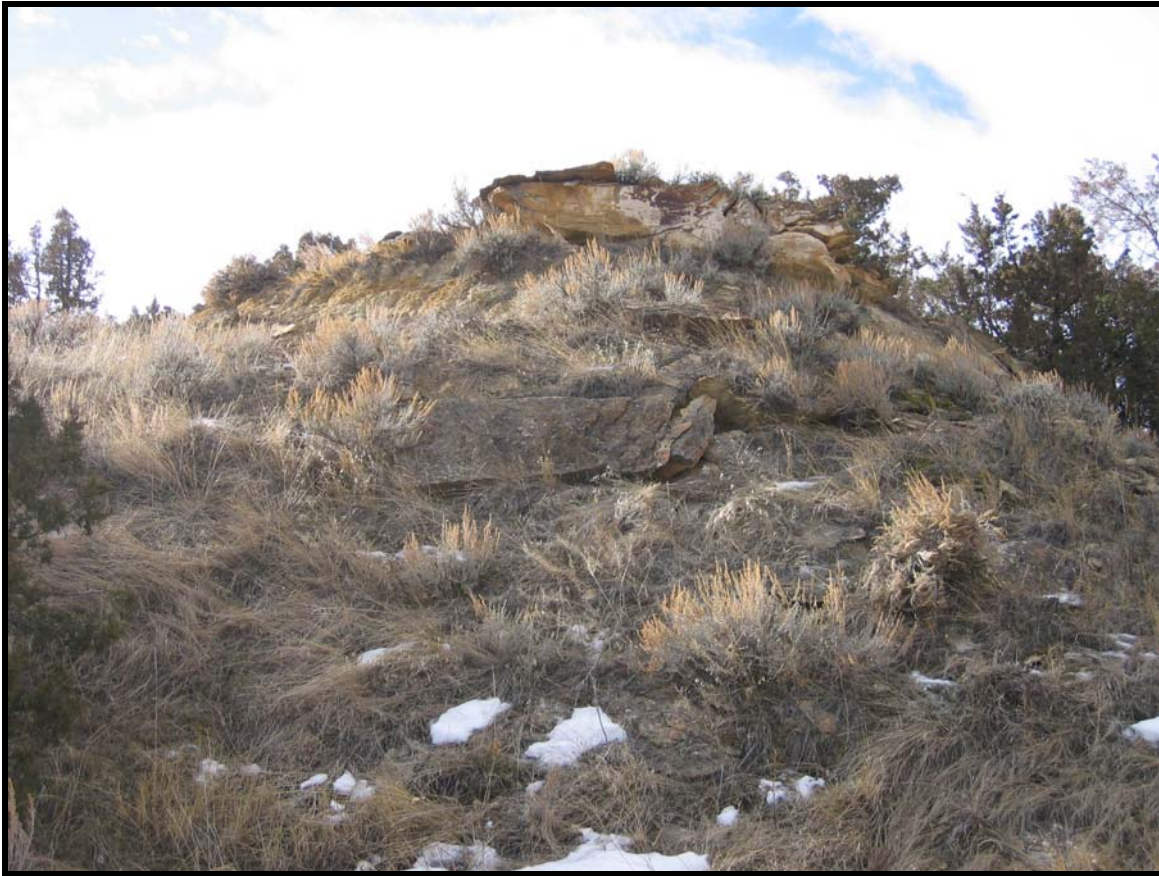
CLIFF FEATURE: C_0018

DESCRIPTION OF FEATURE: The cliff feature shown above has a hard sandstone/siltstone face that rests at the top of a sandy silt slope. The solid rock face of the feature has pockets and crevices due to weathering and erosion. The slope below the feature is vegetated with grass and sagebrush.

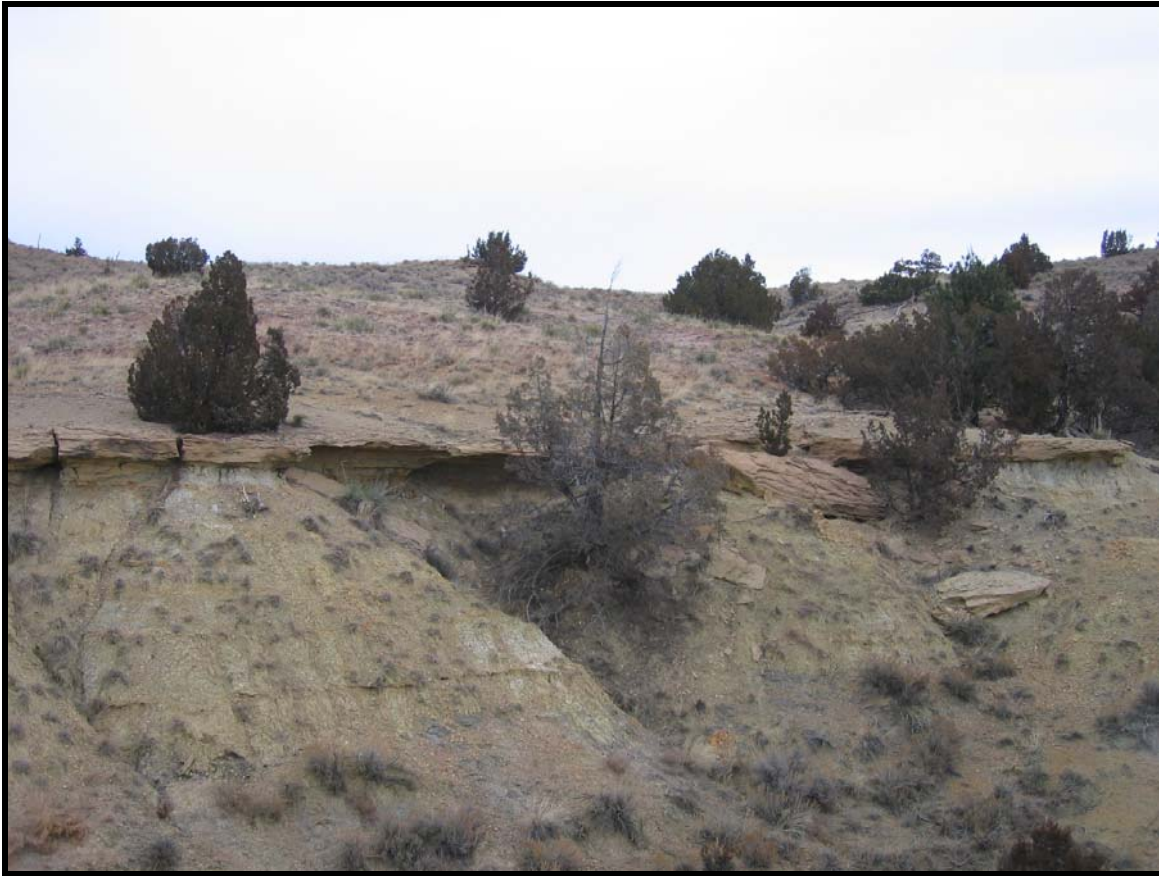
CLIFF FEATURE: C_0028

DESCRIPTION OF FEATURE: The cliff feature shown above has a hard sandstone/siltstone face that rests at the top of a sandy silt slope. Due to the weathering of the subsoil, overhangs have been created below the rock layer. See the picture on the following page for another view of this feature.

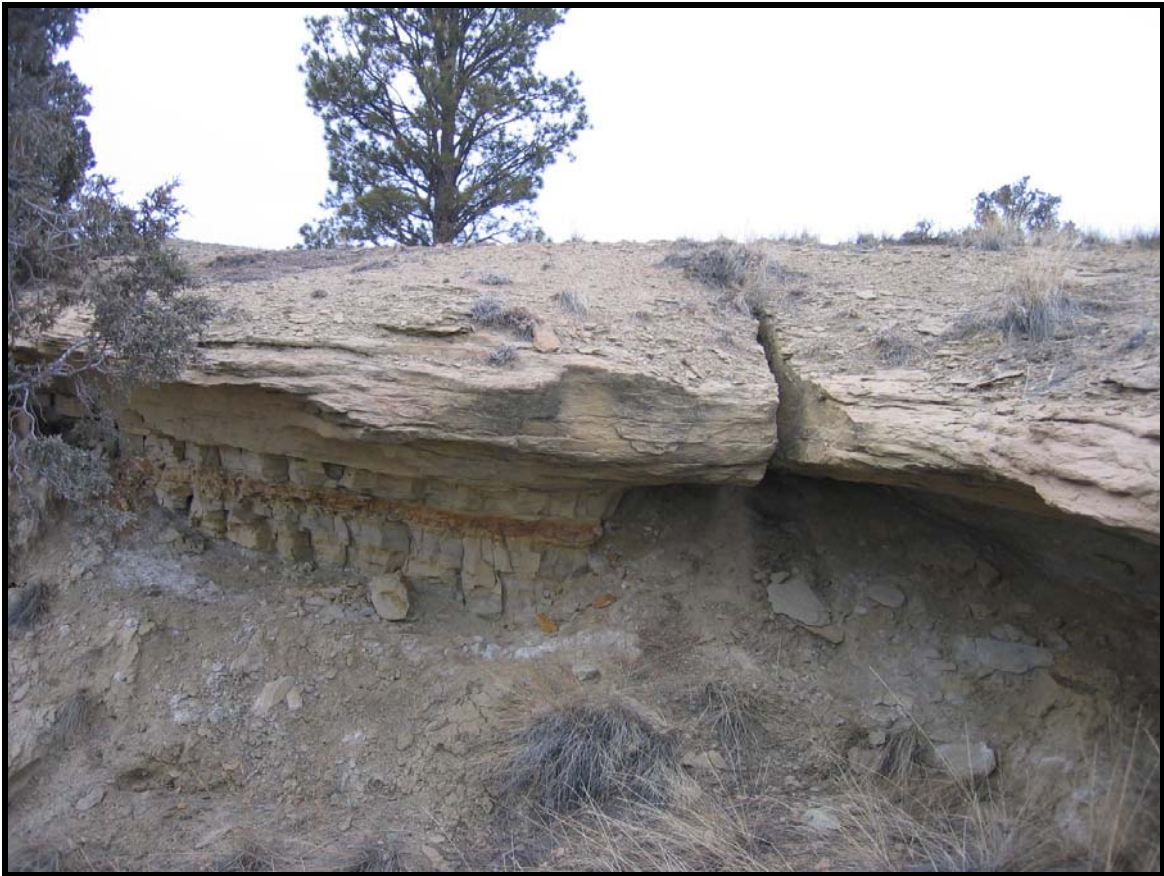
CLIFF FEATURE: C_0028

Photo: 1_17_06_05

Looking West

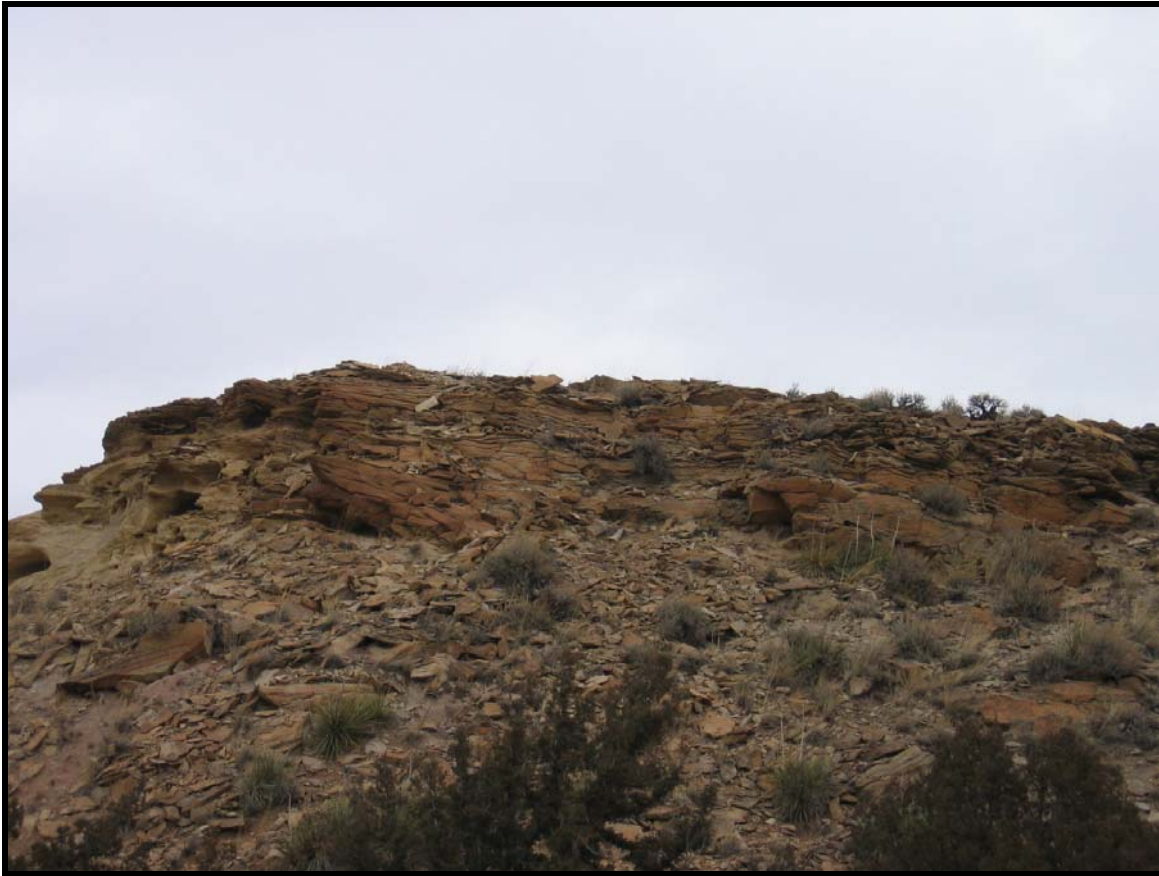
CLIFF FEATURE: C_0029

DESCRIPTION OF FEATURE: The cliff feature shown above is composed hard sandstone/siltstone that rests at the top of a sandy silt slope. The face has pockets and crevices due to erosion. See the picture on the next page for another view of this feature.

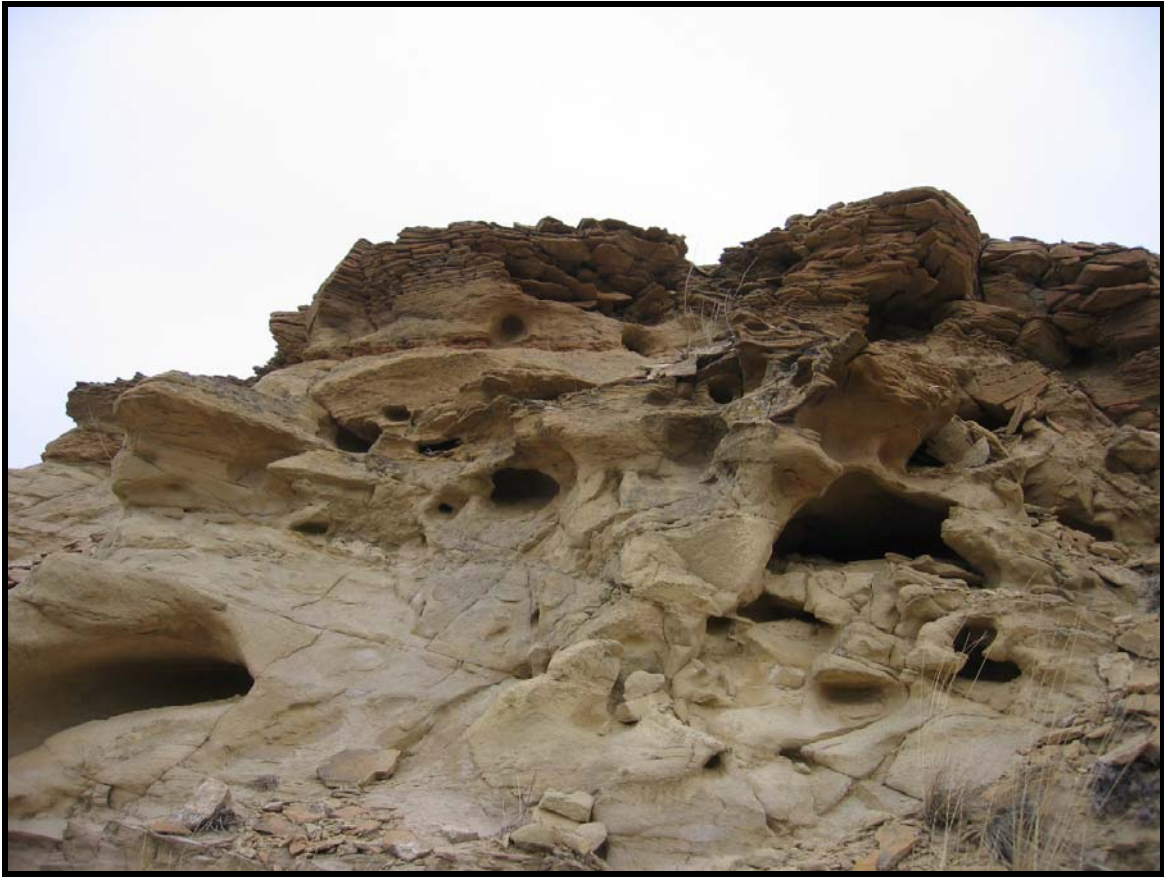
CLIFF FEATURE: C_0029

Photo: 1_17_06_10

Looking East

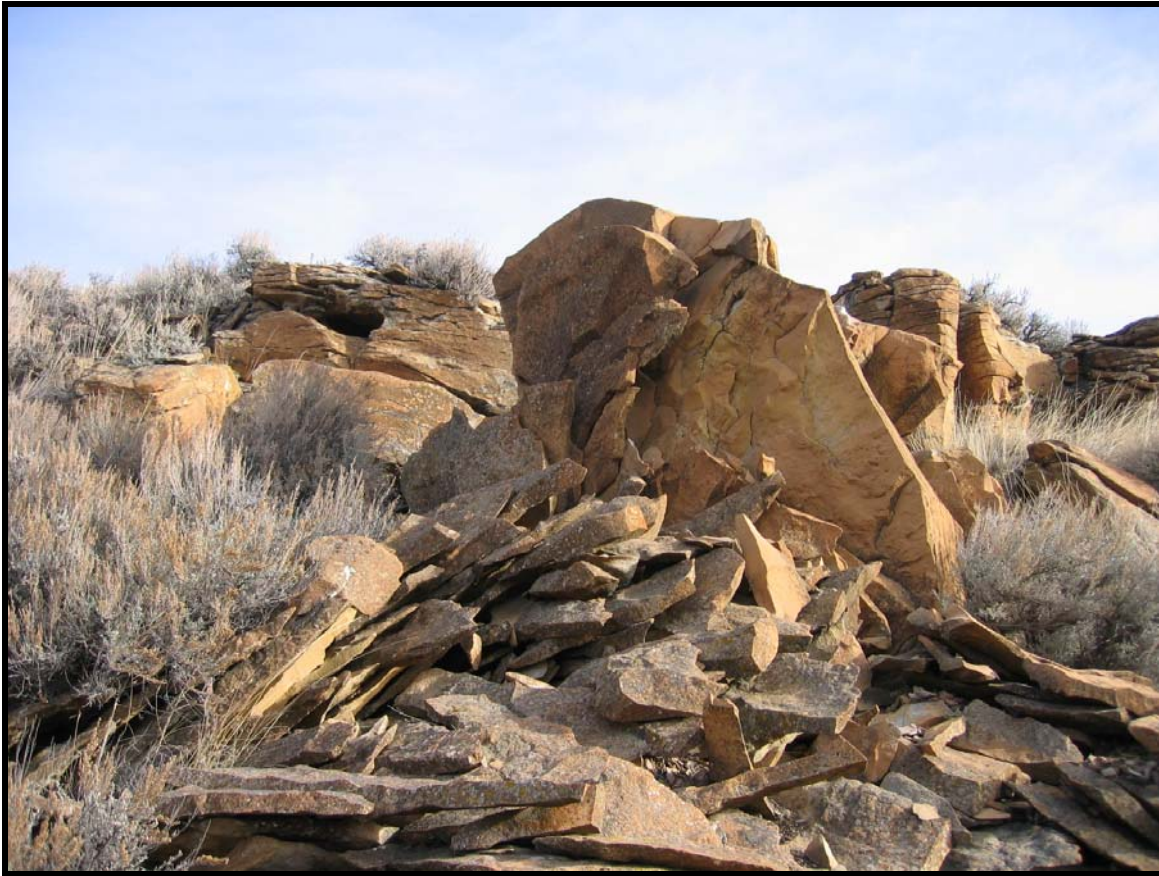
CLIFF FEATURE: C_0035

FEATURE TYPE:	Cliff				
GEOMETRIC DIMENSIONS:	Length: 240 ft		Height: 10 ft		
LOCATION:	Township: 8S		Range: 39E		Section: 36
HANDHELD GPS POINTS:	Northing	Easting		Northing	Easting
	9057	410511.58	2671407.48	9059	410431.42
	9058	410475.39	2671416.41	9060	410325.53
					2671294.67
SUBSTRATE:	Sandstone/siltstone				
EXPOSURE:	Southern facing slope				
DESCRIPTION OF FEATURE:	The small cliff feature shown above is composed of layered sandstone/siltstone that sits on a slope vegetated with grass and sagebrush. The solid rock face of the feature has pockets and crevices due to weathering and erosion.

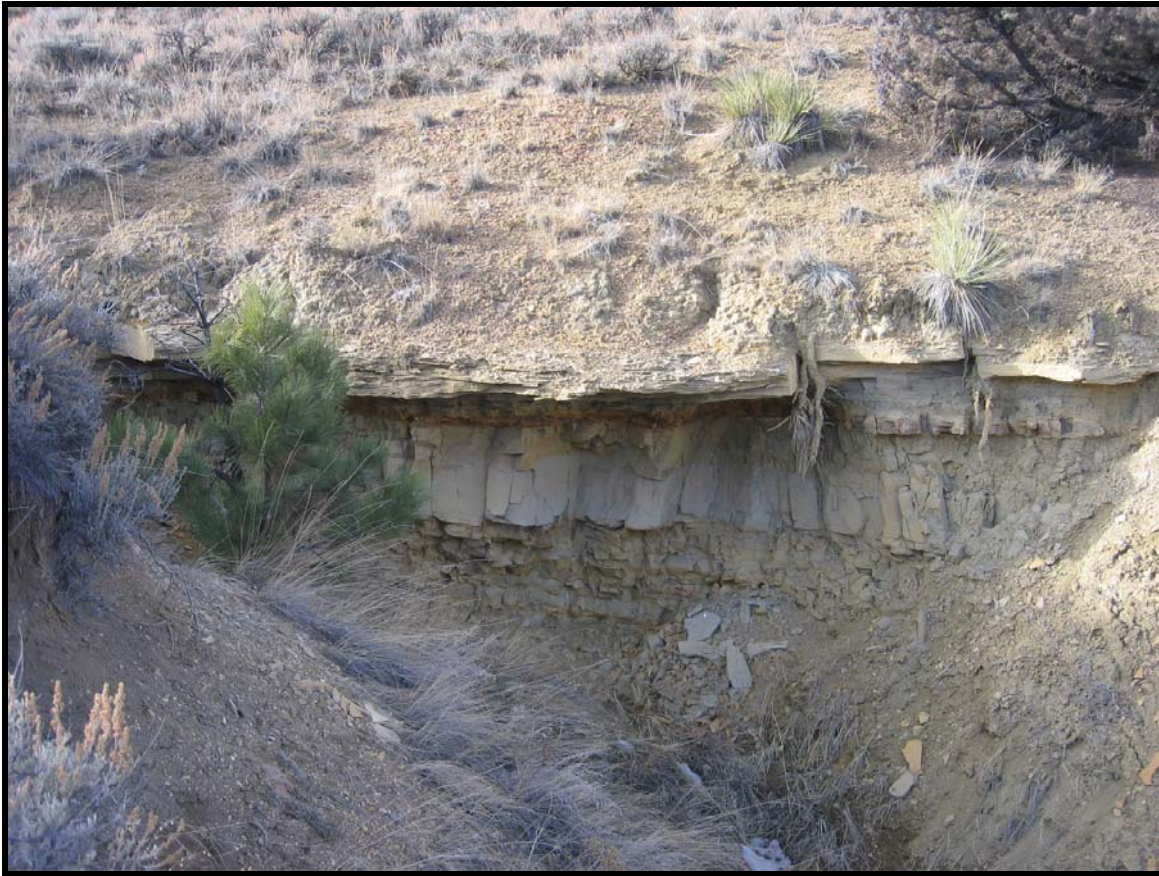
CLIFF FEATURE: C_0036

DESCRIPTION OF FEATURE: The cliff feature shown above is a siltstone rock layer that has been exposed by the erosion of the sandy silt soil surrounding the feature. An overhang has been created below the rock layer, which is located adjacent to a small channel.
