Township 8S, Range 39E
SECTION 36

Cliff Features

Revised 4/06; Reference – South Fork Extension Amendment #00174

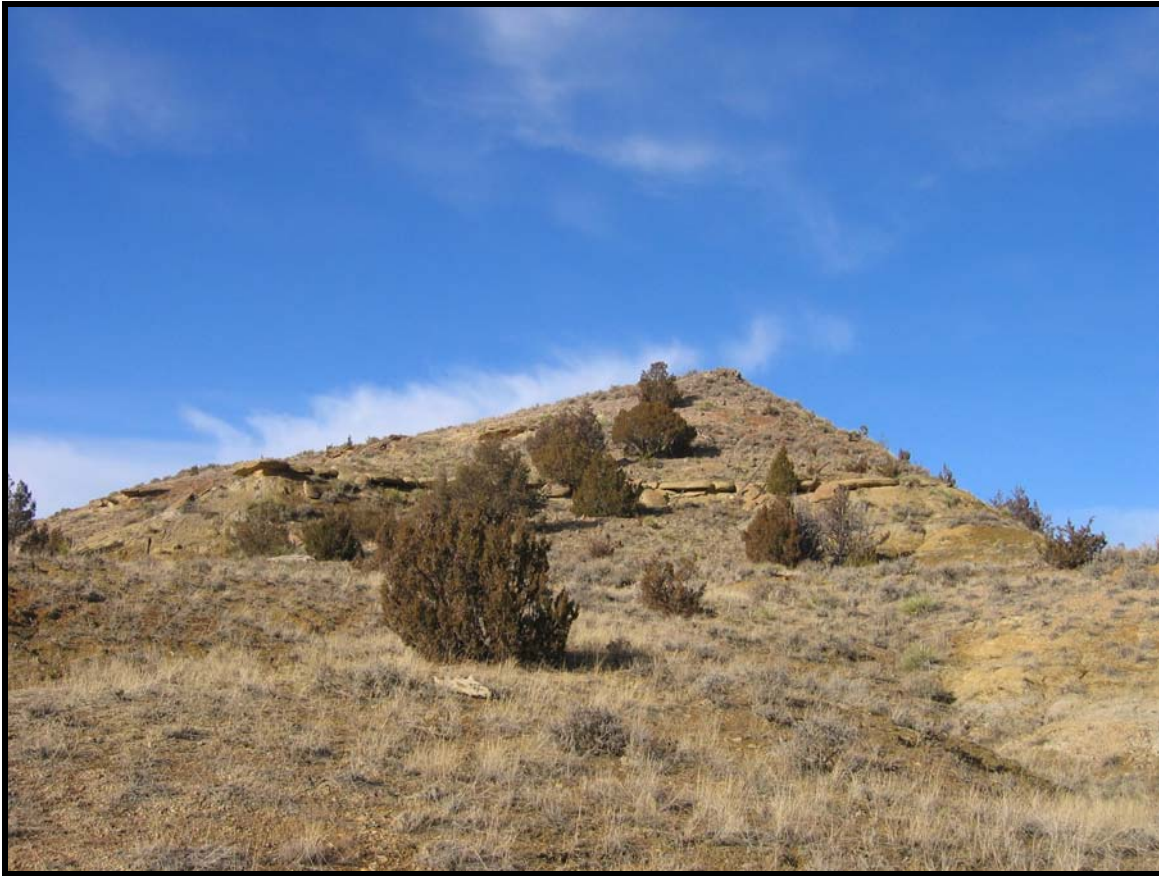
ROCK OUTCROP FEATURE: RO_0006

FEATURE TYPE:	Rock Outcrop		
GEOMETRIC DIMENSIONS:	Length: 410 ft	Height: 10 ft	
LOCATION:	Township: 8S	Range: 39E	Section: 36
HANDHELD GPS POINTS:	Northing	Easting	
	2023	407181.17 2674438.29	
	2024	407091.78 2674381.77	
	2025	407107.54 2674081.49	
SUBSTRATE:	Sandstone/siltstone		
EXPOSURE:	Southern facing slope		
DESCRIPTION OF FEATURE:	The rock outcrop shown above is composed of sandstone/siltstone rocks, which are weathered and stacked. The feature sits on sandy silt soil, which is highly erosive. As the sand beneath the rock layer is eroded, overhangs and more outcrops are created. See the picture on the next page for a closer view of this feature.

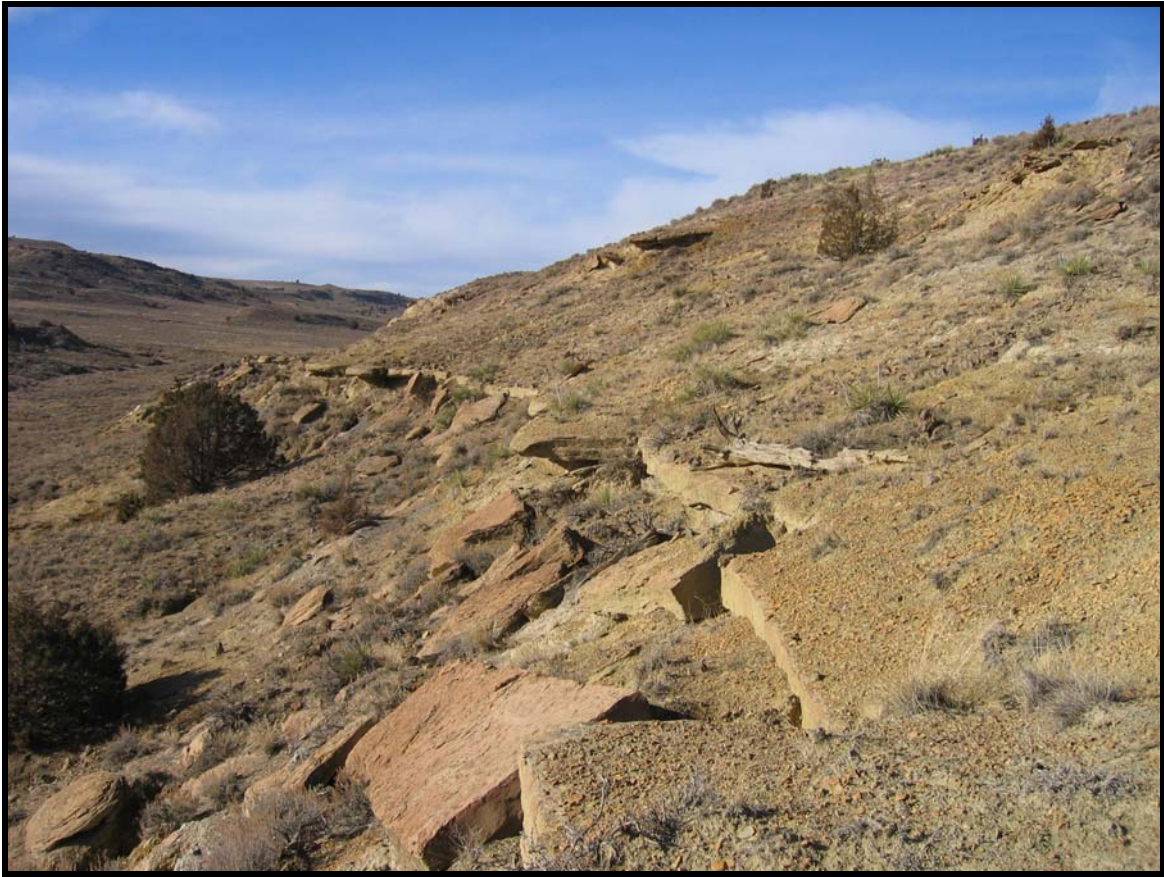
ROCK OUTCROP FEATURE: RO_0006

Photo: 1_4_06_11

Looking West

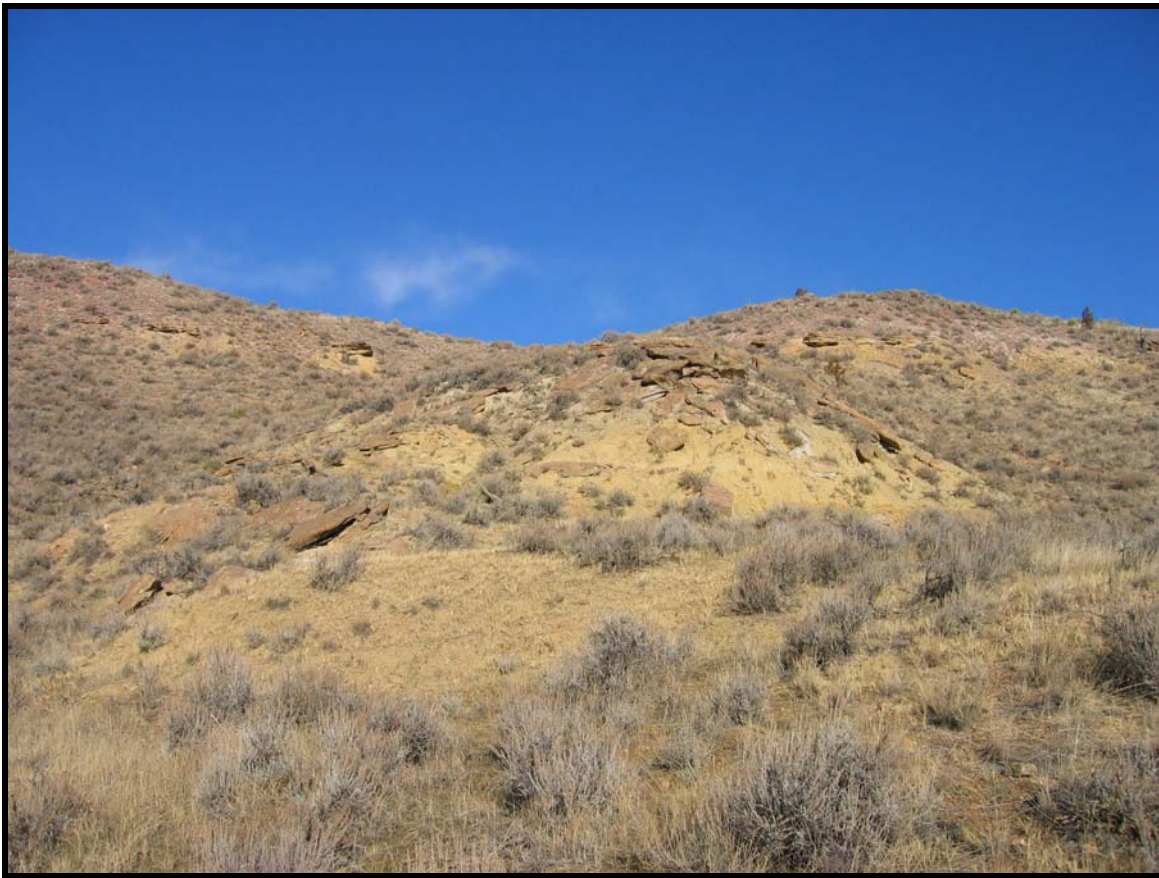
ROCK OUTCROP FEATURE: RO_0007

DESCRIPTION OF FEATURE: The rock outcrop shown above is located on the top of a small mound of soft sandy silt. The flat, rectangular rocks are stacked, which leaves voids between and below the outcrop. Holes in the soil beneath the rocks are frequent in this feature.

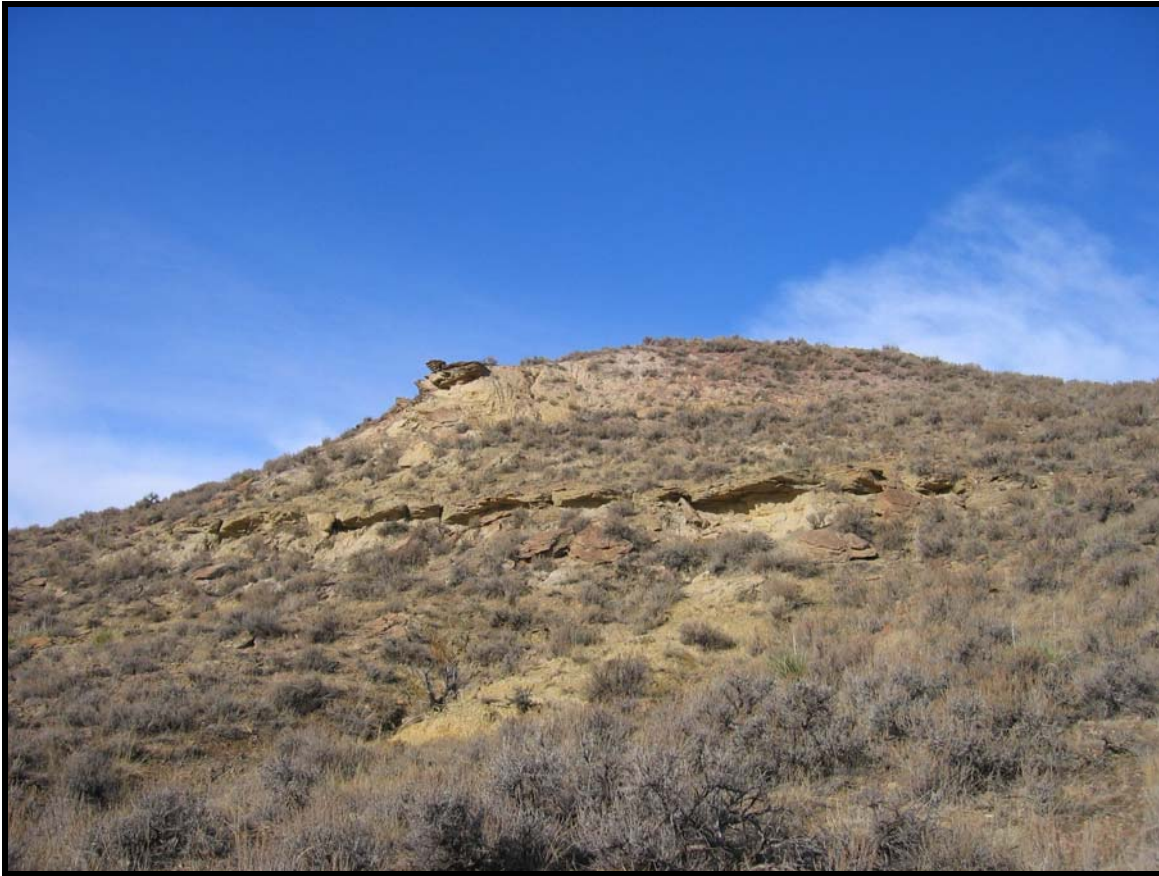
ROCK OUTCROP FEATURE: RO_0008

DESCRIPTION OF FEATURE: The rock outcrop shown above is composed of sandstone/siltstone rocks, which are weathered and stacked. The feature sits on sandy silt soil, which is highly erosive. As the sand beneath the rock layer is eroded, overhangs and more outcrops are created. This feature also includes a very small cliff-like feature at the top of the slope.

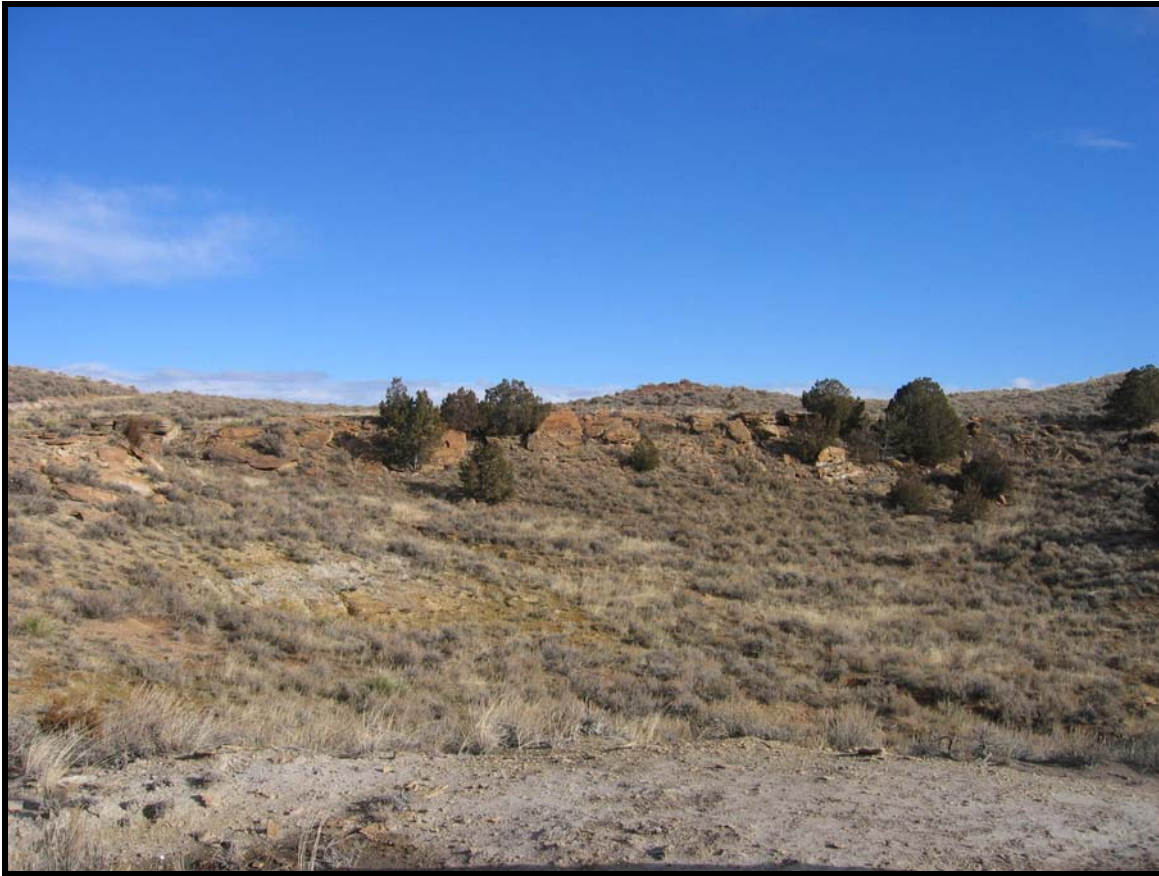
ROCK OUTCROP FEATURE: RO_0009

DESCRIPTION OF FEATURE: The rock outcrop shown above is located at the top of a small hill. The sandstone/siltstone rocks are large and are aligned in a long, narrow pattern. Voids between and below the rocks are frequent in this feature.

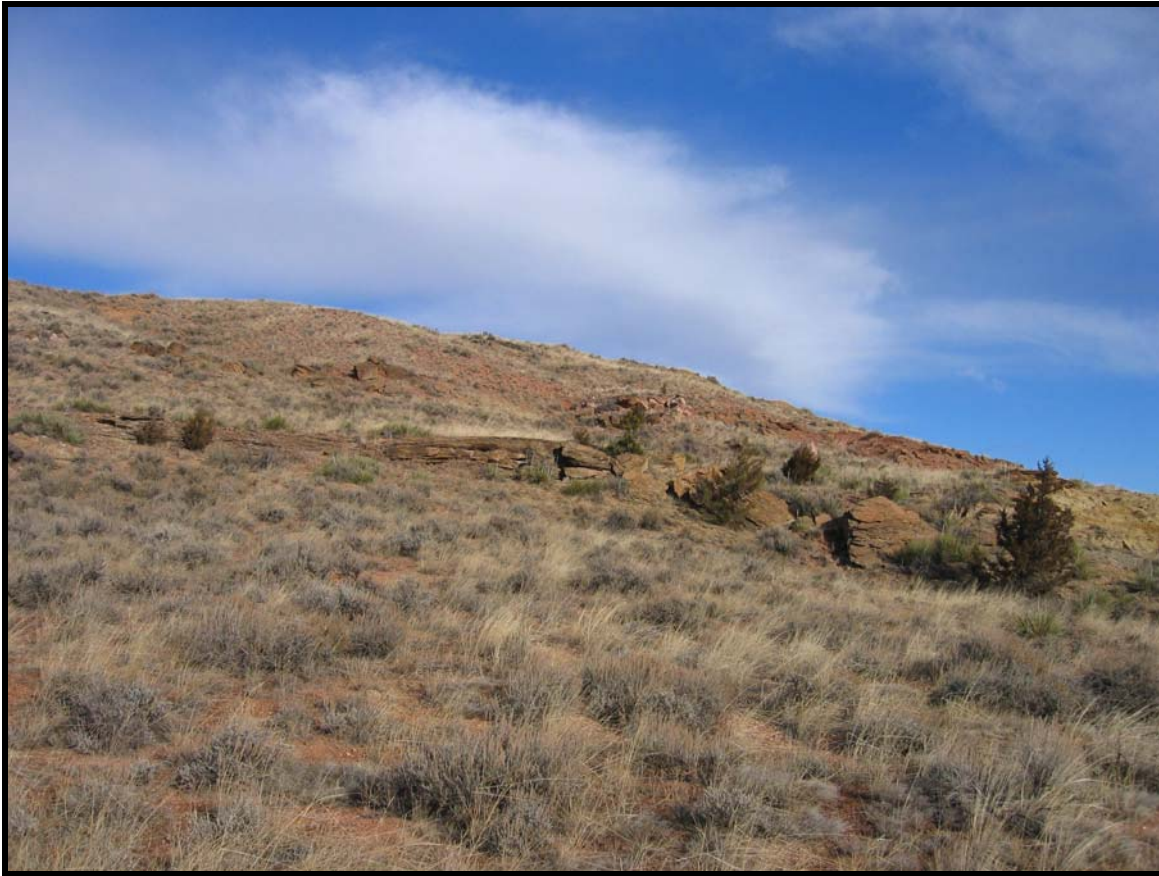
ROCK OUTCROP FEATURE: RO_0010

FEATURE TYPE:	Rock Outcrop		
GEOMETRIC DIMENSIONS:	Length: 230 ft	Height: 5 ft	
LOCATION:	Township: 8S	Range: 39E	Section: 36
HANDHELD GPS POINTS:	Northing	Easting	
	2038	407558.97 2673157.17	
	2039	407608.48 2673109.05	
	2040	407706.57 2672984.40	
SUBSTRATE:	Siltstone		
EXPOSURE:	Southern facing slope		
DESCRIPTION OF FEATURE:	The rock outcrop shown above is composed of sandstone/siltstone rocks, which are weathered and layered. The feature sits on sandy silt soil, which is highly erosive. The surrounding slope is vegetated with grass, sagebrush, and some small trees.

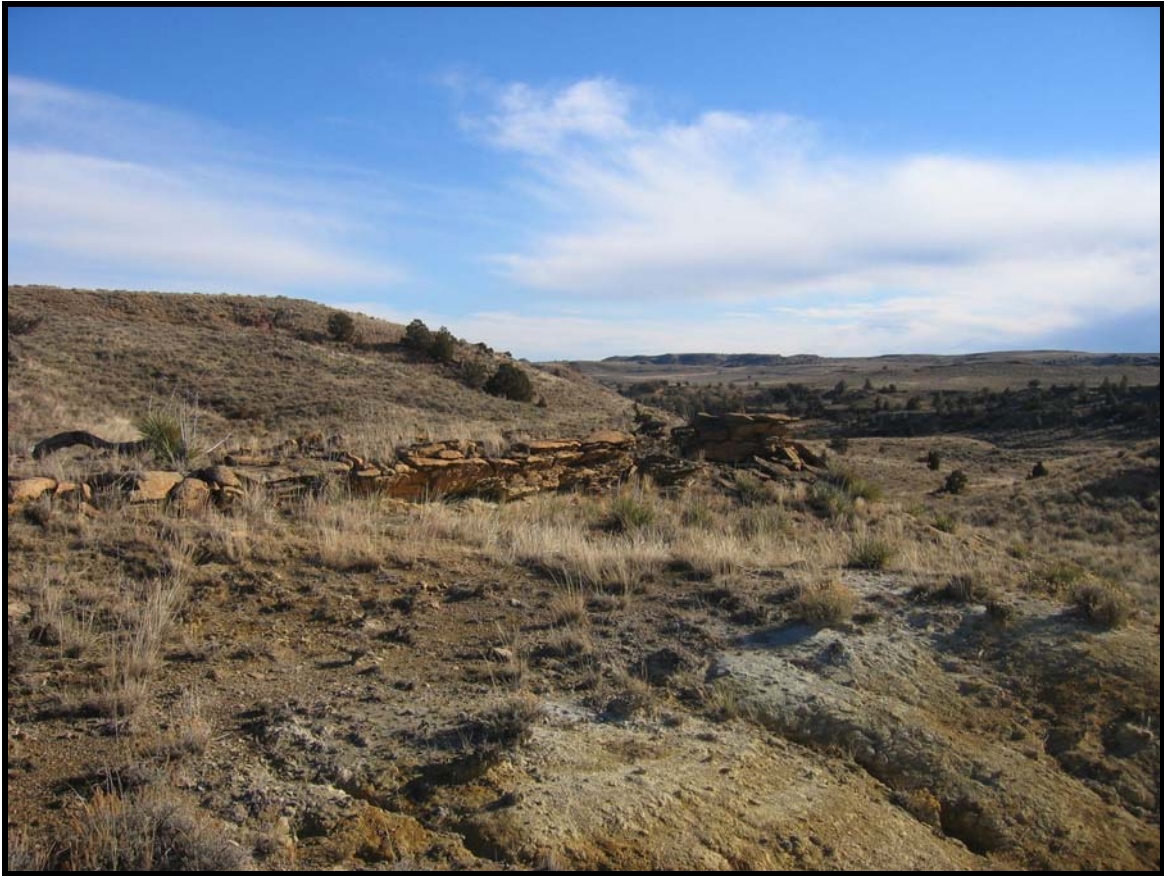
ROCK OUTCROP FEATURE: RO_0011

DESCRIPTION OF FEATURE: The rock outcrop shown above is composed of sandstone/siltstone rocks, which are weathered and layered. Voids between and below the rocks are created as erosion continues.

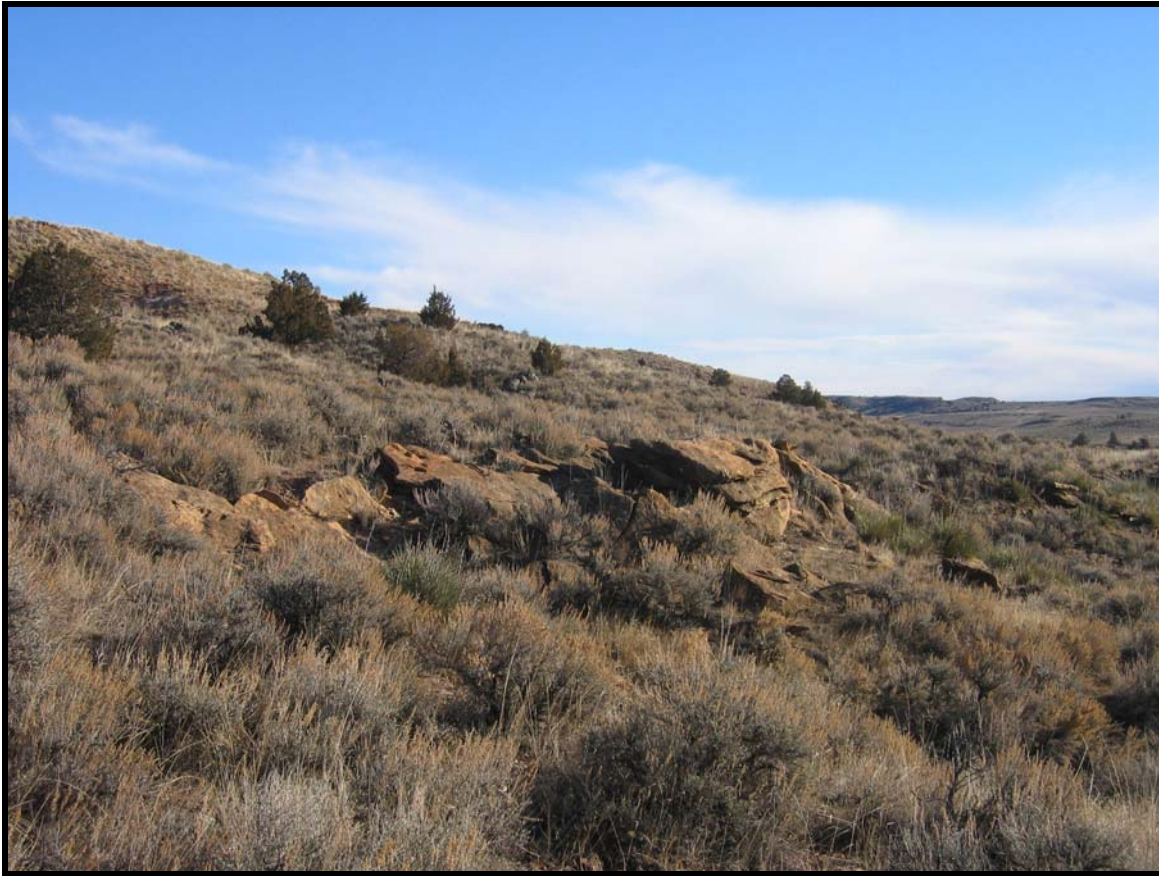
ROCK OUTCROP FEATURE: RO_0012

DESCRIPTION OF FEATURE: The rock outcrop shown above is composed of sandstone/siltstone rocks, which are weathered and layered. The feature sits on sandy silt soil, which is highly erosive. The surrounding slope is vegetated with grass, sagebrush, and some small trees.

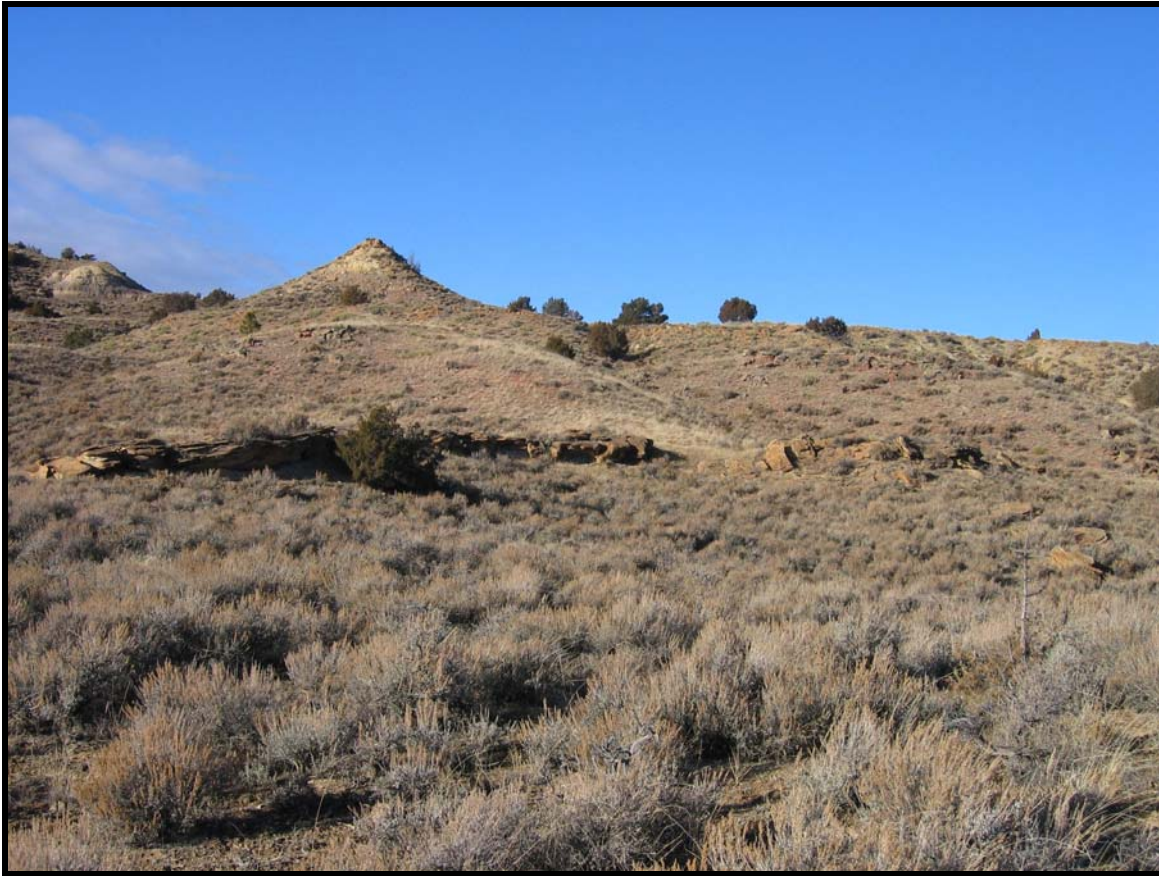
ROCK OUTCROP FEATURE: RO_0013

DESCRIPTION OF FEATURE: The rock outcrop shown above is located on a moderately sloped hill. The sandstone/siltstone rocks are aligned in a long, narrow pattern. This feature is located in an area that is vegetated with grass and sagebrush.

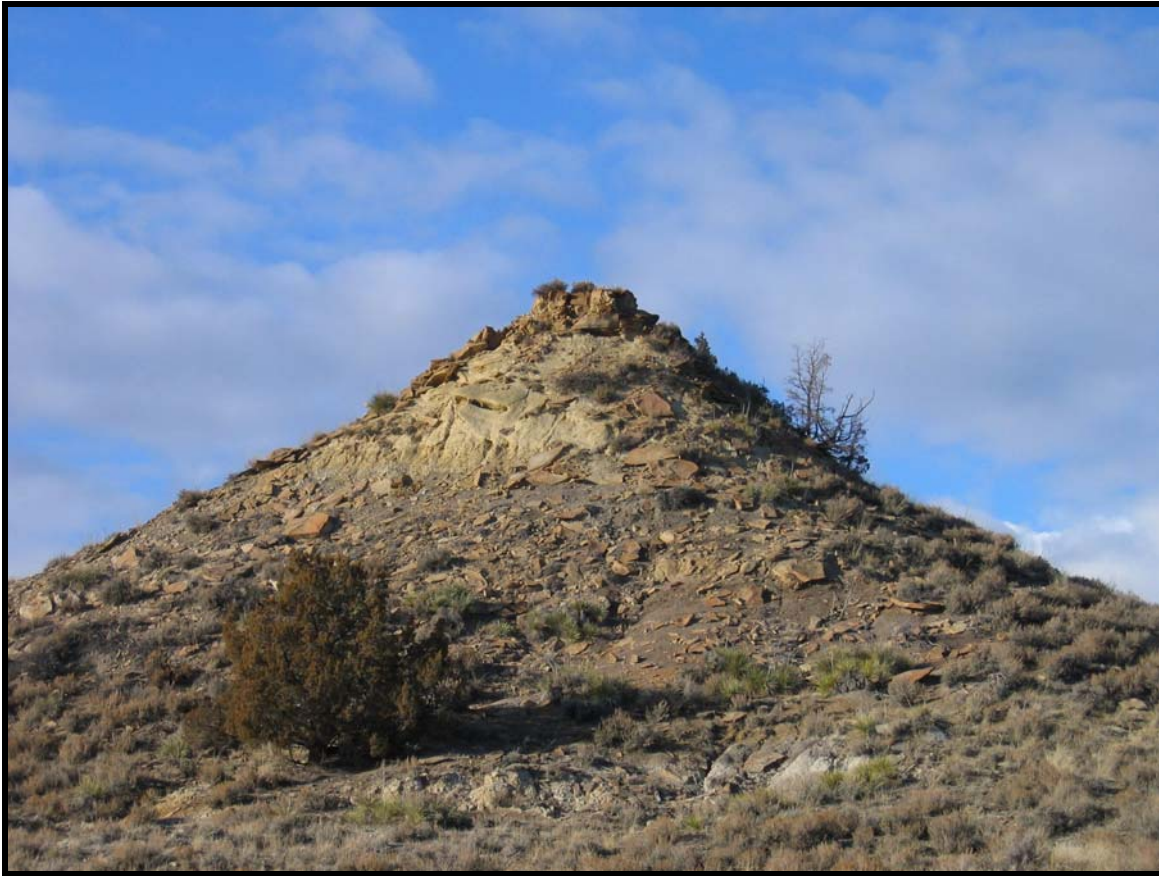
ROCK OUTCROP FEATURE: RO_0014

FEATURE TYPE:	Rock Outcrop					
GEOMETRIC DIMENSIONS:	Area of outcrop: 0.52 acres					
LOCATION:	Township: 8S		Range: 39E		Section: 36	
HANDHELD GPS POINTS:		Northing	Easting		Northing	Easting
	2049	409034.78	2671424.43	2053	409122.20	2671307.90
	2050	408998.22	2671309.34	2054	409195.58	2671321.02
	2051	409051.20	2671255.94	2055	409118.09	2671406.22
	2052	409105.36	2671238.68			
SUBSTRATE:	Sandstone/siltstone					
EXPOSURE:	Not applicable					
DESCRIPTION OF FEATURE:	The rock outcrop shown above is located on a pointed hill. The rocks are composed of sandstone/siltstone and lie over a 360 degree pattern around the point of this hill. The subsoil is sandy silt and is highly erosive.

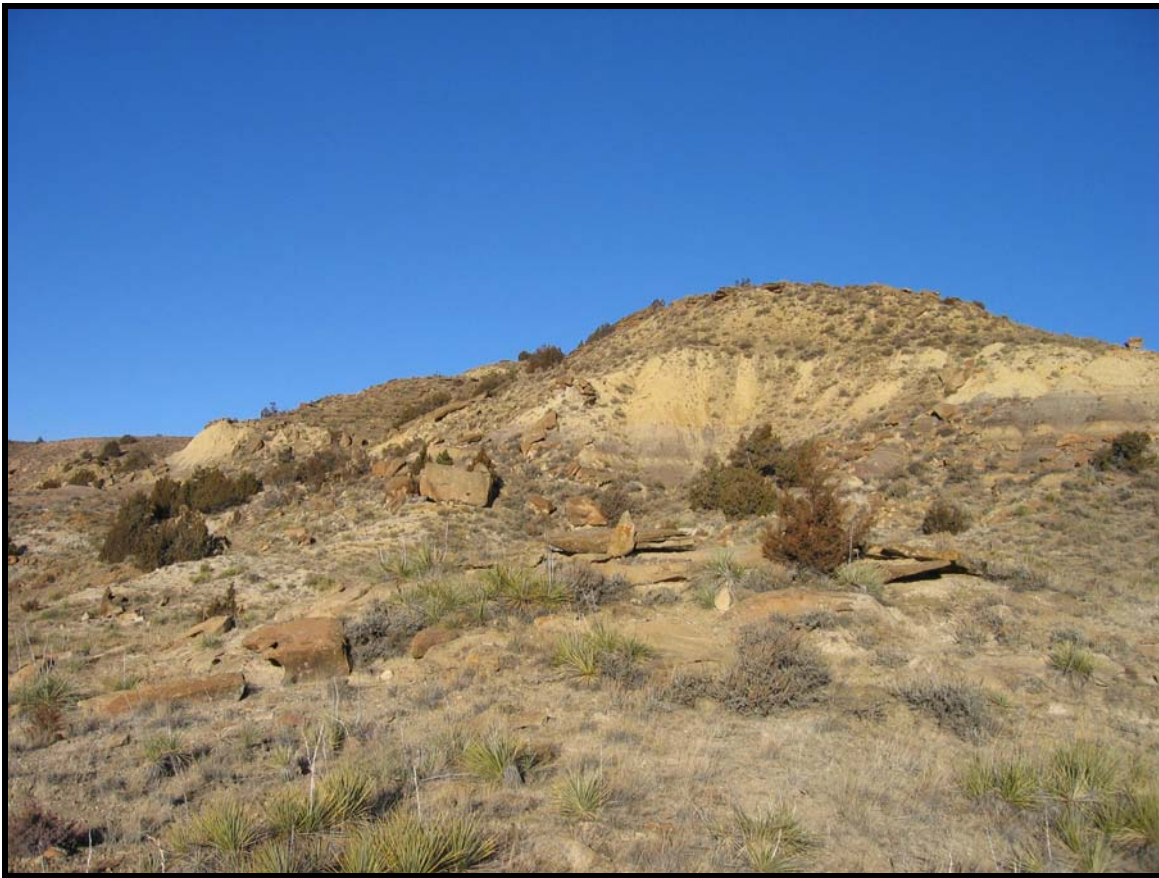
ROCK OUTCROP FEATURE: RO_0015

DESCRIPTION OF FEATURE: The large outcrop shown above is located on a steep (greater than 3H:1V), sandy silt slope. The rocks in this outcrop are large, rectangular and create many areas of protection. The rocks appear to be deposited on the slope due to the erosion of a thick rock layer towards the top of the hill. See the pictures on the following pages for additional views of this feature.

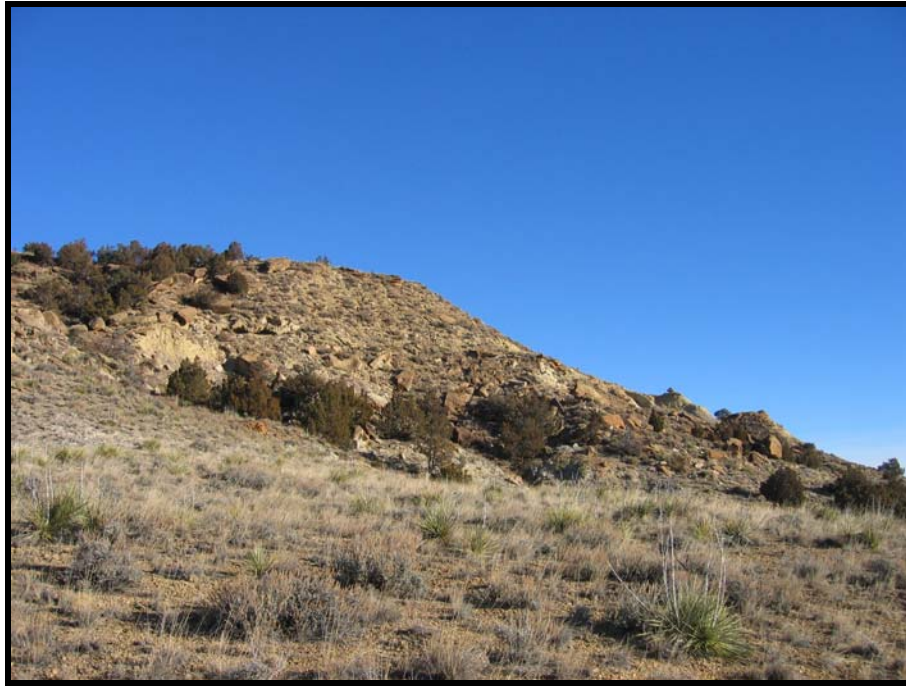
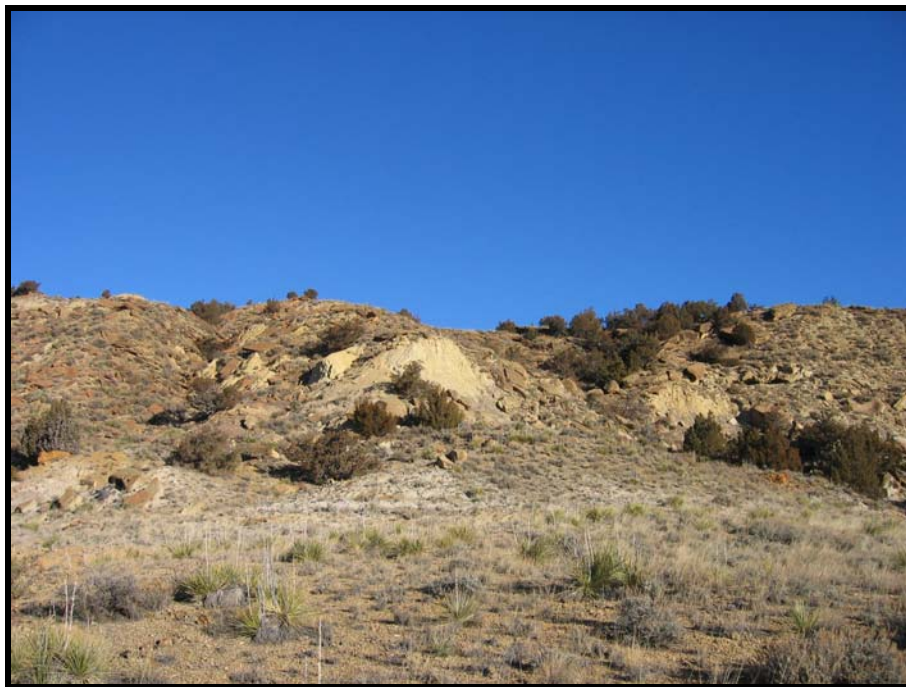
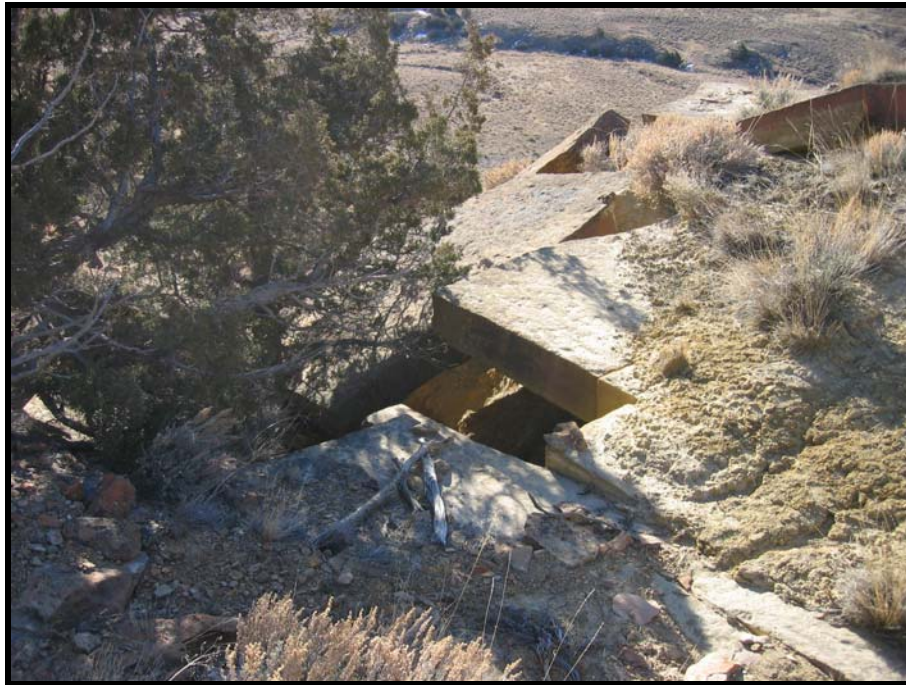
ROCK OUTCROP FEATURE: RO_0015

Photo: 1_5_06_02

Looking Northeast

Photo: 1_5_06_03

Looking North

Photo: 1_5_06_04

Looking South

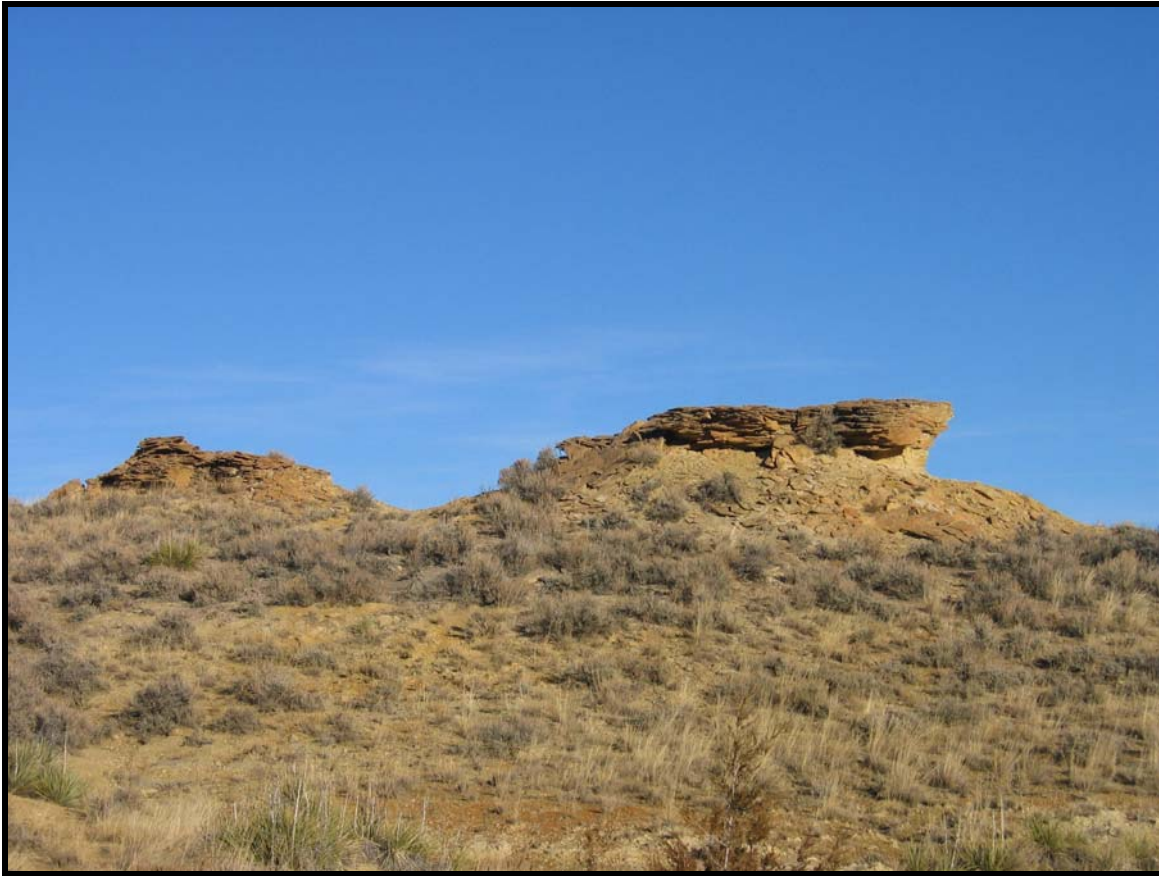
ROCK OUTCROP FEATURE: RO_0017

DESCRIPTION OF FEATURE: The rock outcrop shown above is composed of sandstone/siltstone rocks, which are weathered and stacked. Voids between and below the rocks are created as erosion continues. The feature sits on soft, sandy silt soil.

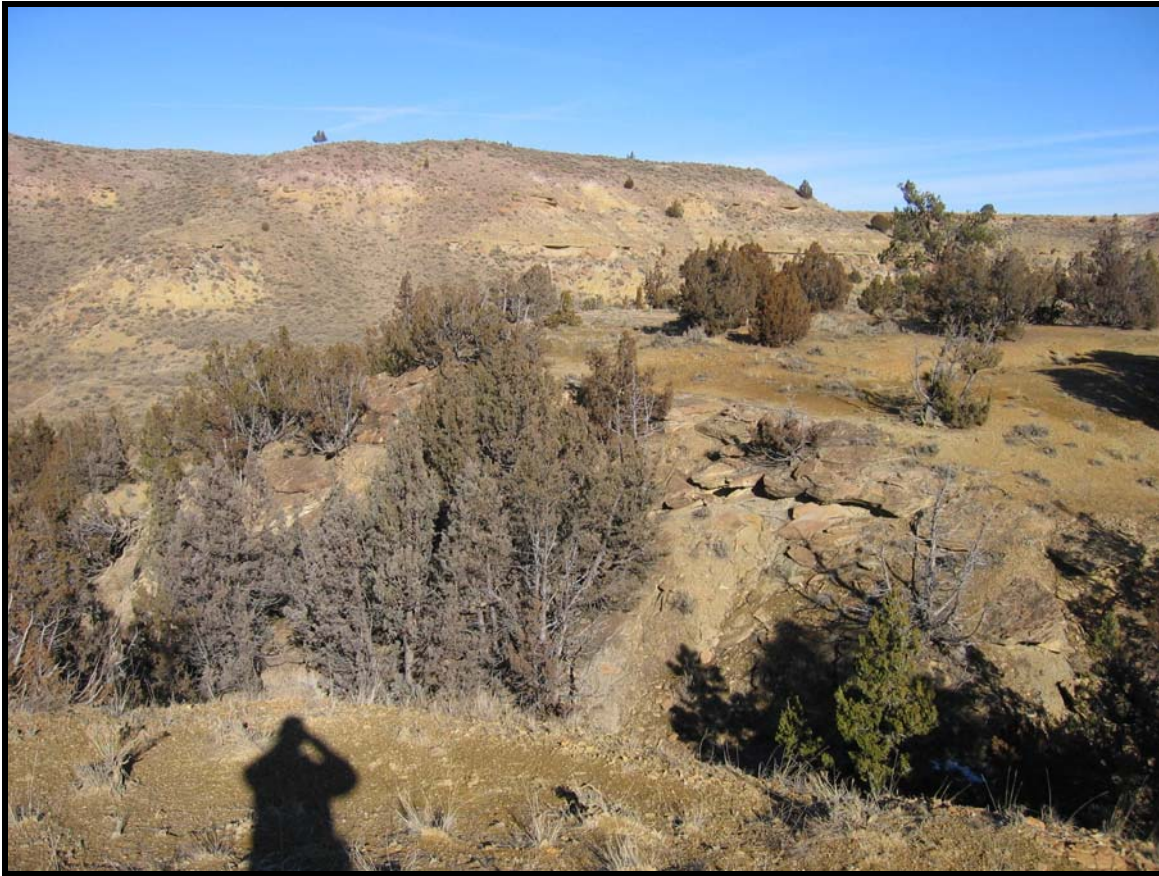
ROCK OUTCROP FEATURE: RO_0020

DESCRIPTION OF FEATURE: Rock outcrops like the one shown above are common in the Pearson Creek drainage area. This rock outcrop is located at the top of a small draw, and erosion from runoff flows has cut the rock and the subsoil. Overhangs are frequent in this feature.

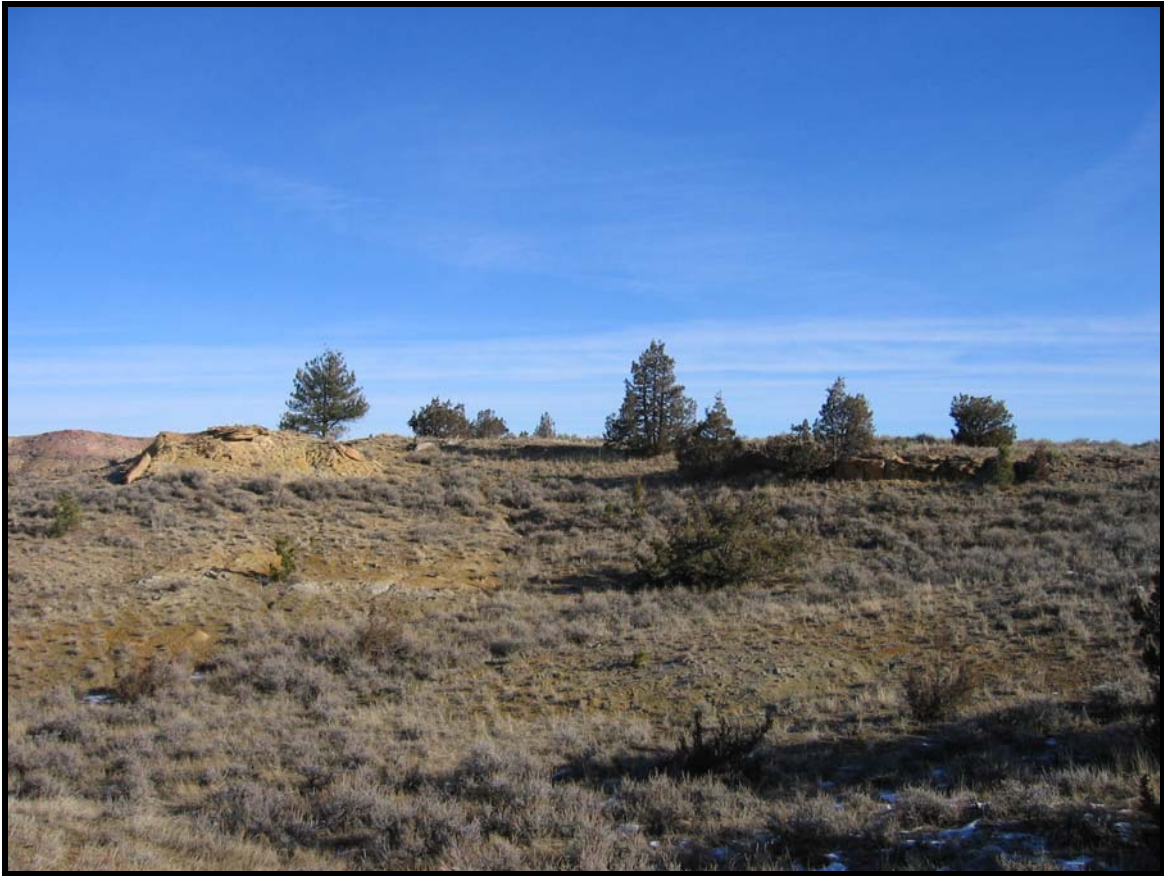
ROCK OUTCROP FEATURE: RO_0021

DESCRIPTION OF FEATURE: The rock outcrop shown above sits at the top of a small hill. The rock is layered sandstone, which has frequent holes and voids along its length. See the picture on the following page for another view of this feature.

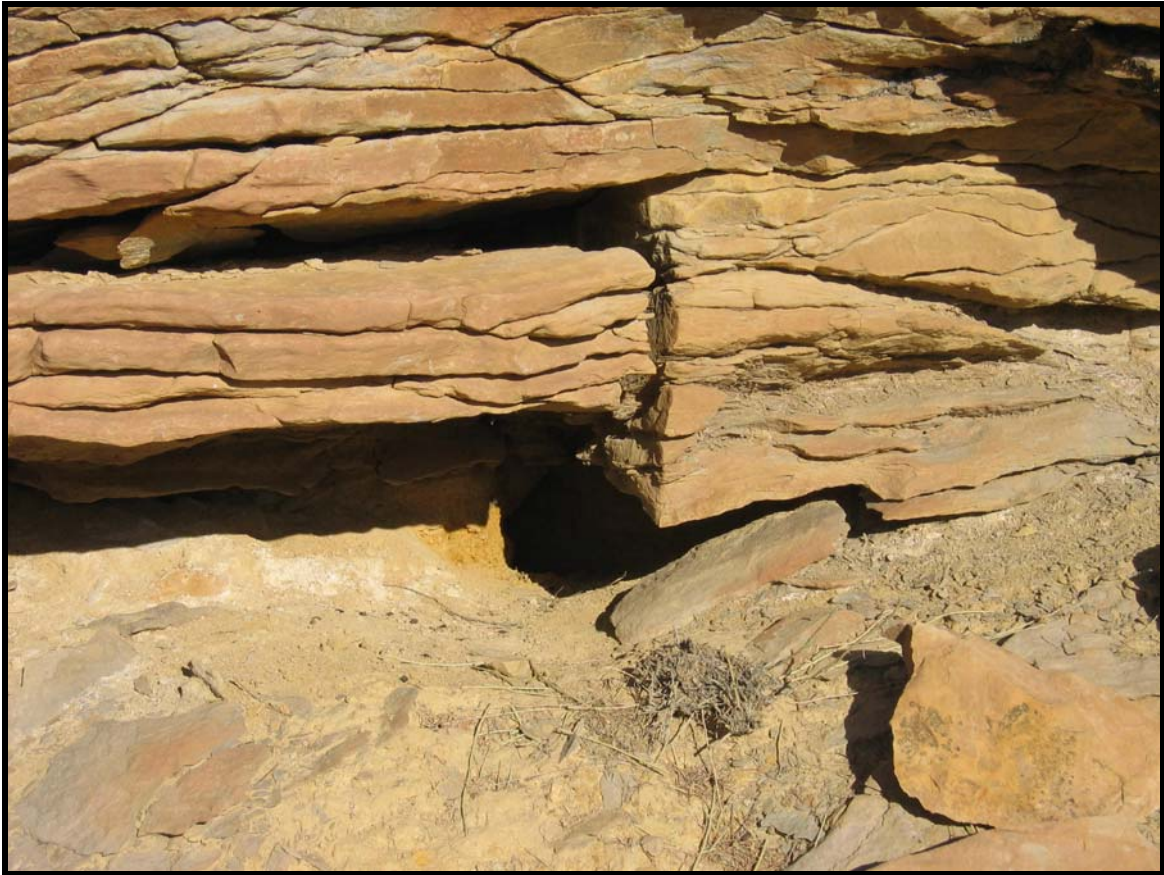
ROCK OUTCROP FEATURE: RO_0021

Photo: 1_9_06_19

Looking North

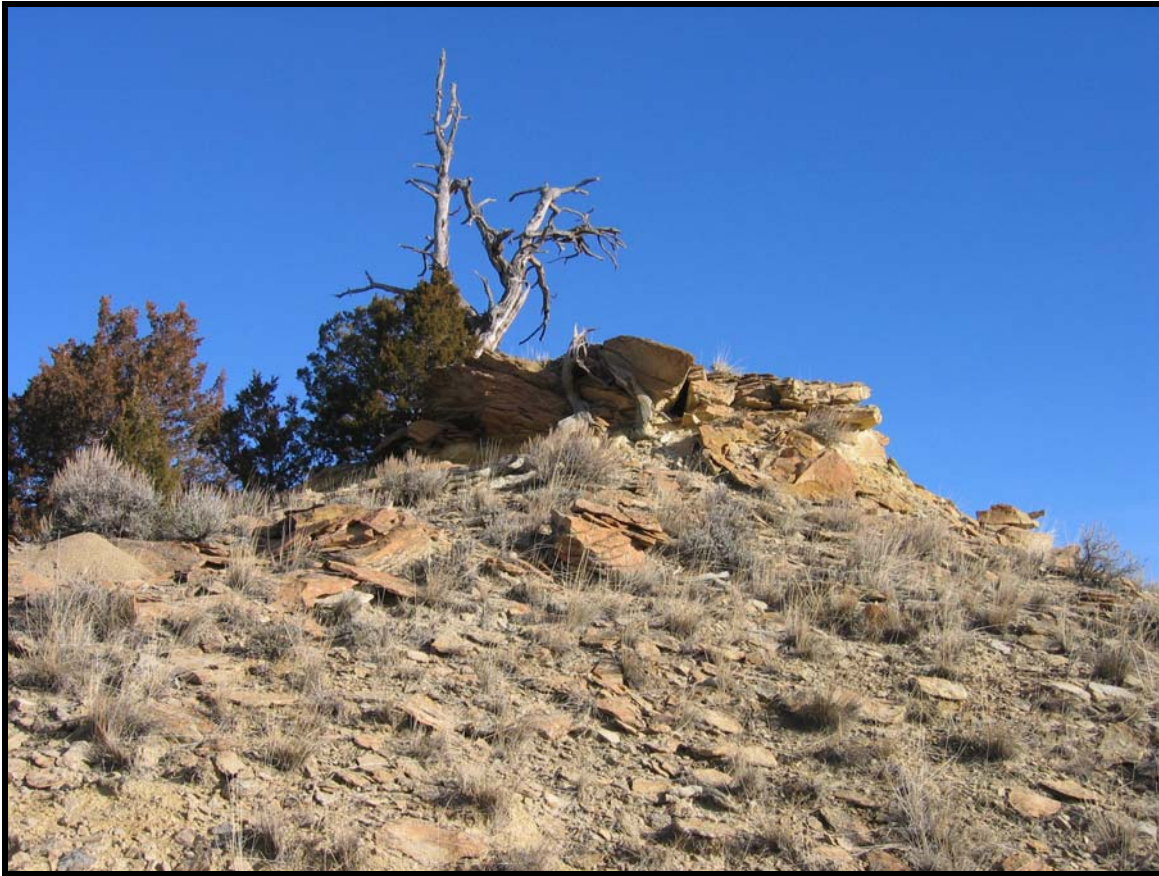
ROCK OUTCROP FEATURE: RO_0022

DESCRIPTION OF FEATURE: The rock outcrop shown above is composed of sandstone/siltstone rocks, which are weathered and layered. Small rocks have been deposited along the sandy silt slope below the feature. The vegetation around this feature is grass, sagebrush, and some small trees.

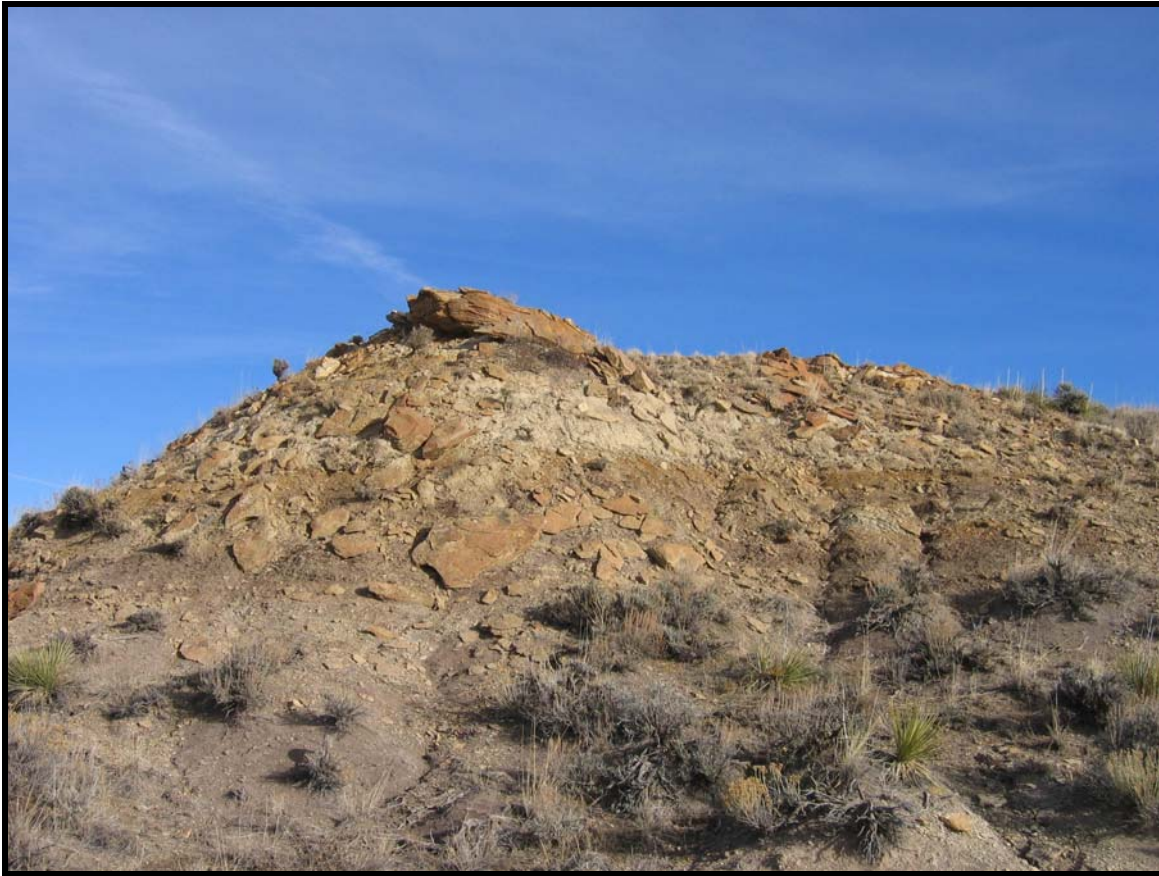
ROCK OUTCROP FEATURE: RO_0023

DESCRIPTION OF FEATURE: The rock outcrop shown above is composed of sandstone/siltstone rocks, which have been exposed due to erosion of the sandy silt slope below the rock layer. Rocks have been deposited on the slope below the feature, creating additional habitat.

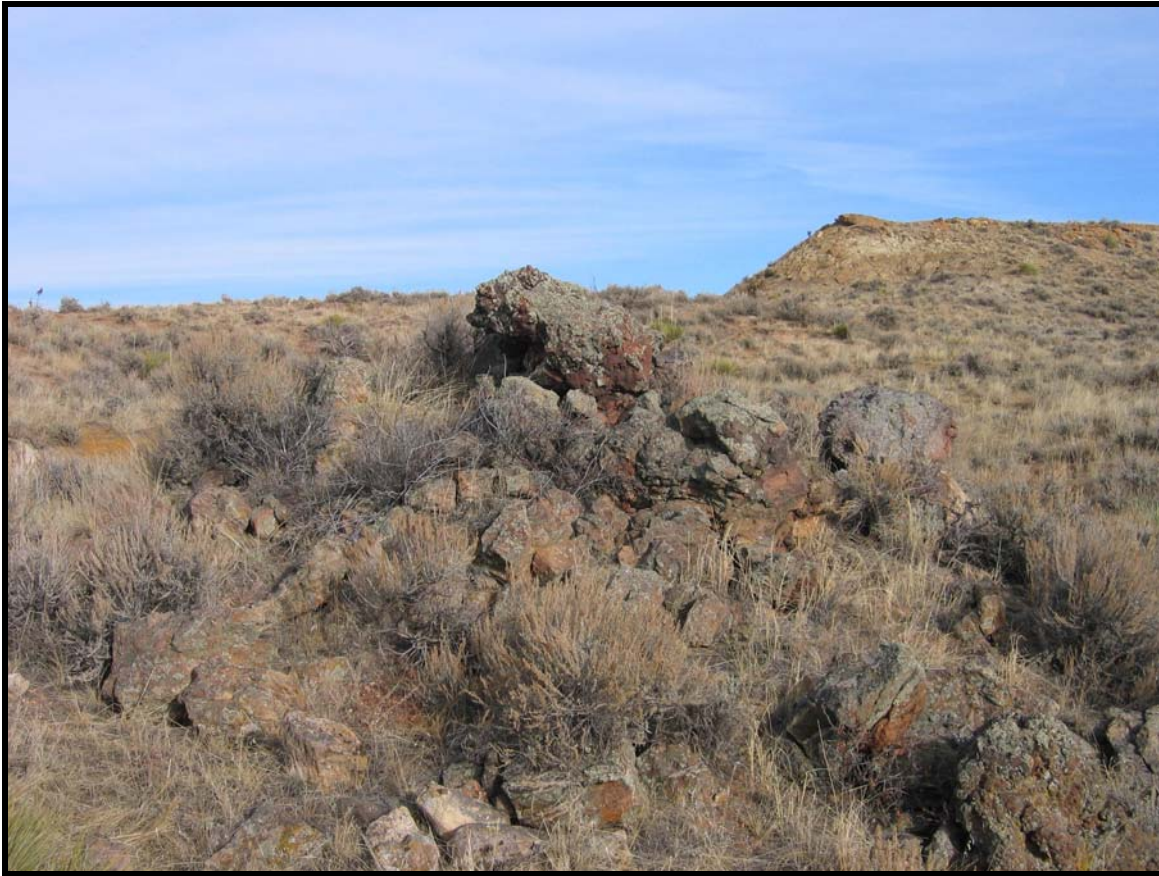
ROCK OUTCROP FEATURE: RO_0024

FEATURE TYPE:	Rock Outcrop				
GEOMETRIC DIMENSIONS:	Area of outcrop: 0.01 acres				
LOCATION:	Township: 8S		Range: 39E		Section: 36
HANDHELD GPS POINTS:		Northing	Easting		Northing
	4046	405788.91	2672343.87	4049	405815.42
	4047	405786.27	2672374.97	4050	405789.58
	4048	405786.52	2672382.71		2672374.02
					2672364.53
SUBSTRATE:	Scoria				
EXPOSURE:	Southern facing slope				
DESCRIPTION OF FEATURE:	Scoria outcrops like the one shown above are common in this area. This feature is composed of scoria that varies in size from small to a several feet in diameter. The feature is located in an area that is relatively flat and is vegetated with grass and sagebrush.

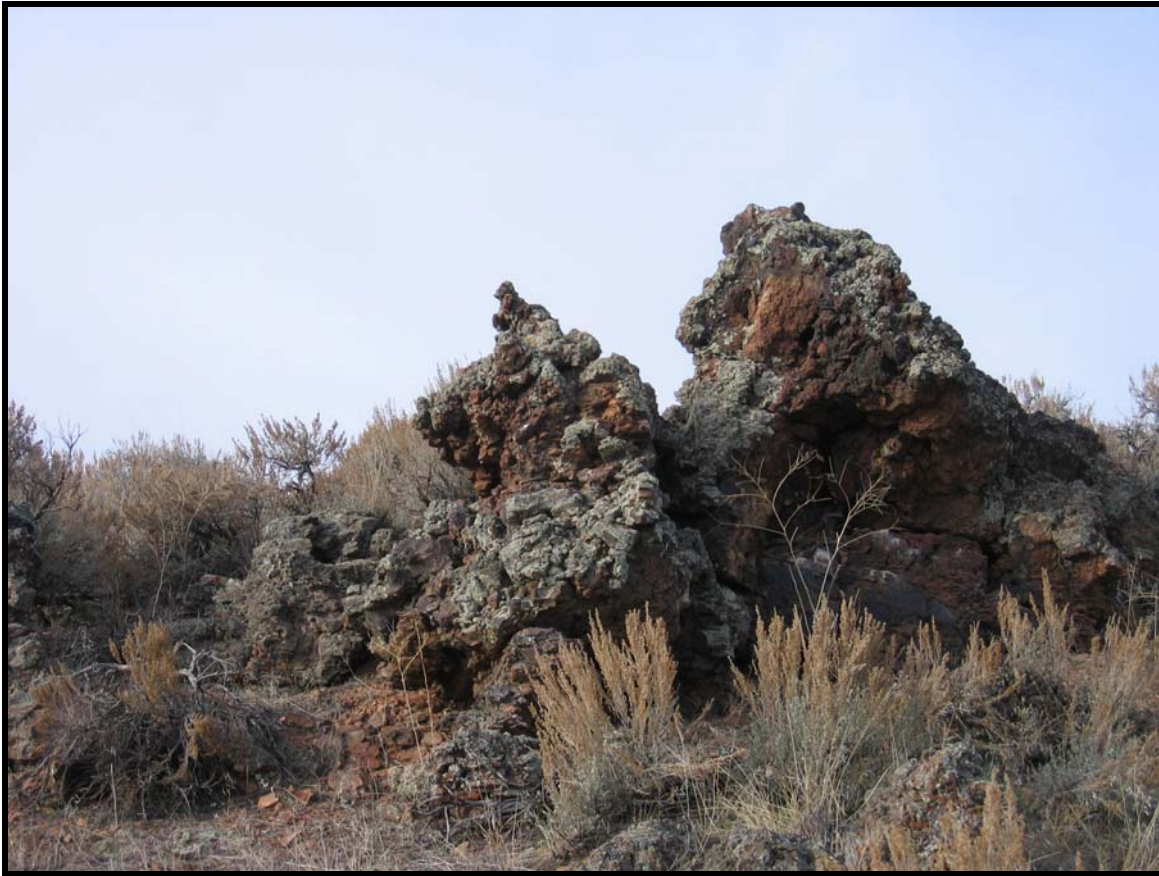
ROCK OUTCROP FEATURE: RO_0025

FEATURE TYPE:	Rock Outcrop		
GEOMETRIC DIMENSIONS:	Length: 25 ft	Height: 10 ft	
LOCATION:	Township: 8S	Range: 39E	Section: 36
HANDHELD GPS POINTS:	Northing	Easting	
	4051	405769.52 2672308.32	
	4052	405761.98 2672300.81	
	4053	405754.52 2672295.89	
SUBSTRATE:	Scoria		
EXPOSURE:	Southern facing slope		
DESCRIPTION OF FEATURE:	Scoria outcrops like the one shown above are common in this area. This feature is composed of scoria that varies in size from small to a several feet in diameter. The feature is located in an area that is relatively flat and is vegetated with grass and sagebrush.
