Township 8S, Range 39E
SECTION 36

Cliff Features

Revised 4/06; Reference – South Fork Extension Amendment #00174

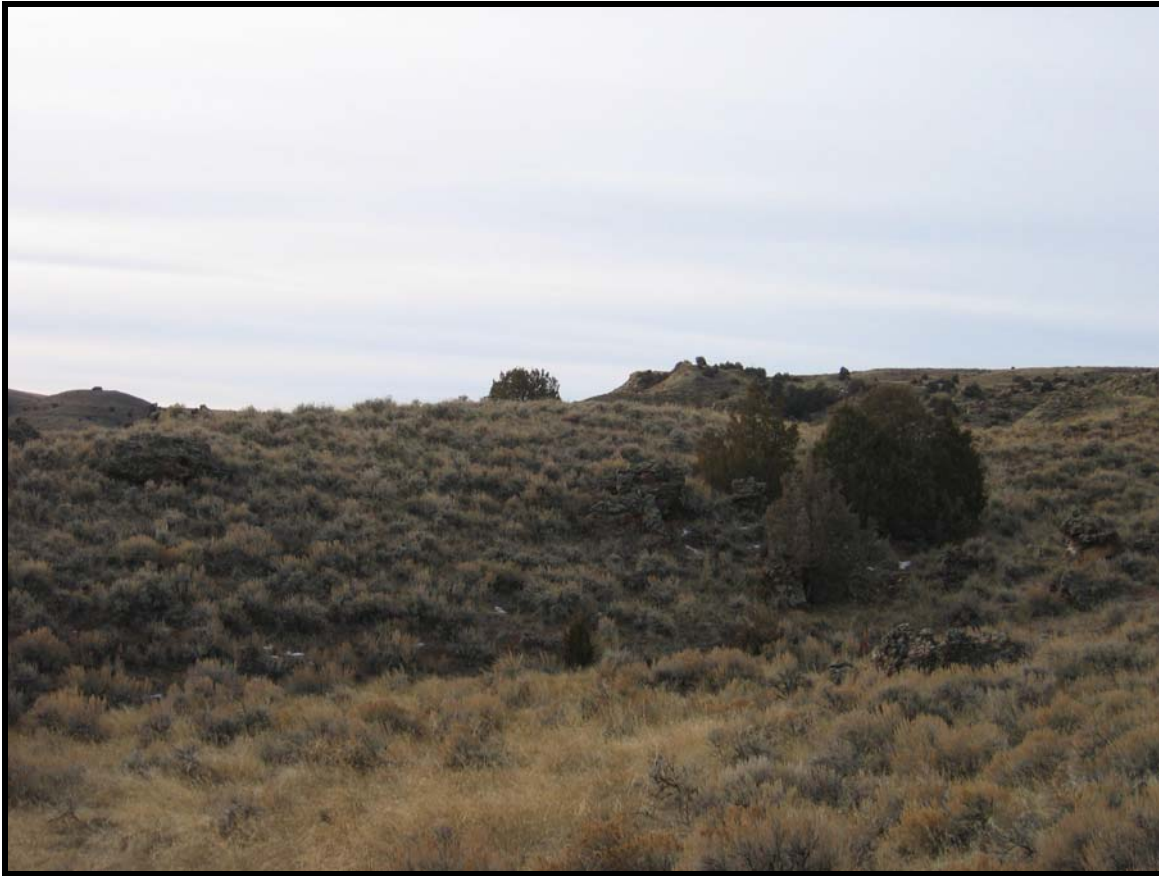
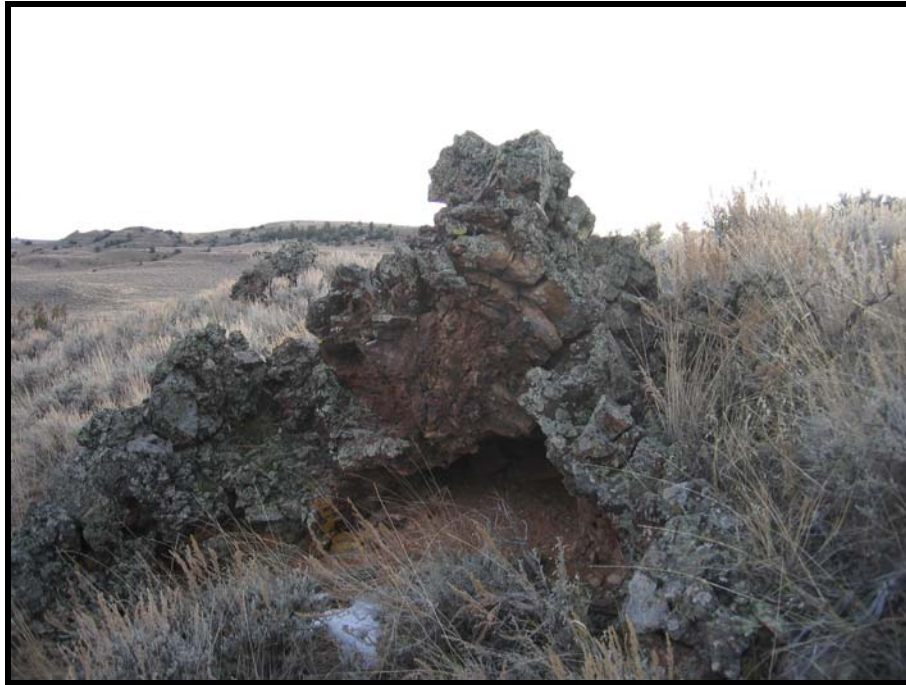
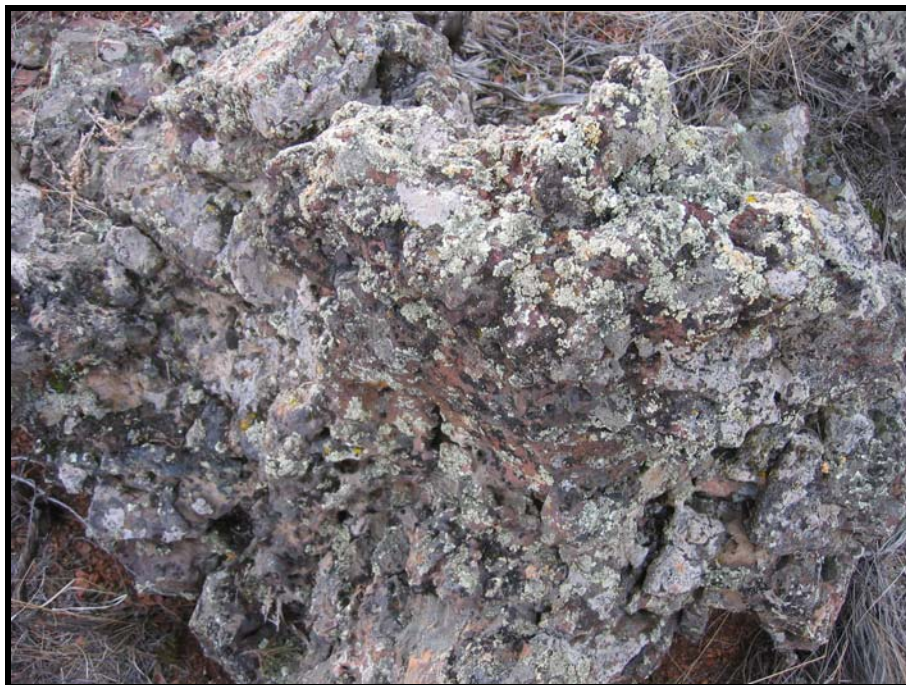
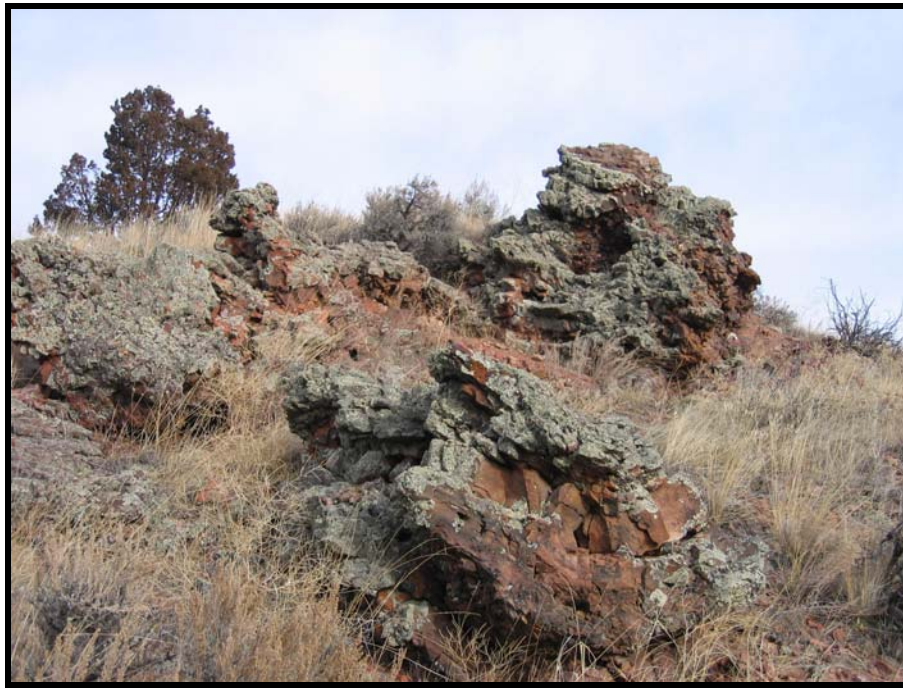
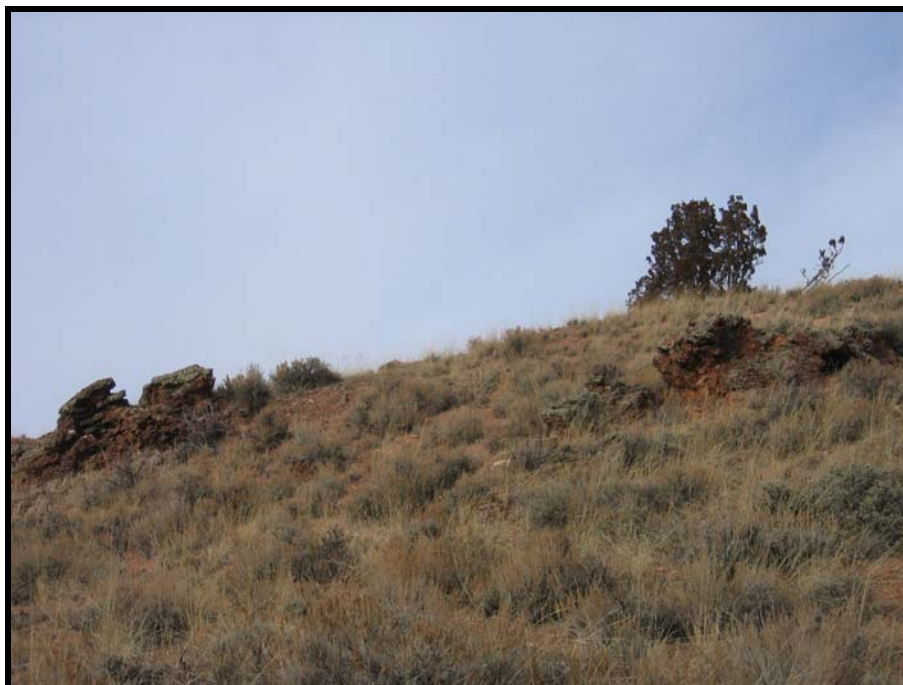
ROCK OUTCROP FEATURE: RO_0026

FEATURE TYPE:	Rock Outcrop		
GEOMETRIC DIMENSIONS:	Length: 25 ft	Height: 10 ft	
LOCATION:	Township: 8S	Range: 39E	Section: 36
HANDHELD GPS POINTS:	Northing	Easting	
	4051	405769.52 2672308.32	
	4052	405761.98 2672300.81	
	4053	405754.52 2672295.89	
SUBSTRATE:	Scoria		
EXPOSURE:	Southern facing slope		
DESCRIPTION OF FEATURE:	Scoria outcrops like the one shown above are common in this area. This feature is composed of scoria that varies in size from small to a several feet in diameter. The feature is located in an area that is relatively flat and is vegetated with grass and sagebrush.

Photo: 1_9_06_24

Looking West

Photo: 1_9_06_25

Looking South

Photo: 1_9_06_26

Looking Southeast

Photo: 1_9_06_27

Looking North

Photo: 1_9_06_28

Looking Northwest

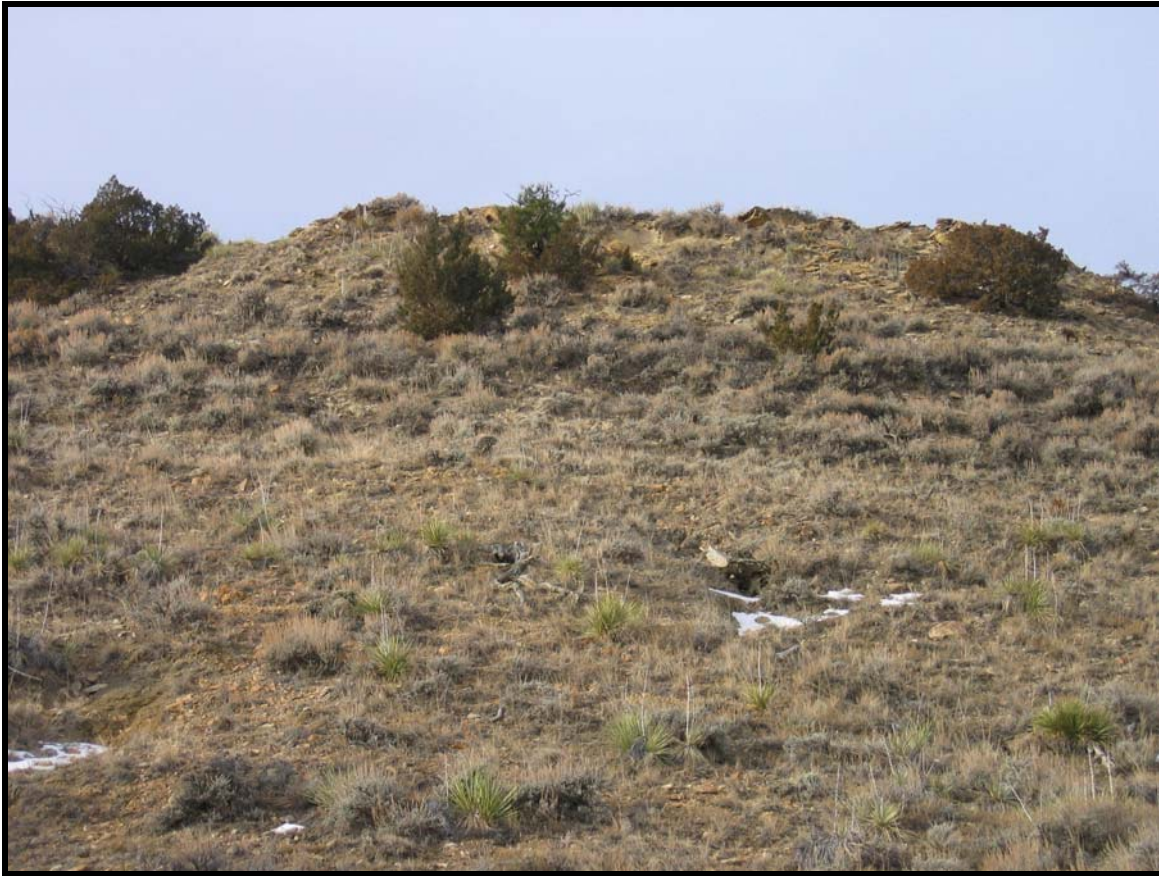
ROCK OUTCROP FEATURE: RO_0026a

DESCRIPTION OF FEATURE: The rock outcrop shown above is composed of sandstone/siltstone rocks, which are weathered and low-lying. The feature is located on a slope that is vegetated with grass and sagebrush.

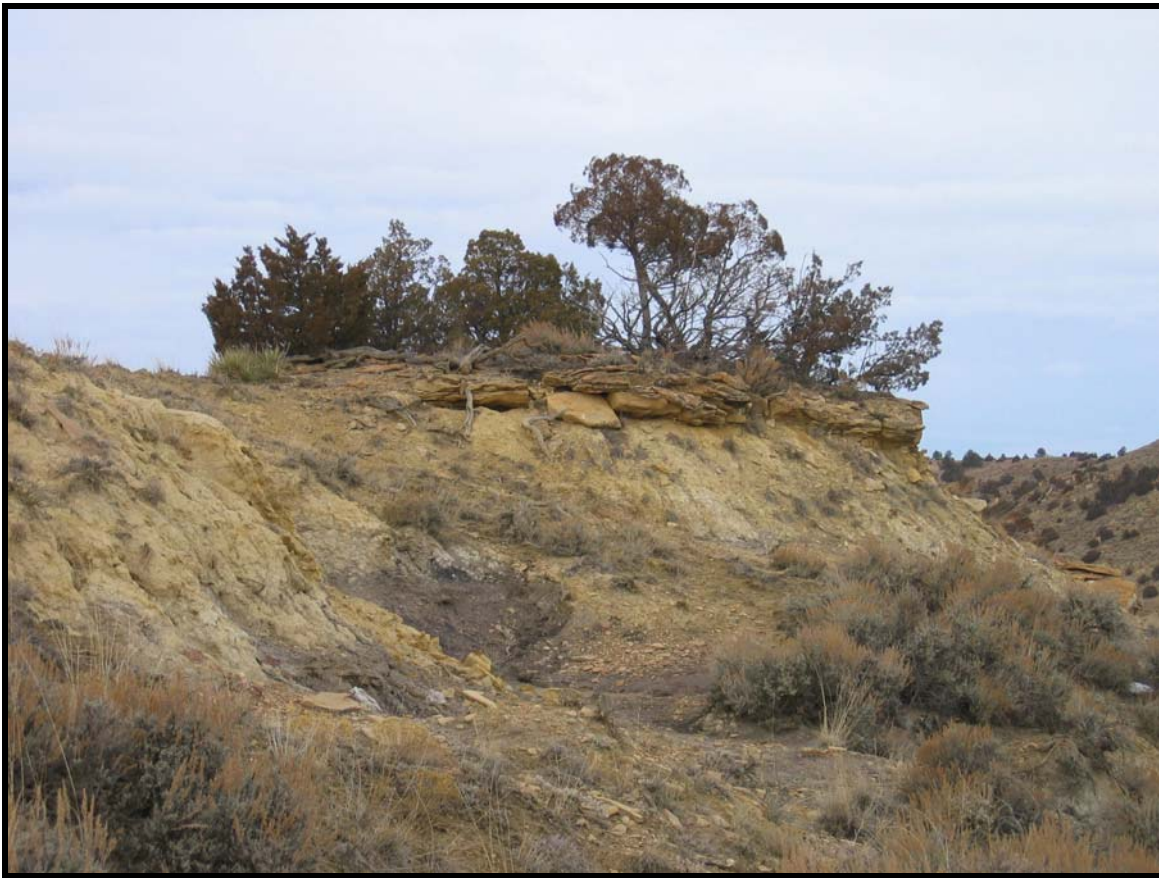
ROCK OUTCROP FEATURE: RO_0027

DESCRIPTION OF FEATURE: The rock outcrop shown above is composed of sandstone/siltstone rocks, which are weathered and layered. Voids between and below the rocks are created as erosion continues.

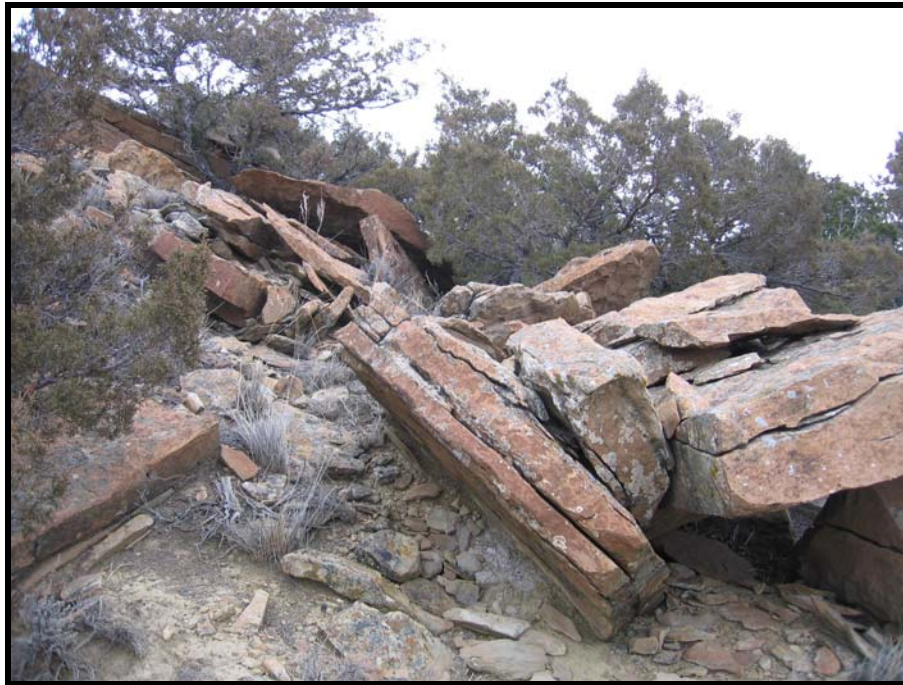
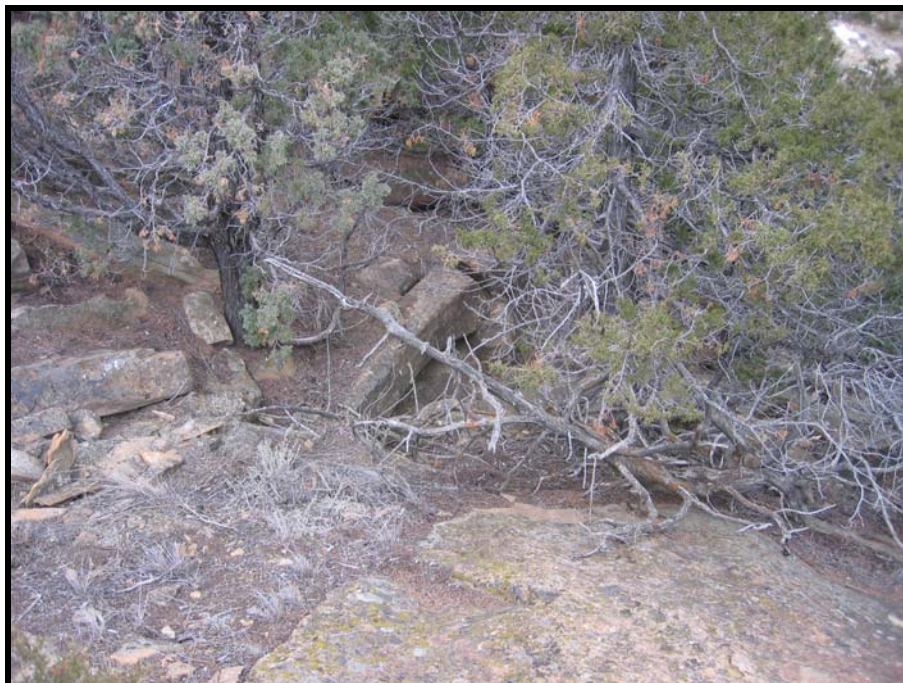
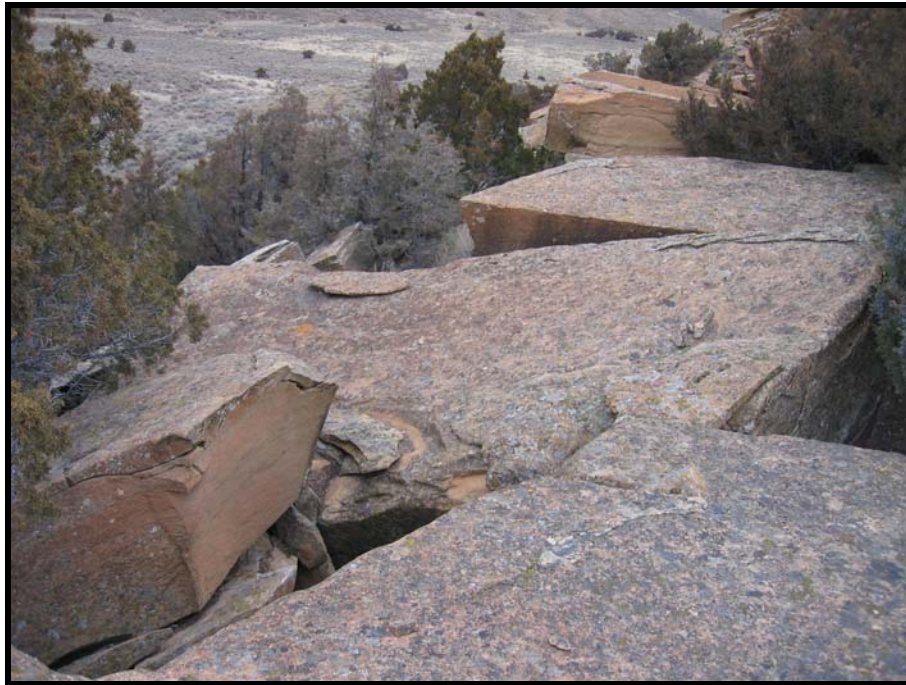
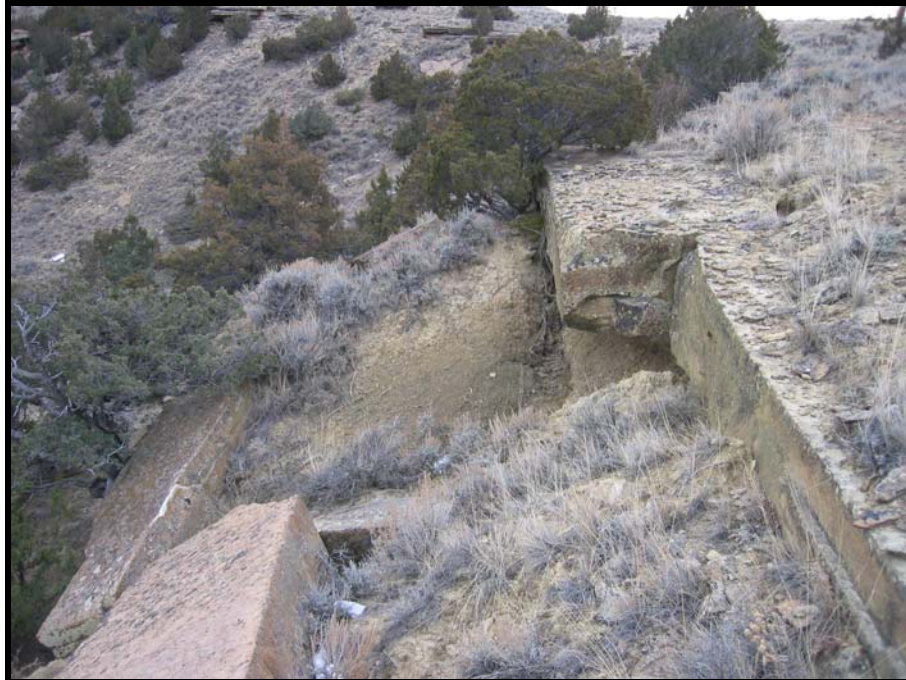
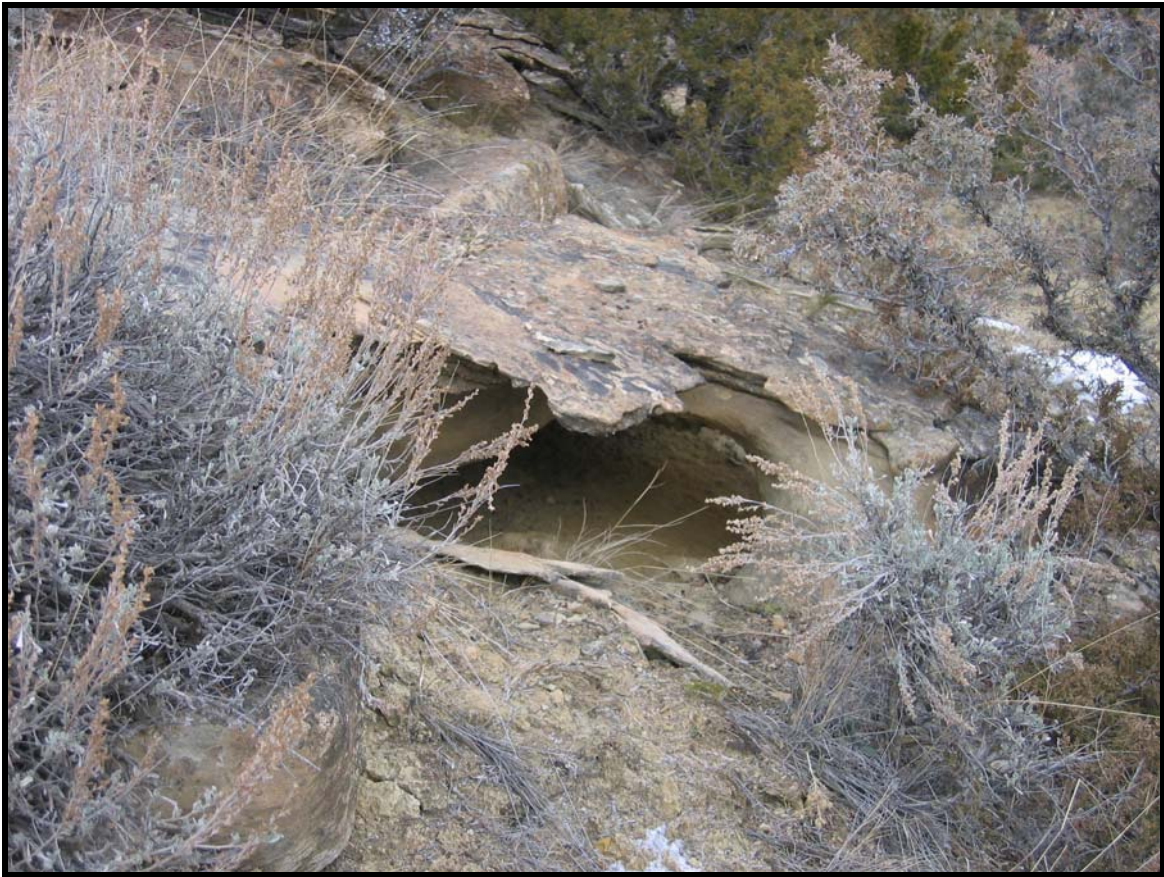
ROCK OUTCROP FEATURE: RO_0028

DESCRIPTION OF FEATURE: The rock outcrop shown above is composed of sandstone/siltstone rocks, which lie at the top of a northern facing slope. The rock layer is approximately 10 to 15 feet thick. Many rocks have been deposited on the slope due to erosion. See the pictures on the following pages for additional views of this feature.

Photo: 1_10_06_12

Looking South

Photo: 1_10_06_13

Photo: 1_10_06_14

Looking Northwest

Photo: 1_10_06_15

Looking Southeast

Photo: 1_10_06_16

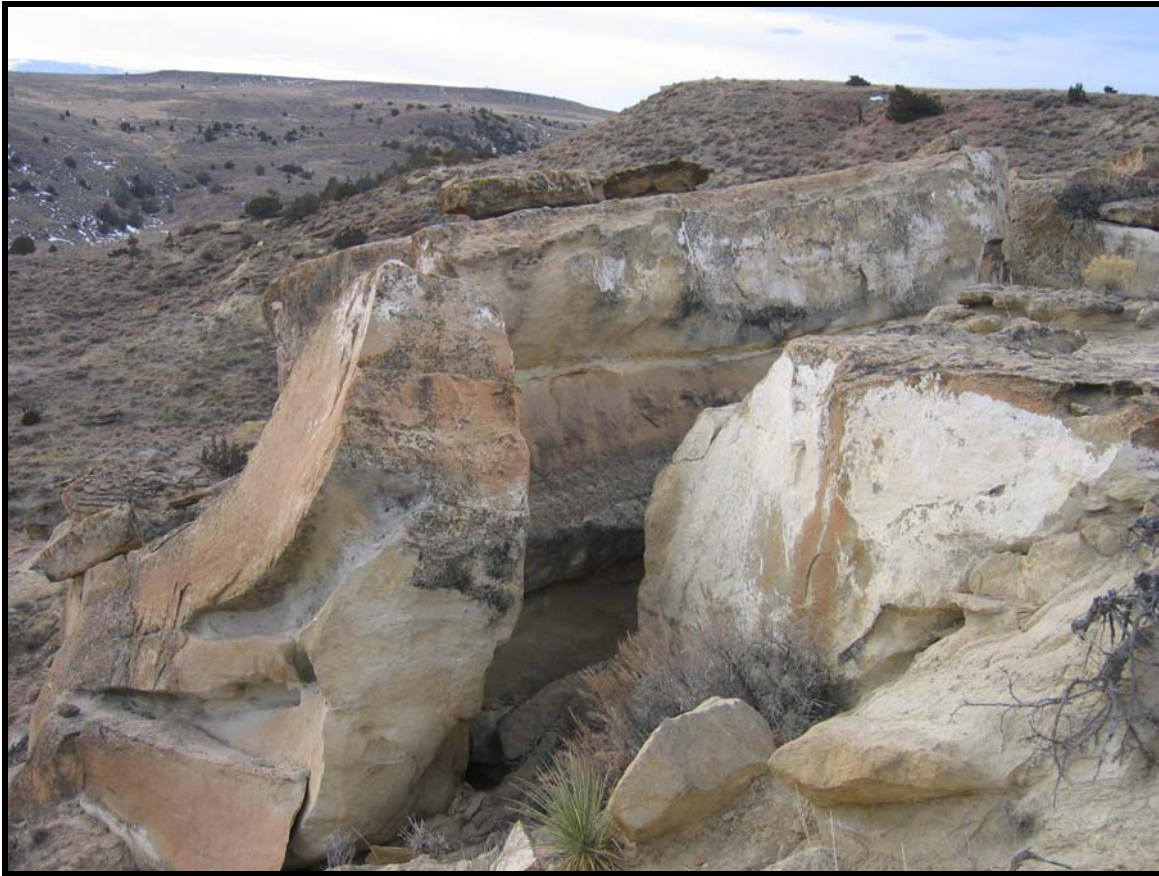
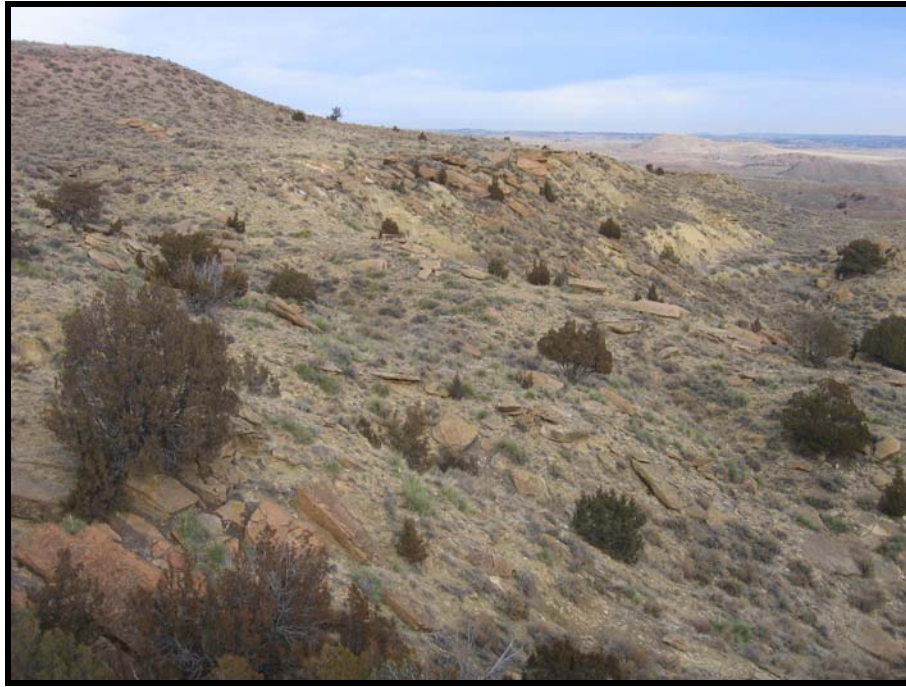
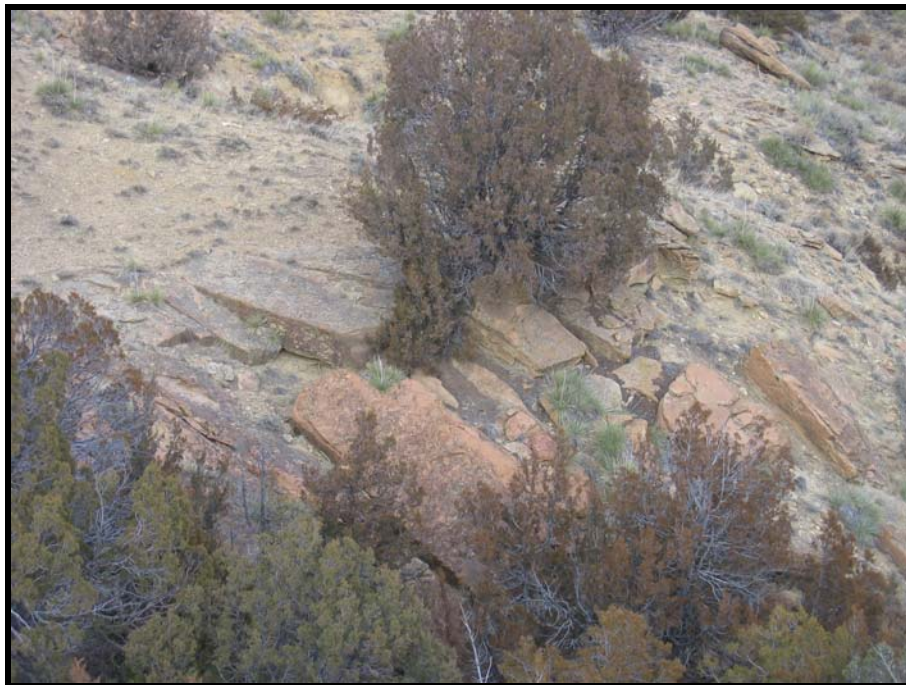
ROCK OUTCROP FEATURE: RO_0038

Photo: 1_10_06_51

Looking East

DESCRIPTION OF FEATURE: The rock outcrop shown above is composed of sandstone/siltstone rocks, which lie at the top of a southern facing slope. The rock layer is approximately 10 to 15 feet thick. Many rocks have been deposited on the slope due to erosion. See the pictures on the following pages for additional views of this feature.

Photo: 1_10_06_52

Photo: 1_10_06_53

Looking Northeast

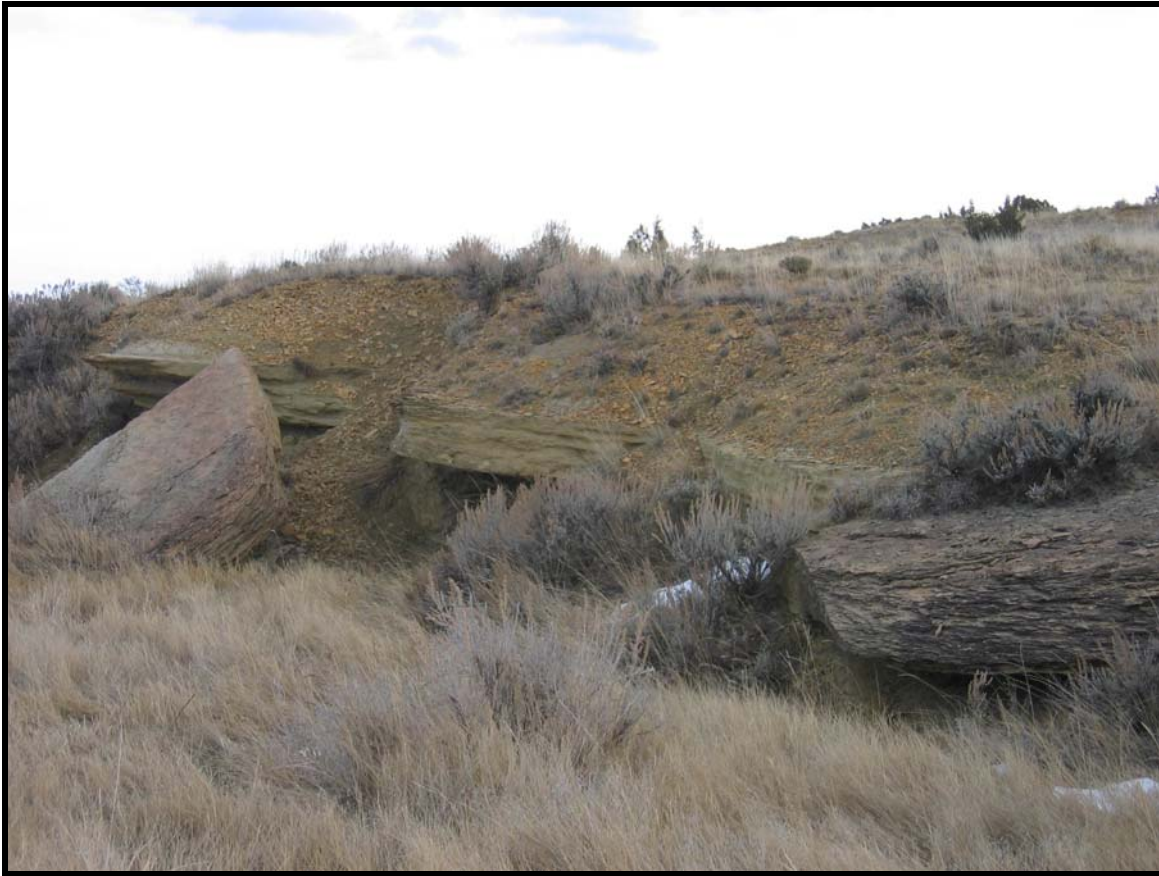
ROCK OUTCROP FEATURE: RO_0041

DESCRIPTION OF FEATURE: This rock outcrop is composed of a sandstone/siltstone rock layer that has been exposed due to erosion caused by runoff flows. This feature is located adjacent to the Pearson Creek channel bottom.

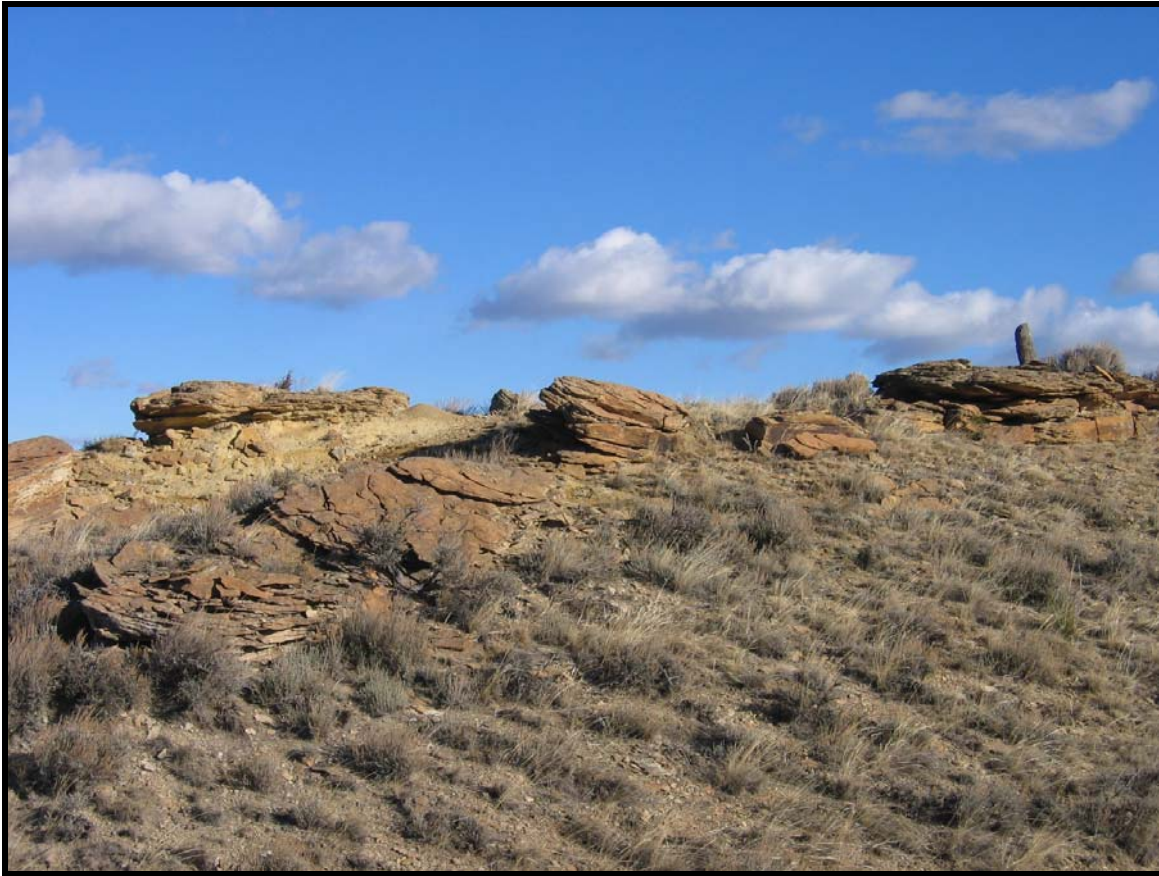
ROCK OUTCROP FEATURE: RO_0081

DESCRIPTION OF FEATURE: The rock outcrop shown above is composed of layered, sandstone/siltstone rocks, which are weathered. The feature sits on sandy silt soil, which is highly erosive. The surrounding slope is vegetated with grass and sagebrush.

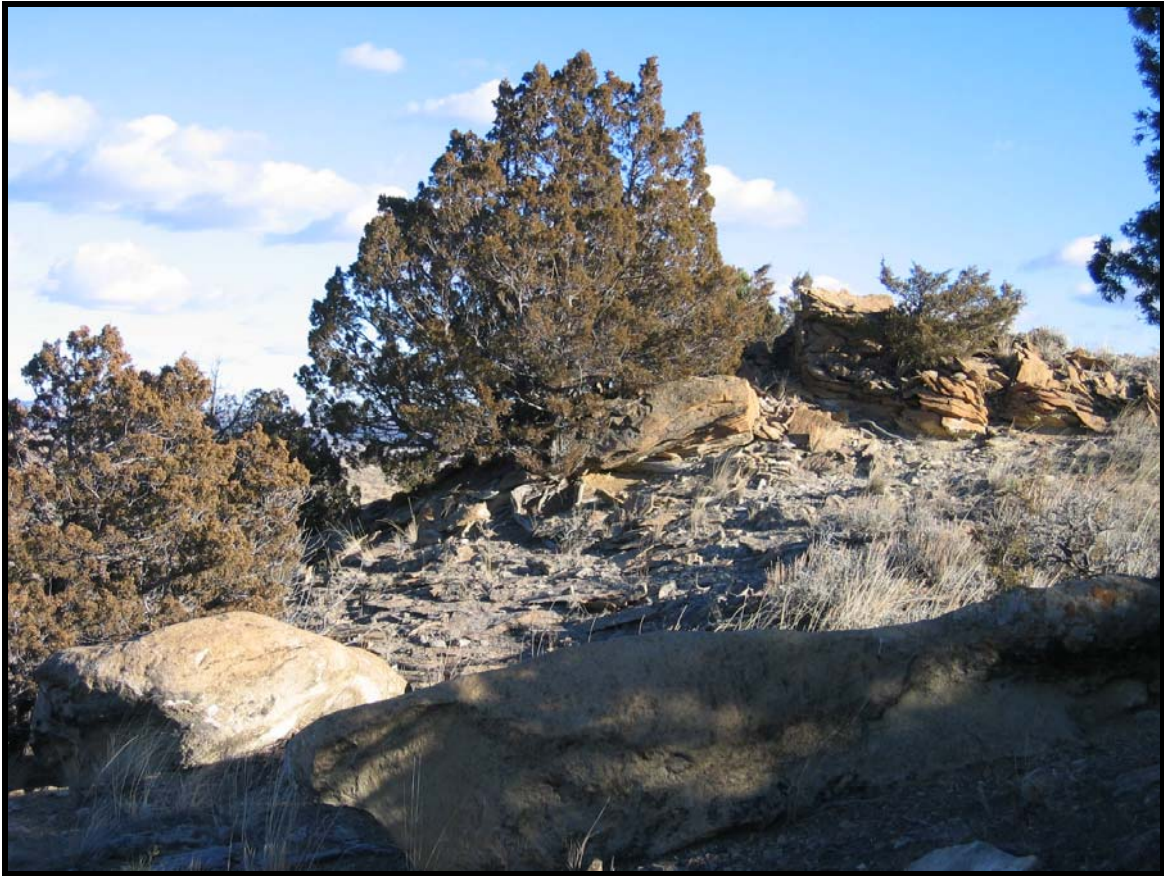
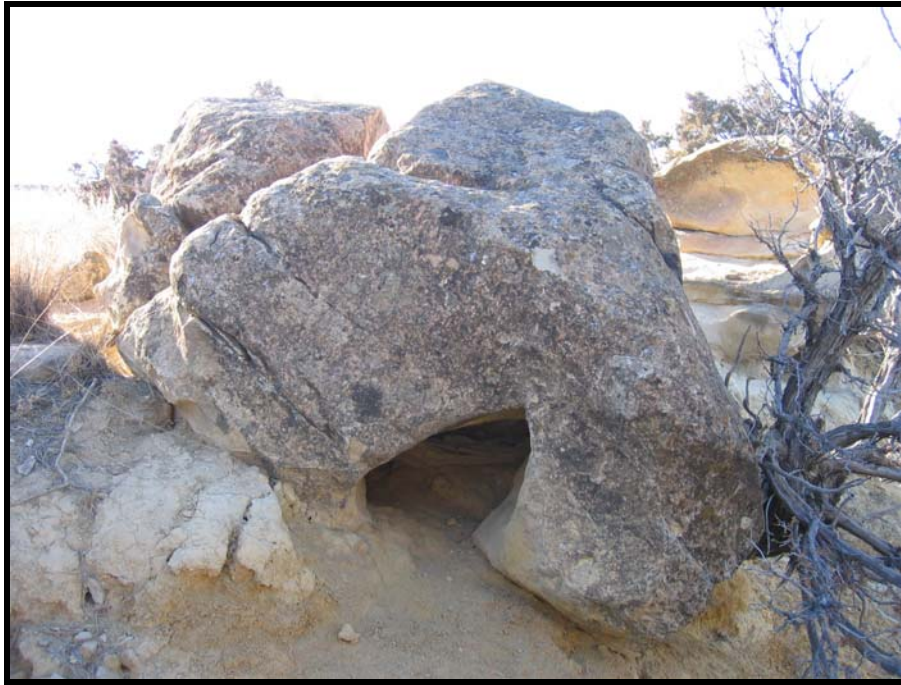
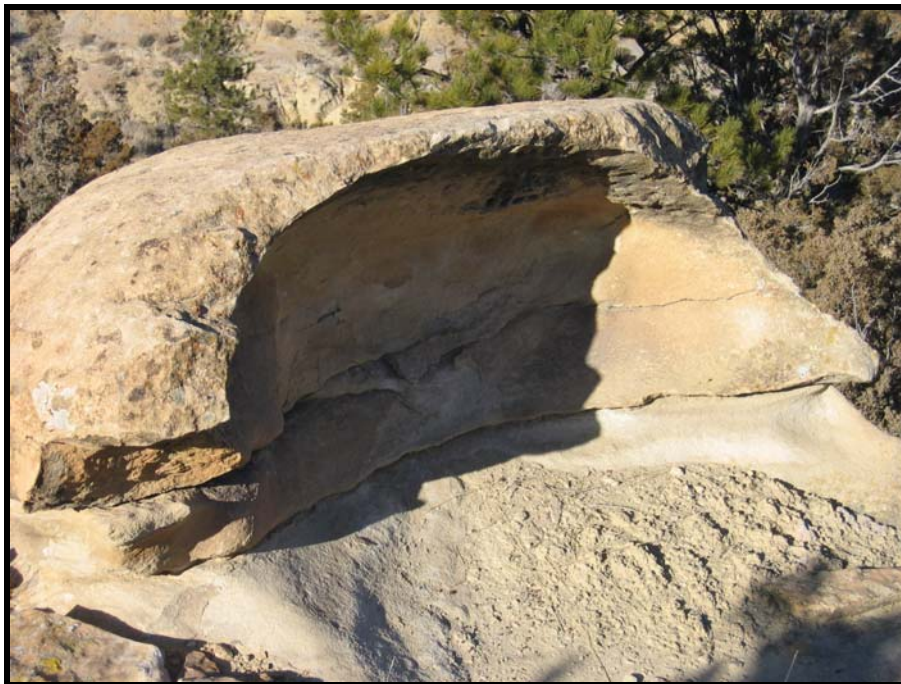
ROCK OUTCROP FEATURE: RO_0082

Photo: 1_16_06_29

Looking East

DESCRIPTION OF FEATURE: The rock outcrop shown above is composed of sandstone/siltstone rocks. The feature sits on sandy silt soil, which is highly erosive. The surrounding slope is vegetated with grass, sagebrush, and some small trees. See the pictures on the next page for additional views of this feature.

Photo: 1_16_06_30

Looking Southwest

Photo: 1_16_06_31

Looking North

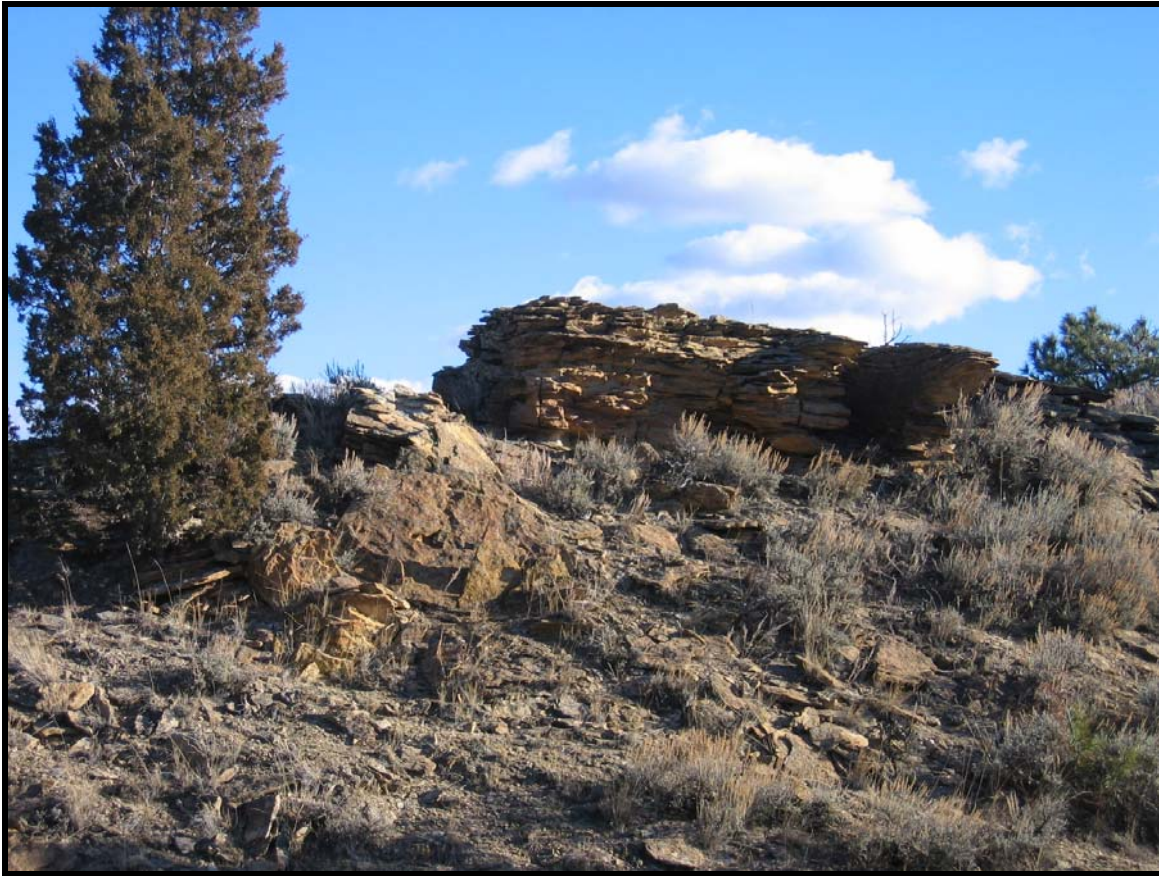
ROCK OUTCROP FEATURE: RO_0083

FEATURE TYPE:	Rock Outcrop					
GEOMETRIC DIMENSIONS:	Length: 110 ft		Height: 10 ft			
LOCATION:	Township: 8S		Range: 39E		Section: 36	
HANDHELD GPS POINTS:		Northing	Easting		Northing	Easting
	8077	409473.21	2673131.04	8079	409407.79	2673138.34
	8078	409447.62	2673129.29	8080	409376.51	2673185.87
SUBSTRATE:	Sandstone/siltstone					
EXPOSURE:	Northern facing slope					
DESCRIPTION OF FEATURE:	The rock outcrop shown above is composed of weathered sandstone/siltstone rocks. The layout of the feature is long and narrow and travels in a curved shape along the top of the draw. See the picture on the next page for another view of this feature.

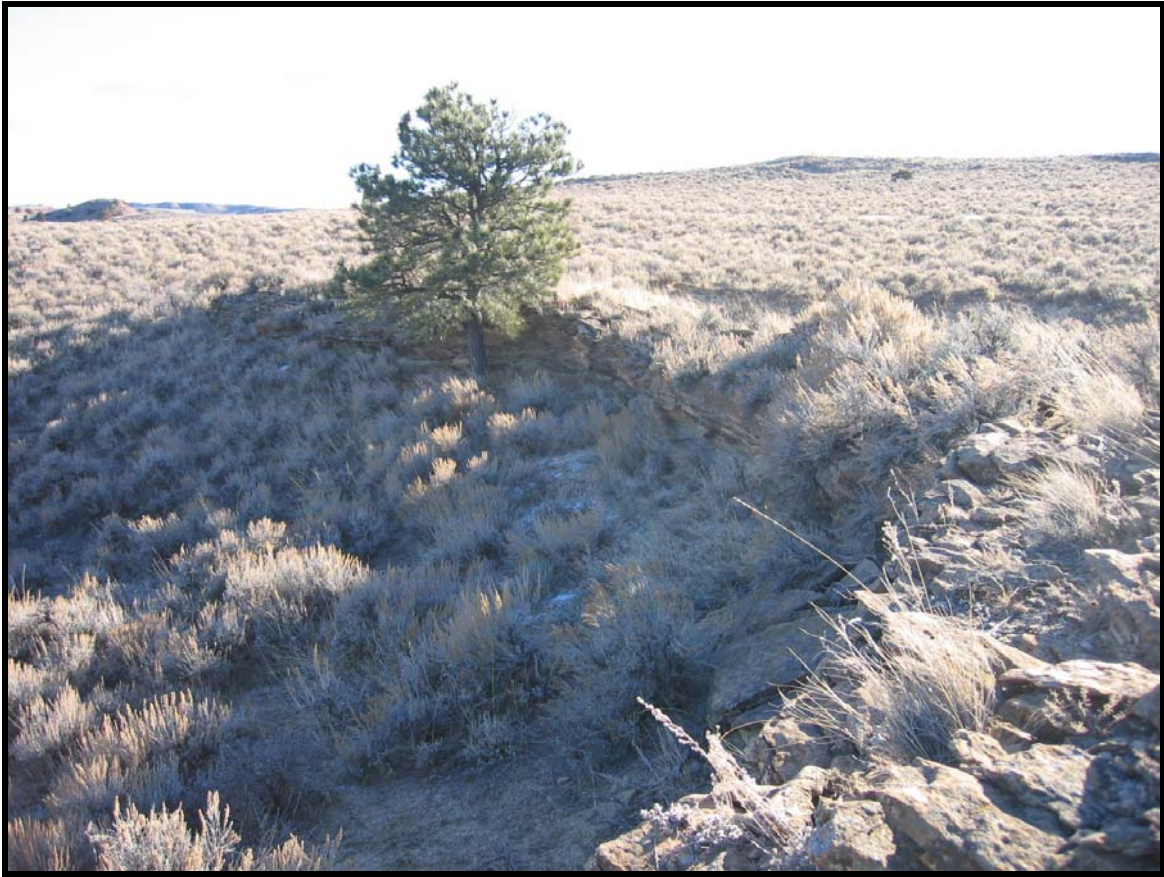
ROCK OUTCROP FEATURE: RO_0083

Photo: 1_16_06_33

Looking South

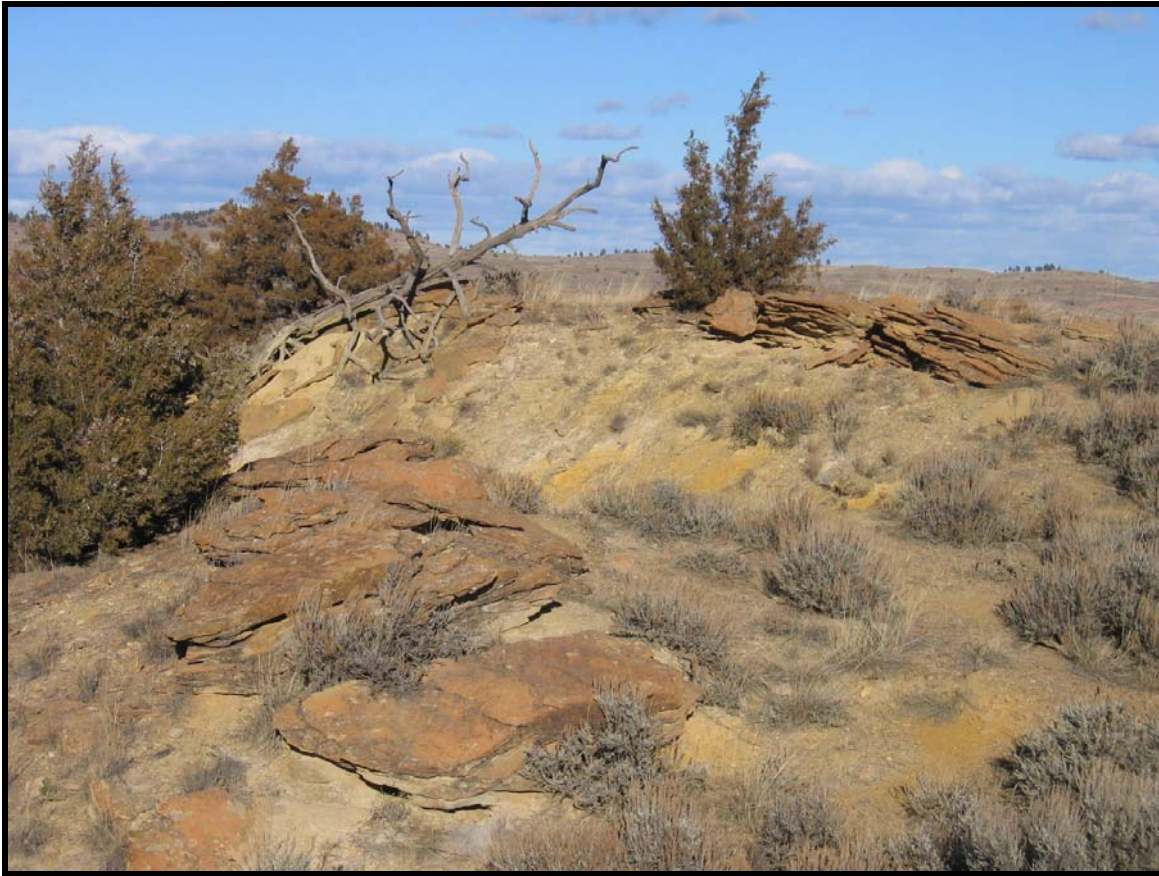
ROCK OUTCROP FEATURE: RO_0084

DESCRIPTION OF FEATURE: The rock outcrop shown above consists of flat sandstone/siltstone rocks, which sit on soft, sandy silt soil. The rocks are layered and low-lying. This feature is located on a northern facing slope that is vegetated with sparse grass, sagebrush, and small trees.

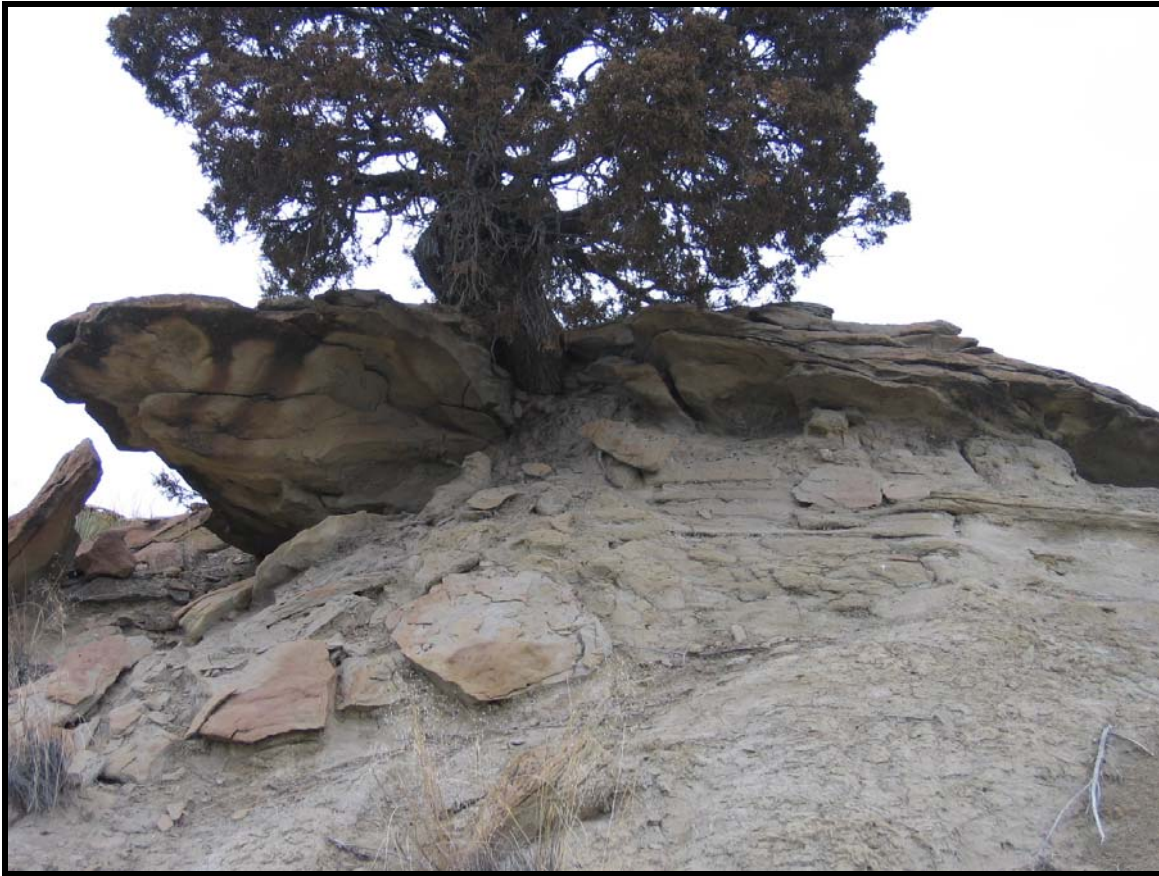
ROCK OUTCROP FEATURE: RO_0091

Photo: 1_17_06_06

Looking Northwest

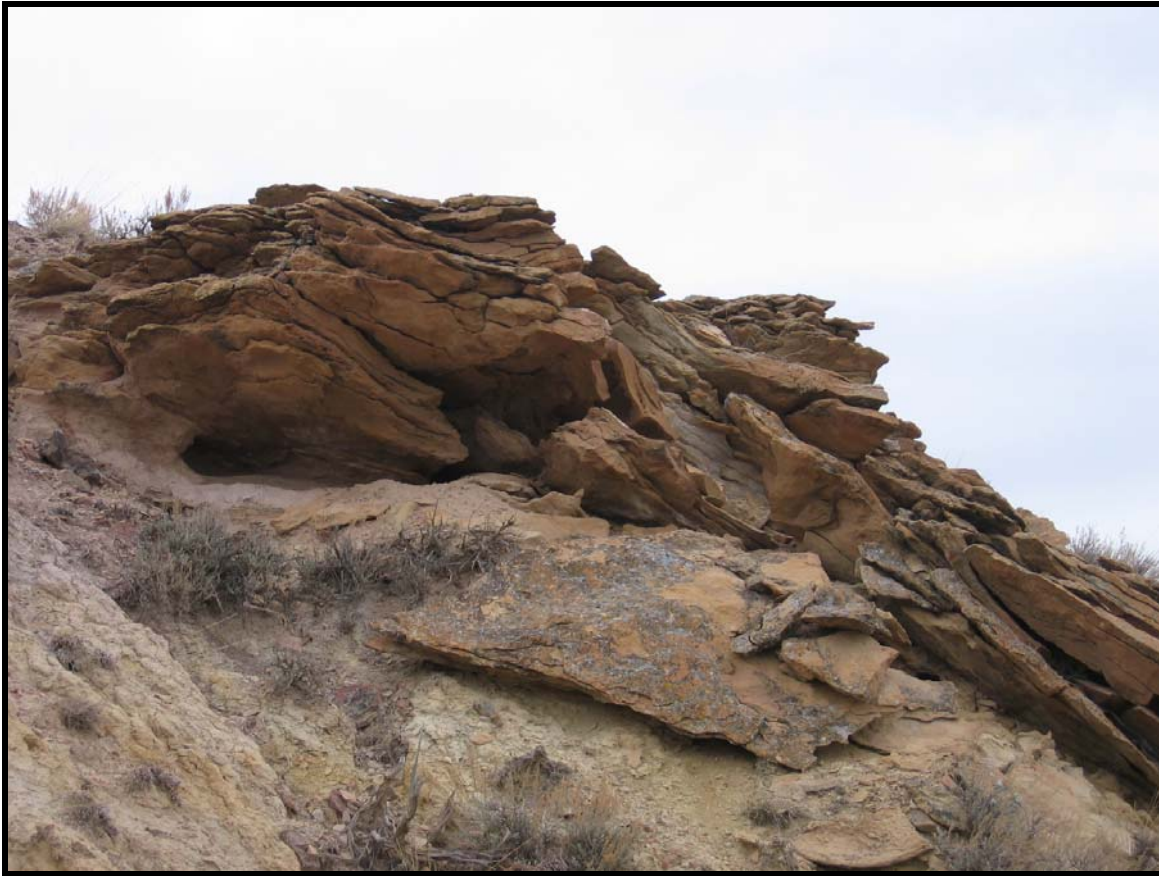
ROCK OUTCROP FEATURE: RO_0092

DESCRIPTION OF FEATURE: The rock outcrop shown above is composed of layered sandstone/siltstone rocks, which are weathered and sit on soft, sandy silt soil. Voids between and below the rocks are created as erosion continues.

Photo: 1_17_06_07

Looking Northeast

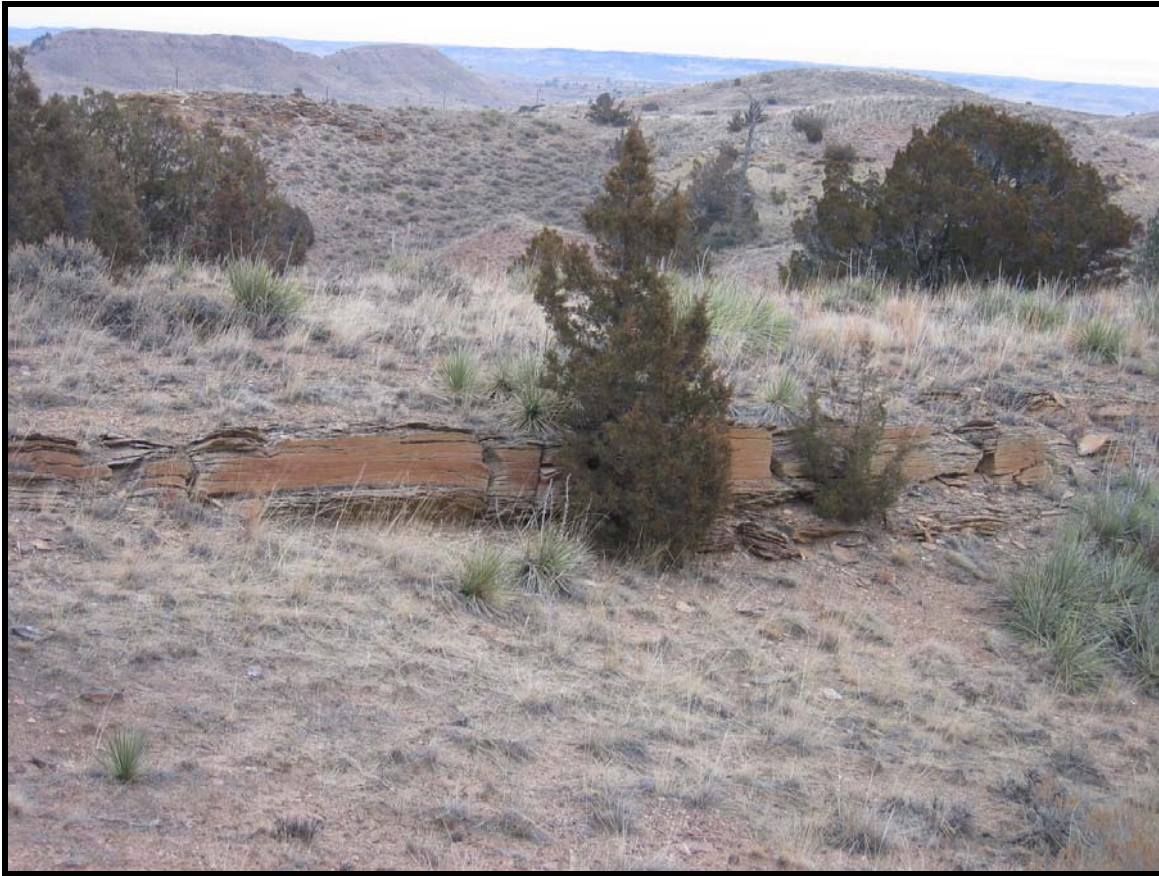
ROCK OUTCROP FEATURE: RO_0093

DESCRIPTION OF FEATURE: The rock outcrop shown above is composed of layered sandstone/siltstone rocks, which are weathered and sit on soft sandy silt soil. Voids between and below the rocks have been created as erosion has continued.

Photo: 1_17_06_08

Looking Northeast
