Township 8S, Range 39E
SECTION 36

Cliff Features

Revised 4/06; Reference – South Fork Extension Amendment #00174

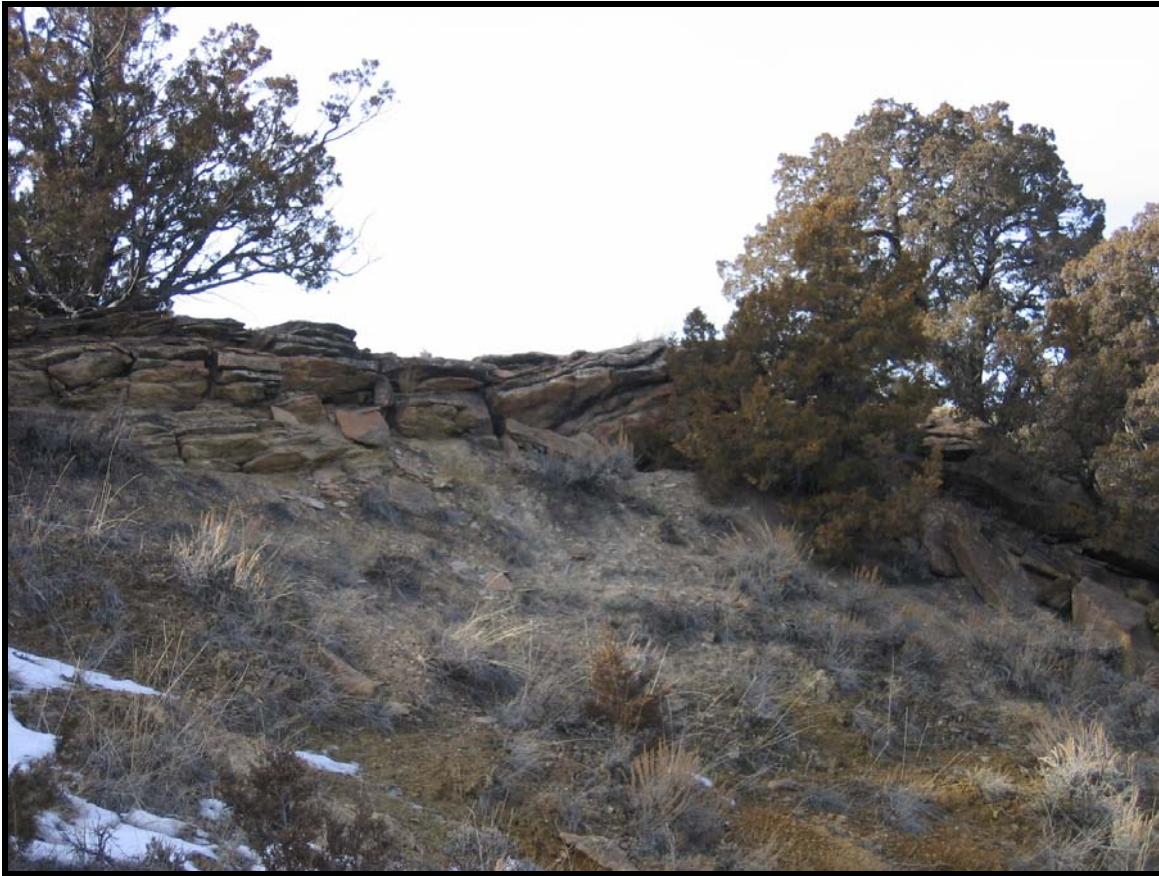
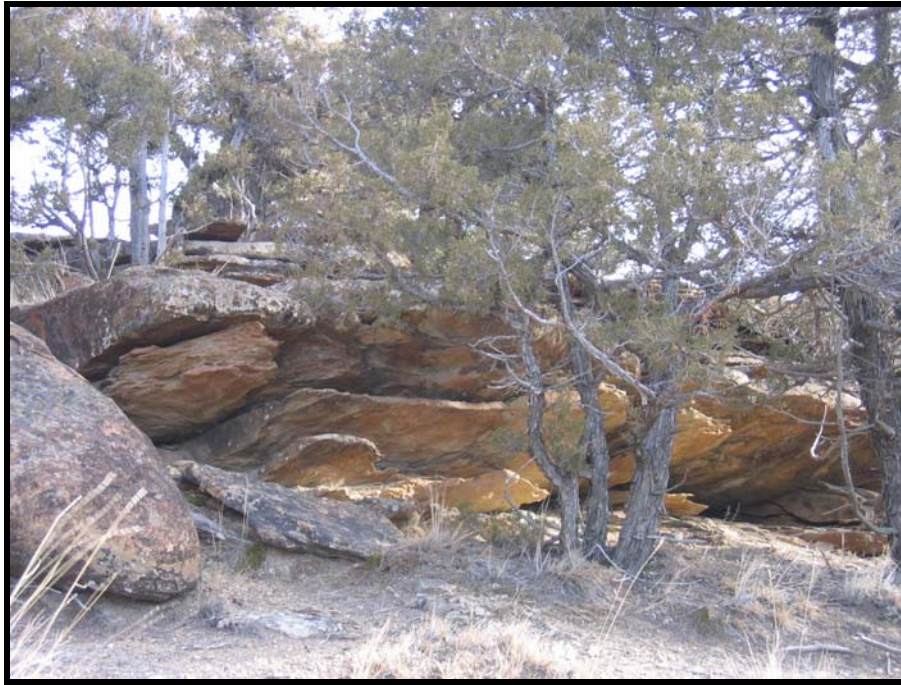
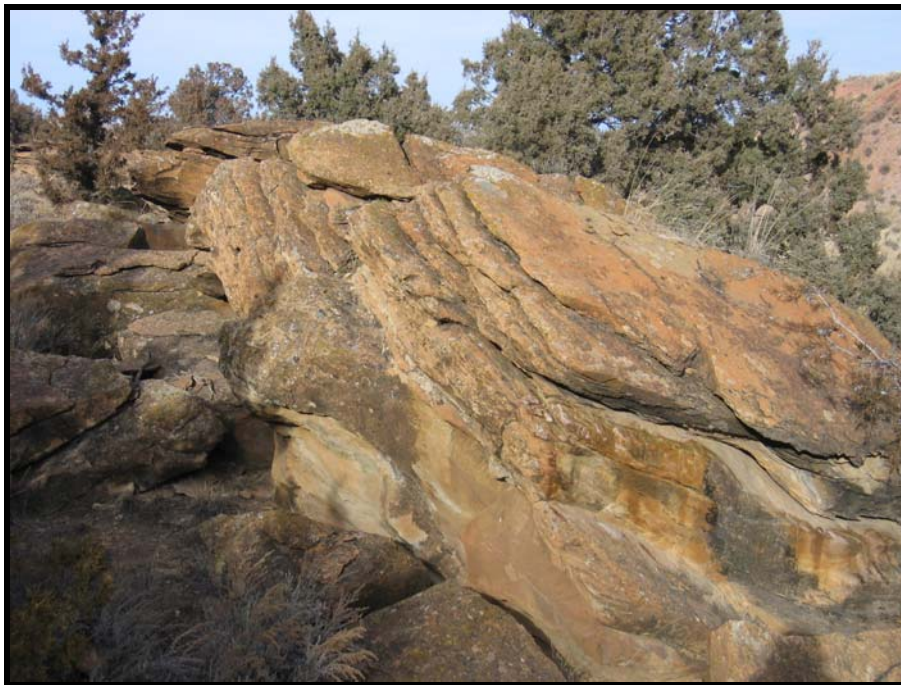
ROCK OUTCROP FEATURE: RO_0099

Photo: 1_17_06_28

Looking Northwest

DESCRIPTION OF FEATURE: Rock outcrops like the one shown above are very common in this area. The layered, sandstone/siltstone rock layer sits at the top of a sandy silt slope. See the pictures on the following page for additional views of this feature.

Photo: 1_17_06_29

Looking East

Photo: 1_17_06_30

Looking Northeast

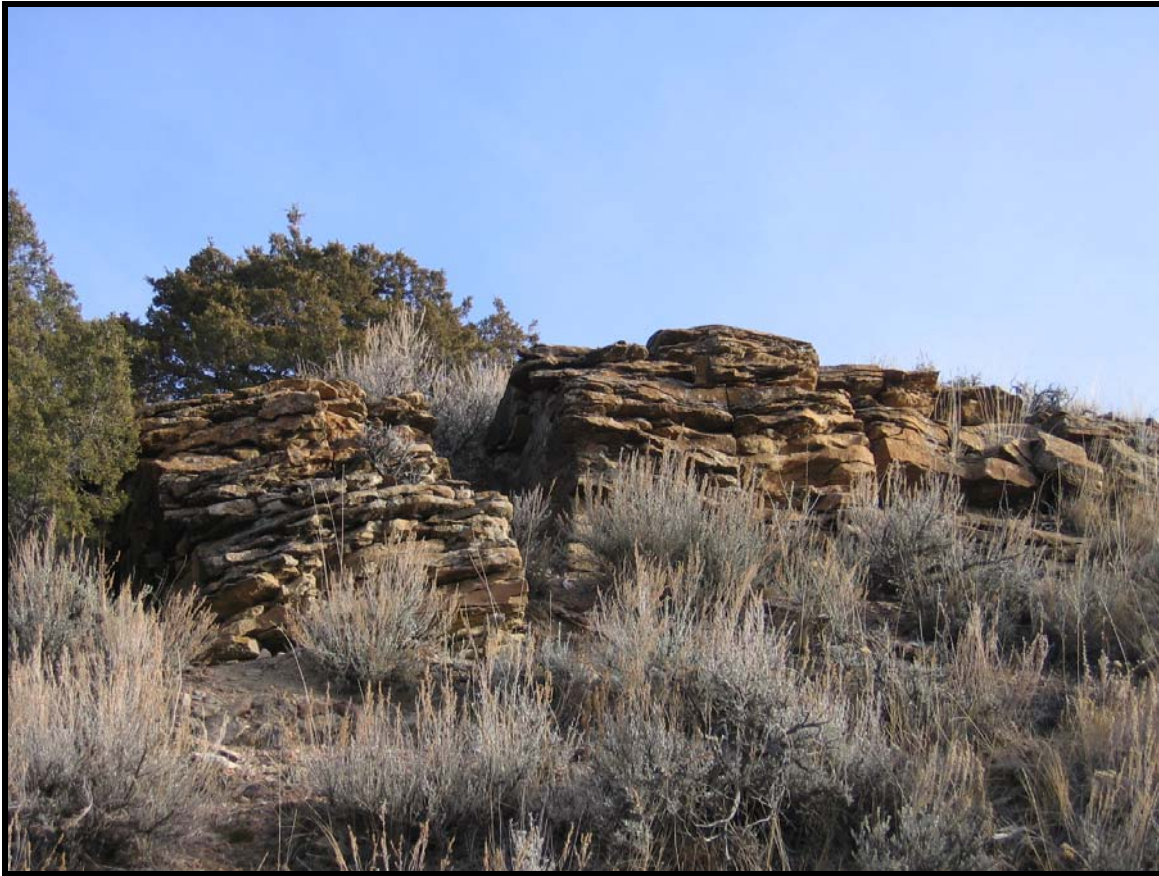
Photo: 1_17_06_32

DESCRIPTION OF FEATURE: The rock outcrop shown above is composed of layered sandstone/siltstone rocks, which are weathered and are located in a flat area. The area is vegetated with grass, sagebrush and some small trees.

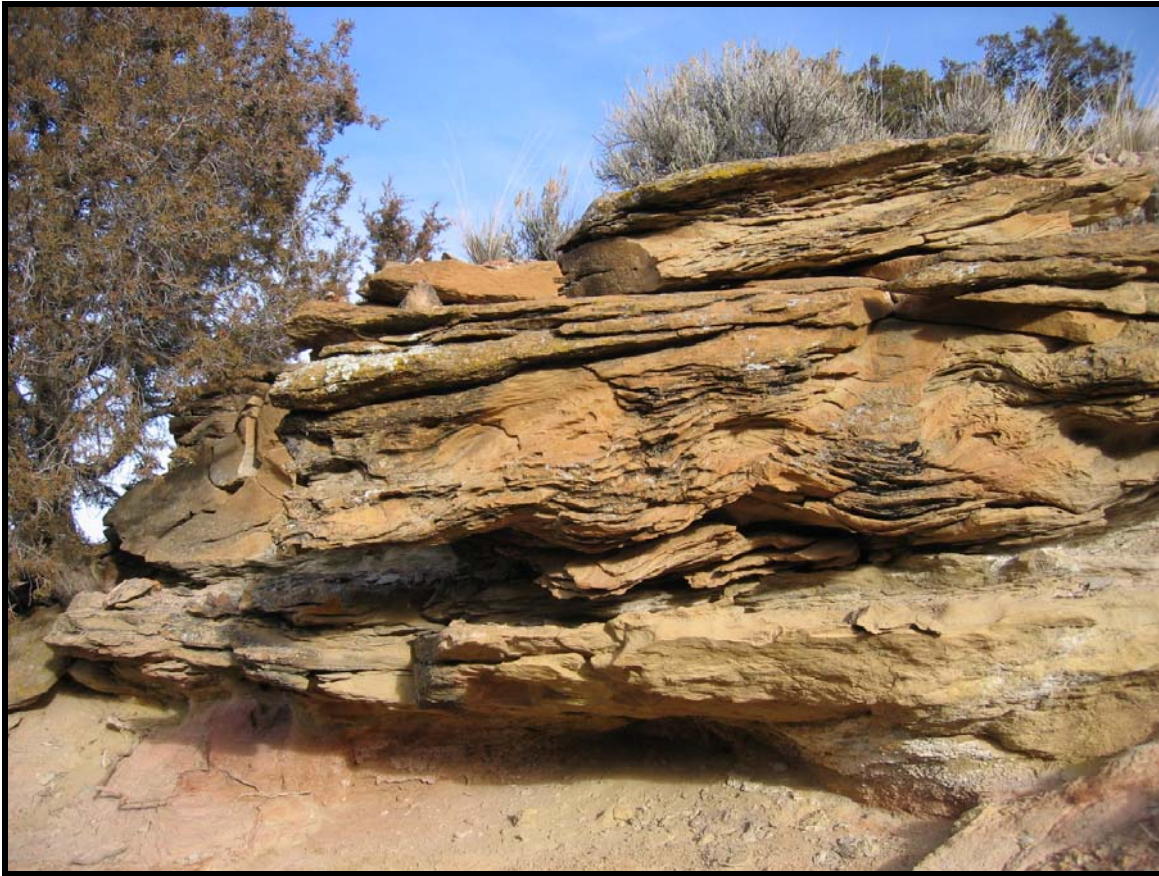
Photo: 1_17_06_34

DESCRIPTION OF FEATURE: Rock outcrops like the one shown above are very common in this area. The layered, sandstone/siltstone rock layer sits at the top of a sandy silt slope. Voids beneath and within the rock are frequent in this feature.

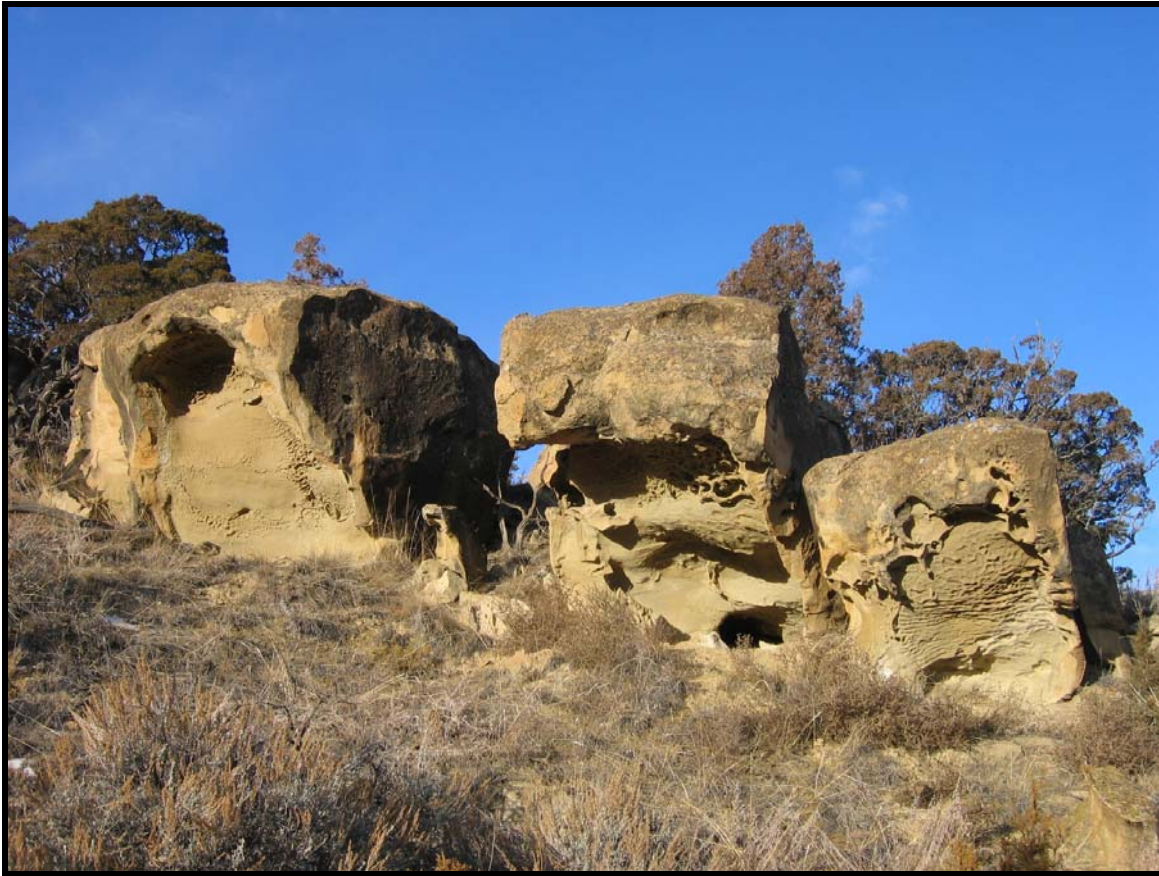
Photo: 1_18_06_01

DESCRIPTION OF FEATURE: The rock outcrop shown above is composed of tall sandstone/siltstone rocks. Due to the composition of the rocks, they have eroded, leaving holes and other unique characteristics. The rocks in this feature are large and rounded. See the picture on the next page for another view of this feature.

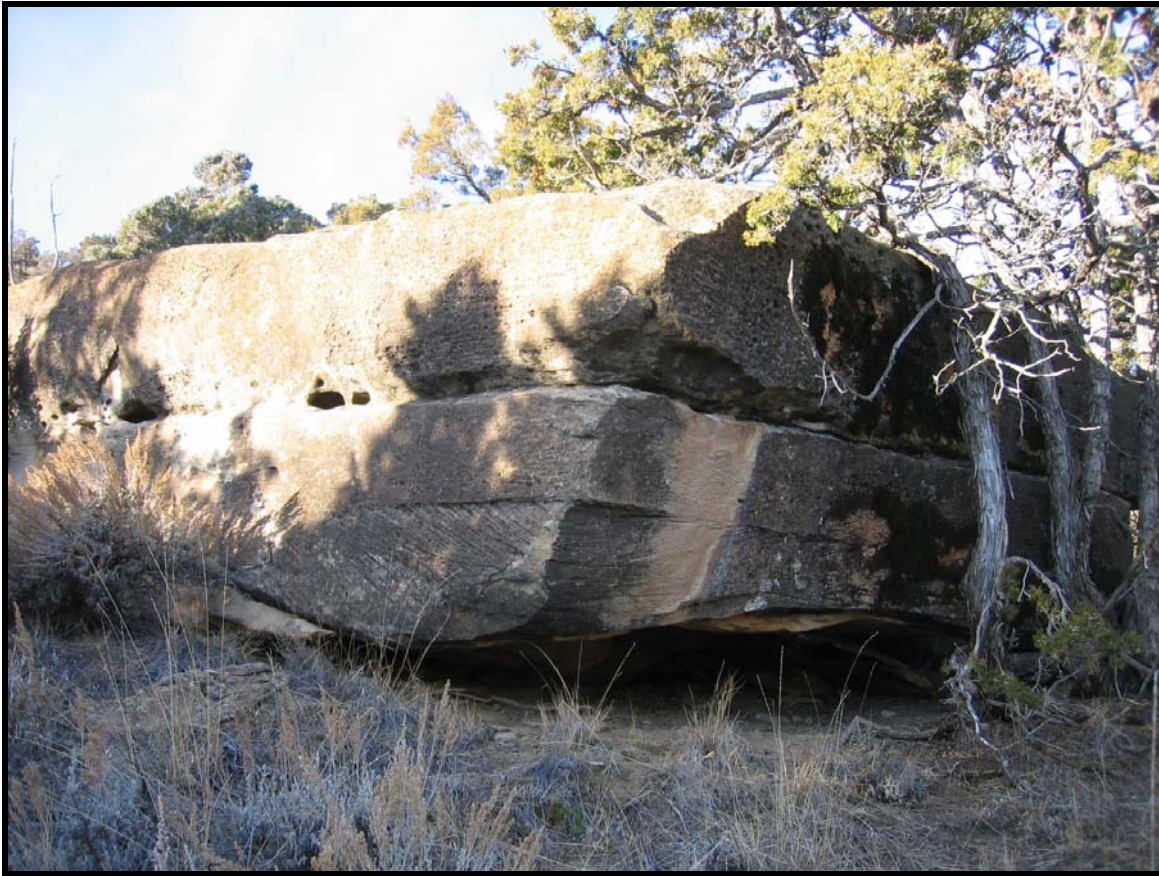
Photo: 1_18_06_03

DESCRIPTION OF FEATURE: The rock outcrop shown above consists of large, sandstone/siltstone rocks that are located on a northern slope that is vegetated with grass, sagebrush and trees. The rocks within this feature are very weathered. The pictures on the next page show additional views of this feature.

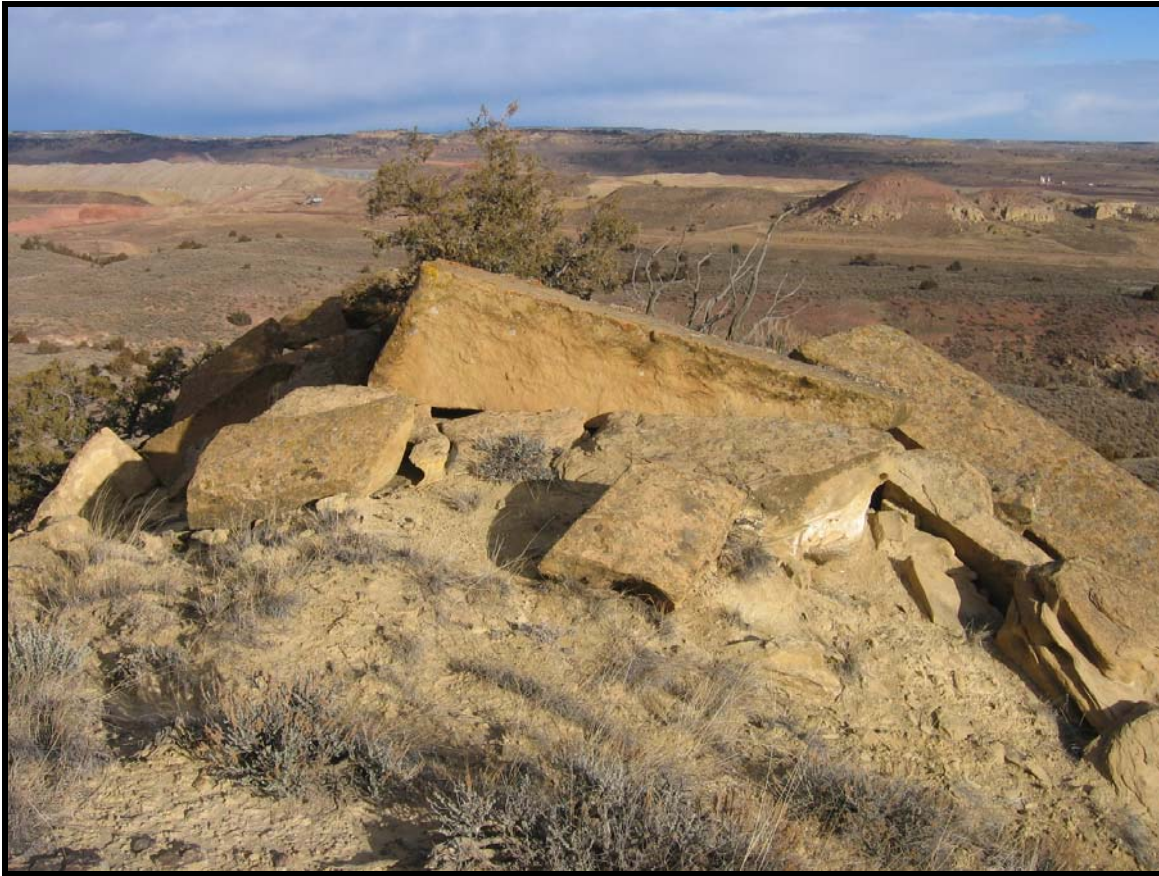
Photo: 1_18_06_06

DESCRIPTION OF FEATURE: This rock outcrop feature sits at the top of a slope consisting of sandy silt soil. The large, rectangular rocks are common to this area. The surrounding area is sparsely vegetated with grass, sagebrush, and small trees.

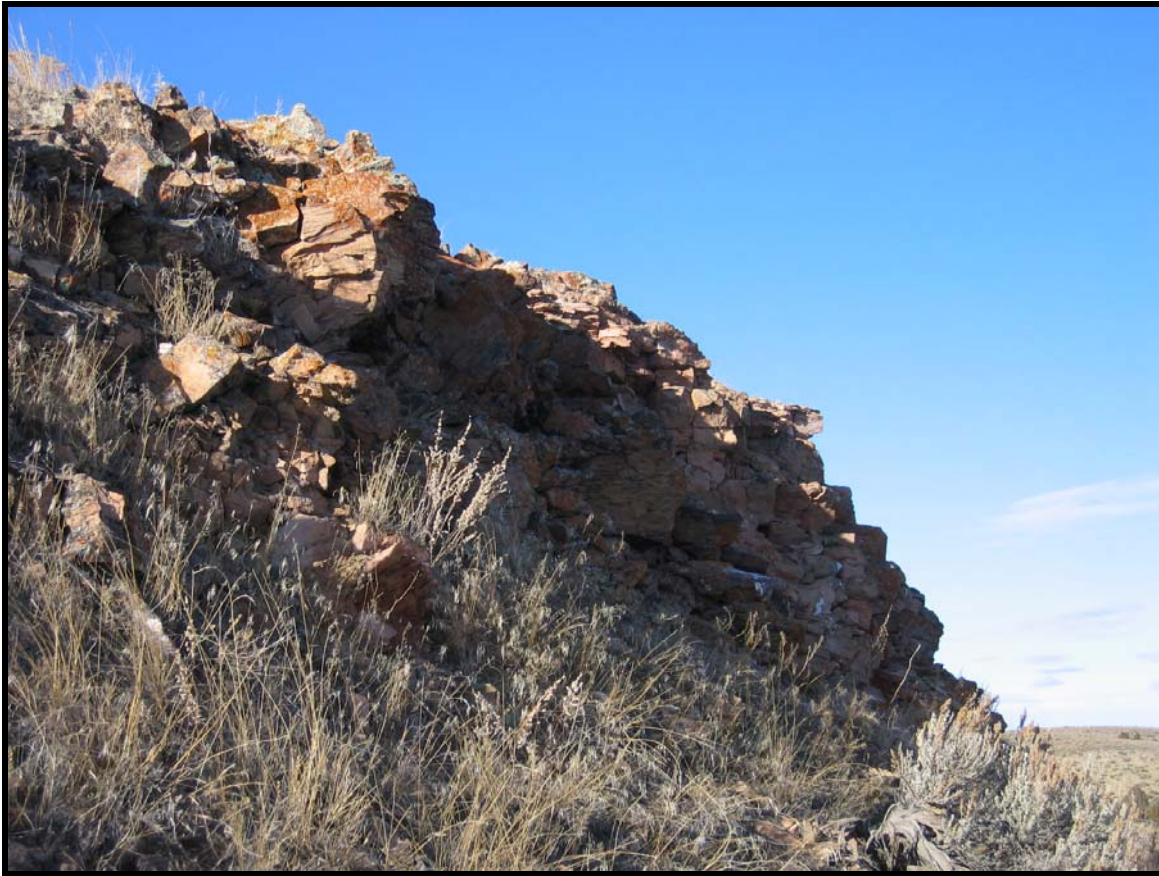
ROCK OUTCROP FEATURE: RO_0107

FEATURE TYPE:	Rock Outcrop		
GEOMETRIC DIMENSIONS:	Length: 50 ft	Height: 10 ft	
LOCATION:	Township: 8S	Range: 39E	Section: 36
HANDHELD GPS POINTS:	Northing	Easting	
	10013	409900.10	2669308.63
	10014	409898.43	2669257.01
SUBSTRATE:	Scoria		
EXPOSURE:	Northern facing slope		
DESCRIPTION OF FEATURE:	Scoria caprocks like the one shown above are common across the mine area. This feature has a fractured, jagged face and sits at the top of a steep (greater than 3H:1V) slope.

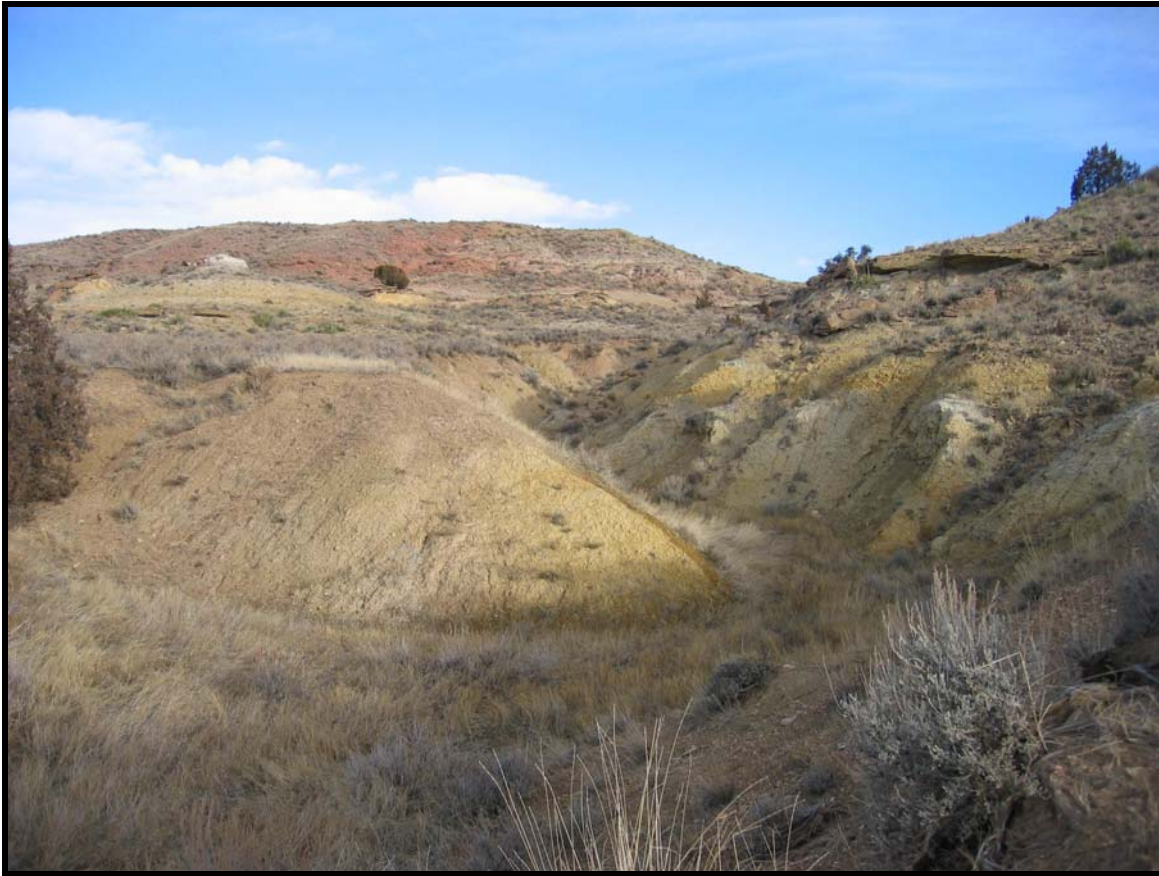
Photo: 1_11_06_10

DESCRIPTION OF FEATURE: The drainage shown above travels through highly erosive sandy silt soil. The bottom width of this feature varies and is generally vegetated with grass and sagebrush.

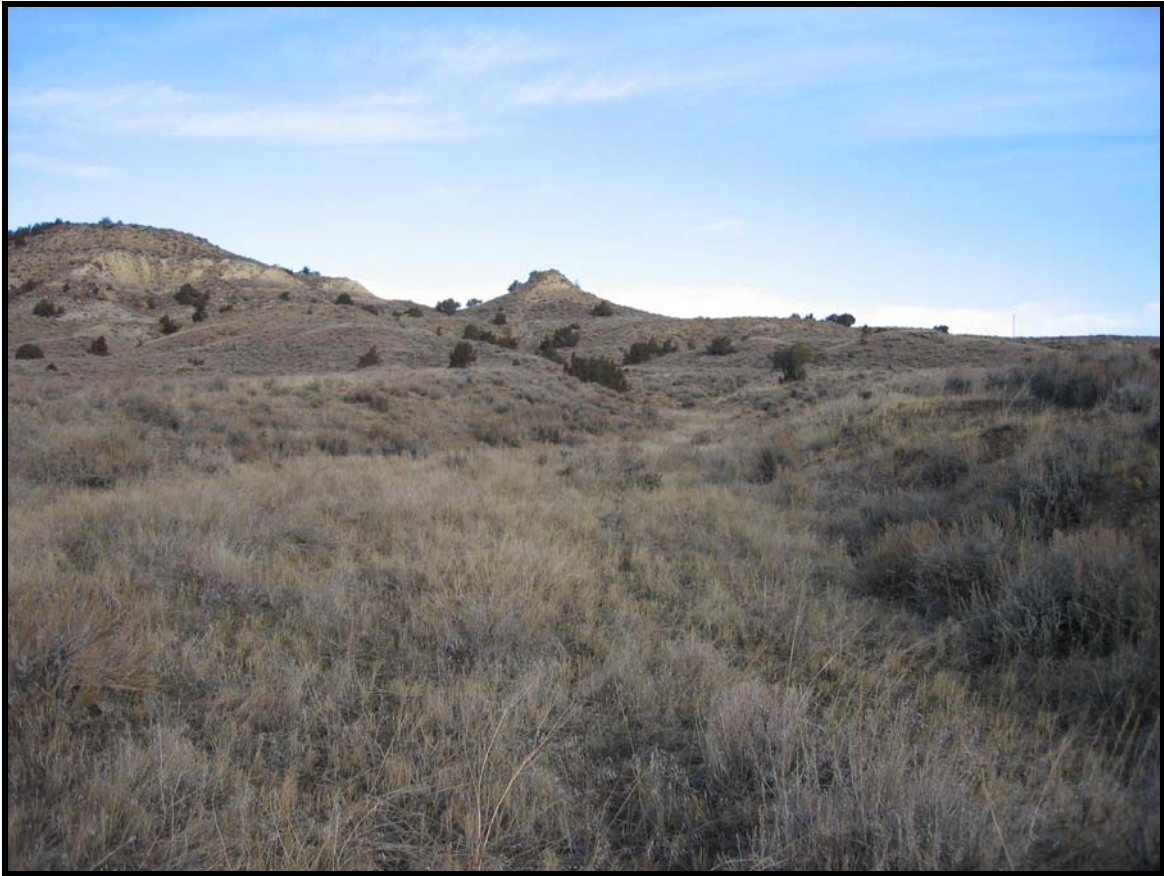
Photo: 1_11_06_11

SUBSTRATE: Not applicable
EXPOSURE: Drainage runs in a southerly direction
DESCRIPTION OF FEATURE: The drainage shown above has a channel with a bottom width of approximately 15 feet that is vegetated with grass and sagebrush. The surrounding hills vary from steep to rolling.

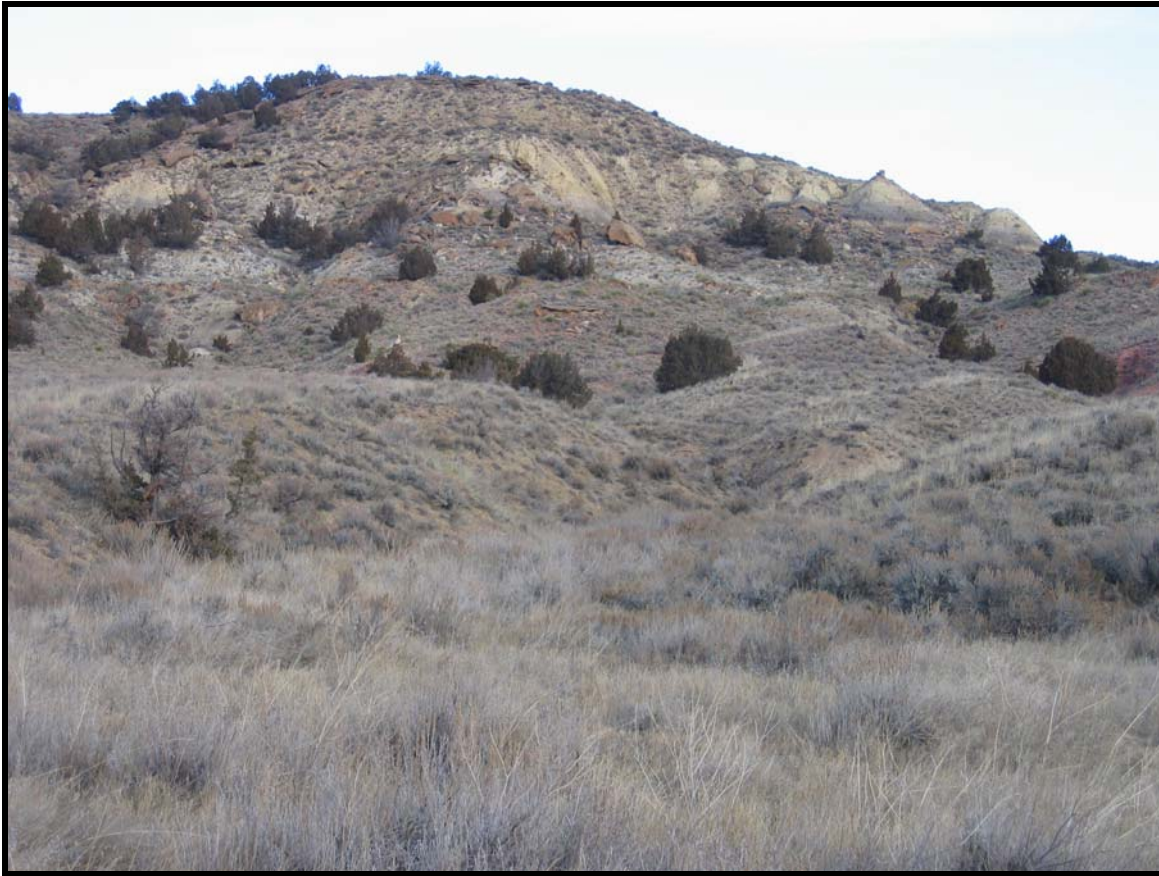
Photo: 1_11_06_12

DESCRIPTION OF FEATURE: The hills at the head of this channel have slopes that are steep (greater than 3H:1V) and are composed of sandy silt soil. Towards the mouth of the channel, the bottom width is approximately ten to twenty feet wide and is vegetated with grass and sagebrush.

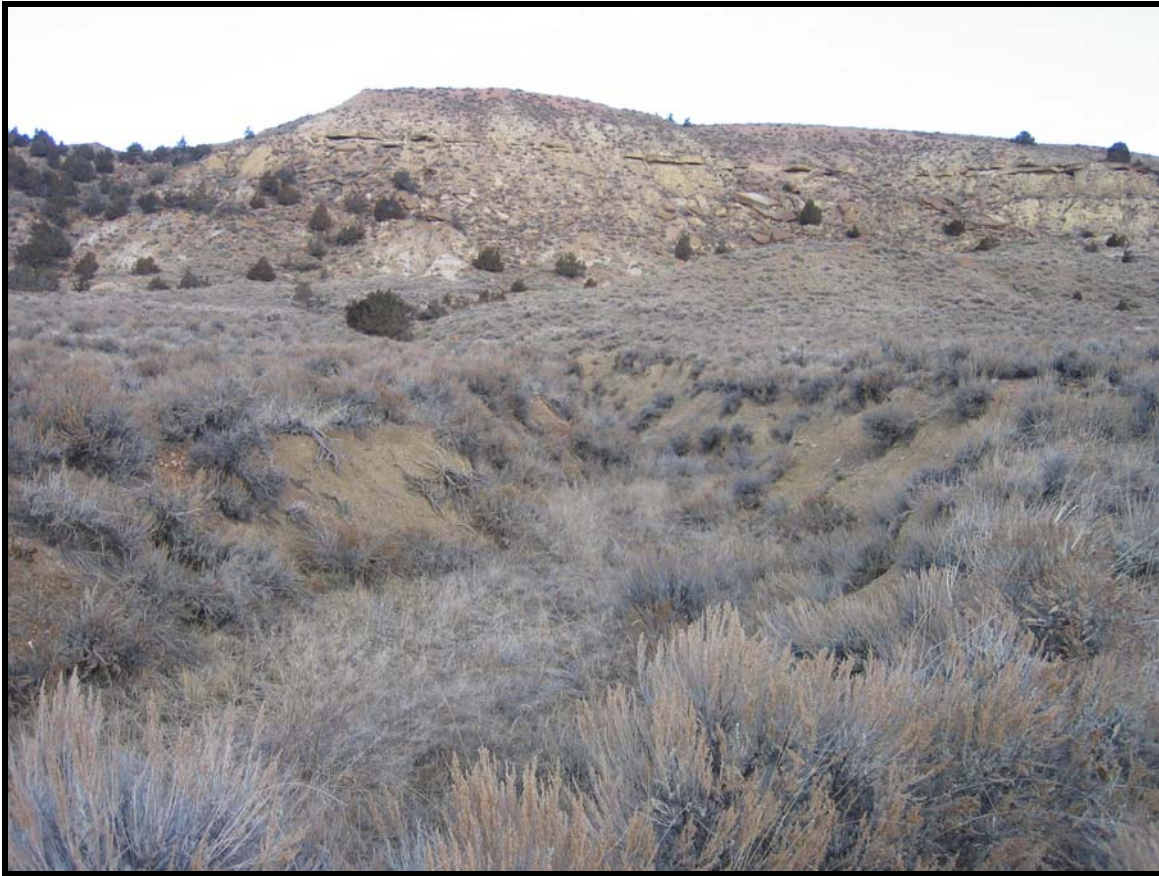
Photo: 1_11_06_13

DESCRIPTION OF FEATURE: The drainage shown above has a channel with a bottom width of approximately 15 feet that is vegetated with grass and sagebrush. The surrounding hills vary from steep to rolling.

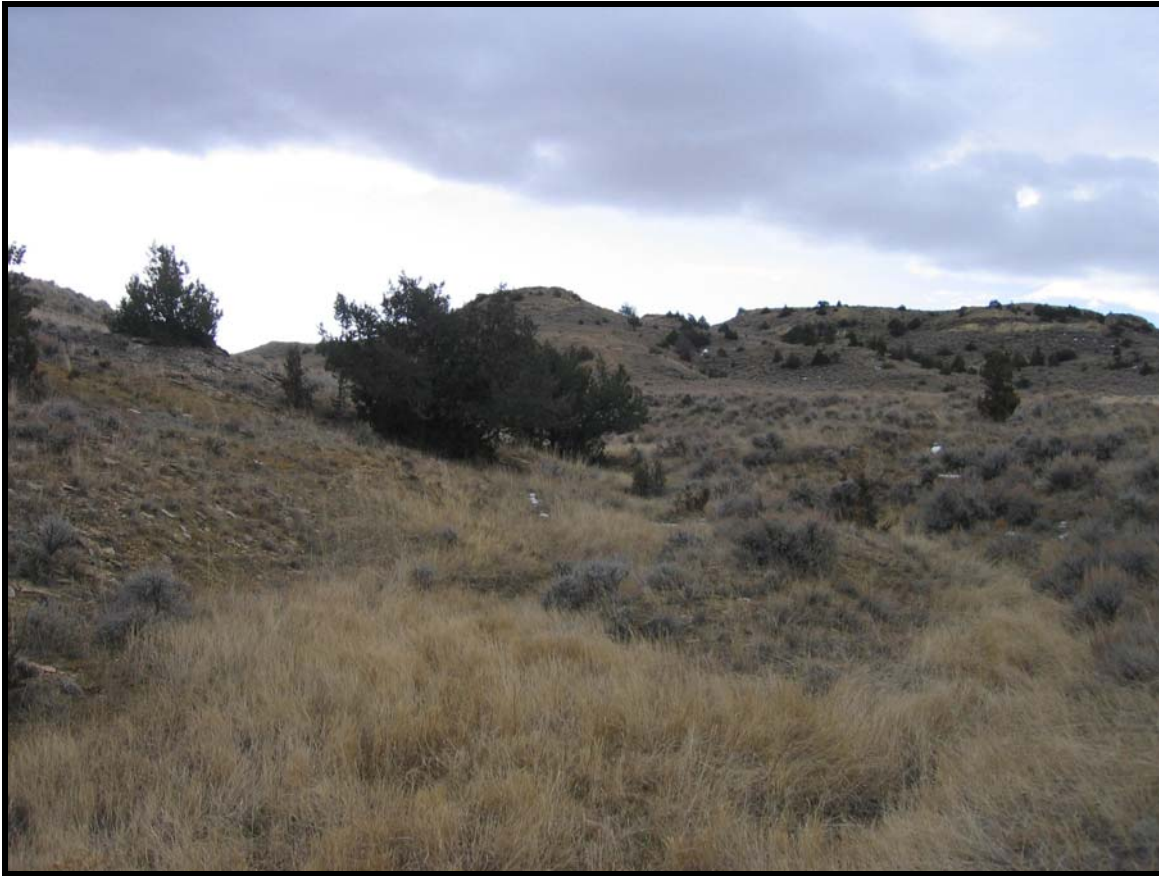
Photo: 1_11_06_27

DESCRIPTION OF FEATURE: This drainage has a channel with a wide bottom. The vegetation in this area consists of grass, sagebrush and sparse trees. The surrounding hills vary from steep to rolling.

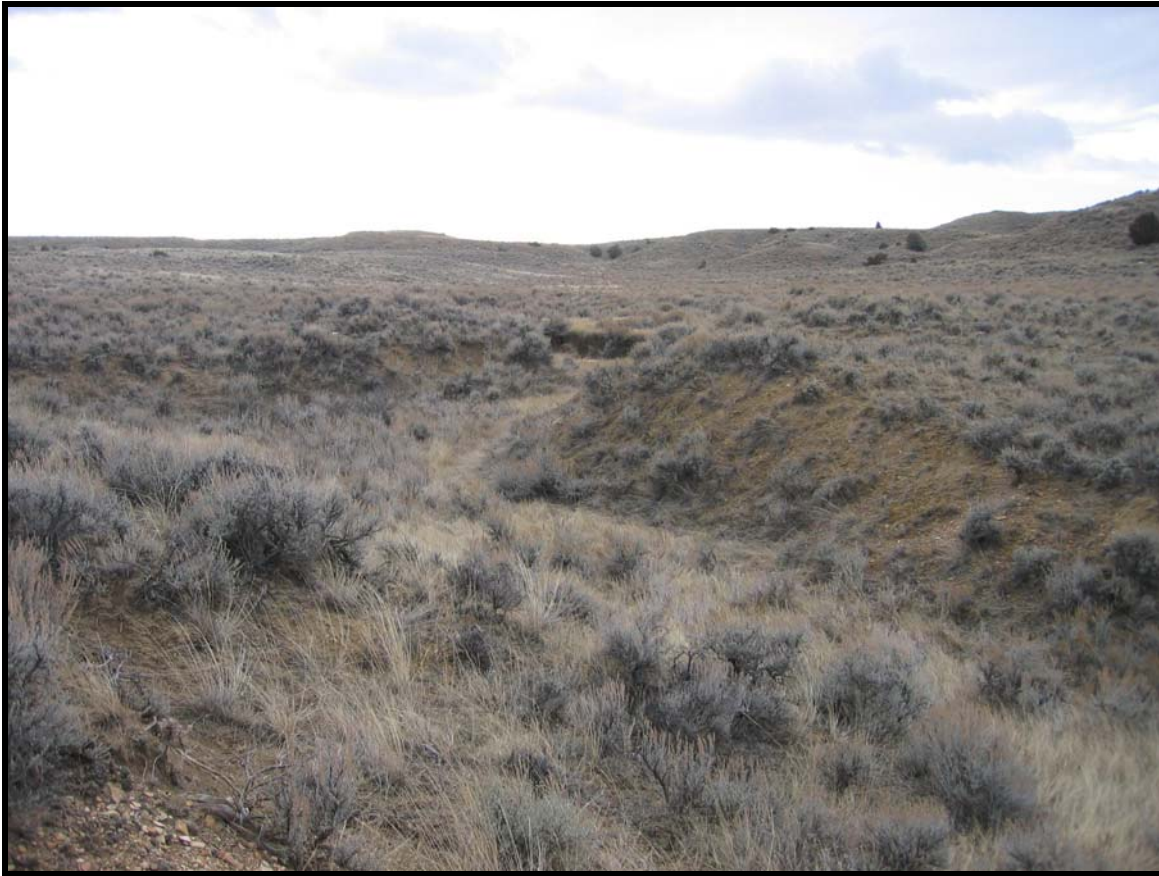
Photo: 1_11_06_29

SUBSTRATE: Not applicable
EXPOSURE: Drainage runs in a northerly direction
DESCRIPTION OF FEATURE: This large drainage has a wide, rounded geometry. The bottom is vegetated with grass, sagebrush and some small trees. This drainage is a tributary to Pearson Creek.

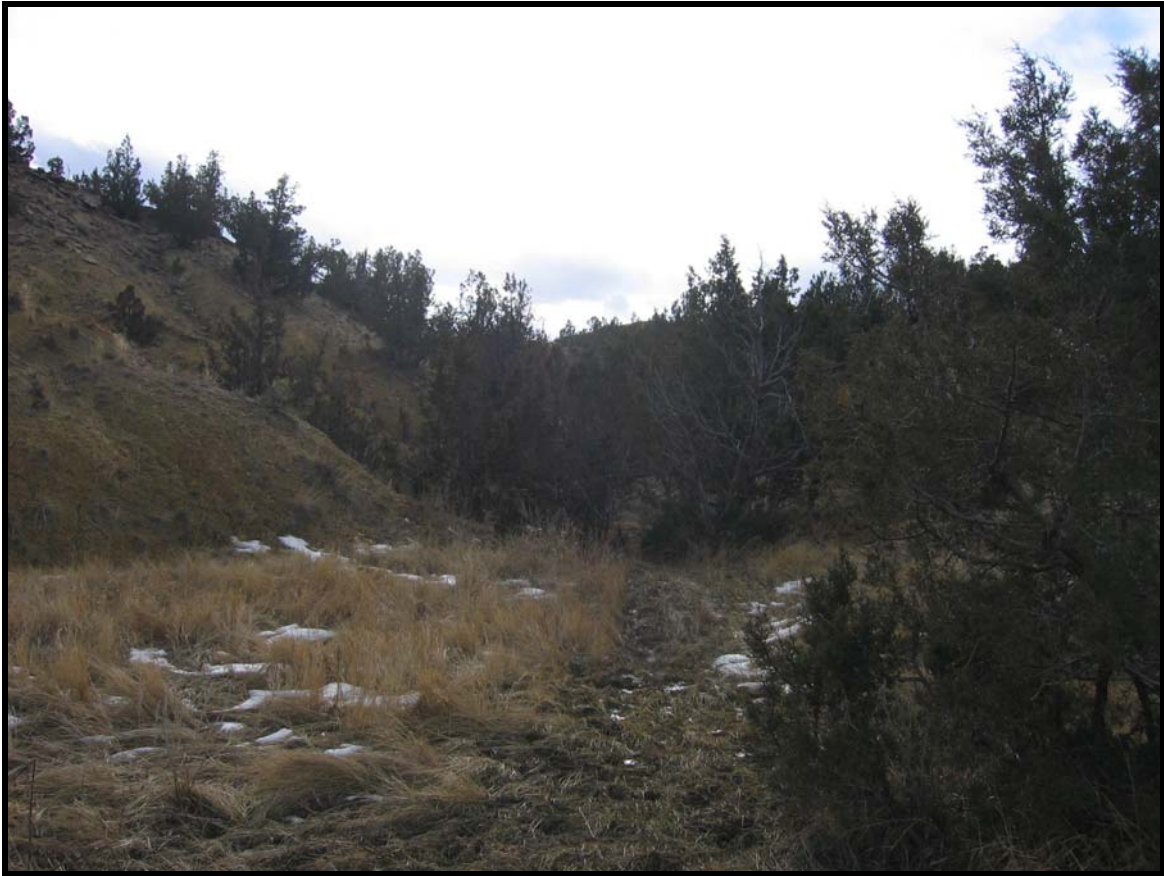
Photo: 1_11_06_30

DESCRIPTION OF FEATURE: This draw has dense vegetation consisting of grass, trees and some sagebrush. The channel bottom is generally narrow over its length. This drainage is a tributary to Pearson Creek.

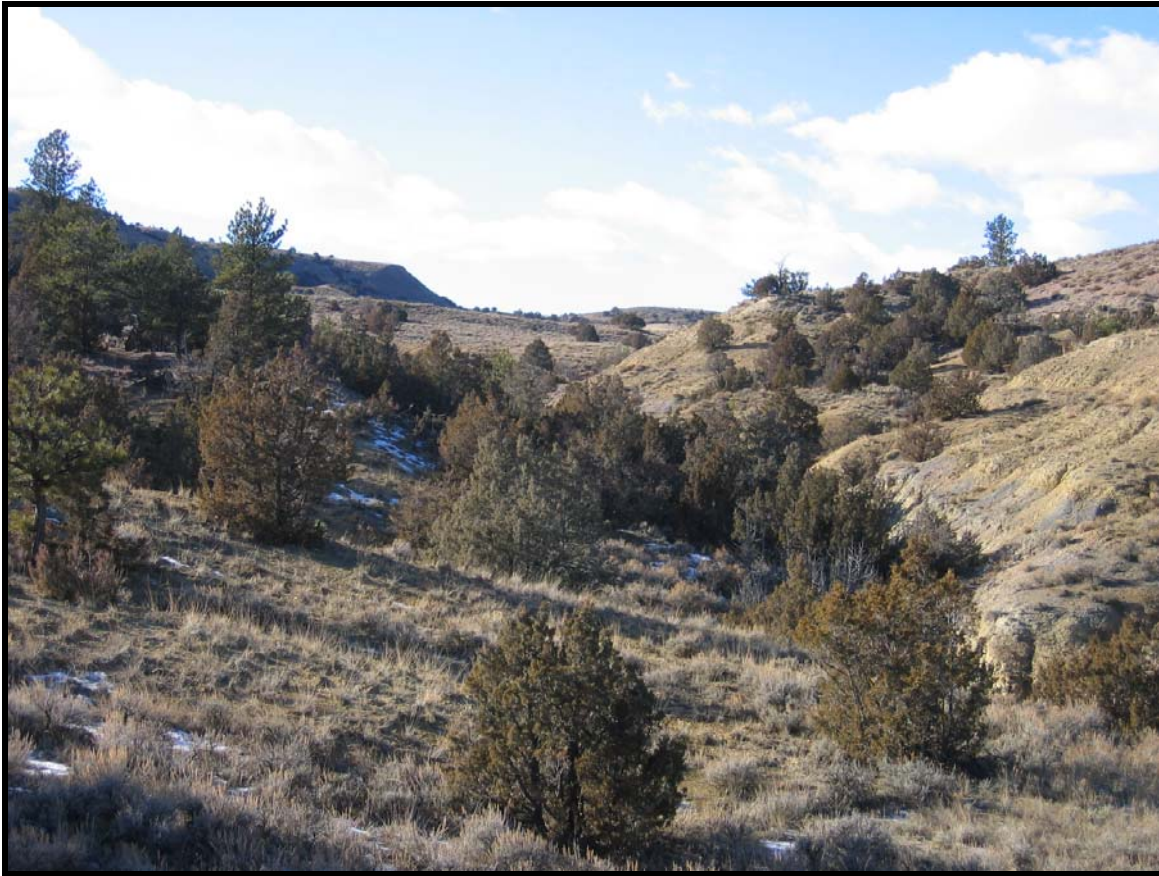
Photo: 1_16_06_28

DESCRIPTION OF FEATURE: This drainage is a tributary draw to South Fork Spring Creek. The channel bottom varies from five to 30 feet in width. The vegetation of the channel consists of grass and sagebrush, but for much of its length the bottom consists of scoria and siltstone.

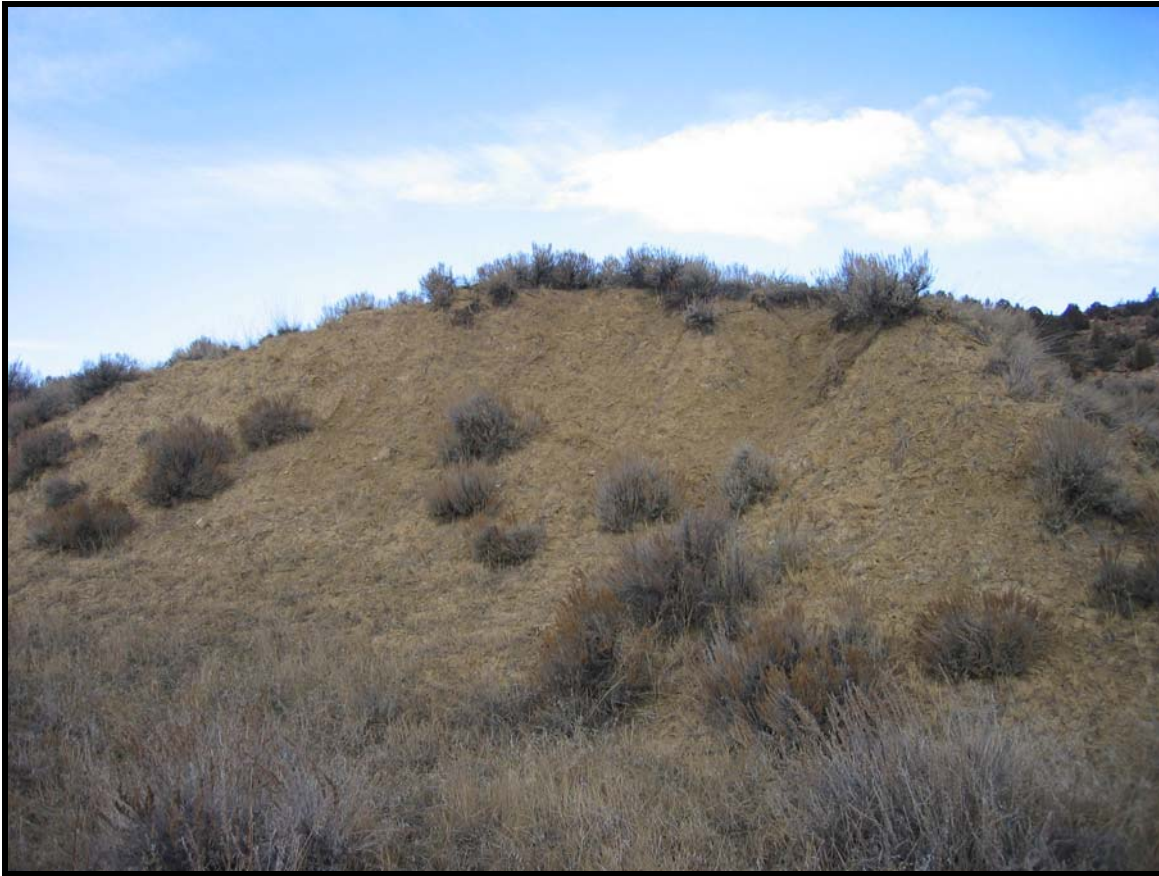
Photo: 1_11_06_14

DESCRIPTION OF FEATURE: This headcut is within the Pearson Creek drainage. The large size and steep face provides holes and habitat for birds and other animals. The soft sandy silt is highly erosive and will continue to erode as flows pass through this drainage.

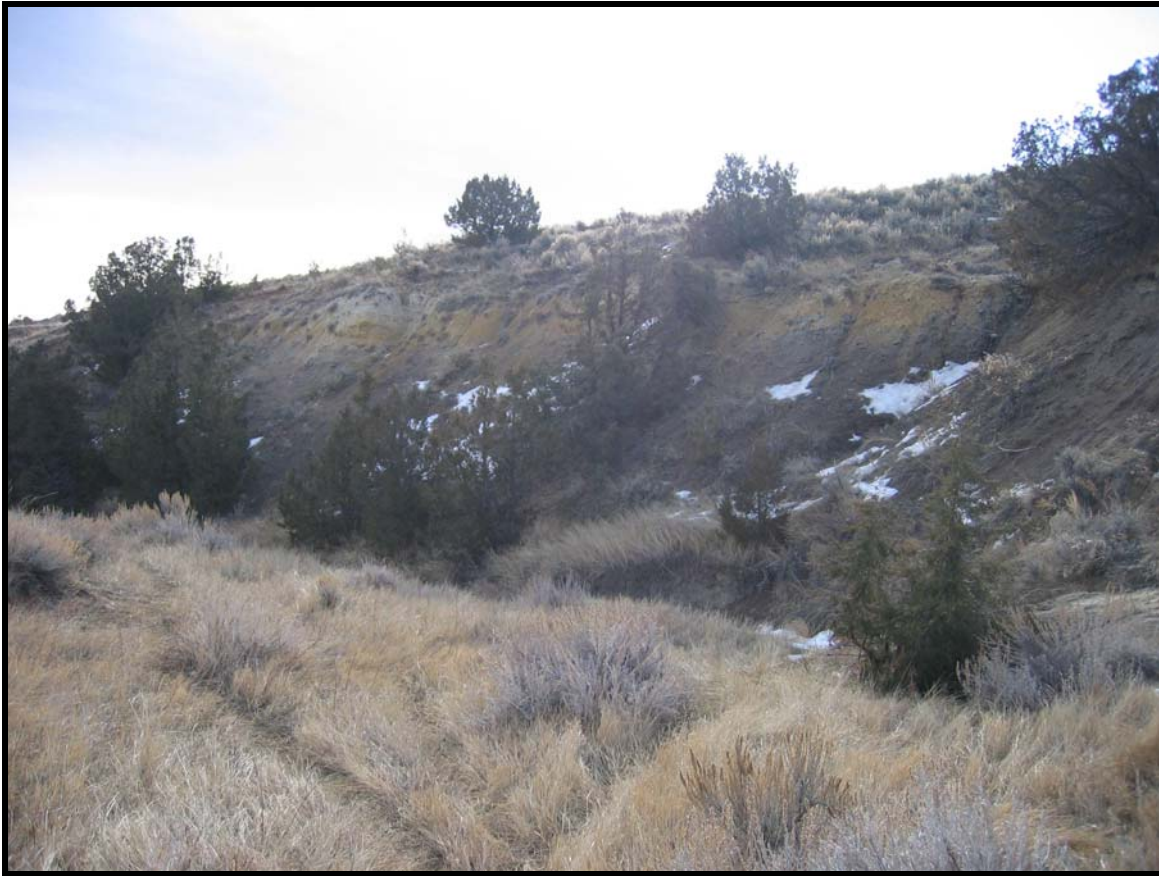
Photo: 1_11_06_23

DESCRIPTION OF FEATURE: As shown in the picture above, this cutbank is adjacent to Pearson Creek. This feature has a large amount of holes in the soft sandy silt material. There is a small number of juniper trees growing near this feature.

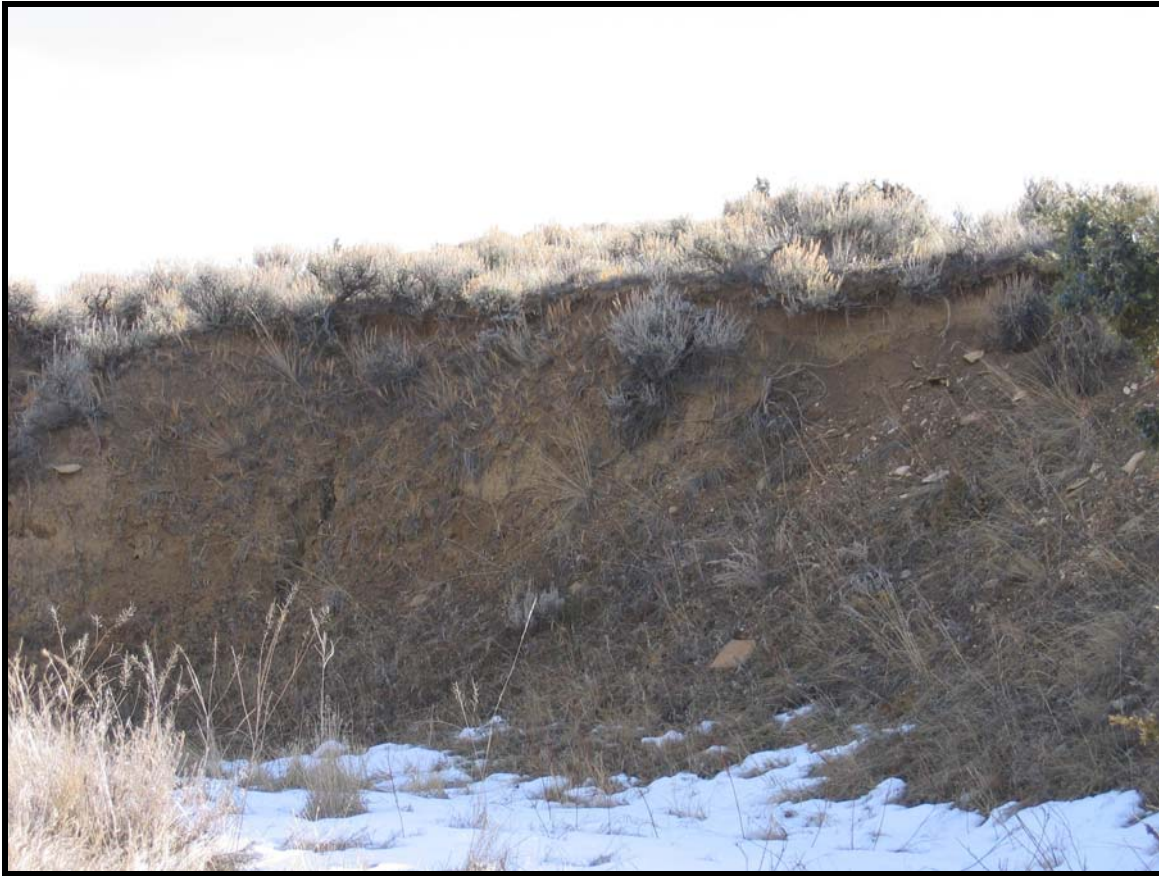
Photo: 1_11_06_24

DESCRIPTION OF FEATURE: This headcut is within the Pearson Creek drainage. The large size and steep face provides holes and habitat for birds and other animals. The soft sandy silt is highly erosive and will continue to erode as flows pass through this drainage.
