**Township 8S, Range 40E**  
**SECTION 30**

*Cliff Features*

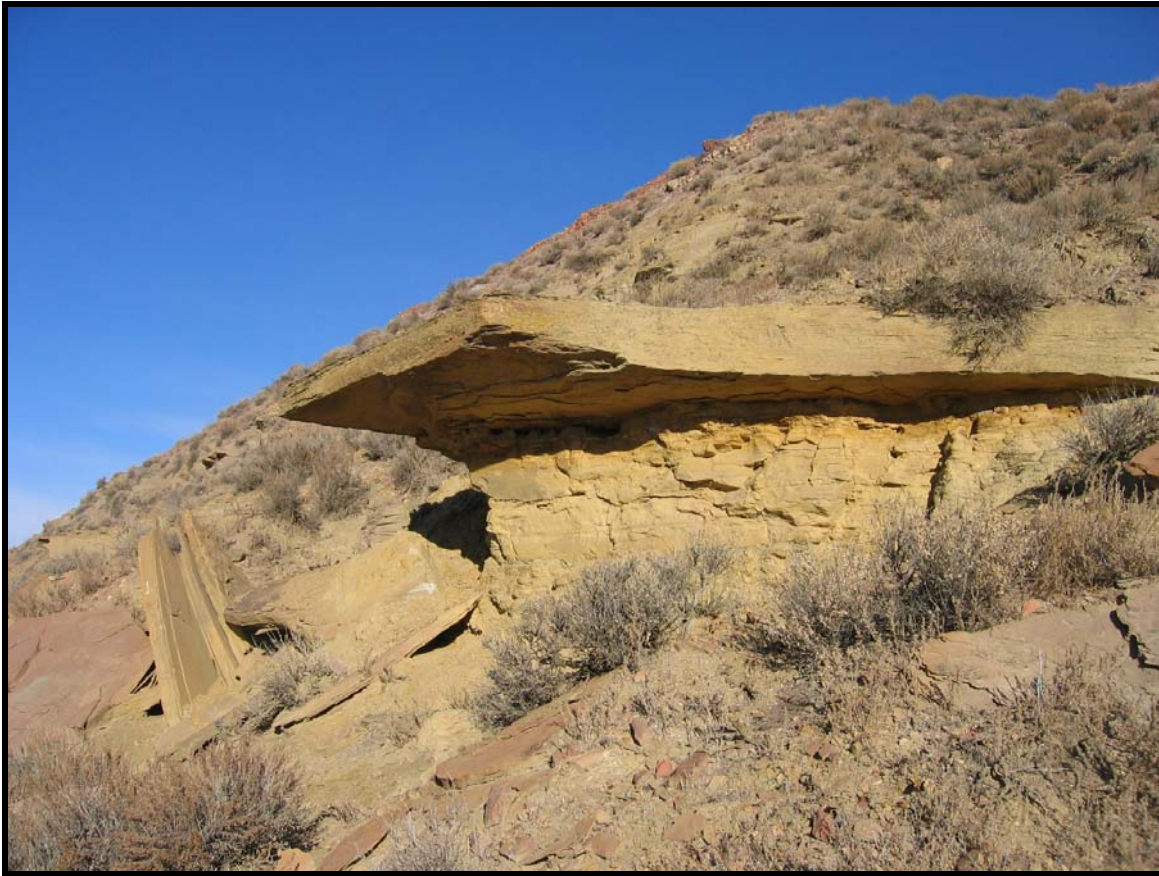
**CLIFF FEATURE: C\_0022**

<b>FEATURE TYPE:</b>	Cliff		
<b>GEOMETRIC DIMENSIONS:</b>	Length: 30 ft	Height: 30 ft	
<b>LOCATION:</b>	Township: 8S	Range: 40E	Section: 30
<b>HANDHELD GPS POINTS:</b>	<b>Northing</b>	<b>Easting</b>	
	<b>8015</b>	411294.03	2679068.44
	<b>8016</b>	411293.19	2679042.63
	<b>8017</b>	411286.49	2679060.93

**SUBSTRATE:** Siltstone/sandstone

**DESCRIPTION OF FEATURE:** This type of cliff is very common throughout the entire permit area. This feature consists of a hard sandstone/siltstone rock layer on top of a highly erosive sandy silt layer. As weathering and erosion occurs, the rock shelf is left exposed, leaving an overhang. In many areas, this overhang eventually cantilevers far enough to cause the rock to fracture and fall down the steep sidehill.

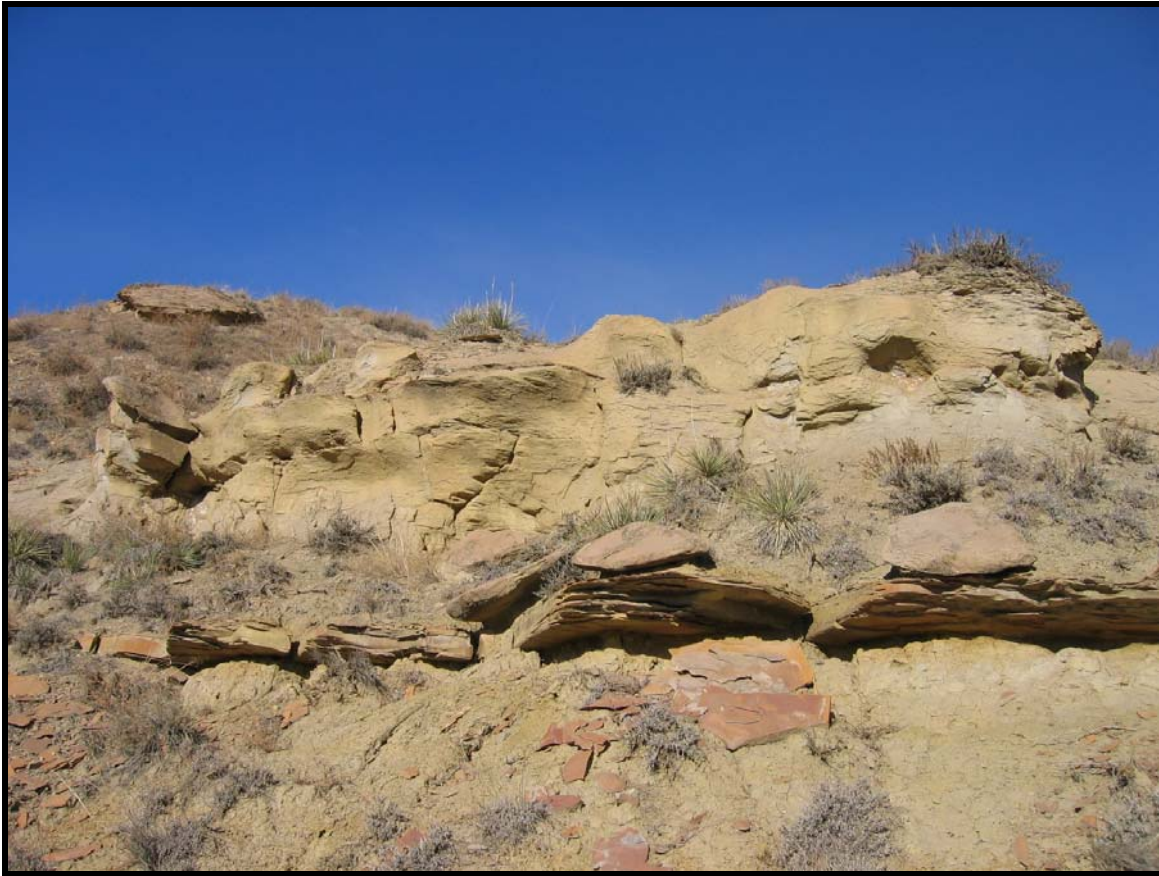
**CLIFF FEATURE: C\_0023**

**GEOMETRIC DIMENSIONS:** Length: 70 ft      Height: 20 ft

**SUBSTRATE:** Soft Sandstone

**DESCRIPTION OF FEATURE:** The cliff feature shown above has a solid sandstone rock face that is pocketed with holes and crevices caused by weathering. The soil surrounding this feature is a sandy silt, and the rock face itself is composed of softer sandstone.

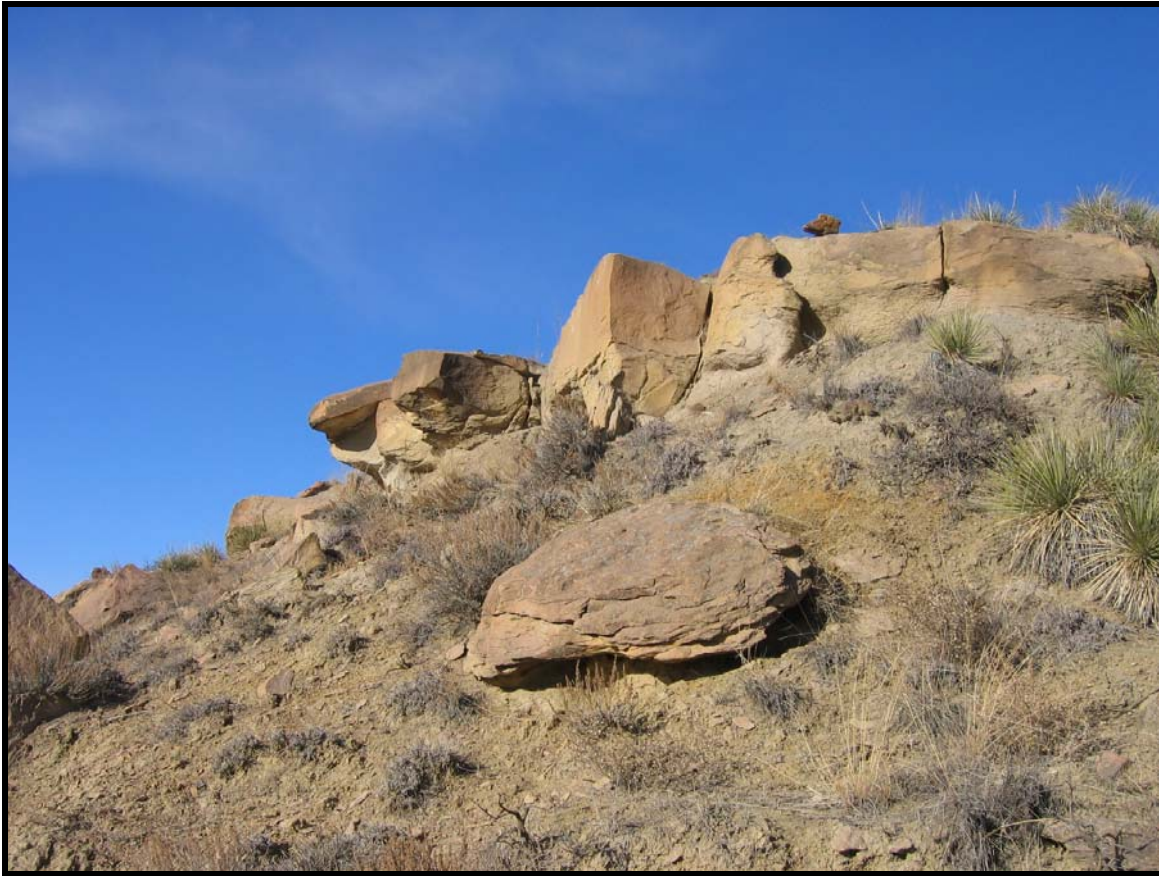
**CLIFF FEATURE: C\_0024**

**GEOMETRIC DIMENSIONS:** Length : 100 ft      Height: 15 ft

**SUBSTRATE:** Siltstone/sandstone

**DESCRIPTION OF FEATURE:** This feature is an exposed rock layer that is approximately fifteen feet thick. The exposure of the rock creates a very steep, solid rock face. This cliff occurs at the top of a moderately steep slope.

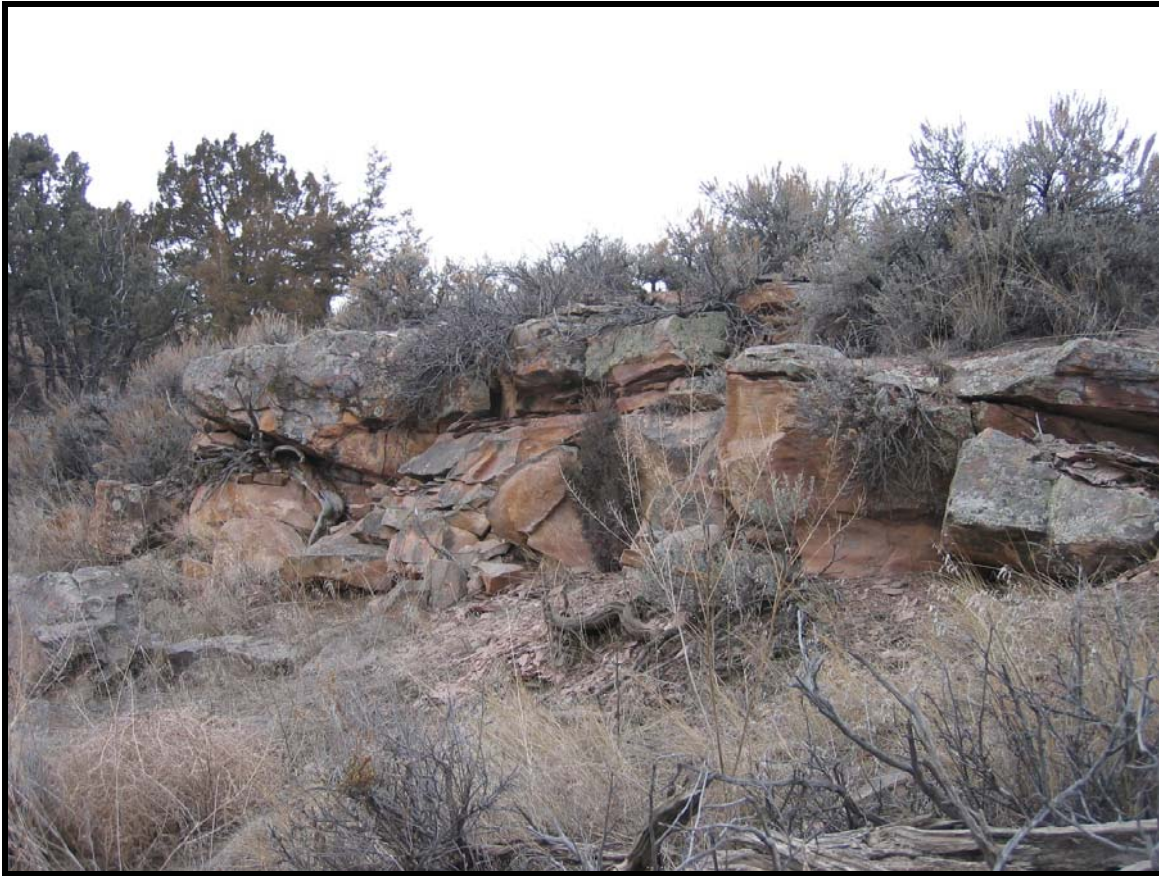
**CLIFF FEATURE: C\_0030**

**GEOMETRIC DIMENSIONS:** Length : 40 ft      Height: 10 ft

**SUBSTRATE:** Siltstone/sandstone

**DESCRIPTION OF FEATURE:** The feature shown above has been listed as a cliff feature because of the geometry of the rock and the fact that the feature is embedded in the side of a hill. This rock face is jagged and overlooks a small tributary draw to South Fork Spring Creek.

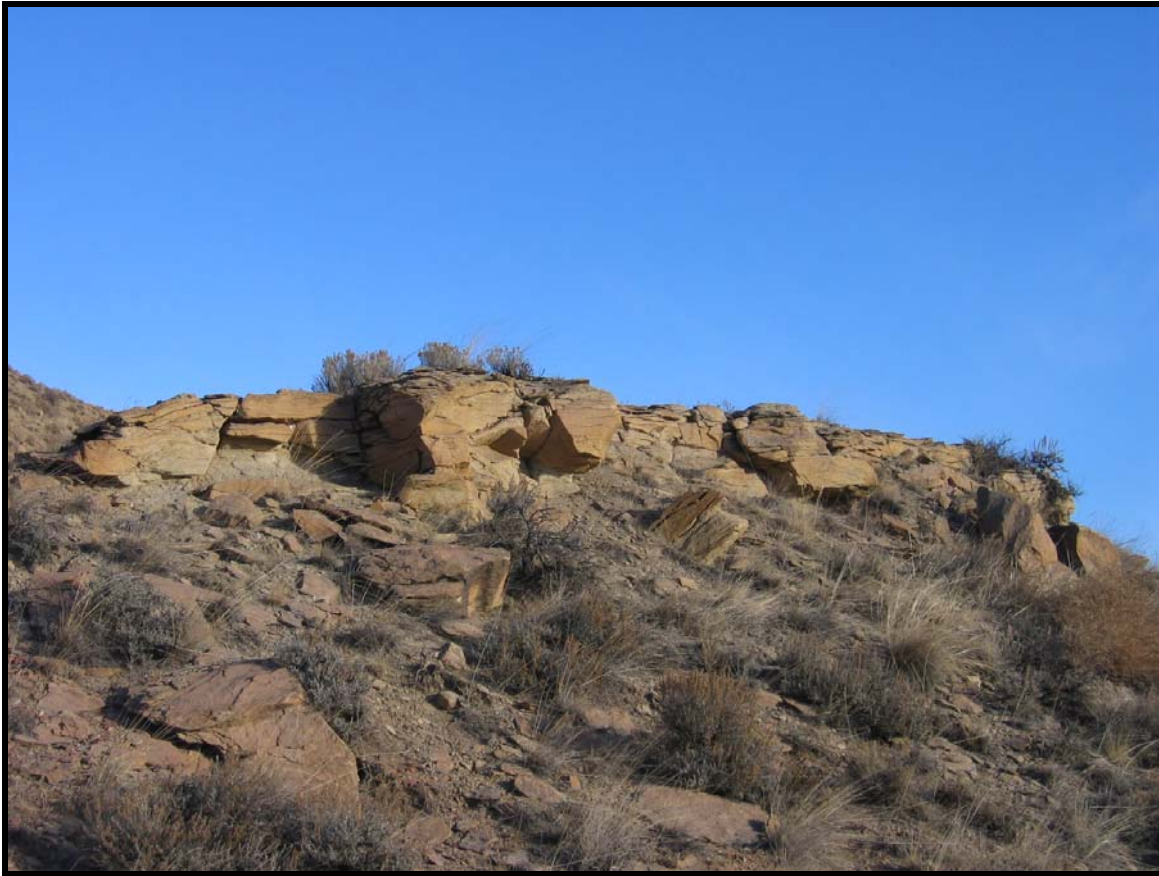
**ROCK OUTCROP FEATURE: RO\_0067**

<b>FEATURE TYPE:</b>	Rock Outcrop		
<b>GEOMETRIC DIMENSIONS:</b>	Length : 85 ft	Height: 5 ft	
<b>LOCATION:</b>	Township: 8S	Range: 40E	Section: 30
<b>HANDHELD GPS POINTS:</b>	<b>Northing</b>	<b>Easting</b>	
	<b>8007</b>	410932.27 2679271.51	
	<b>8008</b>	410967.60 2679347.87	
	<b>8009</b>	410937.01 2679304.95

**DESCRIPTION OF FEATURE:** The rock outcrop shown above occurs in a relatively flat region. The siltstone/sandstone outcrop lies in a long, narrow formation. The rocks in this feature are relatively low-lying and highly fractured.

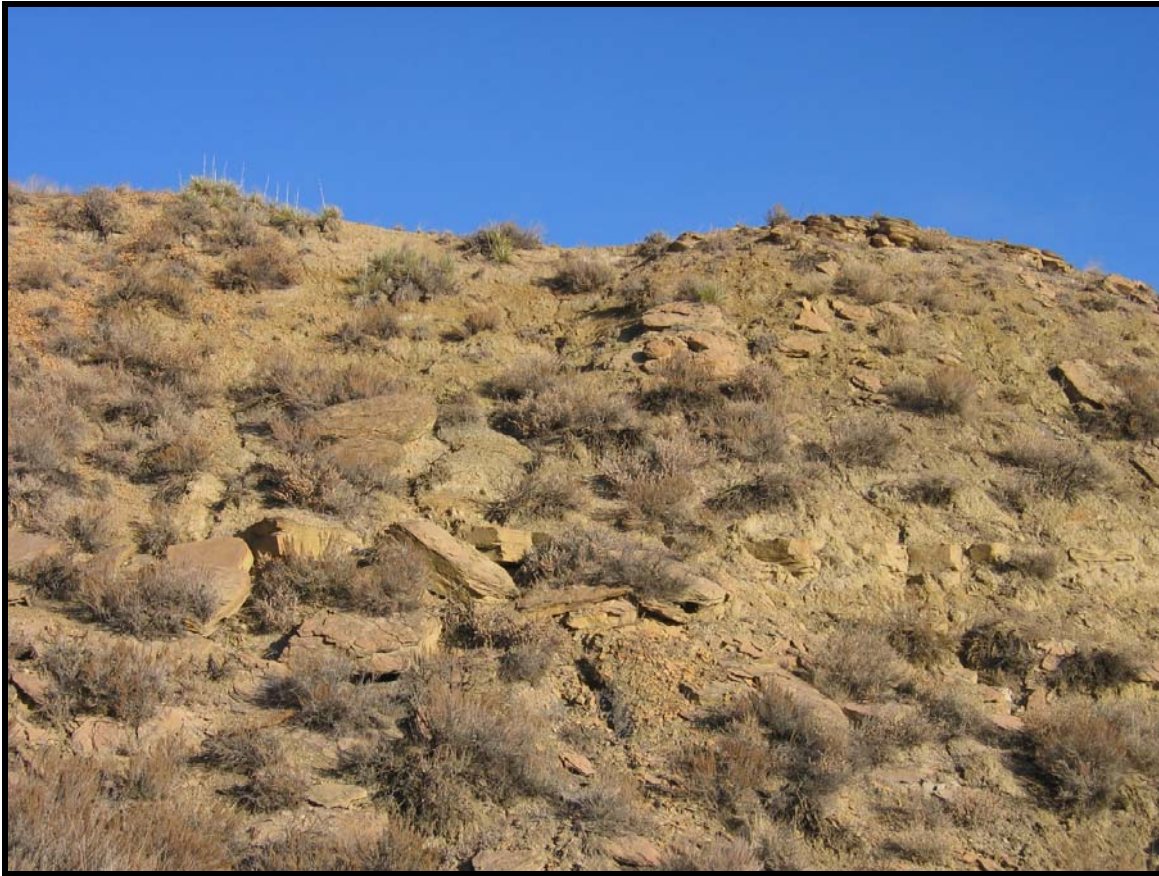
**ROCK OUTCROP FEATURE: RO\_0068**

**GEOMETRIC DIMENSIONS:** Area of Outcrop: 0.02 acres

**SUBSTRATE:** Sand, Silt, and Siltstone/Sandstone

**DESCRIPTION OF FEATURE:** This rock outcrop does not contain rocks of significant size or uniqueness; however, the soil beneath the rocks is soft, sandy silt, allowing animals to use the rocks to burrow between. The steep sidehill contains frequent holes where animals have previously resided.

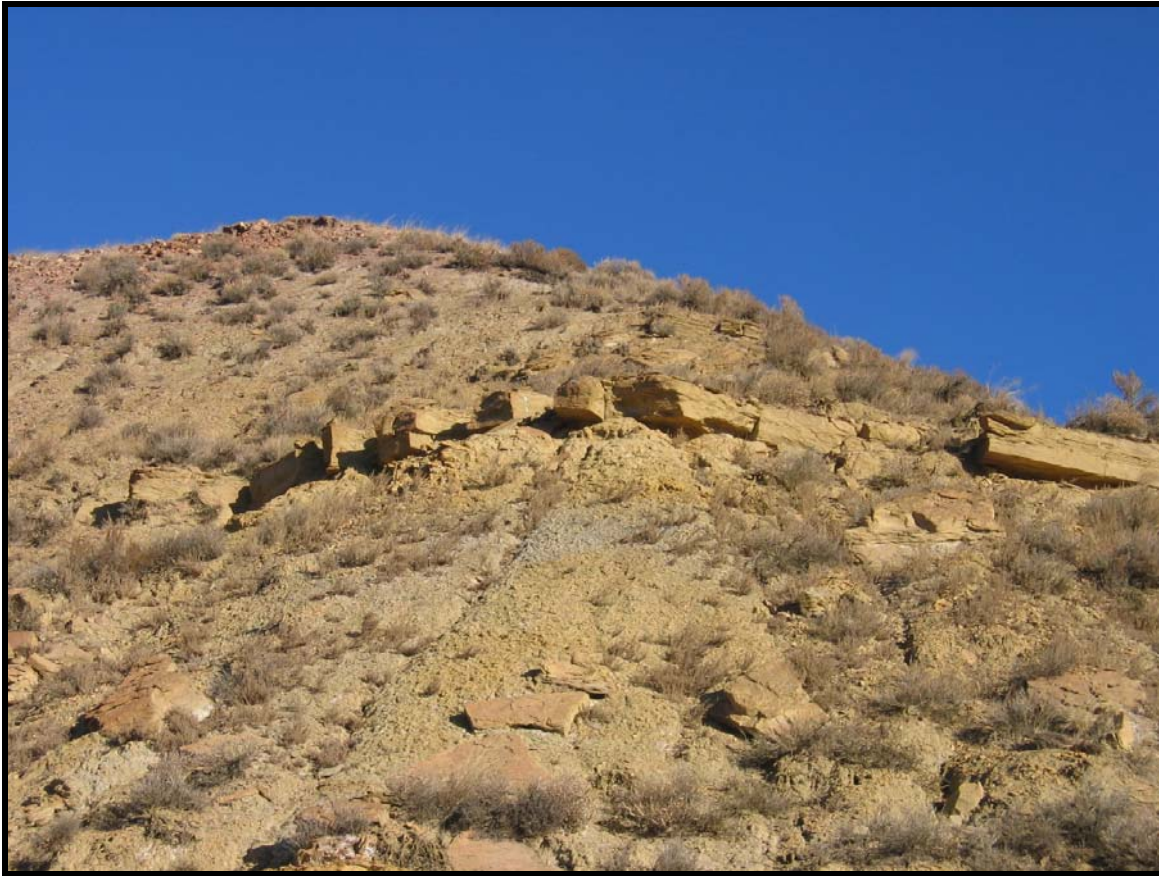
**ROCK OUTCROP FEATURE: RO\_0069**

<b>FEATURE TYPE:</b>	Rock Outcrop		
<b>GEOMETRIC DIMENSIONS:</b>	Length: 120 ft	Height: 5 ft	
<b>LOCATION:</b>	Township: 8S	Range: 40E	Section: 30
<b>HANDHELD GPS POINTS:</b>	<b>Northing</b>	<b>Easting</b>	
	<b>8013</b>	411253.27	2679271.30
	<b>8014</b>	411300.90	2679166.39
<b>SUBSTRATE:</b>	Siltstone/sandstone		
<b>EXPOSURE:</b>	Southern facing slope		
<b>DESCRIPTION OF FEATURE:</b>	The outcrop shown above is the result of a very thin rock layer being exposed by erosion and weathering. A small overhang has been created below the siltstone/sandstone rock.

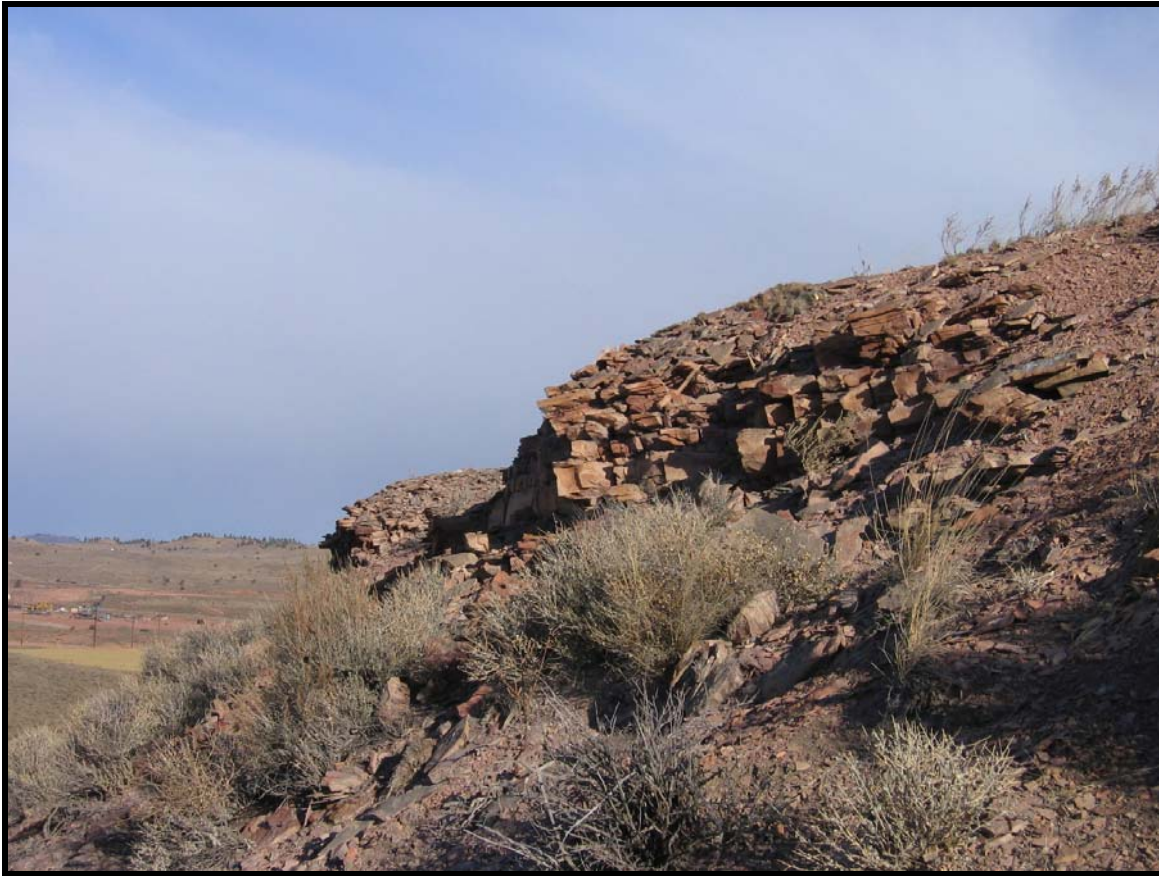
**ROCK OUTCROP FEATURE: RO\_0070**

**GEOMETRIC DIMENSIONS:** Length : 410 ft      Height: 15 ft

**SUBSTRATE:** Scoria

**DESCRIPTION OF FEATURE:** In many areas around the minesite, the peaks of hillsides are capped with a highly fractured scoria rock. This feature is an example of one of these scoria caprocks.

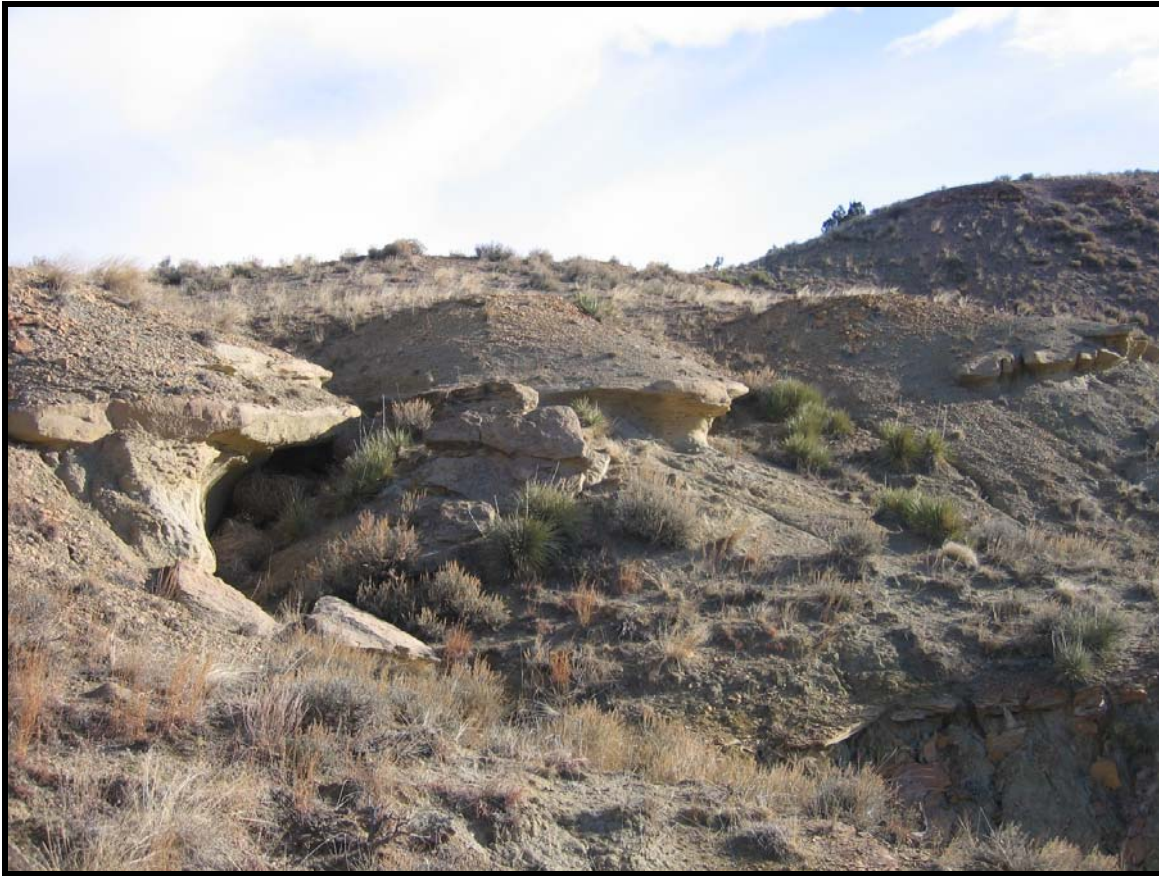
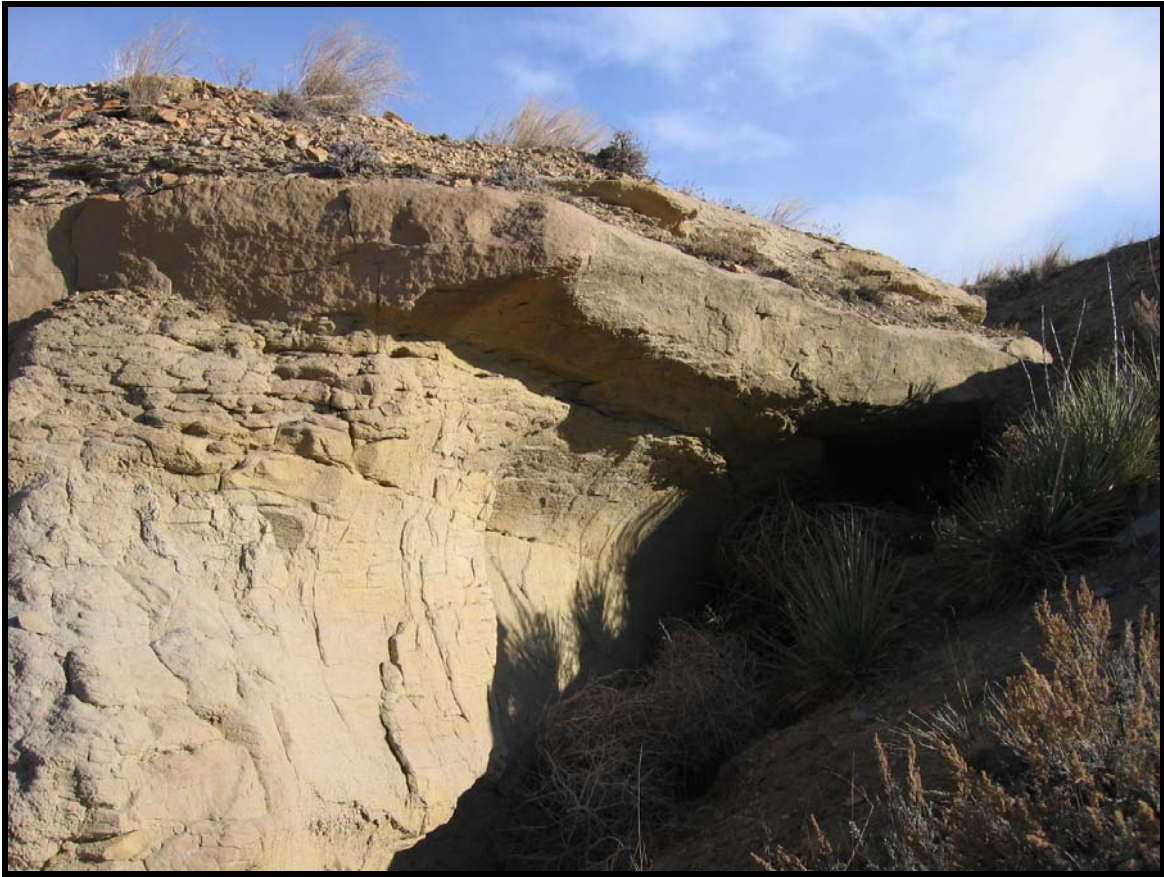
**ROCK OUTCROP FEATURE: RO\_0071**

<b>FEATURE TYPE:</b>	Rock Outcrop		
<b>GEOMETRIC DIMENSIONS:</b>	Length: 110 ft	Height: 10 ft	
<b>LOCATION:</b>	Township: 8S	Range: 40E	Section: 30
<b>HANDHELD GPS POINTS:</b>	<b>Northing</b>	<b>Easting</b>	
	<b>8022</b>	411611.24 2678618.80	
	<b>8023</b>	411552.34 2678713.74	
	<b>8024</b>	411580.39 2678679.24	
<b>SUBSTRATE:</b>	Soft Sandstone		
<b>EXPOSURE:</b>	Southern facing slope		
<b>DESCRIPTION OF FEATURE:</b>	The soft sandstone that makes up this rock outcrop is very similar to the rock in feature C_0023. The sandstone has been eroded away at the bottom, leaving an overhang and pockets. Picture 1_16_06_09 on the next page shows a closer view of this feature.

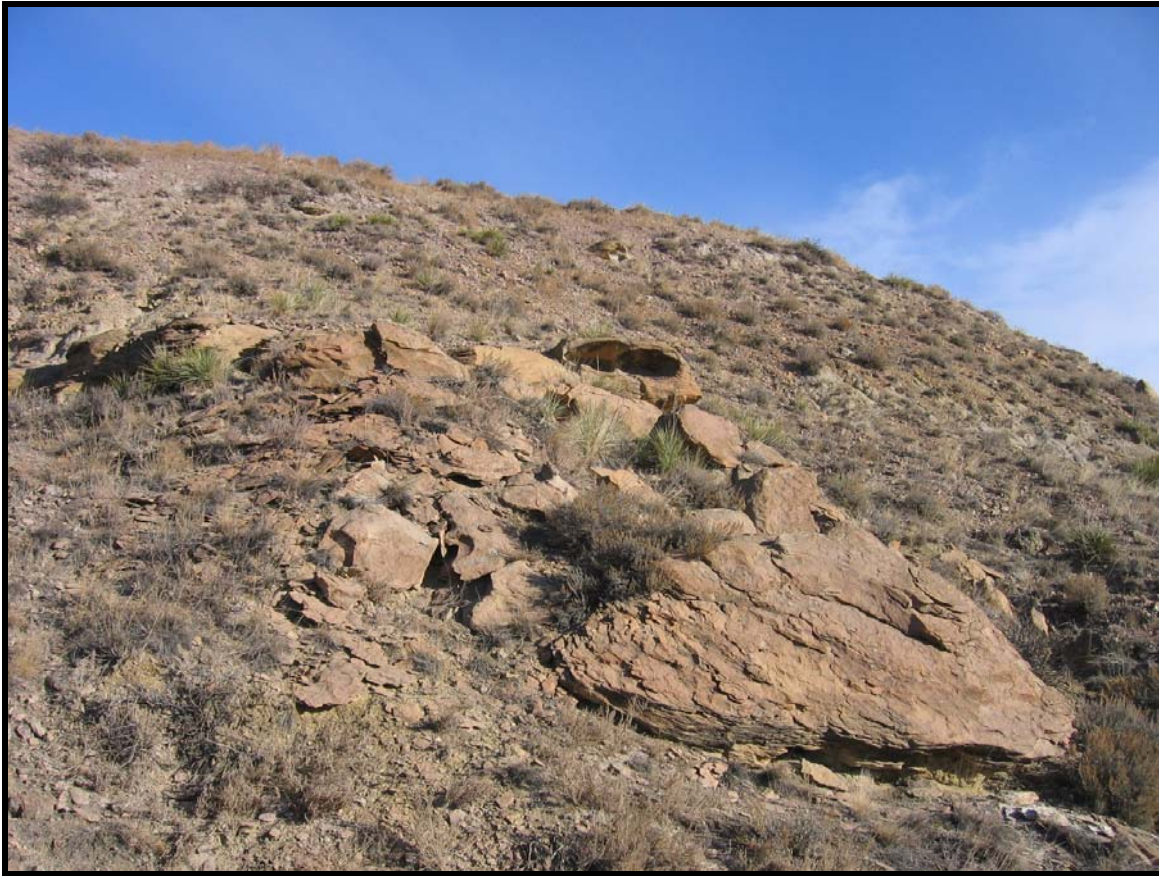
**ROCK OUTCROP FEATURE: RO\_0072**

**GEOMETRIC DIMENSIONS:** Area of outcrop: 0.01 acres

**SUBSTRATE:** Siltstone/sandstone

**DESCRIPTION OF FEATURE:** These large sandstone/siltstone rocks are positioned near the middle of this moderate slope. This feature is located on soft, sandy silt soil and is not surrounded by significant vegetation.

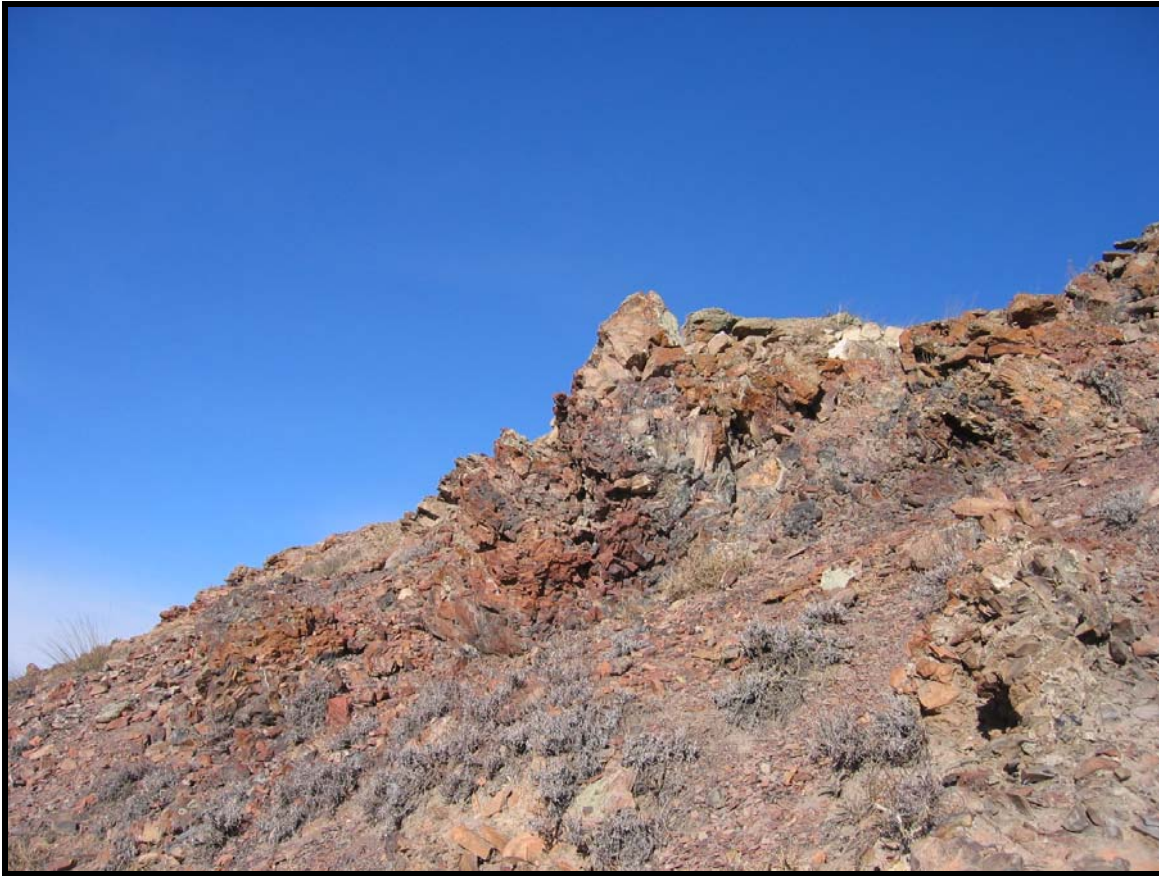
**ROCK OUTCROP FEATURE: RO\_0073**

**GEOMETRIC DIMENSIONS:** Length : 580 ft      Height: 15 ft

**SUBSTRATE:** Scoria

**DESCRIPTION OF FEATURE:** In many areas around the minesite, the peaks of hillsides are capped with a highly fractured scoria rock. This feature is an example of one of these scoria caprocks, however, it is longer than typical scoria outcrops in the area.

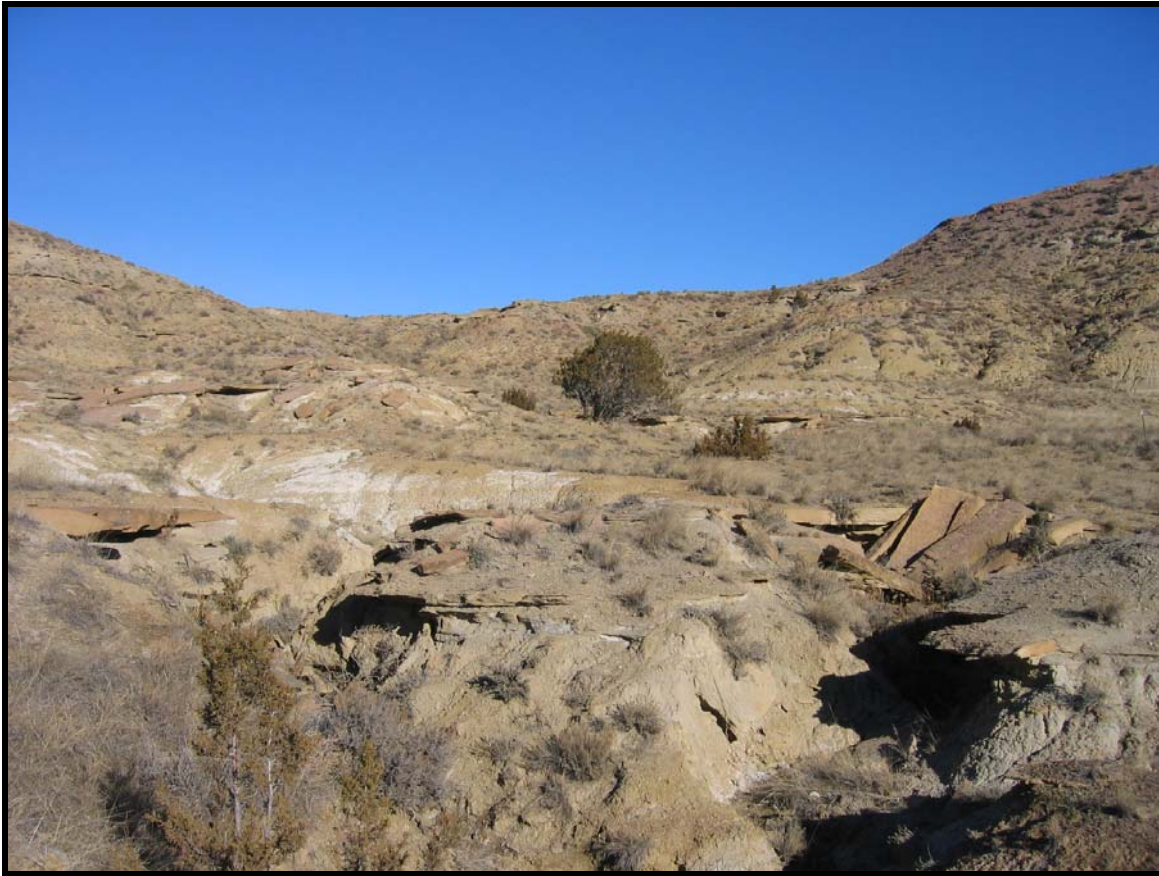
**ROCK OUTCROP FEATURE: RO\_0074**

**GEOMETRIC DIMENSIONS:** Area of outcrop: 0.63 acres

**SUBSTRATE:** Silstone/sandstone

**DESCRIPTION OF FEATURE:** This outcrop sits on a highly erosive sand and silt soil. Due to runoff from the adjacent hill, the rocks have been exposed. The average rock thickness is approximately 4 feet. The rocks have fallen into the stream channel in areas where the soil beneath the rocks has been eroded.

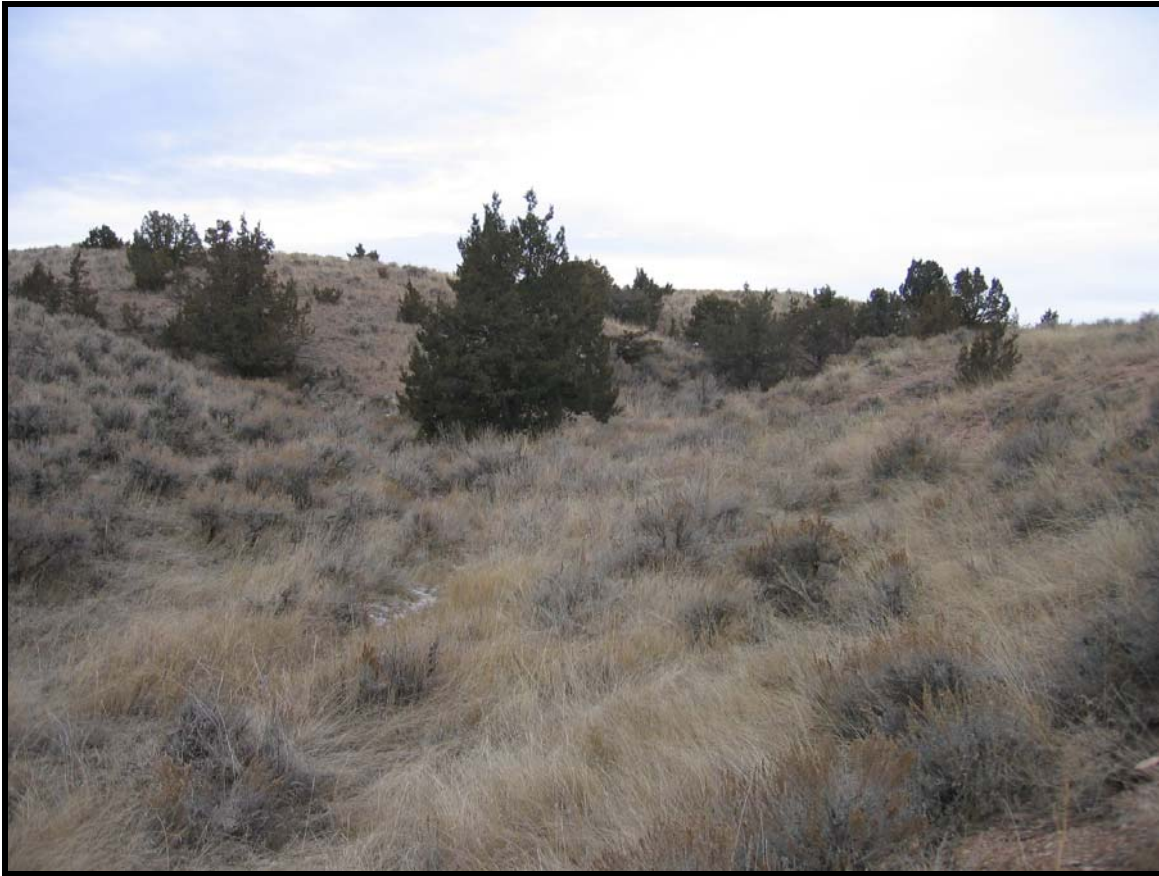
**RIPARIAN FEATURE: R\_0032**

**EXPOSURE:** Drainage runs in a northerly direction

**DESCRIPTION OF FEATURE:** The draw shown above is a tributary stream channel to South Fork Spring Creek. At the head of the draw the channel slope is relatively shallow. The channel in this area could be characterized as a swale. As the draw nears the South Fork Spring Creek channel, however, the walls of the channel and the channel slope itself become steeper and more prominent.
