Township 8S, Range 40E
SECTION 31

Cliff Features

Revised 4/06; Reference – South Fork Extension Amendment #00174

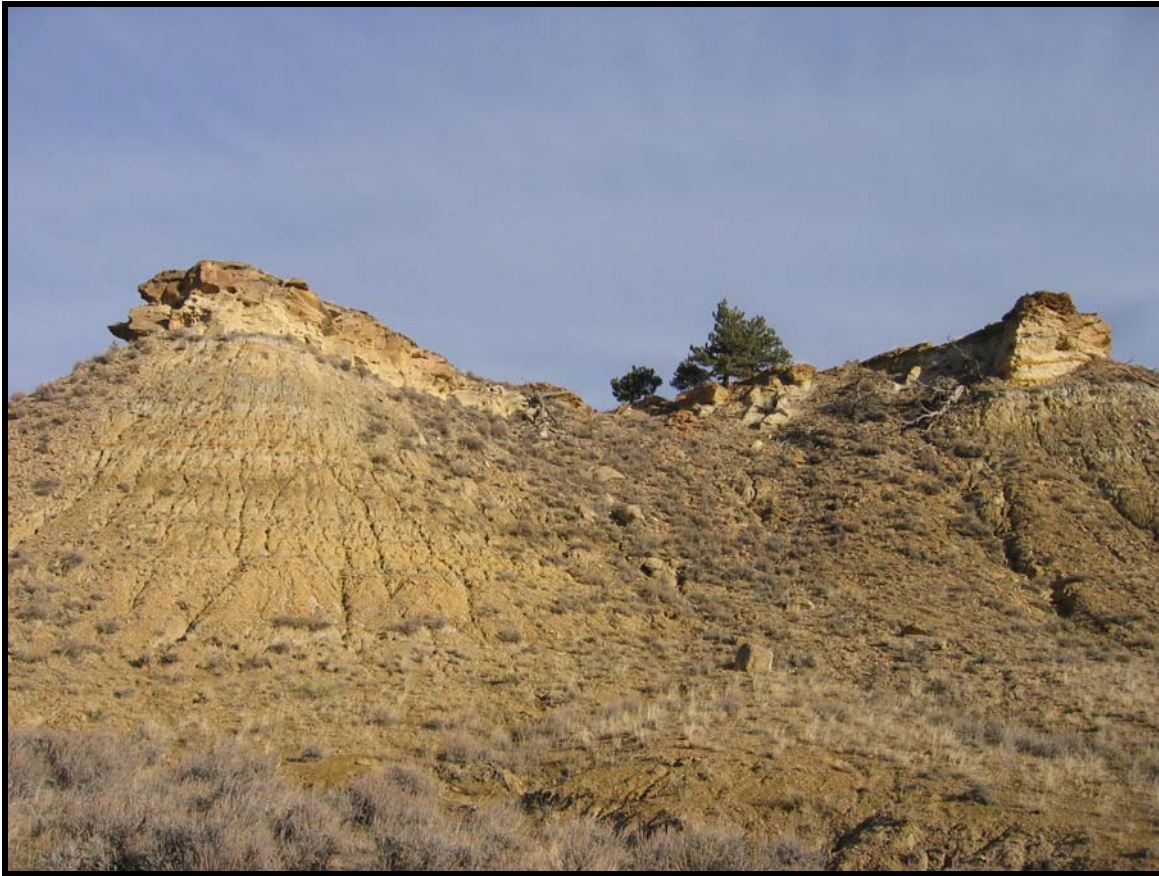
Photo: 12_30_05_04

FEATURE TYPE:	Cliff				
GEOMETRIC DIMENSIONS:	Length : 500 ft		Height: 50 ft		
LOCATION:	Township: 8S		Range: 40E		Section: 31
HANDHELD GPS POINTS:	1002	Northing 405918.73	Easting 2678560.12	1005	Northing 406047.05
	1003	405914.59	2678322.50	1006	405994.66
	1004	406029.43	2678153.34		2678245.79
					2678428.42
SUBSTRATE:	Sandstone/Siltstone				
EXPOSURE:	Southern facing slope				
DESCRIPTION OF FEATURE:	This cliff feature is a hard sandstone/siltstone rock face that is on top of a soft, sandy silt slope. The slope is highly erosive and steep (greater than 3H:1V). The solid rock face of the cliff feature is pocketed and has numerous holes from weathering. Pictures 12_30_05_3 and 1_9_06_2 show the cliff feature and the weathering that has occurred along its face.

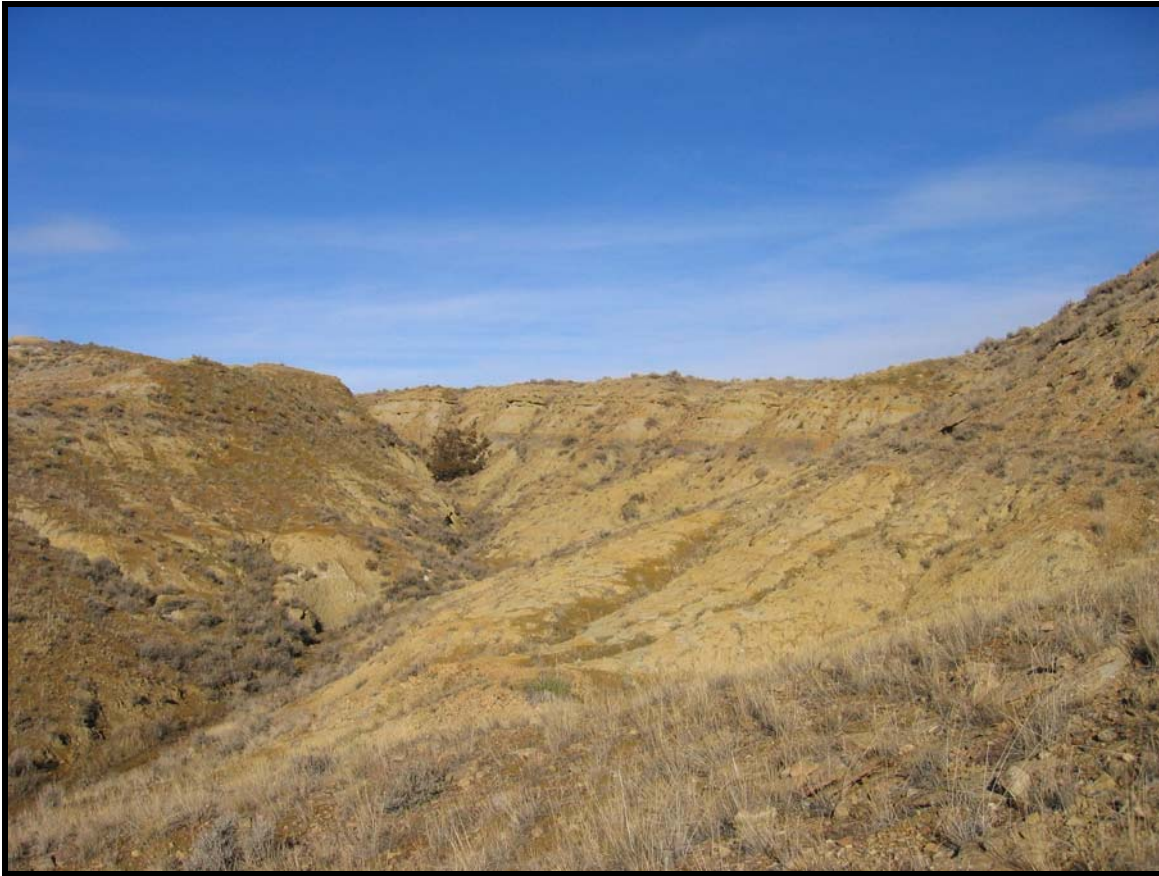
Photo: 12_30_05_07

GEOMETRIC DIMENSIONS: Length : 1000 ft Height: 15 ft

SUBSTRATE: Sandstone/Siltstone

DESCRIPTION OF FEATURE: This cliff feature overlooks draw R_0006 in the Pearson Creek drainage. The sandstone/siltstone rock creates an overhang at the top of the slope. Picture 12_30_05_7 shows the cliffs looking up the drainage. The cliffs have a total length of about 350 feet and range from 5 feet to 20 feet in height.

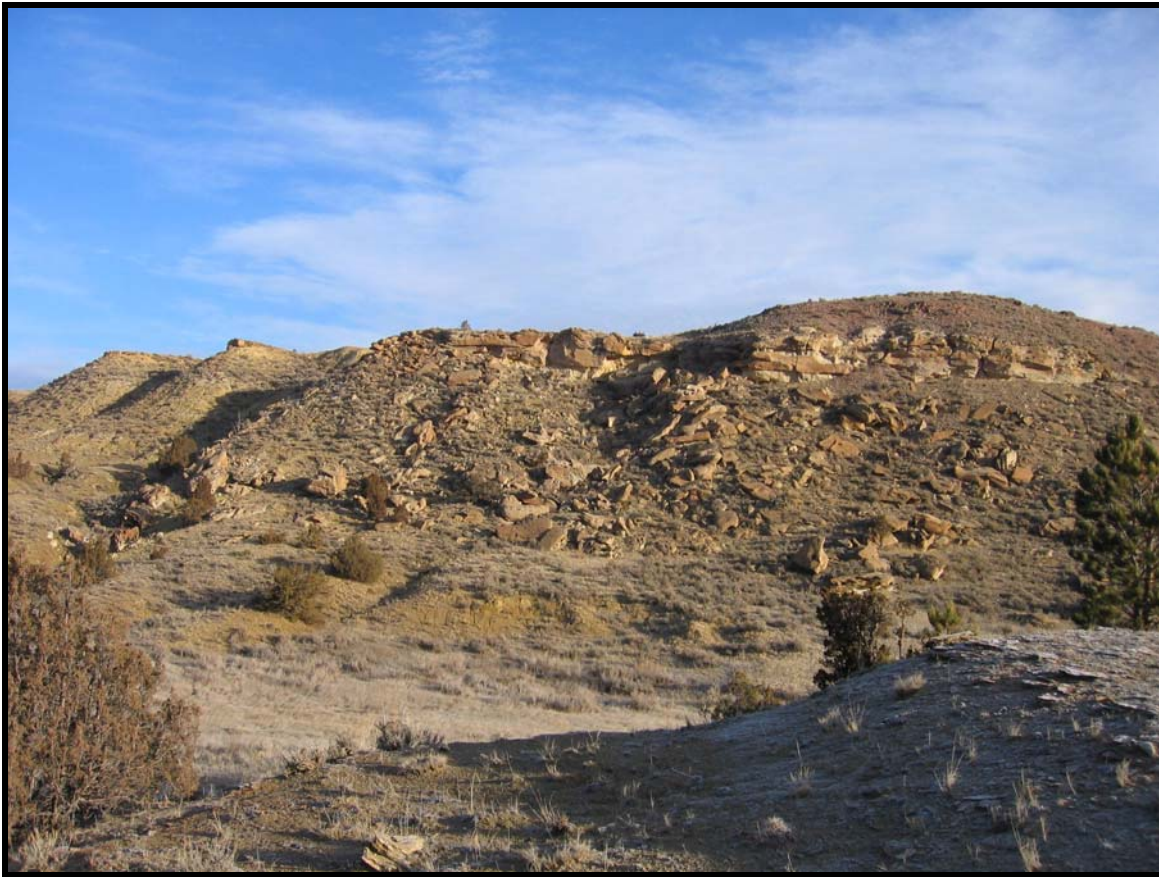
Photo: 1_4_06_01

GEOMETRIC DIMENSIONS: Length : 300 ft Height: 15 ft
Area of Outcrop: 2.2 acres

DESCRIPTION OF FEATURE: This cliff feature is very typical within this drainage. The cliff at the top of the slope is hard siltstone/sandstone. The rocks that make up the feature are large, flat and rectangular. Many pockets and holes have formed between and in the sandstone rock. The pictures on the following pages show additional views of this feature.

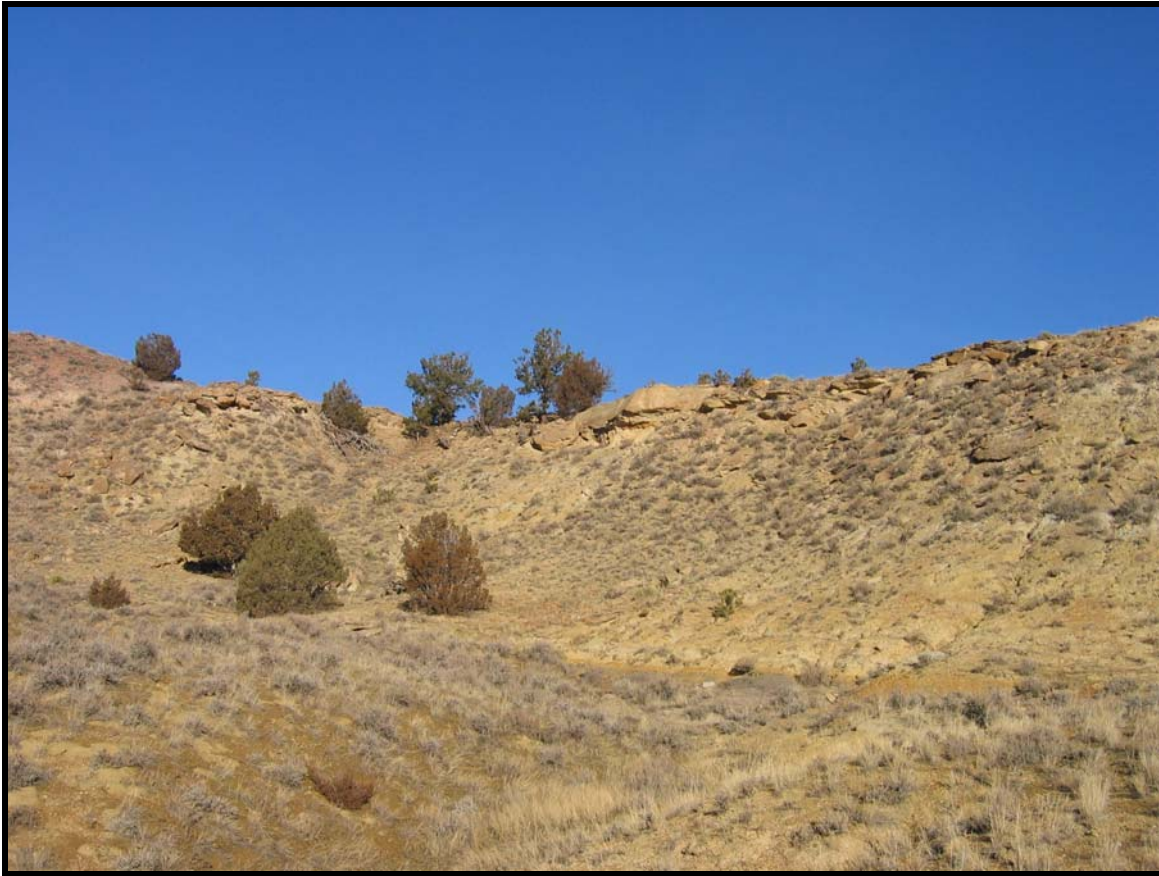
Photo: 1_4_06_04

FEATURE TYPE:	Cliff					
GEOMETRIC DIMENSIONS:	Length: 120 ft		Height: 40 ft			
LOCATION:	Township: 8S		Range: 40E		Section: 31	
HANDHELD GPS POINTS:		Northing	Easting		Northing	Easting
	2011	407099.11	2675278.24	2014	407169.74	2675095.04
	2012	407114.44	2675301.00	2015	407133.39	2675098.81
	2013	407149.45	2675255.92

DESCRIPTION OF FEATURE: This sandstone/siltstone cliff feature consists of two sections that are composed of solid rock. Each section is 50 feet long. The remainder of the length appears like a rock outcrop. The solid rock faces are pocketed with holes and depressions caused by weathering.

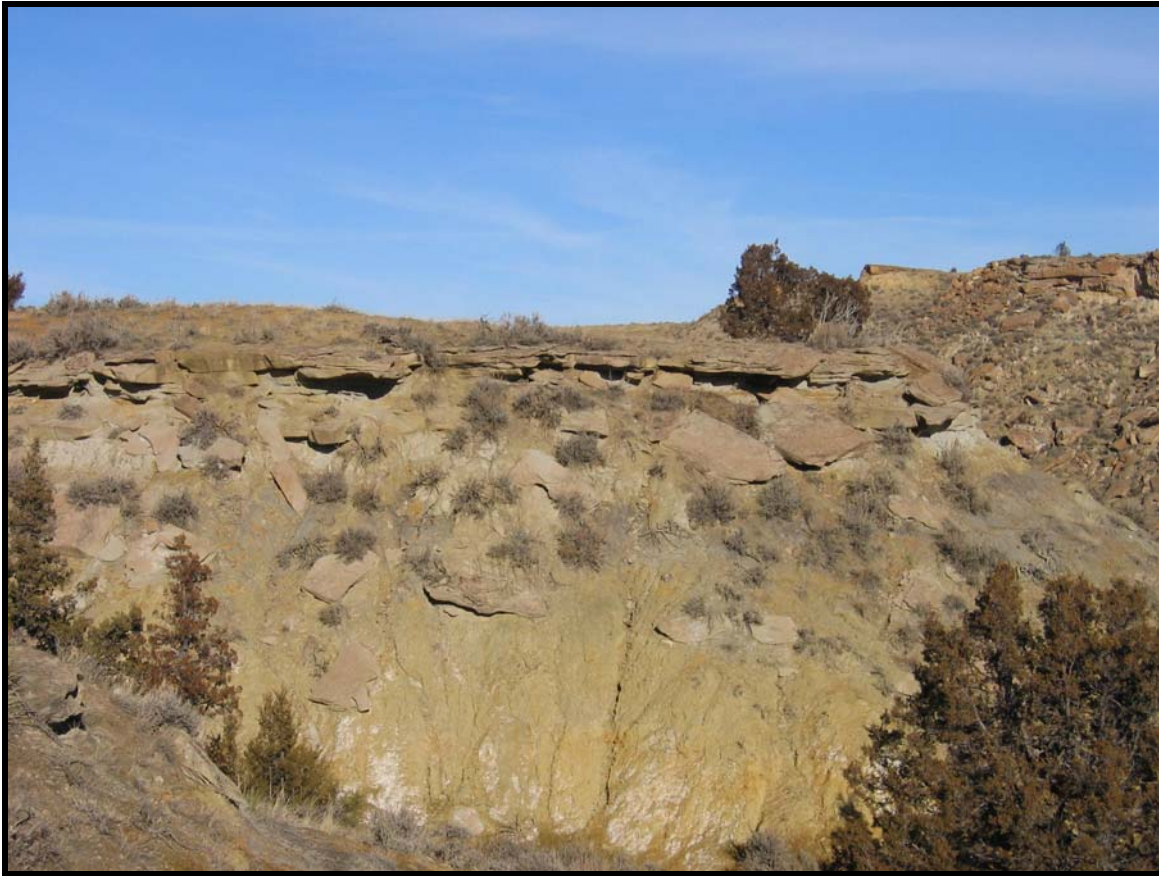
Photo: 1_9_06_07

FEATURE TYPE:	Cliff					
GEOMETRIC DIMENSIONS:	Length: 200 ft		Height: 40 ft			
LOCATION:	Township: 8S		Range: 40E		Section: 31	
HANDHELD GPS POINTS:		Northing	Easting		Northing	Easting
	4010	405794.34	2676207.27	4013	405825.34	2676263.11
	4011	405814.58	2676268.63	4014	405862.05	2676158.54
	4012	405827.20	2676319.91			
SUBSTRATE:	Sand, Silt, and Sandstone/Siltstone					
EXPOSURE:	Northern facing slope					
DESCRIPTION OF FEATURE:	This cliff feature is located at the top of a steep (greater than 3H:1V) slope that consists primarily of soft sand and silt. The sandstone/siltstone feature at the top of the slope is a rock shelf that has been eroded. The rocks that composed this feature are large, flat and rectangular.

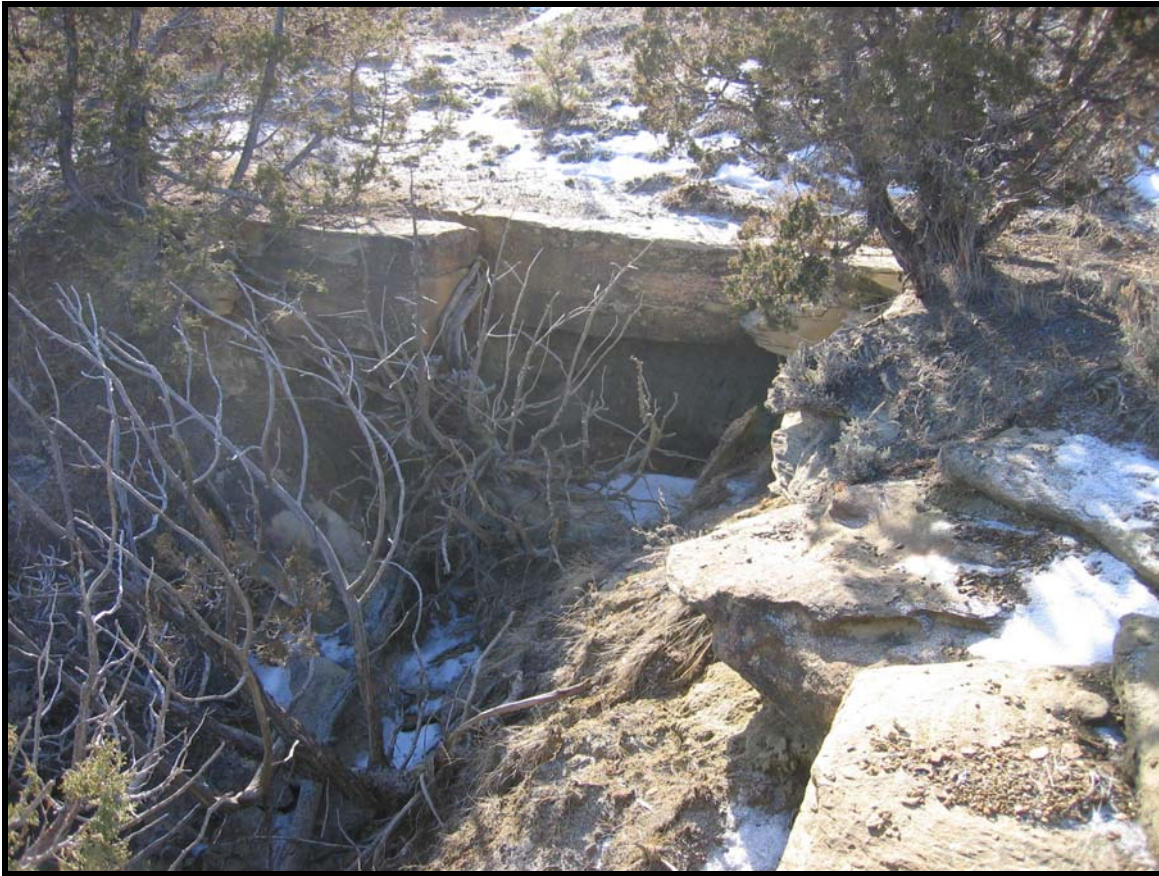
Photo: 1_9_06_12

FEATURE TYPE:	Cliff					
GEOMETRIC DIMENSIONS:	Length : 100 ft		Height: 10 ft			
LOCATION:	Township: 8S		Range: 40E		Section: 31	
HANDHELD GPS POINTS:		Northing	Easting		Northing	Easting
	4015	405972.12	2675731.11	4018	406014.17	2675678.05
	4016	405939.16	2675727.02	4019	406011.28	2675701.40
	4017	405934.09	2675683.25

DESCRIPTION OF FEATURE: This sandstone/siltstone cliff feature creates a large overhang beneath the rock shelf. This feature is at the head of a small draw. Beneath the overhang are large, flat, rectangular rocks that have fallen down the slope. Pictures 1_9_06_13 and 1_9_06_14 on the next page show the rocks and overhang.

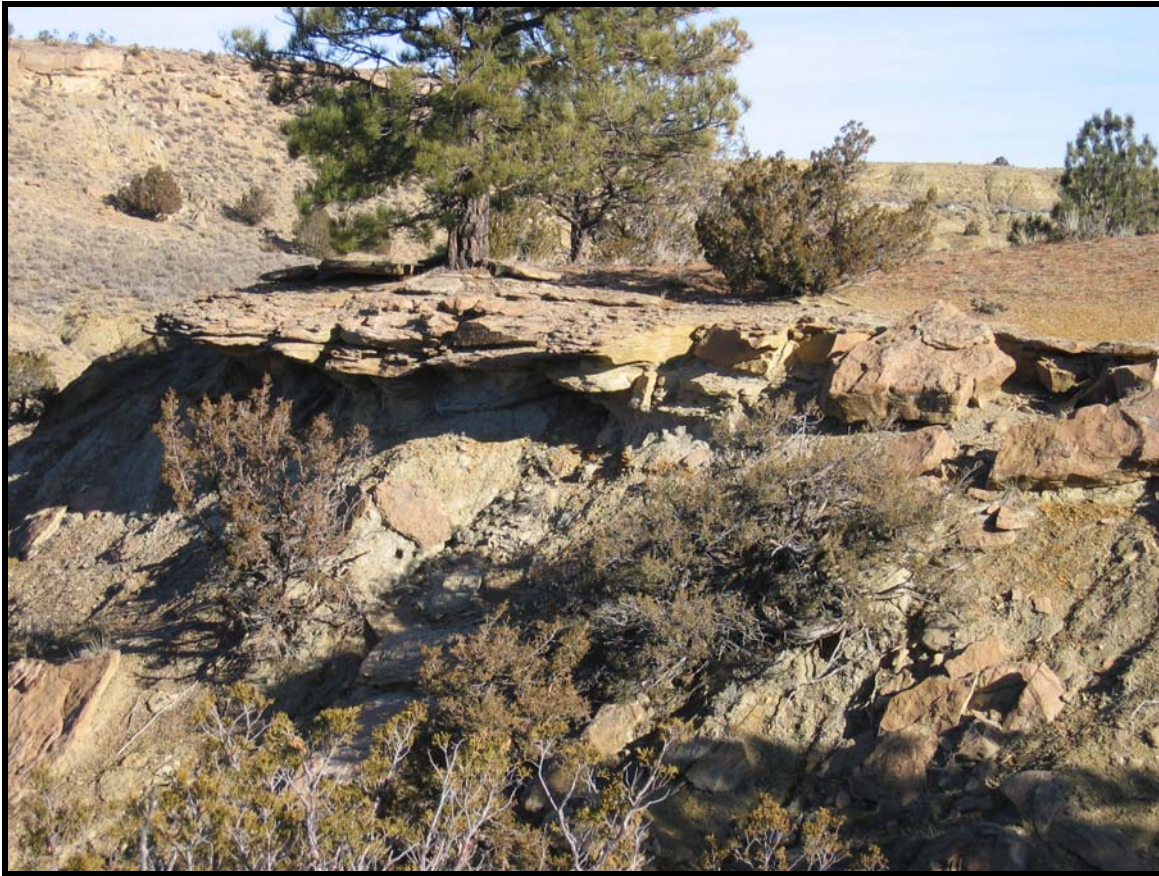
Photo: 1_9_06_16

GEOMETRIC DIMENSIONS: Length: 80 ft Height: 10 ft

DESCRIPTION OF FEATURE: This type of cliff feature is very typical in this area. Created by the erosion from the adjacent channel, the rock shelf has been exposed, making an area beneath the overhang. See picture 1_9_06_16 above for a view of the cliff feature.

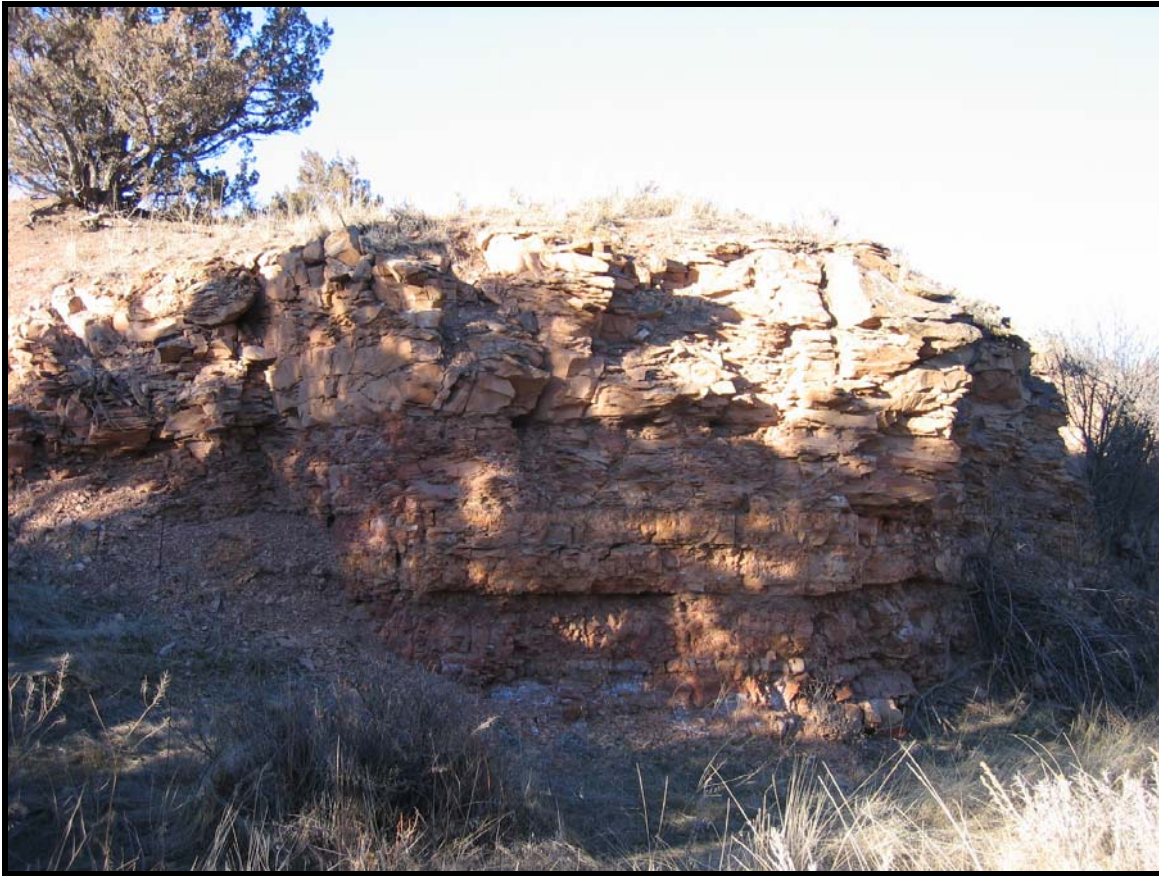
Photo: 1_16_06_35

GEOMETRIC DIMENSIONS: Length: 40 ft Height: 20 ft

DESCRIPTION OF FEATURE: This cliff feature is adjacent to a stream channel and has been eroded by runoff flows. The face is jagged and is composed of a sandstone/siltstone rock with frequent pieces of scoria.

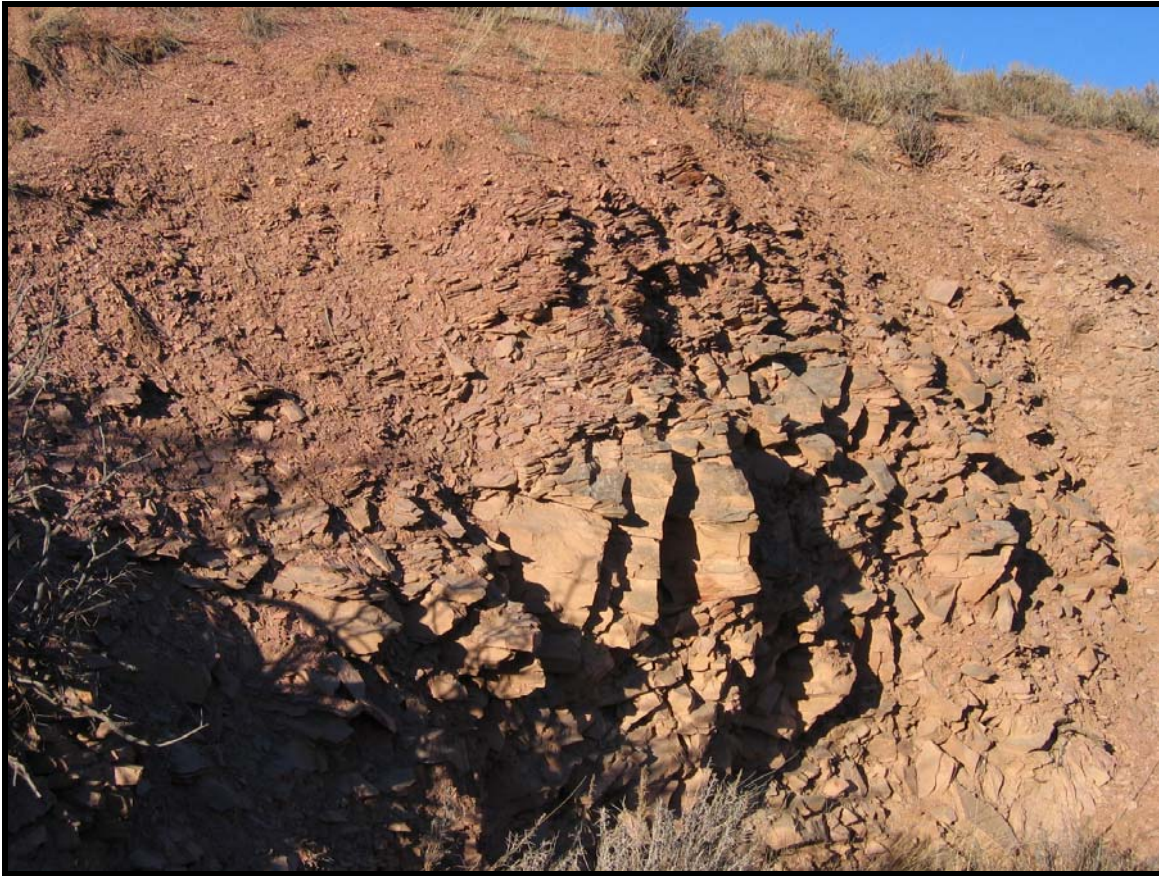
Photo: 1_16_06_37

GEOMETRIC DIMENSIONS: Length: 30 ft Height: 20 ft

DESCRIPTION OF FEATURE: This cliff feature is adjacent to a stream channel and has been eroded by runoff flows. The face is jagged and is composed of a sandstone/siltstone rock with frequent pieces of scoria. The feature appears on the same channel as C_0025.

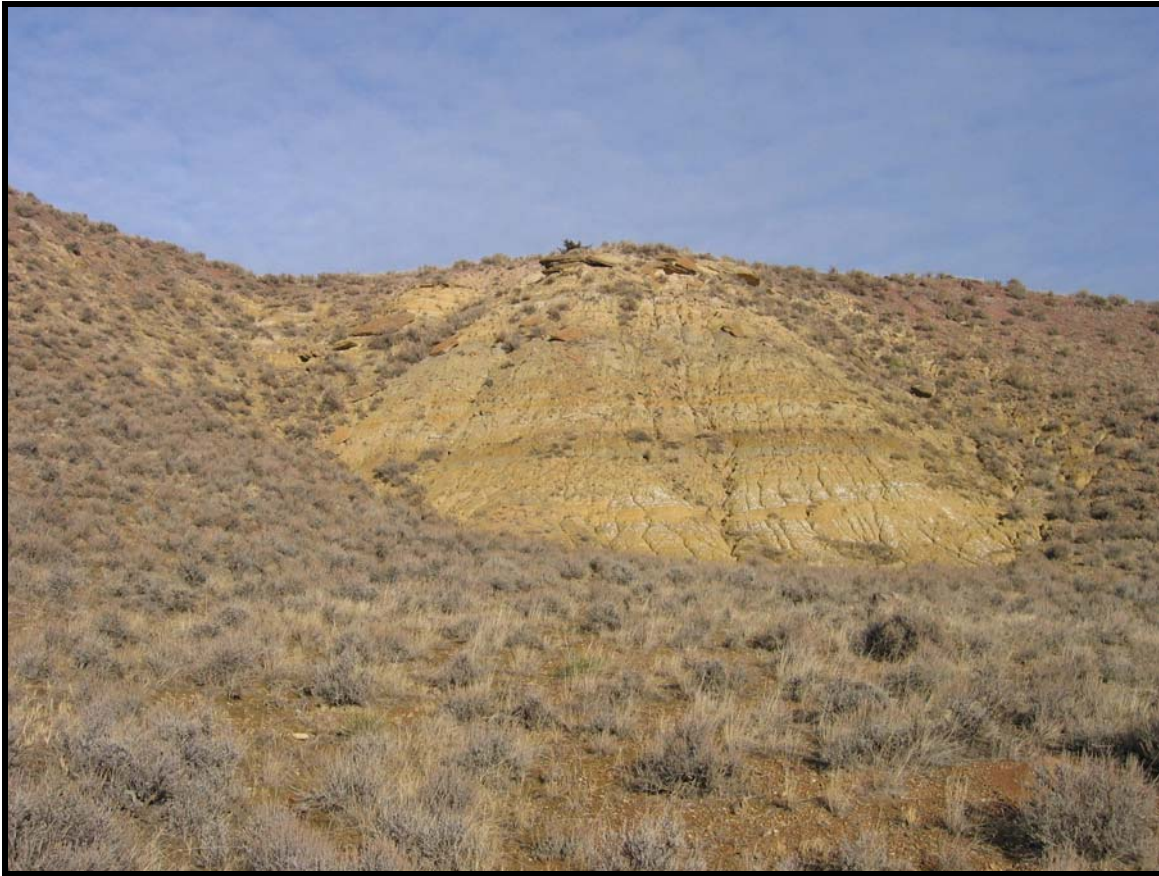
Photo: 12_30_05_05

FEATURE TYPE:	Rock Outcrop		
GEOMETRIC DIMENSIONS:	Length: 150 ft	Height: 50 ft	
LOCATION:	Township: 8S	Range: 40E	Section: 31
HANDHELD GPS POINTS:	Northing	Easting	
	1011	406050.38 2677901.97	
	1012	406060.45 2677986.92	
	1013	406189.86 2677928.41	
SUBSTRATE:	Sand, Silt, and Sandstone/Siltstone		
EXPOSURE:	Southern facing slope		
DESCRIPTION OF FEATURE:	This feature has a hard siltstone/sandstone outcrop at the top of a steep slope. The slope consists of soft sand and silt. The outcropped rock has a jagged rock face and small areas beneath the rock overhang.

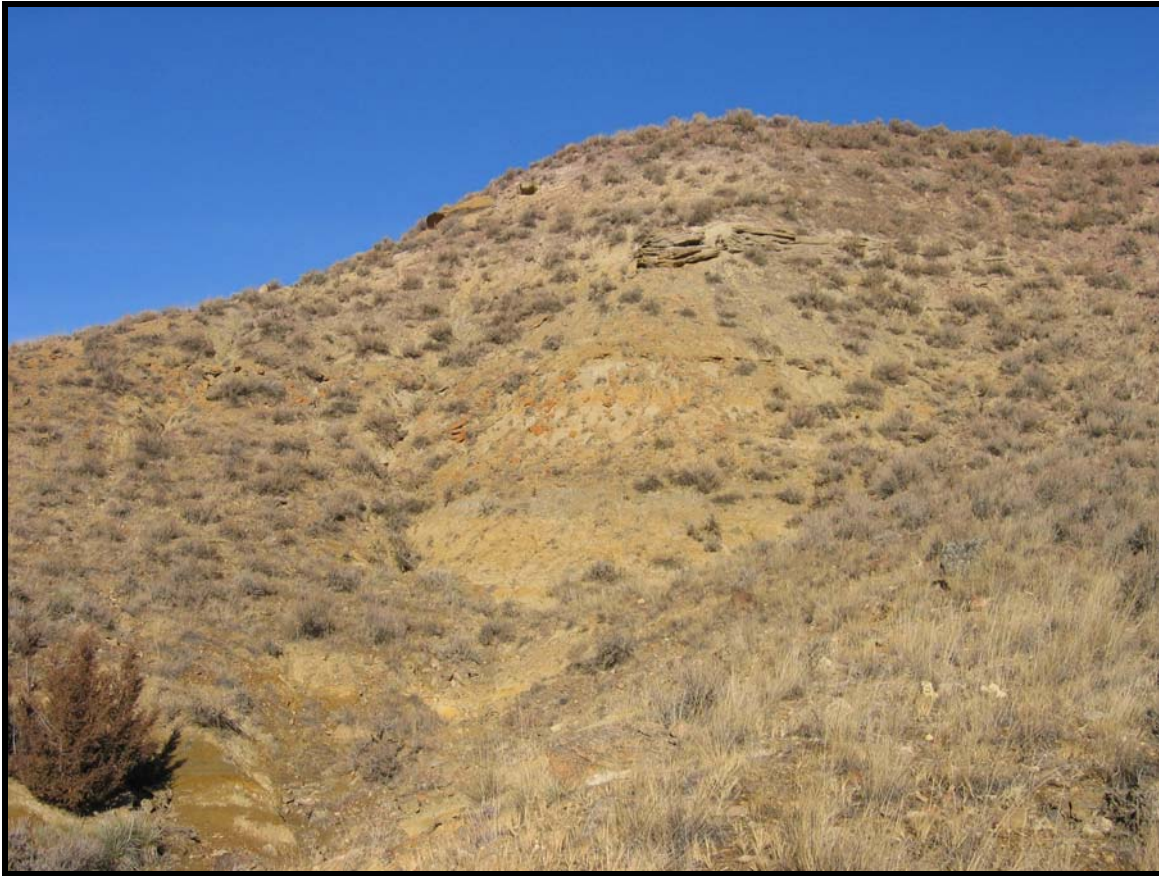
Photo: 12_30_05_06

GEOMETRIC DIMENSIONS: Length: 40 ft Height: 30 ft

DESCRIPTION OF FEATURE: This feature has a hard siltstone/sandstone outcrop at the top of a steep slope. The slope consists of soft sand and silt. The outcropped rock has a jagged rock face and small areas beneath the rock overhang. See picture 12_30_05_06 above for a view of the feature.

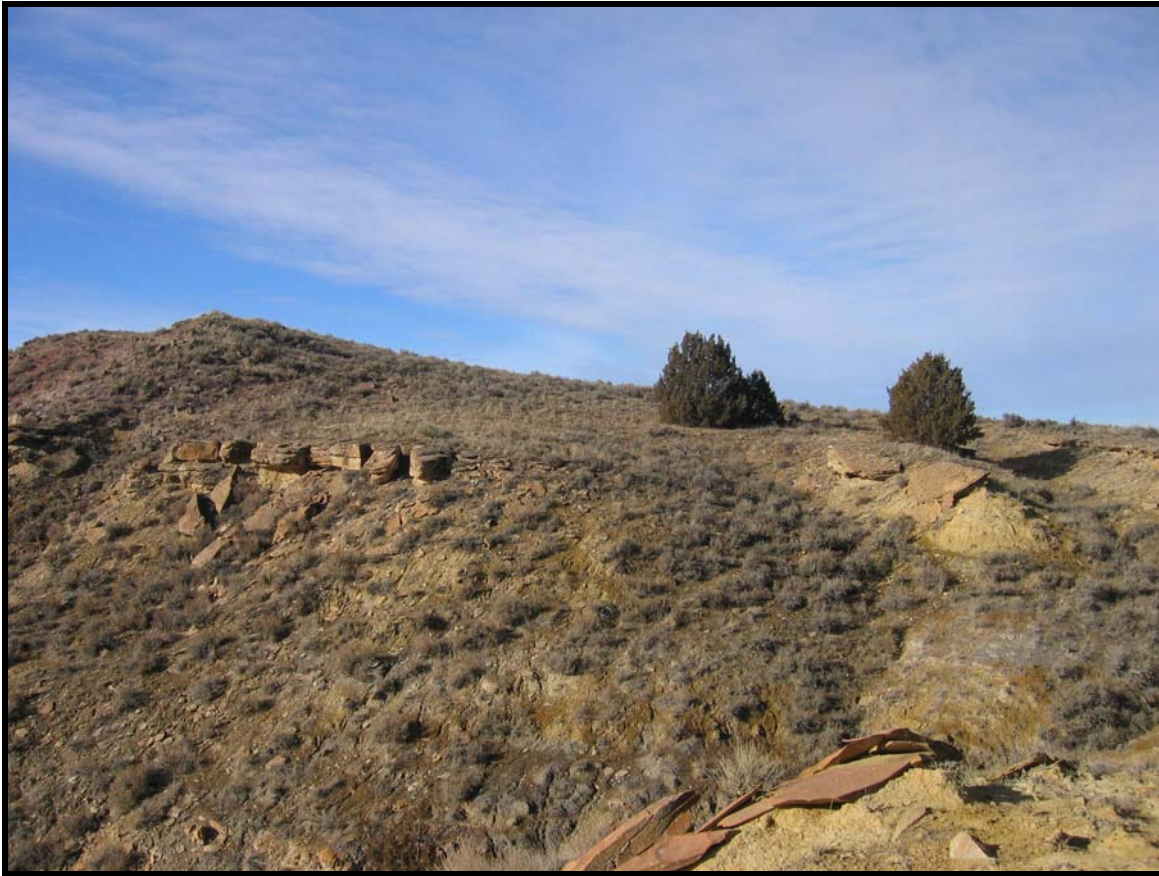
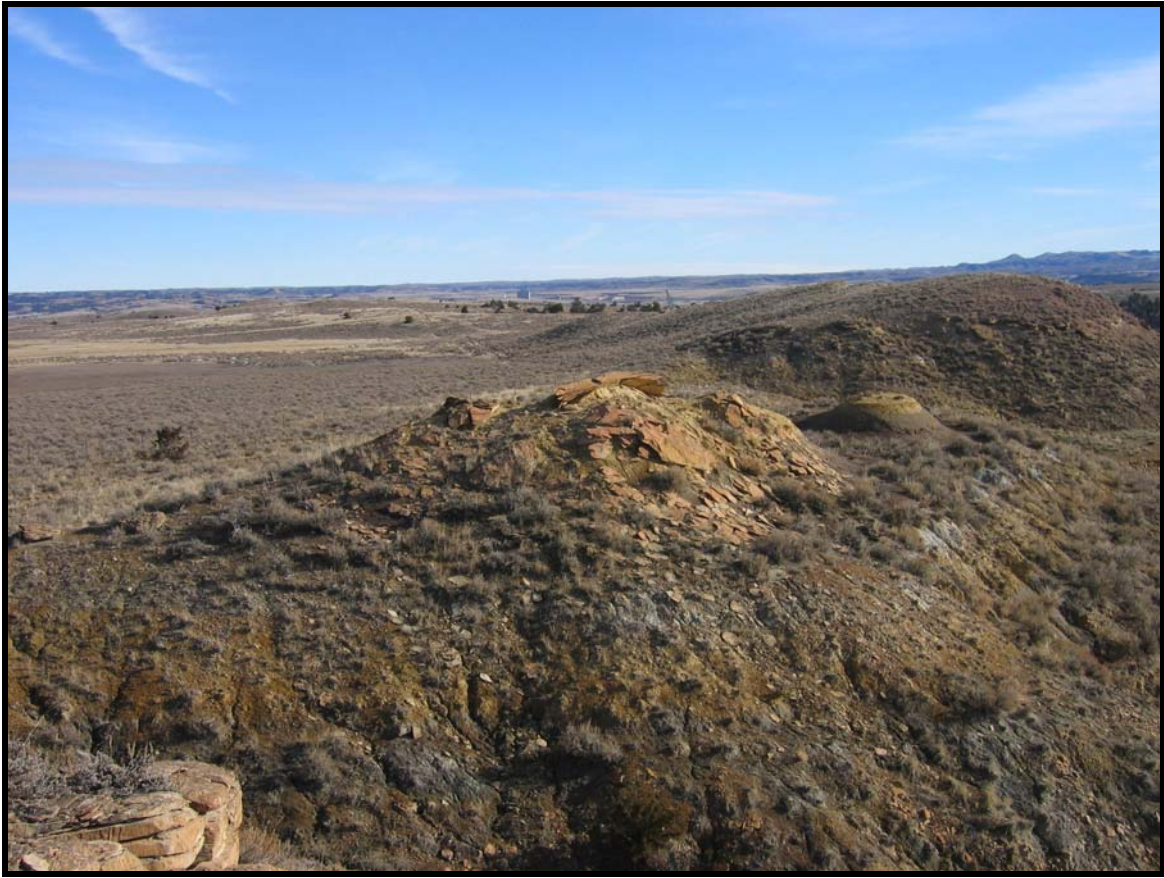
Photo: 12_30_05_08

GEOMETRIC DIMENSIONS: Length : 100 ft Width: 40 ft

DESCRIPTION OF FEATURE: This feature consists of two outcrops at the top of a steep slope (greater than 3H:1V) in the Pearson Creek drainage. The hard sandstone/siltstone rocks can be seen in picture 12_30_05_08 and picture 12_30_05_09 on the next page.

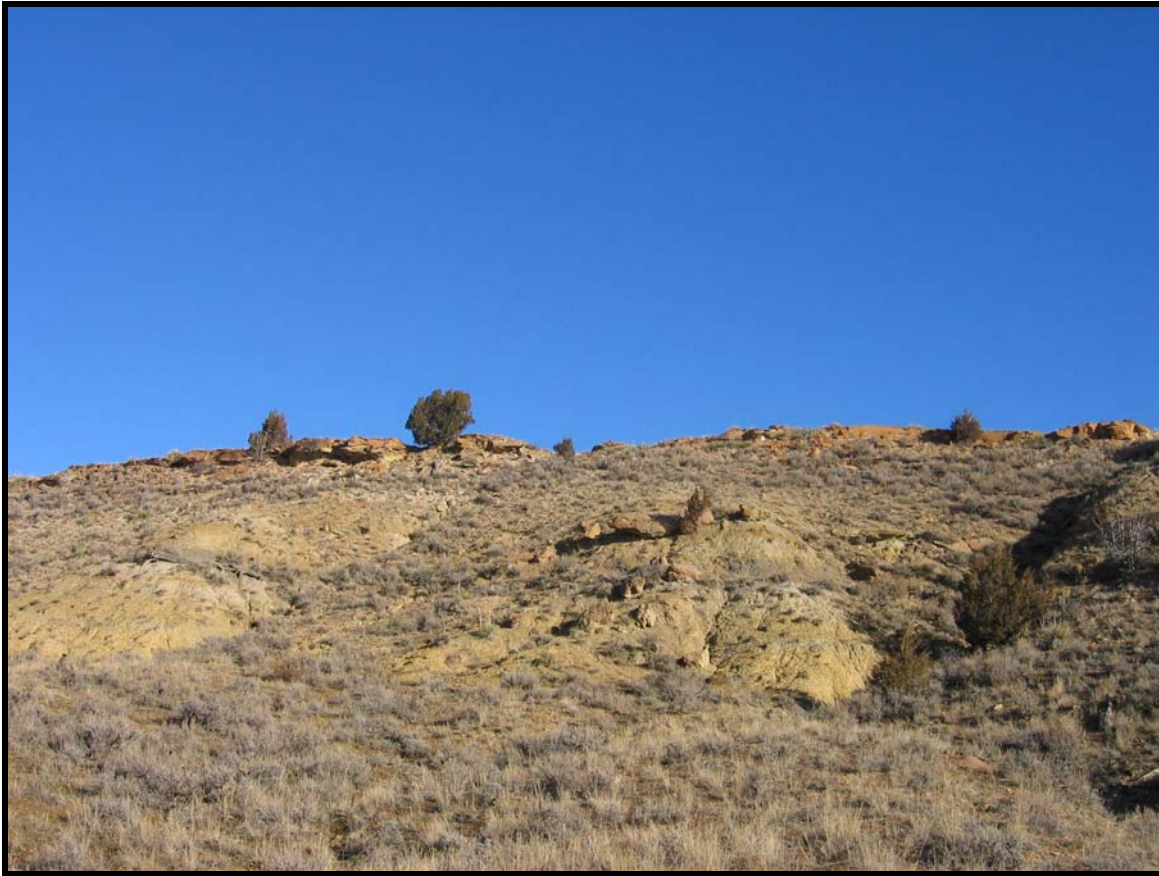
Photo: 1_4_06_06

GEOMETRIC DIMENSIONS: Length : 340 ft Height: 10 ft

DESCRIPTION OF FEATURE: This feature is composed of both solid rock and scattered layered rock. The sandstone and siltstone rock is at the top of a steep (greater than 3H:1V) sandy, silt slope. This feature is at approximately the same elevation as other rock outcrops in this area.

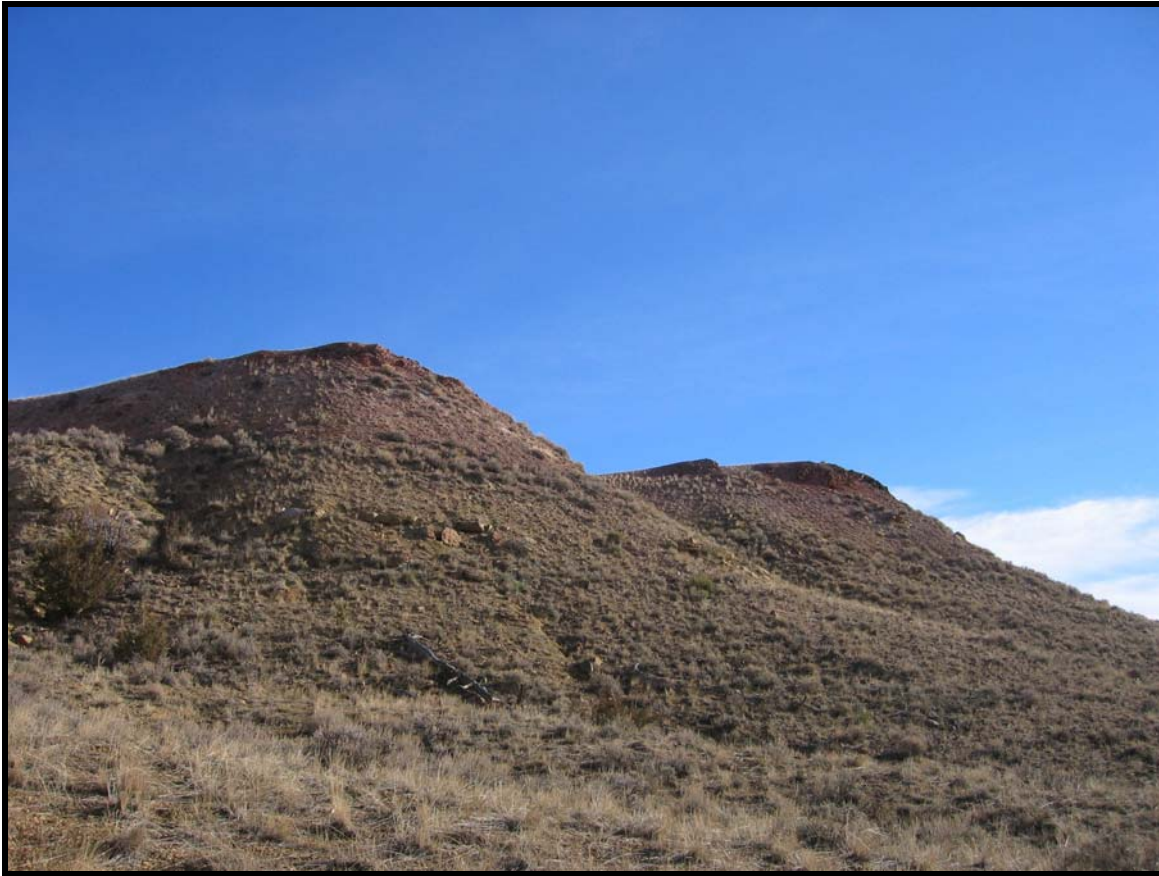
Photo: 1_4_06_07

FEATURE TYPE:	Rock Outcrop					
GEOMETRIC DIMENSIONS:	Length: 130 ft		Height: 10 ft			
LOCATION:	Township: 8S		Range: 40E		Section: 31	
HANDHELD GPS POINTS:		Northing	Easting		Northing	Easting
	2018	407332.51	2674828.73	2021	407201.55	2674951.87
	2019	407293.18	2674853.27	2022	407162.23	2674976.41
	2020	407241.47	2674945.40			
SUBSTRATE:	Scoria					
EXPOSURE:	Southern facing slope					
DESCRIPTION OF FEATURE:	This outcrop feature is two scoria caprocks at the top of a steep slope. The total length of the feature was taken as the length of both caprocks added together. The caprocks were very fractured and had a height less than 10 feet.

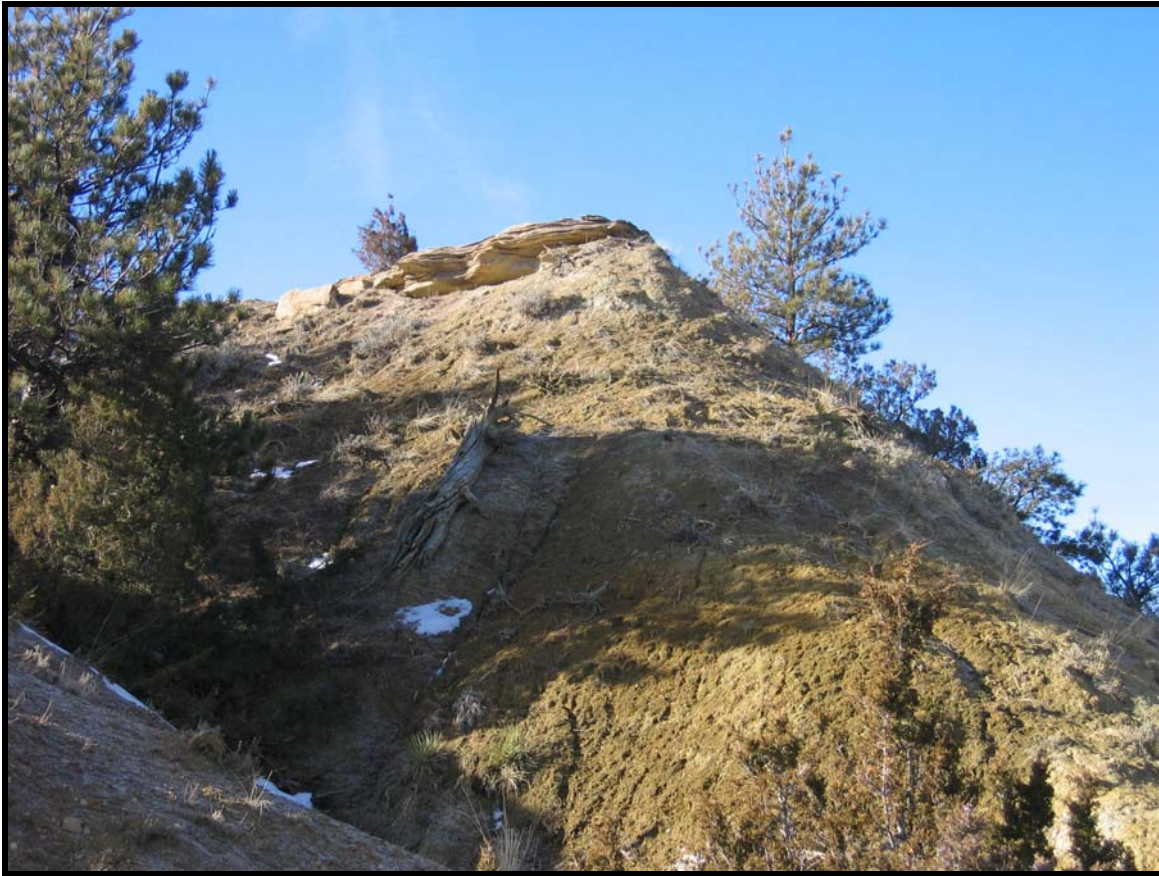
Photo: 1_9_06_15

GEOMETRIC DIMENSIONS: Length: 80 ft Height: 10 ft

DESCRIPTION OF FEATURE: There are many different outcrops in the Pearson Creek drainage that are similar to this feature. A weathered sandstone/siltstone rock shelf is at the top of a highly erosive, sandy silt, steep slope.

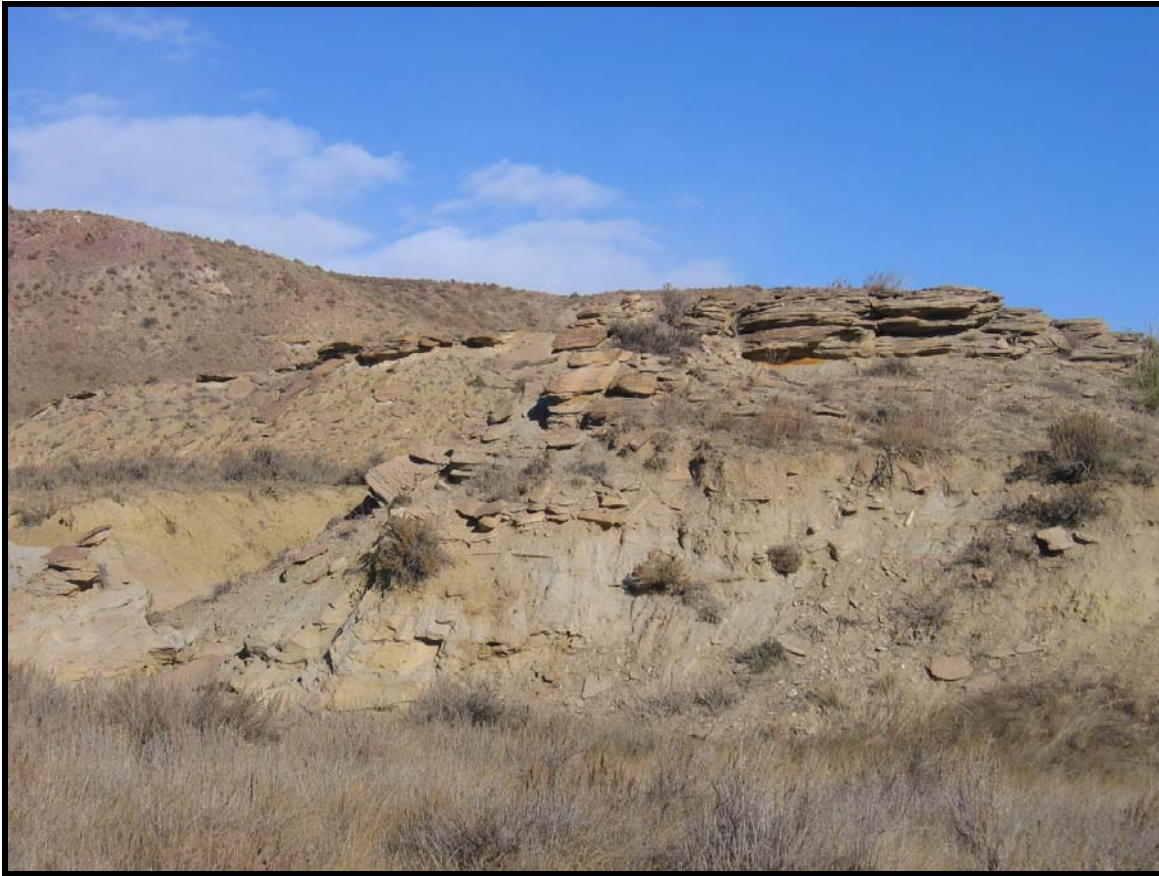
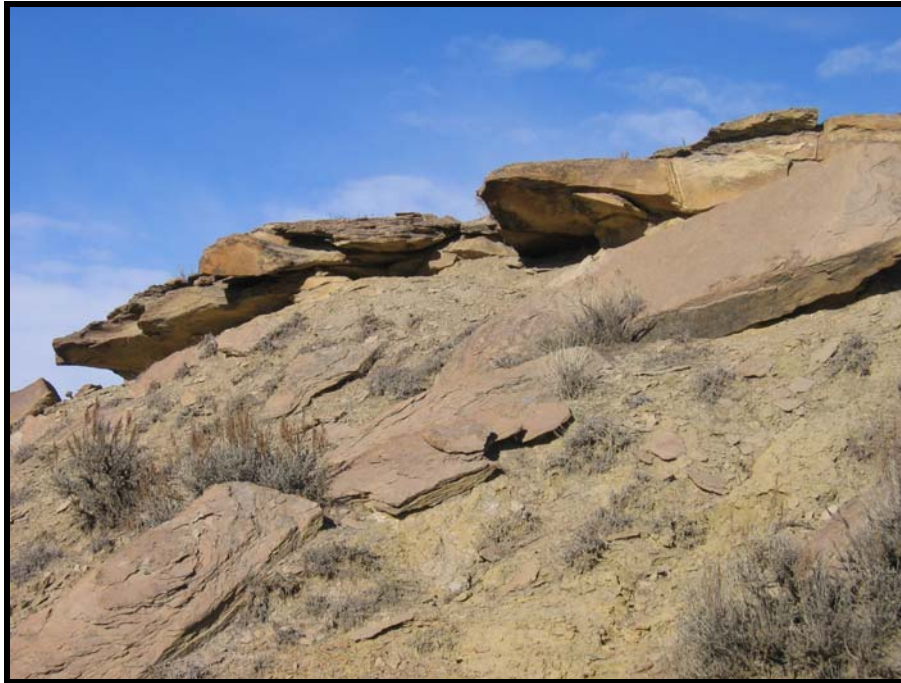
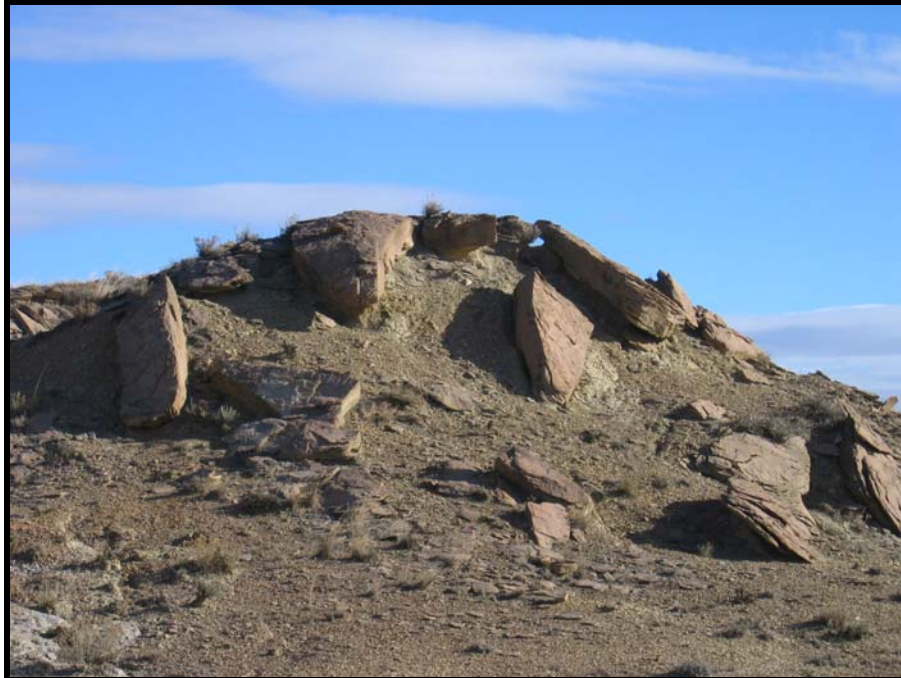
Photo: 1_16_06_16

GEOMETRIC DIMENSIONS: Area of Outcrop: 1.1 acres

DESCRIPTION OF FEATURE: This outcrop sits on a highly erosive sand and silt soil. Due to runoff from the adjacent hill, the rocks have been exposed. The average rock thickness is approximately 4 feet. The rocks have fallen into the stream channel in areas where the soil beneath the rocks has been eroded. The pictures on the following page show additional views of this feature.

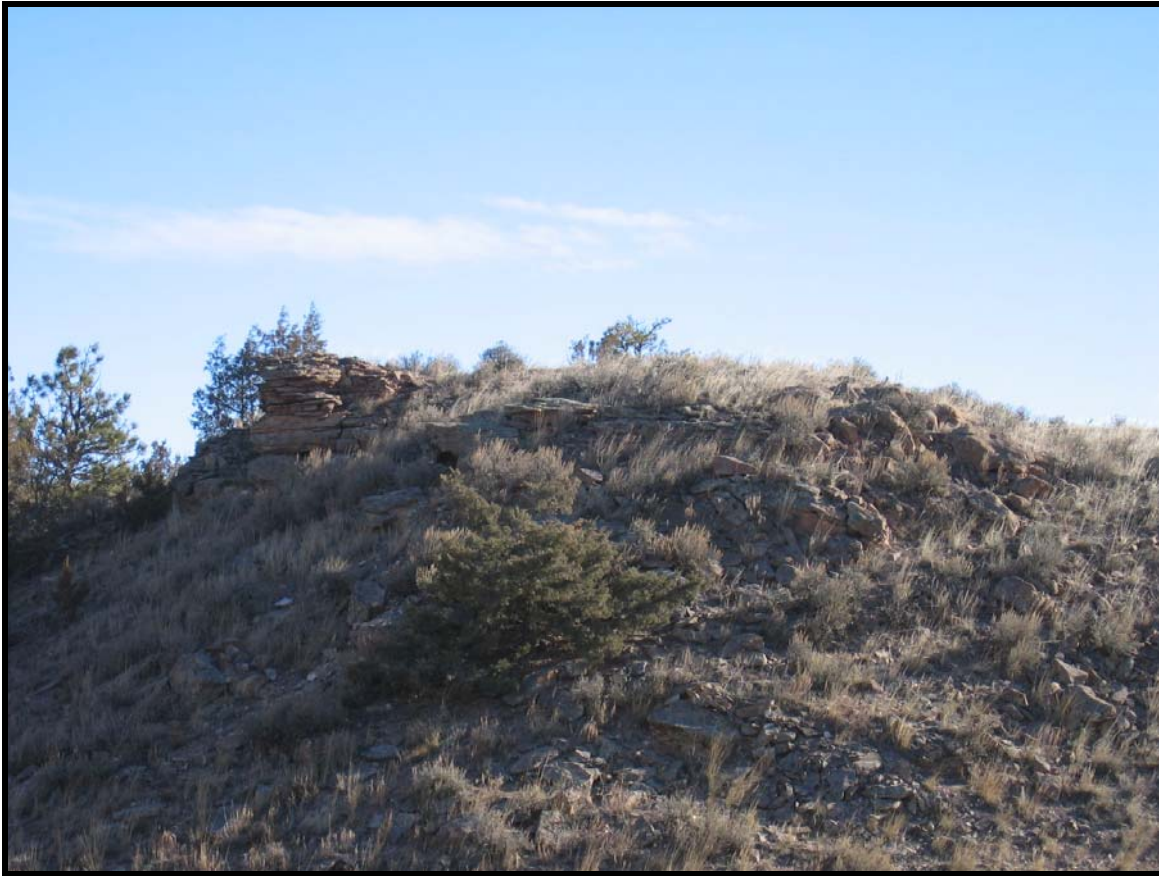
Photo: 1_16_06_19

GEOMETRIC DIMENSIONS: Length: 180 ft Height: 15 ft

DESCRIPTION OF FEATURE: This southern facing feature is at the top of a moderately steep slope. The rock is composed of hard sandstone/siltstone with intermittent scoria. This feature overlooks the South Fork Spring Creek stream channel.

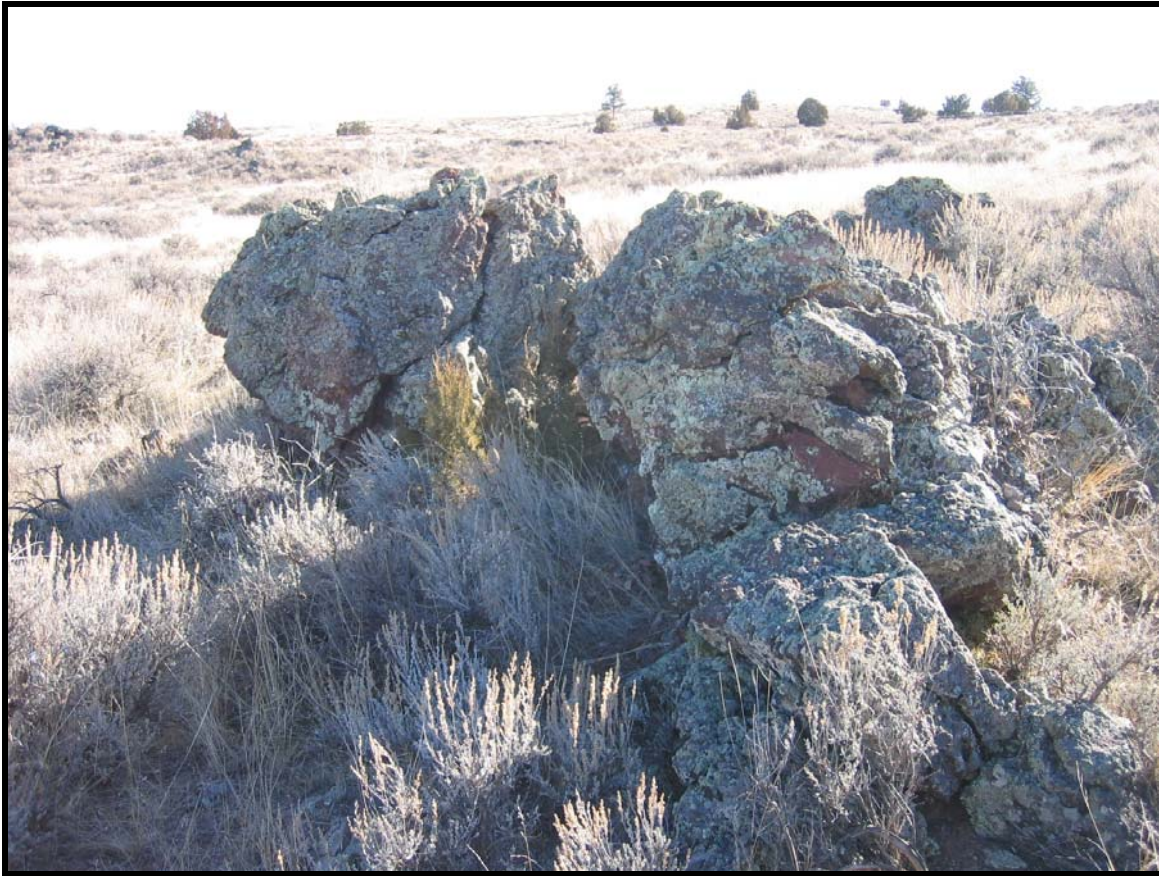
Photo: 1_16_06_22

GEOMETRIC DIMENSIONS: Area of Outcrop: 8.8 acres

DESCRIPTION OF FEATURE: This rock outcrop is located on very flat area. The rocks that make up the outcrop range in size from a foot in diameter to 10 feet in diameter. Although the area of the outcrop is large, the rocks are spaced as far as several hundred feet between outcrops.
