Township 8S, Range 40E
SECTION 31

Cliff Features

Revised 4/06; Reference – South Fork Extension Amendment #00174

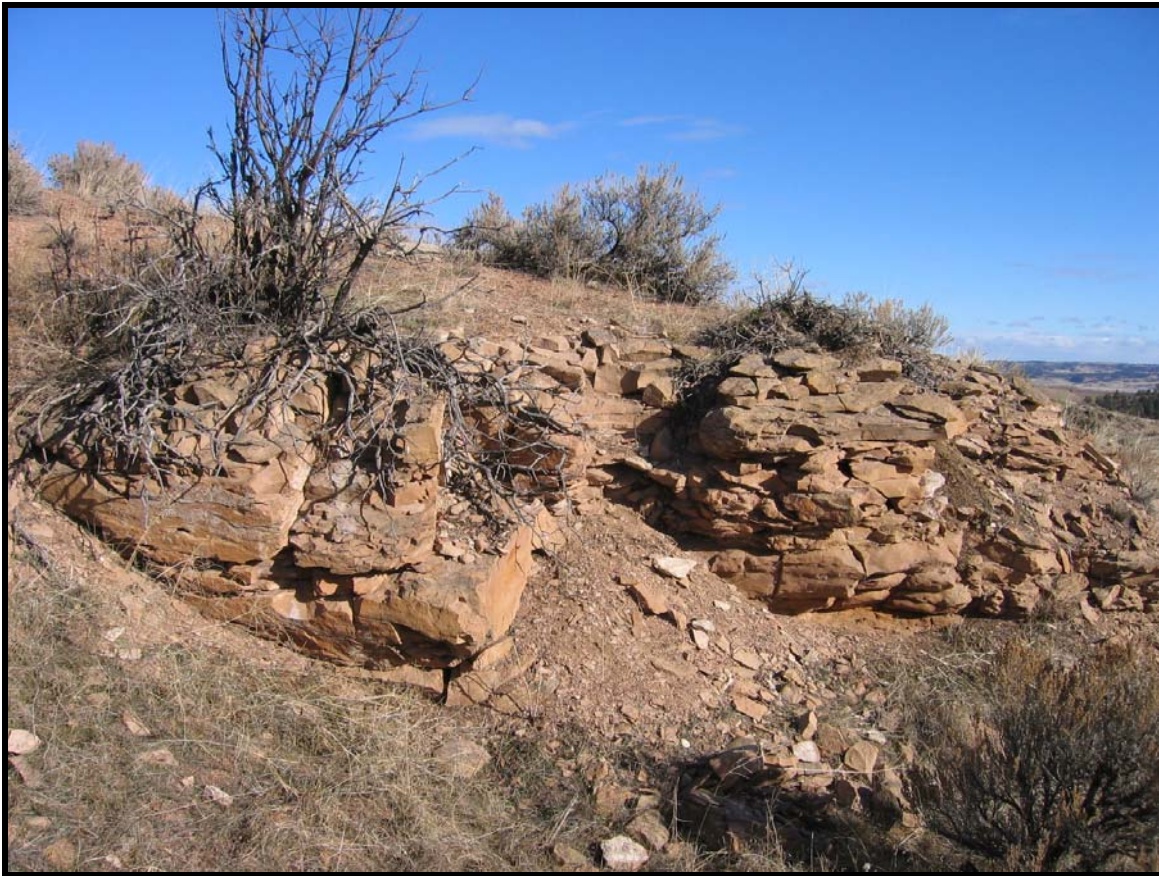
Photo: 1_16_06_23

GEOMETRIC DIMENSIONS: Length: 60 ft Height: 10 ft

DESCRIPTION OF FEATURE: This is a small outcrop that is adjacent to a small channel in the middle of Section 31. The face of the outcrop is very jagged and showed signs of erosion due to runoff in the stream channel.

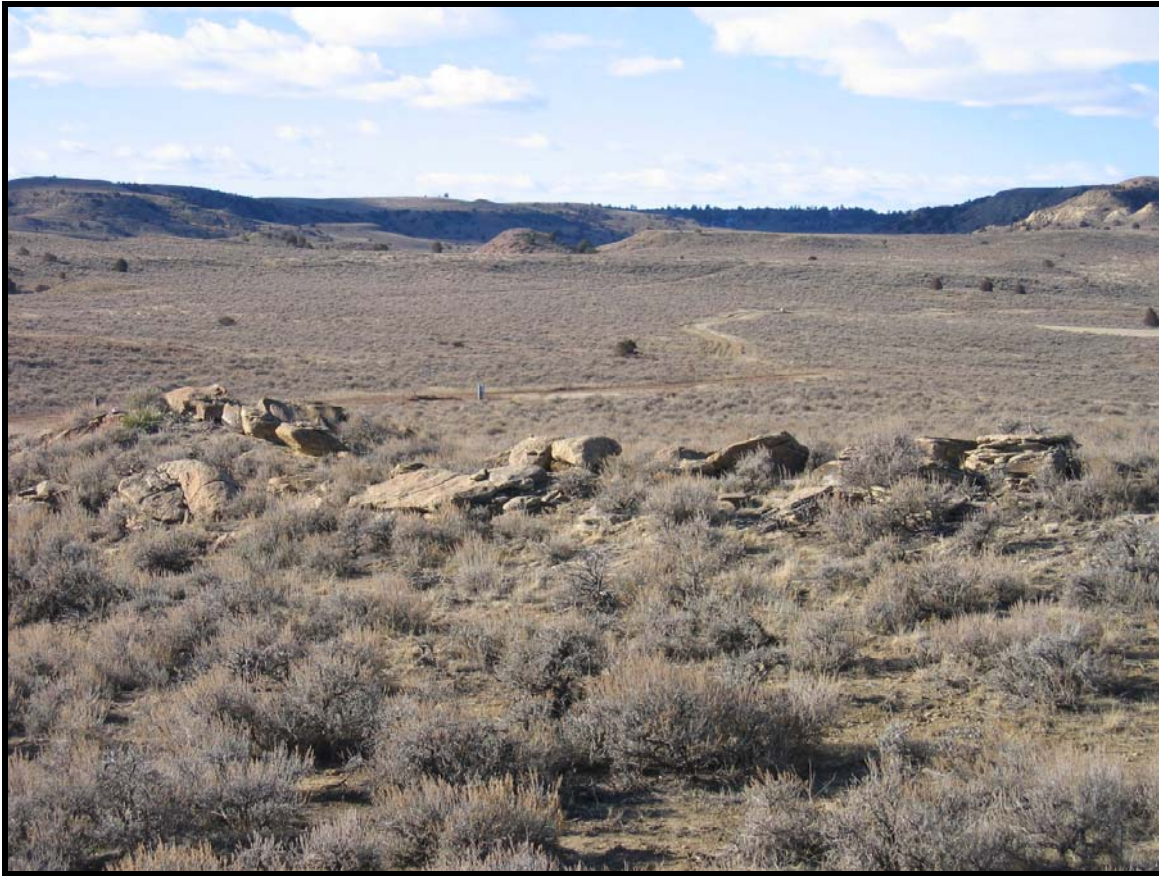
Photo: 1_16_06_24

GEOMETRIC DIMENSIONS: Area of Outcrop: 0.70 acres

DESCRIPTION OF FEATURE: This outcrop is located at the top of a hill in a very flat area. The rocks that make up this outcrop are very weathered and range from low-lying to approximately 5 feet tall. The area around this outcrop has a high population of sagebrush.

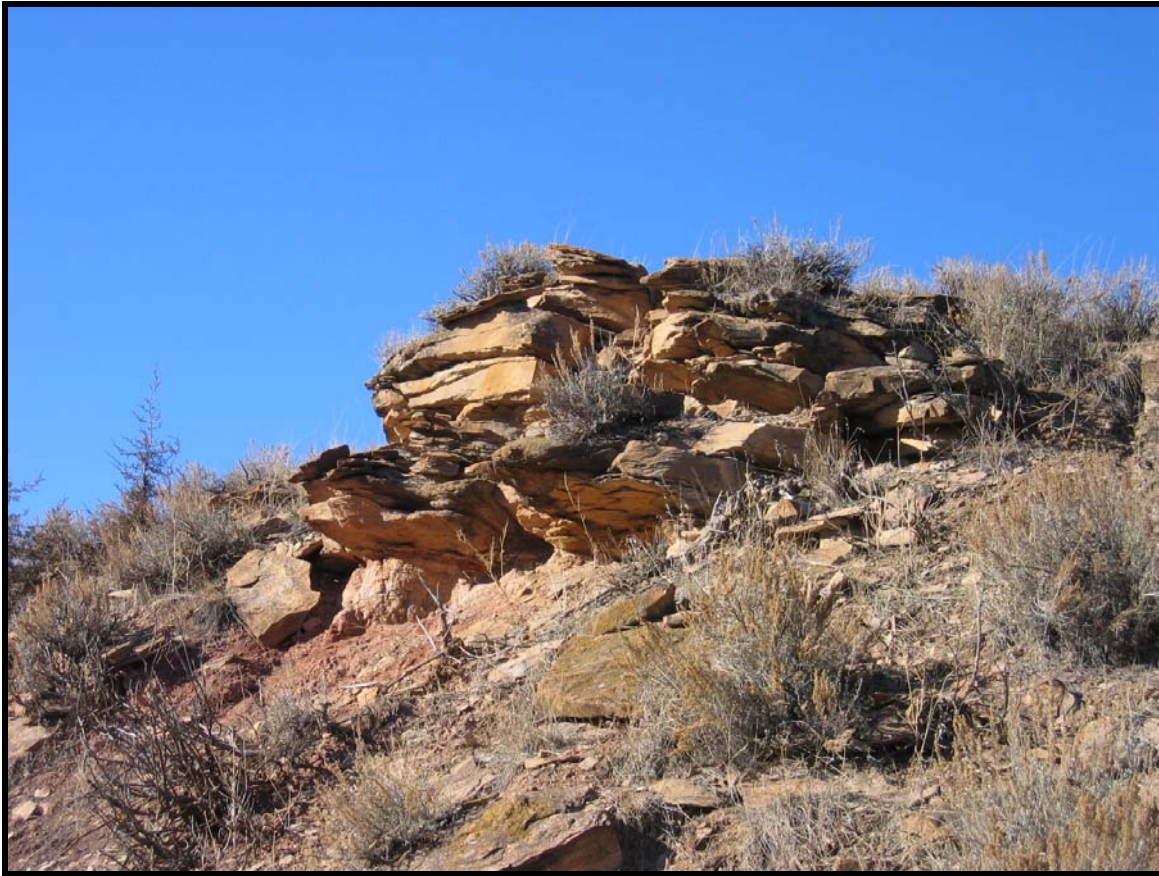
Photo: 1_16_06_26

GEOMETRIC DIMENSIONS: Length: 110 ft Height: 10 ft

DESCRIPTION OF FEATURE: This southern facing feature is at the top of a moderately steep slope. The rock is composed of hard sandstone/siltstone with intermittent scoria. This feature is located adjacent to a small draw in Section 31.

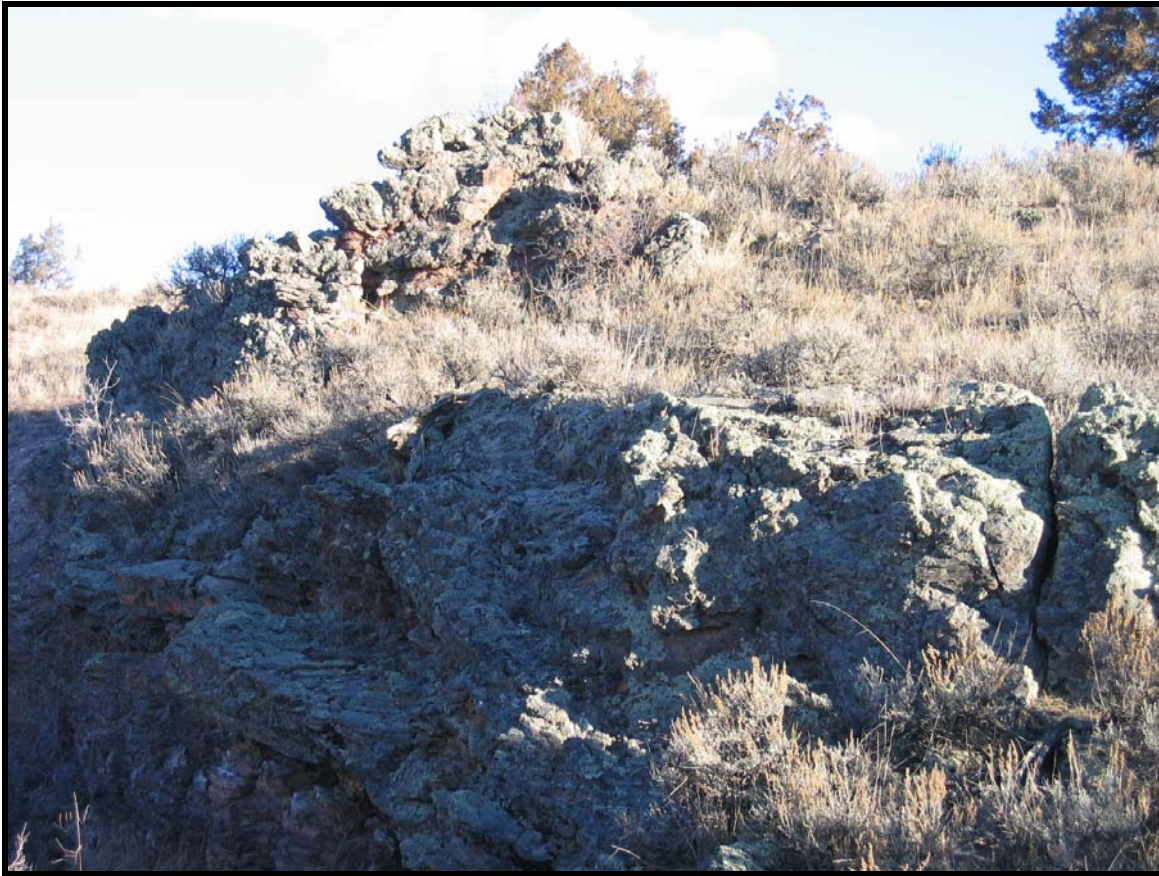
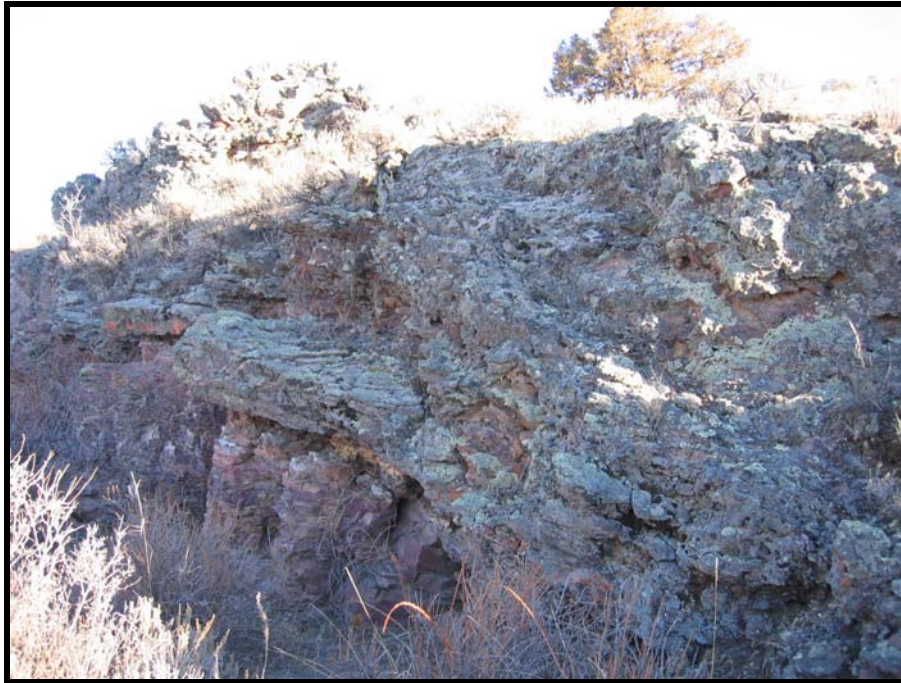
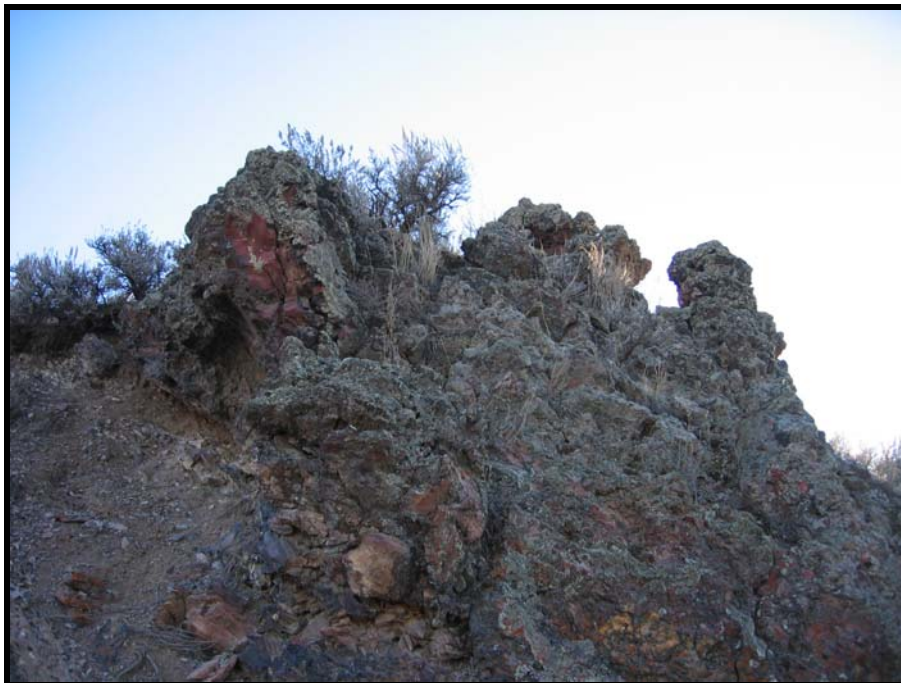
Photo: 1_16_06_38

FEATURE TYPE:	Rock Outcrop		
GEOMETRIC DIMENSIONS:	Length: 50 ft	Height: 25 ft	
LOCATION:	Township: 8S	Range: 40E	Section: 31
HANDHELD GPS POINTS:	Northing	Easting	
	8090	409864.52	2677076.73
	8091	409858.92	2677128.59
	8092	409851.63	2677128.83
SUBSTRATE:	Scoria		
EXPOSURE:	Northern facing slope		
DESCRIPTION OF FEATURE:	This large scoria feature is located on the bank of a small draw in Section 31. The feature extends higher than other scoria features in the area. Pictures 1_16_06_39 and 1_16_06_40 on the next page show the same feature from other angles.

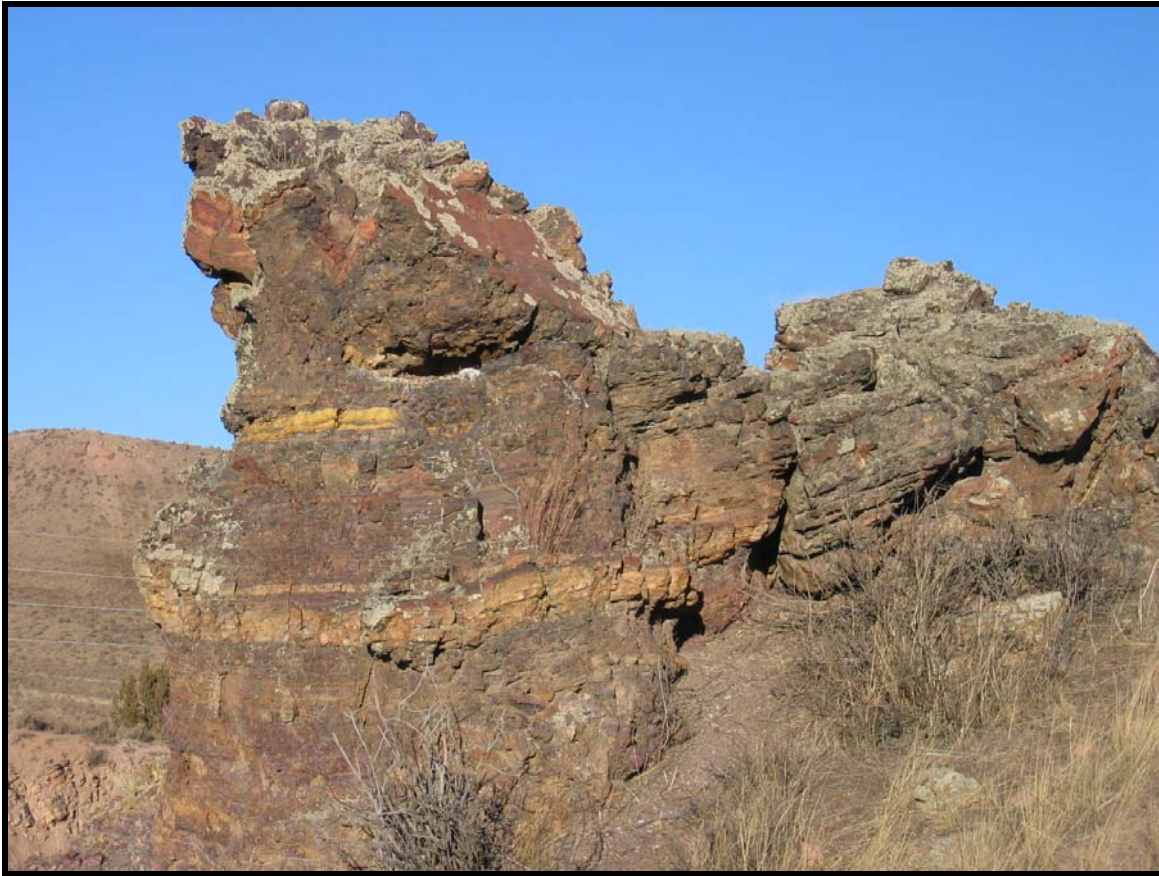
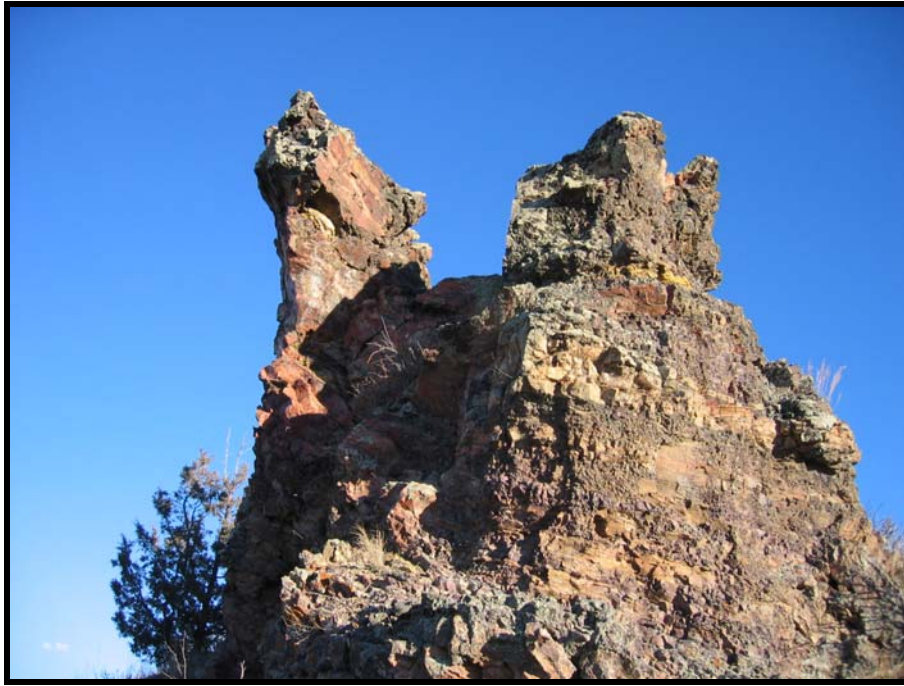
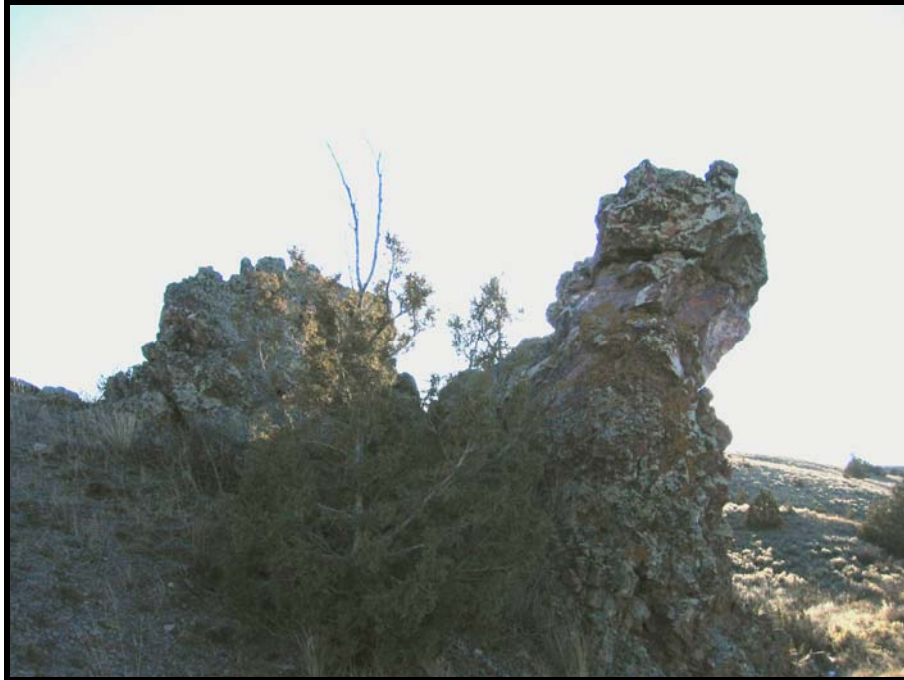
Photo: 1_16_06_41

GEOMETRIC DIMENSIONS: Length: 50 ft Height: 25 ft

DESCRIPTION OF FEATURE: This large scoria feature is located on the bank of a small draw in Section 31. The feature is similar to RO_0085 and is located in the same general area. Pictures 1_16_06_42 and 1_16_06_43 on the next page show the same feature from other angles.

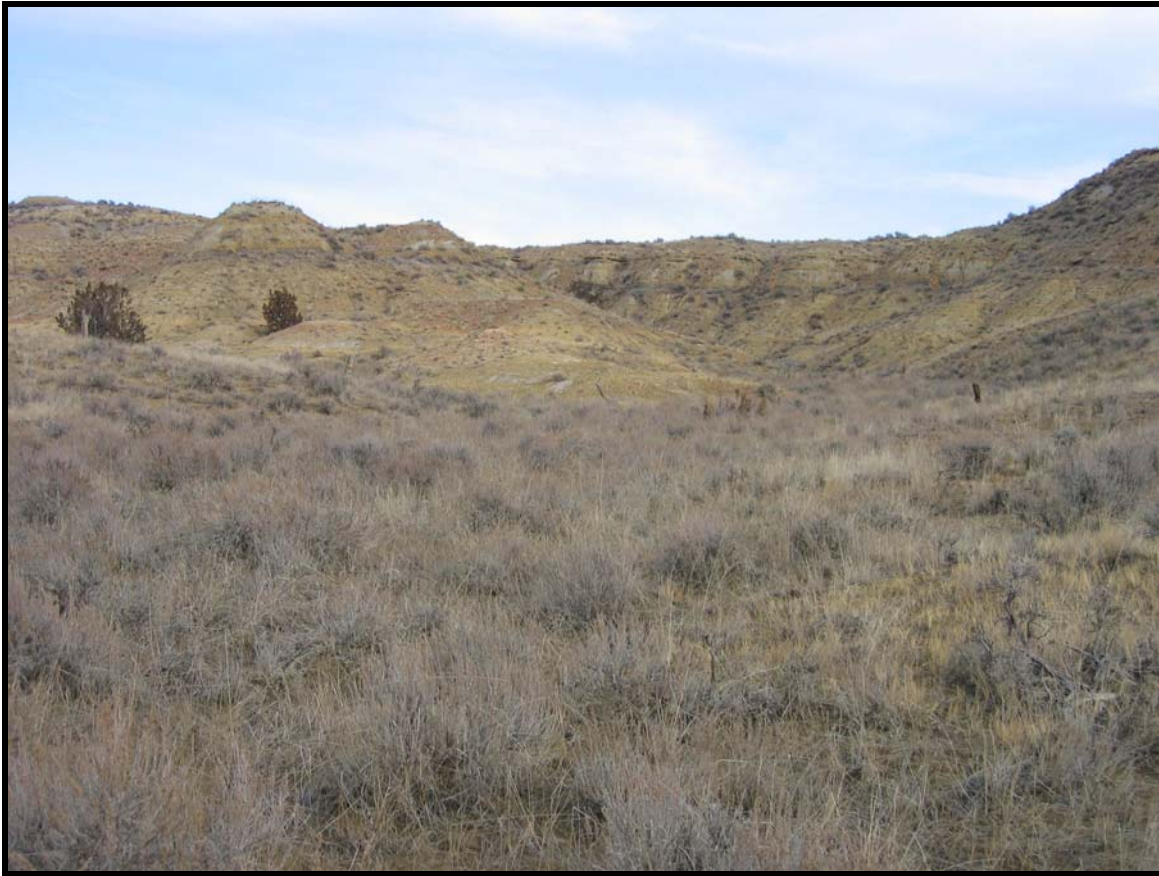
Photo: 1_11_06_02

DESCRIPTION OF FEATURE: This draw is located in the Pearson Creek drainage. A high population of sagebrush has reduced the amount of erosion in this draw even though the soil is sandy silt.

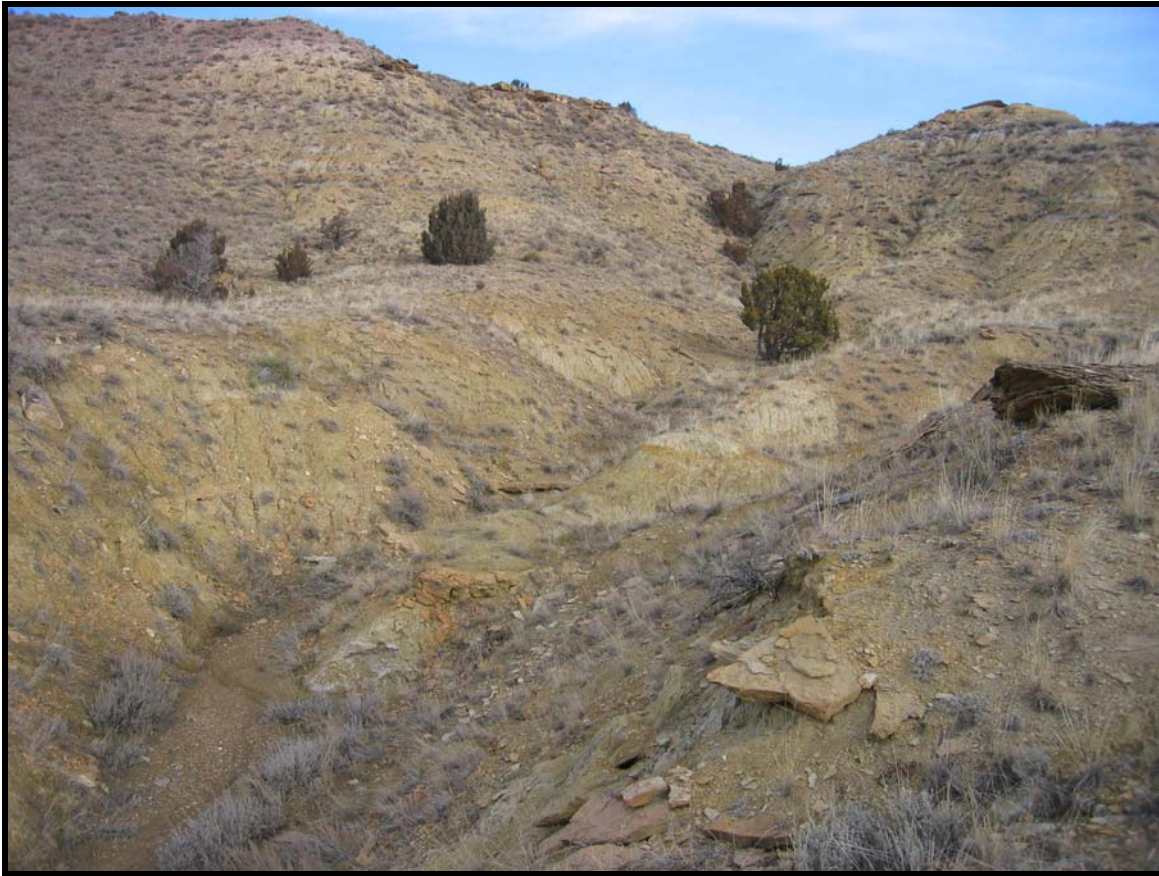
Photo: 1_11_06_05

DESCRIPTION OF FEATURE: This draw is located in the Pearson Creek drainage. The presence of sandy silt soil has caused the runoff to cut a deep channel. Features O_0004 and O_0003 appear on either side of this draw as it enters Pearson Creek.

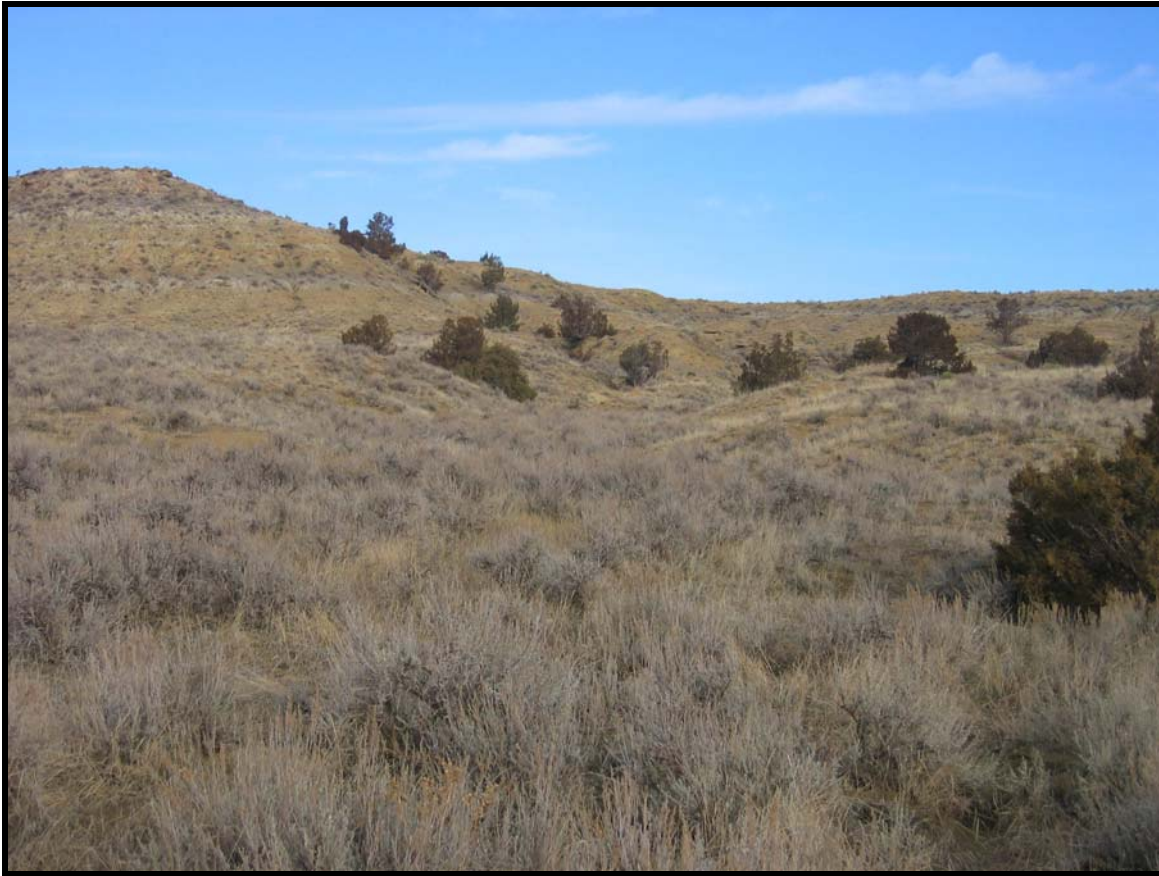
Photo: 1_11_06_07

DESCRIPTION OF FEATURE: This draw is located in the Pearson Creek drainage. The draw, as can be seen on the topo map, enters Pearson Creek at point 6013. Unlike many other draws in this area, the channel has not cut into the sidehill significantly.

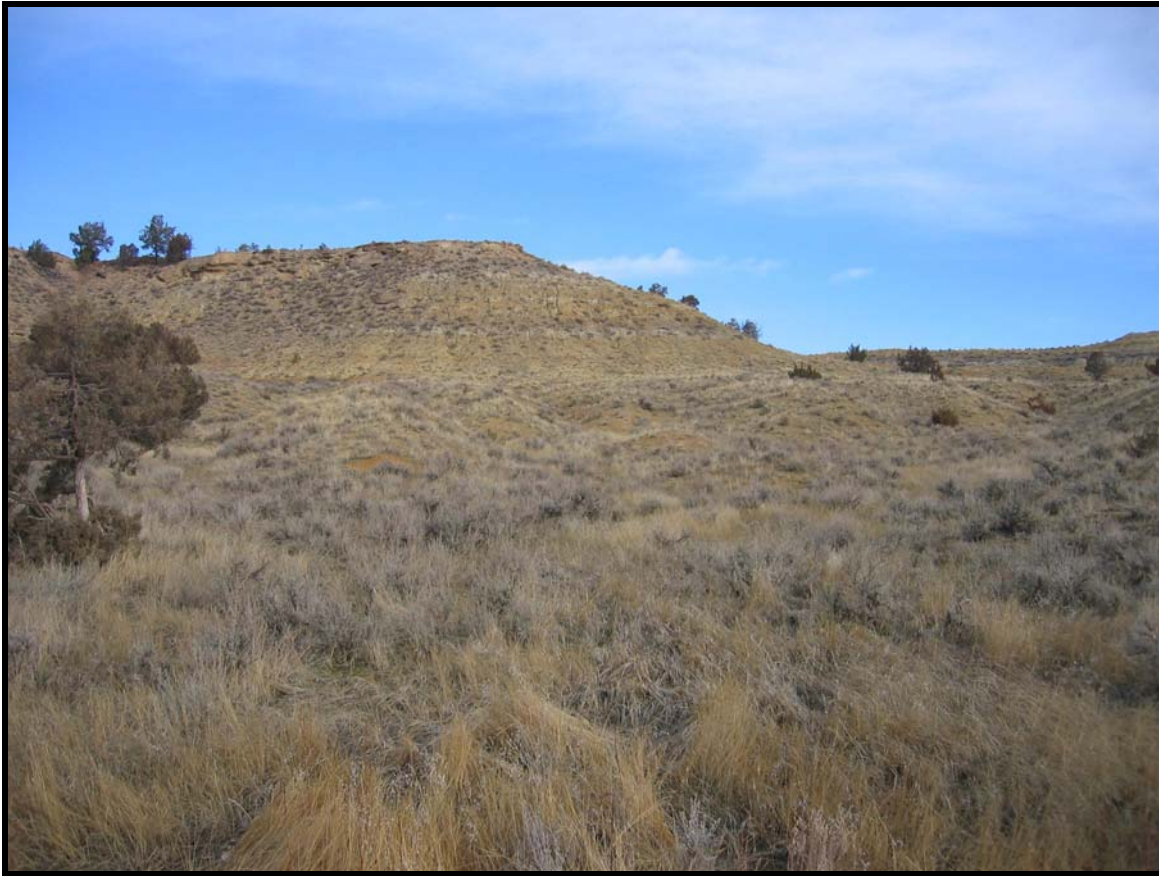
Photo: 1_11_06_08

DESCRIPTION OF FEATURE: This draw is located in the Pearson Creek drainage. This drainage is very similar to others in this area. The presence of sandy silt soil has caused the runoff to cut a deep channel.

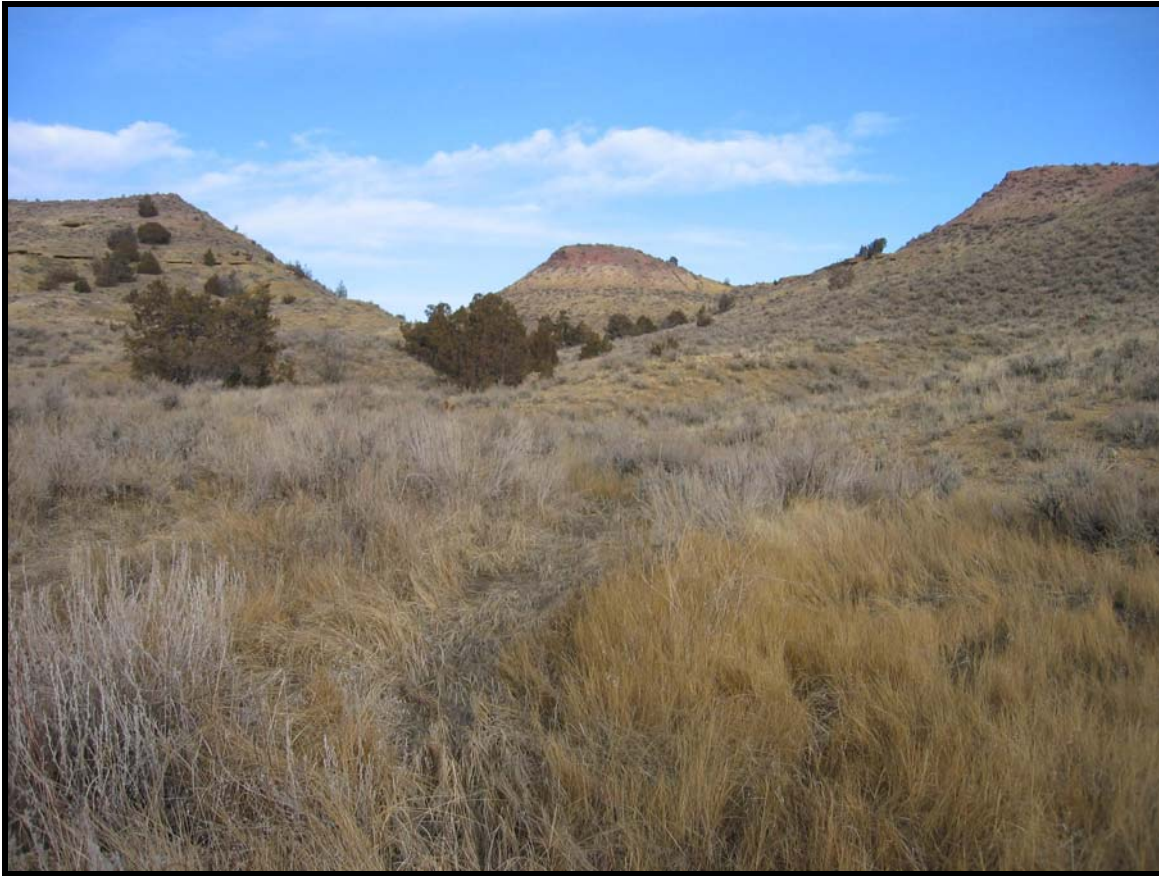
Photo: 1_11_06_09

DESCRIPTION OF FEATURE: This draw is located in the Pearson Creek drainage. The slopes at the head of the channel are steep. The bottom of the channel consists of sandy silt and is highly erosive.

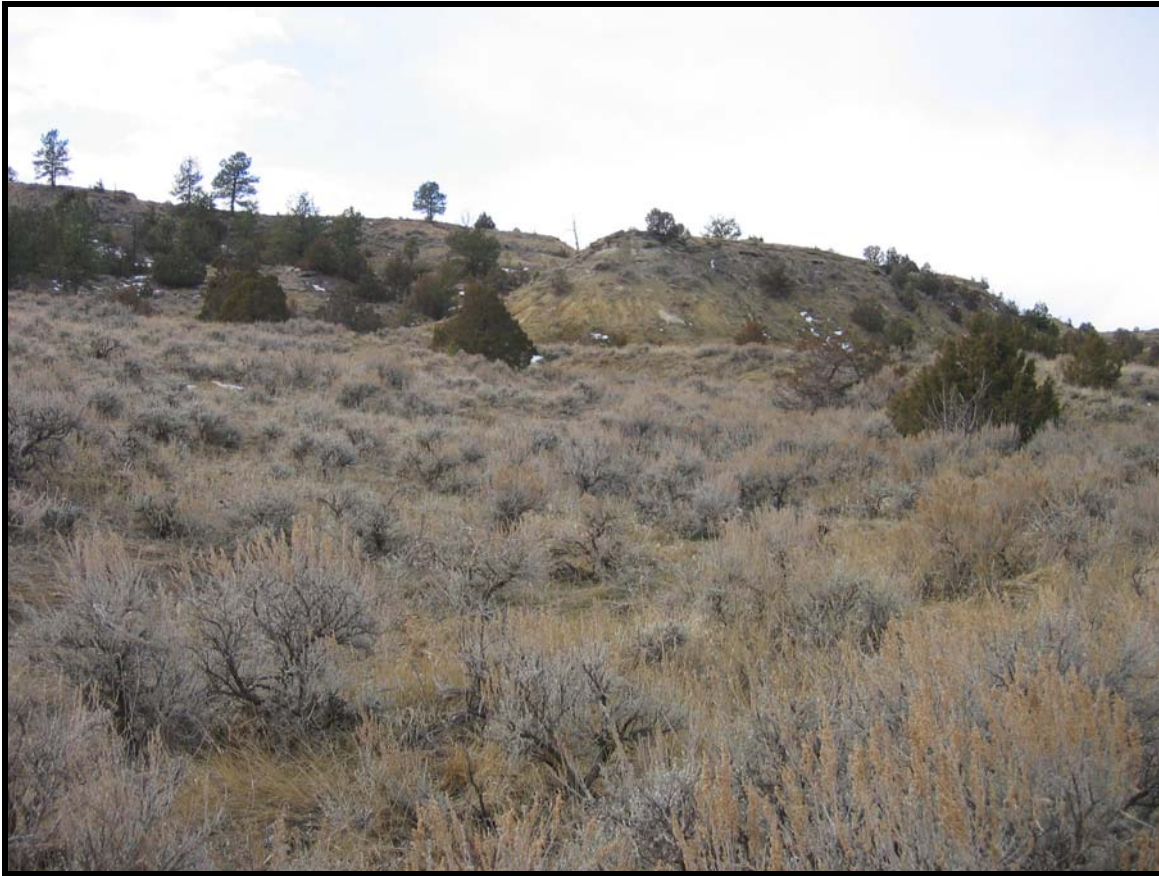
Photo: 1_11_06_31

DESCRIPTION OF FEATURE: This draw is located in the Pearson Creek drainage. Although the drainage area is relatively small, the channel has significant erosion due to the steep slope and the sandy silt subsoil.

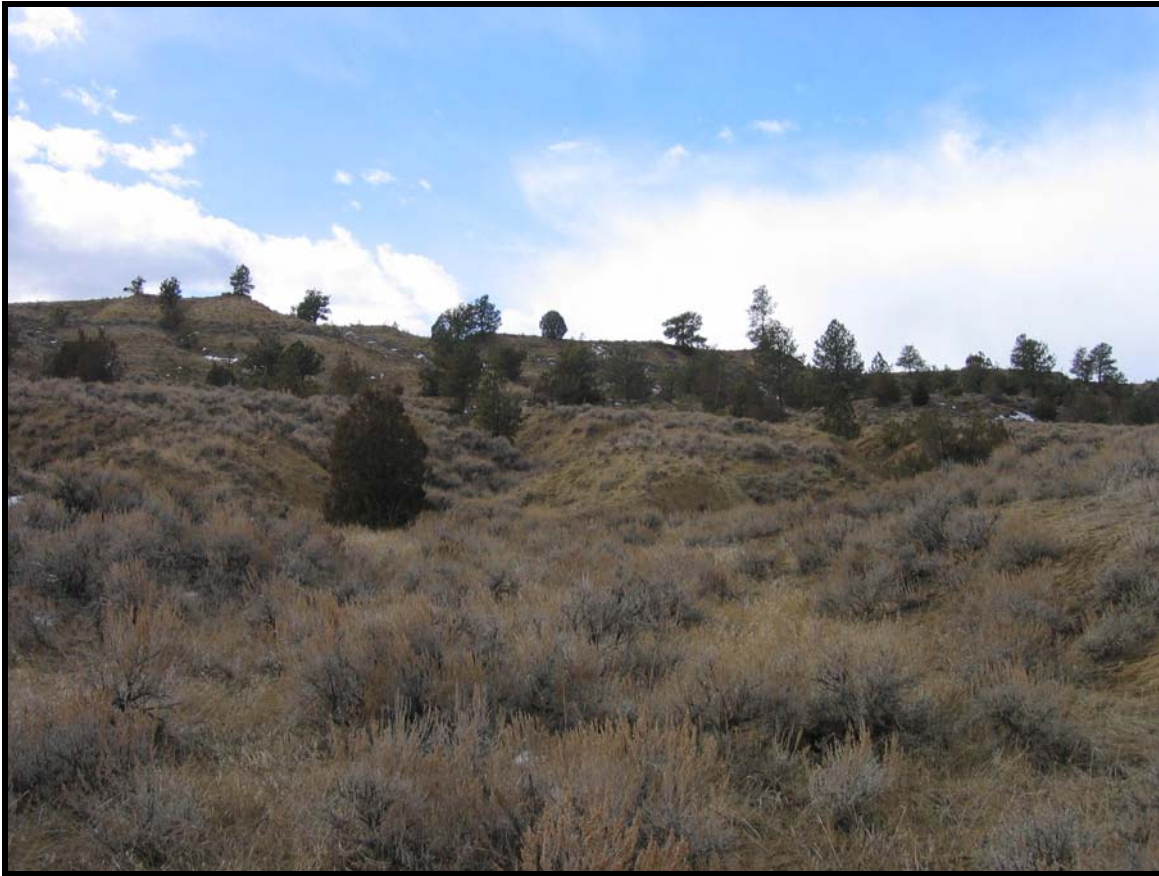
Photo: 1_11_06_32

DESCRIPTION OF FEATURE: This draw is located in the Pearson Creek drainage. The drainage area for this draw is relatively small, but has a steep slope, especially at the head of the draw.

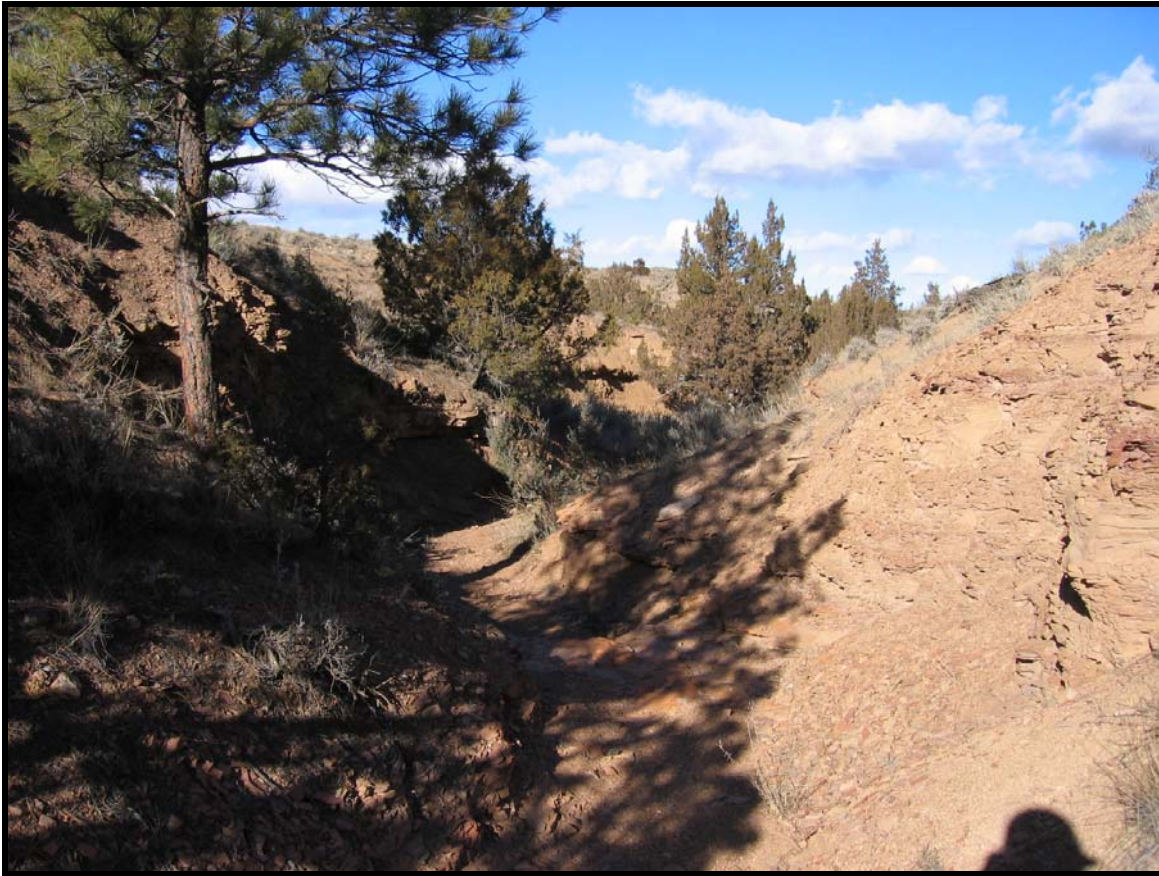
Photo: 1_16_06_25

DESCRIPTION OF FEATURE: This draw has very steep sideslopes and has a bottom width that ranges from five to nearly twenty feet. The walls of the channel consist of siltstone, sandstone and scoria.

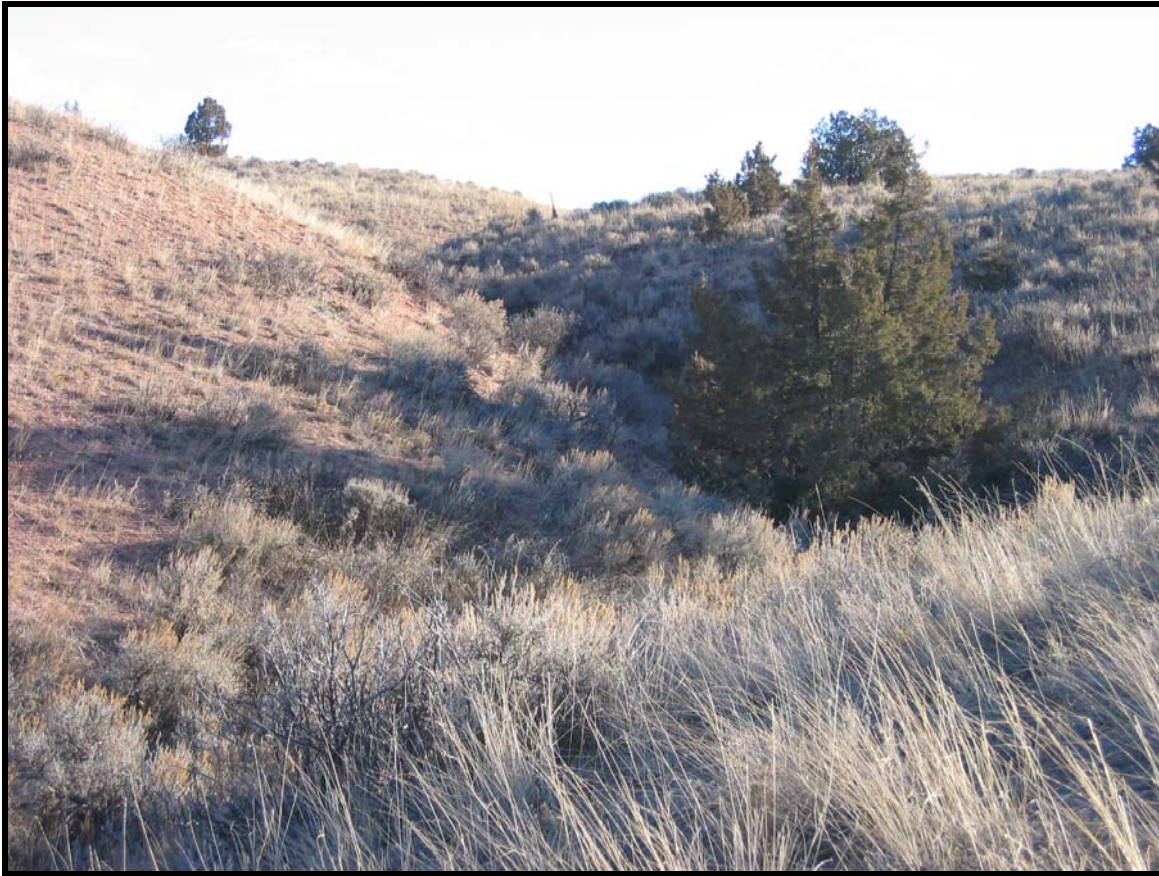
Photo: 1_16_06_36

DESCRIPTION OF FEATURE: This is a tributary draw to South Fork Spring Creek. At the head of this draw the slope is small with rolling hills. Just before entering the South Fork Spring Creek channel, however, the walls of the channel become steep and the channel slope increases.

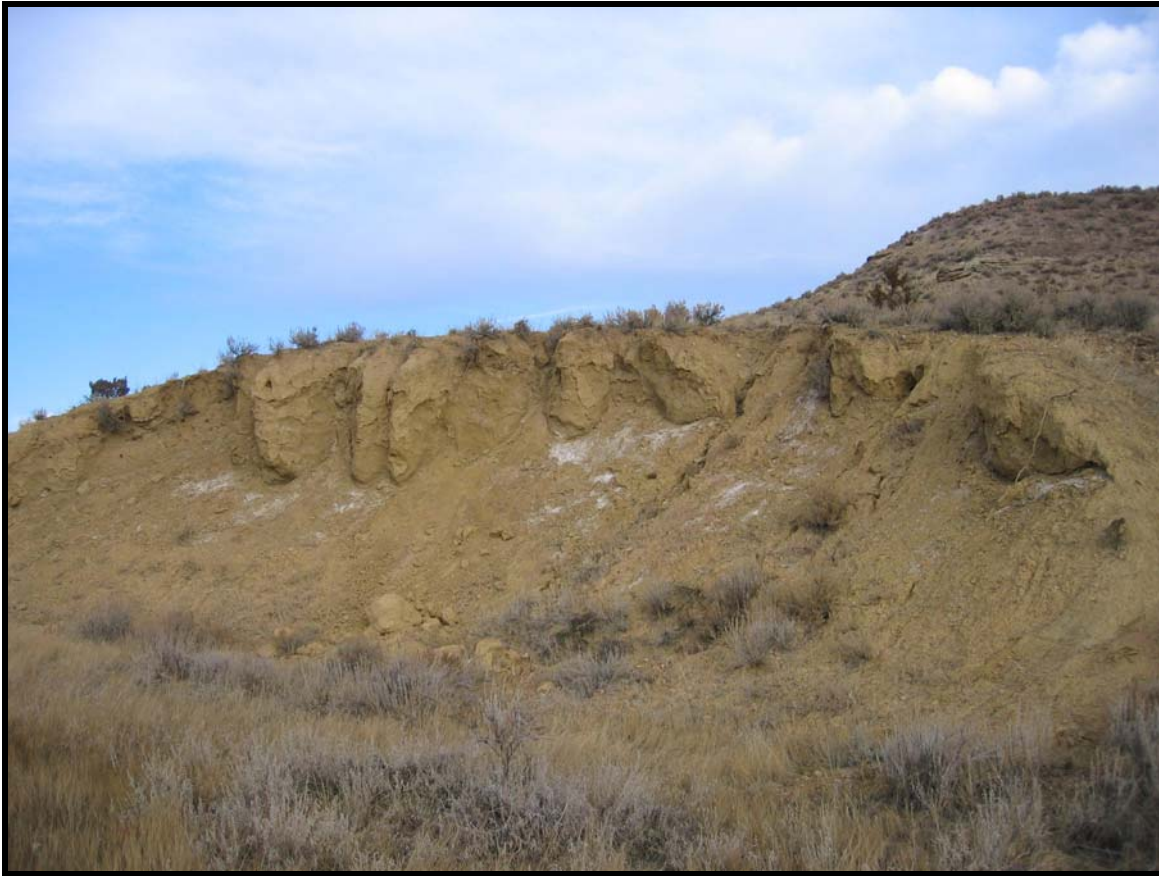
Photo: 1_11_06_01

GEOMETRIC DIMENSIONS: Length: 90 ft Height: 15 ft

DESCRIPTION OF FEATURE: This cutbank is within the Pearson Creek drainage. The large size and steep face provides holes and habitat for birds and other animals. The soft sandy silt is highly erosive and will continue to erode as flows pass through this drainage.

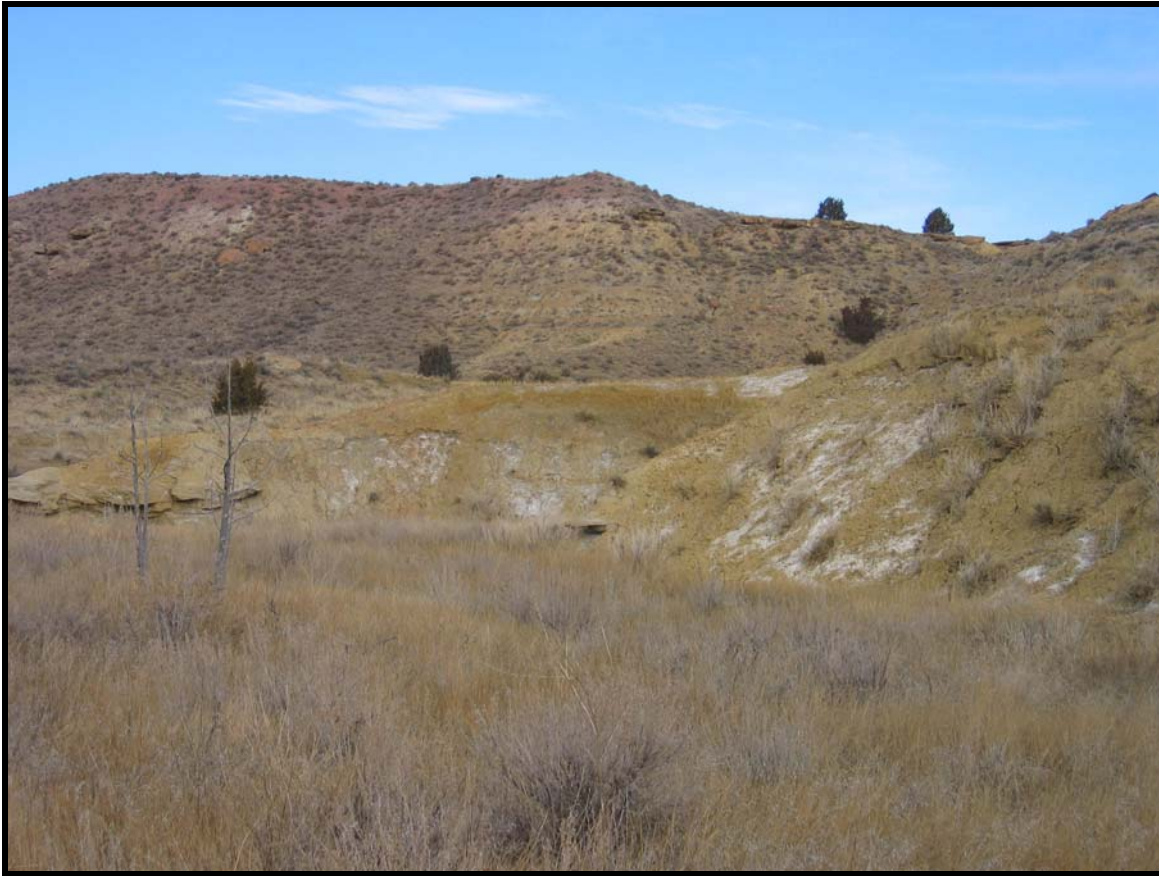
Photo: 1_11_06_03

GEOMETRIC DIMENSIONS: Length: 180 ft Height: 20 ft

DESCRIPTION OF FEATURE: This cutbank is within the Pearson Creek drainage. The large size and steep face provides holes and habitat for birds and other animals. The soft sandy silt is highly erosive and will continue to erode as flows pass through this drainage.

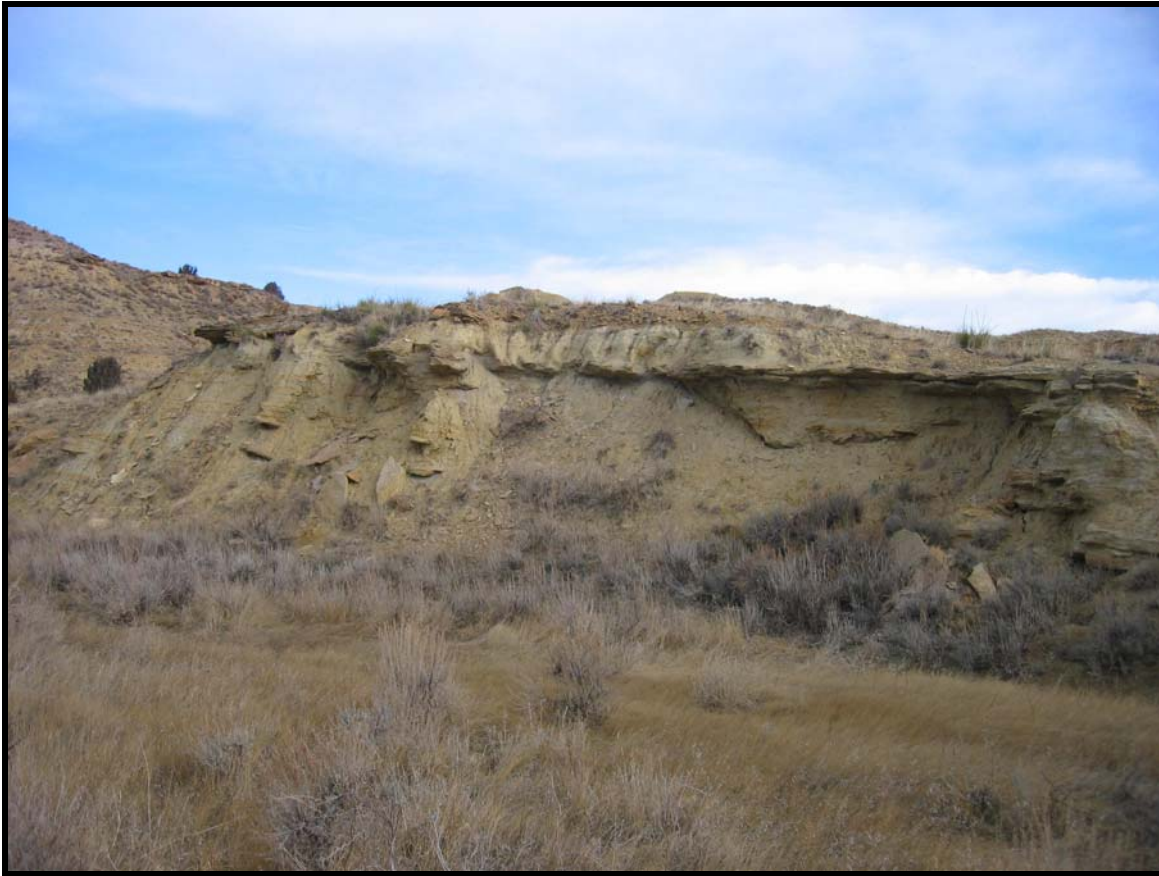
Photo: 1_11_06_04

GEOMETRIC DIMENSIONS: Length: 120 ft Height: 20 ft

DESCRIPTION OF FEATURE: This cutbank is within the Pearson Creek drainage. The large size and steep face provides holes and habitat for birds and other animals. The soft sandy silt is highly erosive and will continue to erode as flows pass through this drainage. This feature has a harder sandstone layer at the top of the cut.

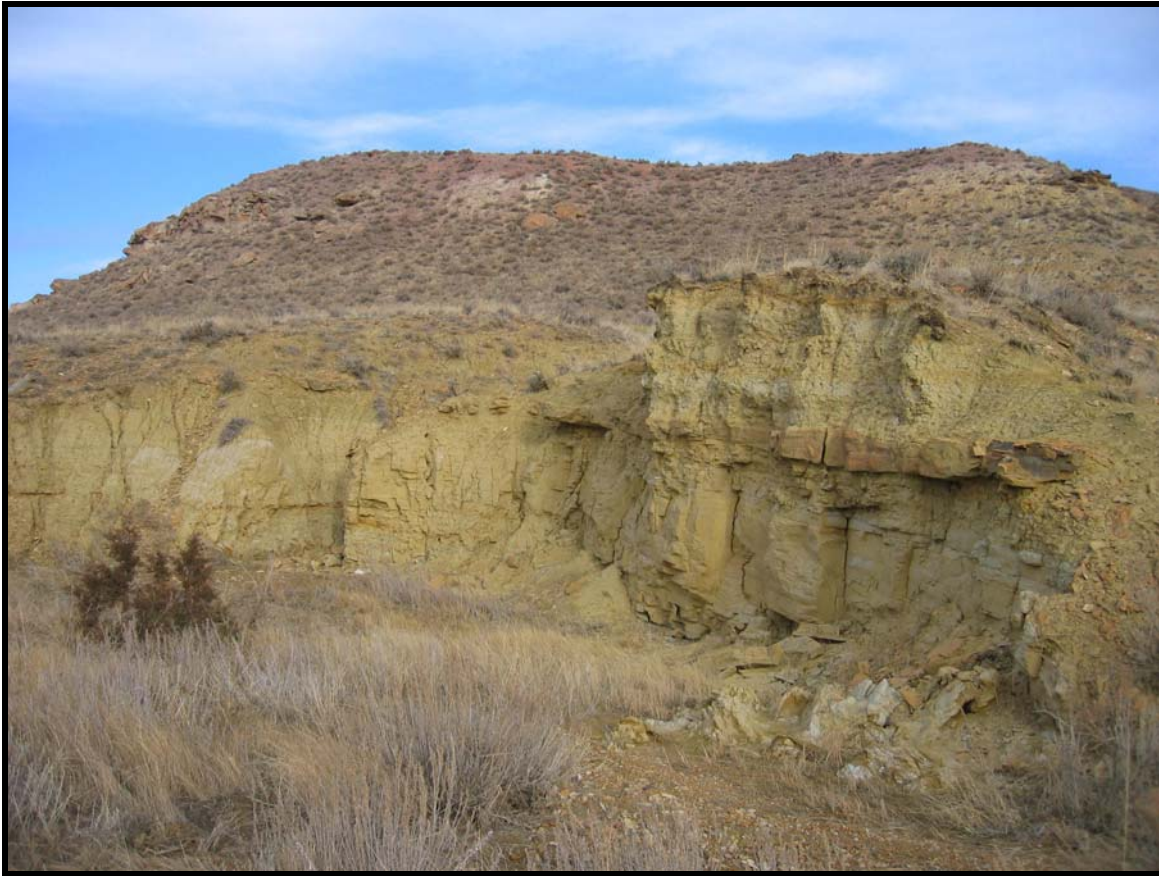
Photo: 1_11_06_06

FEATURE TYPE:	Cutbank		
GEOMETRIC DIMENSIONS:	Length: 70 ft	Height: 20 ft	
LOCATION:	Township: 8S	Range: 40E	Section: 31
HANDHELD GPS POINTS:	Northing	Easting	
	6009	406144.06 2676751.46	
	6010	406209.82 2676754.48	
	6011	406173.89 2676771.16	
	6012	406176.44 2676737.48	
SUBSTRATE:	Sandy Silt		
EXPOSURE:	Southern facing slope		
DESCRIPTION OF FEATURE:	This cutbank is within the Pearson Creek drainage. The large size and steep face provides holes and habitat for birds and other animals. The soft sandy silt is highly erosive and will continue to erode as flows pass through this drainage. This feature has a harder sandstone layer in the middle of the cut.
