Township 8S, Range 40E
SECTION 31

Cliff Features

Revised 4/06; Reference – South Fork Extension Amendment #00174

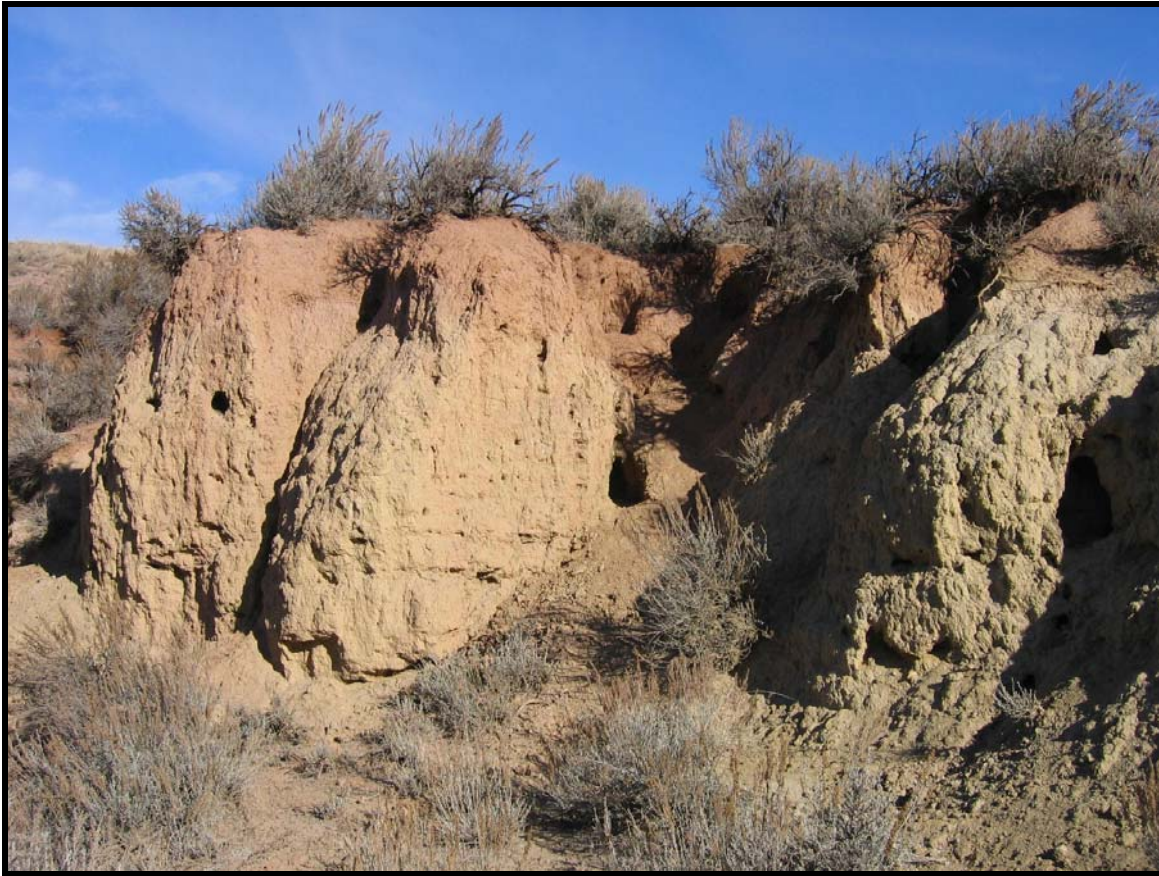
Photo: 1_16_06_20

FEATURE TYPE:	Cutbank		
GEOMETRIC DIMENSIONS:	Length: 70 ft	Height: 20 ft	
LOCATION:	Township: 8S	Range: 40E	Section: 31
HANDHELD GPS POINTS:	Northing	Easting	
	6009	406144.06 2676751.46	
	6010	406209.82 2676754.48	
	6011	406173.89 2676771.16	
	6012	406176.44 2676737.48	
SUBSTRATE:	Sandy Silt		
EXPOSURE:	Southern facing slope		
DESCRIPTION OF FEATURE:	This cutbank is within the Pearson Creek drainage. The large size and steep face provides holes and habitat for birds and other animals. The soft sandy silt is highly erosive and will continue to erode as flows pass through this drainage. This feature has a harder sandstone layer in the middle of the cut.

Looking Northwest
