Township 9S, Range 40E
SECTION 6

Cliff Features

Revised 4/06; Reference – South Fork Extension Amendment #00174

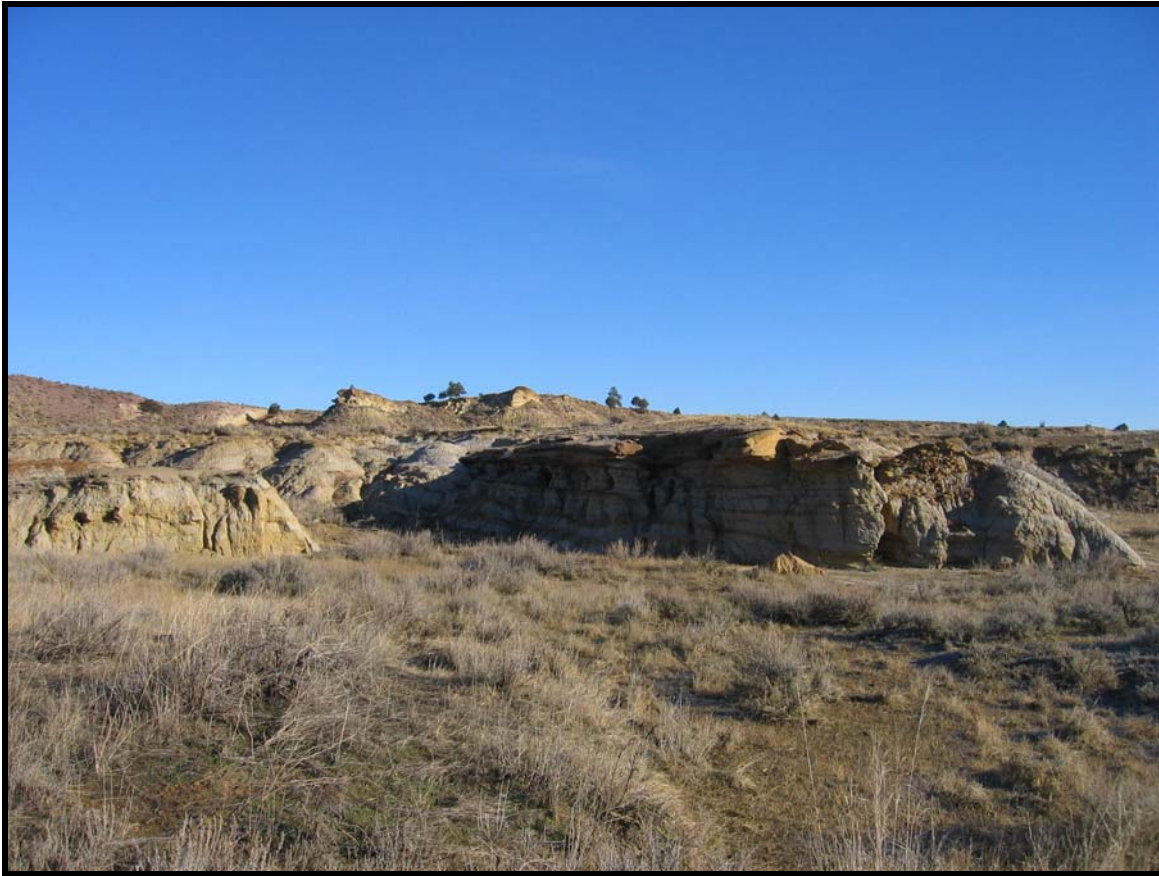
Photo: 1_9_06_03

FEATURE TYPE:	Cliff				
GEOMETRIC DIMENSIONS:	Length: 170 ft		Height: 15 ft		
LOCATION:	Township: 9S		Range: 40E		Section: 6
HANDHELD GPS POINTS:		Northing	Easting		Northing Easting
	4001	405084.84	2677825.07	4004	405160.26 2677789.00
	4002	405043.91	2677800.57	4005	405105.18 2677777.88
	4003	405123.23	2677772.12	4006	405090.69 2677780.94

SUBSTRATE: Sandstone

EXPOSURE: Southern facing slope

DESCRIPTION OF FEATURE: The cliff feature shown above has a hard sandstone/siltstone face that rests at the top of a sandy silt slope. The solid rock face of the feature has pockets and crevices due to weathering and erosion. This feature is located adjacent to the Pearson Creek channel bottom. The exposed rock layer is approximately five feet thick. The pictures on the following page show additional views of this feature.

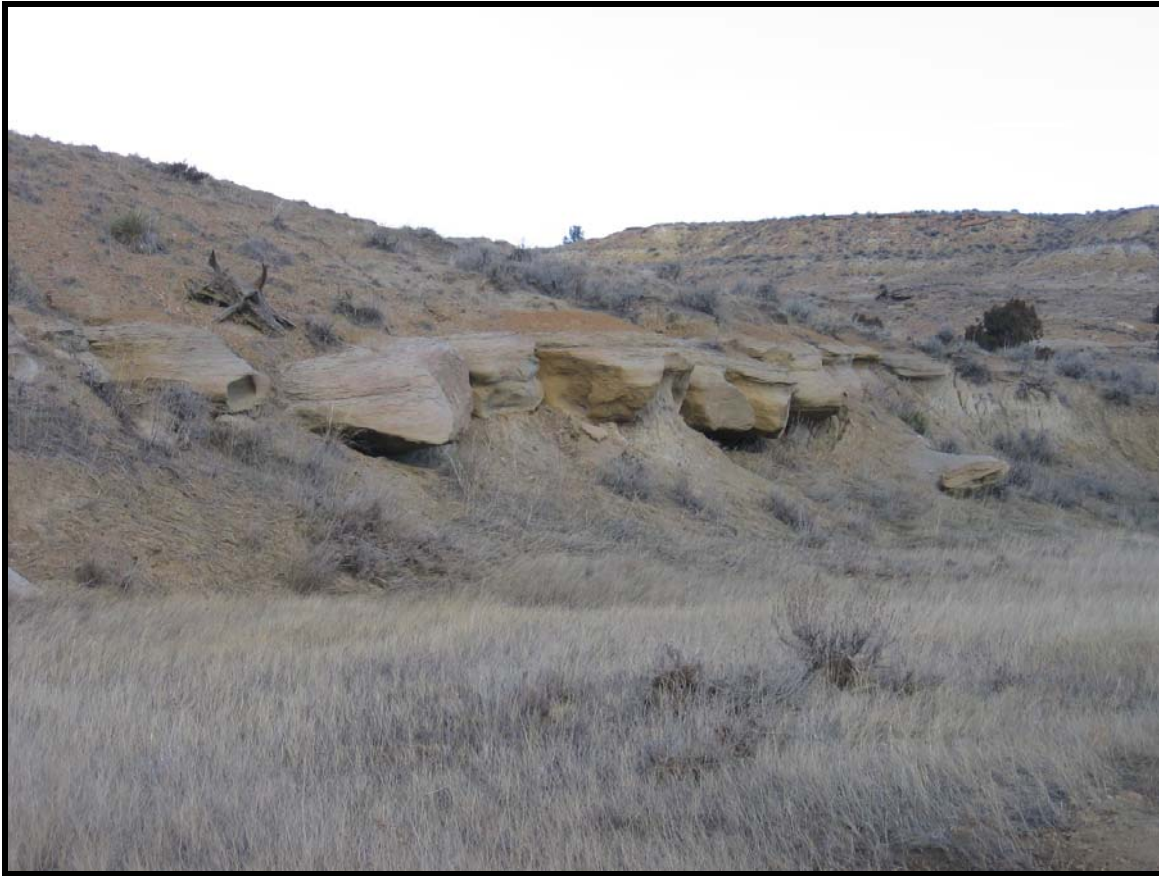
Photo: 1_12_06_33

GEOMETRIC DIMENSIONS: Length: 150 ft Height: 15 ft

SUBSTRATE: Sandstone/siltstone

DESCRIPTION OF FEATURE: The cliff feature shown above has a hard sandstone/siltstone face that rests at the top of a sandy silt slope. Voids exist beneath the solid rock face of the feature due to weathering and erosion.

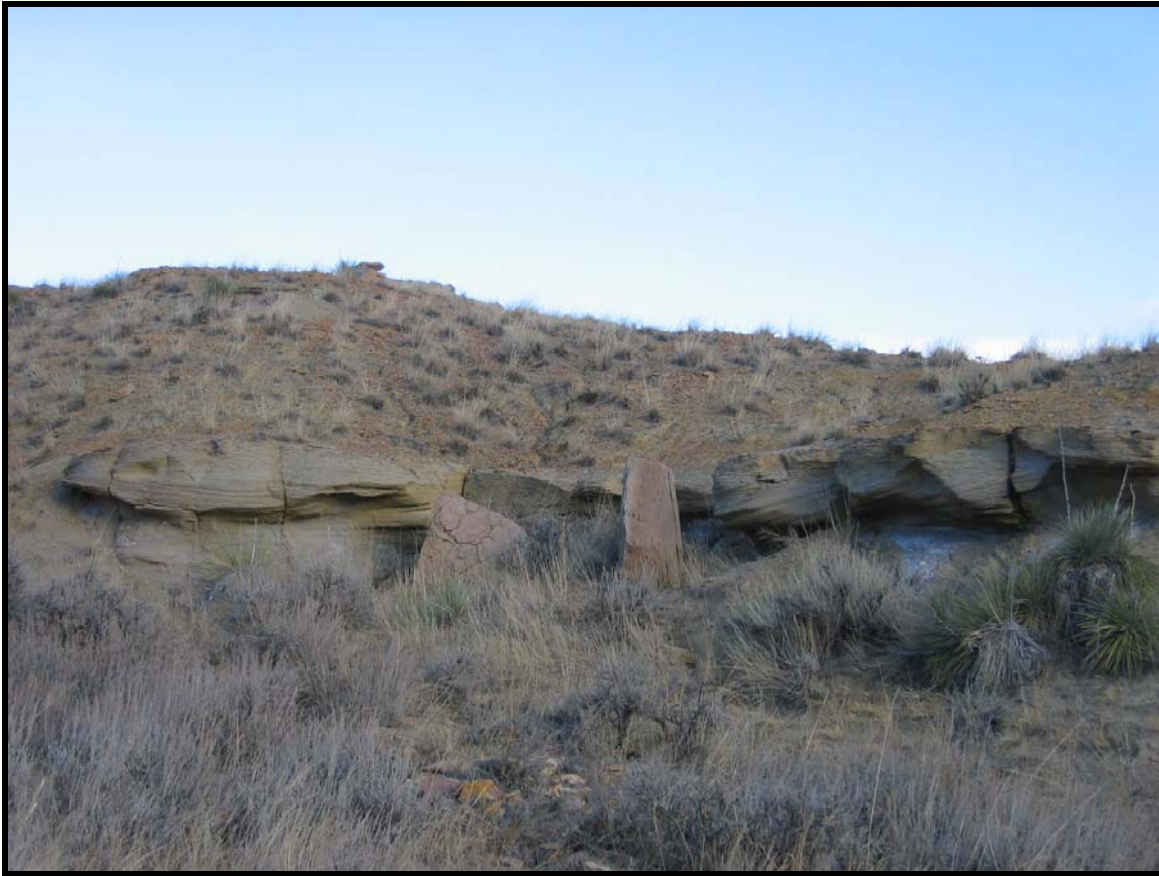
Photo: 1_12_06_40

GEOMETRIC DIMENSIONS: Length: 70 ft Height: 15 ft

SUBSTRATE: Sandstone/siltstone

DESCRIPTION OF FEATURE: The cliff feature shown above has a hard sandstone/siltstone face that overlooks a small draw. The solid rock face sits on top of soft sandy silt material that is highly erosive. Overhangs have been created due to runoff flows.

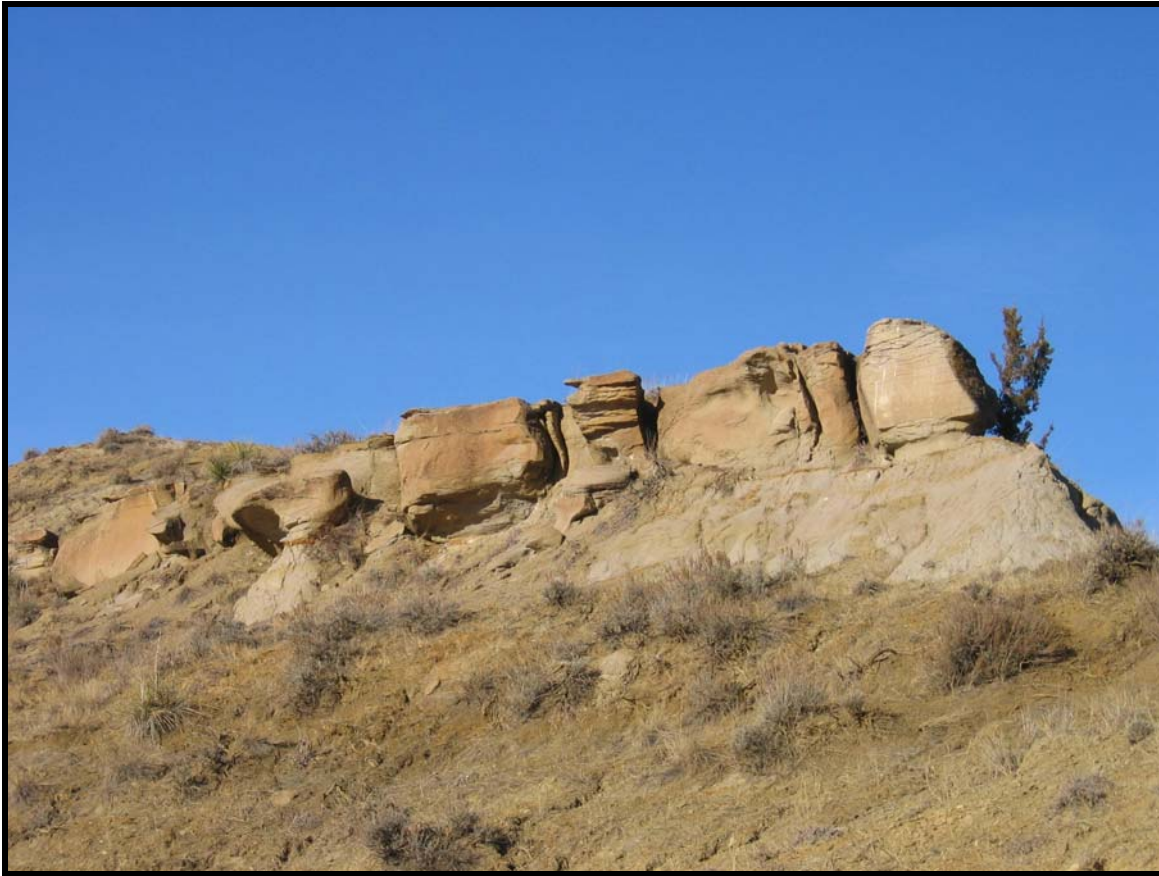
Photo: 1_9_06_06

GEOMETRIC DIMENSIONS: Length: 115 ft Height: 15 ft

SUBSTRATE: Sandstone/siltstone

DESCRIPTION OF FEATURE: The rock outcrop shown above is composed of sandstone/siltstone rocks, which are weathered and layered. Voids between and below the rocks are created as erosion continues. This feature overlooks two channel bottoms.

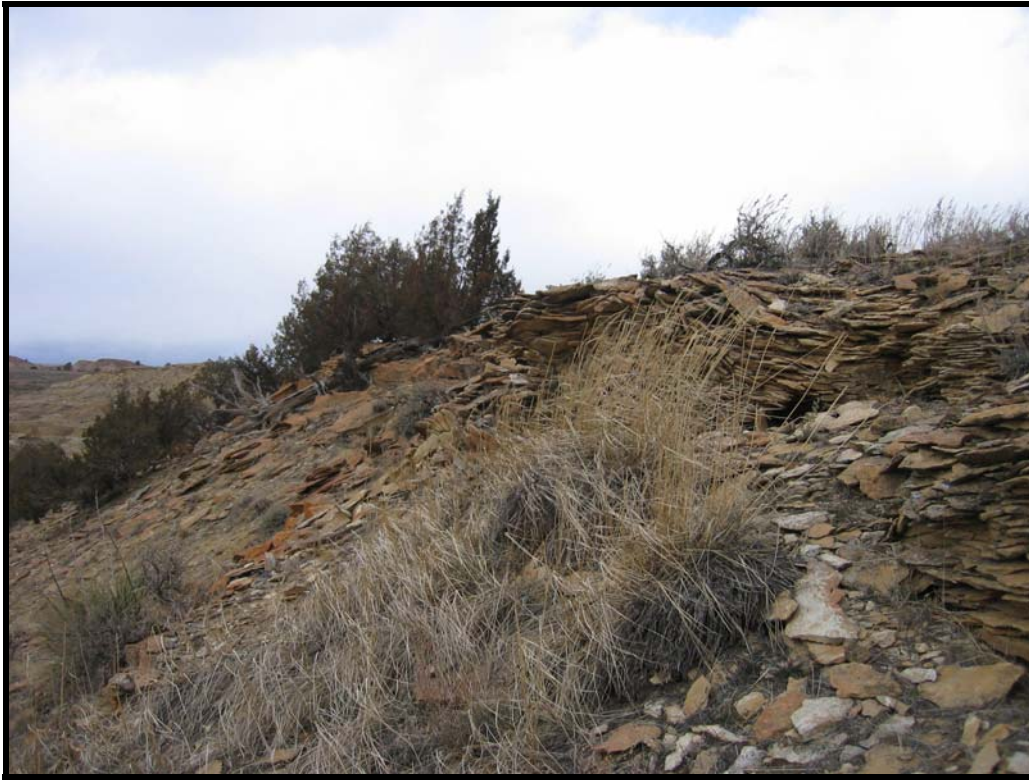
Photo: 1_11_06_33

GEOMETRIC DIMENSIONS: Length: 3890 ft Height: 20 ft

SUBSTRATE: Sandstone/siltstone

DESCRIPTION OF FEATURE: The rock outcrop shown above is a long rock layer, which has been eroded, leaving a large number of rocks on the side of a hill in Section 6. The rocks vary in size and thickness, with some of the larger rocks having a thickness up to 10 feet. The pictures on the following pages show additional views of this feature.

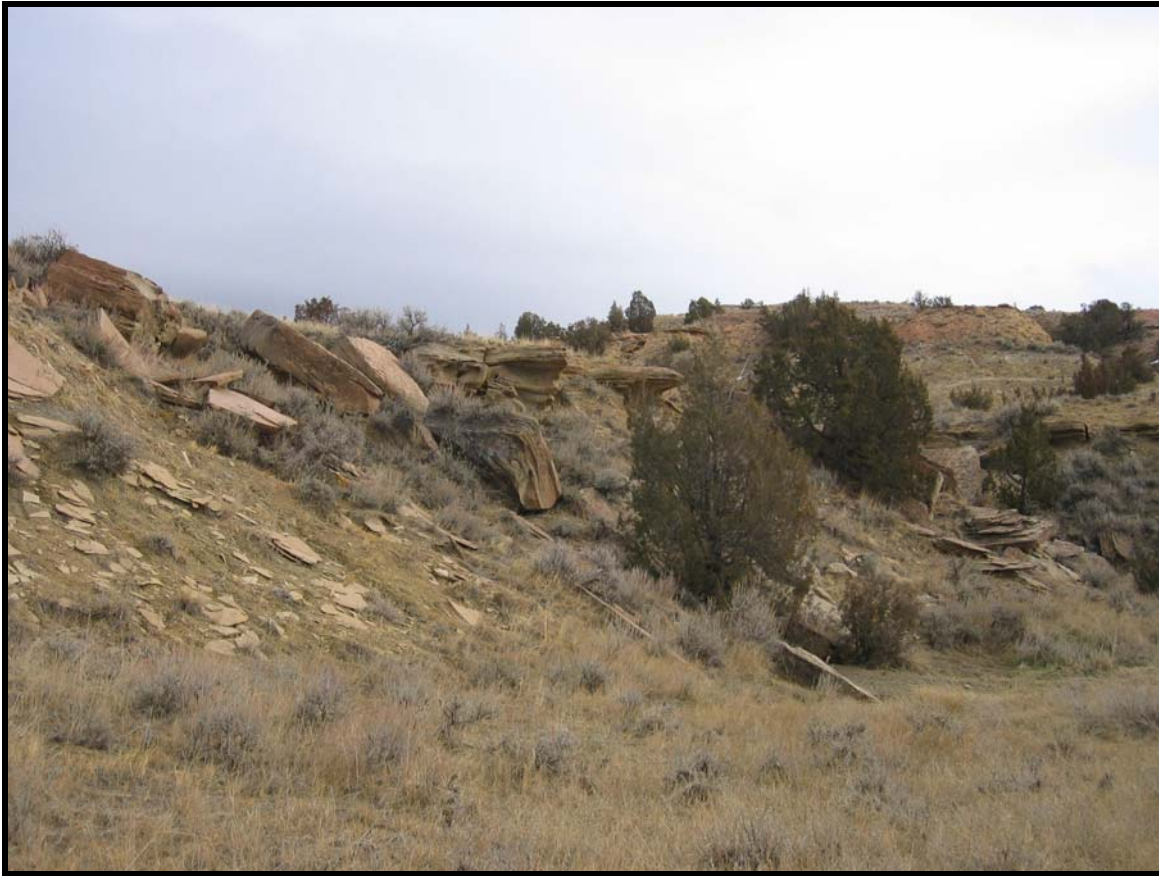
Photo: 1_11_06_39

GEOMETRIC DIMENSIONS: Area of outcrop: 0.13 acres

SUBSTRATE: Sandstone/siltstone

DESCRIPTION OF FEATURE: The rock outcrop shown above is composed of layered, sandstone/siltstone rocks. Voids between and below the rocks are created as erosion continues. The outcrop is located at the top of a small hill composed of sandy silt material. See the pictures on the following pages for additional views of this feature.

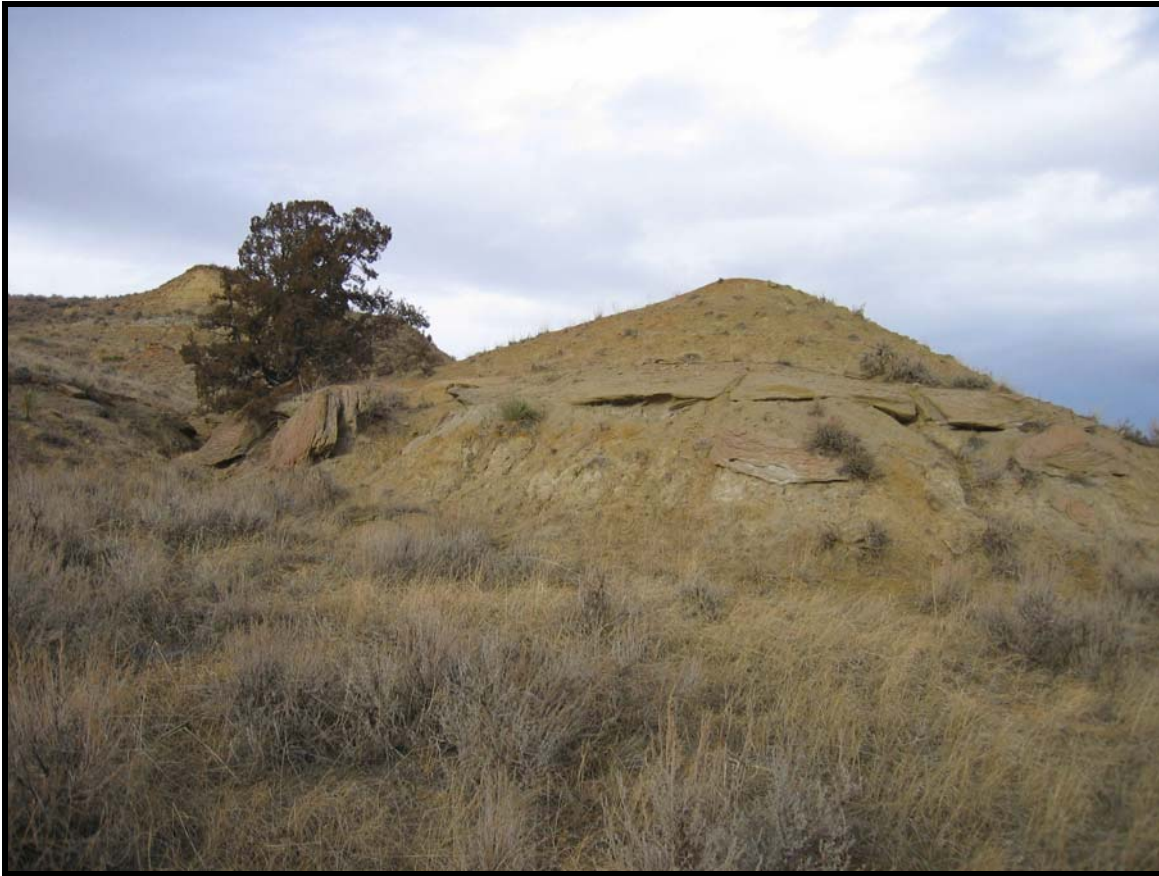
Photo: 1_11_06_44

GEOMETRIC DIMENSIONS: Length: 120 ft Height: 10 ft

SUBSTRATE: Sandstone/siltstone

DESCRIPTION OF FEATURE: The rock outcrop shown above is composed of sandstone/siltstone rocks. Voids between and below the rocks are created as erosion continues. The rock layer is exposed within a soft sandy silt material.

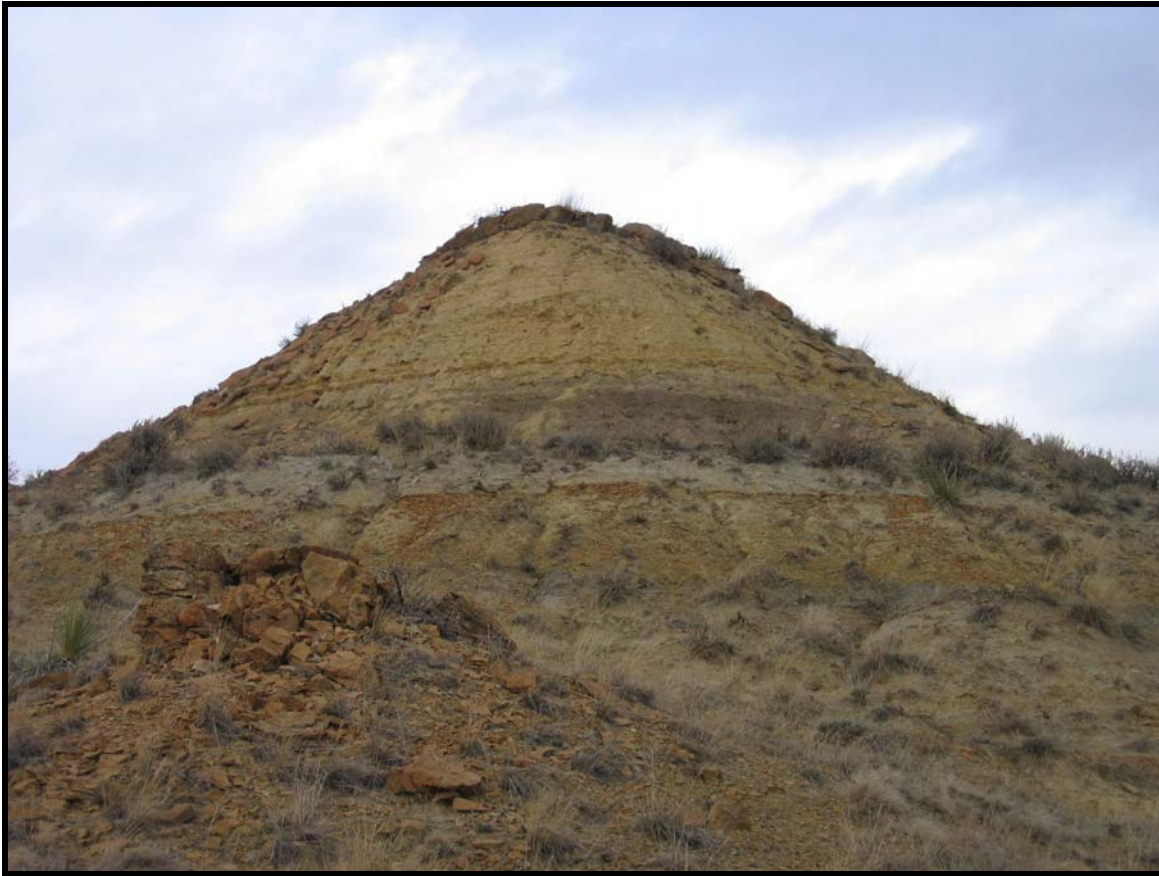
Photo: 1_11_06_45

FEATURE TYPE:	Rock Outcrop		
GEOMETRIC DIMENSIONS:	Length: 100 ft	Height: 20 ft	
LOCATION:	Township: 9S	Range: 40E	Section: 6
HANDHELD GPS POINTS:	Northing	Easting	
	6090	404889.41 2676534.07	
	6091	404909.08 2676466.23	
	6092	404938.32 2676467.86

SUBSTRATE: Scoria

DESCRIPTION OF FEATURE: The rock outcrop feature shown above is located on a steep (greater than 3H:1V) slope consisting of sandy silt material. Scoria caprocks like this feature are common in this area. The face of the scoria caprock is fractured and jagged.

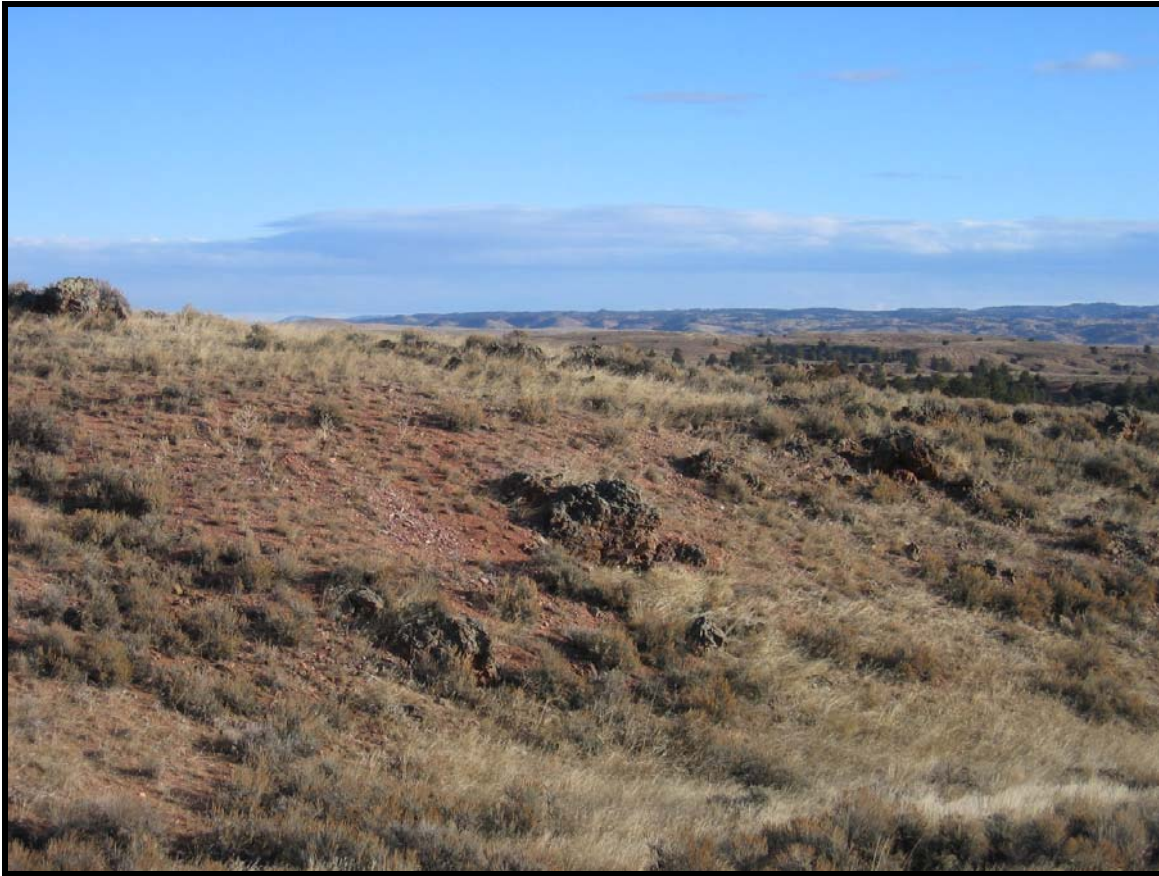
Photo: 1_12_06_02

GEOMETRIC DIMENSIONS: Area of outcrop: 2.61 acres

SUBSTRATE: Scoria

DESCRIPTION OF FEATURE: The scoria outcrop shown above contains scoria, which ranges in size from small pieces to rocks six feet in diameter. Over the area of the feature, the scoria can be spaced as much as 100 feet apart from the next closest rock in the outcrop.

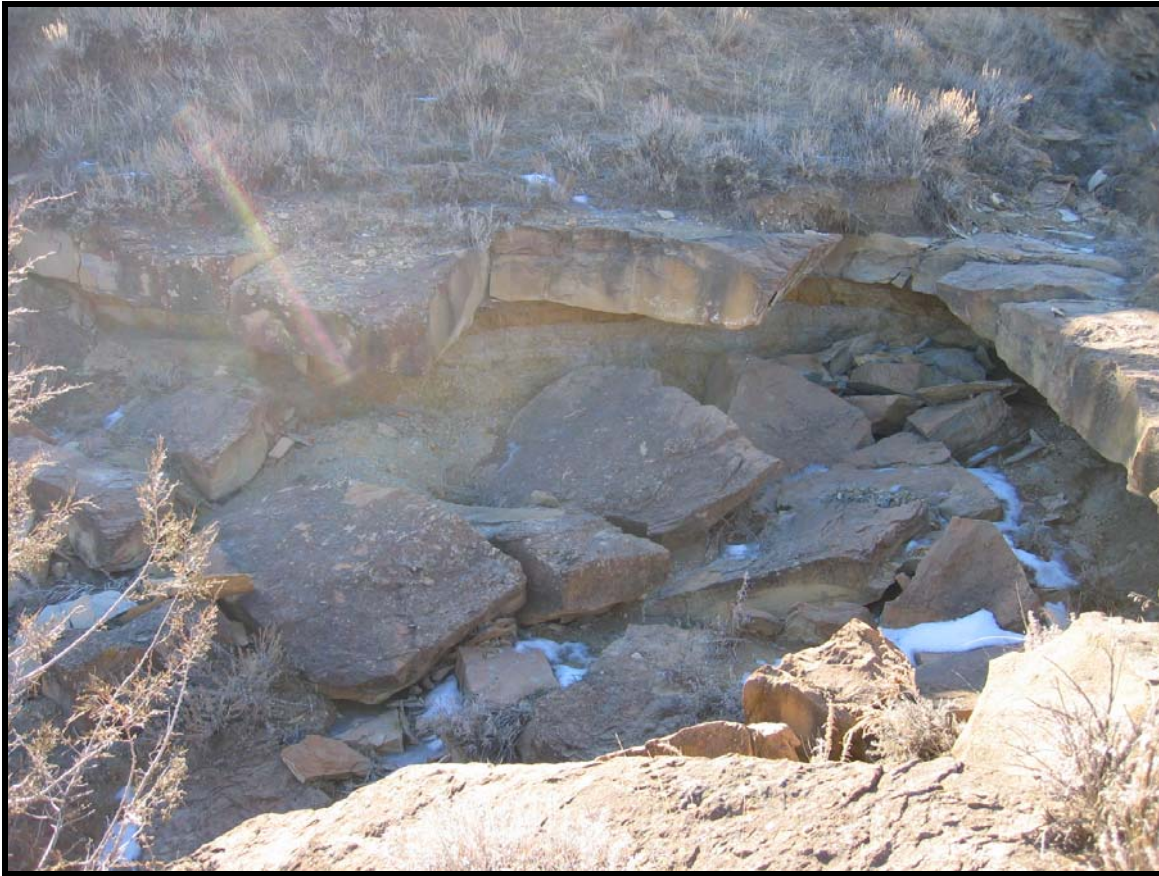
Photo: 1_12_06_03

FEATURE TYPE:	Rock Outcrop				
GEOMETRIC DIMENSIONS:	Length: 60 ft		Height: 10 ft		
LOCATION:	Township: 9S		Range: 40E		Section: 6
HANDHELD GPS POINTS:	Northing	Easting		Northing	Easting
	7007	401518.49	2679198.21	7010	401568.83
	7008	401524.94	2679172.15	7011	401590.78
	7009	401558.07	2679181.40		2679175.88
					2679177.74

SUBSTRATE: Sandstone/siltstone

DESCRIPTION OF FEATURE: The rock outcrop shown above is a rock layer that is located at the bottom of riparian feature, R_0024. The erosion caused by runoff flows has eroded the surrounding soil, leaving this outcrop. Beneath the rock layer the soil has also eroded, leaving a large overhang. The picture on the next page shows another view of this feature.

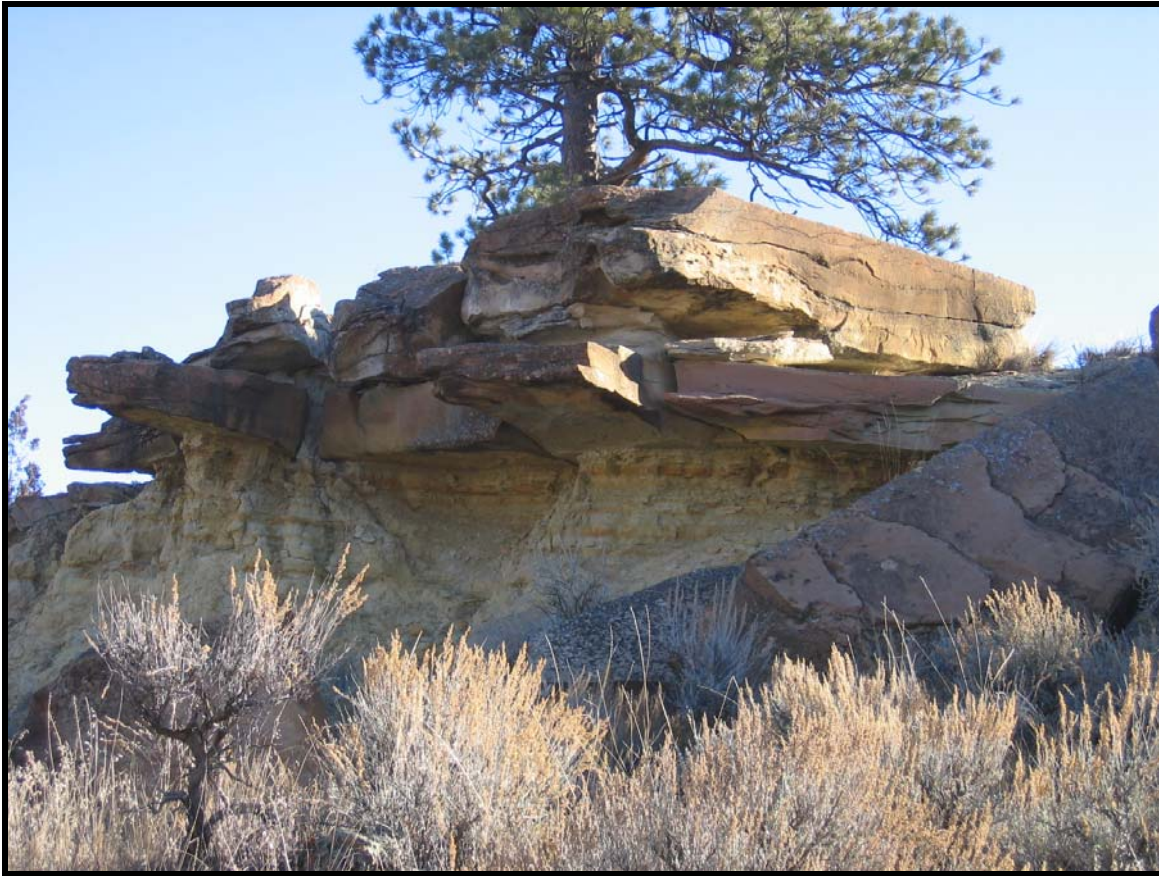
Photo: 1_12_06_06

GEOMETRIC DIMENSIONS: Length: 40 ft Height: 10 ft

SUBSTRATE: Sandstone/siltstone

DESCRIPTION OF FEATURE: The rock outcrop shown above is a large, layered rock that overlooks riparian feature, R_0024. The feature sits at the top of a sandy silt slope and has a weathered, jagged face.

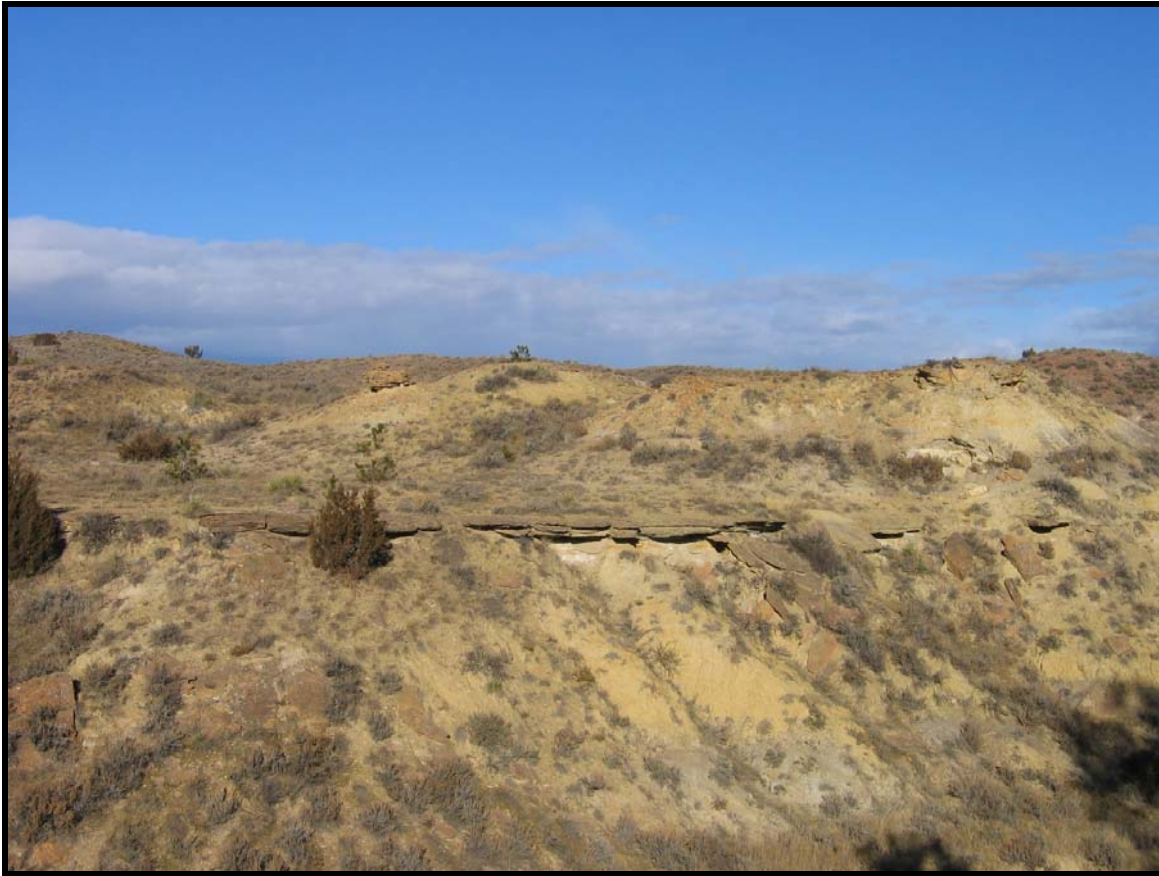
Photo: 1_12_06_07

GEOMETRIC DIMENSIONS: Length: 105 ft Height: 5 ft

SUBSTRATE: Sandstone/siltstone

DESCRIPTION OF FEATURE: This sandstone/siltstone rock outcrop occurs in the middle of a soft, sandy silt slope. The rock layer has been exposed by runoff flows in riparian feature R_0024 and is approximately five feet thick. Overhangs and crevices are frequent in this outcrop.

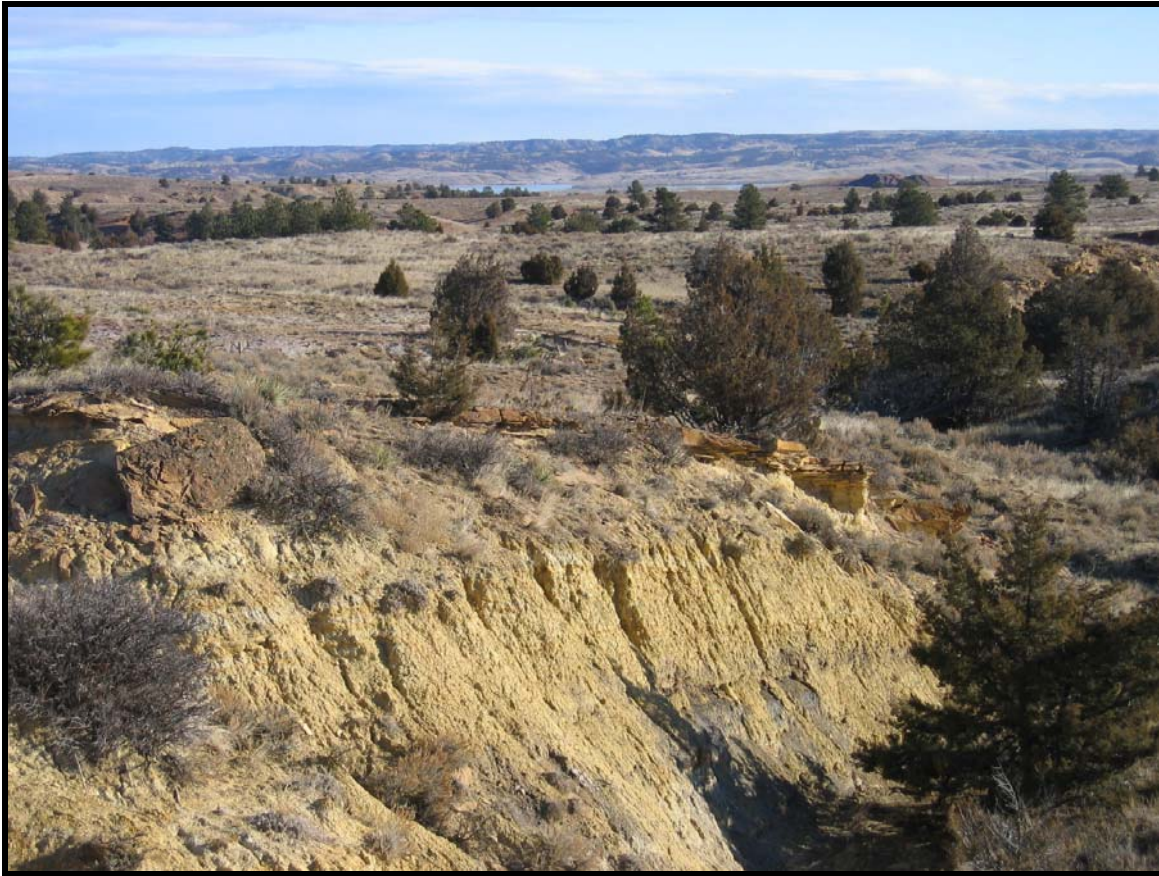
Photo: 1_12_06_08

GEOMETRIC DIMENSIONS: Length: 100 ft Height: 25 ft

SUBSTRATE: Sand, silt, and sandstone/siltstone

DESCRIPTION OF FEATURE: The rock outcrop shown above is located adjacent to RO_0049. The sandstone/siltstone rock layer is weathered and has a significant number of overhangs. Also included in this feature is the large, sandy silt cutbank directly beneath the rock layer.

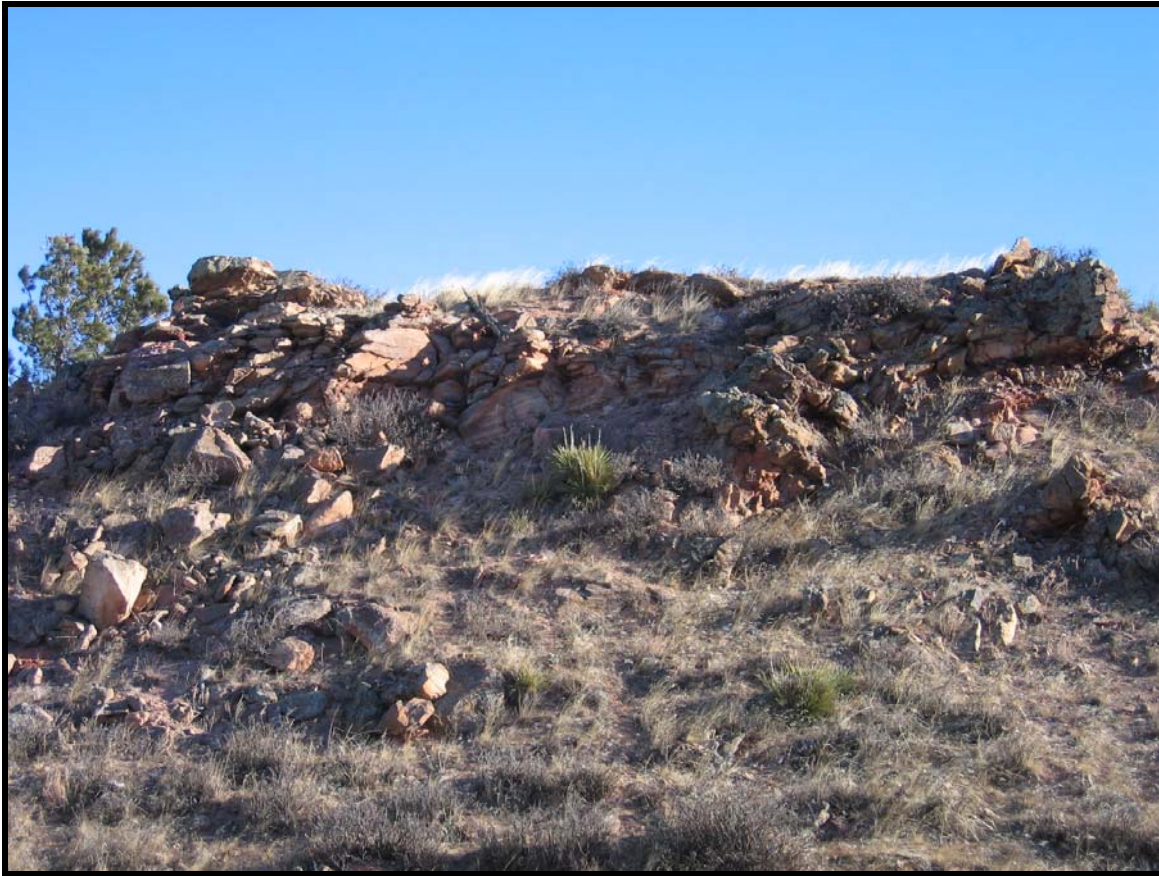
Photo: 1_12_06_10

GEOMETRIC DIMENSIONS: Area of Outcrop: 0.64 acres

SUBSTRATE: Scoria and sandstone/siltstone

DESCRIPTION OF FEATURE: The scoria outcrop shown above is located at the top of a hill overlooking a small draw. The sizes of the scoria range from small to almost ten feet high. The pictures on the following page for additional views of this outcrop.

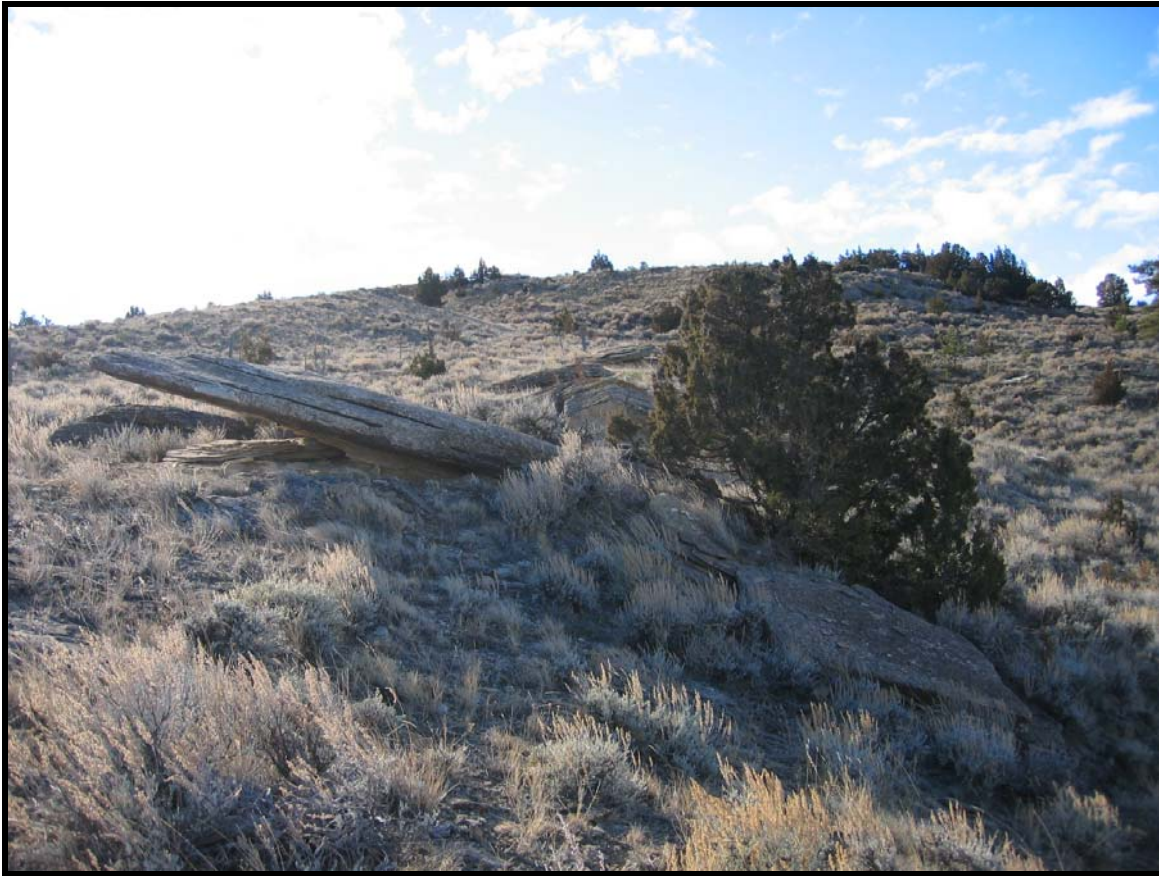
Photo: 1_12_06_13

GEOMETRIC DIMENSIONS: Area of outcrop: 0.19 acres

SUBSTRATE: Sandstone/siltstone

DESCRIPTION OF FEATURE: The rock outcrop shown above is located at the very southern portion of Section 6. The large sandstone/siltstone rocks are sometimes separated more than 50 feet from the nearest rock in the outcrop. The pictures on the next page show additional views of this outcrop.

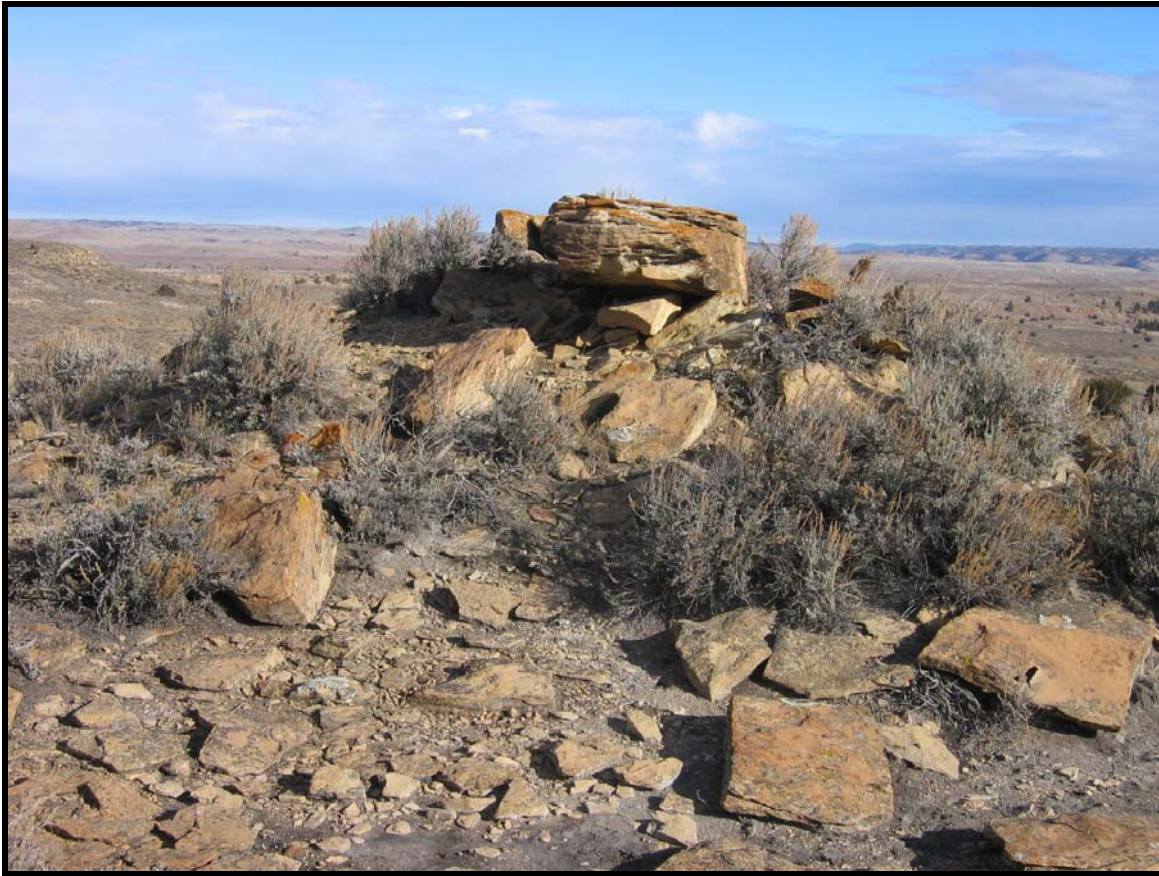
Photo: 1_12_06_17

GEOMETRIC DIMENSIONS: Length: 15 ft Height: 10 ft

SUBSTRATE: Sandstone/siltstone

DESCRIPTION OF FEATURE: The rock outcrop shown above sits on a small mound of sandy silt soil. This feature is surrounded by a sparse population of grass and sagebrush.

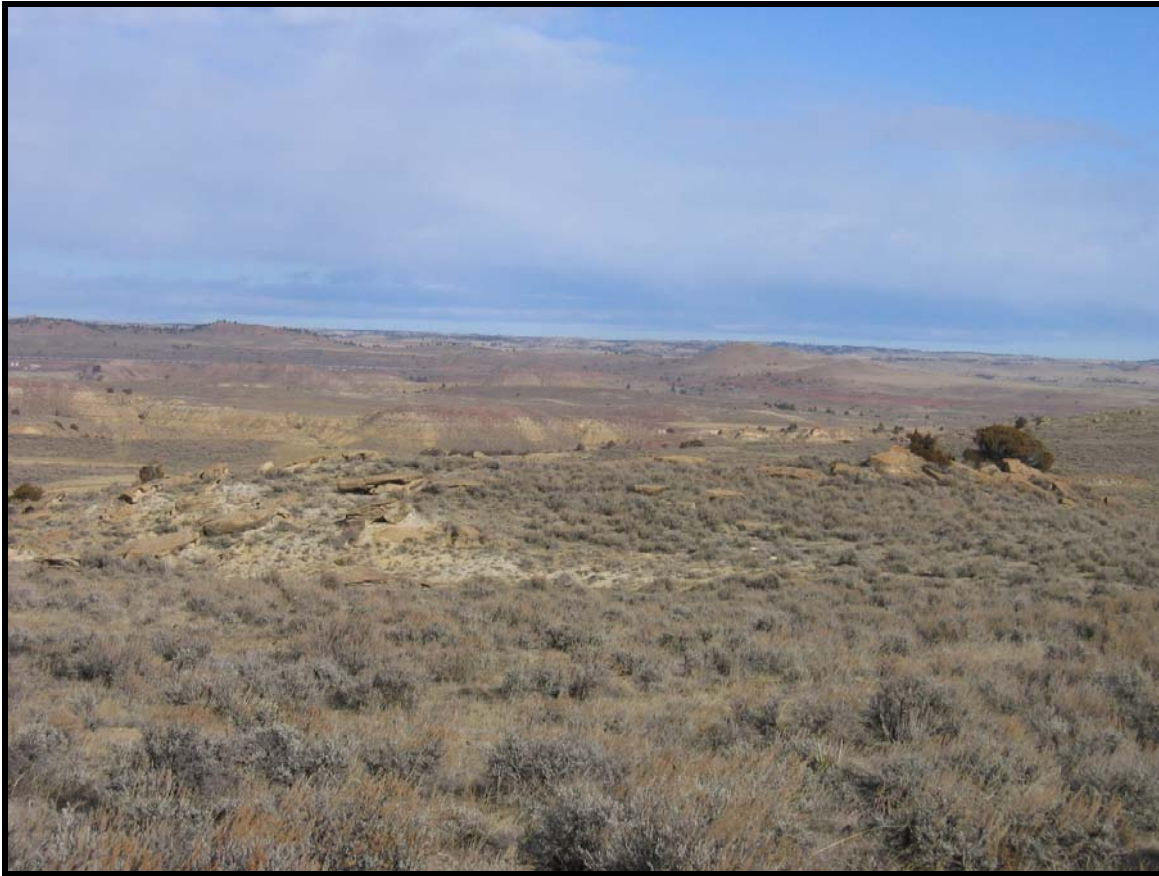
Photo: 1_12_06_18

GEOMETRIC DIMENSIONS: Area of outcrop: 9.68 acres

SUBSTRATE: Sandstone/siltstone

DESCRIPTION OF FEATURE: The rock outcrop shown above travels through the southern boundary of Section 6. The sandstone/siltstone rocks are large and low-lying. The vegetation surrounding this feature is grass and sagebrush. See the pictures on the following page for more views of this feature.

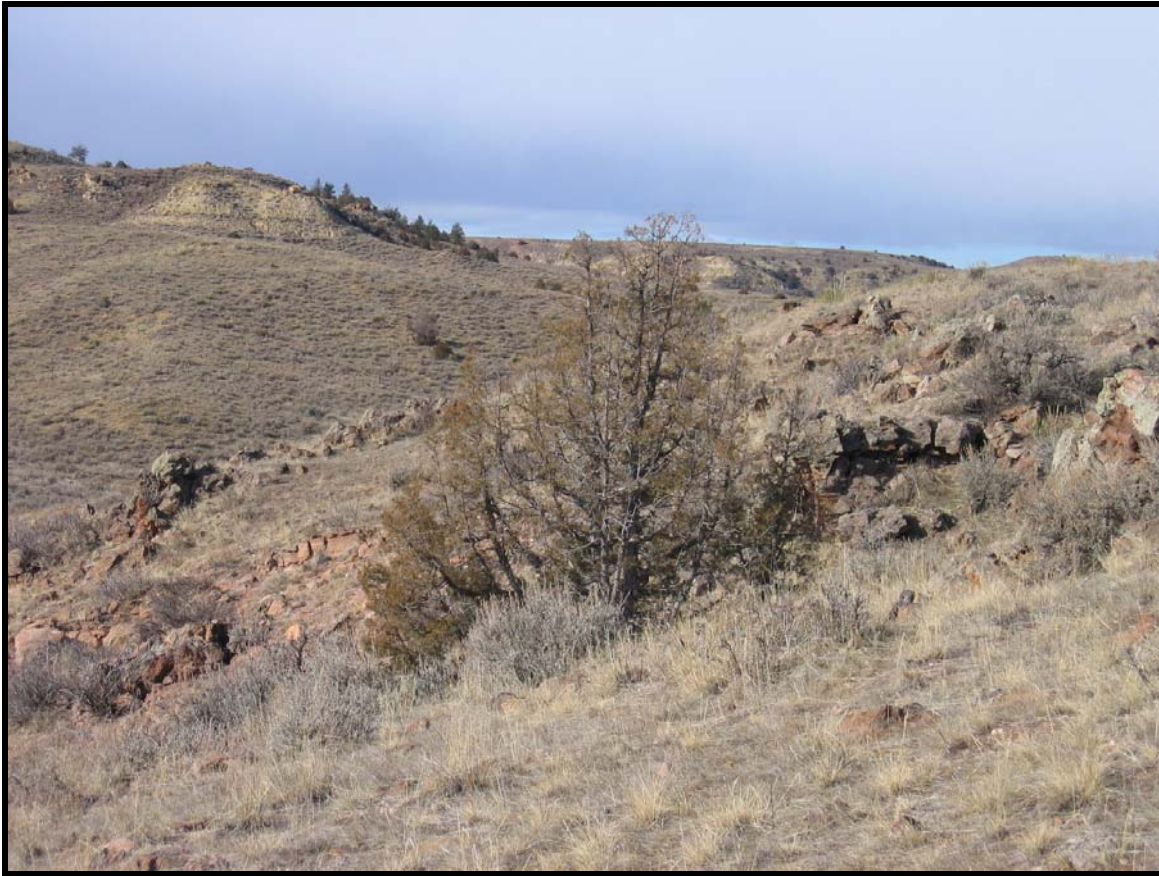
Photo: 1_12_06_22

GEOMETRIC DIMENSIONS: Area of outcrop: 2.47 acres

SUBSTRATE: Scoria

DESCRIPTION OF FEATURE: Scoria rock outcrops, like the one shown above, are very common in this area. This feature is located adjacent to the channel bank of a small draw. The sizes of the scoria rocks range from small to several feet in diameter.

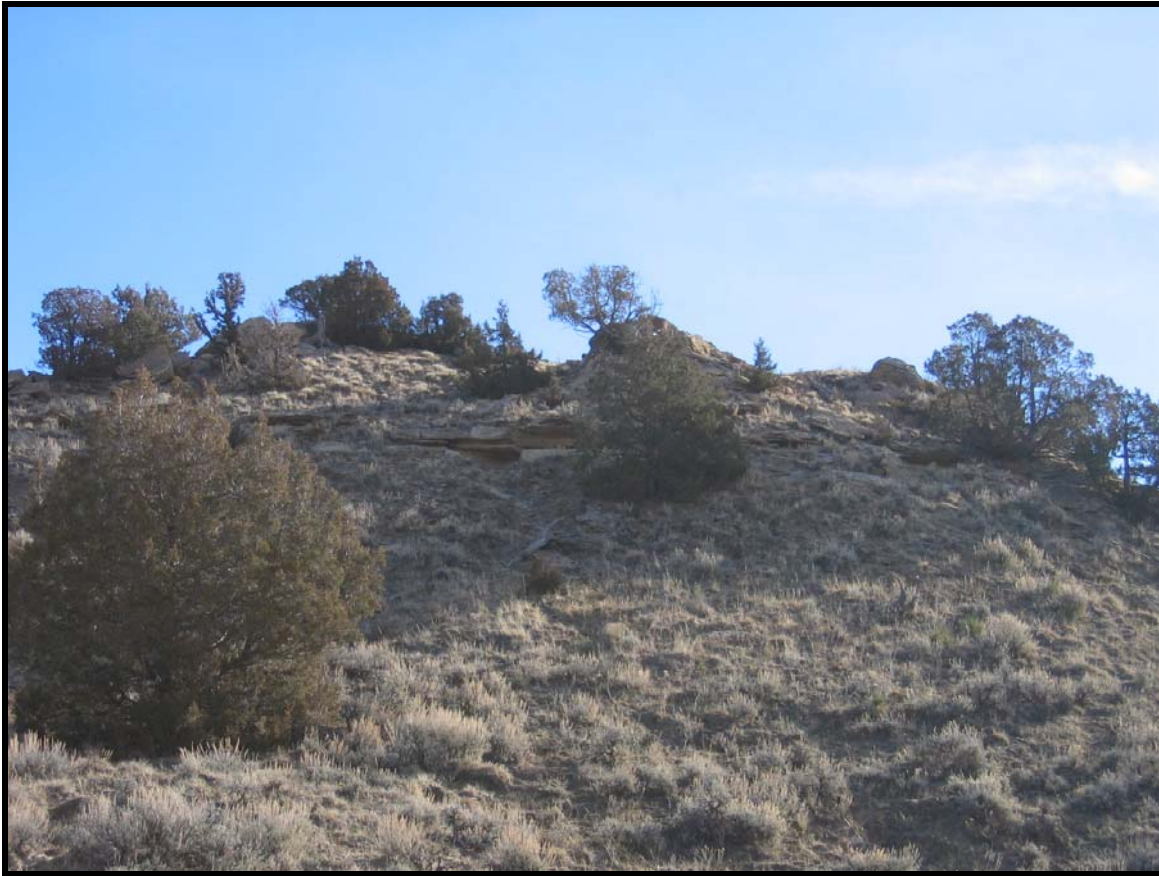
Photo: 1_12_06_24

GEOMETRIC DIMENSIONS: Length: 100 ft Height: 15 ft

SUBSTRATE: Sandstone/siltstone

DESCRIPTION OF FEATURE: The rock outcrop shown above consists of sandstone/siltstone rocks at the top of a sandy silt hill. The feature is surrounded by grass, sagebrush and some small trees. Voids between and below the rocks are frequent in this feature.

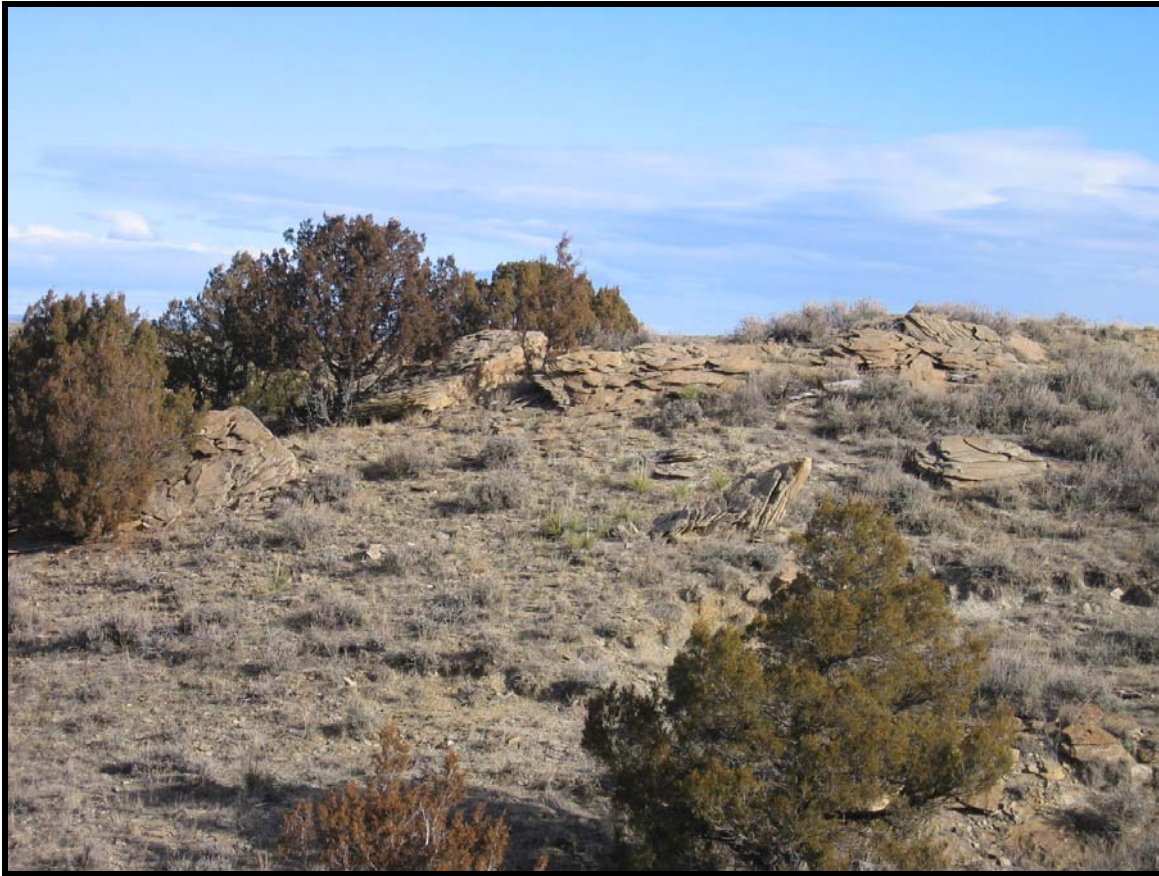
Photo: 1_12_06_25

GEOMETRIC DIMENSIONS: Area of outcrop: 0.18 acres

SUBSTRATE: Sandstone/siltstone

DESCRIPTION OF FEATURE: The rock outcrop shown above is composed of weathered, sandstone/siltstone rocks. Voids between and below the rocks are created as erosion continues. The vegetation surrounding this feature consists of grass, sagebrush, and small trees.
