Township 9S, Range 40E
SECTION 6

Cliff Features

Revised 4/06; Reference – South Fork Extension Amendment #00174

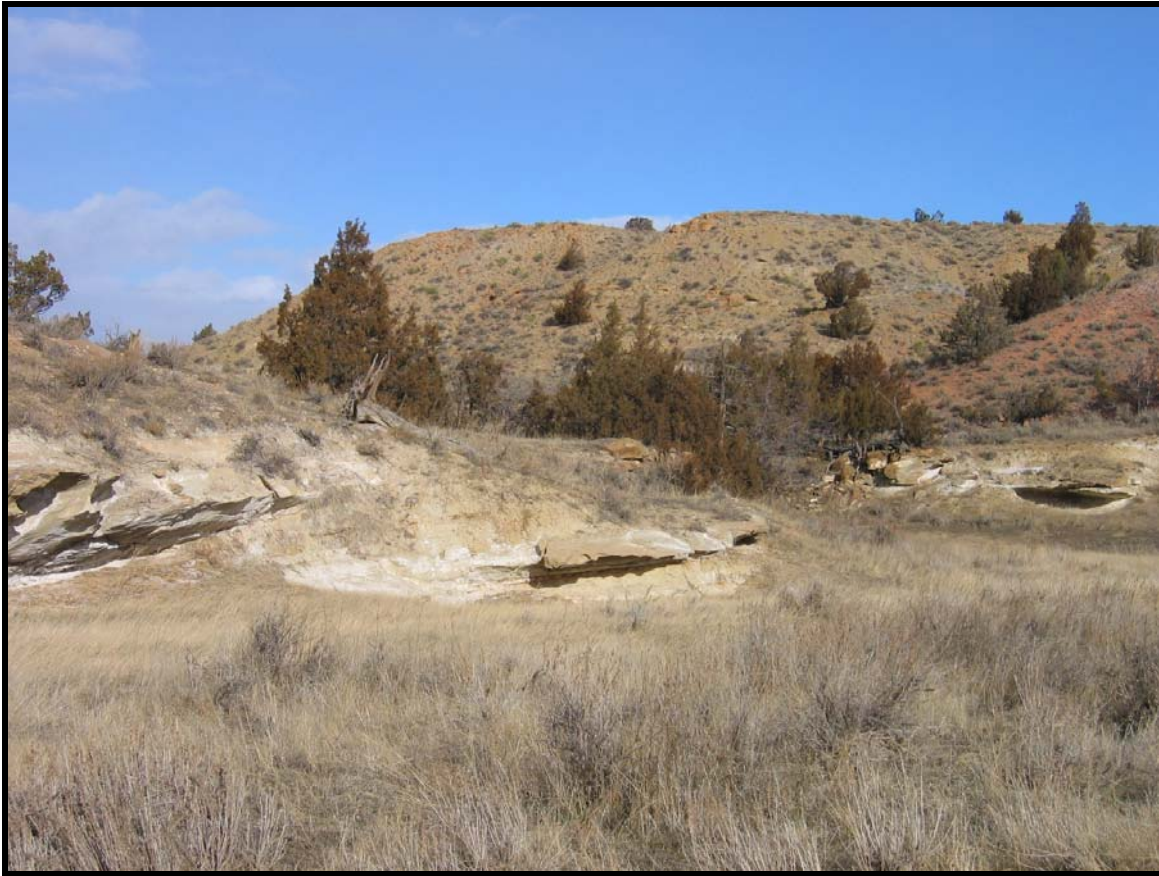
Photo: 1_12_06_26

GEOMETRIC DIMENSIONS: Length: 270 ft Height: 10 ft

SUBSTRATE: Sandstone/siltstone

DESCRIPTION OF FEATURE: The rock outcrop shown above is located adjacent to R_0028. The total length of this feature is the summation of two separate sections. The feature consists of sandstone/siltstone rocks and has large voids beneath the rock layer due to erosion caused by runoff flows.

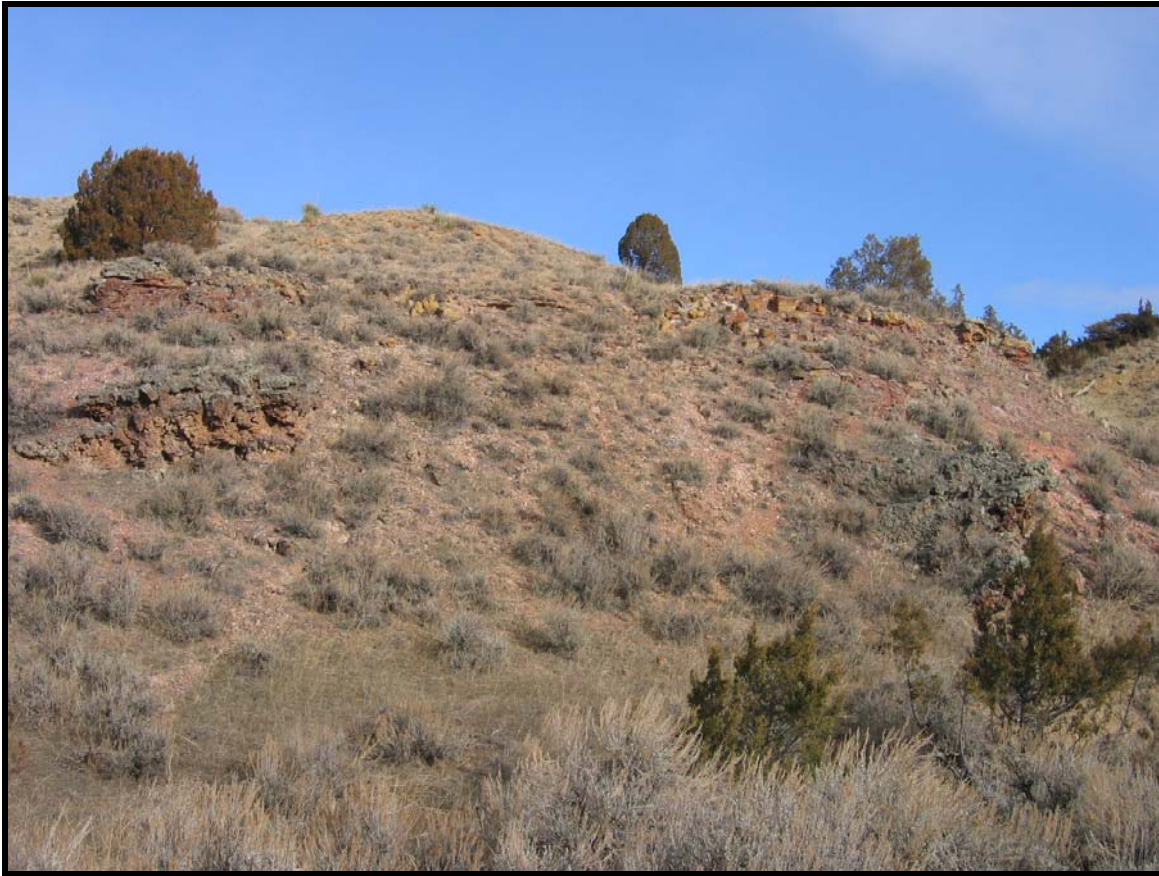
Photo: 1_12_06_27

GEOMETRIC DIMENSIONS: Area of outcrop: 0.11 acres

SUBSTRATE: Scoria

DESCRIPTION OF FEATURE: This small outcrop of scoria is located on the southern facing bank of a small draw. The sizes of the scoria rocks range from small to several feet in diameter. This type of outcrop is very common in this area. See the picture on the next page for a closer view of this feature.

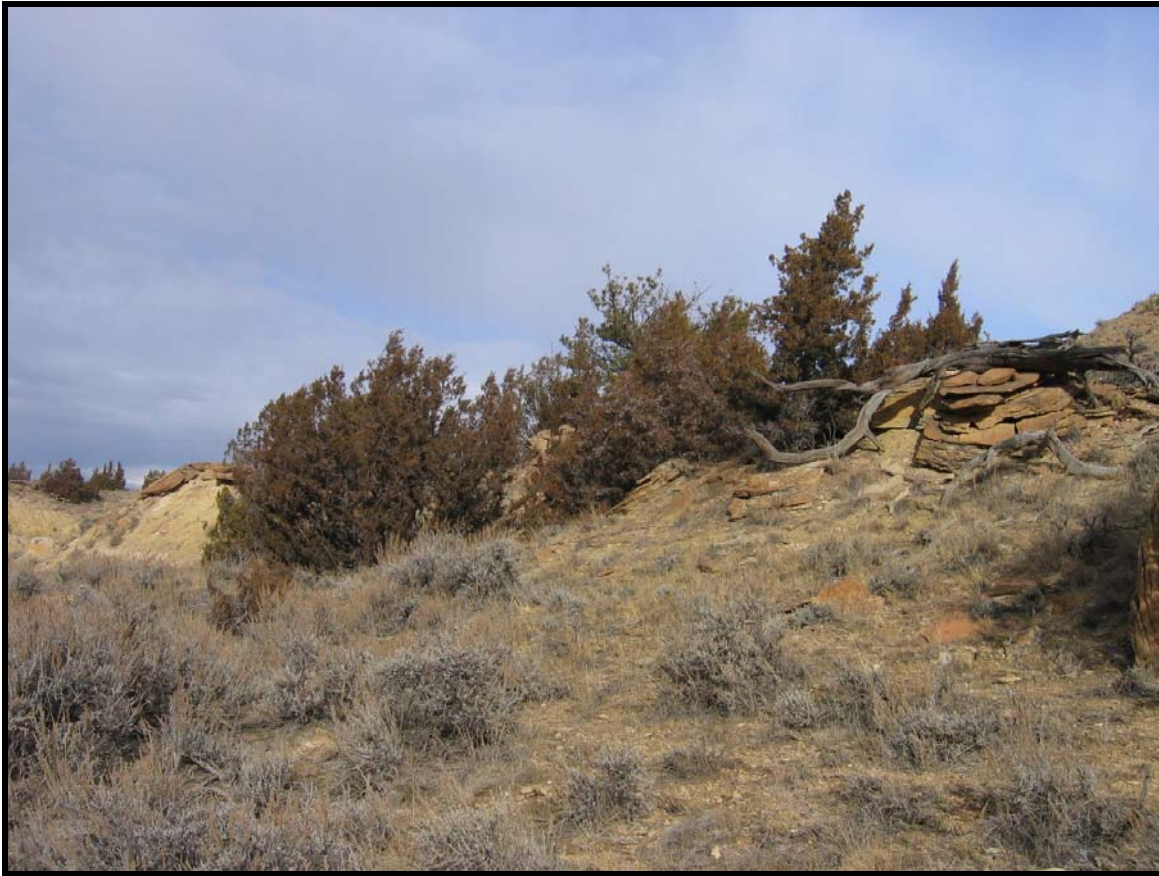
Photo: 1_12_06_29

FEATURE TYPE:	Rock Outcrop				
GEOMETRIC DIMENSIONS:	Length: 1810 ft		Height: 10 ft		
LOCATION:	Township: 9S		Range: 40E		Section: 6
HANDHELD GPS POINTS:		Northing	Easting		Northing
	7060	403088.23	2674770.79	7063	403635.07
	7061	403306.19	2674743.00	7064	404123.82
	7062	403556.81	2674597.84		2675765.65

SUBSTRATE: Sandstone/siltstone

DESCRIPTION OF FEATURE: The rock outcrop shown above is composed of sandstone/siltstone rocks. Voids between and below the rocks are created as erosion continues. This outcrop is very similar to feature RO_0042 in type and location. The two features were considered separately because there is a break between the two features at the east end of RO_0060. See the picture on the next page for another view of this feature.

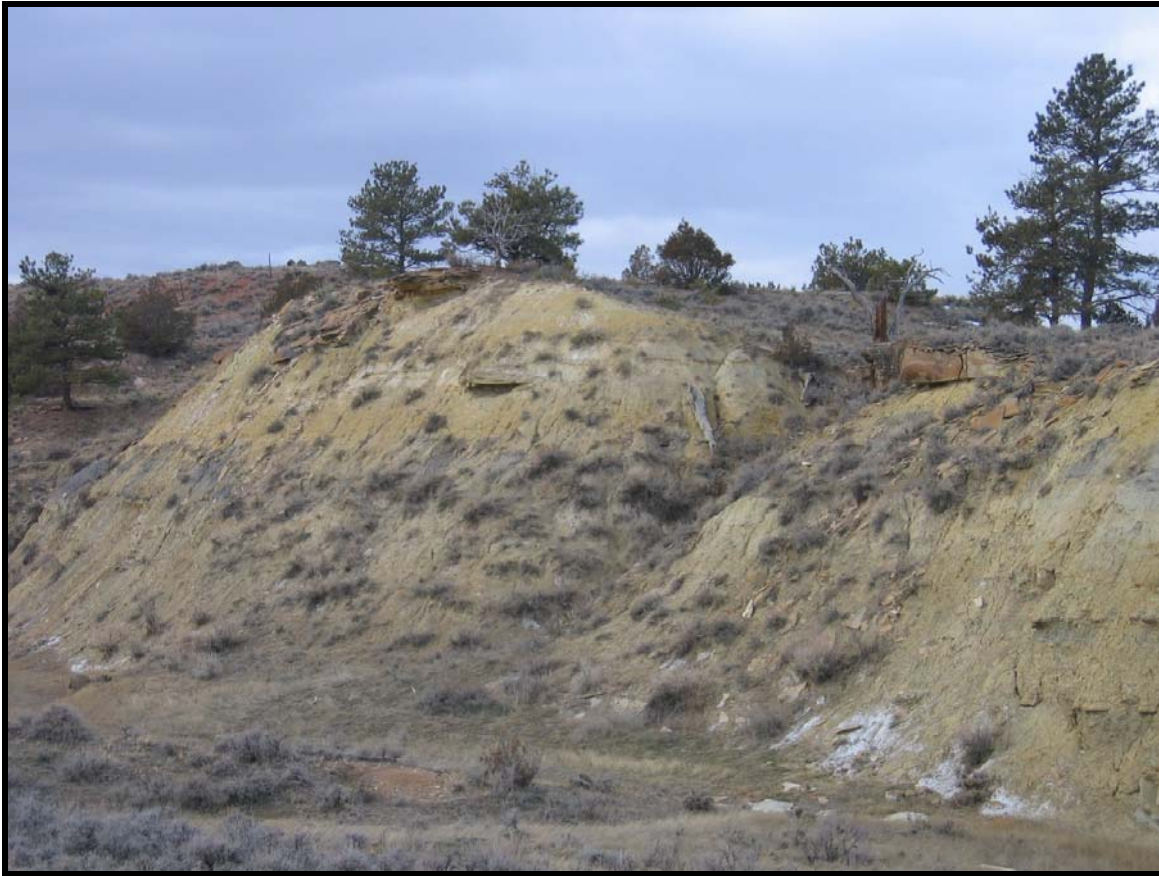
Photo: 1_12_06_31

GEOMETRIC DIMENSIONS: Length: 555 ft Height: 20 ft

SUBSTRATE: Sandstone/siltstone, sand, and silt

DESCRIPTION OF FEATURE: The rock outcrop shown above is located at the top of a hill, overlooking a small draw. Also included in this feature is the large, steep, sandy slope just below the rock outcrop. The height and length include this slope.

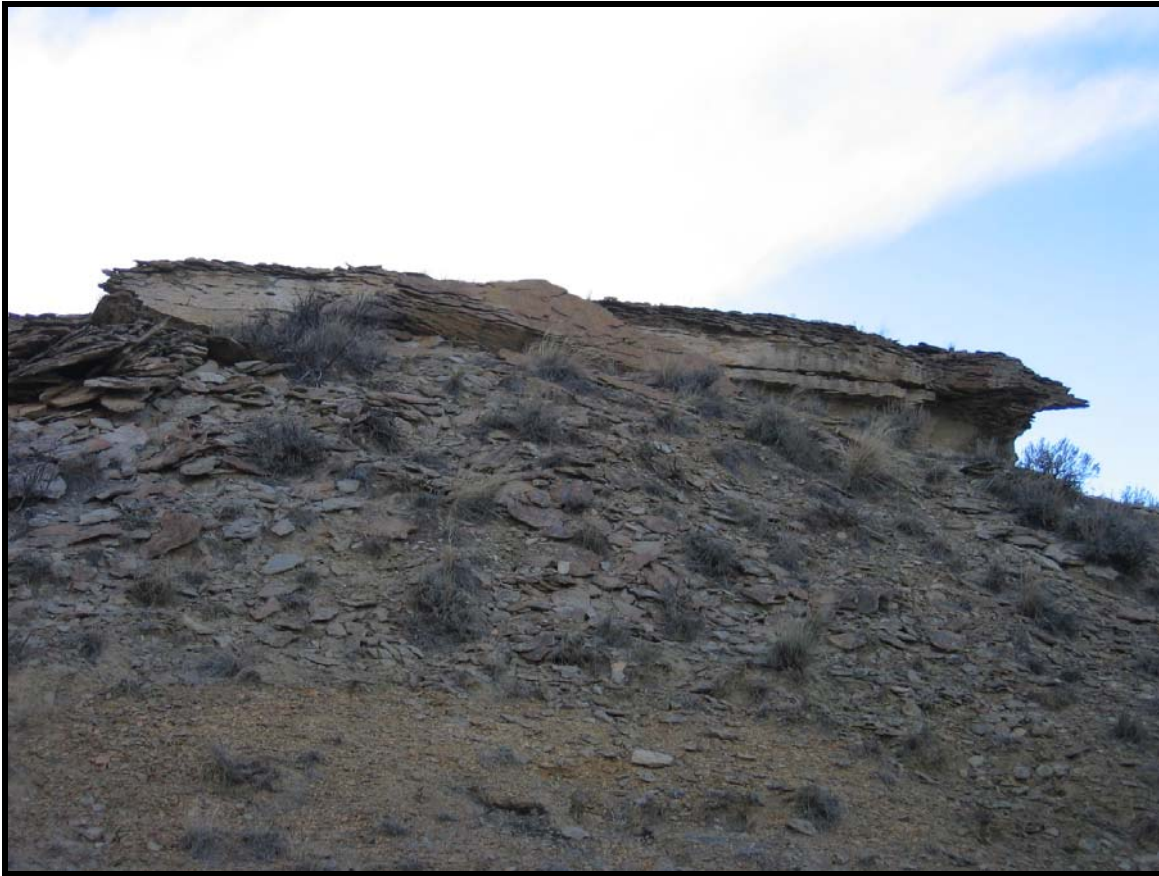
Photo: 1_12_06_34

FEATURE TYPE:	Rock Outcrop				
GEOMETRIC DIMENSIONS:	Length: 1830 ft		Height: 10 ft		
LOCATION:	Township: 9S		Range: 40E		Section: 6
HANDHELD GPS POINTS:		Northing	Easting		Northing
	7077	405127.62	2674779.21	7081	404839.79
	7078	404964.19	2675024.89	7082	405119.95
	7079	405094.92	2675118.83	7083	404950.99
	7080	405174.89	2675222.18		2676185.74

SUBSTRATE: Sandstone/siltstone

DESCRIPTION OF FEATURE: The rock outcrop shown above lies at the top of a sandy silt slope. The feature travels a significant distance at a consistent elevation. Along its length, there are many areas of potential habitat. See the pictures on the following page for more views of this feature.

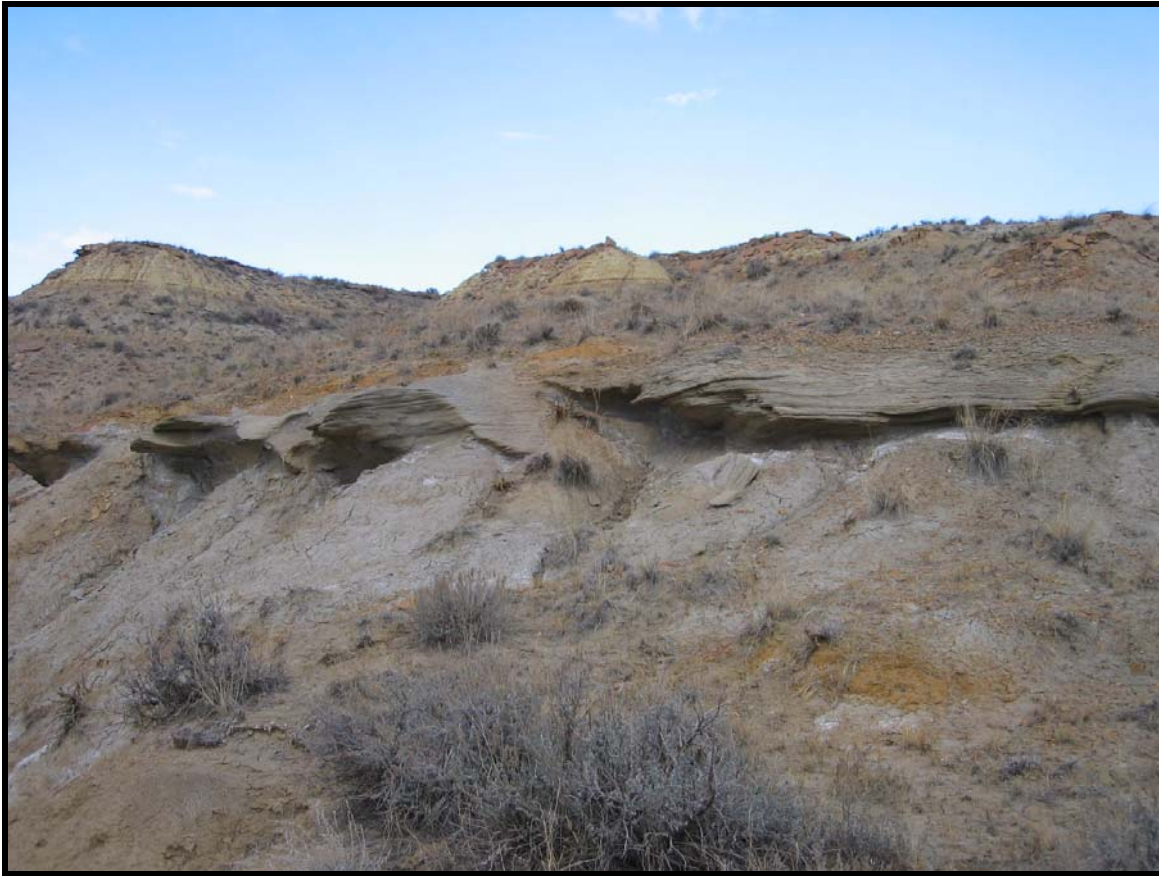
Photo: 1_12_06_37

GEOMETRIC DIMENSIONS: Length: 125 ft Height: 5 ft

SUBSTRATE: Sandstone/siltstone

DESCRIPTION OF FEATURE: This rock outcrop consists of a grey, sandstone/siltstone rock layer on sandy silt subsoil. The soil beneath the rock layer has eroded due to runoff flows. As shown by the above picture, this feature also includes overhangs.

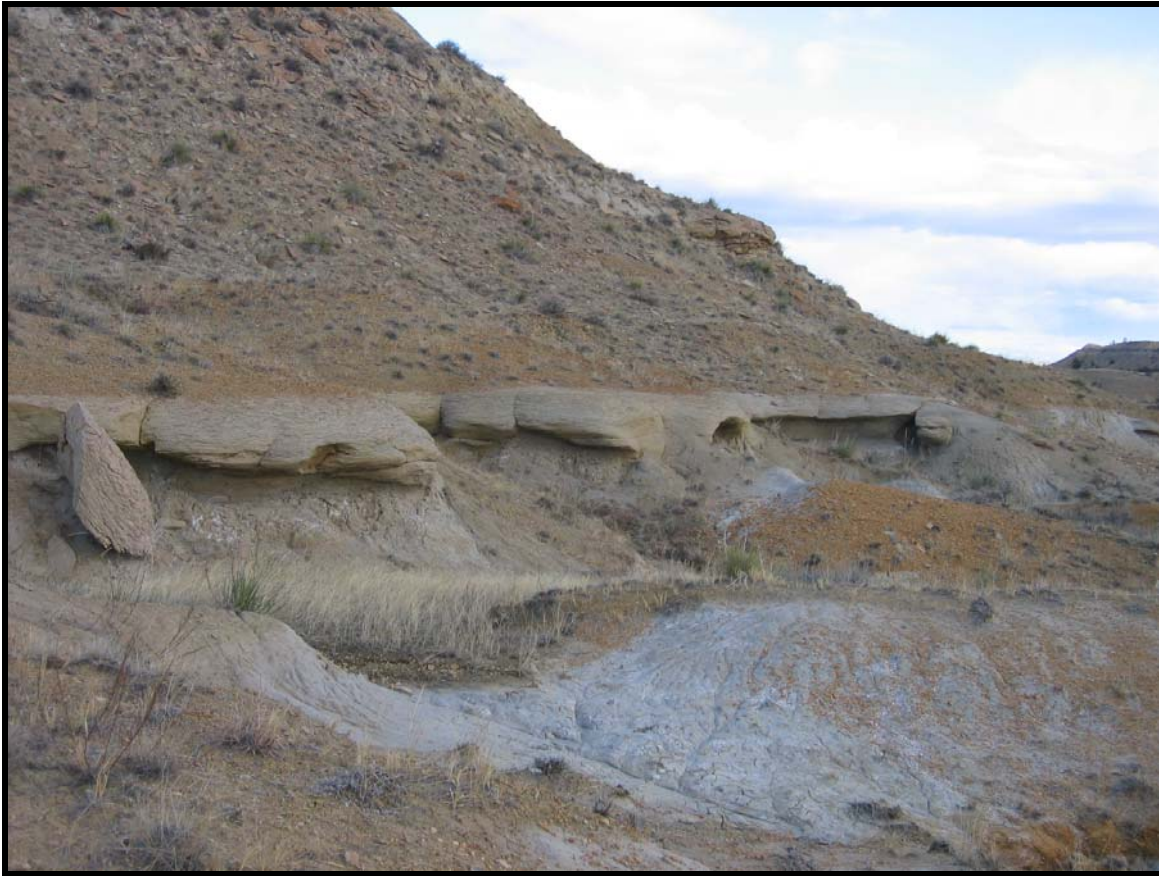
Photo: 1_12_06_39

FEATURE TYPE:	Rock Outcrop		
GEOMETRIC DIMENSIONS:	Length: 135 ft	Height: 5 ft	
LOCATION:	Township: 9S	Range: 40E	Section: 6
HANDHELD GPS POINTS:	Northing	Easting	
	7090	404778.14	2675584.04
	7091	404775.24	2675718.53

SUBSTRATE: Sandstone/siltstone

DESCRIPTION OF FEATURE: This rock outcrop consists of a grey, sandstone/siltstone rock layer on sandy silt subsoil. The soil beneath the rock layer has eroded due to runoff flows. As shown by the above picture, this feature also includes areas of overhangs.

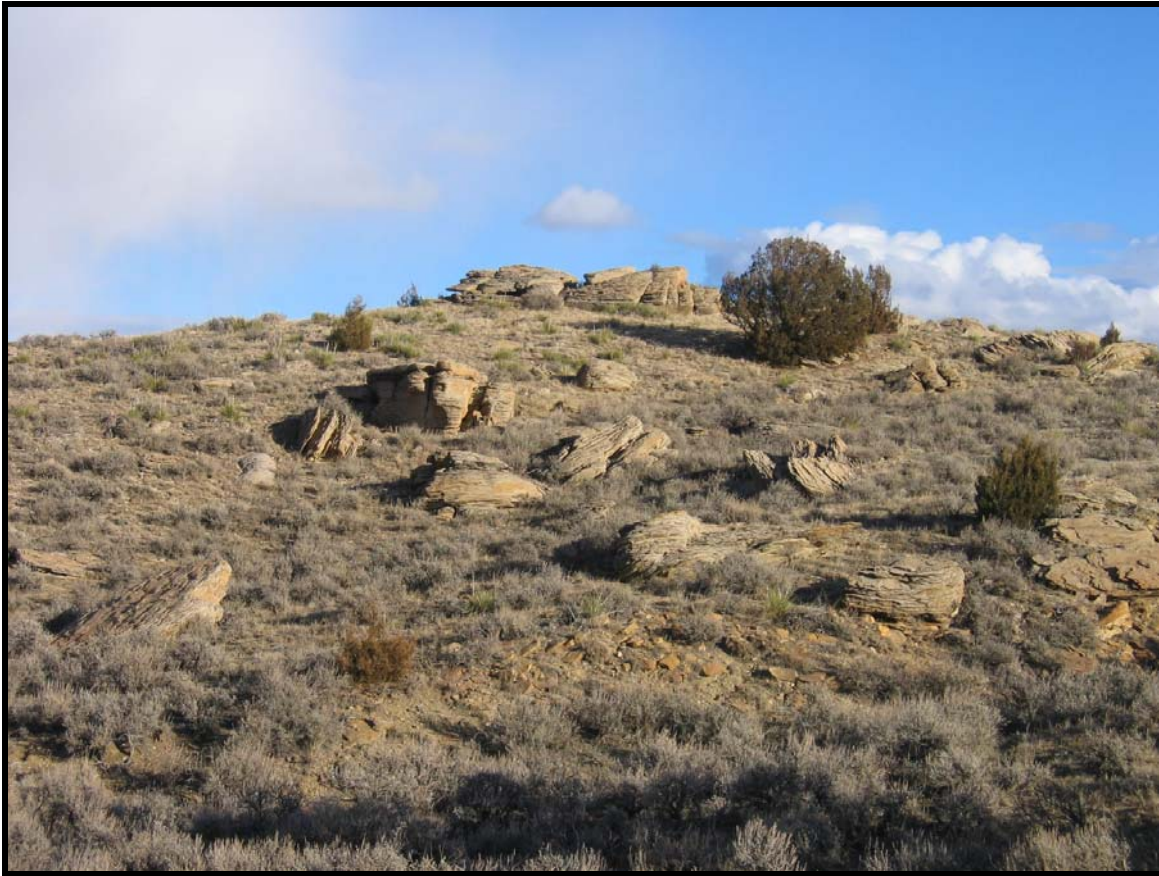
Photo: 1_12_06_41

FEATURE TYPE:	Rock Outcrop					
GEOMETRIC DIMENSIONS:	Area of outcrop: 9.12 acres					
LOCATION:	Township: 9S		Range: 40E		Section: 6	
HANDHELD GPS POINTS:		Northing	Easting		Northing	Easting
	7095	403021.00	2677404.20	7099	402483.85	2678044.72
	7096	403398.93	2677583.09	7100	402300.48	2677903.40
	7097	402952.05	2677972.51	7101	402159.48	2677719.33
	7098	402735.78	2678051.97	7102	402198.39	2677570.72

SUBSTRATE: Sandstone/siltstone

DESCRIPTION OF FEATURE: The large rock outcrop shown above consists of large, sandstone/siltstone rocks at the top of a small hill. The rocks are rounded and sometimes reach a height of five to ten feet. The hill is vegetated with grass and sagebrush. See the pictures on the following pages for additional views of this outcrop.

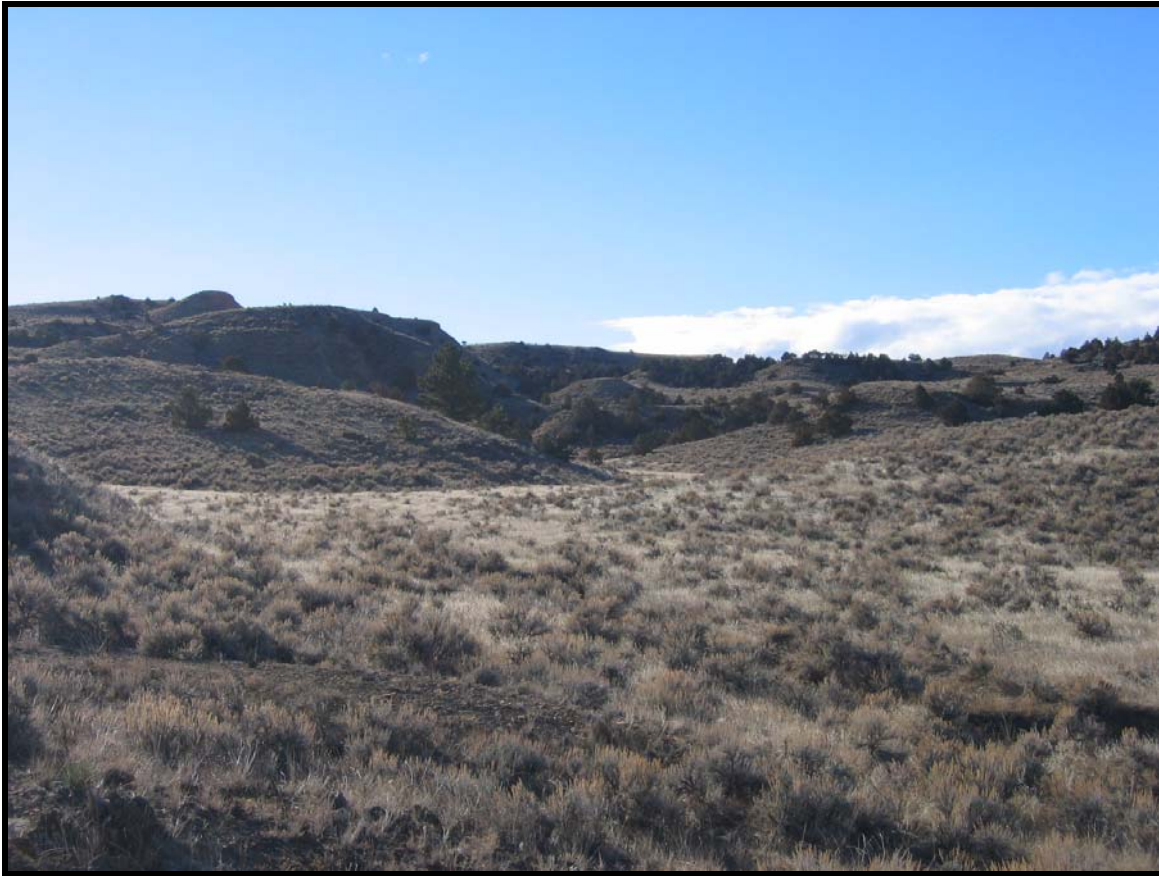
Photo: 1_12_06_09

DESCRIPTION OF FEATURE: This drainage has a wide bottom width, which is vegetated with grass and sagebrush. The hills surrounding this drainage have gentle to moderate slopes.

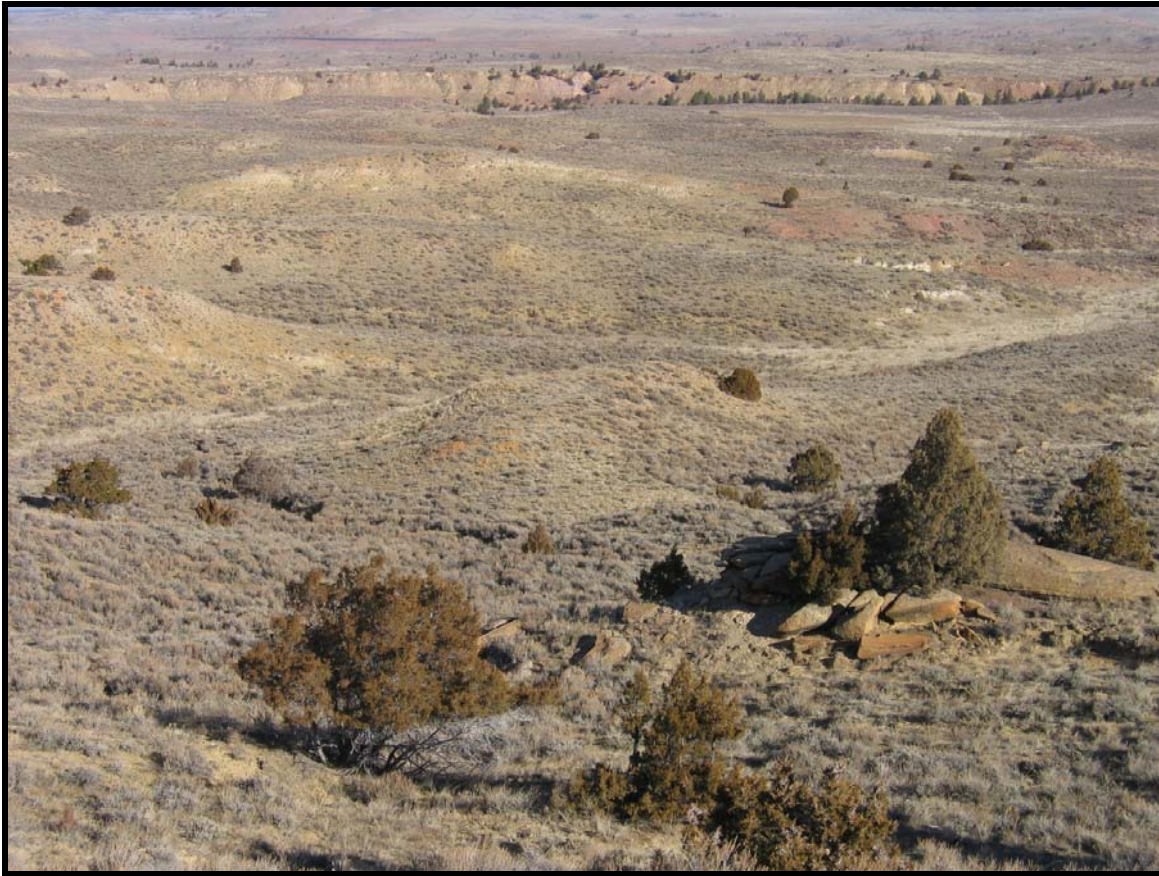
Photo: 1_12_06_16

DESCRIPTION OF FEATURE: The drainage shown above has a wide bottom width, which is vegetated with grass and sagebrush. The hills surrounding this drainage have gentle to moderate slopes.

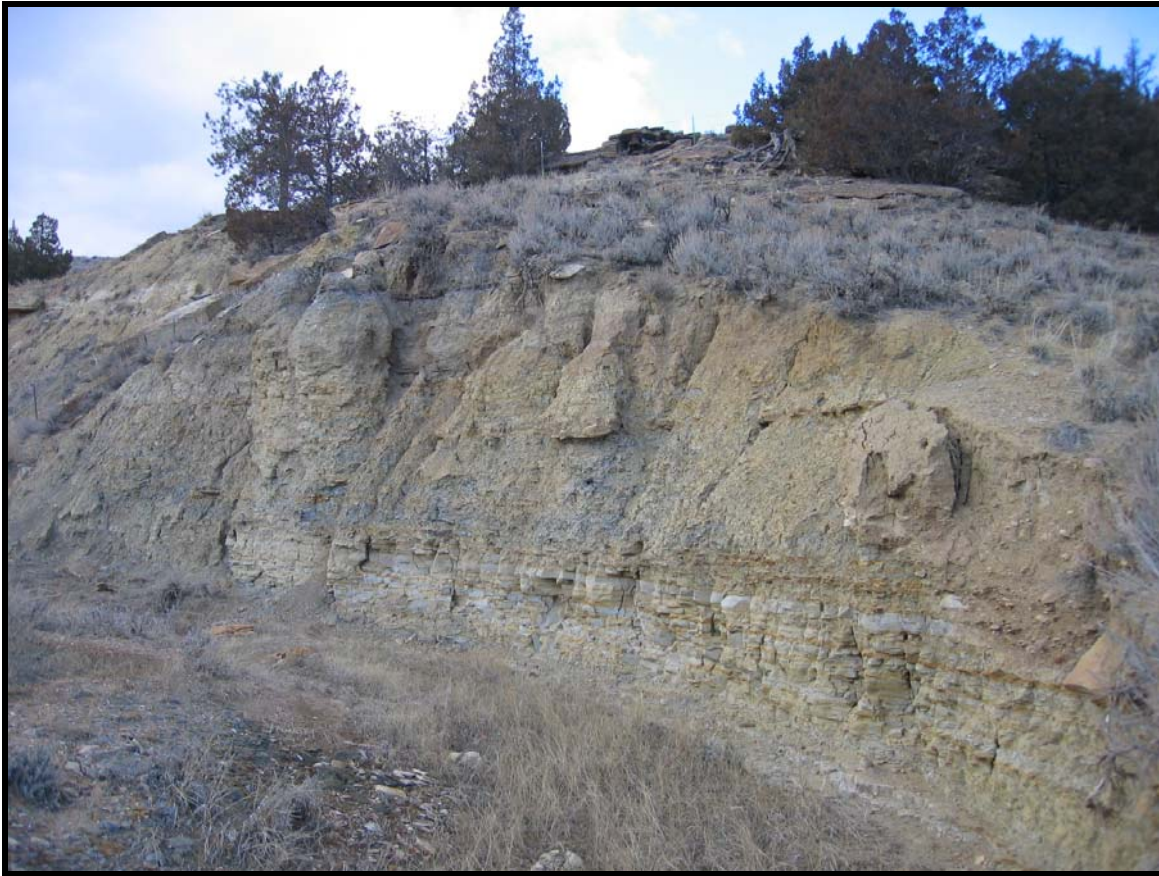
Photo: 1_12_06_32

DESCRIPTION OF FEATURE: This large cut bank is located at the western border of Section 6. The sandy silt slope has been created by the flows in the adjacent channel. The face of the feature is pocketed with holes.

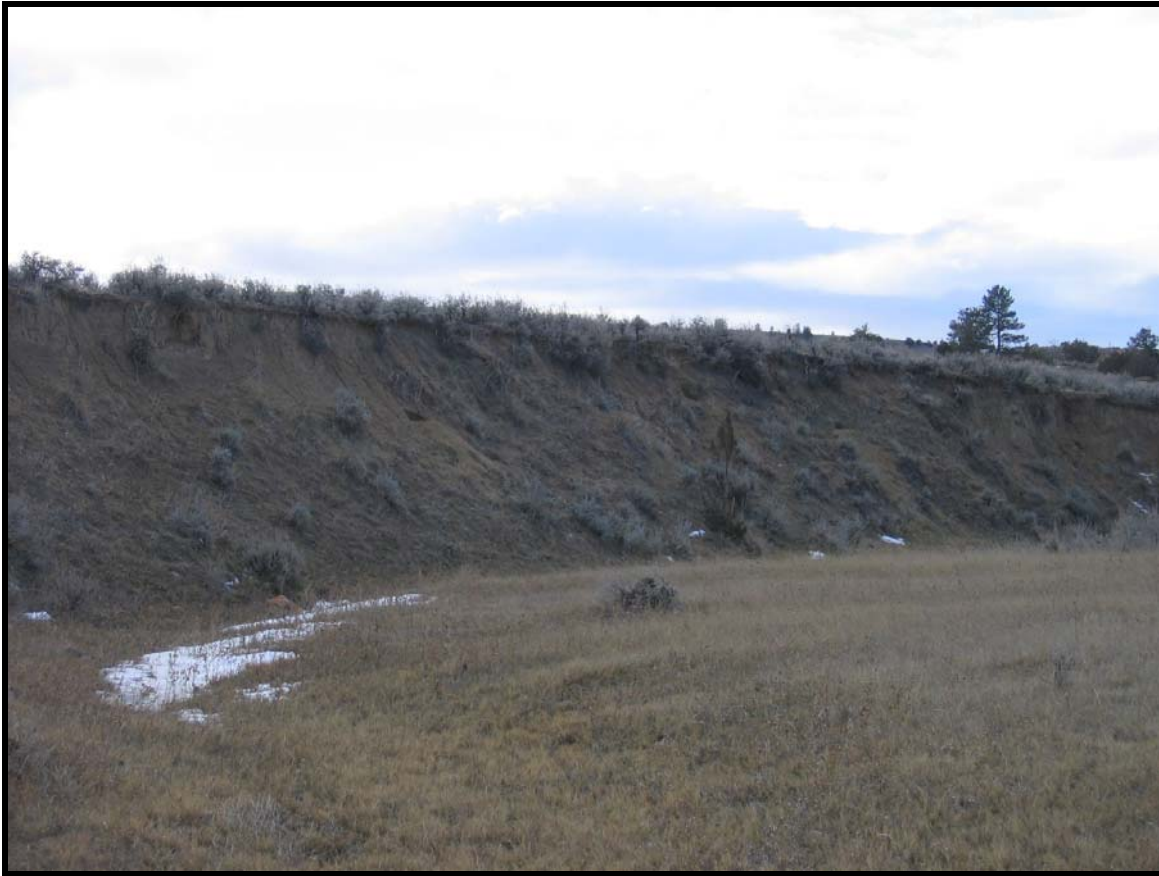
Photo: 1_16_06_38

DESCRIPTION OF FEATURE: The cutbank shown above was caused by runoff flows through the adjacent channel bottom. The sandy silt bank has holes for habitat for birds and other animals.
